# **Hazardous Building Materials Assessment**

Point Pelee National Park  
407 Monarch Lane,  
Leamington, Ontario

June 10, 2015

Pinchin File: 104300

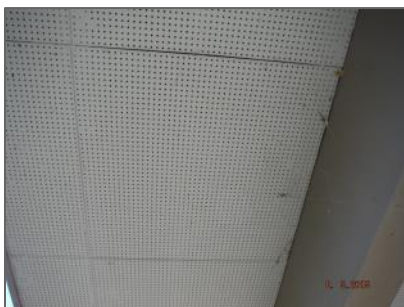
Transite cement sheeting, containing chrysotile asbestos (sample 0002), was observed as a ceiling on the exterior overhang of the building as well as in the Life Guard Room (Location 3), Women's Change Room (Location 5), Women's Washroom (Location 6), Men's Washroom (Location 7) and in the Men's Change Room (Location 8). Transite cement sheeting is a non-friable material and was observed in good condition.

Transite present on the building Exterior overhang (Location

1).

Remove all asbestos-containing materials (ACM) prior to renovation, alteration, maintenance or demolition work or if ACM may be disturbed by the work.

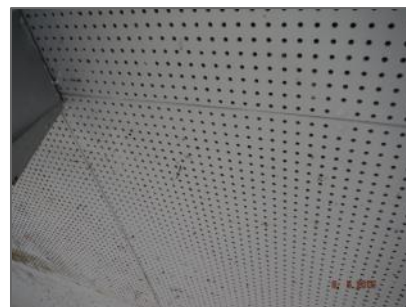
Transite ceiling in the Men's Washroom (Location 7).

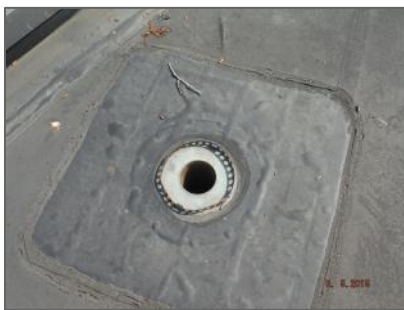
The black mastic present on the roof penetrations of the building was sampled (Sample 0003) and was determined to be non-asbestos by laboratory analysis.

Non-asbestos black mastic on the roof penetrations (Location 2).

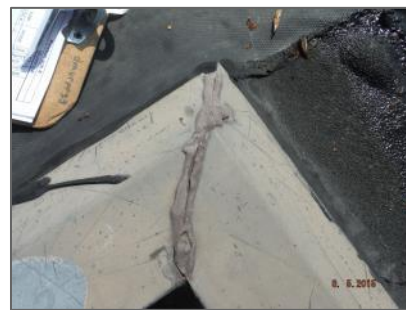
The brown caulking present on the steal flashing of the roof of the building was sampled (Sample 0004) and was determined by laboratory analysis to contain chrysotile asbestos. Caulking is a non-friable material and was observed in good condition.

Asbestos-containing brown caulking present on the steal flashing on the roof of the building (Location 2).

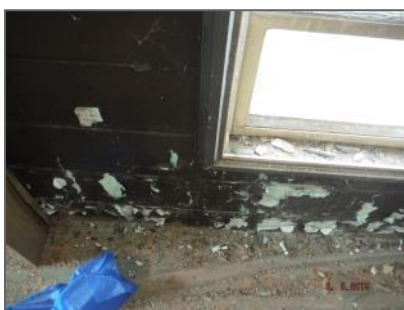
- Dark brown paint present on the masonry block walls in the Life Guard Room (Location 3).

Peeling and flaking paint in the Life Guard Room (Location 3).

Lead-painted items may be a hazardous waste. Test lead-painted materials for leachable lead prior to disposal.

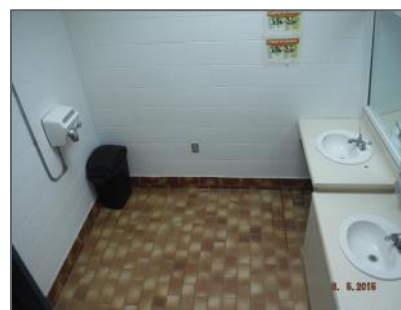
White block wall paint found in the Men's Washroom (Location 7).

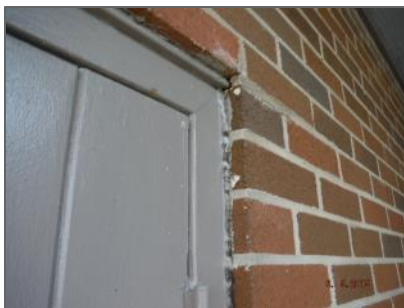
The grey caulking present on the exterior doors of the building was sampled for PCB content (Sample PCB-01) and contains < 0.5 ppm PCBs. The material is considered a non-PCB solid based on the threshold given in SOR/2008-273 (50 ppm).

Grey exterior door caulking determined to be a non-PCB solid by laboratory analysis.

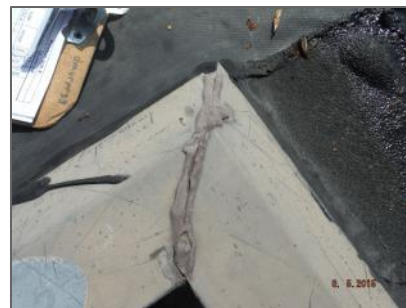
The brown caulking present on the steel flashing of the roof was sampled for PCB content (Sample PCB-03) and contains < 0.5 ppm PCBs. The material is considered a non-PCB solid based on the threshold given in SOR/2008-273 (50 ppm).

Brown exterior roof caulking determined to be a non-PCB solid by laboratory analysis.

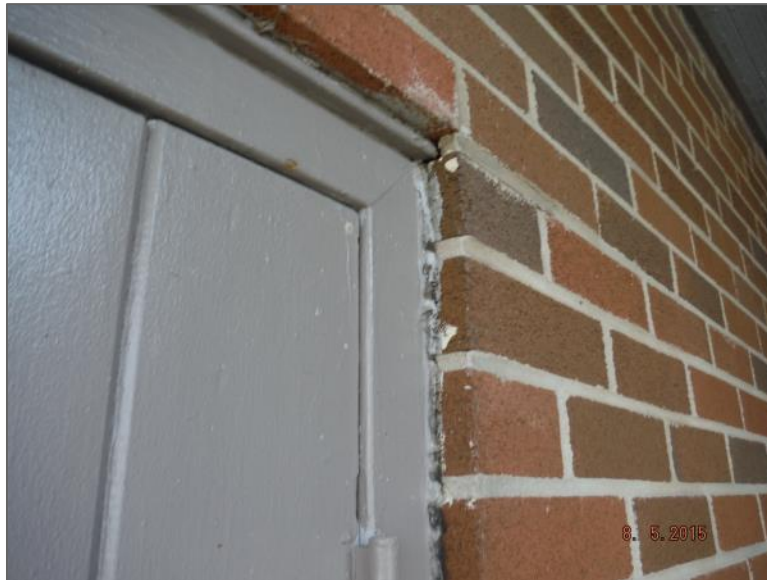
Three (3) samples of the grey caulking present on the exterior doors were collected (Sample 0001), Laboratory analysis determined that the grey exterior caulking contains chrysotile asbestos. Caulking is a non-friable material and was observed in good condition.

Asbestos-containing grey caulking present on the exterior doors of the building.

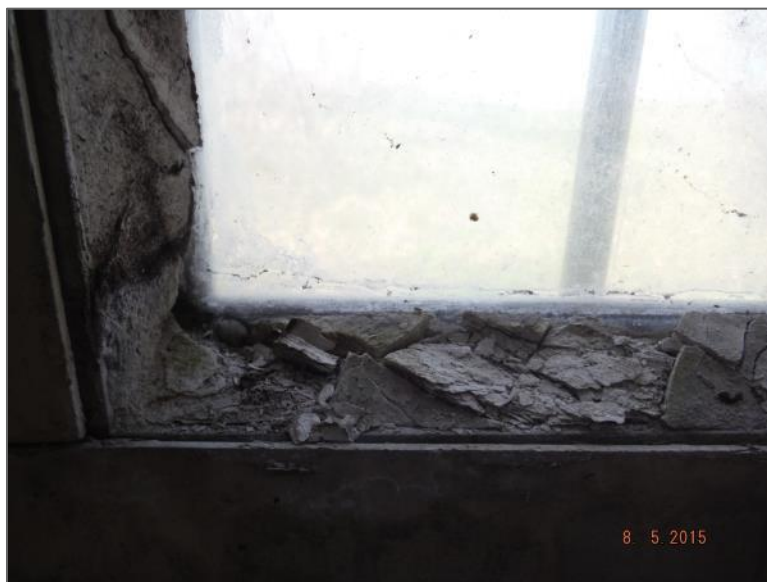
Three samples of the white putty material present in the window of the Life Guard Room (Location 3) was collected (Sample 0005) and was determined to be non-asbestos by laboratory analysis.

Non-asbestos white putty material present in the window of the Life Guard Room (Location 3).

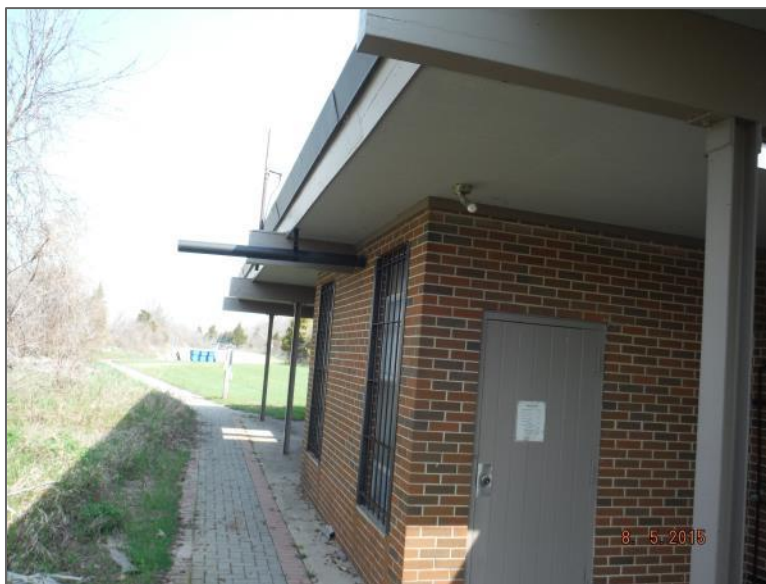
Brown exterior paint on trim and columns.
