<b>Title - Sujet</b> Pump Station Upgrade - PEI Parks	
<b>Solicitation No. - N° de l'invitation</b> ED001-160896/A	<b>Amendment No. - N° modif.</b> 004
<b>Client Reference No. - N° de référence du client</b> R.075015.001	<b>Date</b> 2015-09-14
<b>GETS Reference No. - N° de référence de SEAG</b> PW-\$PWC-010-3680	
<b>File No. - N° de dossier</b> PWC-5-38056 (010)	<b>CCC No./N° CCC - FMS No./N° VME</b>
<b>Solicitation Closes - L'invitation prend fin</b> <b>at - à 02:00 PM</b> <b>on - le 2015-09-17</b>	<b>Time Zone</b> <b>Fuseau horaire</b> Atlantic Daylight Saving Time ADT
<b>F.O.B. - F.A.B.</b> <b>Plant-Usine:</b> <input type="checkbox"/> <b>Destination:</b> <input checked="" type="checkbox"/> <b>Other-Autre:</b> <input type="checkbox"/>	
<b>Address Enquiries to: - Adresser toutes questions à:</b> MacDonald, Anne (PWC) D.	<b>Buyer Id - Id de l'acheteur</b> pwc010
<b>Telephone No. - N° de téléphone</b> (902) 626-4949 ( )	<b>FAX No. - N° de FAX</b> (902) 566-7514

**ADDENDUM No.4**

# Hazardous Building Materials Survey

## Brackley Beach Sewage Pumping Station, PEI

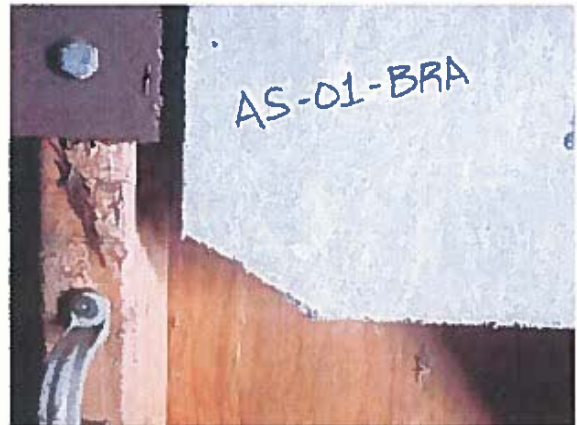
- Two panels of wall board approximately 1.6 m<sup>2</sup> (transite) was identified. CBCL would recommend that the two sections of transite board be removed prior to demolition and be managed as asbestos containing.

**Photo 2: Photo of sample AS-01-BRA, two sections of wall board (containing 15% chrysotile).**

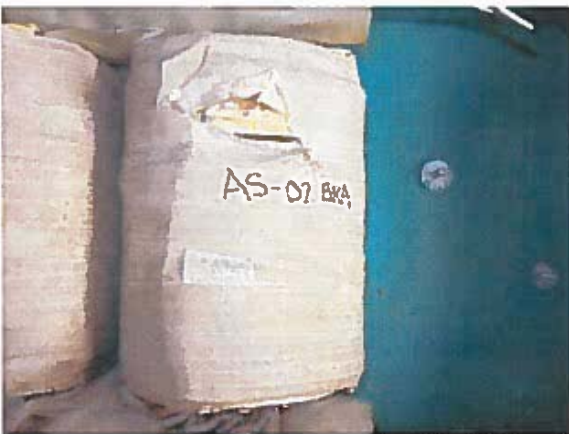
**Photo 3: Photo of sample AS-02-BRA, canvas covering over some former electrical components.**

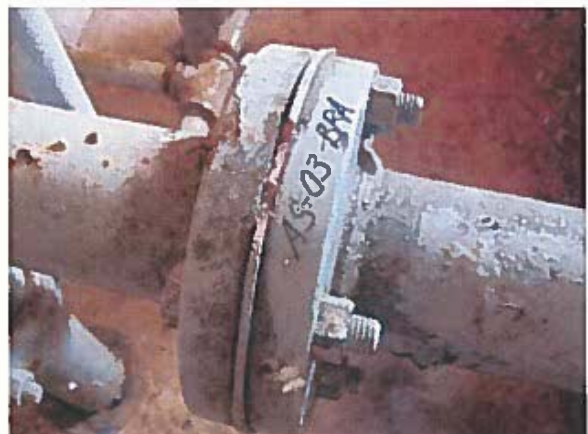
**Photo 4: Photo of sample AS-03-BRA, gasket material on a pipe flange.**

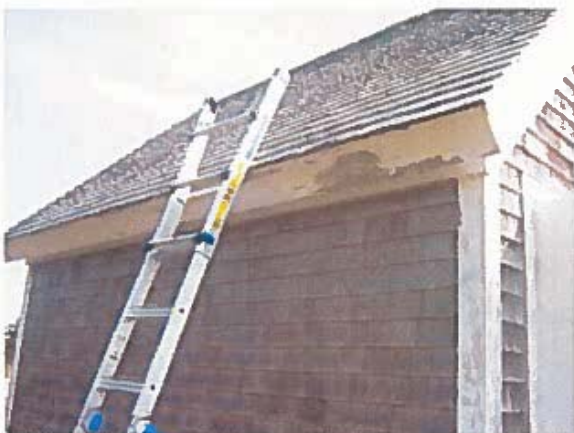
**Photo 5: Photo of sample AS-04-BRA, tar paper roof, under shingles.**

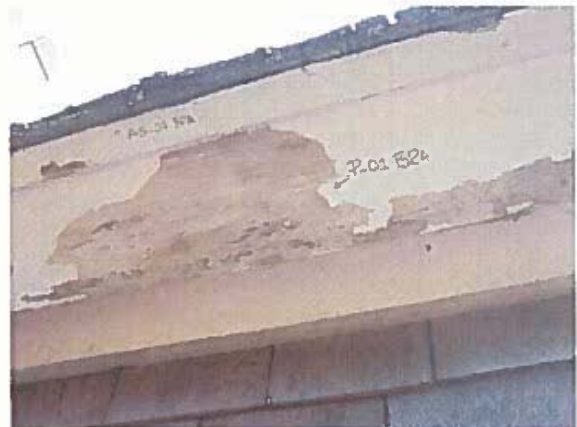
**Photo 6: Photo of paint sample P-01-BRA, white exterior paint.**

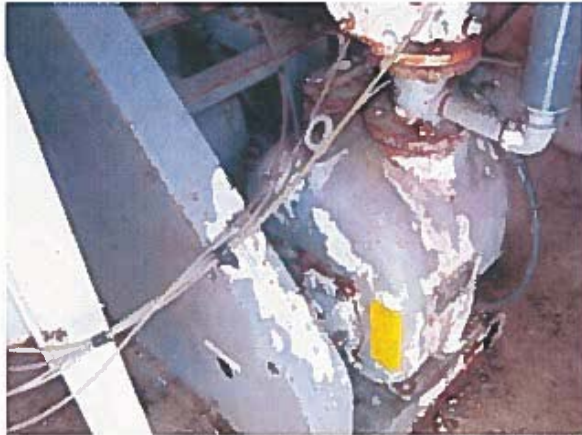
**Photo 7– Photo of paint sample P-02-BRA, grey pump paint.**

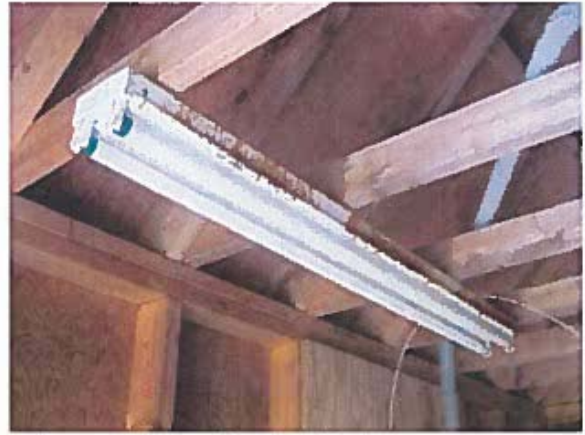
Fluorescent light bulbs, which contain mercury vapour, were observed in the building. No other mercury containing equipment was noted during the site visit.

**Photo 8 – Photo of typical lighting.**

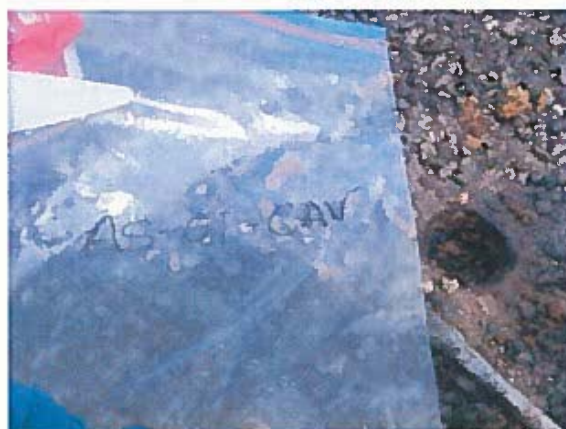
**Photo 2: Photo of sample AS-01-CAV, roofing material.**

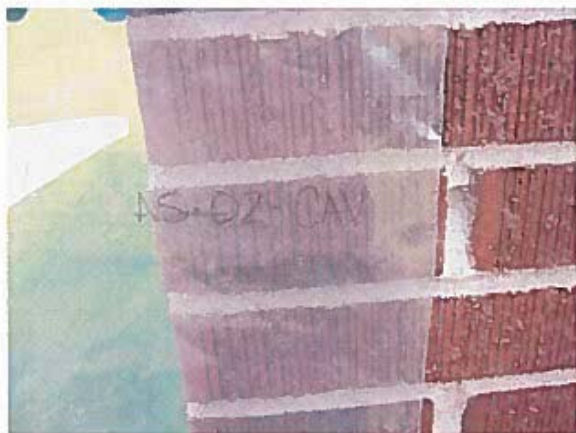
**Photo 3: Photo of sample AS-02-CAV, brick mortar.**

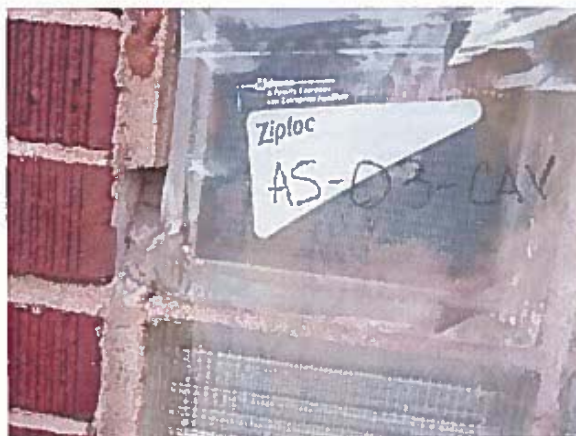
**Photo 4: Photo of sample AS-03-CAV, mortar around window casing.**

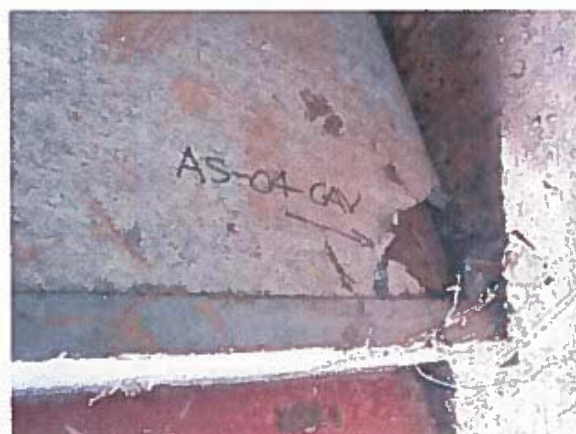
**Photo 5: Photo of sample AS-04-CAV, wall board interior surfaces.**

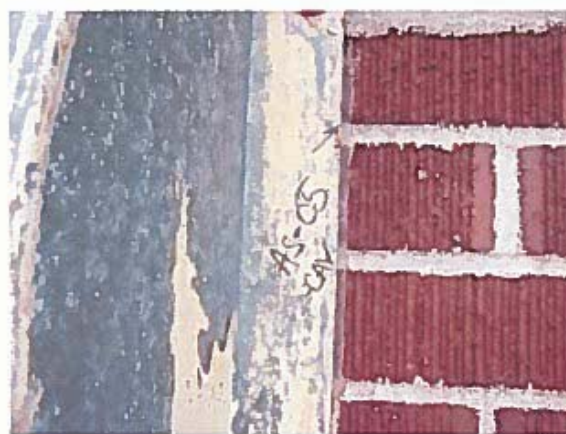
**Photo 6: Photo of sample AS-05-CAV, caulking around heat shield.**

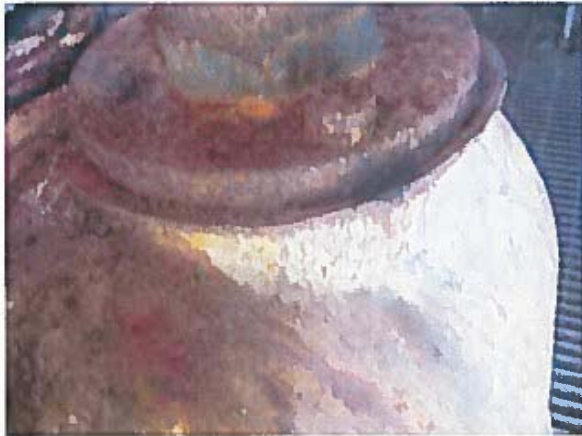
**Photo 7– Photo of paint sample AS-06-CAV, gasket material (containing 9.0% chrysotile).**

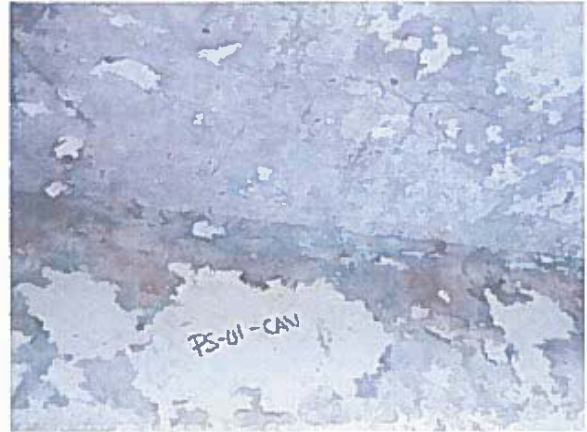
**Photo 8 – Photo of paint sample P-01-CAV, white exterior trim paint (lead 3640 mg/kg, mercury 25.3 mg/kg). PS-01-CAV was determined to be lead leachate hazardous.**
