**Hazardous Building Materials Assessment
Visitor Centre
Point Pelee National Park
Leamington, Ontario**

Pinchin File: 91797

March 7, 2014

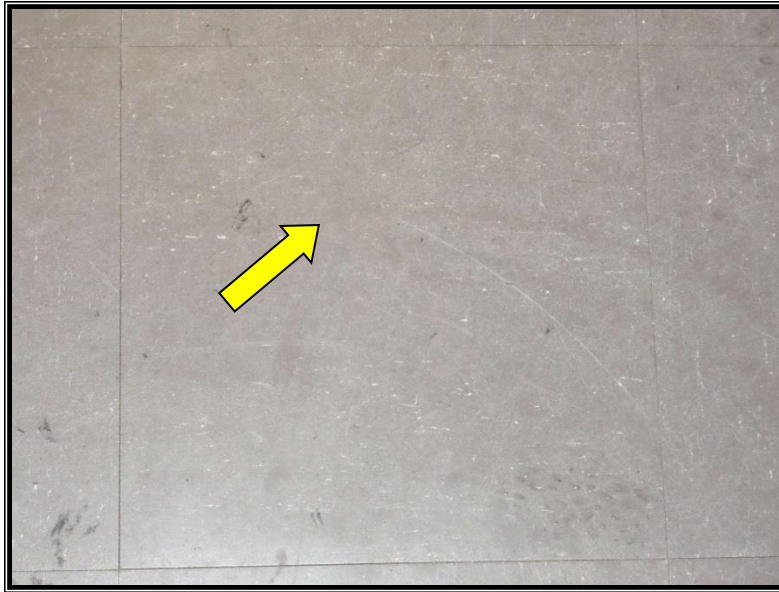
Photo 1

Tile Size (inches)	Colour	Locations (Quantity in Square Feet)	Sample Numbers	Asbestos Type - Vinyl Floor Tile	Asbestos Type - Mastic
12" x 12"	Dark grey with white specs	Upper A/V Booth (Location 2 – 130 sq. ft.) Lower A/V Booth (Location 3 – 10 sq. ft.)	S0002 A-C	Chrysotile	Chrysotile
12" x 12"	Light grey with white and grey flecks	Stairwell (Location 4 – 40 sq. ft.)	S0004 A-C	None Detected	Chrysotile
9" x 9"	Dark grey with white streaks	Lower A/V Booth (Location 3 – 120 sq. ft.)	S0005 A-C	Chrysotile	Chrysotile

All vinyl floor tiles are non-friable materials and were observed in good condition.

Asbestos-containing 12"x12" vinyl floor tiles (S 0002 A-C) in the Upper A/V Booth (Location 2).

Material	Location	Recommended Abatement Procedure
Vinyl floor tiles and floor tile adhesive	Upper A/V Booth (Location 2), Lower A/V Booth (Location 3) and the Stairwell (Location 4)	Type 1 Abatement
Drywall Joint Compound (DJC)	Theatre (Location 1), Upper A/V Booth (Location 2), Lower A/V Booth (Location 3), the Stairwell (Location 4), the Furnace Room #1 (Location 5), the Furnace Room #2 (Location 6), Storage #1 (Location 8), Storage #1 (Location 7) and Furnace Room #3 (Location 9)	Type 2 Abatement

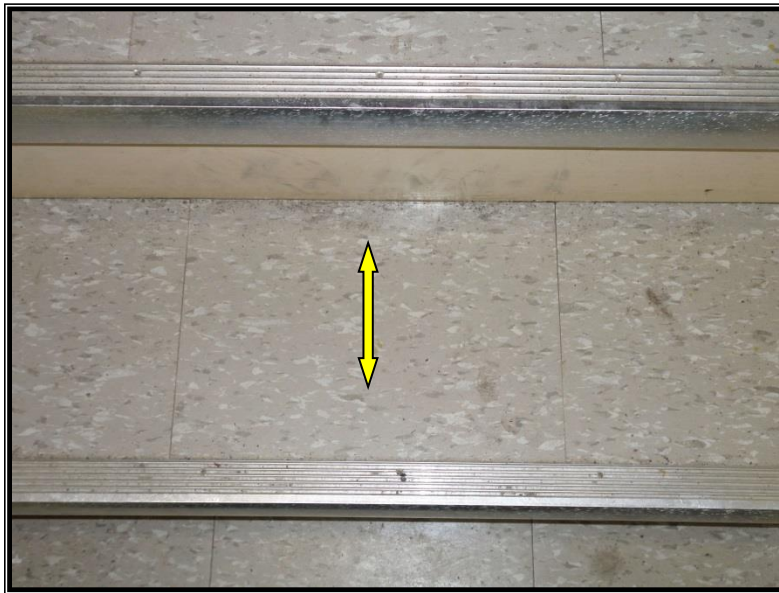
Photo 2

Asbestos-containing 12"x12" vinyl floor tiles (S 0004 A-C) in the Stairway (Location 4).

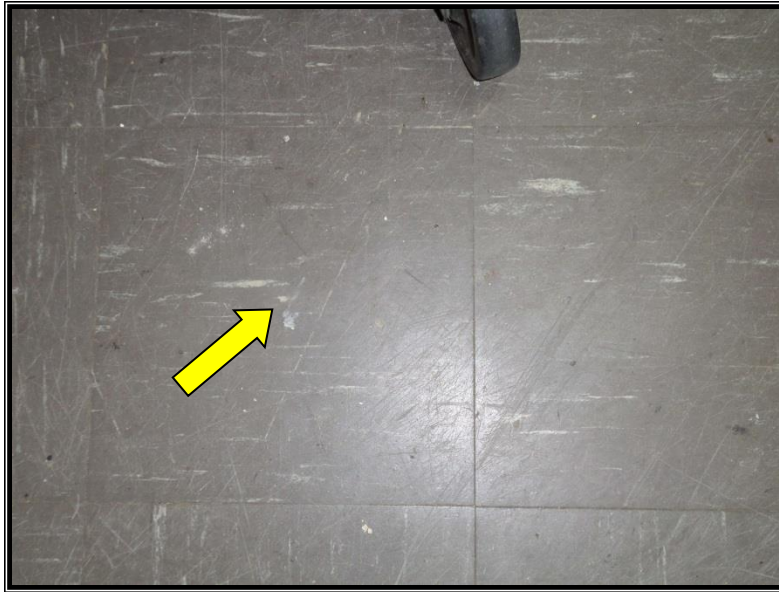
Photo 3

Asbestos-containing 9"x9" vinyl floor tiles (S 0005 A-C) in the lower A/V Booth (Location 3)

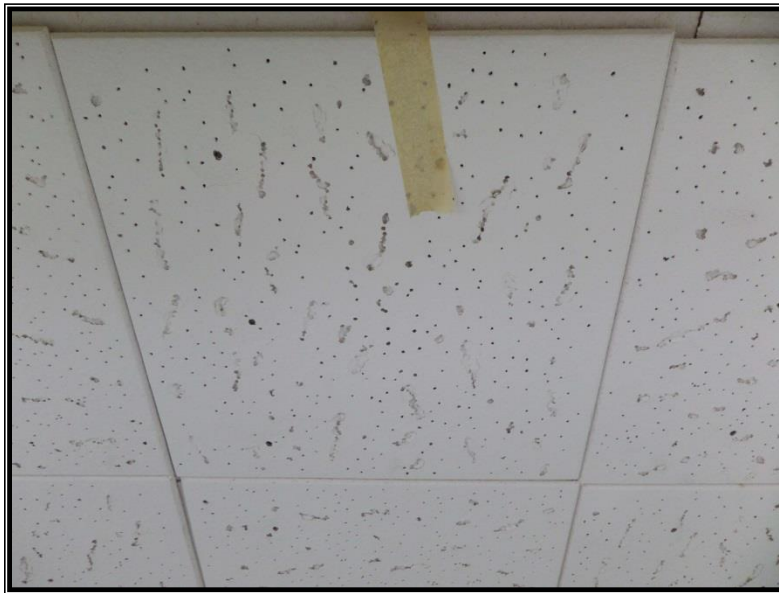
Photo 4

Tile Size (inches)	Type of Tile	Pattern	Locations (Quantity in Square Feet)	Sample Number/Date Code	Asbestos Type
12" x 12"	Splined	AT-01, Long fissure and medium pinhole	Lower A/V Booth (Location 3)	Visually assessed as non-asbestos (consists of cellulose materials)	None

Non-asbestos splined ceiling tiles located in the lower A/V Booth (Location 3)

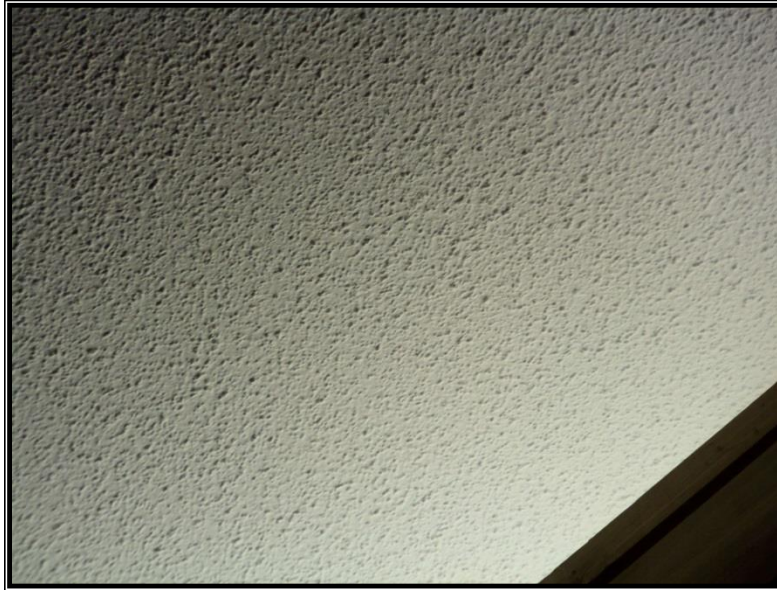
Photo 5

A texture finish is present on the surface of plaster ceilings throughout the planned renovation areas. Five (5) samples of the texture finish were collected (samples 0006 A-E) and laboratory analysis determined that this material is non-asbestos.

Non-asbestos texture coat (S 0006 A-C) present on the surface of the plaster ceilings in the Theatre (Location 1).

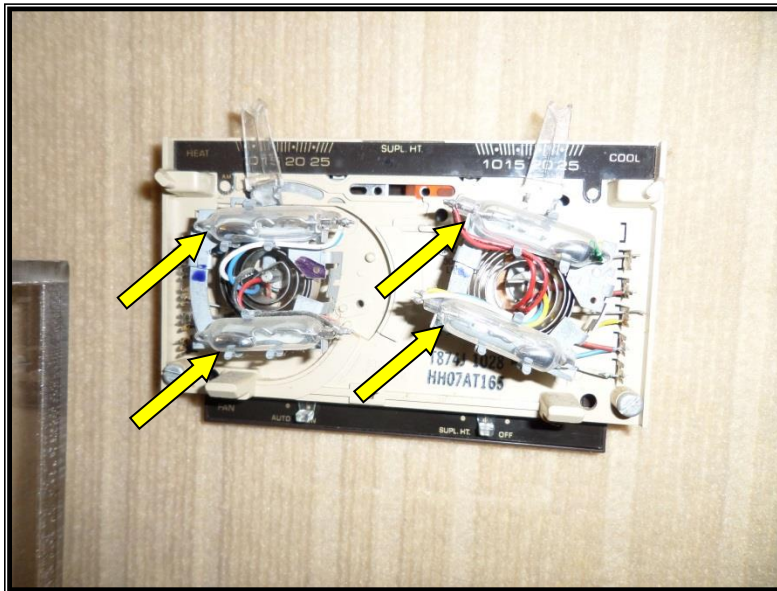
Photo 6

Mercury-containing thermostat present in the Theatre (Location 1).

Do not break lamps or separate liquid mercury from components. Mercury-containing materials and lamps should be recycled to reclaim the mercury. Disposal in significant quantities would require mercury-containing materials to be disposed of as hazardous waste.
