Department of Fisheries and Oceans, Pacific Region

RE-INSPECTION OF WATER SUPPLY TUNNELS & RELATED FACILITIES
FOR THE FULTON RIVER SPAWNING CHANNEL, BABINE LAKE, B.C.
DFO PURCHASE ORDER: F1700-070271

V13101063

January 2008

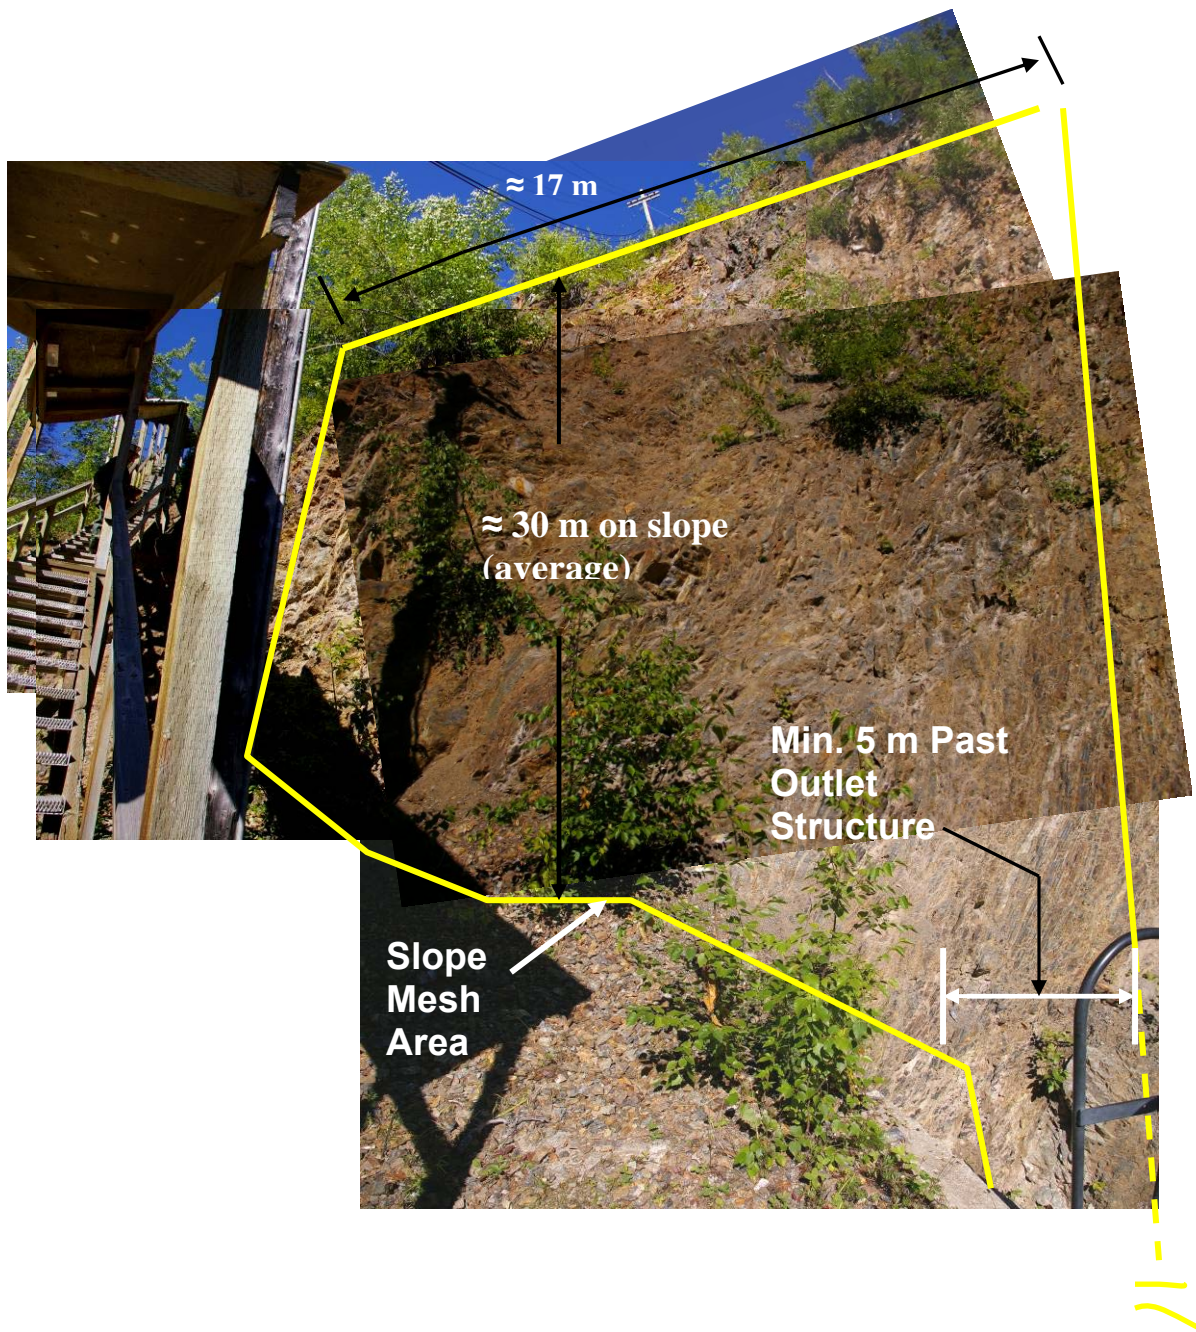
This slope presents a hazard of rockfall that could damage the access stairs and/or injure personnel accessing the regulating tunnel outlet building. Most loose rock fragments on the slope are cobble size or smaller but several areas near the middle to top of the slope could produce larger rockfalls. Rockfalls large enough to damage the outlet structure itself are unlikely. The potential for a large-scale slope instability that could potentially affect the outlet structure is discussed separately (2007 Inspection Fulton Dam, by EBA, December 2007 – Issued for Review).

The slope was scaled in 1994 as part of regular maintenance and was observed to be in good condition during the 1995 inspection. DFO's maintenance personnel indicated that scaling was required every 5 to 10 years to control the rockfall hazard. EBA are not aware if the slope has been scaled since 1994 but there is currently a significant quantity of loose material on some areas of the slope that is a potential source of rockfall.

Photo 1 (August 15, 2007) Slope above Regulating Tunnel Outlet Structure – Scale slope above outlet structure and access stairway and install slope mesh in area approximately as shown.

EBA recommends that stabilization/mitigation measures to reduce the rockfall hazard be implemented. As a minimum, the slope should be scaled to remove loose rock fragments as was done in 1994. This should be repeated every approximately 10 years to maintain a relatively low hazard.

Consideration should be given to implementing a more permanent solution that would reduce future requirements for scaling, and reduce the rockfall hazard. Improved protection against rockfalls can be provided by installing a rockfall catchment fence across the slope a short distance above the access stairs and outlet structure as described in EBA's 2002 inspection report, or by installing a draped slope mesh in the area shown on Photo 1.

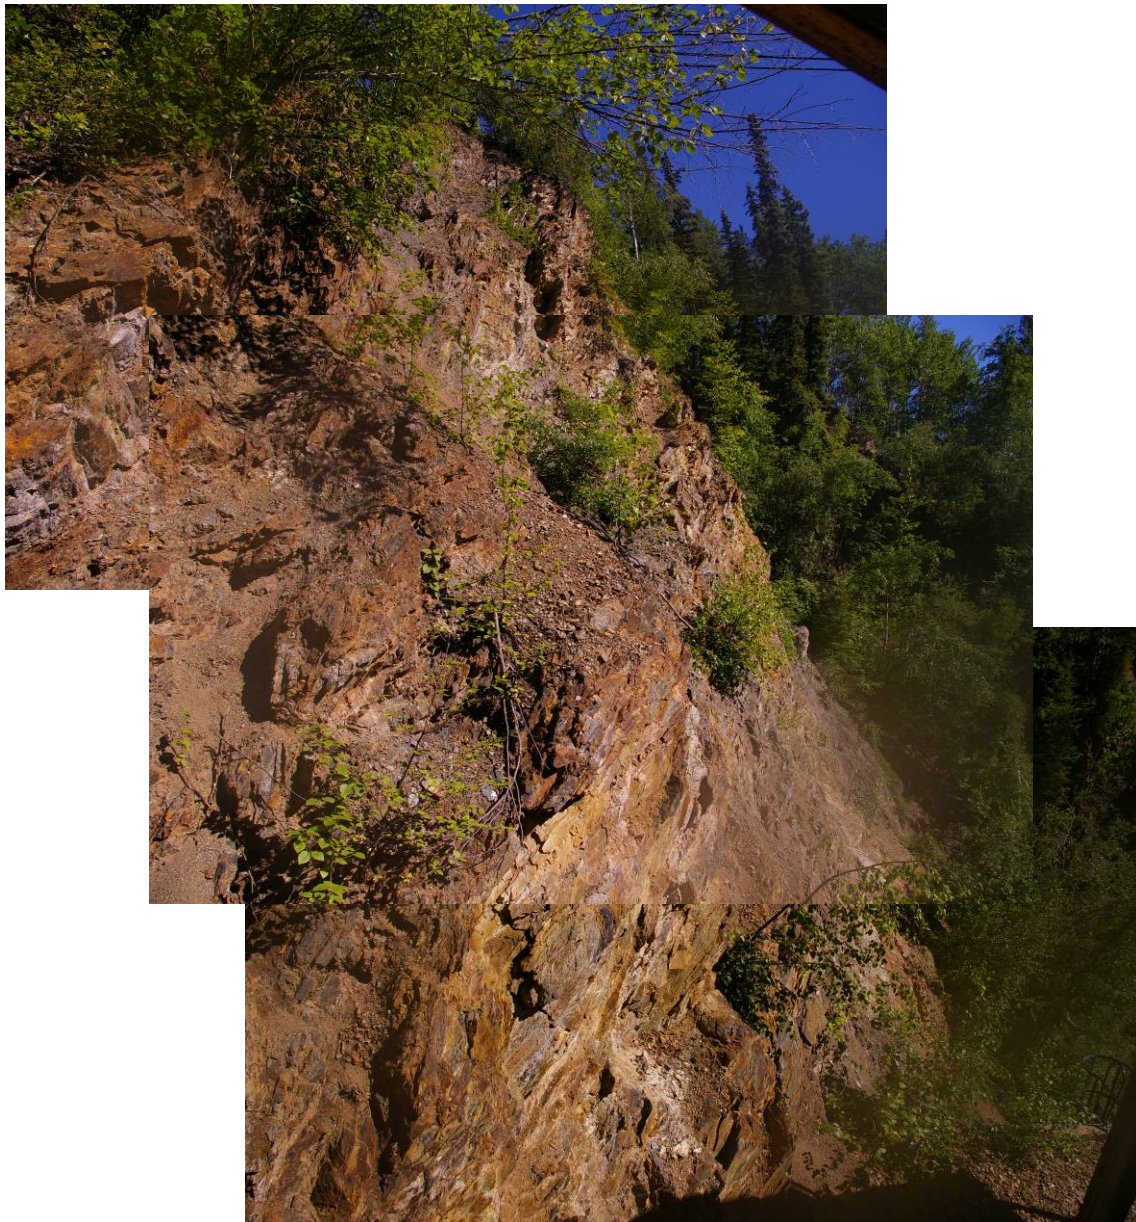
Photo 2 (August 15, 2007) Slope above Regulating Tunnel Outlet Structure – Side view of slope shown in Photo 1.

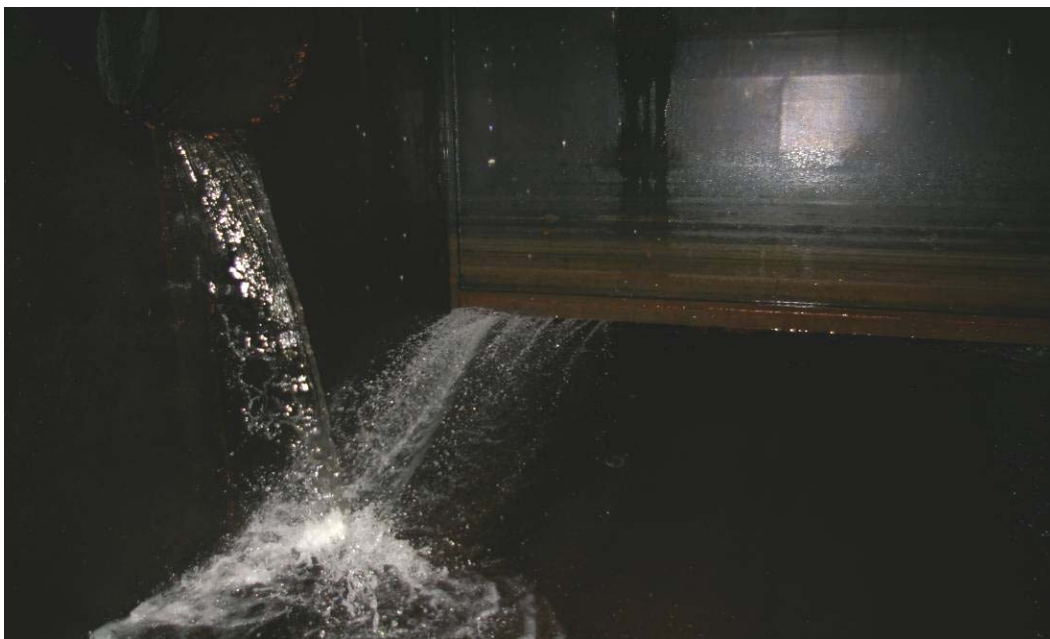
During the current inspection some leakage was observed beneath the right side of the Main Service Gate, and from the Low Level Gate, both of which were shut to allow inspection of the tunnels. The leakage is shown in Photo 3 and is not deemed sufficient to justify remedial work such as gate seal replacement at this time.

Photo 3 (August 15, 2007) Regulating Tunnel – Leakage beneath right side of Main Service Gate. Flow on left side of photo is leakage past the 1500 mm diameter Low Level Intake Gate.

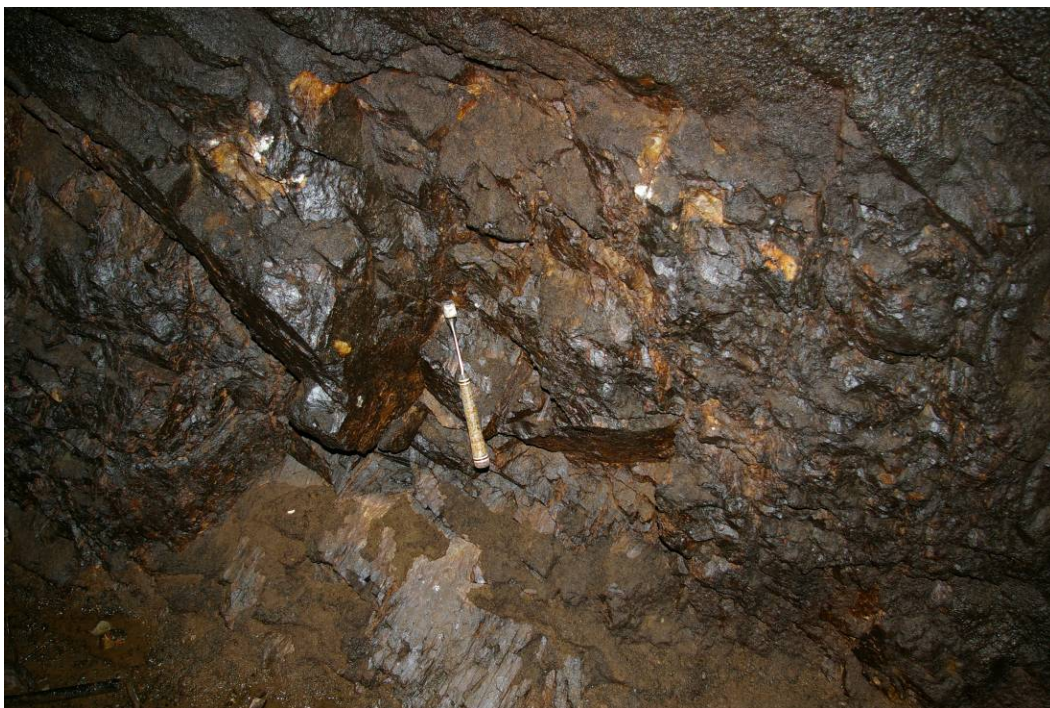
Some areas of the unlined tunnel sections were observed to be sound and with negligible loose material as shown in Photo 5. However, as in the 2002 inspection, the 2007 inspection identified some areas in unlined portions of the tunnel were loose or “drummy” rock fragments could be removed easily with a geologic hammer as shown in Photo 4. Localized small rock fall fragments (smaller than 10 to 15 cm) were observed along the tunnel invert in isolated areas as shown in Photo 6. However, there does not appear to be any areas where a rockfall larger than about 0.05 m³ in aggregate (multiple pieces) could occur.

Photo 4 (August 15, 2007) West Supply Tunnel – Typical areas of loosened “drummy” rock on lower wall of tunnel (below shotcrete lining).

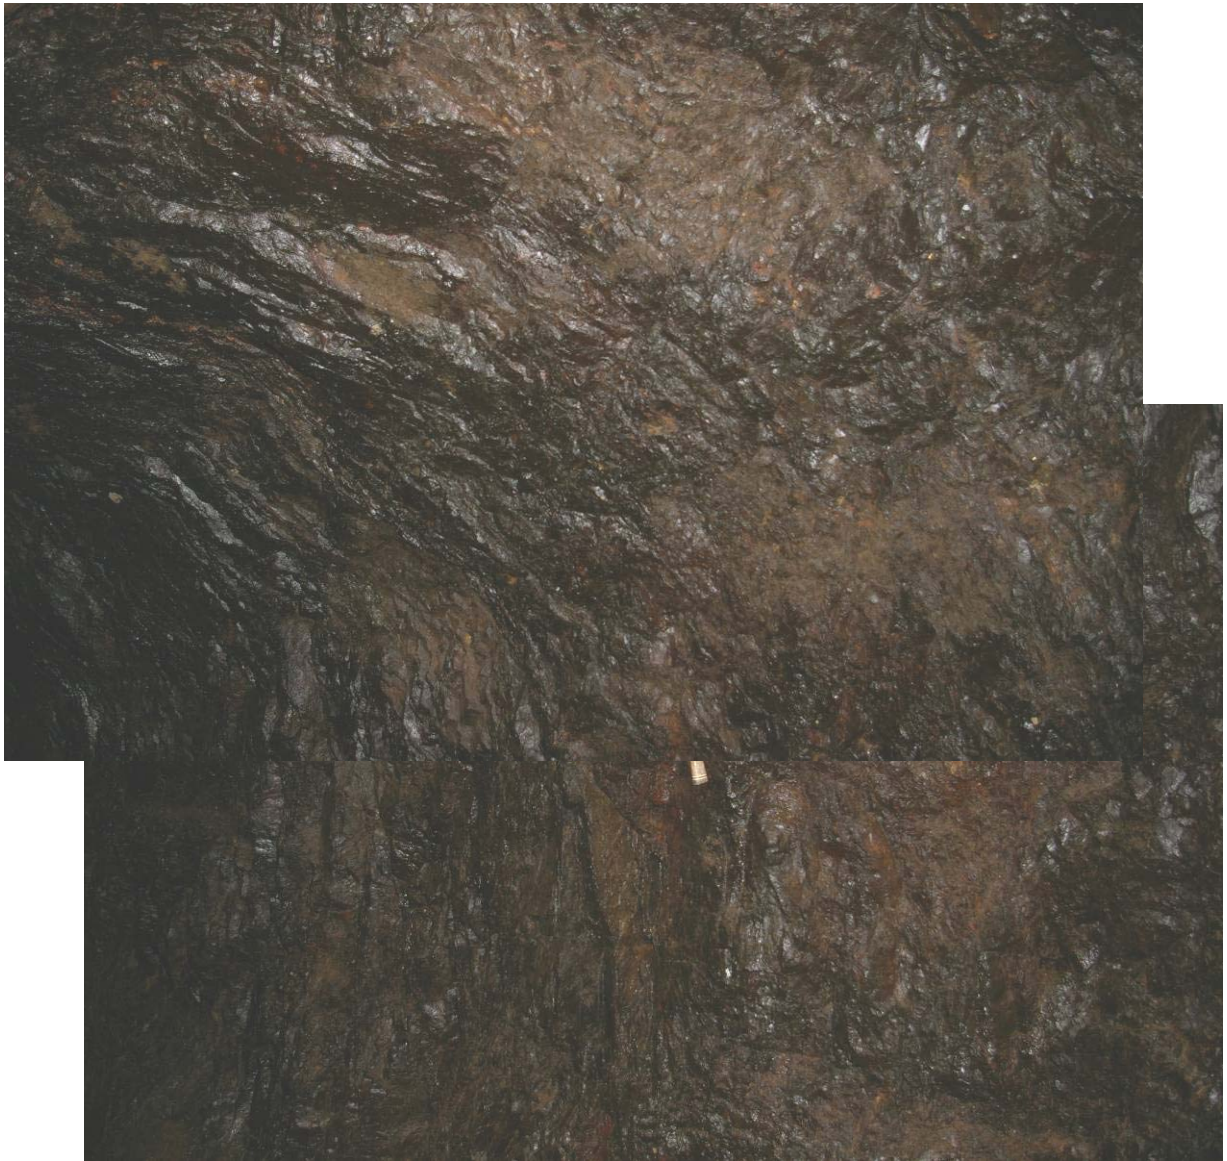
Photo 5 (August 15, 2007) West Supply Tunnel – Unlined tunnel section in chert (?) rock. Rock is sound with negligible loose material.

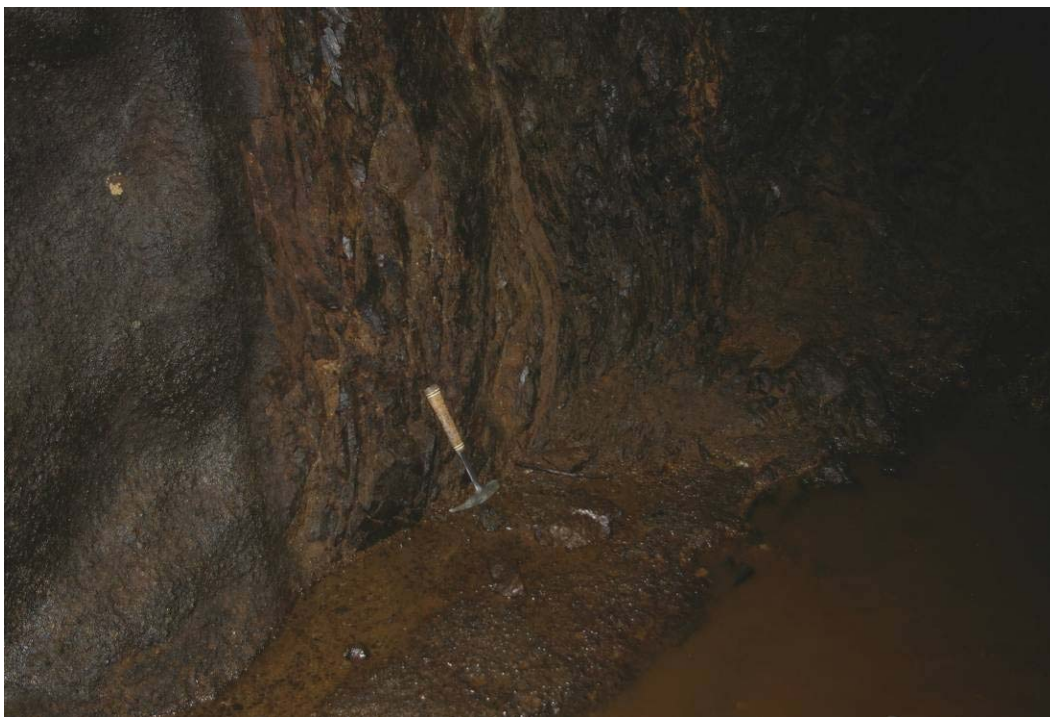
Photo 6 (August 15, 2007) West Supply Tunnel – Minor (≤ 150 mm) rockfall on tunnel invert below unlined tunnel section (shotcrete visible on left).

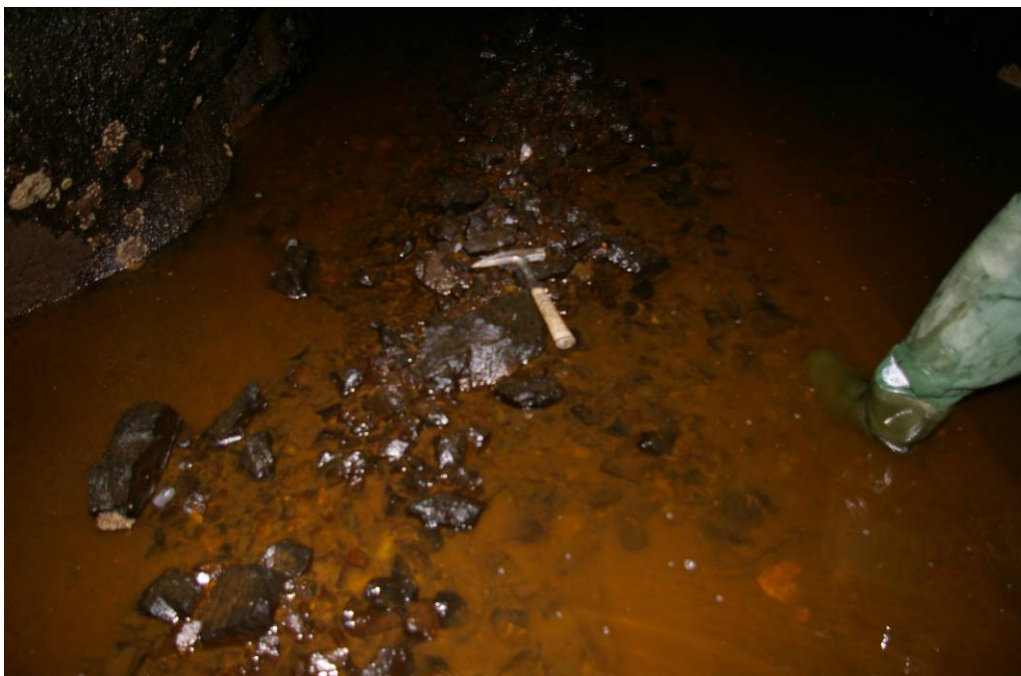
Photo 7 (August 15, 2007) West Supply Tunnel – Localized “wind-row” of rocks just downstream of small refuge bay on left side of tunnel (compare with Photo 2 of EBA December, 2002 report - no change noted in 2007).

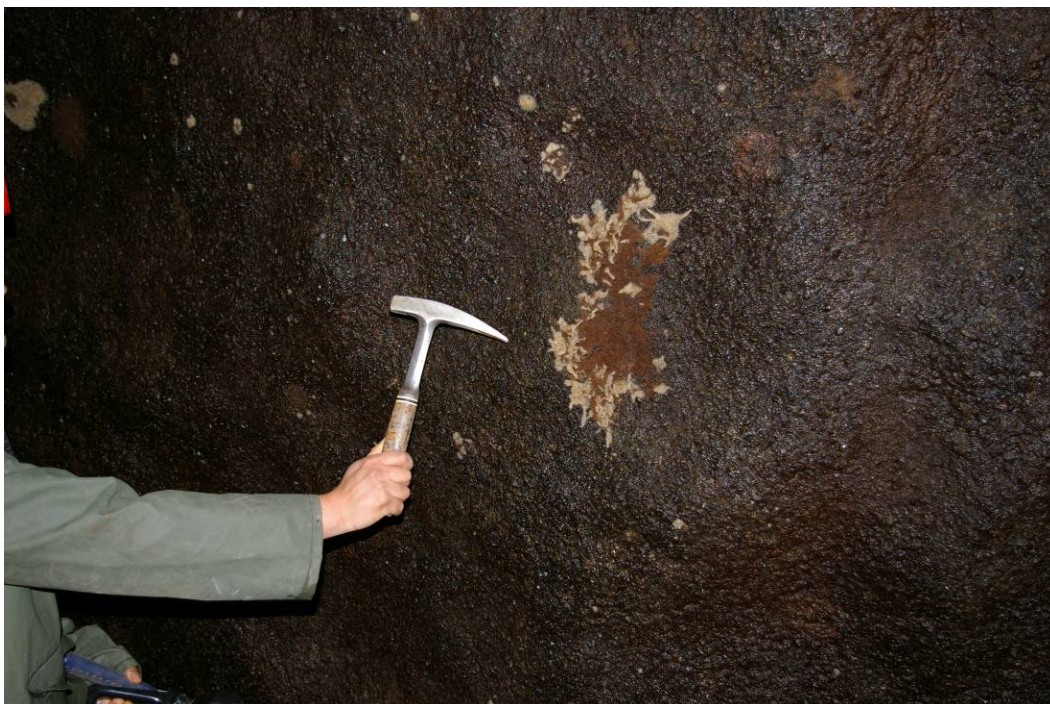
As in the 1995 and 2002 inspections, during the 2007 inspection a light coloured biological growth shown in Photos 8 and 9 was observed throughout the length of the water supply tunnel on both shotcrete and bare rock surfaces. The growth is gradually becoming more extensive as time passes and is suspected to be a freshwater sponge. Unlike previous inspections, this growth was also noted to be present on the tunnel invert in isolated areas during 2007 as shown in Photo 10. The growth was less prevalent near the upstream end of the tunnel, where turbulence due to the sharp entrance from the regulating tunnel may limit growth, and was also less prevalent in the east tunnel, again possibly due to increased turbulence downstream of the steel pipe section crossing Beaver Creek.

Photo 8 (August 15, 2007) West Supply Tunnel – Typical biological growth (possibly freshwater sponge) on shotcreted tunnel wall.

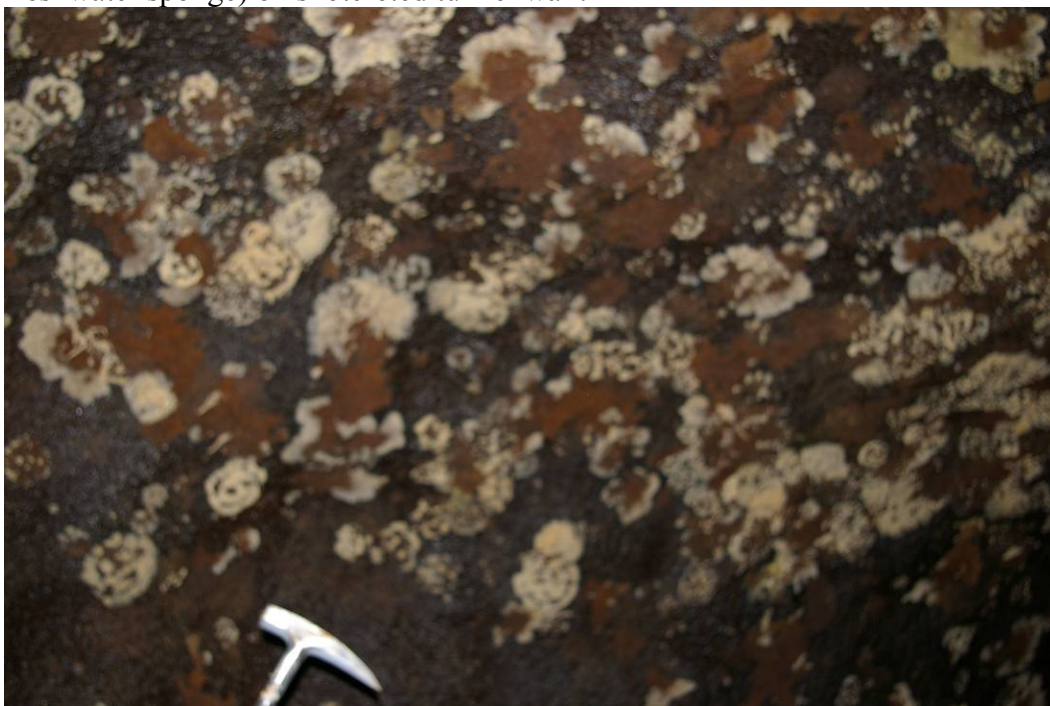
Photo 9 (August 15, 2007) West Supply Tunnel – Typical area of extensive biological growth (possibly freshwater sponge) on upper walls and crown of tunnel.

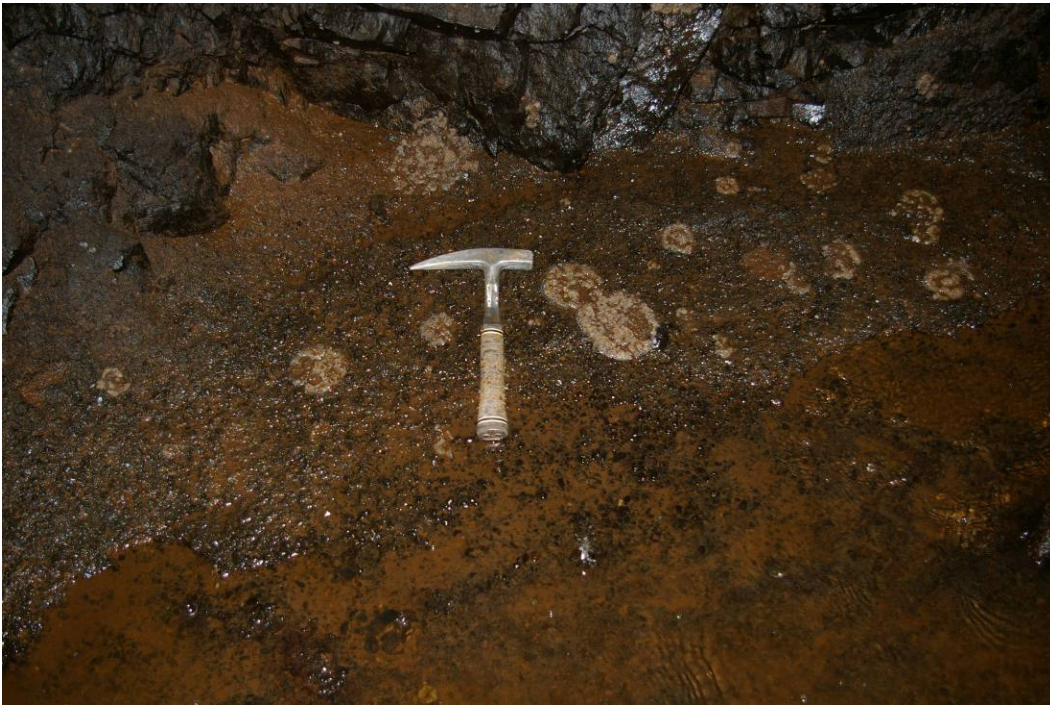
Photo 10 (August 15, 2007) West Supply Tunnel – Localized areas of biological growth (possibly freshwater sponge) on tunnel invert that were not noted during previous inspections.

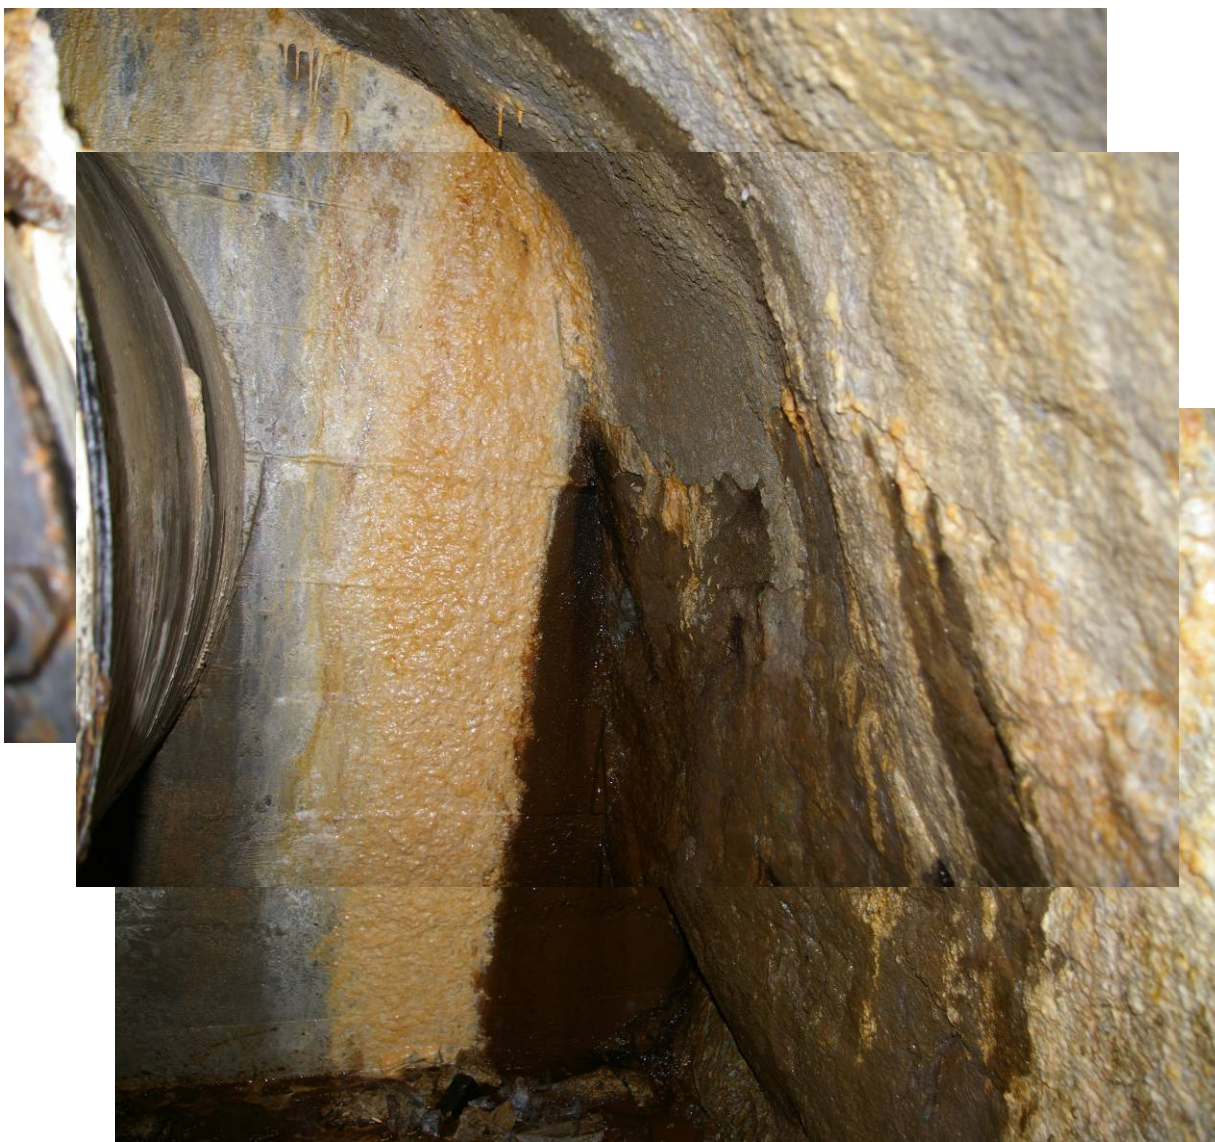
Photo 11 (October 10, 2007) West Supply Tunnel Bulkhead (looking upstream) –
Minor seepage (<0.05 l/min by visual estimate) evident on left side of bulkhead with
tunnel pressurized.

The bulkhead should be checked for evidence of leakage on an annual basis when the tunnel is pressurized. Consideration should also be given to installing a flow measurement weir about 3 m downstream from the bulkhead so that the total quantity of seepage/leakage past the bulkhead can be accurately measured.

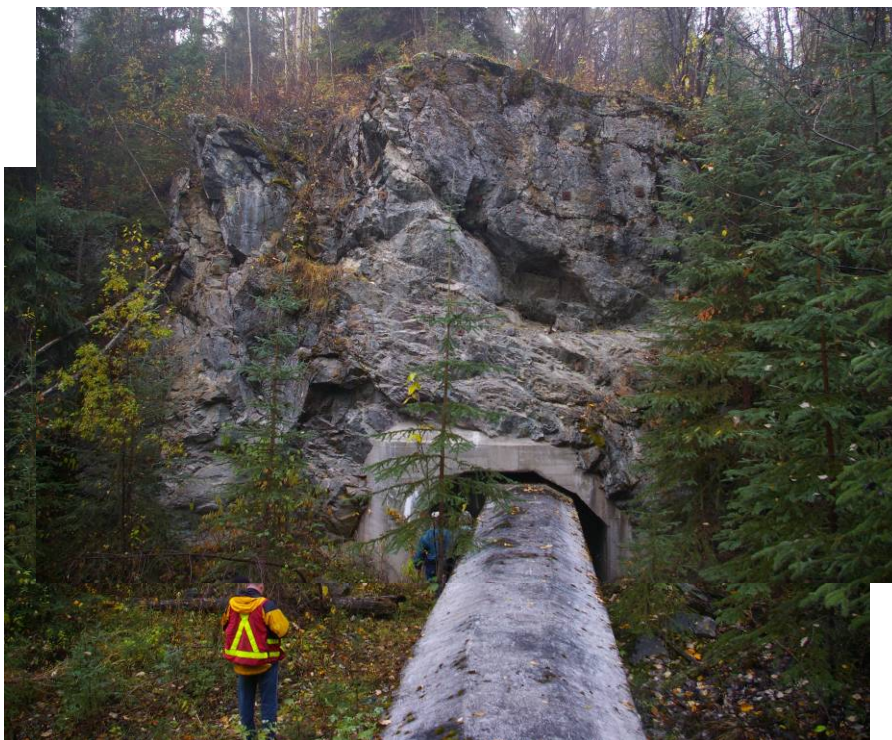
Photo 12 (October 10, 2007) West Supply Tunnel portal at Beaver Creek –
No change noted since previous inspection; slope should be checked scaled.

EBA recommends that the slope above the west portal at Beaver Creek should be check scaled to remove any potential rockfall material the next time a rock scaling crew is at site to address the slope above the regulating tunnel outlet.

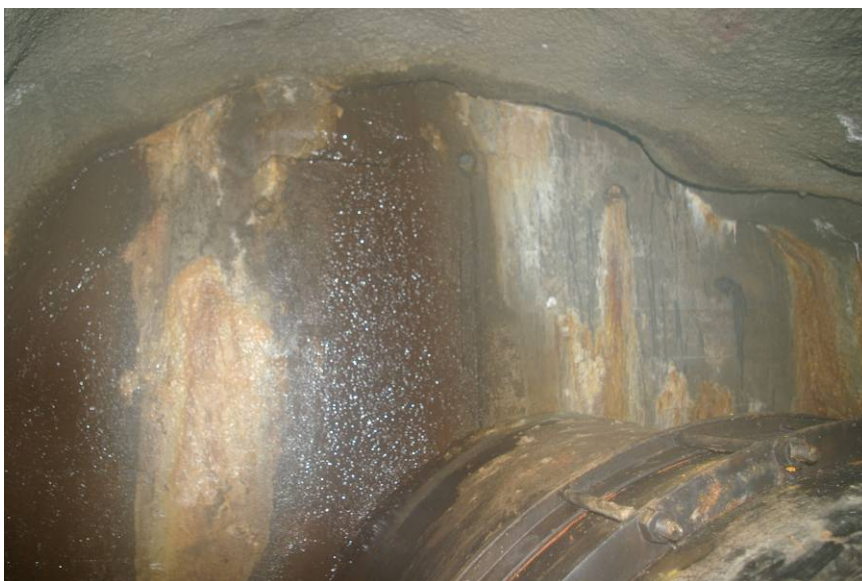
Inspection of the bulkhead on October 9, 2007 (while the tunnel was pressurized) revealed that the bulkhead was leaking from the concrete to rock contact at the top left side of the bulkhead as shown in Photo 13. The leakage rate was visually estimated to be about 0.35 litres per minute (approximately one to two cups per minute).

Although the bulkhead seepage rate is not yet considered sufficient to warrant remedial pressure grouting, it is considered to be significant and may indicate there is a relatively continuous void extending over some portion of the rock/concrete contact area. As such, there may be relatively high seepage gradients in some areas that could potentially cause leakage rates to increase.

Photo 13 (October 9, 2007) East Supply Tunnel, Beaver Creek Bulkhead
(Looking downstream) - The seepage rate (approximately 0.35 l/min by visual estimate) from crown of bulkhead on left side with tunnel “watered-up” should be monitored regularly for evidence of deterioration.

The rate of leakage past the westernmost bulkhead in the east tunnel should be closely monitored for evidence of deterioration (increased leakage) when the tunnel is pressurized to determine if the rate of leakage is stable or increasing over time. In order to facilitate a more repeatable quantitative measurement than is possible by visual means, it is recommended that a small gutter be installed against the face of the bulkhead below the leakage area to collect the seepage for measurement in a graduated container. The gutter could for example consist of 25 mm diameter PVC tubing that is cut in half lengthwise, sealed against the concrete with caulking, and held in place with conduit straps/clamps screwed to the concrete.

Initially, seepage should be monitored bi-monthly for one year to establish a baseline. This frequency can then be gradually decreased if monitoring indicates conditions are stable.

If conditions are deteriorating, then remedial pressure grouting should be carried out. Since the presence of the 1200 mm diameter pipeline will severely limit or prevent drilling grout holes on the optimal alignment from the atmospheric side of the bulkhead, grouting would need to be scheduled for a July – August window when the tunnel can be drained, allowing drilling/grouting from the pressure side of the bulkhead.

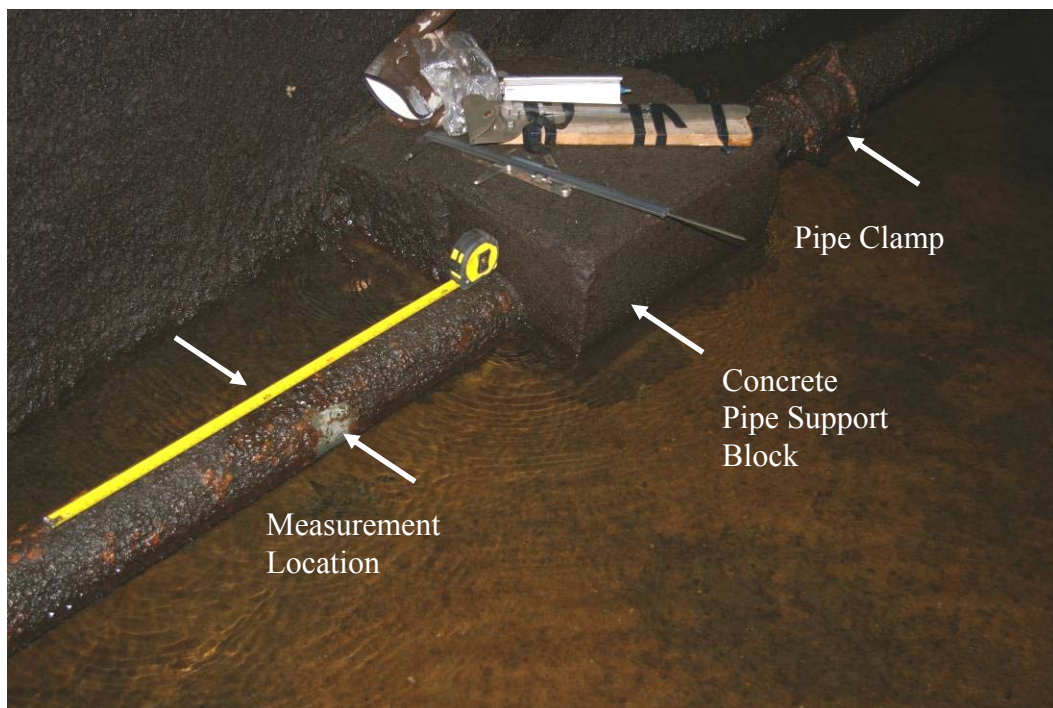
Photo 14 (August 15, 2007) East Supply Tunnel – Drain pipe measurement Location #1 (approx. 12 m downstream from Beaver Creek Bulkhead).

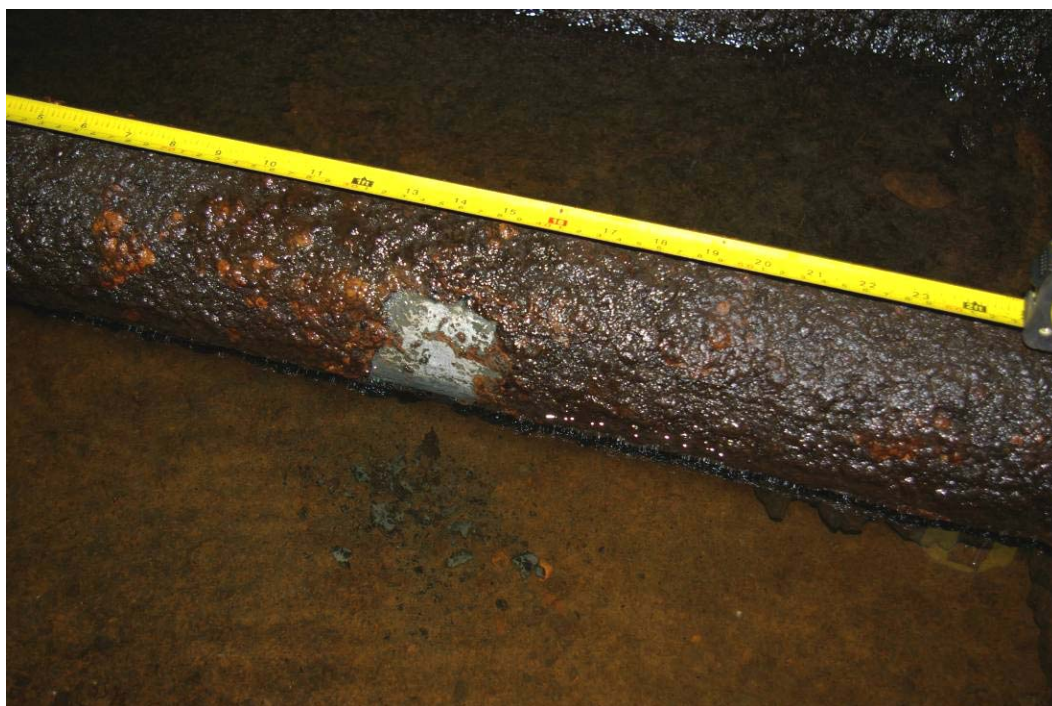
Photo 15 (August 15, 2007) East Supply Tunnel – Drain pipe measurement Location #1 – close up view. Pitting of pipe appears relatively shallow.

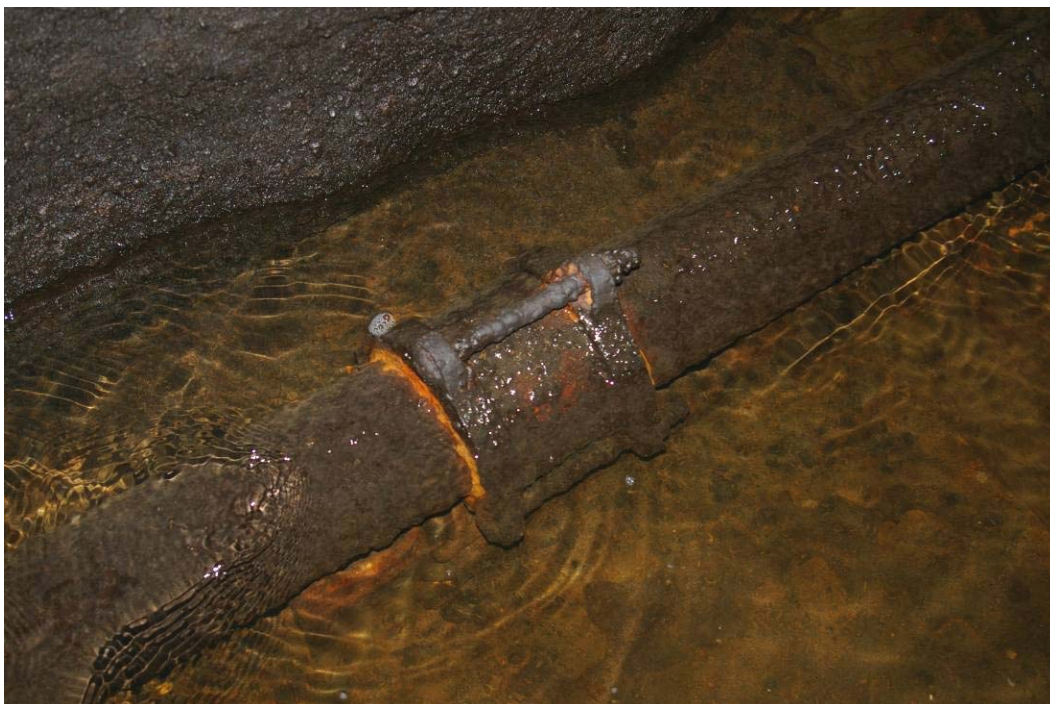
Photo 16 (August 15, 2007) East Supply Tunnel – Typical condition of clamp connections on drain pipe.

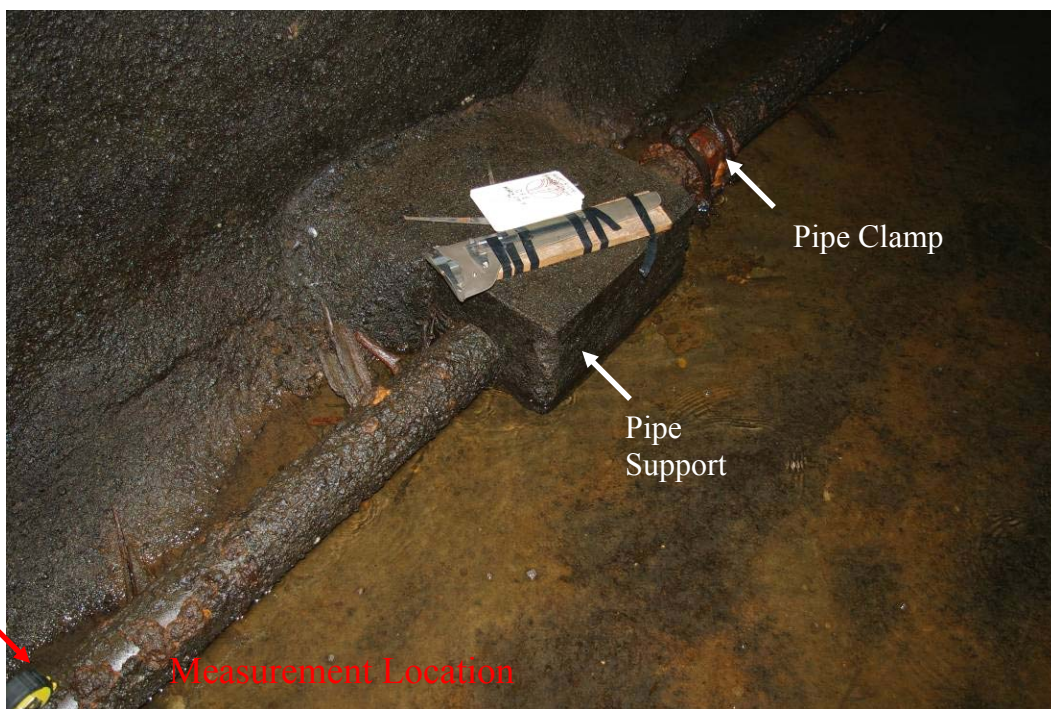
Photo 17 (August 15, 2007) East Supply Tunnel – Drain pipe measurement Location #2 (1.2 m upstream from third pipe support).

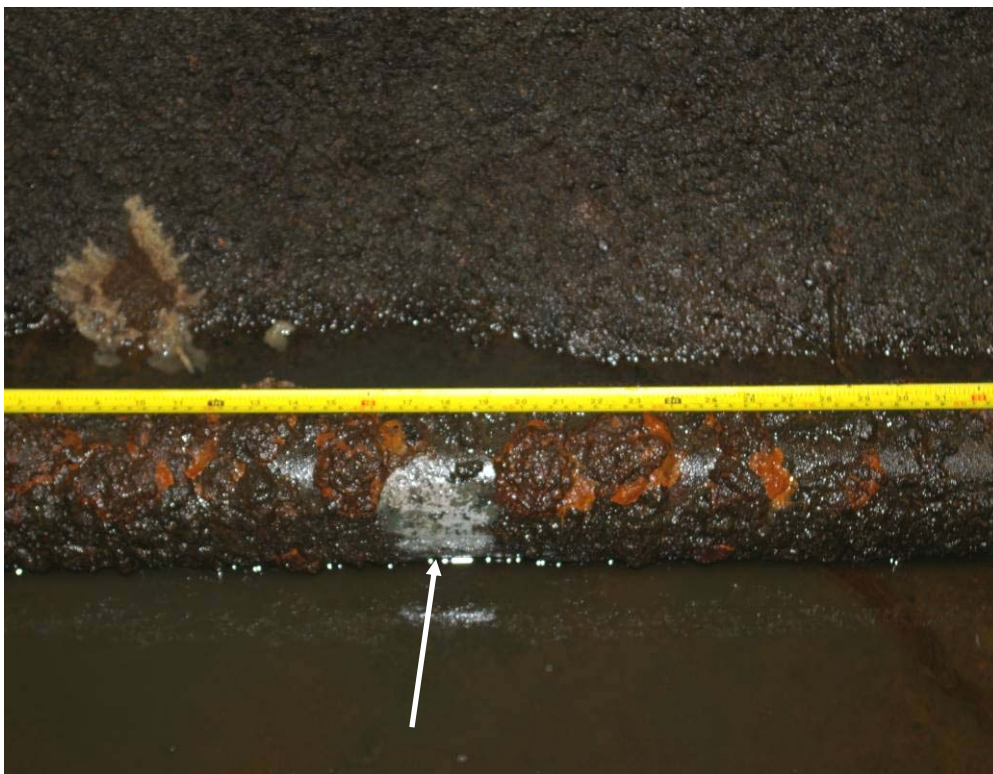
Photo 18 (August 15, 2007) East Supply Tunnel – Drain pipe measurement Location #2 – close up view.

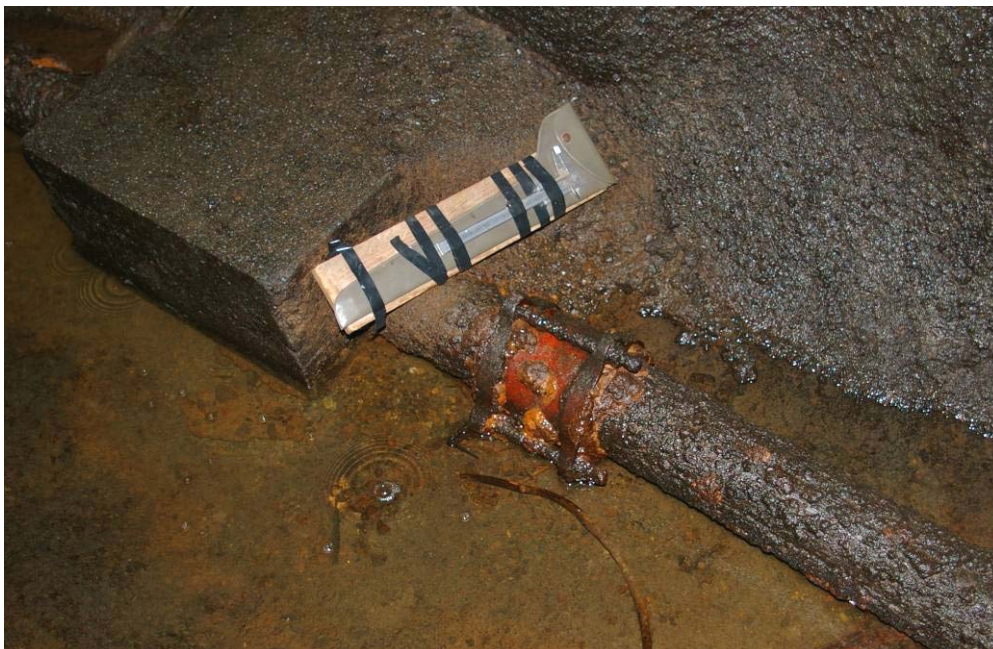
Photo 19 (August 15, 2007) East Supply Tunnel – Pipe clamp at drain pipe measurement Location #2.

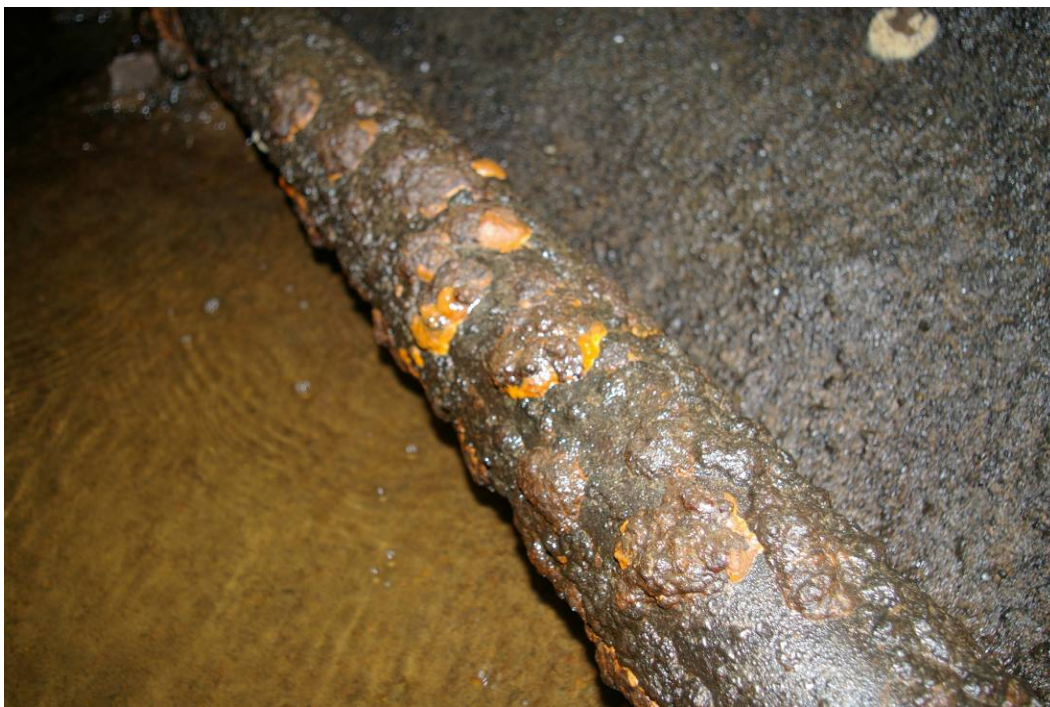
The rust scale thickness varies considerably due to the rough “blistered” surface (see Photo 20). The diameter of the pipe including the rust scale was measured at the first location as 118.75 mm (4.675 inches) which indicates the rust scale is approximately 2.5 mm (0.10 inch) thick. However, individual blisters were estimated to be upwards of 5.0 mm (0.20 inch) thick. The corrosion of the drain pipe appeared to decrease gradually moving downstream.

Photo 20 (August 15, 2007) East Supply Tunnel – Typical corrosion blisters on drain pipe.

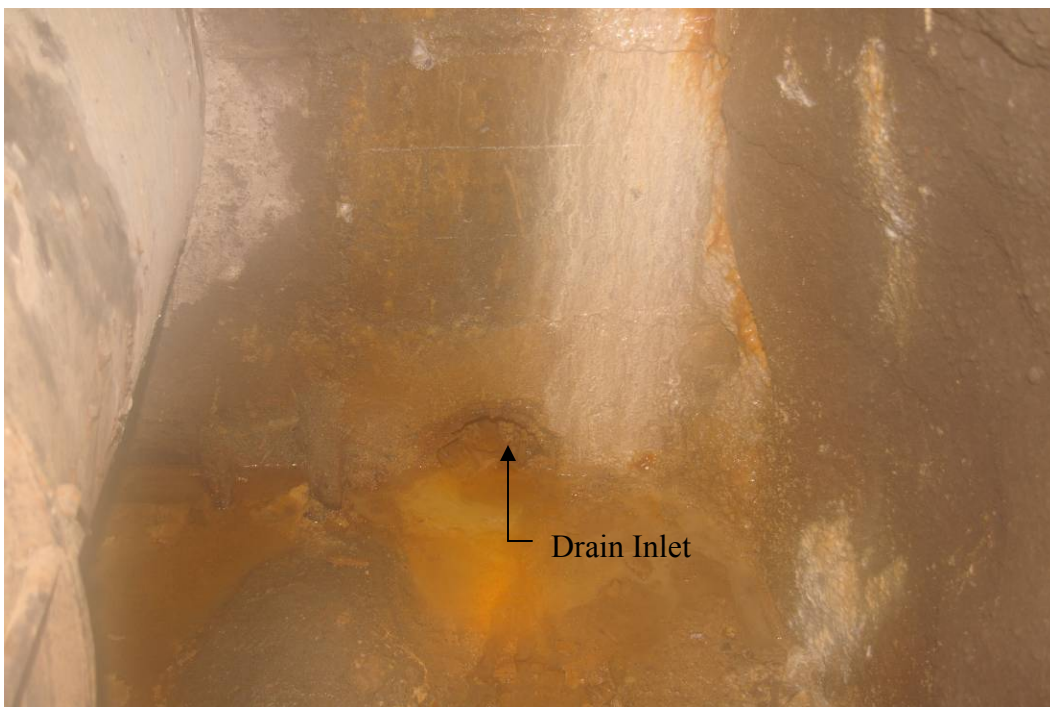
The inlet of the drain pipe at the base of the downstream face of the east bulkhead is shown on Photo 21. The total flow exiting the drain pipe upstream of the west bulkhead was visually estimated to be less than 0.05 litre/minute (three tablespoons per minute) with the tunnel pressurized. This appears to be similar to the flow entering the pipe as shown in Photo 21. Therefore, there appears to be little if any pressurized water within the tunnel leaking in to the drain pipe.

Photo 21 (October 9, 2007) East Supply Tunnel, East Bulkhead (looking upstream) – Inlet of drain pipe at east portal bulkhead. Bulkhead is damp to wet but no distinct areas of seepage were noted.

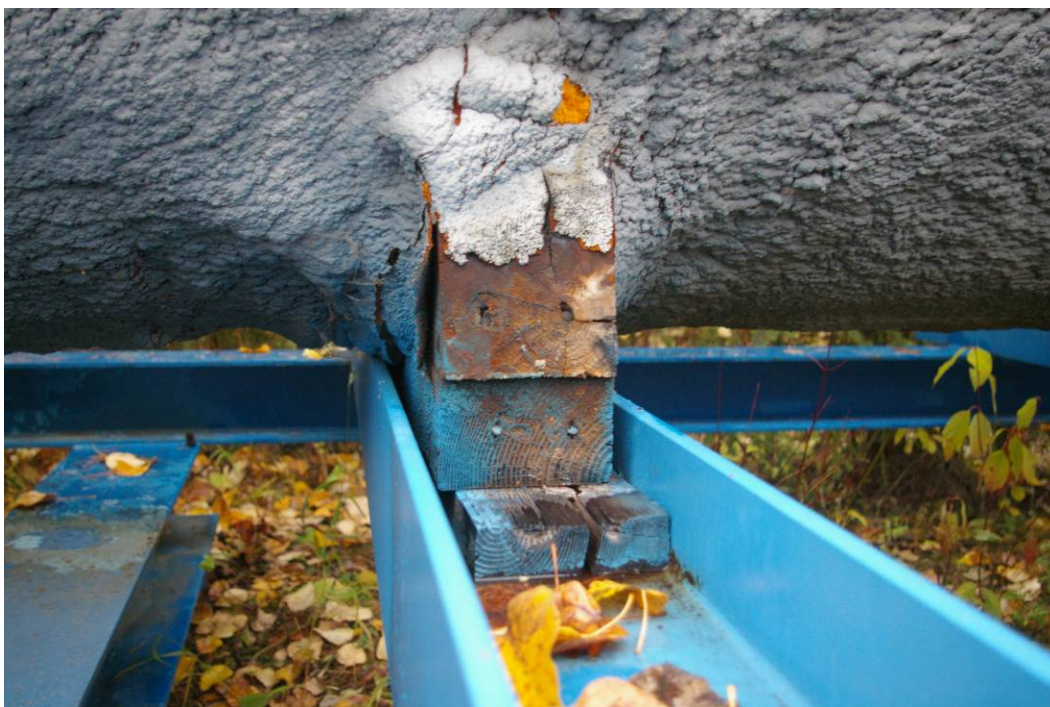
Photo 23 (October 9, 2007) Pipeline Trestle – Typical wood wedges used to support the supply pipeline on trestle show only relatively minor decay.

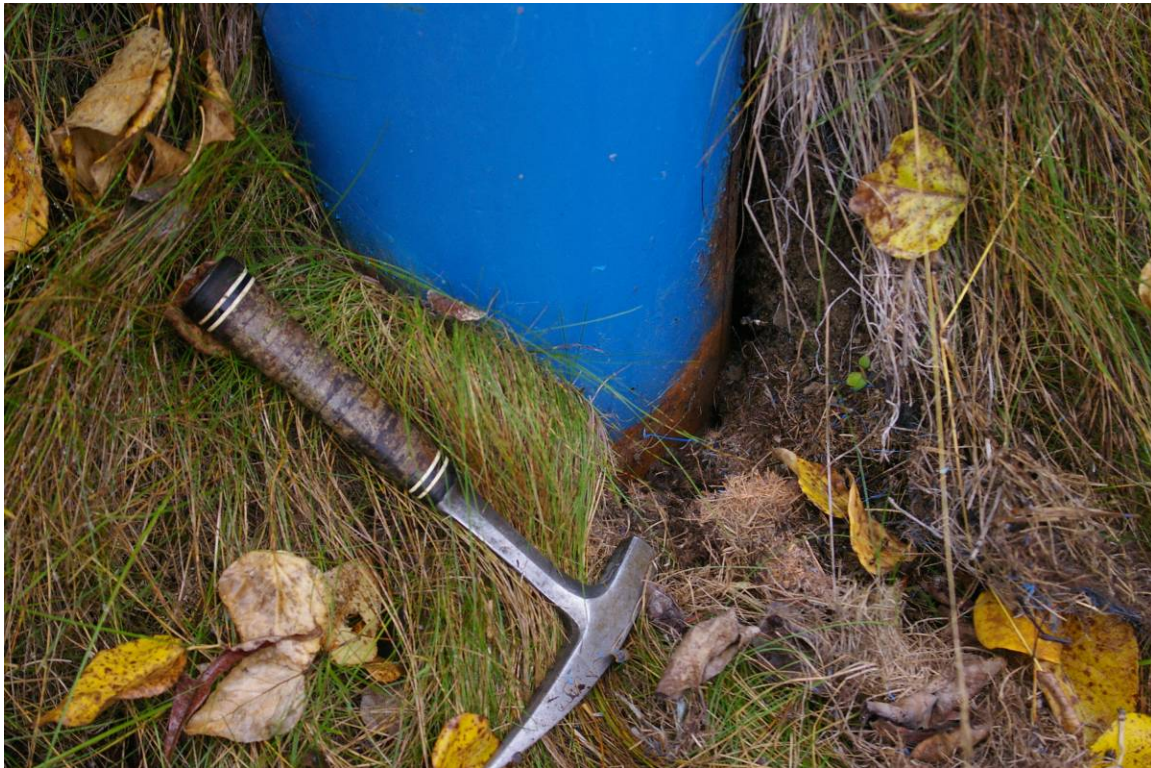
Photo 24 (October 9, 2007) Pipeline Trestle – Minor separation of soil noted adjacent to two piles does not appear to be recent.
