Fulton River Dam

**DAM SAFETY REPORT
FOR
MECHANICAL AND ELECTRICAL EQUIPMENT**

13 JANUARY 2009

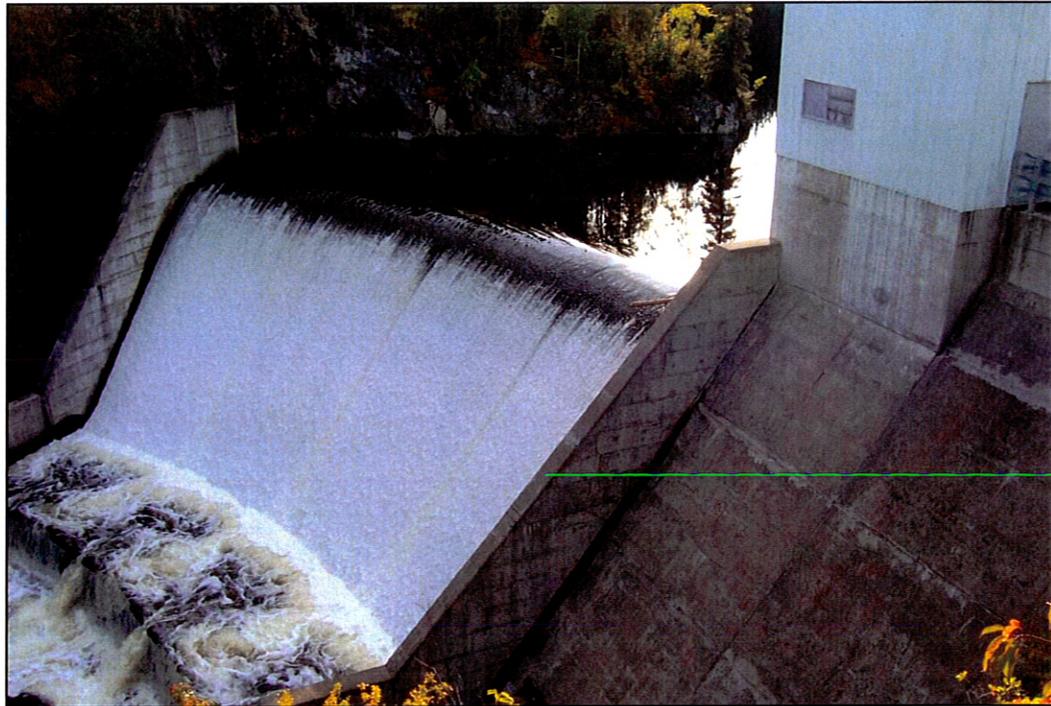
Figure 1: Flow over spillway.

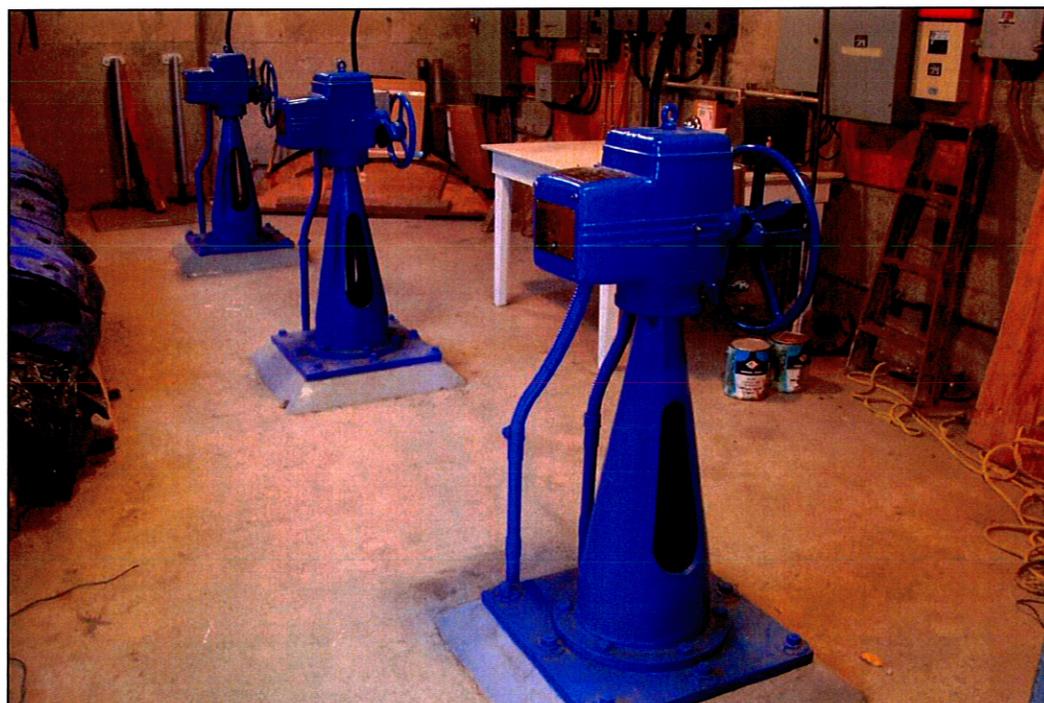
The actuators and controls for the valves are located in a control room above the valves. The actuators had been recently painted. One of the valve actuators was not operational due to an electrical problem. The site staff indicated that they were getting the problem looked at. In the meantime, the valve is being operated manually using the handwheel.

Item	Rating	Remarks
Valves	S	Recently painted
Valve actuators	S	Recently painted. One actuator has electrical problems, requires manual operation.
Operating linkages	S	
Seals/leakage	S	No leakage noted.
other unusual conditions	S

Figure 2: Regulating works hollow-cone valve actuators.

- Repair the actuator for the hollow cone valve.

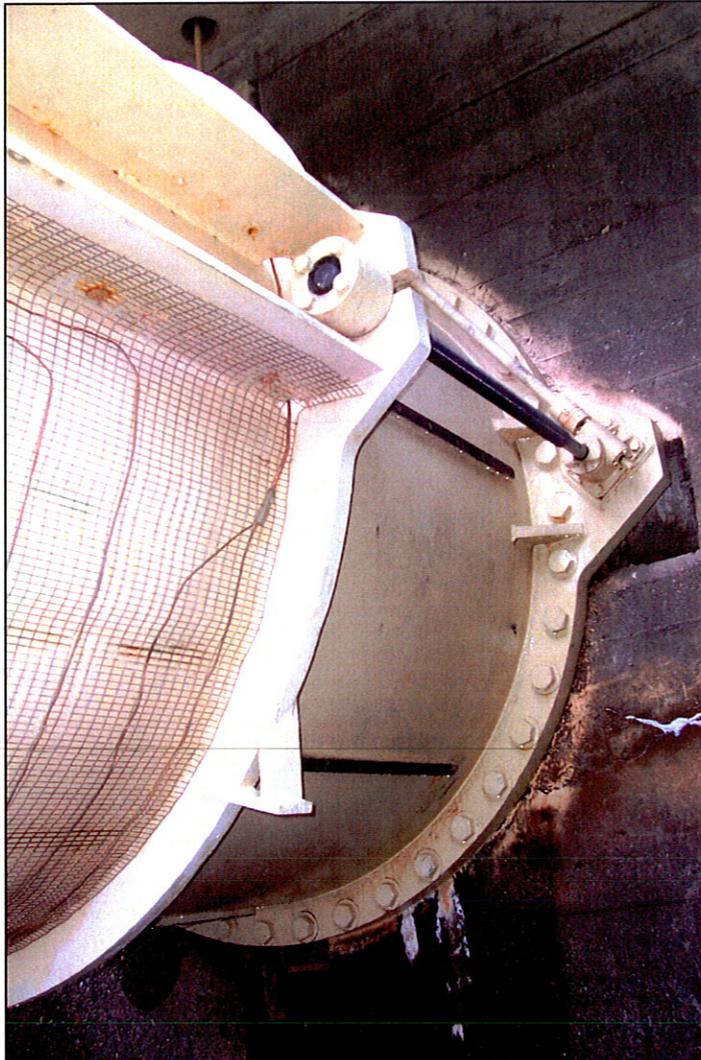
An external inspection of the hollow cone valves was carried out. The exterior of the valves had been recently painted. Site personnel indicated that the valves had been recently repaired, including filling of corrosion pitting, and painting. The valves appeared in reasonable condition. KCBL were not provided with any report on the condition of the valves, or depth of corrosion pitting prior to our inspection.

Figure 3: Hollow-cone valve recently painted.

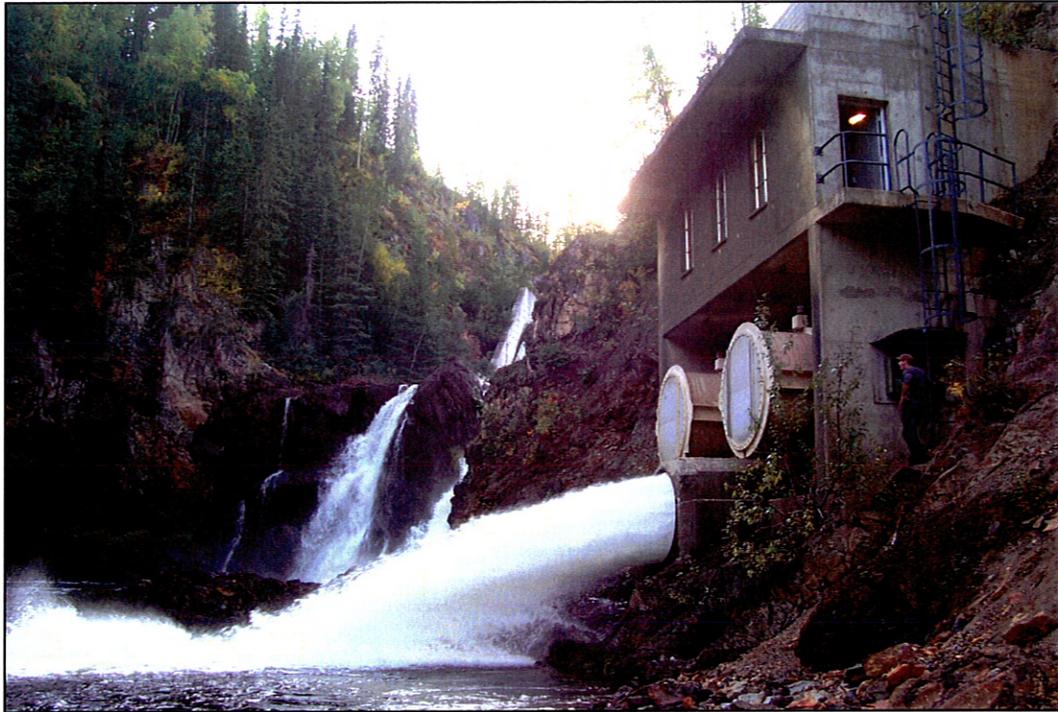
The 36" valve was operated while KCBL engineers were on site. The valve appeared to operate satisfactorily with no undue vibration or difficulty in operation.

Figure 4: 36 in Hollow cone valve in operation.

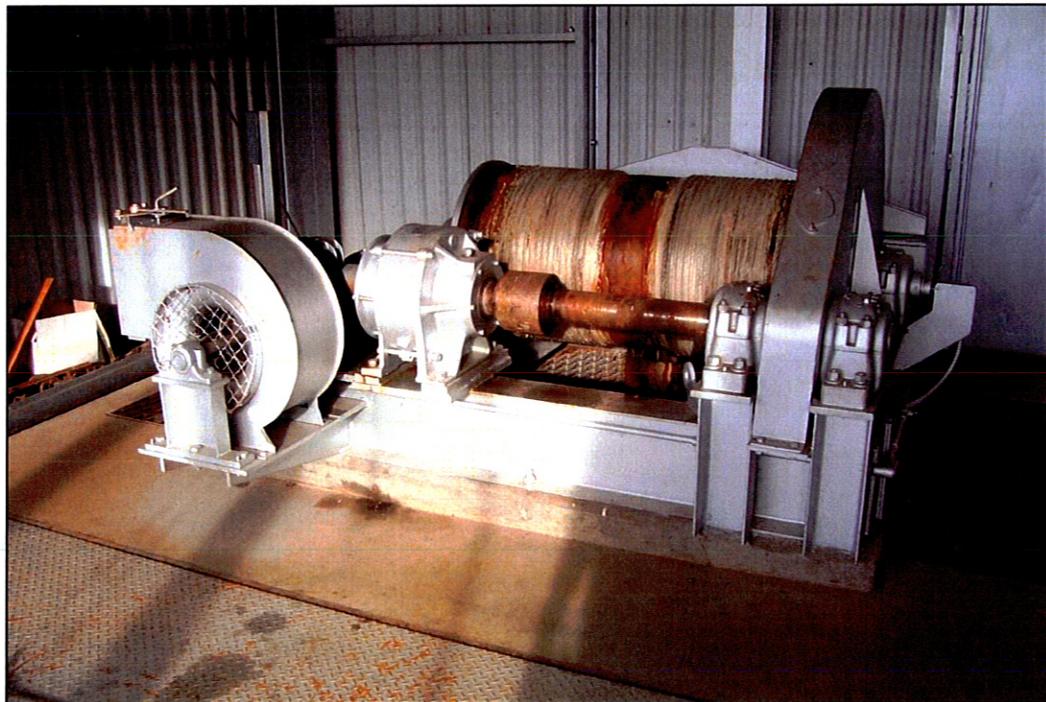
The service gate is raised and lowered by a dedicated wire-rope hoist located in the gate house. Although not tested, the wire rope hoist appeared in satisfactory condition, having recently been painted and the drum and wire rope greased.

Figure 5: Service Gate hoist for regulating works.

An emergency closure test should be carried out on the gate to confirm the closure rate is set as specified in the original operating and maintenance manual.

- Carry out an emergency closure test of the service gate in the regulating works under flow conditions. The lowering speed should be checked and adjusted if needed.

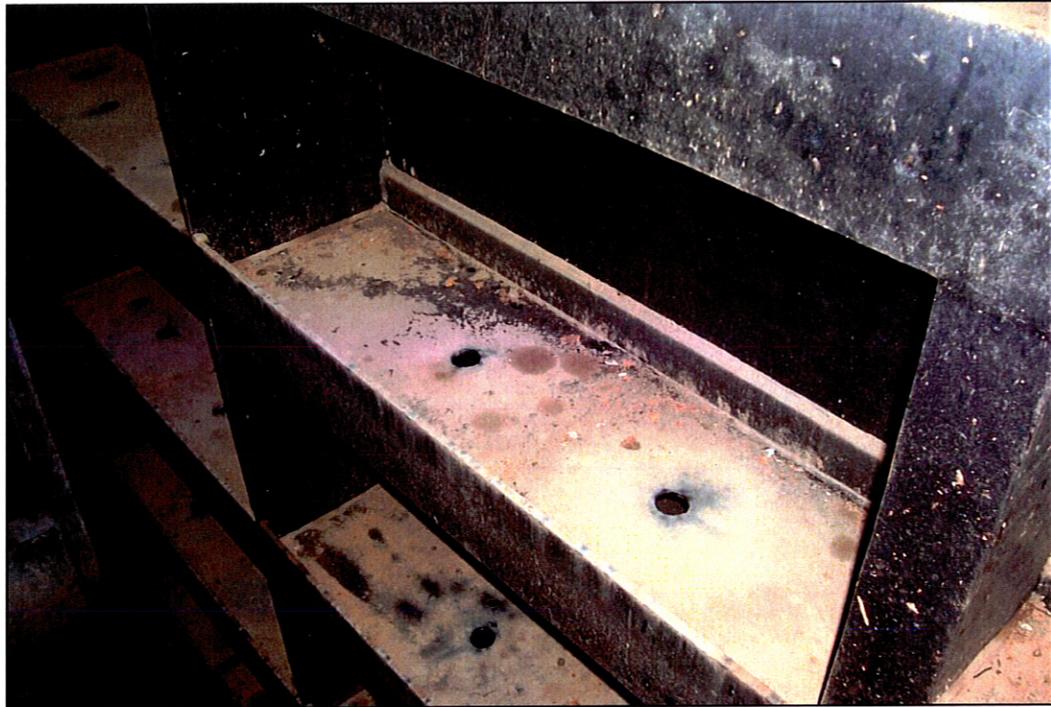
Because the spawning channels were in use, the tunnel could not be dewatered to inspect the gate. The service gate was in the open position during the site visit and only the top portion of the gate could be seen. From the limited view, the gate appeared in good condition, with only minor corrosion. The seals and wheels were not able to be inspected. The service gate should be inspected by closing the bulkhead gate, dewatering the tunnel and inspecting both the upstream and downstream side of the gate.

Figure 6: Regulating works Service Gate.
