Department of Fisheries and Oceans

2007 INSPECTION
FULTON DAM

V13101063

February 2008

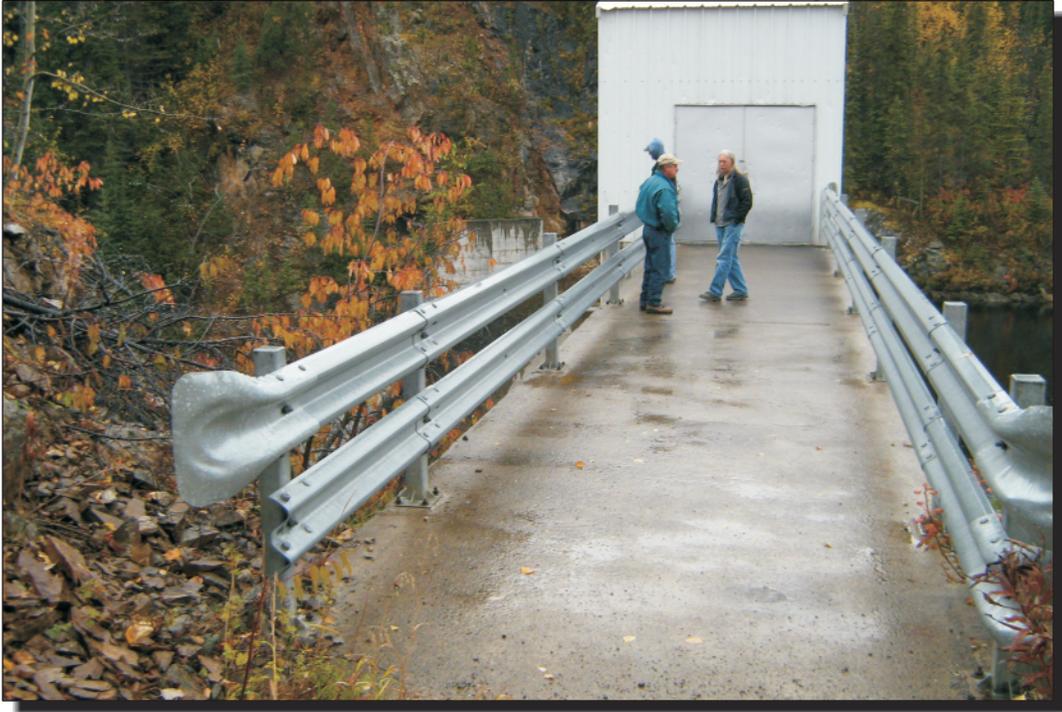
Photo 1
Crest of dam viewed from left abutment.

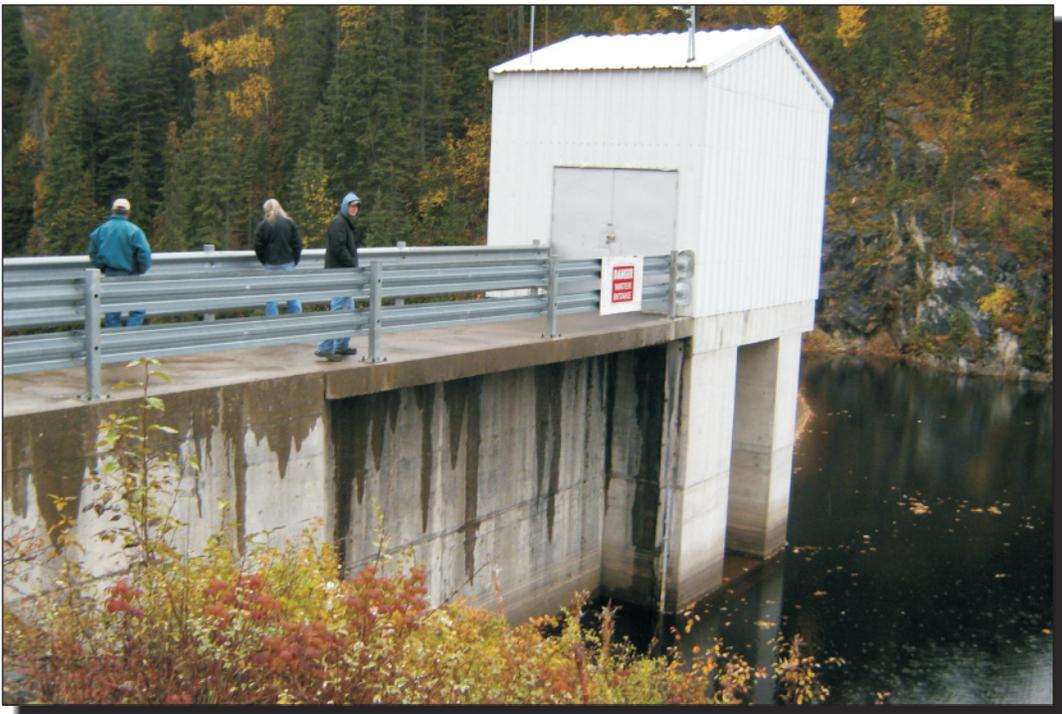
Photo 2
Upstream face of dam viewed from left abutment.

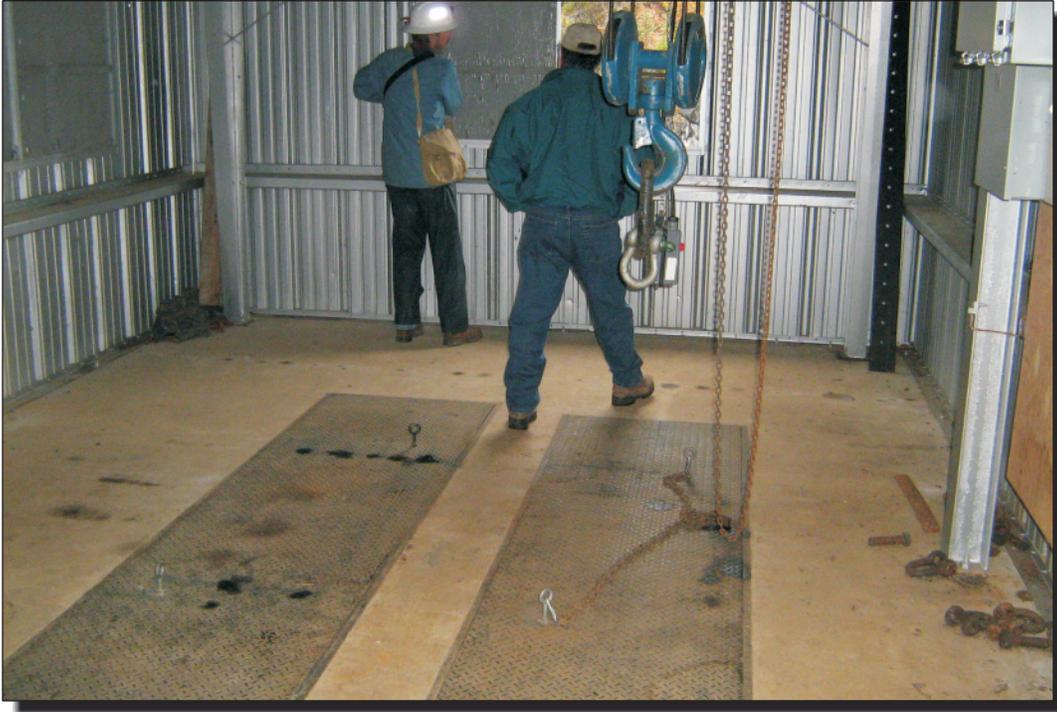
Photo 3

- The gate seals at the dam were sufficiently worn or damaged that a significant volume of water was passing through the low level outlet at the time of inspection. The poor condition of the seals do not impact safe operation of the dam as poor seals do not inhibit gate opening during a flood event to pass flood water;

Inside of gatehouse on crest of dam. Note two portals in floor beneath which the two gates are located.

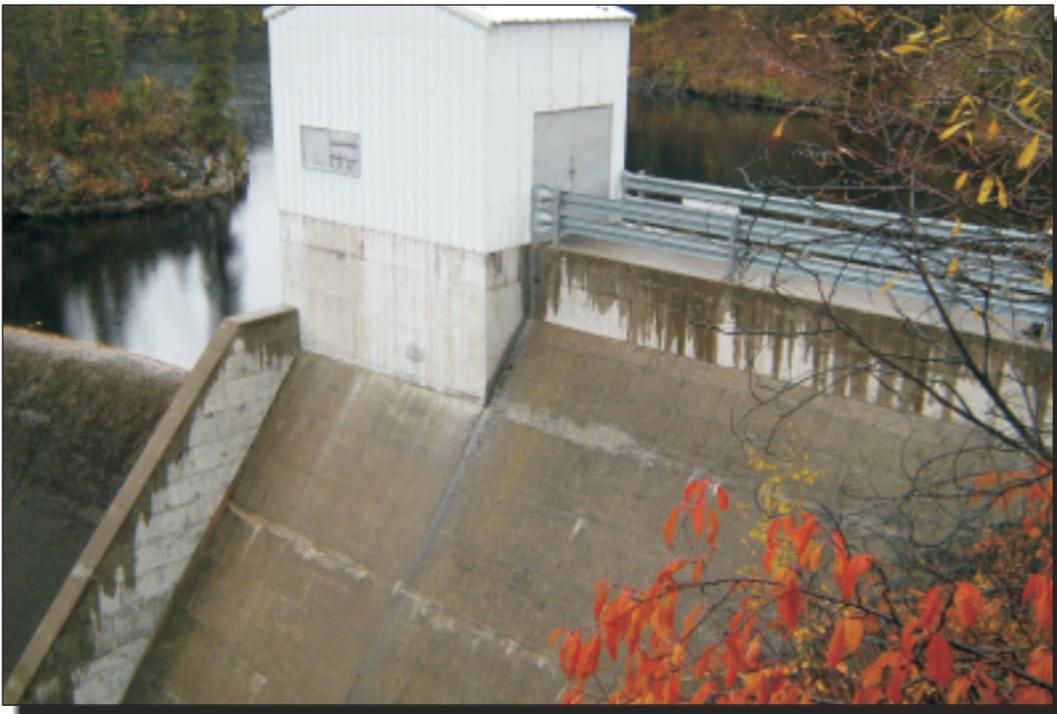
Photo 4

Upper downstream face, crest of dam and gatehouse.

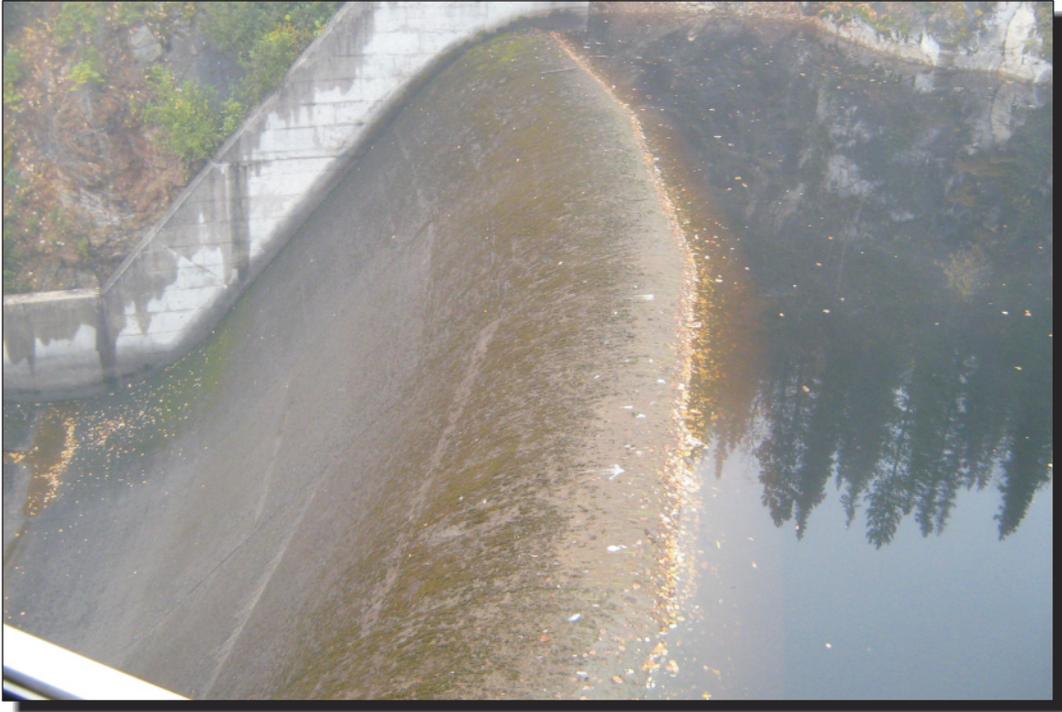
from the left abutment. The concrete on the walking surface was in good condition. The concrete at the crest of the spillway section was viewed from the gate house window and appeared to be in good condition with some exposed aggregate areas, but no indication of significant or widespread concrete deterioration was observed. Photographs of the crest of the dam, downstream face and gatehouse taken from the crest of the dam or the left abutment are presented in Photos 1 through 9.

Photo 5
Crest of spillway section.

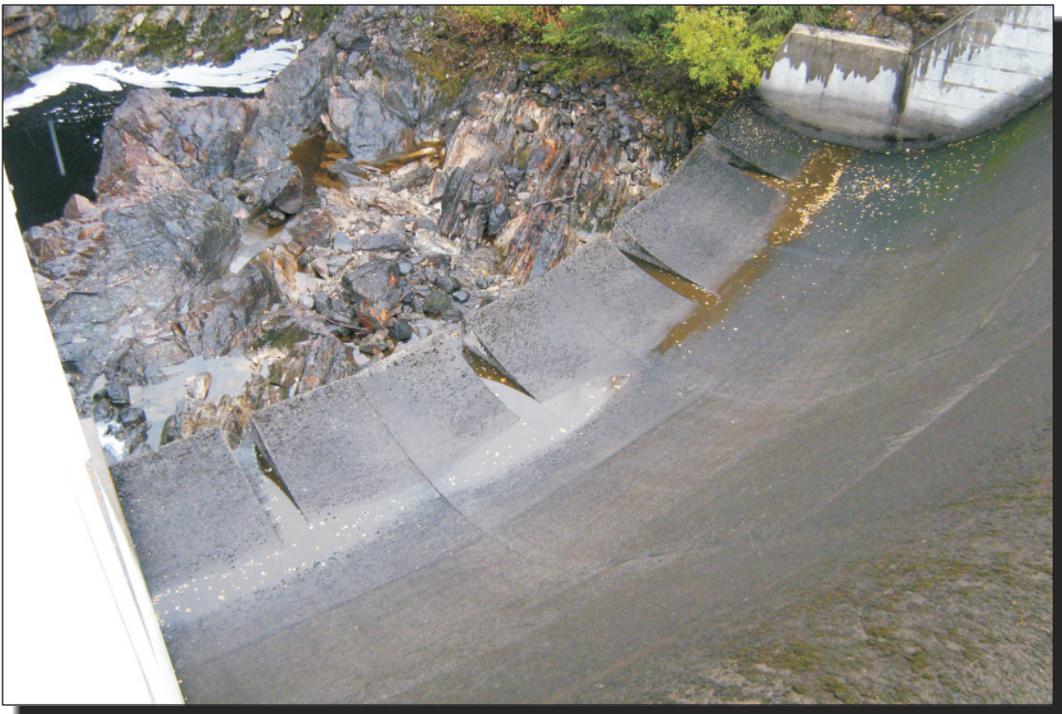
Photo 6
Downstream face of spillway section viewed from gatehouse.

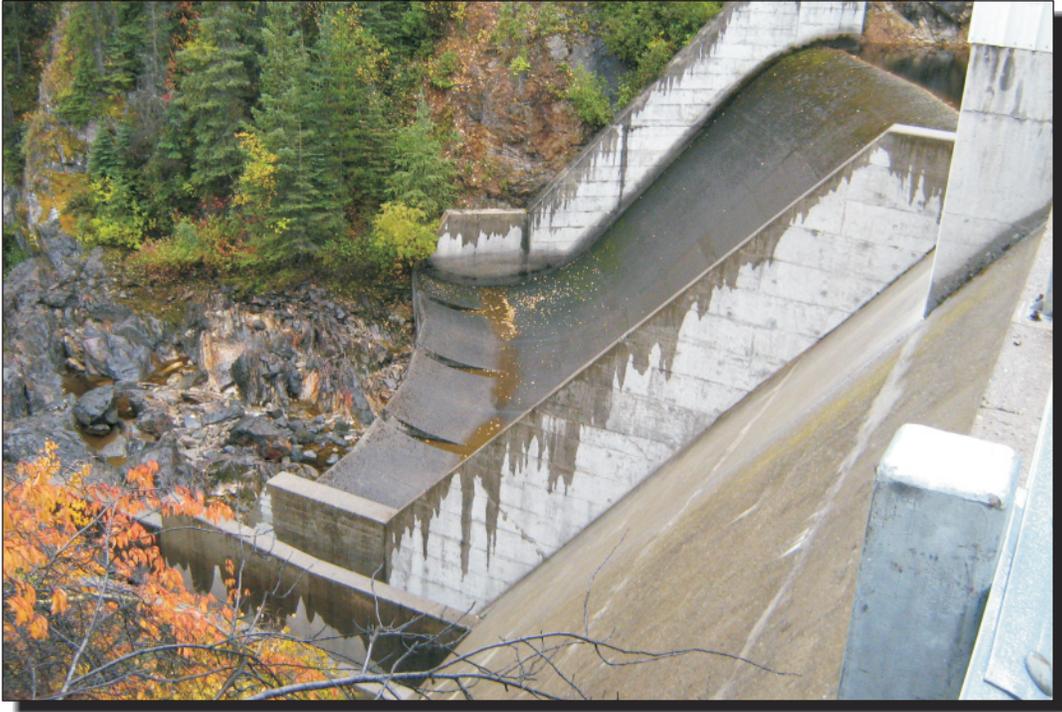
Photo 7

Downstream face of non-overflow and spillway viewed from crest of dam near left abutment.

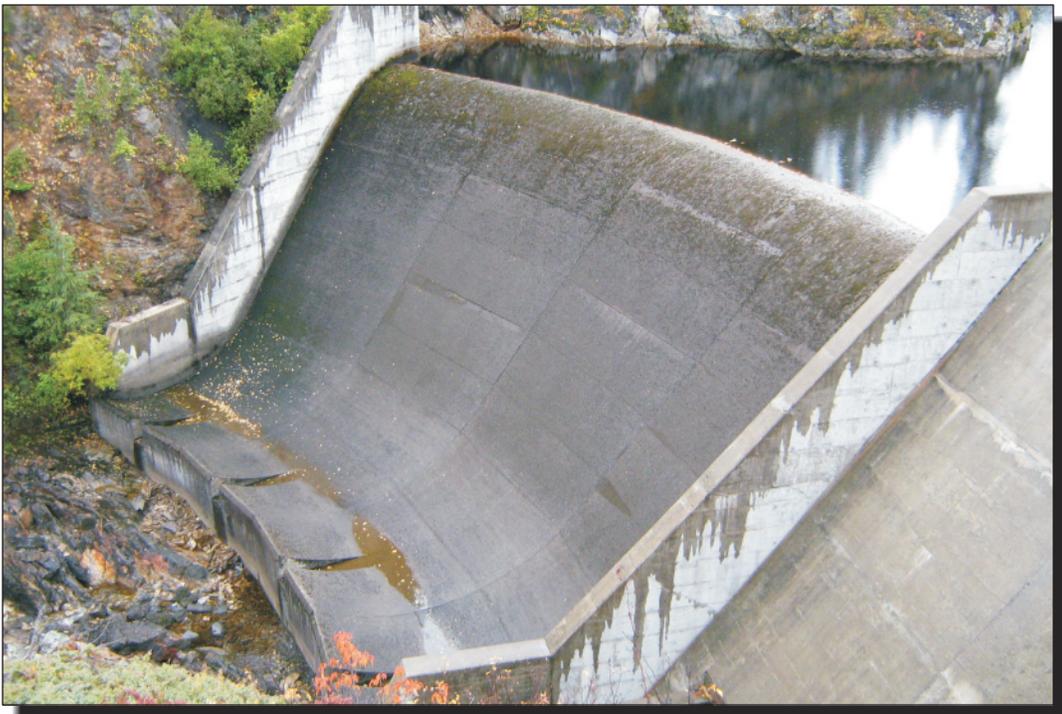
Photo 8

Downstream face of spillway viewed from bluff downstream of left abutment.

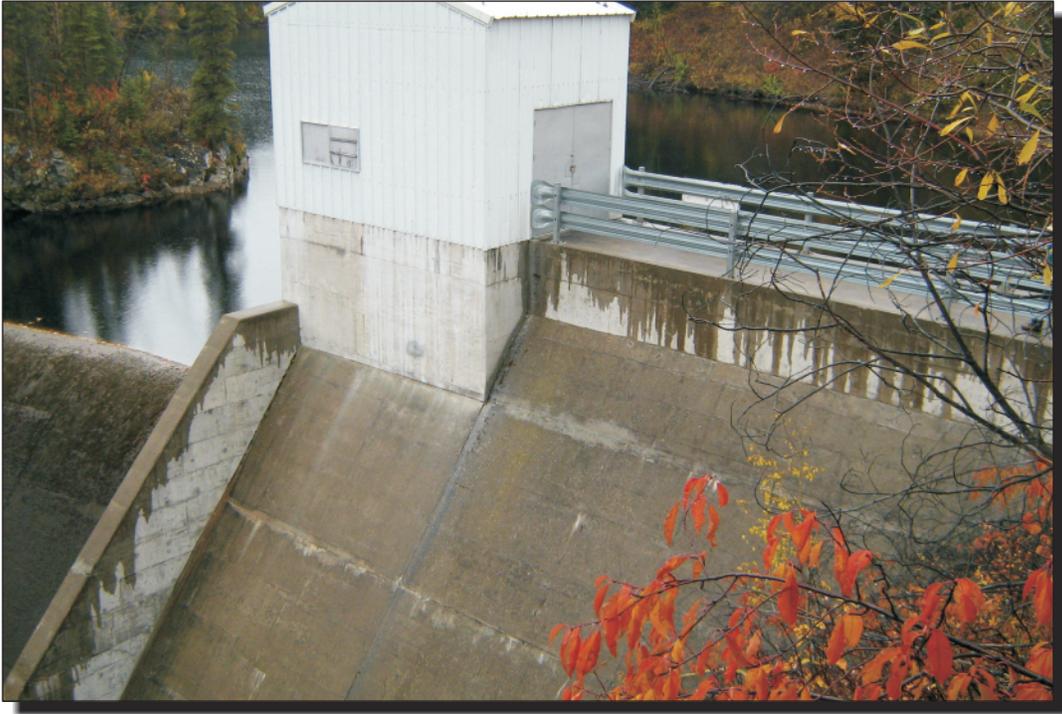
Photo 9

Downstream face of dam viewed from bluff downstream of left abutment.

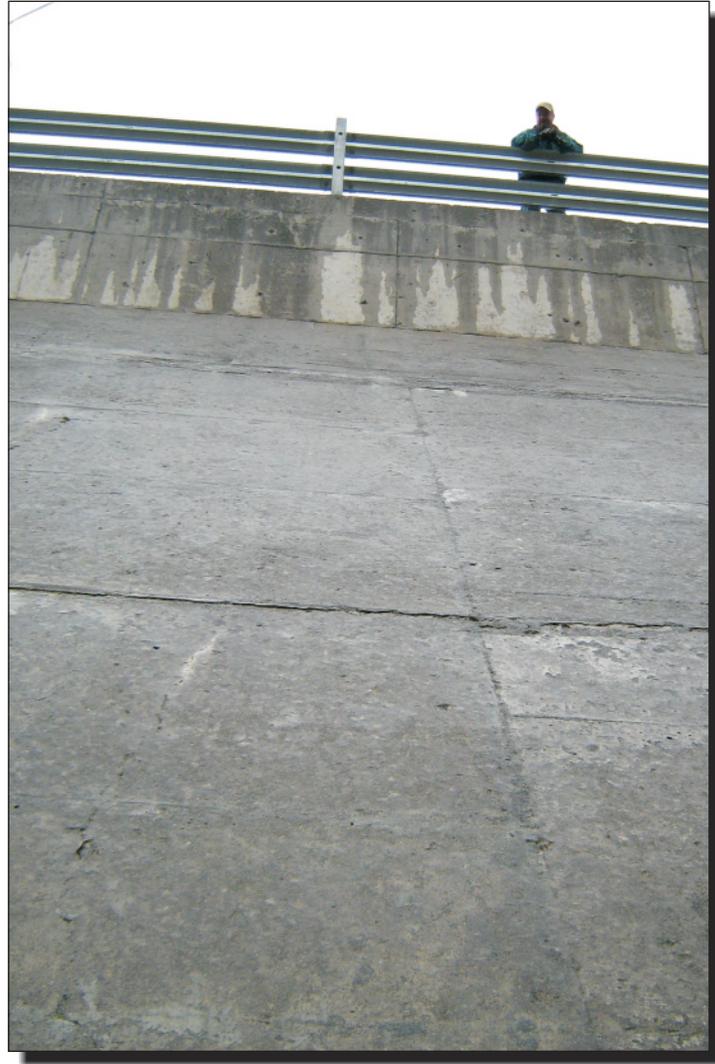
Photo 10

some evidence of erosion at construction joints and exposed aggregate at the spillway. However, these deteriorated conditions were judged to be minor in nature;

Downstream face of dam viewed from toe of dam. Note minor deterioration of concrete at construction joint.

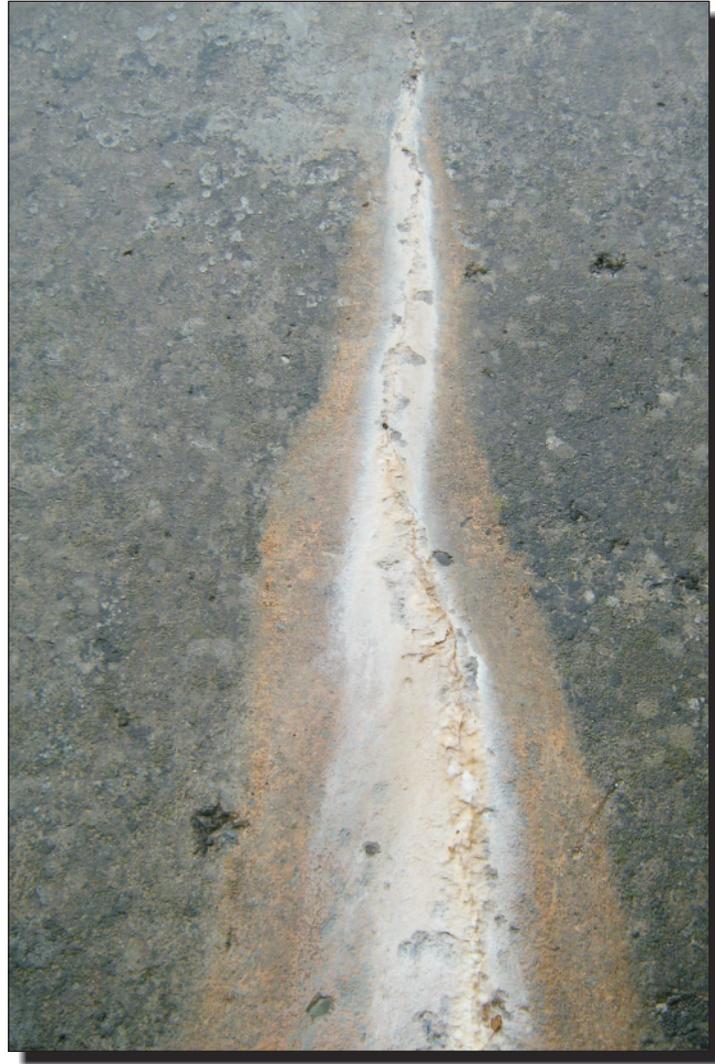
Photo 11

- The concrete structure of the dam and appurtenance structures is in generally good condition. There was some efflorescence at one construction joint on the dam and

Mineral build up on downstream face of dam near toe of dam.
Very small amounts of seepage appears to be passing through
a crack/ construction joint in the dam

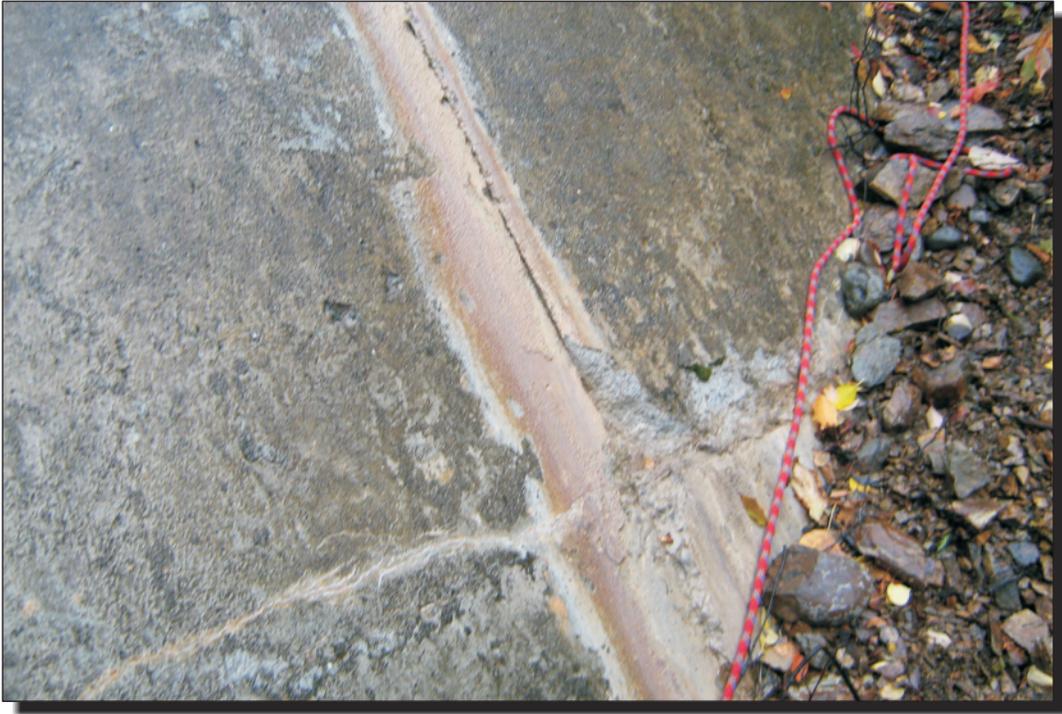
Photo 12

Mineral build up on downstream toe of dam at toe of dam (different view of site shown in Photo 11).

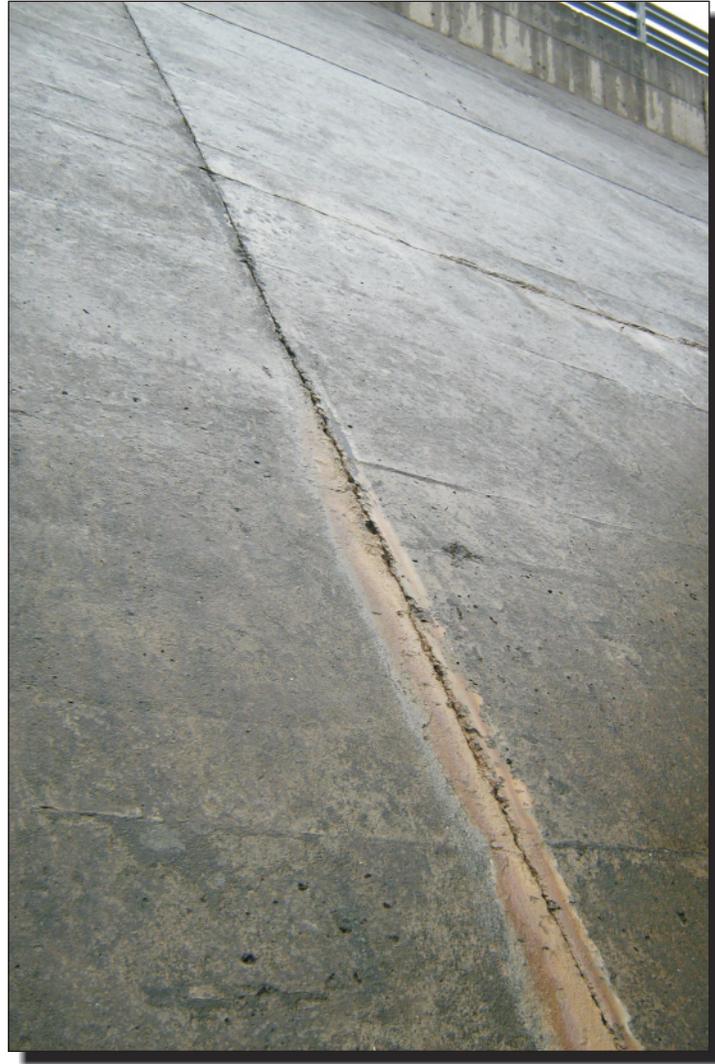
Photo 13

Mineral build up on a construction joint on downstream face of dam, viewed from downstream toe. Mineralization is due to very small amount of seepage passing through dam along the construction joint.

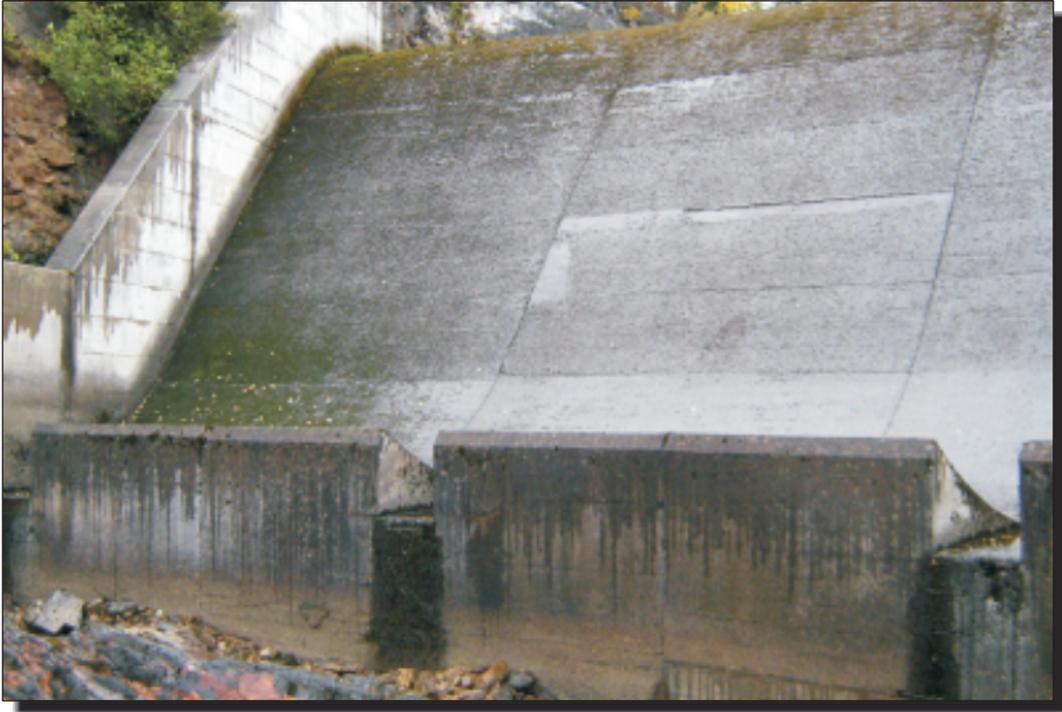
Photo 14

Spillway section viewed from downstream toe. Note deterioration of concrete at construction joints and patches applied sometime in the past. Note toe of flip bucket/energy dissipation structure is in contact with the bedrock foundation.

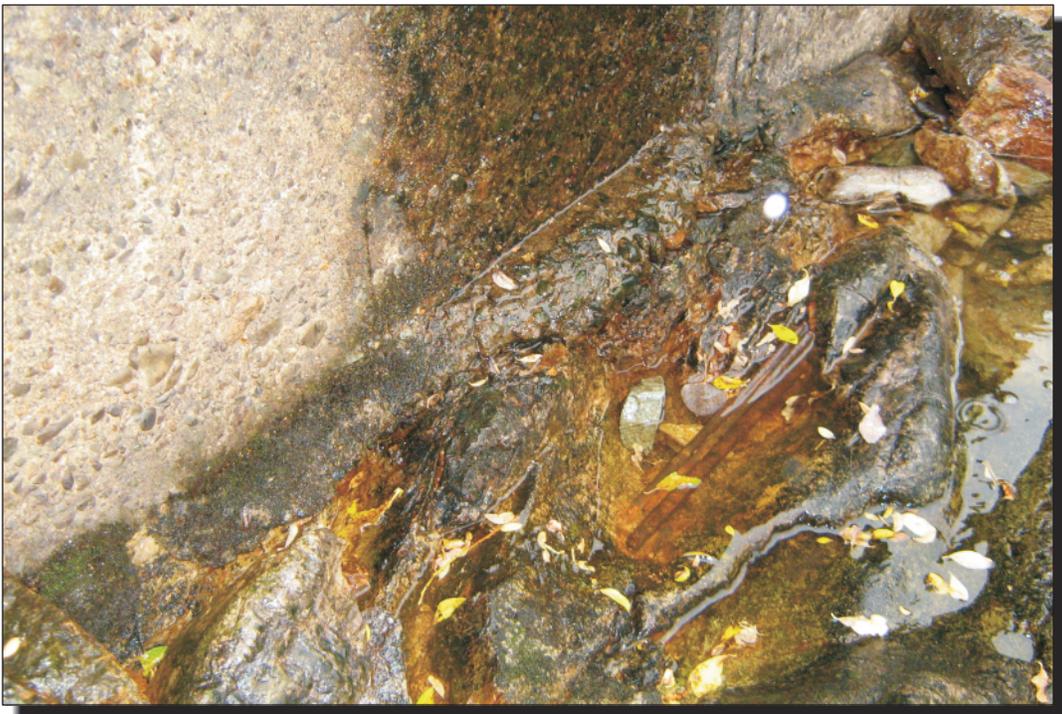
Photo 15

Concrete bedrock contact at downstream toe of dam.

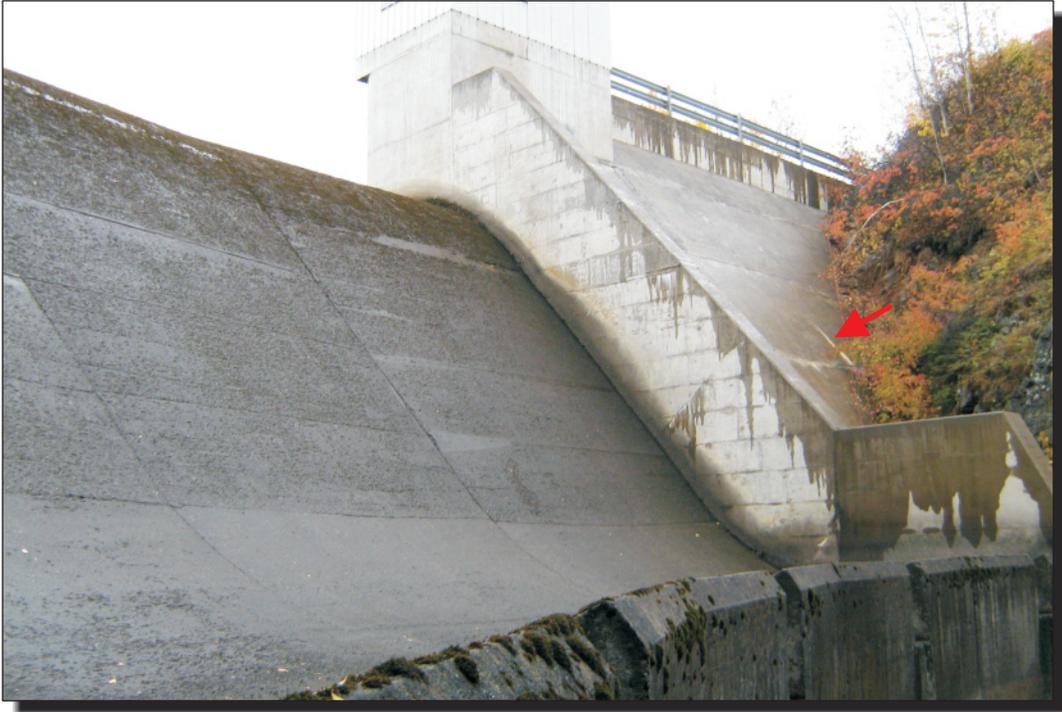
Photo 16

Left (non-overflow) portion of dam and spillway gatehouse. Red arrow indicates zone of mineralization presented in photos 11, 12 and 13.

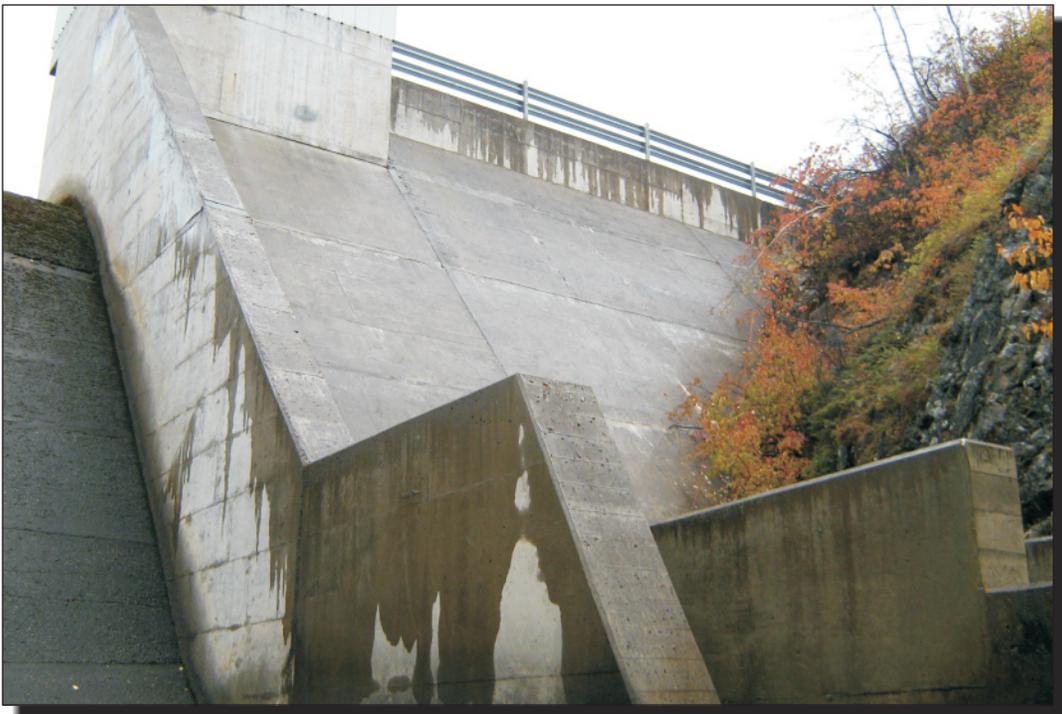
Photo 17

Left portion (non-overflow) of dam and low level outlet structure.
Note minor deterioration of concrete at construction joints.

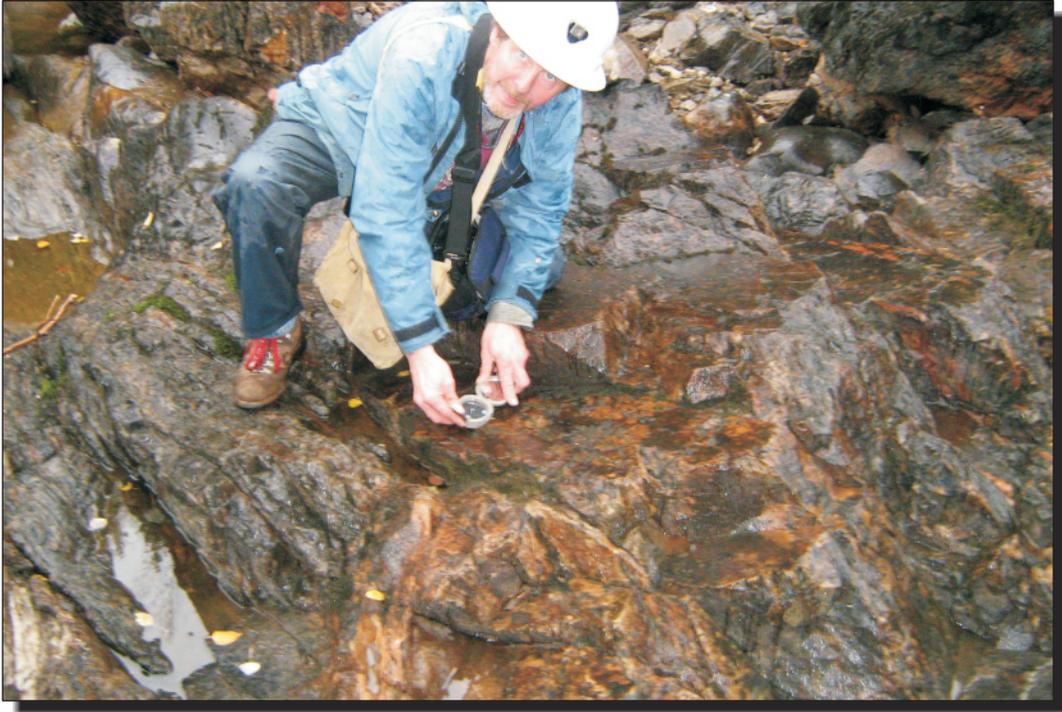
Photo 18
Condition of bedrock immediately downstream of dam.

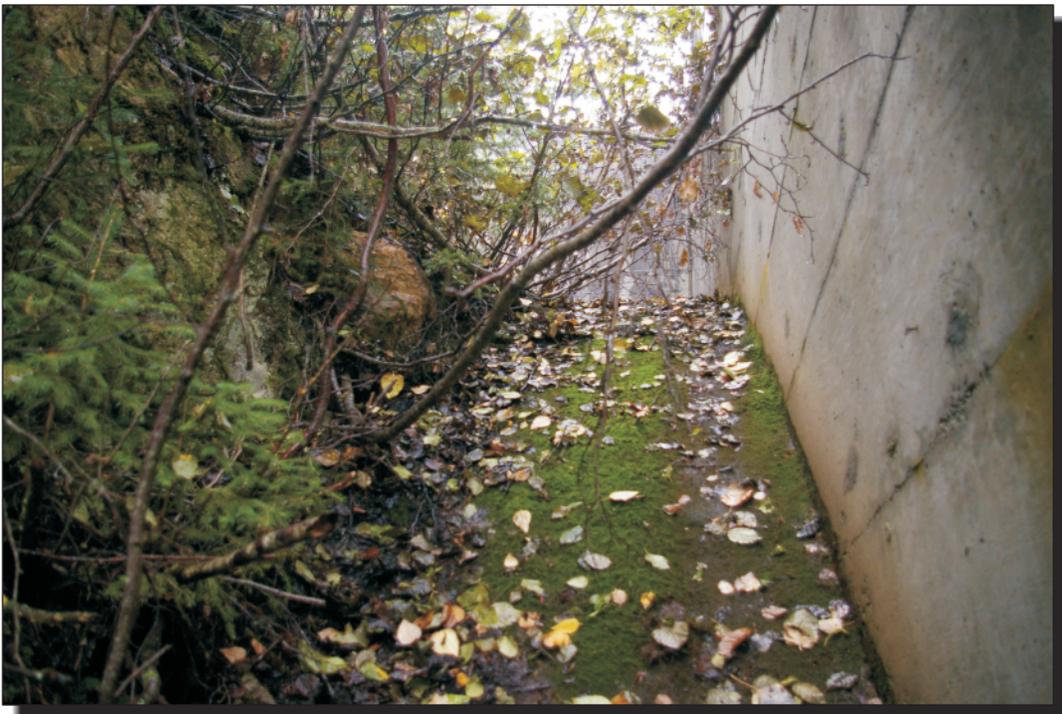
Photo 19
Right abutment between spillway wingwall and rock abutment.

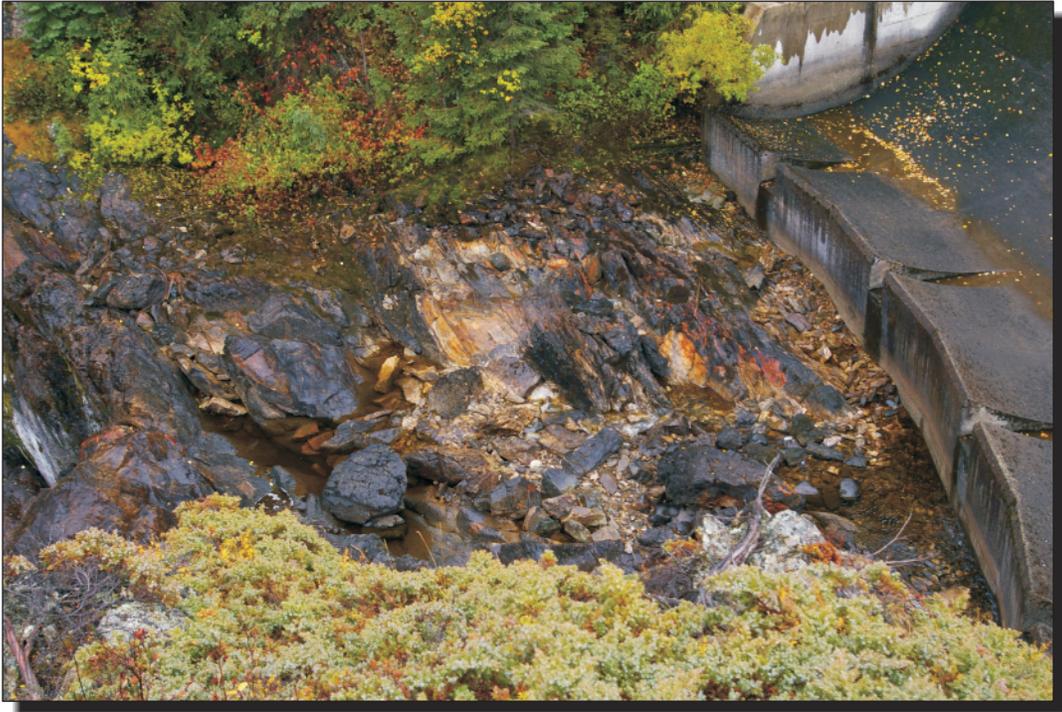
Photo 20.

Bedrock downstream of spillway section. Photo taken from bluff downstream of left abutment.

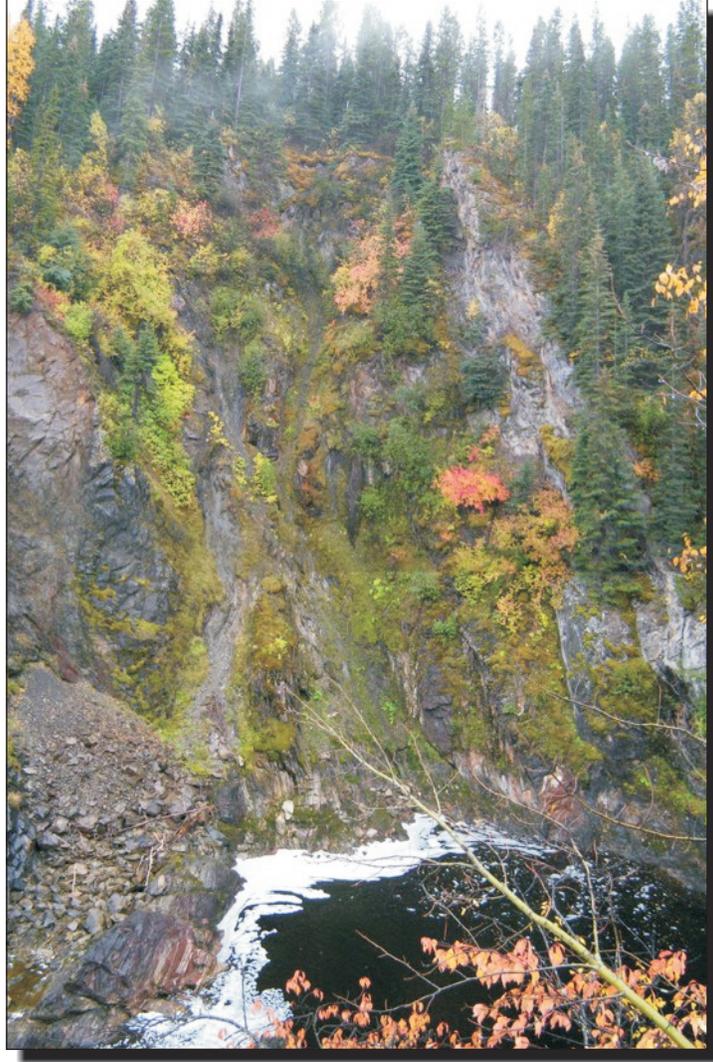
Photo 21
Shear zone downstream of drop off.

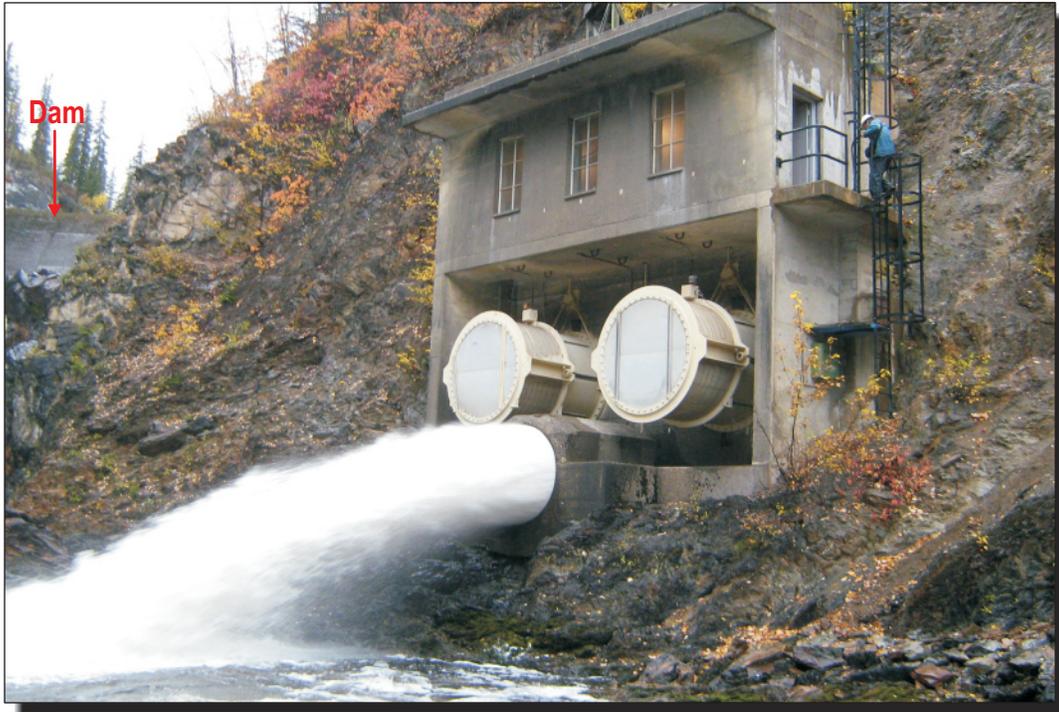
Photo 22

The Regulating Outlet Structure was viewed during the dam inspection. In general, the concrete structure is in good condition and the valve operation house is neat and orderly. The smallest of the three outlets, the 30 inch (0.76 m) diameter outlet, at this facility was in operation. The two 84 inch (2.13 m) diameter outlets were covered. All three outlets consist of cone valves. Although the valve mechanisms were not observed during the inspection, site personnel indicated that the epoxy coating on the valves were overdue for repair. A photograph of the Regulating Outlet Structure in operation is presented in Photo 22.

30 inch outlet at Regulating Outlet Structure in operation. Note the dam to the left of the structure.

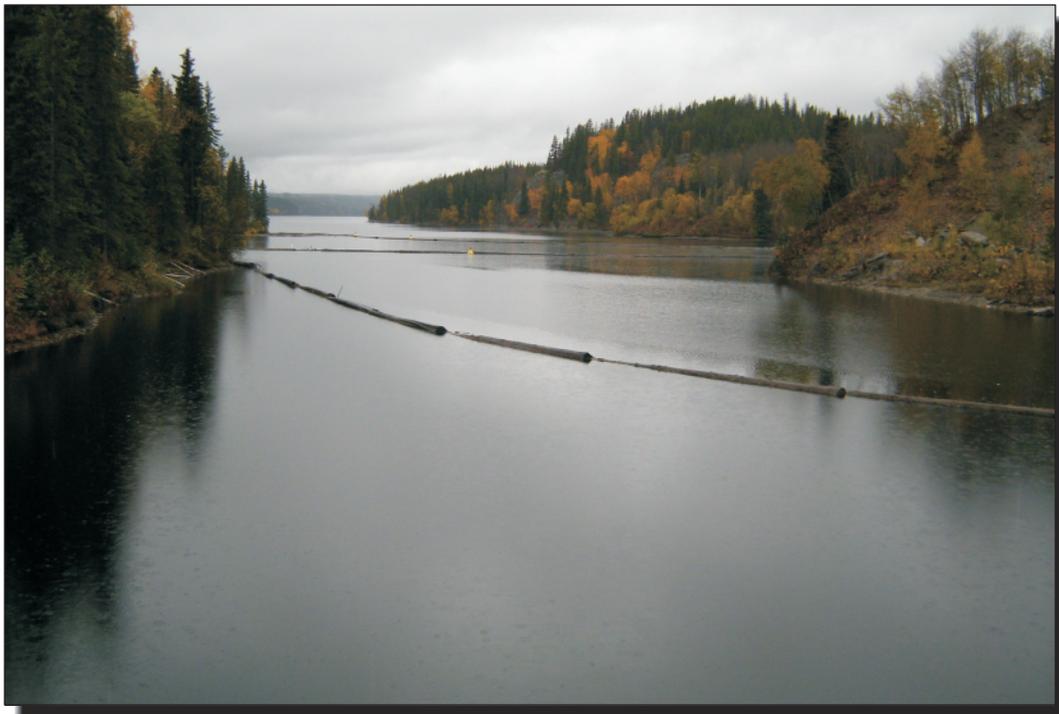
Photo 23

The penstock intake structure was observed to be in good condition. The gates, lifting apparatus, and other mechanical and structural elements of the facility were not inspected by EBA. A series of log booms were observed upstream of the intake structure as shown in Photo 23. The amount of debris that is retained by these booms is understood to be relatively minor based on the annual expenditures for debris removal (approximately \$2,000 to \$5,000).

Log booms upstream of the regulating intake structure.

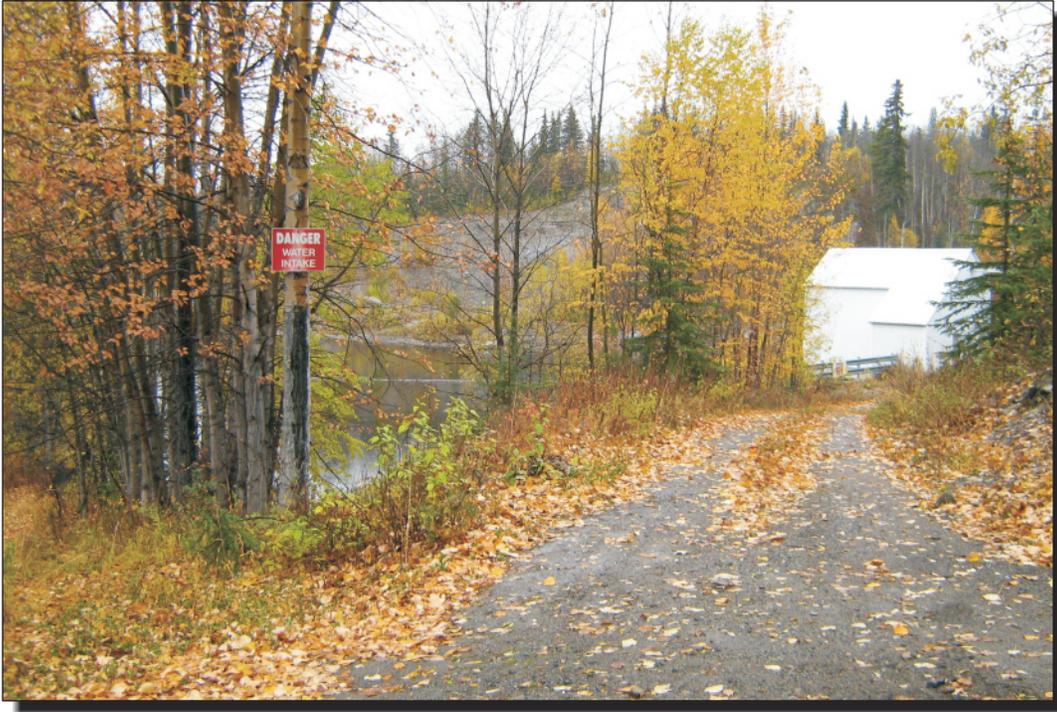
Photo 24
Warning sign for regulating intake structure.

- Improve signage to specifically state the hazards, include cartoons or illustrations showing the hazard that is easily understood and incorporate large, easily read text that is visible from an appropriate distance. This would include signs or buoys on the log booms warning the public on watercraft upstream of the dam;

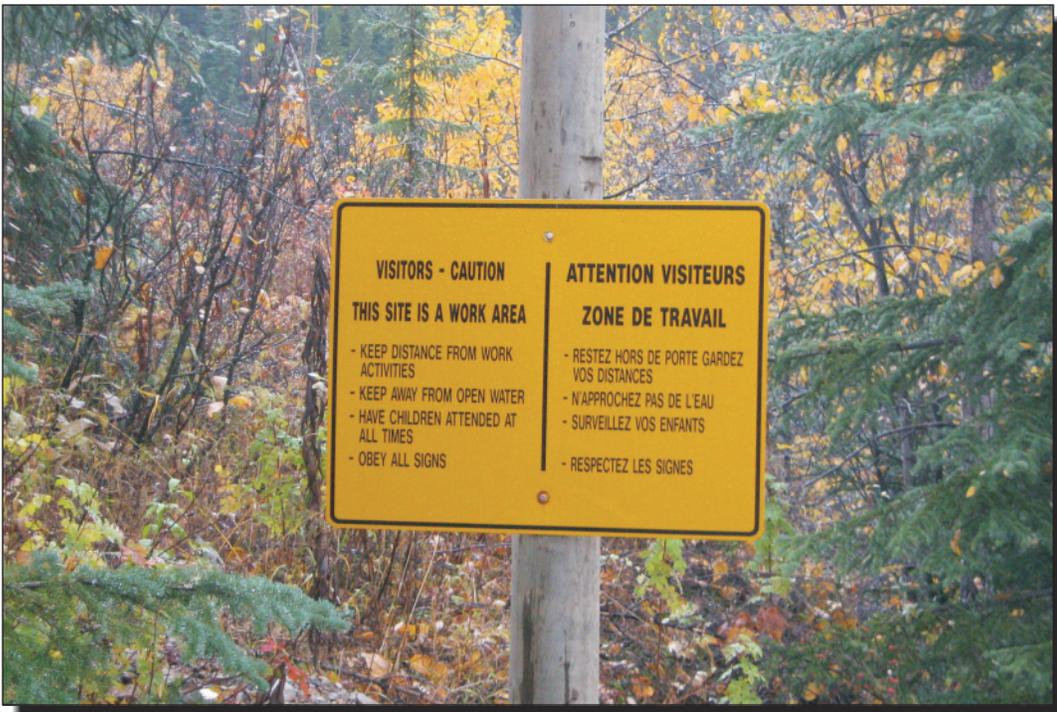
Photo 25
Warning sign on road before dam.

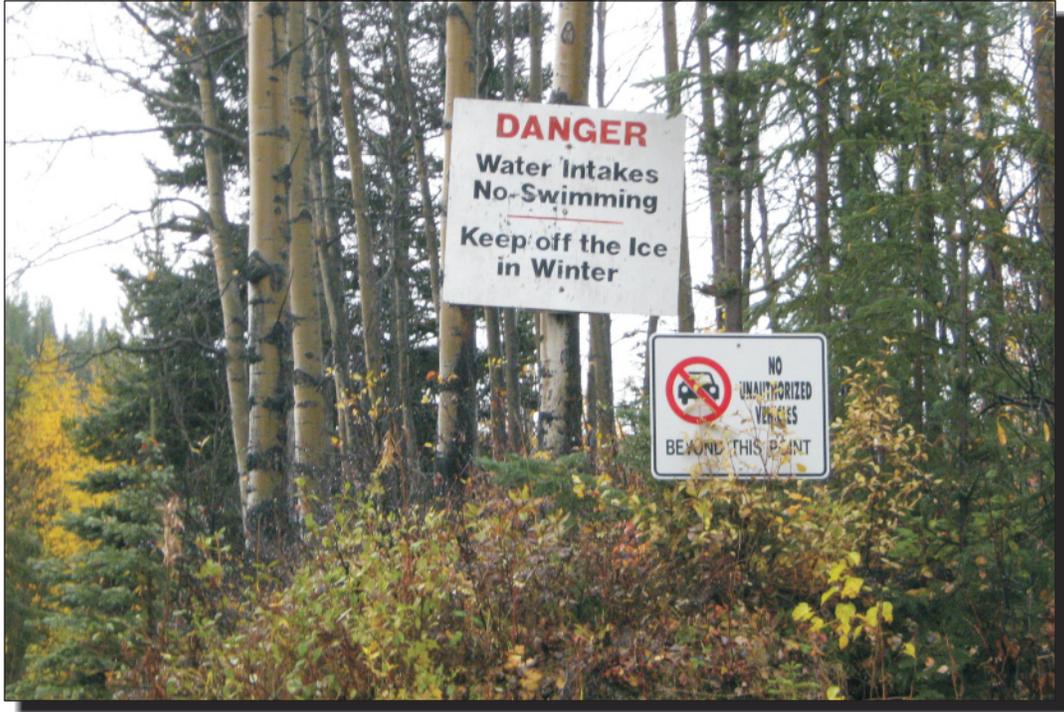
Photo 26

Warning sign for regulating intake structure. Note that sign says no unauthorized vehicles.

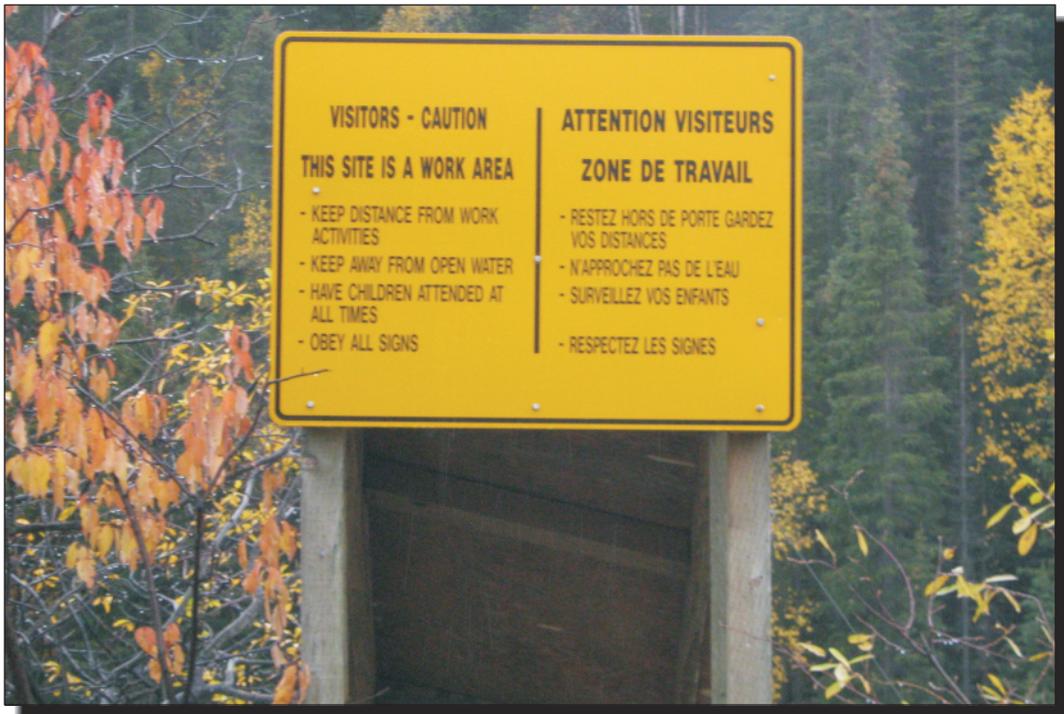
Photo 27

Warning sign for stairway access to Regulating Outlet Structure and Fulton River downstream of dam.
