**Asbestos-Containing Building Materials
Survey
Natural Resources Canada
Northern Forestry Building
Edmonton, Alberta**

Document No. 1318900400-REP-V0001-02

PWGSC Project No.: R.061377.001

JUNE 2013

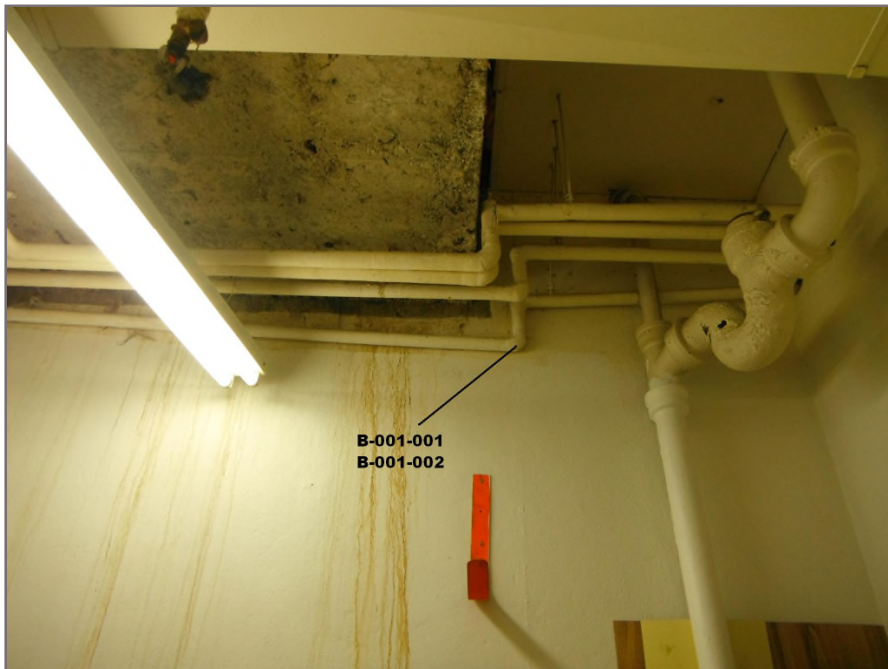
- Asbestos-containing friable mudded pipe insulation (Tetra Tech sample #B-001-001) containing 40% chrysotile asbestos. The ACM was associated with the elbow of a 2" diameter pipe at ceiling level in a basement storage room as shown on Figure 1a in Appendix C. There were two pipes present with a total of 9 elbows. The ACM was in good condition at the time of assessment as shown in Photo 6, in Appendix B, and should be managed in place. The ACM within the storage room is considered Access (C) Exposed.

Photo 6: Asbestos-containing mudded pipe insulation applied to the 2" diameter pipe elbow in the basement storage room. Tetra Tech sample B-001-001.

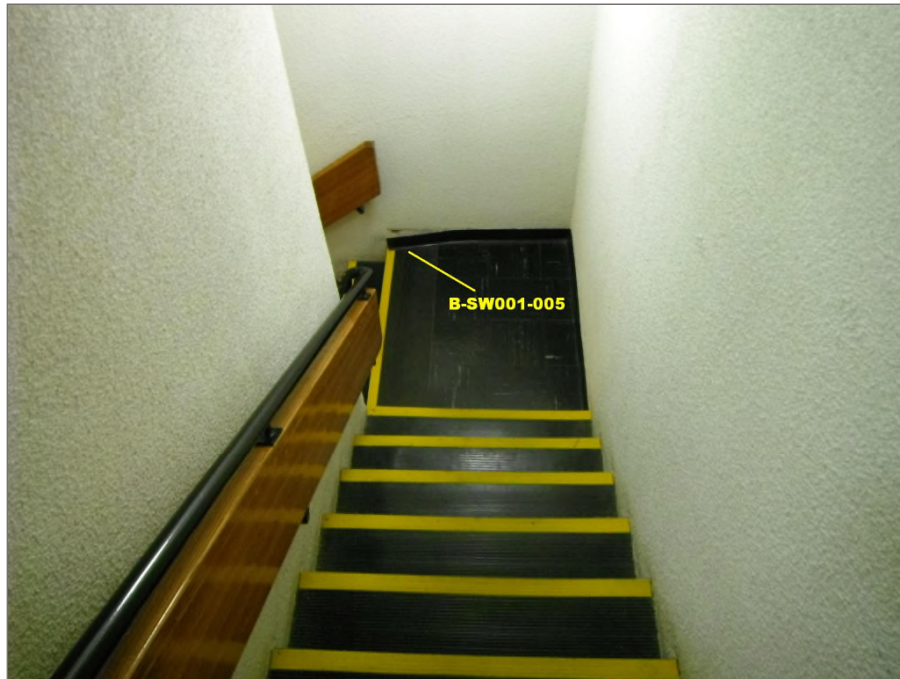
- Asbestos-containing non-friable 12"x12" black with white fleck vinyl floor tiles (Tetra Tech sample B-SW001-005) containing 1.2% chrysotile asbestos. The ACM was located on the landings within the eastern stairwell as shown on Figure 1a totalling approximately 30 m². The ACM was in good condition at the time of assessment as shown in Photo 7 and should be managed in place. The ACM within the stairwell is considered Access (A).

Photo 7: Asbestos-containing 12"x12" black with white fleck vinyl floor tile in eastern stairwell. Tetra Tech sample B-SW001-005.

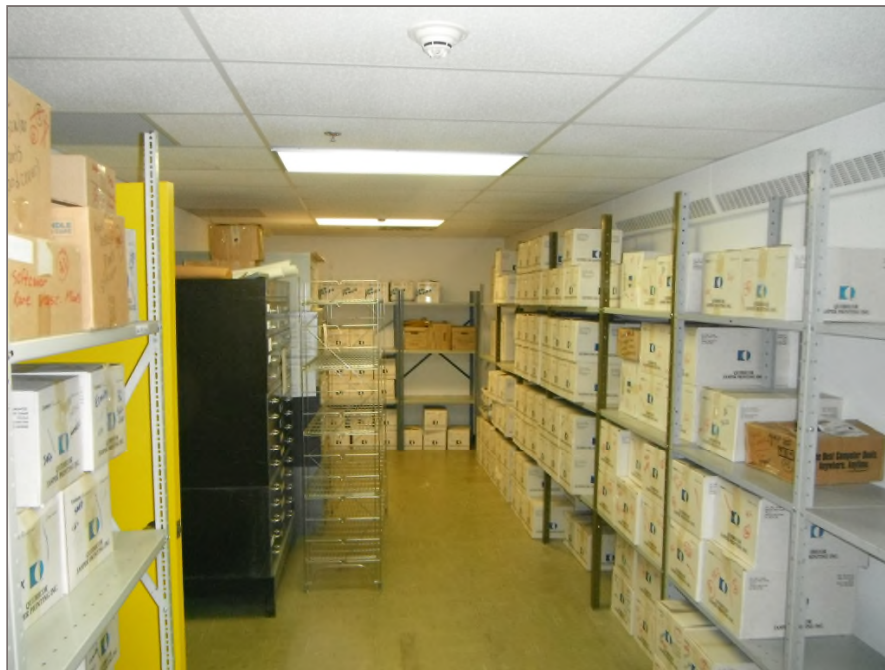
- Asbestos-containing non-friable drywall joint compound (Tetra Tech sample B-008-011) containing 1.6% chrysotile asbestos. The ACM was associated with the column within the publications storage room as shown on Figure 1a totalling approximately 80 m² in total for all columns within the room. The ACM was in good condition at the time of assessment as shown in Photo 8 and should be managed in place. The ACM within the publications storage room is considered Access (A).

Photo 8: Publications room where asbestos-containing drywall joint compound is applied to the columns. Tetra Tech sample B-008-011.

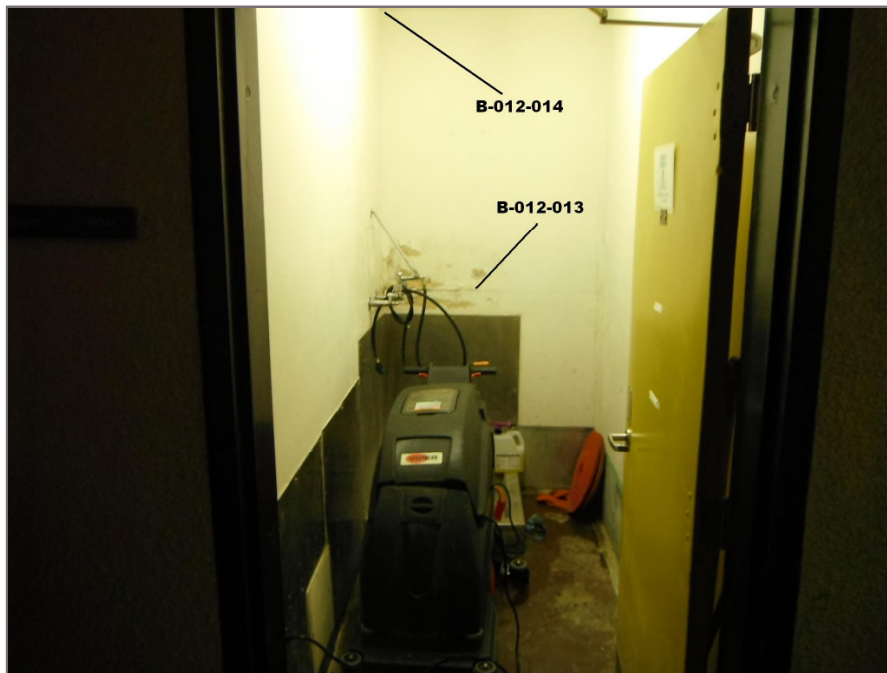
- Asbestos-containing non-friable drywall joint compound (Tetra Tech sample B-012-013/ B-012-014) containing 1.4% and 1.5% chrysotile asbestos applied to the walls and ceiling of the janitorial room as shown on Figures 1a and 1b totalling approximately 80 m². The ACM was in good condition at the time of assessment as shown in Photo 9 and should be managed in place. The ACM within the janitorial room is considered Access (B).

Photo 9: Asbestos-containing drywall joint compound applied to the walls and ceiling of the janitorial room within the basement. Tetra Tech sample B-012-013/014.

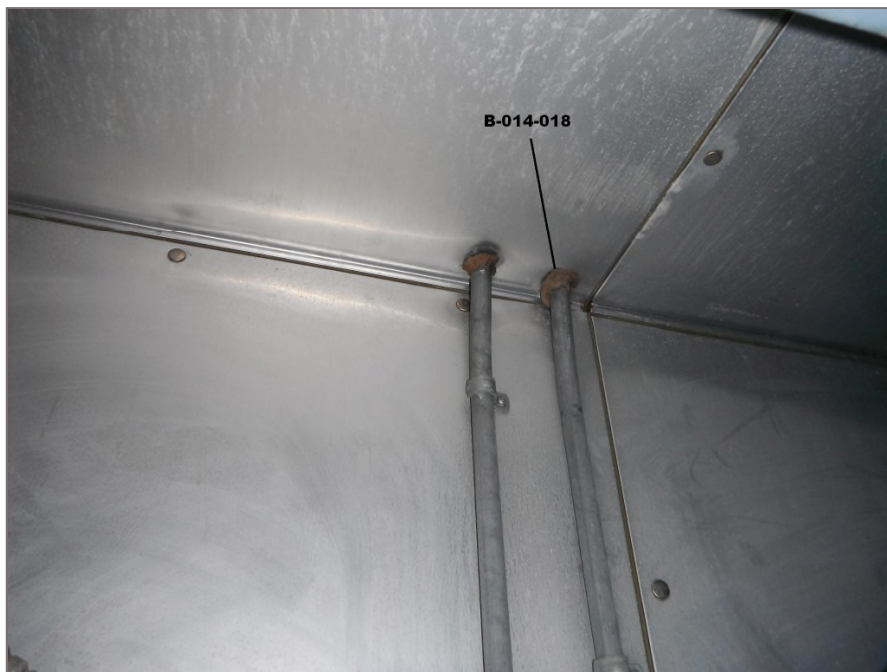
- Asbestos-containing non-friable tan mastic (Tetra Tech sample B-014-018) containing 10% chrysotile asbestos applied at a pipe penetration extending from the ceiling of the walk-in cooler as shown on Figure 1b totalling approximately 0.01 m². The ACM was in good condition at the time of assessment as shown in Photo 10 and should be managed in place. The ACM within the walk-in cooler is considered Access (C) exposed.

Photo 10: Asbestos-containing tan putty applied to the pipe penetration of the walk-in cooler within the basement. Tetra Tech sample B-014-018.

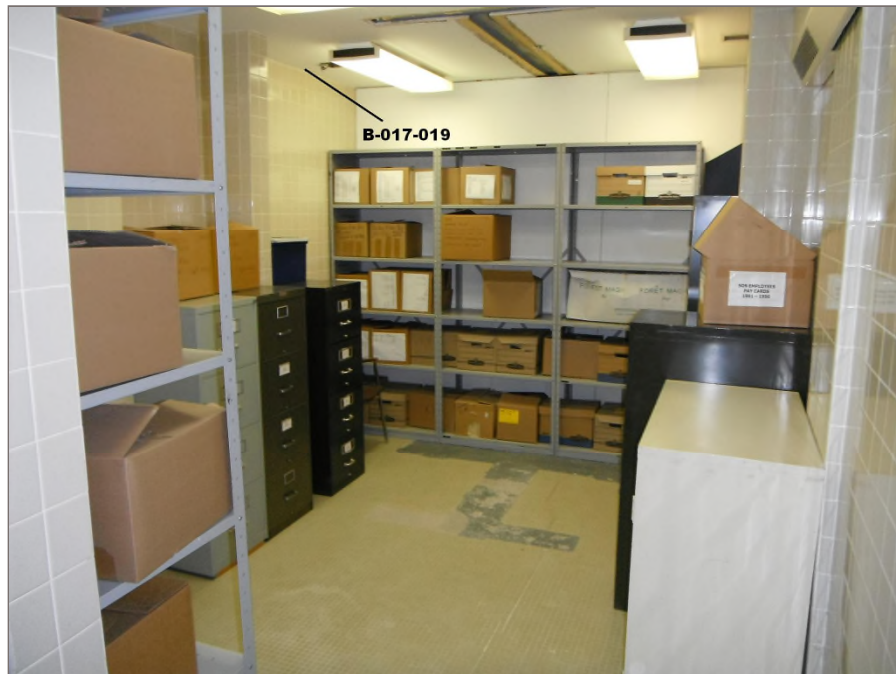
- Asbestos-containing non-friable drywall joint compound (Tetra Tech sample B-017-019) containing 1.3% chrysotile asbestos applied to the ceiling of the storage room as shown on Figure 1b totalling approximately 55 m². The ACM was in fair condition at the time of assessment as shown in Photo 11 and should be patched where there is a penetration or abated in full. The ACM within the storage room is considered Access (C) exposed.

Photo 11: Asbestos-containing drywall joint compound associated with the ceiling of the basement storage room. Tetra Tech sample B-017-019.

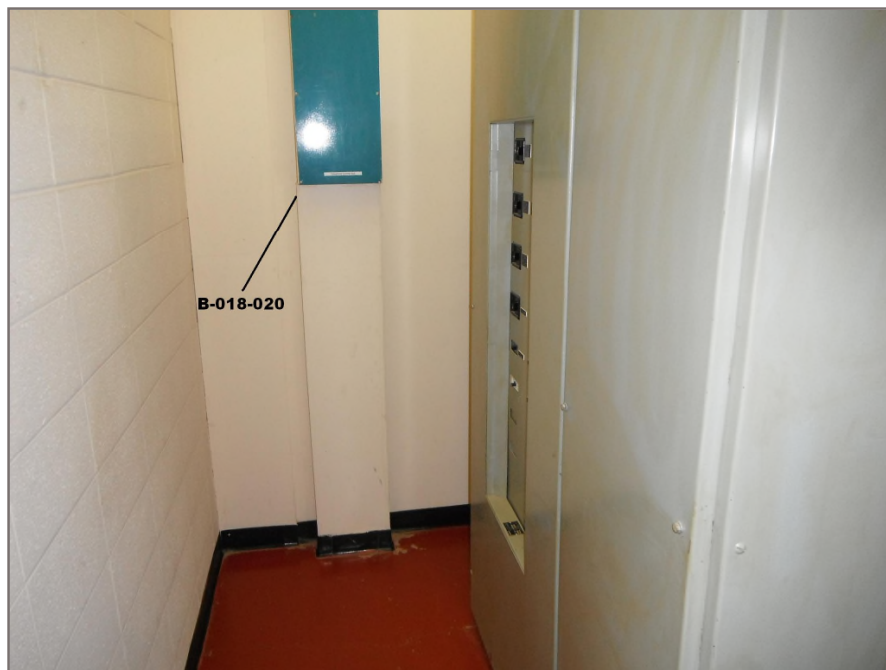
- Asbestos-containing non-friable drywall joint compound (Tetra Tech sample B-018-020) containing 1.9% chrysotile asbestos applied to the column of the electrical room as shown on Figure 1b totalling approximately 100 m² in total for all columns within the room. The ACM was in good condition at the time of assessment as shown in Photo 12 and should be managed in place. The ACM within the electrical room is considered Access (B).

Photo 12: Asbestos-containing drywall joint compound associated with the column in the basement electrical room. Tetra Tech sample B-018-020.

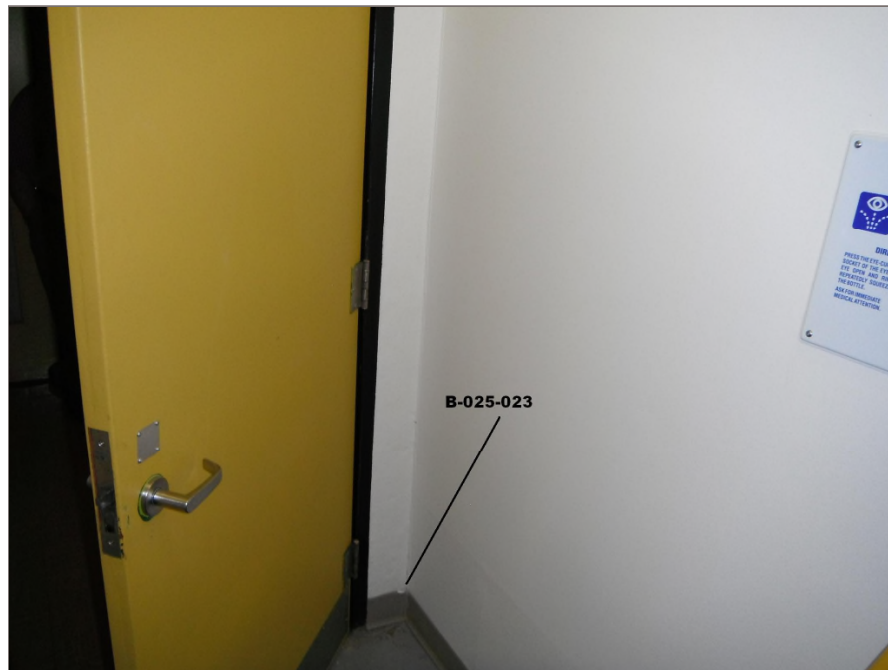
- Asbestos-containing non-friable drywall joint compound (Tetra Tech sample B-025-023) containing 1.4% chrysotile asbestos applied to the wall of the janitorial room as shown on Figures 1a and 1b totalling approximately 100 m². The ACM was in good condition at the time of assessment as shown in Photo 13 and should be managed in place. The ACM within the janitorial room is considered Access (B).

Photo 13: Asbestos-containing drywall joint compound applied to the interior wall of the basement janitor room. Tetra Tech sample B-025-023.

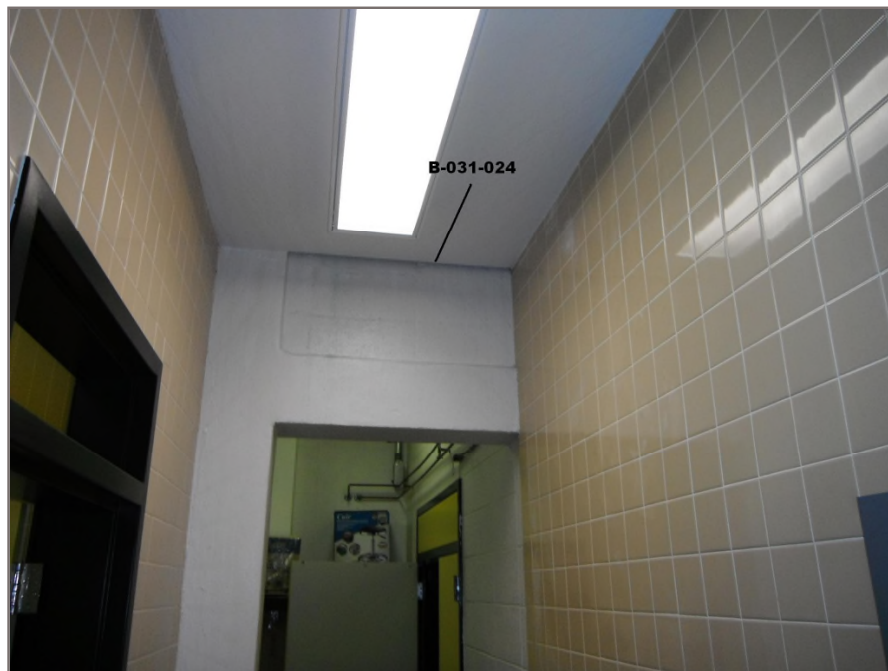
- Asbestos-containing non-friable drywall joint compound (Tetra Tech sample B-031-024) containing 1.2% chrysotile asbestos applied to the ceiling of the cafeteria as shown on Figures 1a and 1b totalling approximately 200 m². The ACM was in good condition at the time of assessment as shown in Photo 14 and should be managed in place. The ACM within the cafeteria is considered Access (C) exposed.

Photo 14: Asbestos-containing drywall joint compound applied to the ceiling of the cafeteria within the basement. Tetra Tech sample B-031-024.

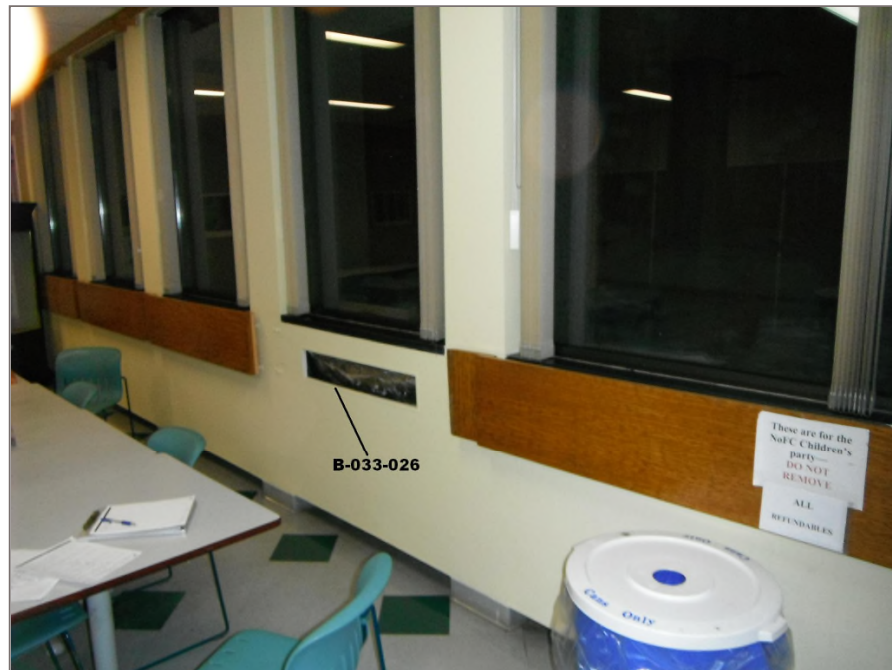
- Asbestos-containing non-friable drywall joint compound (Tetra Tech sample B-033-026) containing 1.9% chrysotile asbestos applied to the perimeter wall of the lunch room as shown on Figure 1a totalling approximately 180 m². The ACM was in good condition at the time of assessment as shown in Photo 15 and should be managed in place. The ACM within the lunch room is considered Access (B).

Photo 15: Asbestos-containing drywall joint compound applied to the perimeter wall of the lunch room within the basement. Tetra Tech sample B-033-026.

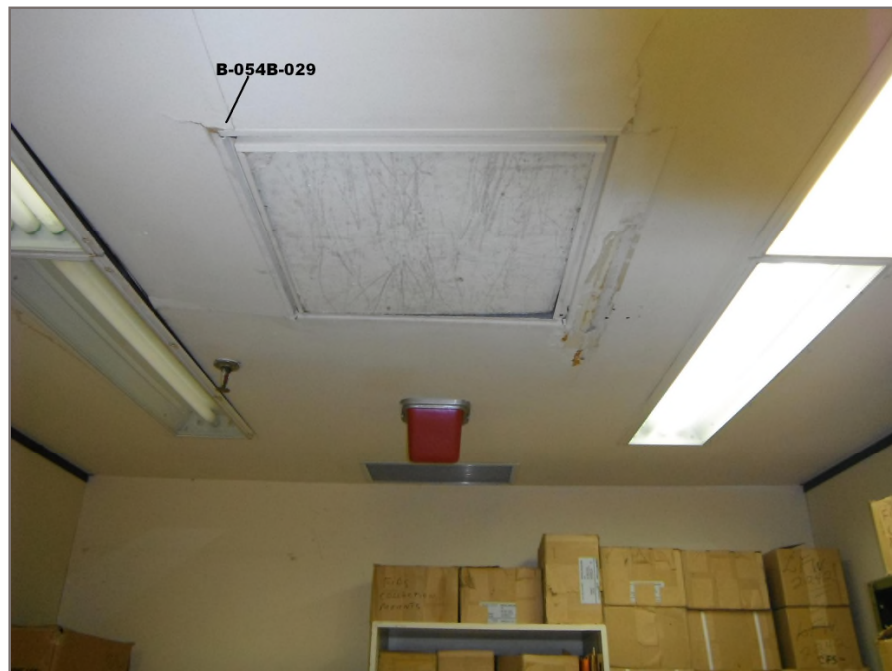
- Asbestos-containing non-friable drywall joint compound (Tetra Tech sample B-054B-029) containing 1.7% chrysotile asbestos applied to the ceiling of the office space as shown on Figures 1a and 1b totalling approximately 100 m². The ACM was in poor condition at the time of assessment as shown in Photo 16 and should be patched, encapsulated or abated in full. The ACM within the office space is considered Access (C) exposed.

Photo 16: Asbestos-containing drywall joint compound applied to the ceiling of the office space within the basement. Tetra Tech sample B-054B-029.

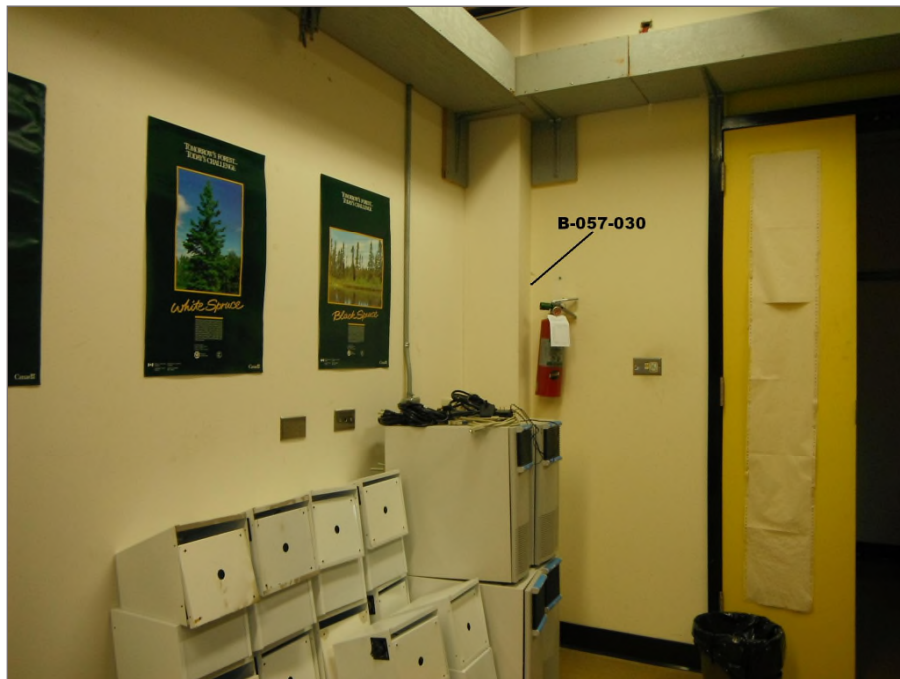
- Asbestos-containing non-friable drywall joint compound (Tetra Tech sample B-057-030) containing 1.3% chrysotile asbestos applied to the column of the telephone room as shown on Figures 1a and 1b totalling approximately 10 m² in total for all columns within the room. The ACM was in good condition at the time of

Photo 17: Asbestos-containing drywall joint compound applied to the column of the telephone room within the basement. Tetra Tech sample B-057-030.

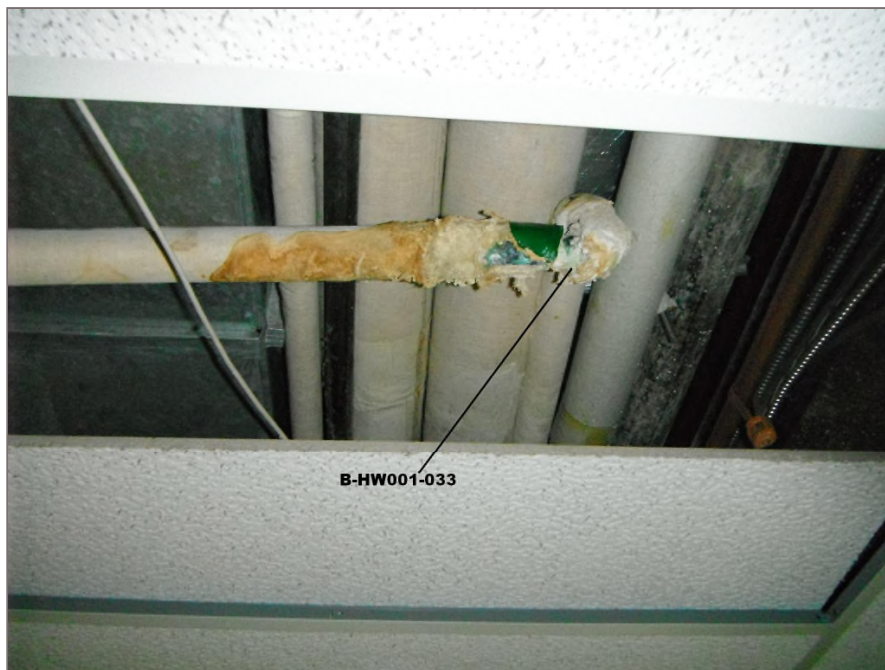
- Asbestos-containing friable mudded insulation (Tetra Tech sample B-HW001-033) containing 10% chrysotile asbestos applied to the elbow of the 2" diameter pipe above the ceiling tiles in the hallway adjacent to the cafeteria as shown on Figure 1a totalling approximately 42 elbows. The ACM was in poor condition at the time of assessment as shown in Photo 18 and should be abated. The ACM within the hallway is considered Access (C) concealed.

Photo 18: Asbestos-containing mudded pipe insulation applied to the elbow of a 2" diameter pipe within the basement hallway. Tetra Tech sample B-HW001-033.

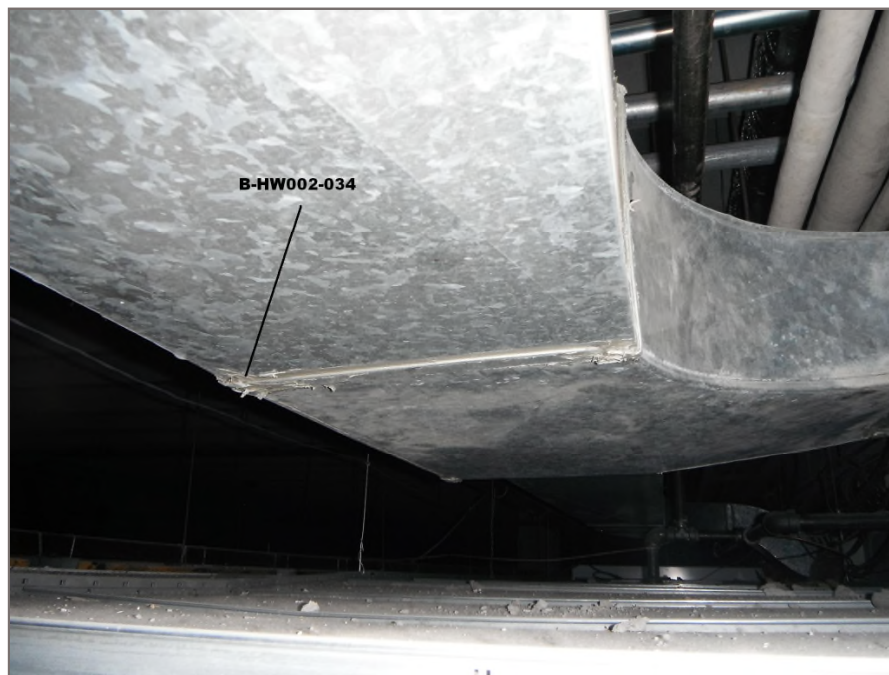
- Asbestos-containing non-friable grey mastic (Tetra Tech sample B-HW002-034) containing 1.5% chrysotile asbestos applied to the square HVAC ducting above the ceiling tiles in the north east hallway as shown on Figures 1a and 1b. The ACM was in good condition at the time of assessment as shown in Photo 19 and should be managed in place. The ACM within the hallway is considered Access (C) concealed.

Photo 19: Asbestos-containing grey mastic applied to the HVAC ducting within the basement hallway ceiling space. Tetra Tech sample B-HW002-034.

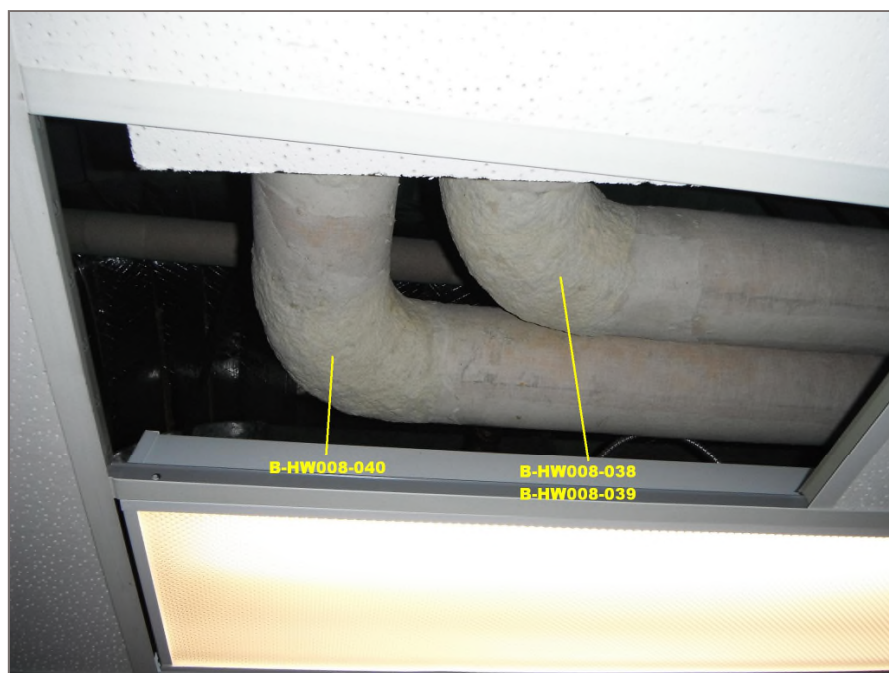
- Asbestos-containing friable mudded insulation (Tetra Tech sample B-HW008-038/ B-HW008-040) containing 10% chrysotile asbestos applied to the elbows of the 4" diameter piping above the ceiling tiles in the hallway adjacent to the service corridors as shown on Figures 1a and 1b totalling approximately 8 elbows. The ACM was in good condition at the time of assessment as shown in Photo 20 and should be managed in place. The ACM within the hallway is considered Access (C) concealed.

Photo 20: Asbestos-containing mudded pipe insulation applied to the elbow of a 4" diameter pipe within the basement hallway ceiling space. Tetra Tech sample B-HW008-038/-040.

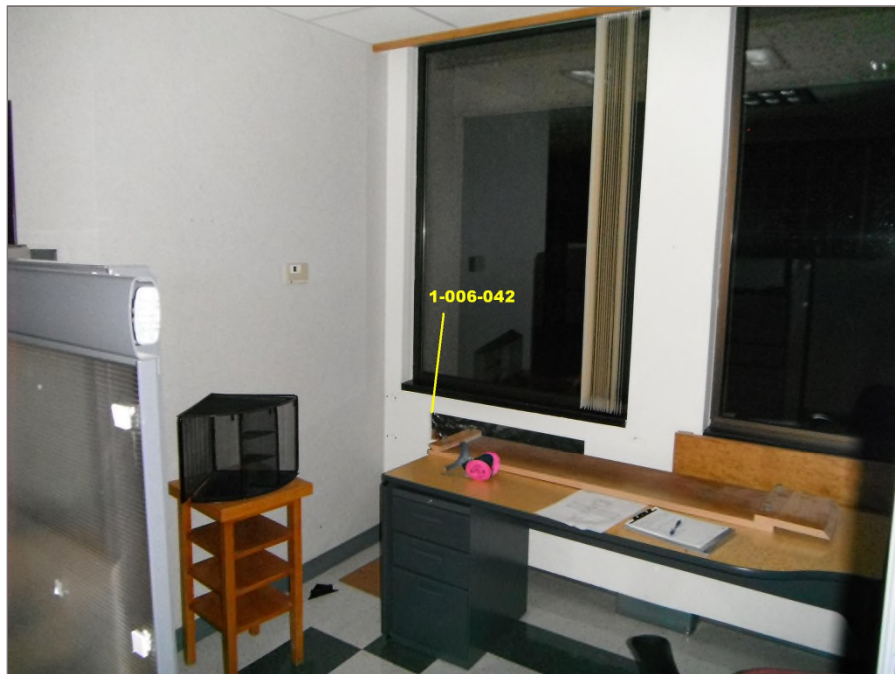
- Asbestos-containing non-friable drywall joint compound (Tetra Tech sample 1-006-042) containing 1.1% chrysotile asbestos applied to the perimeter wall of the cubicle office spaces in the east wing as shown on Figure 2a totalling approximately 380 m². The ACM was in good condition at the time of assessment as shown in Photo 21 and should be managed in place. The ACM within the office space is considered Access (A).

Photo 21: Asbestos-containing drywall joint compound applied to the perimeter wall of a cubicle space in the east wing. Tetra Tech sample 1-006-042.

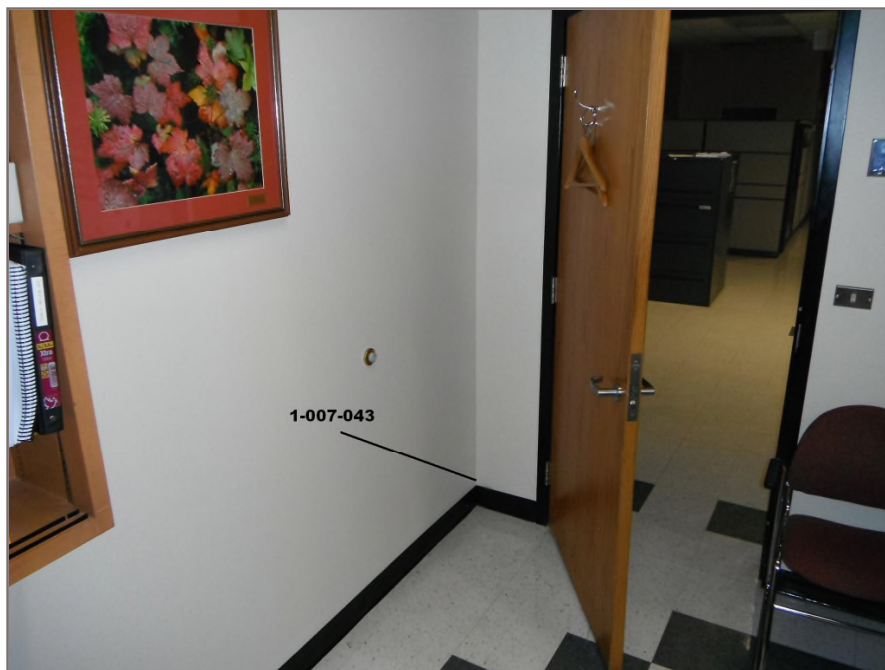
- Asbestos-containing non-friable drywall joint compound (Tetra Tech sample 1-007-043) containing 2.1% chrysotile asbestos applied to the interior wall adjacent to the door of an office within the east wing as shown on Figure 2a totalling approximately 170 m². The ACM was in good condition at the time of assessment as shown in Photo 22 and should be managed in place. The ACM within the office space is considered Access (A).

Photo 22: Asbestos-containing drywall joint compound associated with the interior wall of an office space in the east wing. Tetra Tech sample 1-007-043.

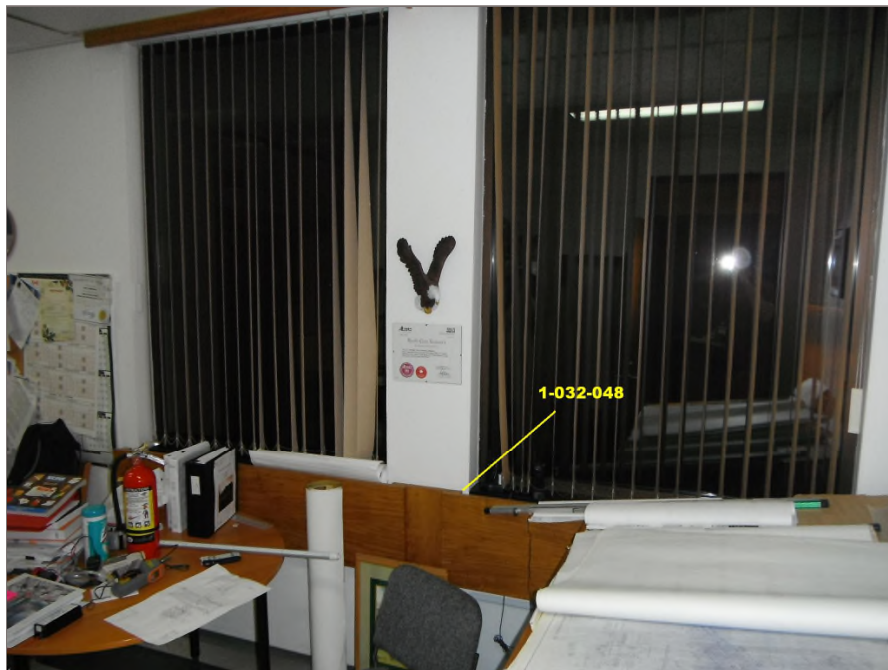
- Asbestos-containing non-friable drywall joint compound (Tetra Tech sample 1-032-048) containing 1.6% chrysotile asbestos applied to the perimeter wall at the window of an office within the central core as shown on Figures 2a and 2b totalling approximately 35 m². The ACM was in good condition at the time of assessment as shown in Photo 23 and should be managed in place. The ACM within the office space is considered Access (A).

Photo 23: Asbestos-containing drywall joint compound associated with the perimeter wall of a first floor office. Tetra Tech sample 1-032-048.

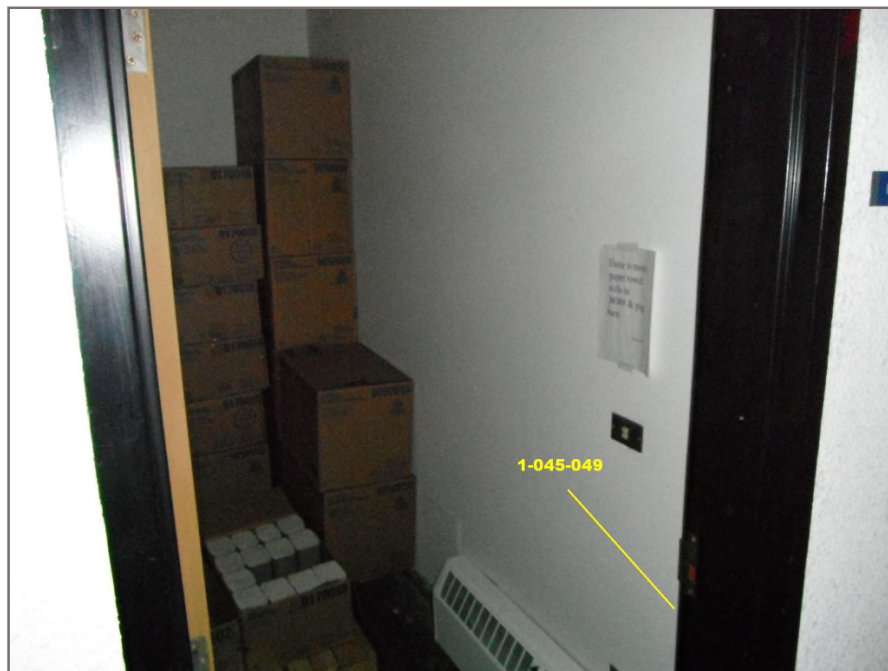
shown on Figure 2a totalling approximately 35 m². The ACM was in good condition at the time of assessment as shown in Photo 24 and should be managed in place. The ACM within the janitorial room is considered Access (A).

Photo 24: Asbestos-containing drywall joint compound applied to the wall of the first floor janitorial room. Tetra Tech sample 1-045-049.

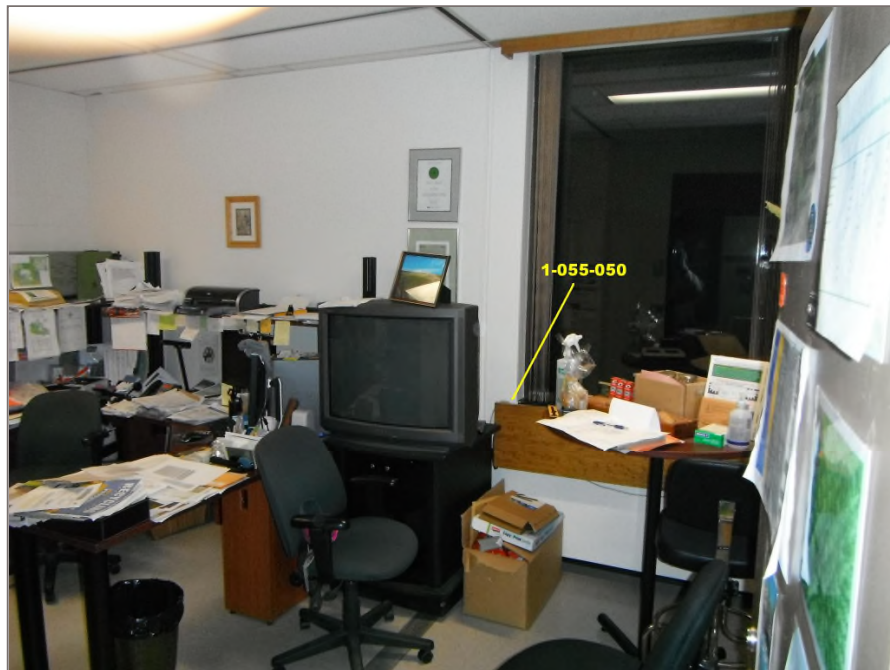
- Asbestos-containing non-friable drywall joint compound (Tetra Tech sample 1-055-050) containing 1.5% chrysotile asbestos applied to the perimeter wall of an office in the central core as shown on Figure 2a totalling approximately 35 m². The ACM was in good condition at the time of assessment as shown in Photo 25 and should be managed in place. The ACM within the office space is considered Access (A).

Photo 25: Asbestos-containing drywall joint compound associated with the perimeter wall of a first floor office. Tetra Tech sample 1-055-050.

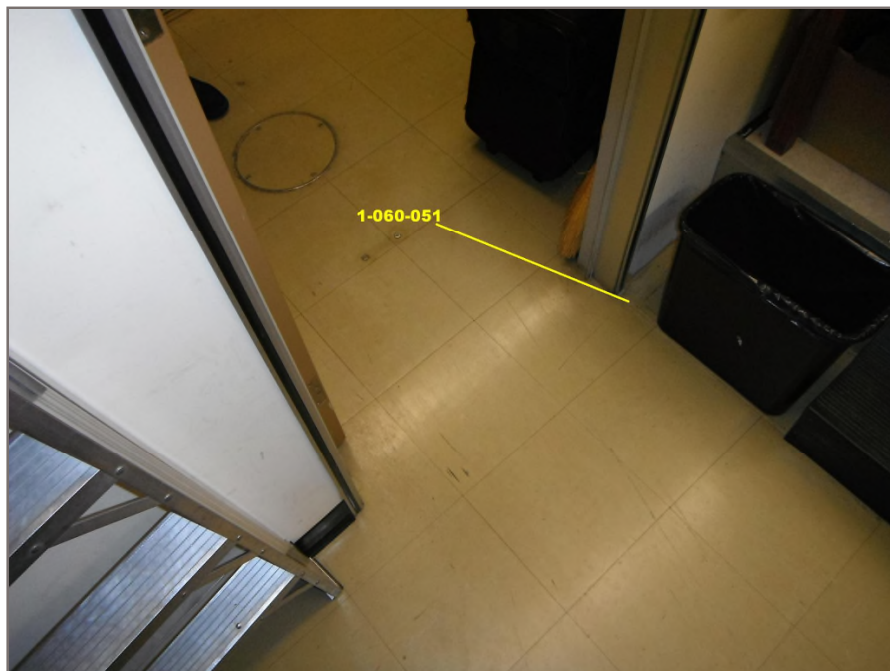
- Asbestos-containing non-friable 12"x12" greenish vinyl floor tiles (Tetra Tech sample 1-060-051) containing 1.1% chrysotile asbestos within an office in the central core as shown on Figure 2a totalling approximately 120 m². The ACM was in good condition at the time of assessment as shown in Photo 26 and should be managed in place. The ACM within the office space is considered Access (A).

Photo 26: Asbestos-containing 12"x12" greenish vinyl floor tiles within a first floor office. Tetra Tech sample 1-060-051.

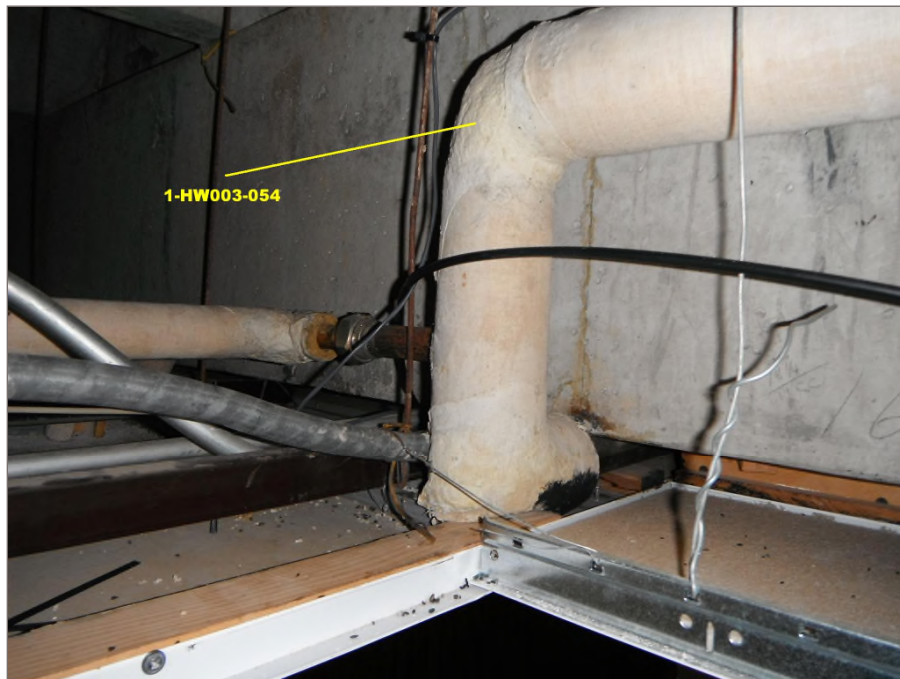
- Asbestos-containing friable mudded pipe insulation (Tetra Tech sample 1-HW003-054) containing 10% chrysotile asbestos applied to the 4" diameter pipe elbow above the ceiling space in the northwest hallway as shown on Figures 2a and 2b totalling approximately 4 elbows. The ACM was in good condition at the time of assessment as shown in Photo 27 and should be managed in place. The ACM within the hallway is considered Access (C) concealed.

Photo 27: Asbestos-containing mudded insulation applied to the elbow of a 4" diameter pipe within the ceiling space of the first floor hallway. Tetra Tech sample 1-HW003-054.

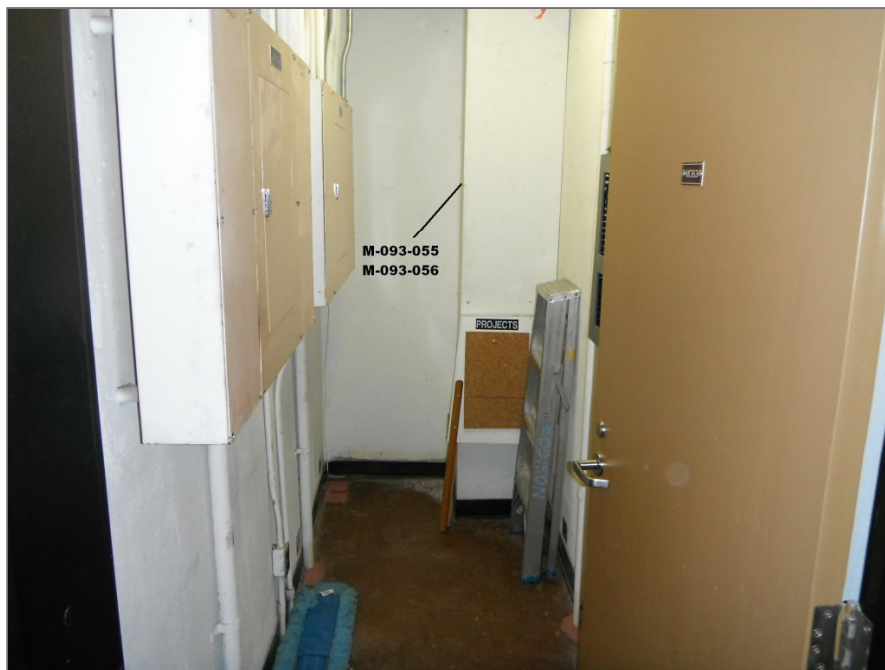
- Asbestos-containing non-friable drywall joint compound (Tetra Tech sample 1-093-055) containing 1.6% chrysotile asbestos applied to the column of the janitorial room as shown on Figure 2a totalling approximately 15 m². The ACM was in good condition at the time of assessment as shown in Photo 28 and should be managed in place. The ACM within the janitorial room is considered Access (B).

Photo 28: Asbestos-containing drywall joint compound associated with the walls of a janitorial room on the first floor. Tetra Tech sample 1-093-055.

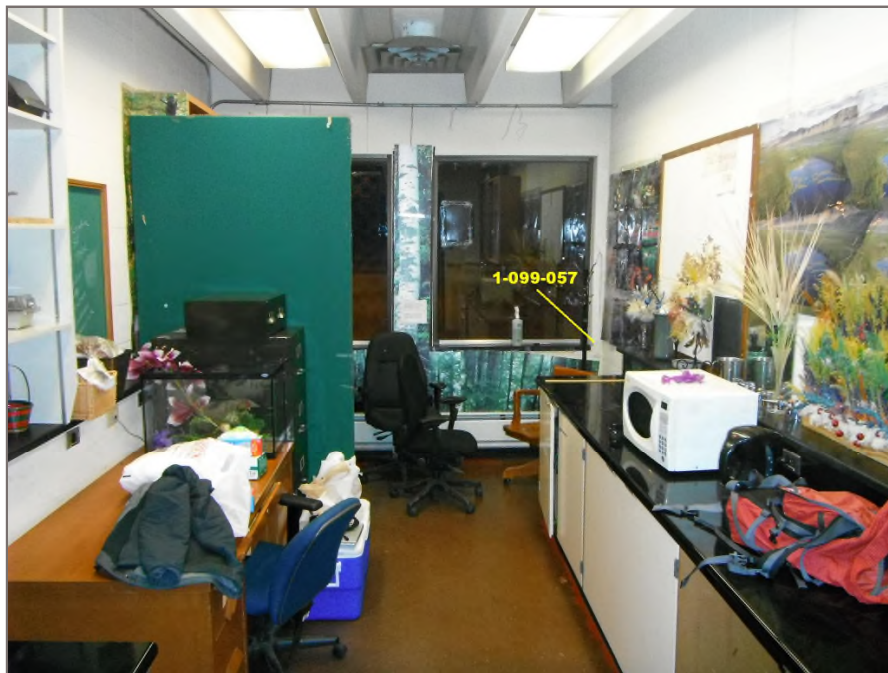
- Asbestos-containing non-friable drywall joint compound (Tetra Tech sample 1-099-057) containing 1.3% chrysotile asbestos applied to the perimeter wall of an office in the central core as shown on Figure 2b totalling approximately 35 m². The ACM was in good condition at the time of assessment as shown in Photo 29 and should be managed in place. The ACM within the office space is considered Access (A).

Photo 29: Asbestos-containing drywall joint compound associated with the perimeter wall of an office on the first floor. Tetra Tech sample 1-099-057.

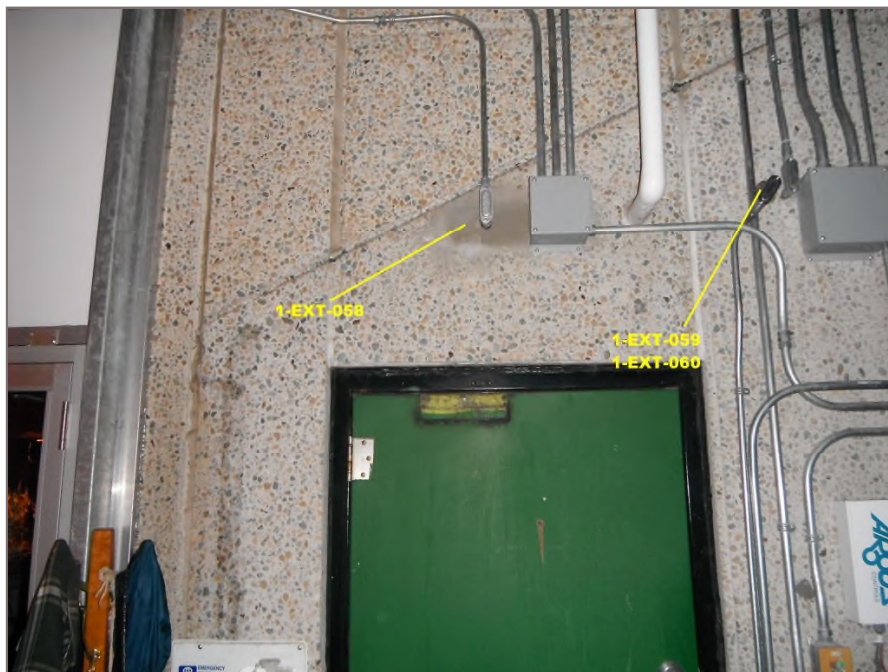
- Asbestos-containing non-friable light grey caulking (Tetra Tech sample 1-EXT-059) containing 1.2% chrysotile asbestos applied to the perimeter separation joints of the pre-cast walls as shown on Figure 2b. The ACM was in good condition at the time of assessment as shown in Photo 30 and should be managed in place. The ACM of the exterior is considered Access (A).

Photo 30: Asbestos-containing light grey caulking applied to the exterior expansion joints of the pre-cast walls. Tetra Tech sample 1-EXT-059.

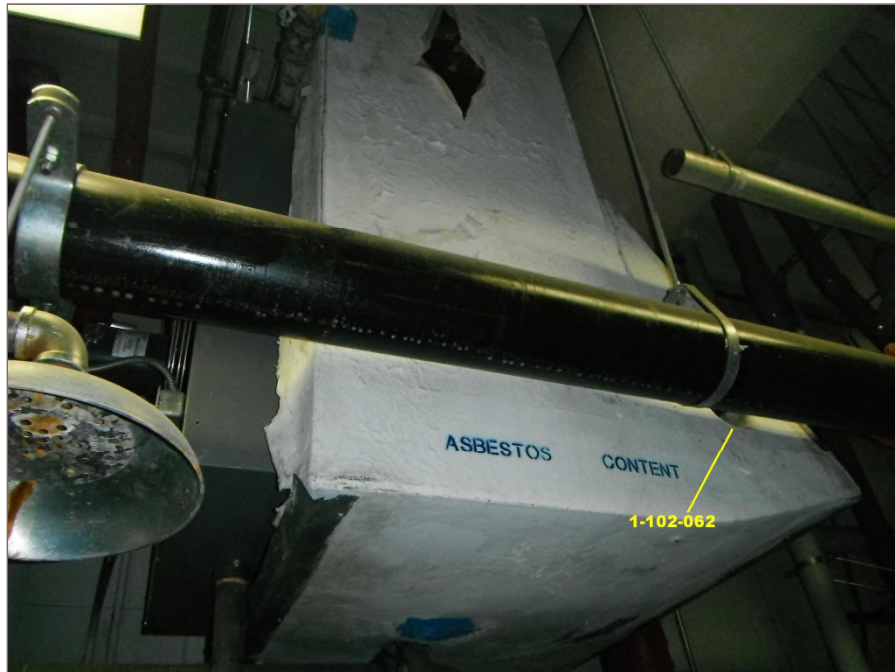
- Asbestos-containing friable mudded insulation (Tetra Tech sample 1-102-062) containing 20% chrysotile asbestos applied to the air handling unit located at the west end of the boiler room as shown on Figure 2b totalling approximately 10 m². The ACM was in poor condition at the time of assessment as shown in Photo 31 and should be repaired, encapsulated or abated. The ACM within the boiler is considered Access (B).

Photo 31: Asbestos-containing mudded insulation applied to the air handling unit located at the west end of the boiler room. Tetra Tech sample 1-102-062.

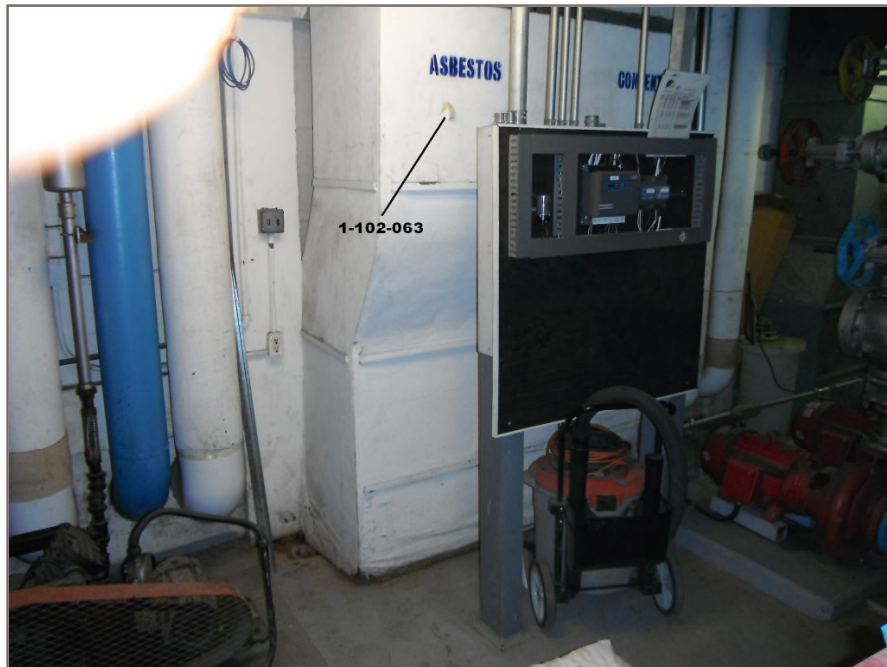
north end of the boiler room as shown on Figure 2b totalling approximately 10 m². The ACM was in poor condition at the time of assessment as shown in Photo 32 and should be repaired, encapsulated or abated. The ACM within the boiler is considered Access (B).

Photo 32: Asbestos-containing mudded insulation applied to the air handling unit located at the north end of the boiler room. Tetra Tech sample 1-102-063.

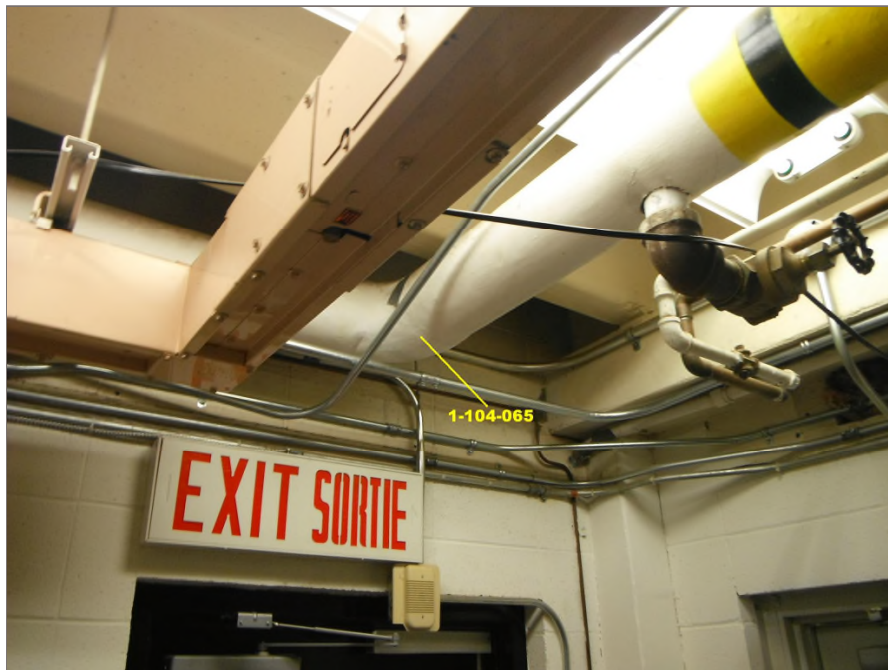
- Asbestos-containing friable mudded insulation (Tetra Tech sample 1-104-065) containing 50% chrysotile asbestos applied to the 6" diameter pipe elbow within the laboratory as shown on Figure 2b totalling approximately 3 elbows. The ACM was in good condition at the time of assessment as shown in Photo 33 and should be managed in place. The ACM within the laboratory is considered Access (A).

Photo 33: Asbestos-containing mudded insulation applied to the 6" diameter pipe elbow within the laboratory. Tetra Tech sample 1-104-065.

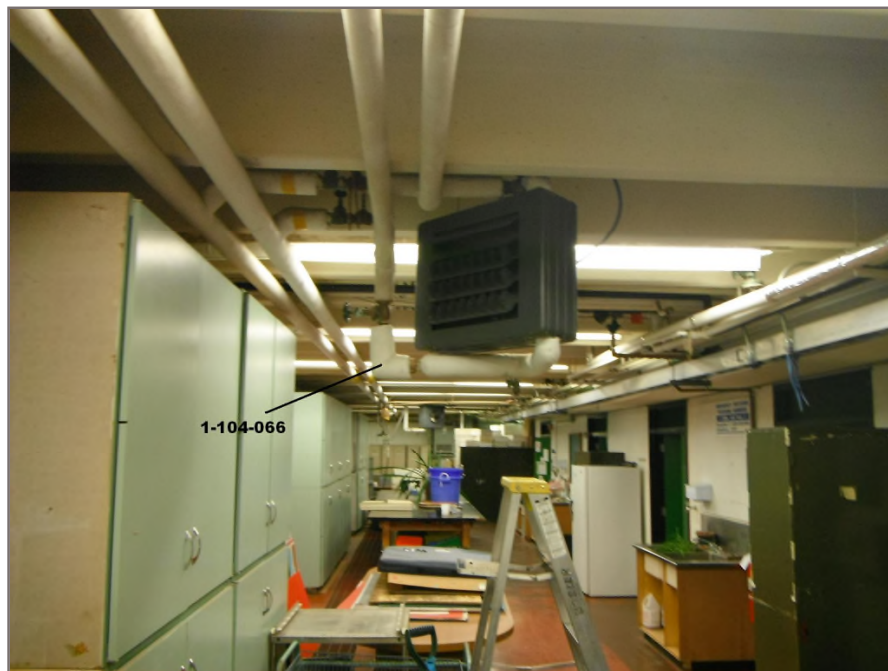
Photo 34: Asbestos-containing mudded insulation applied to the 2" diameter pipe elbow within the laboratory. Tetra Tech sample 1-104-066.

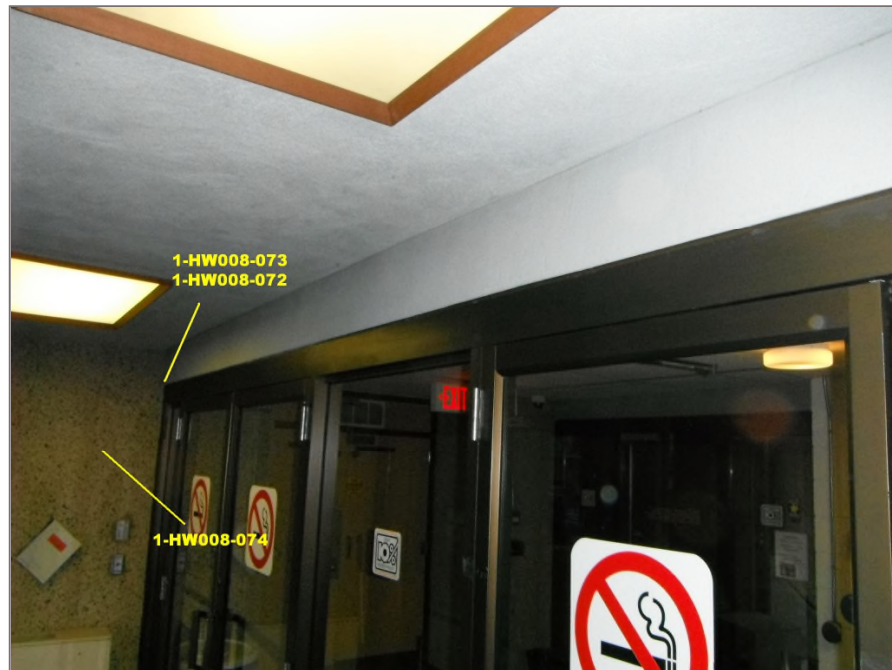
Photo 35: Asbestos-containing brown mastic applied to the door frame of the northwest entrance. Tetra Tech sample 1-HW008-072.
