**Asbestos-Containing Building Materials
Survey
Natural Resources Canada
Northern Forestry Building
Edmonton, Alberta**

Document No. 1318900400-REP-V0001-02

PWGSC Project No.: R.061377.001

JUNE 2013

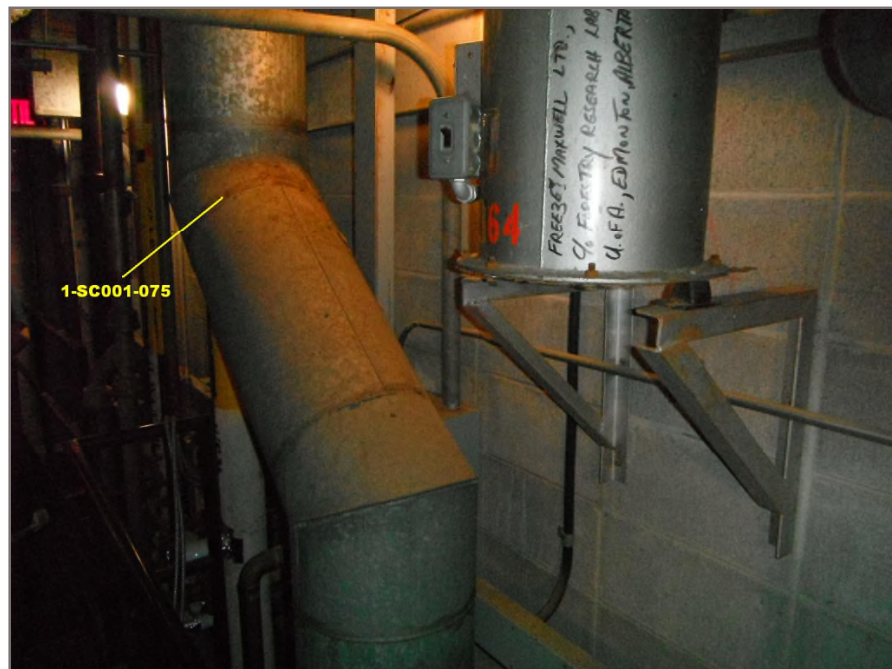
Photo 36: Asbestos-containing silver mastic applied to the 16" diameter pipe within the south service corridor of the first floor. Tetra Tech sample 1-SC001-075.

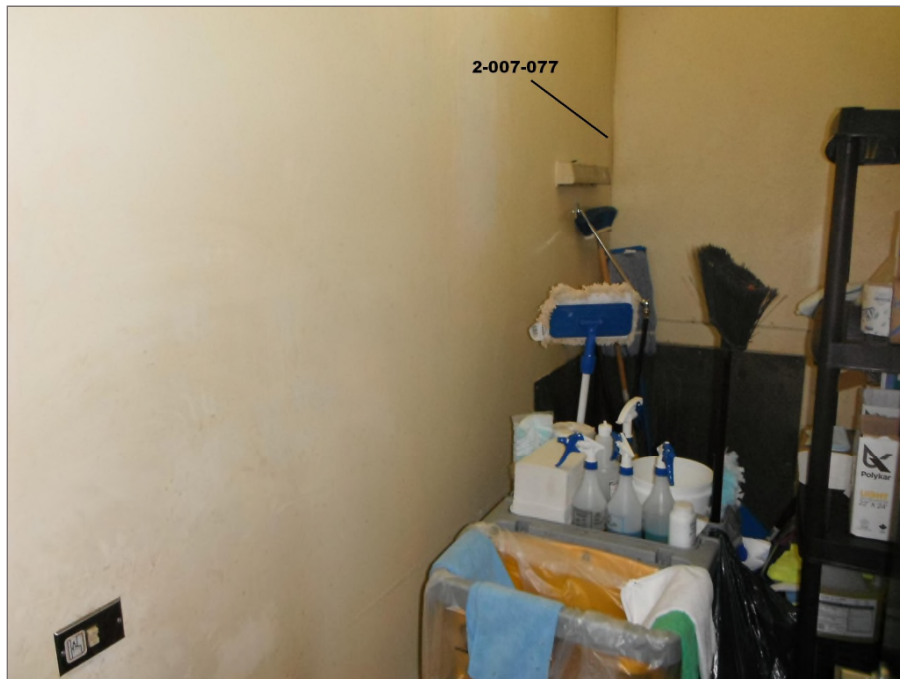
Photo 37: Asbestos-containing drywall joint compound applied to the interior wall of the second floor janitorial room. Tetra Tech sample 2-007-077.

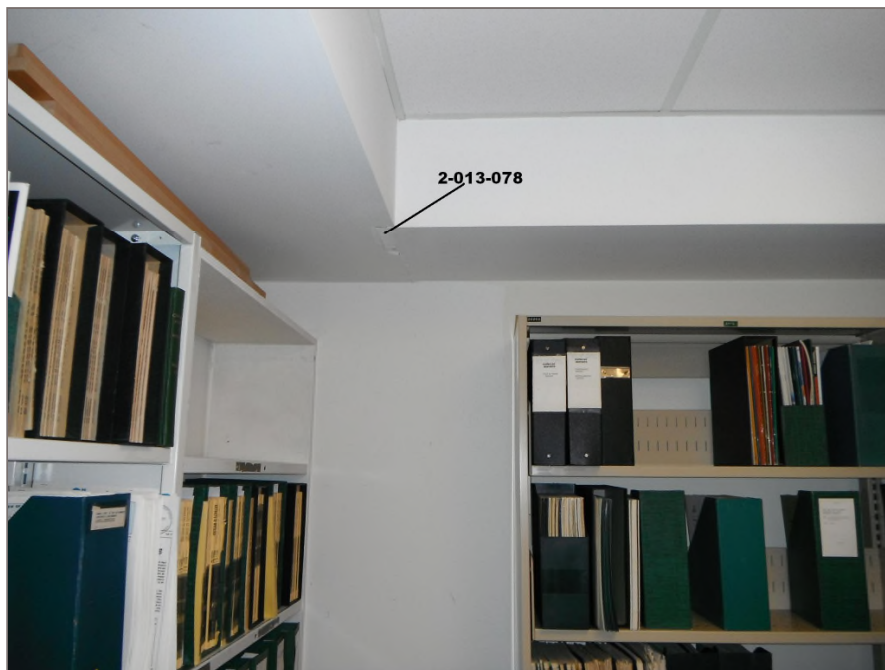
Photo 38: Asbestos-containing drywall joint compound applied to the bulkhead of the second floor library. Tetra Tech sample 2-013-078.

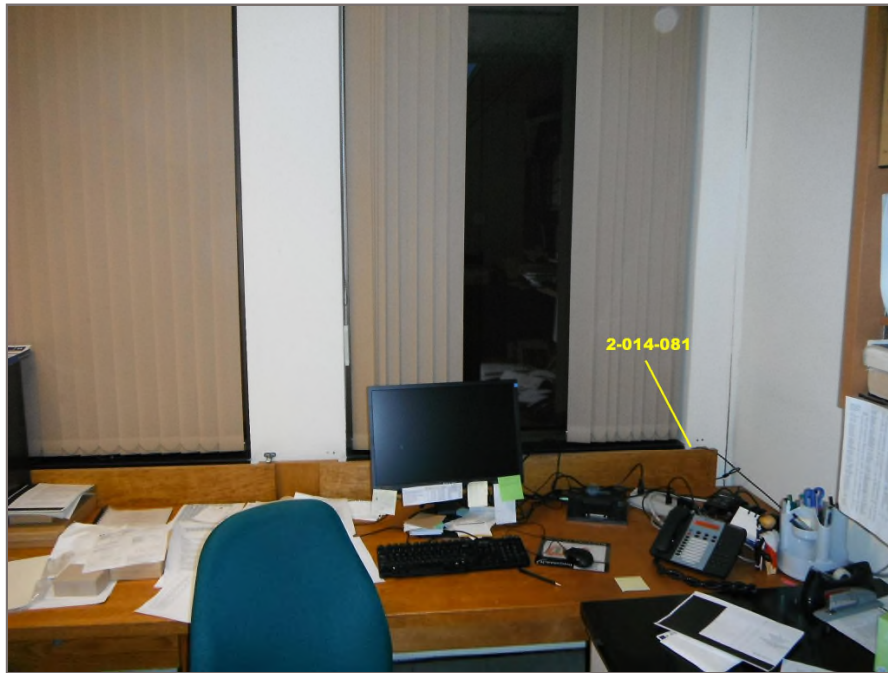
Photo 39: Asbestos-containing drywall joint compound applied to the interior wall of a second floor office. Tetra Tech sample 2-014-081.

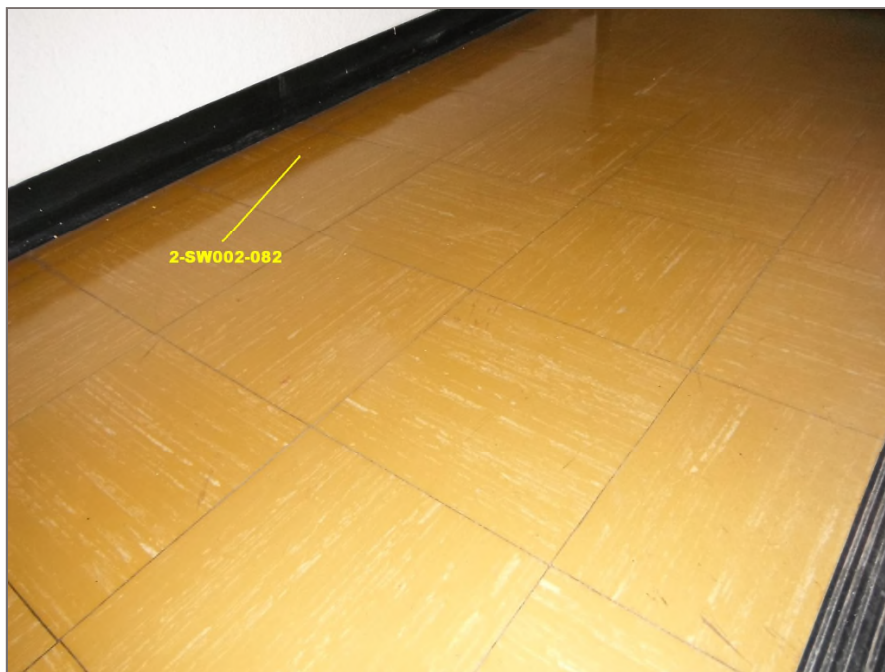
Photo 40: Asbestos-containing 12"x12" olive vinyl floor tiles within the southwestern stairwell. Tetra Tech sample 2-SW002-082.

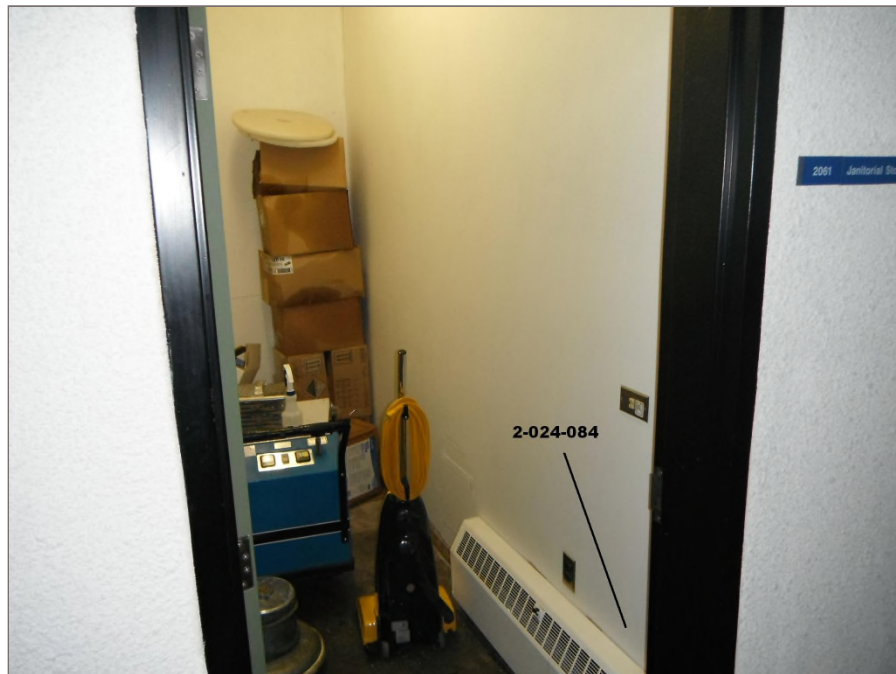
Photo 41: Asbestos-containing drywall joint compound applied to the interior wall of the second floor janitorial room. Tetra Tech sample 2-024-084.

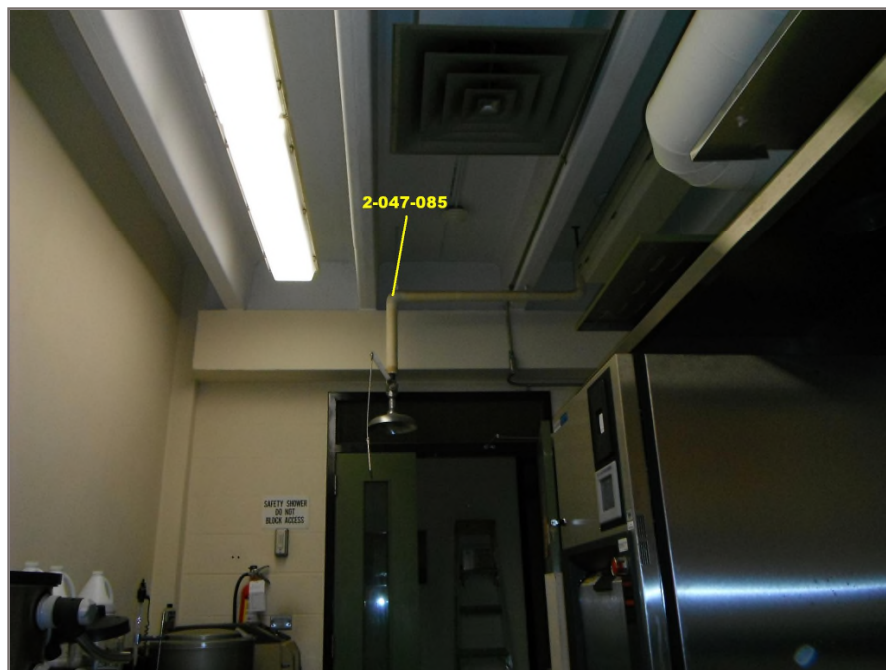
Photo 42: Asbestos-containing mudded insulation applied to the 2" diameter pipe elbow within the second floor laboratory. Tetra Tech sample 2-047-085.

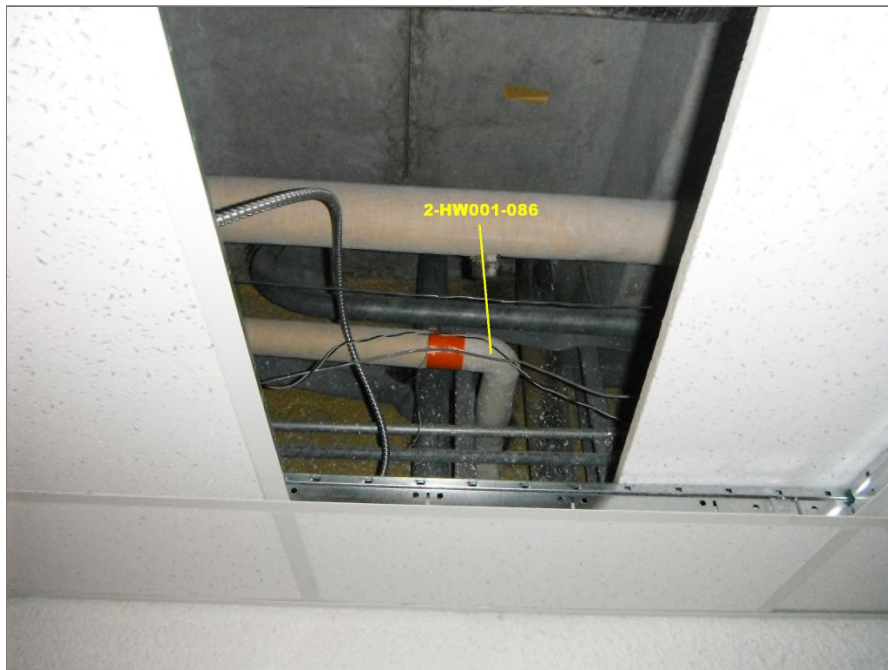
Photo 43: Asbestos-containing mudded insulation applied to the 2" diameter pipe elbow within the northeastern hallway of the second floor. Tetra Tech sample 2-HW001-086.

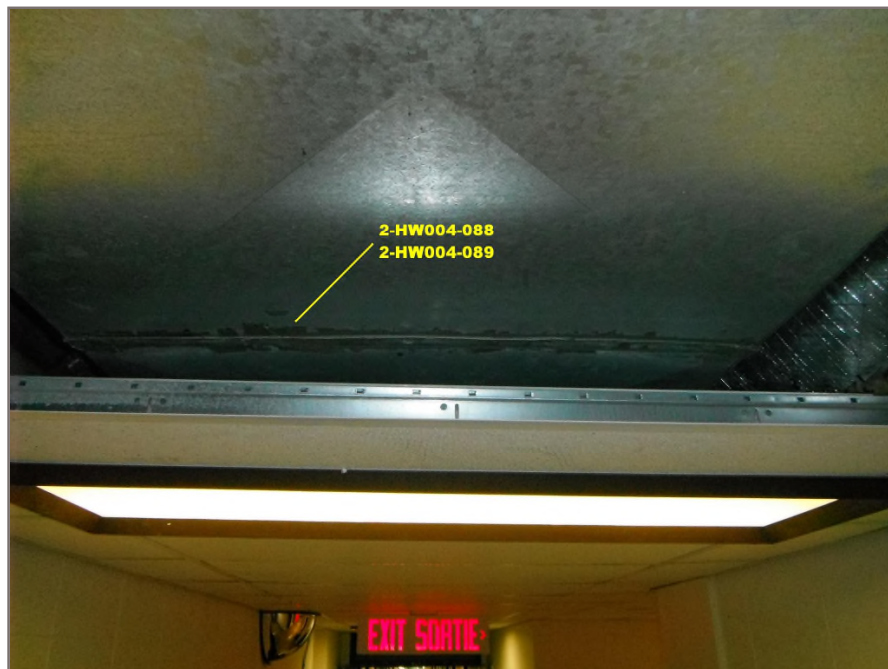
Photo 44: Asbestos-containing grey mastic applied to the square HVAC ducting within the southwestern hallway of the second floor. Tetra Tech sample 2-HW004-088.

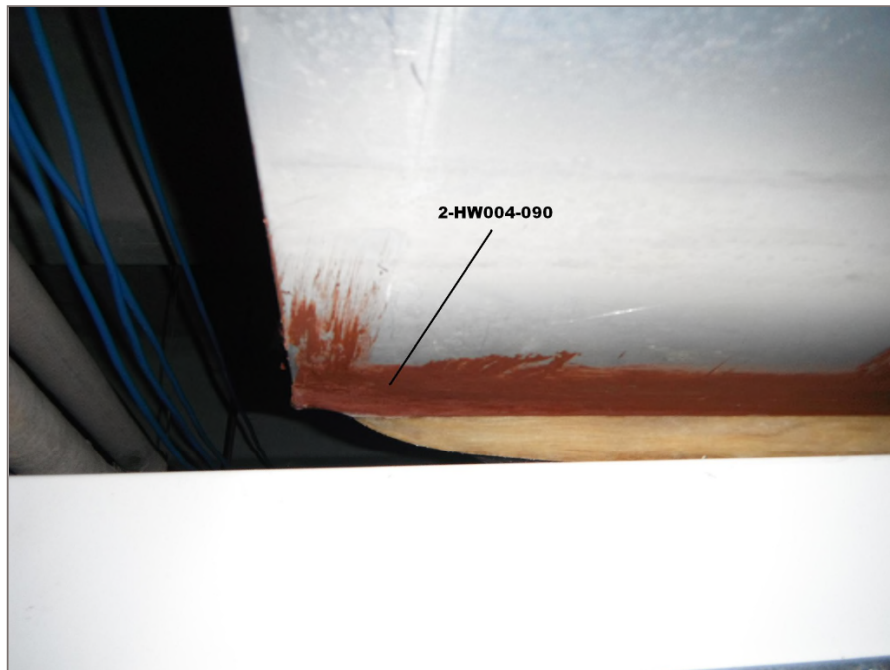
Photo 45: Asbestos-containing red mastic applied to the square HVAC ducting within the southwestern hallway of the second floor. Tetra Tech sample 2-HW004-090.

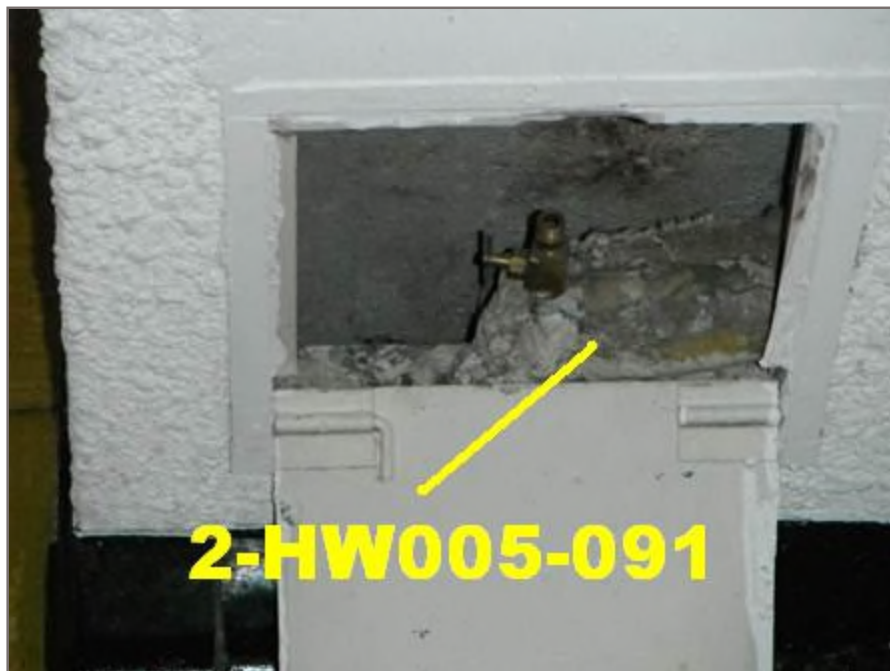
Photo 46: Asbestos-containing mudded insulation applied to the 2" diameter pipe elbow within the south hallway perimeter wall. Tetra Tech sample 2-HW005-091.

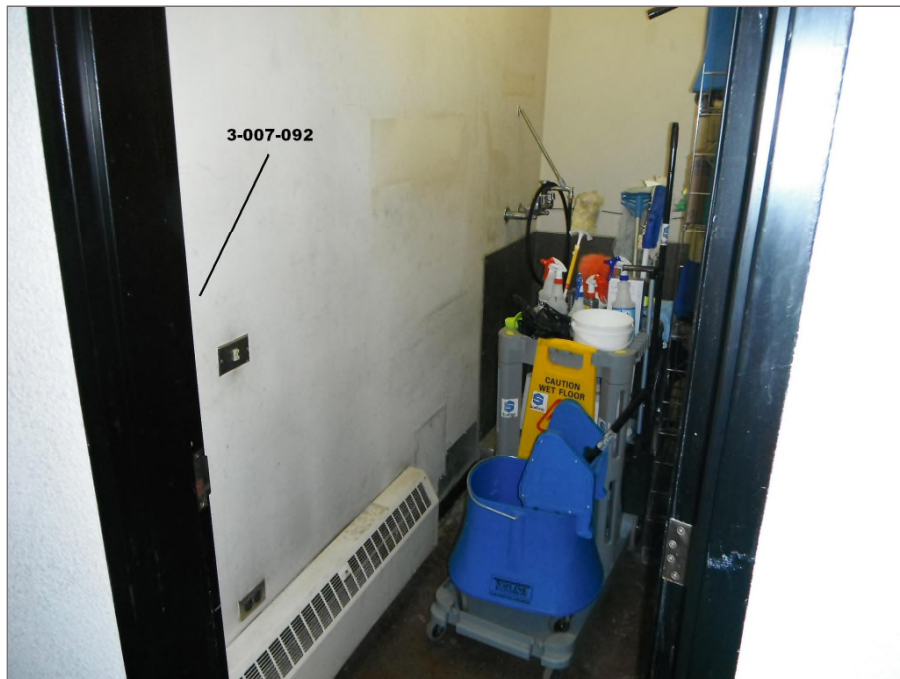
condition at the time of assessment as shown in Photo 47 and should be managed in place. The ACM within the janitorial room is considered Access (B).

Photo 47: Asbestos-containing drywall joint compound applied to the interior wall of the janitorial room on the third floor. Tetra Tech sample 3-007-092.

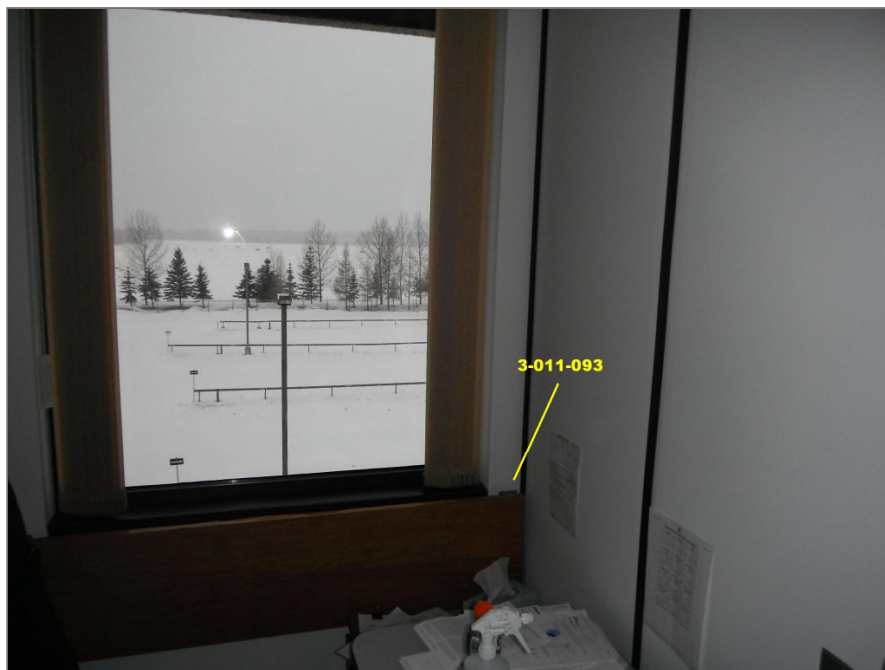
Photo 48: Asbestos-containing drywall joint compound applied to the office perimeter wall on the second floor. Tetra Tech sample 3-011-093.

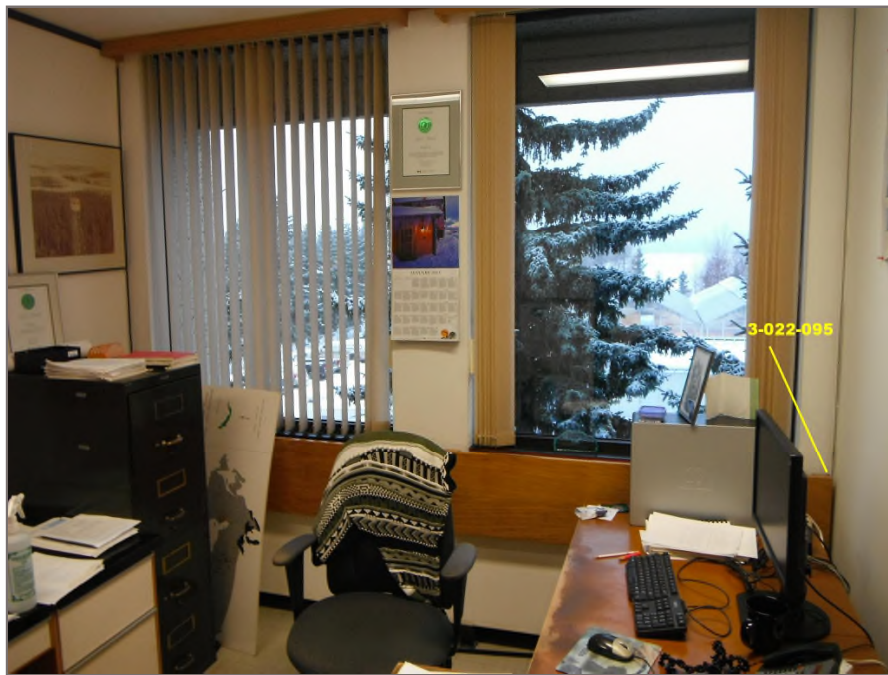
Photo 49: Asbestos-containing drywall joint compound applied to the office perimeter wall on the third floor. Tetra Tech sample 3-022-095.

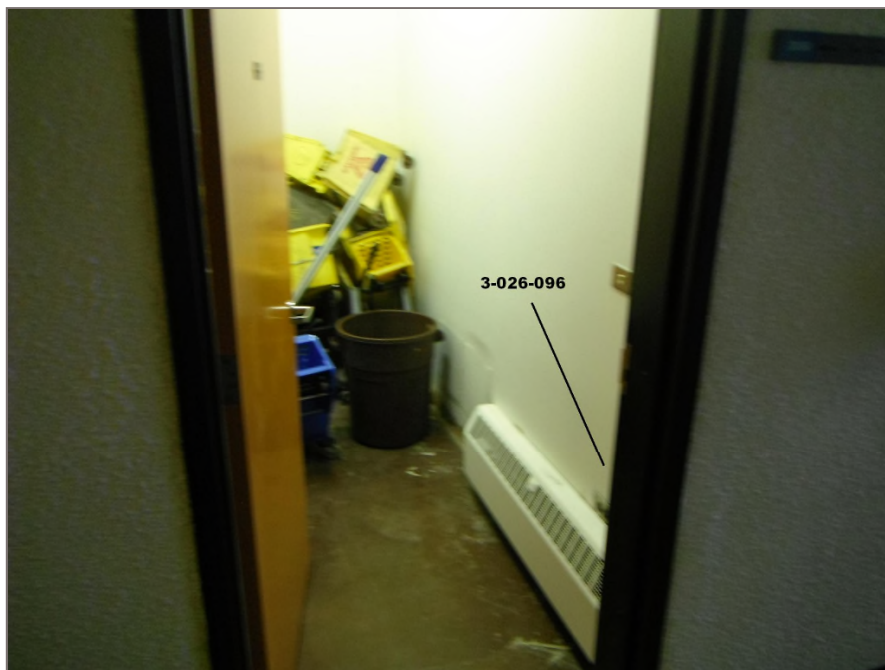
Photo 50: Asbestos-containing drywall joint compound applied to the interior wall of the janitorial room on the third floor. Tetra Tech sample 3-026-096.

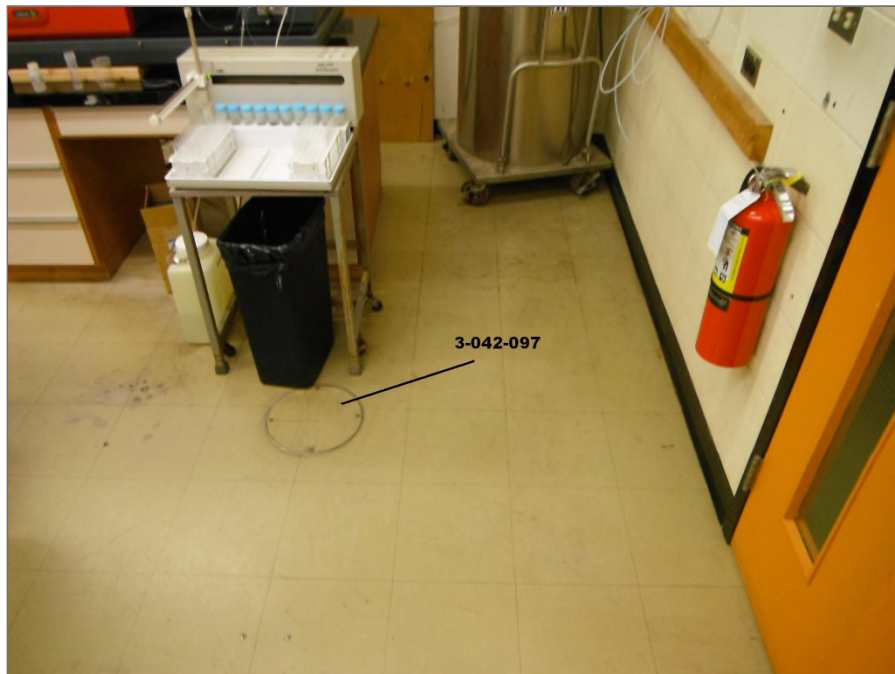
Photo 51: Asbestos-containing 12"x12" greenish with white vinyl floor tiles within a third floor laboratory. Tetra Tech sample 3-042-097.

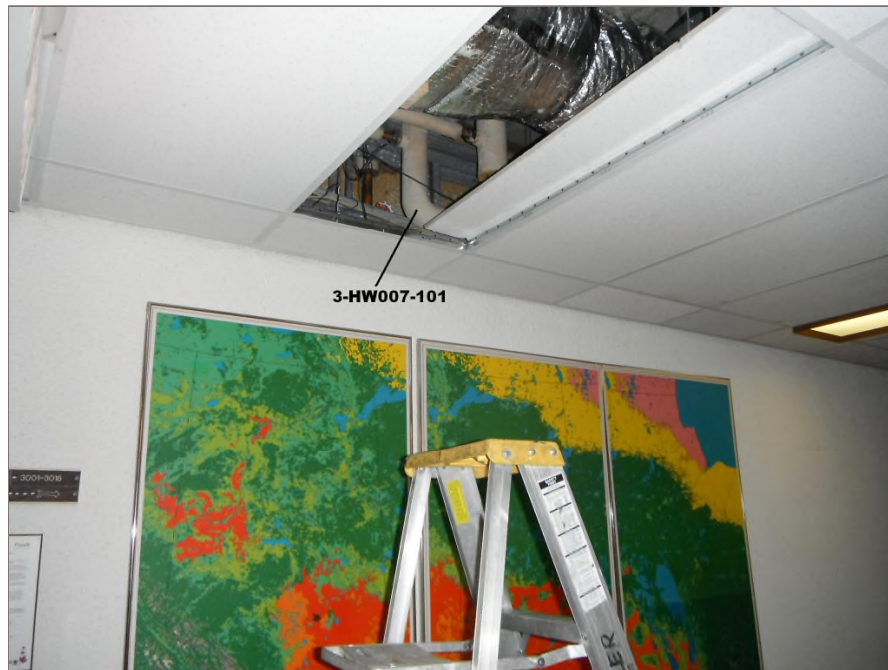
Photo 53: Asbestos-containing mudded insulation applied to the 2" diameter pipe elbow within the third floor central hallway ceiling space. Tetra Tech sample 3-HW007-101.

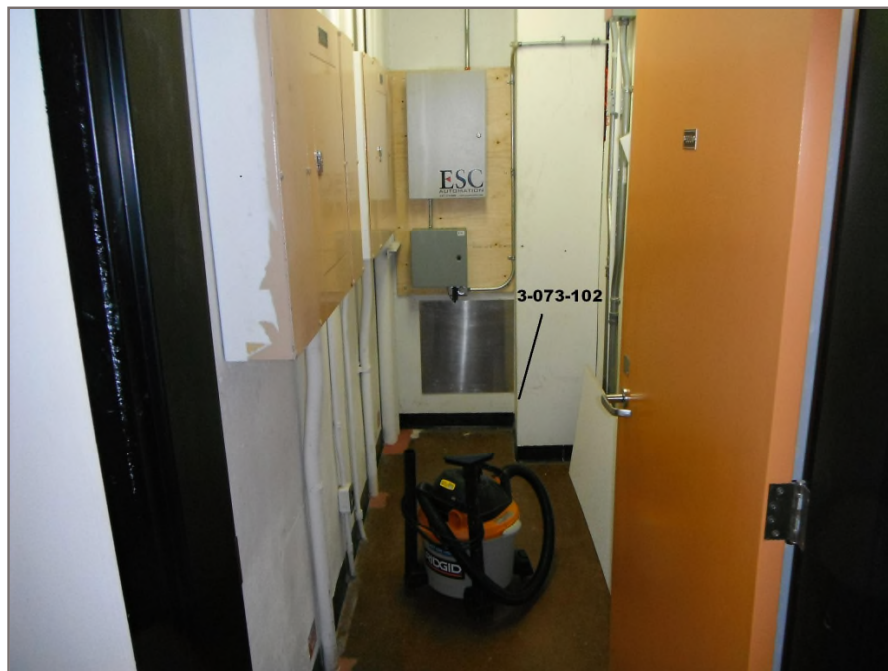
Photo 54: Asbestos-containing drywall joint compound applied to the interior column of the third floor janitorial room. Tetra Tech sample 3-073-102.

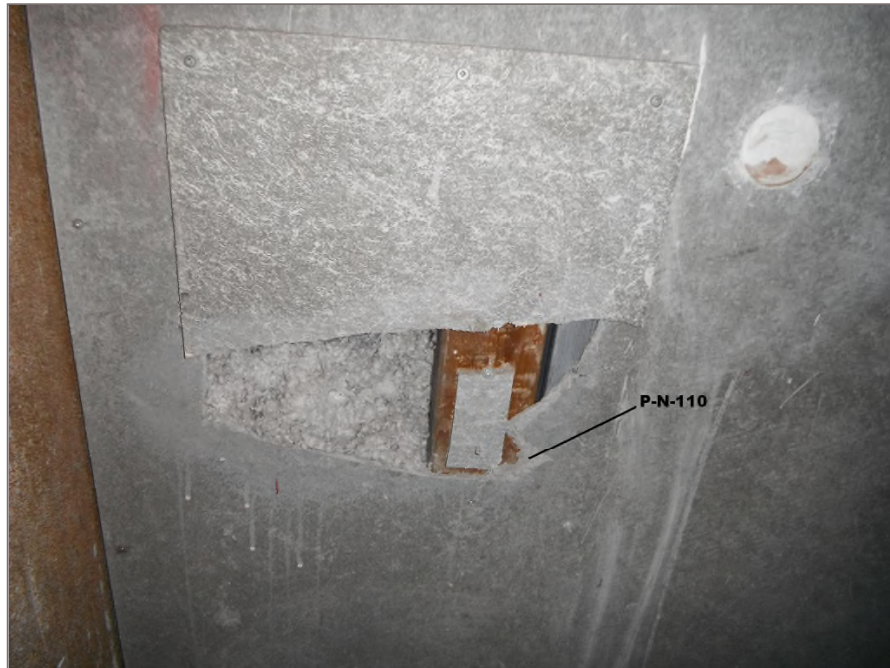
Photo 55: Asbestos-containing transite cement board applied to the perimeter walls of the penthouse. Tetra Tech sample P-N-110.

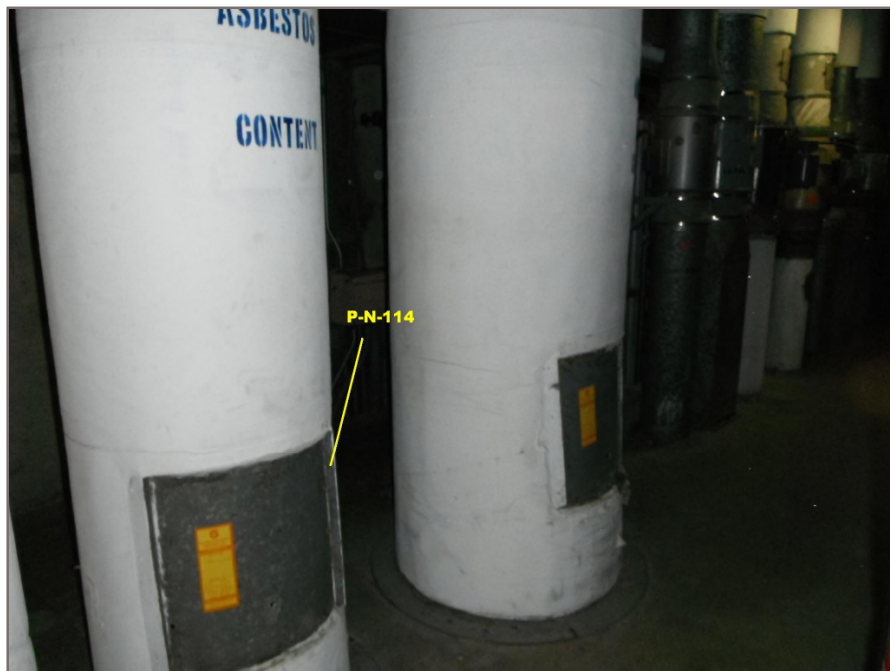
Photo 56: Asbestos-containing mudded mechanical insulation applied to the 24" diameter pipe within the penthouse. Tetra Tech sample P-N-114.

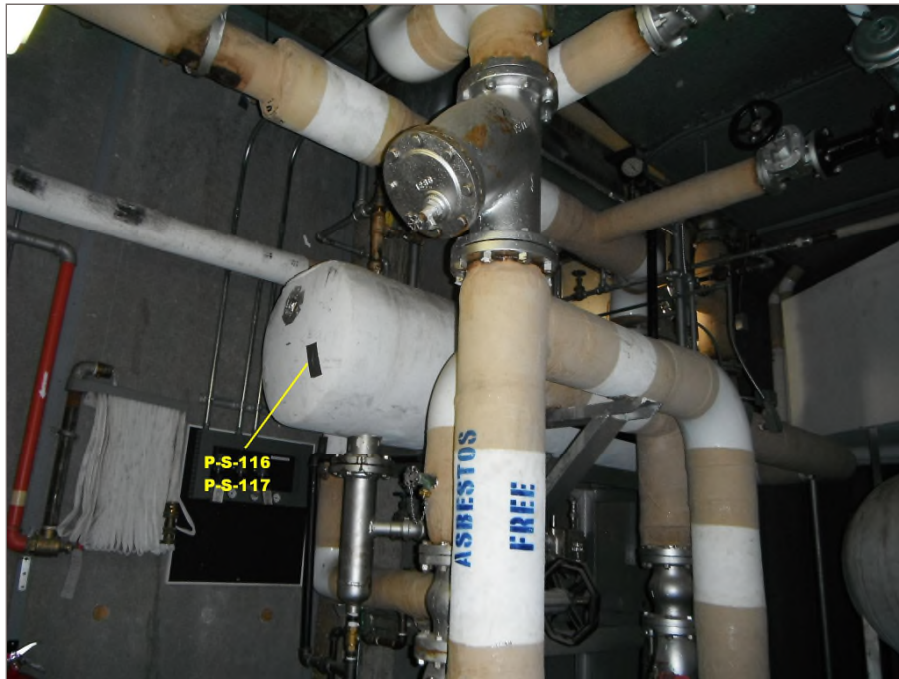
Photo 57: Asbestos-containing mudded mechanical insulation applied to the glycol heat exchanger within the penthouse. Tetra Tech sample P-S-116.

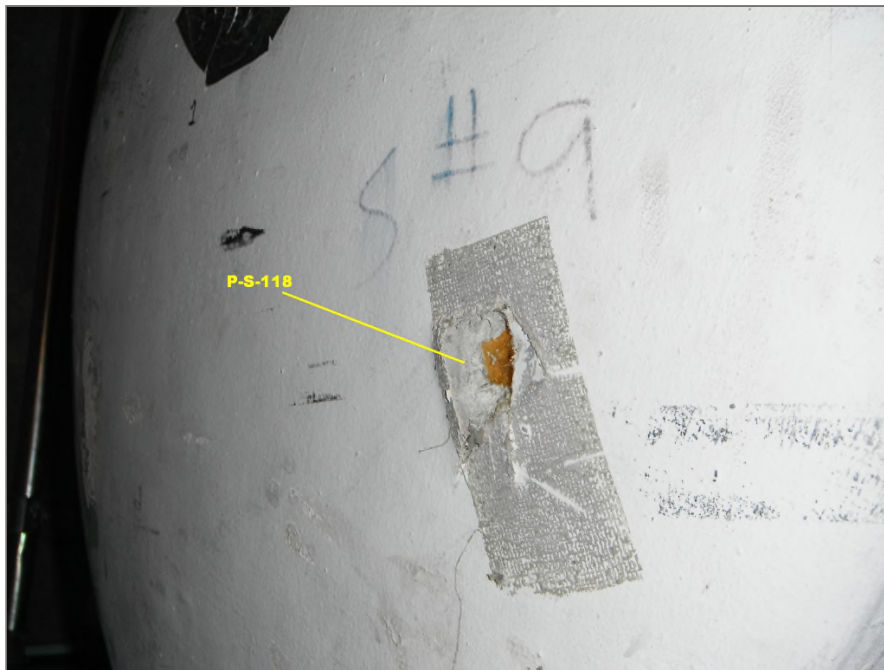
Photo 58: Asbestos-containing mudded mechanical insulation applied to the AHU #2 cold and hot decks within the penthouse. Tetra Tech sample P-S-118.

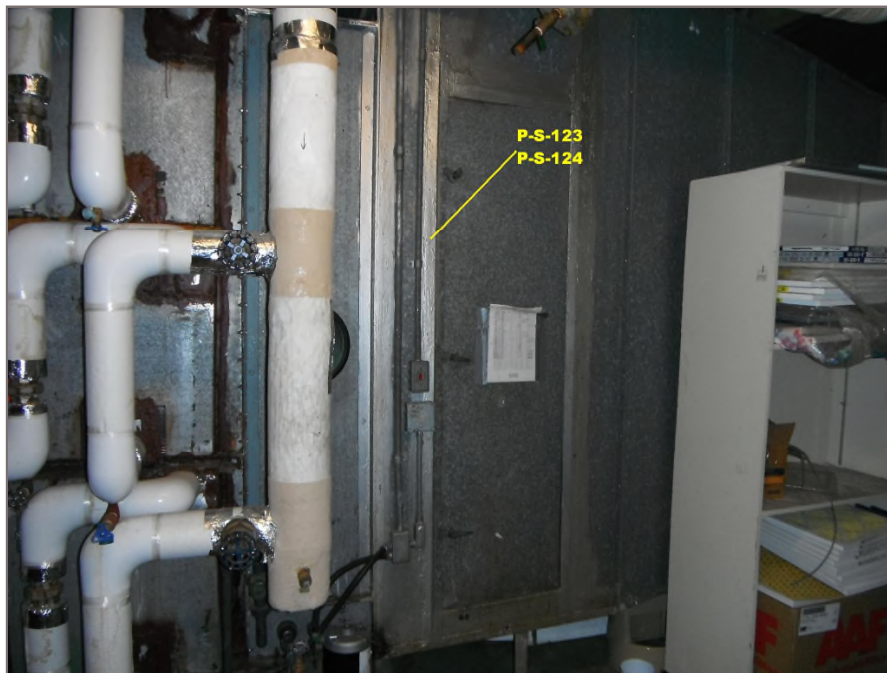
Photo 59: Asbestos-containing grey mastic applied to the metal ducting around the door of the AHU #2 cold deck within the penthouse. Tetra Tech sample P-S-123.

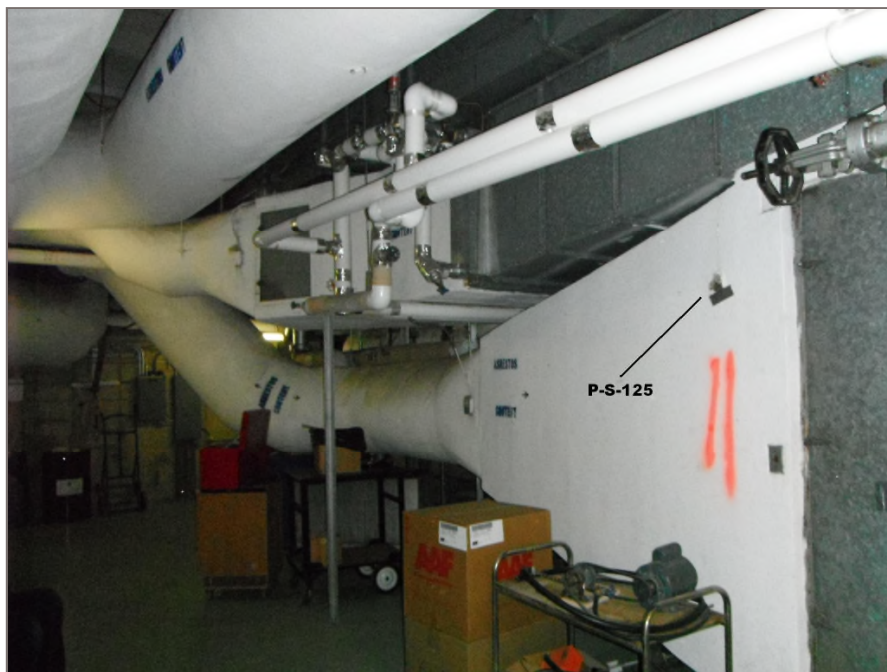
Photo 60: Asbestos-containing mudded mechanical insulation applied to the AHU #2 cold deck within the penthouse. Tetra Tech sample P-S-125.

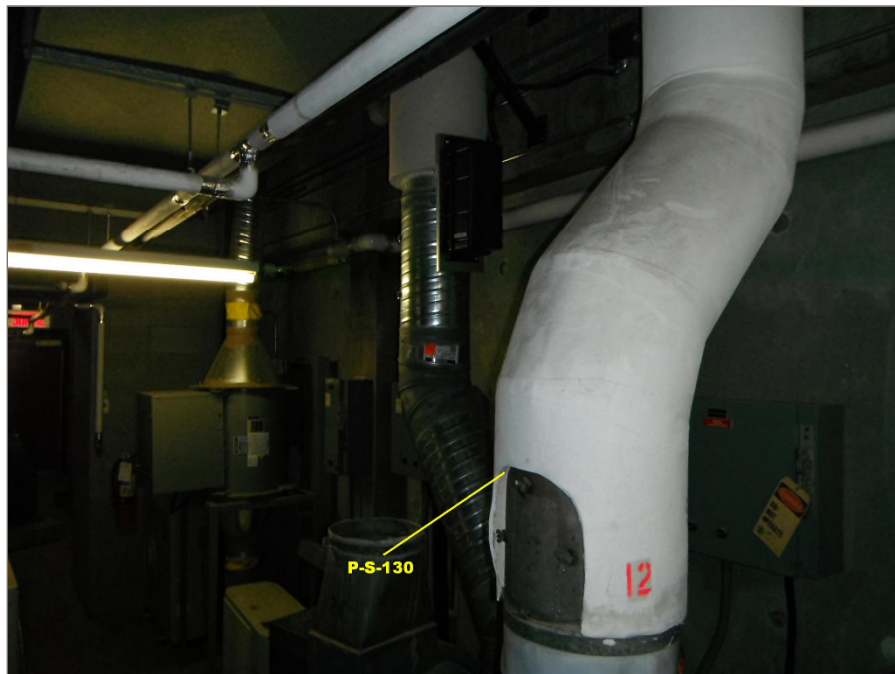
Photo 61: Asbestos-containing mudded mechanical insulation applied to exhaust fan #49 within the south end of the penthouse adjacent to the exit door. Tetra Tech sample P-S-130.

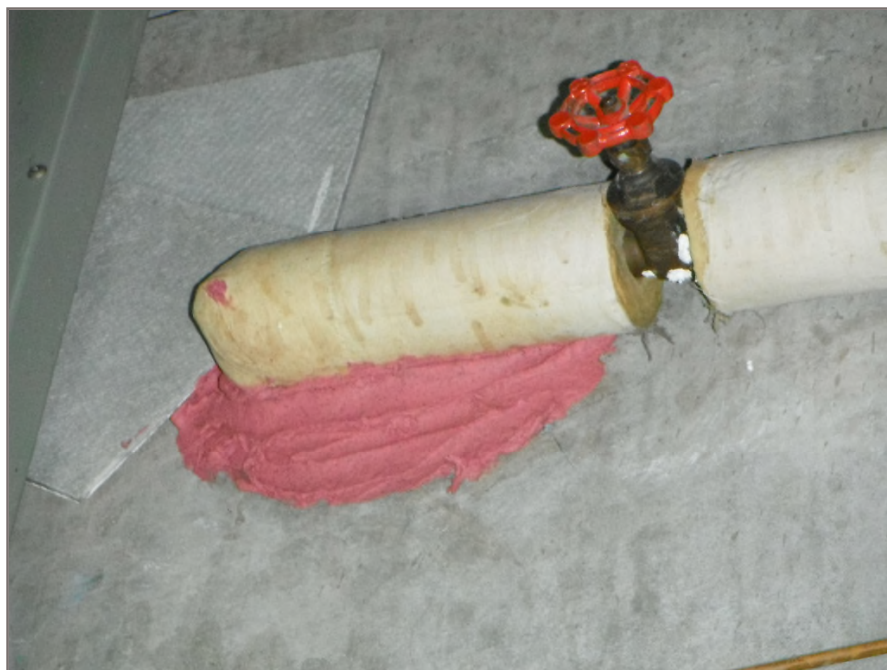
Photo 62: Asbestos-containing transite cement board used as a fire stop at penetrations where fume hood piping was historically present.

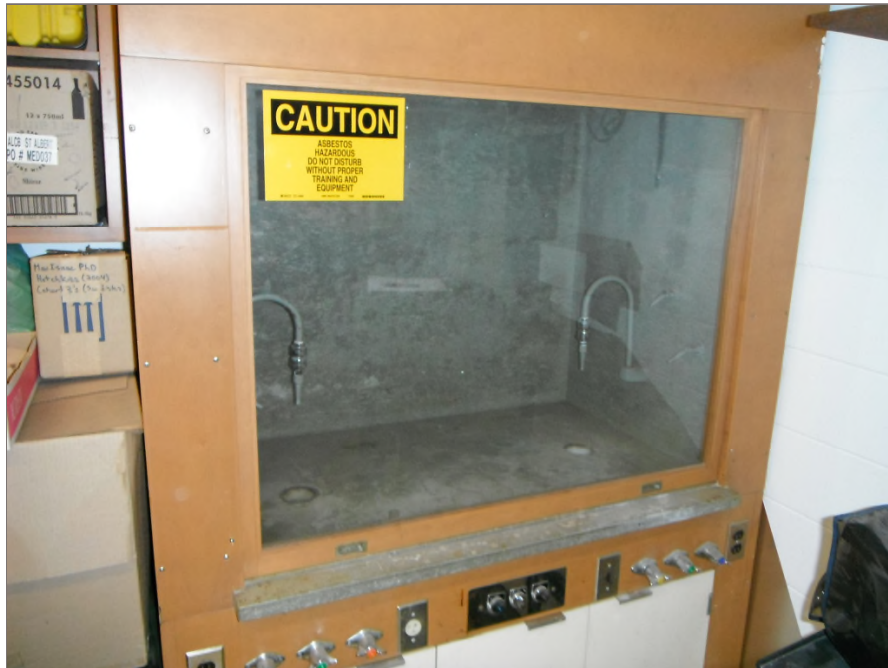
Photo 63: Asbestos-containing transite cement wall board present within a fume hood.

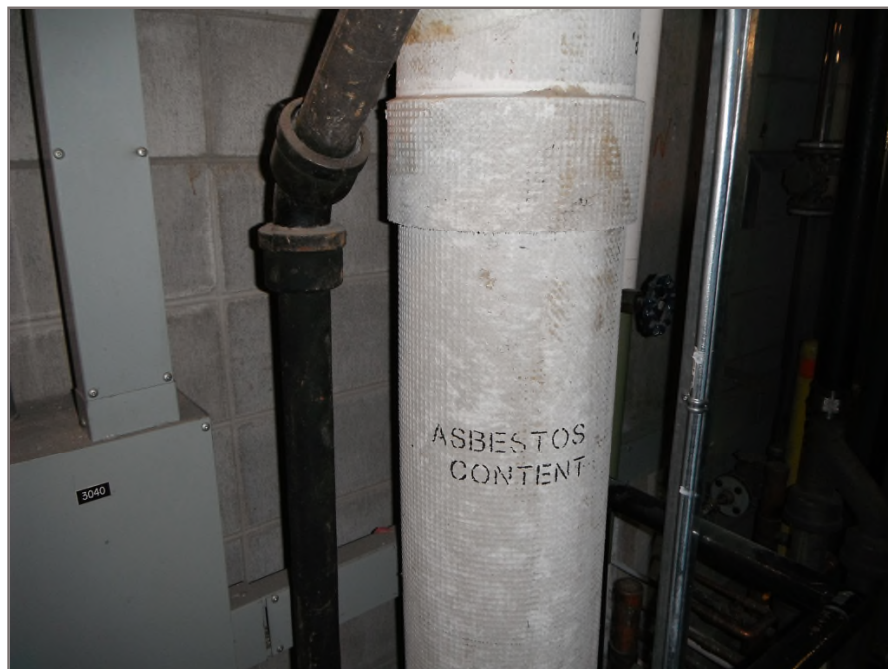
Photo 64: Asbestos-containing transite cement pipe present within the Penthouse.

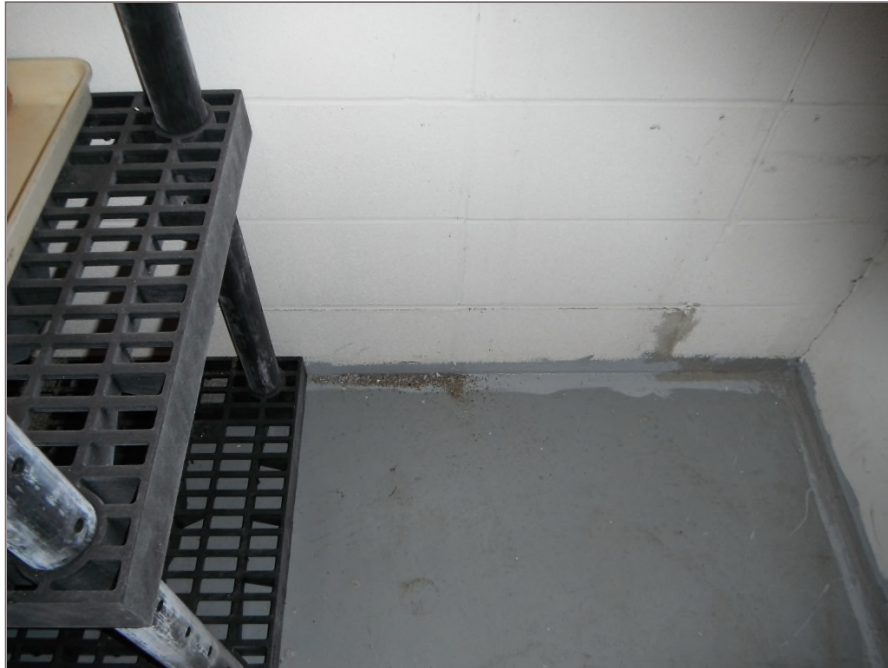
Photo 65: Vermiculite insulation present on the floor of the HAZMAT shed storage room.
