Prepared for:  
National Research Council Canada  
Herzberg Institute of Astrophysics  
5071 West Saanich Road  
Victoria, BC  
V9E 2E7

# Limited Hazardous Materials Assessment Herzberg Institute of Astrophysics Admin Building 1916 Wing

Project No. 27008 HMA V1.0  
Date issued: October 22<sup>nd</sup> 2015

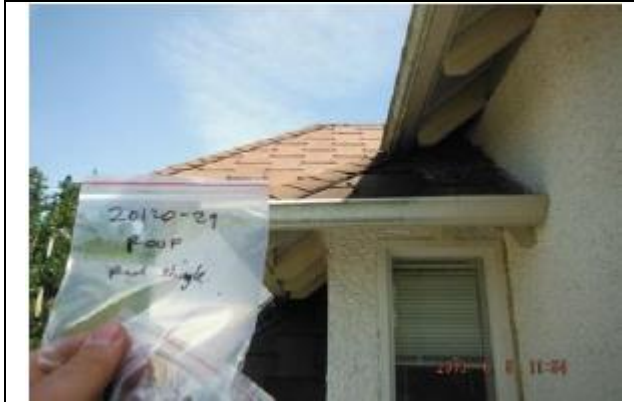
<p>Sample: 27008-03                  Location: Exterior - Roof                  Description: Wood Shake                  Lead Content: 27 000 mg/kg</p>	<p>Sample: 20120-28                  Location: Exterior - Roof                  Description: Lower Shingle                  Asbestos: None detected</p>

Sample: 20120-29  
Location: Exterior - Roof  
Description: Red Shingle  
Asbestos: None detected

5. **Lead:** Analytical results confirm the presence of lead in the renovation area. Ensure work impacting the paint coatings, paint debris and other lead containing materials proceeds in a manner that will contain fumes or paint dust and be in full compliance with WorkSafeBC Regulations. An occupational lead in air sample must be collected at beginning of the project to ensure proper worker PPE is being worn and work procedures are effective in controlling lead dust.
