Prepared for:
National Research Council Canada

Hazardous Materials Survey

**1916 Wing Building
Victoria, BC
NWEG Project 20120**

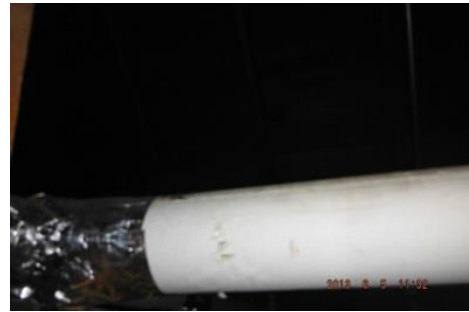
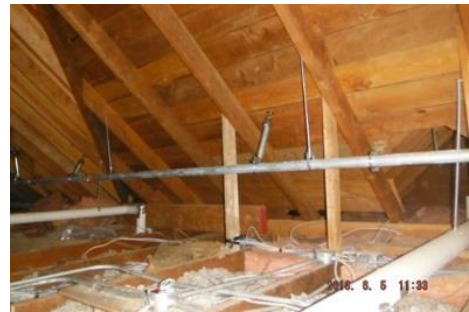
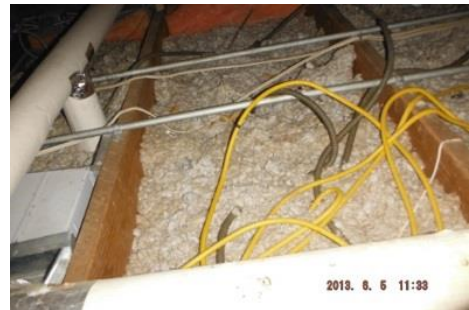
Fibreglass insulation and pipe insulation

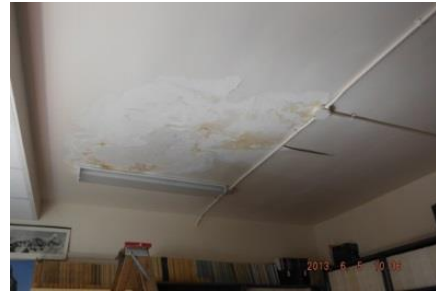
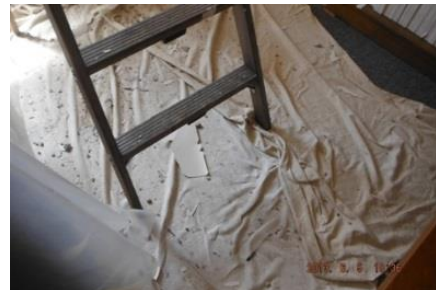
20120-14; 20120-15

Overall, paint coatings were found to be in good condition, with the exception of Room 316 where the ceiling was damaged. Where damaged and deteriorating, paint should be removed following procedures designed to protect the workers from heavy metal exposure and to avoid the spread of contamination. Lead content of painted materials should not increase their disposal costs however; concentrated paint chips would need to be disposed as hazardous waste. Routine removal of lead paint is not recommended; rather it should be managed in place and removed on an “as needed” basis.

Damage to plaster and paint

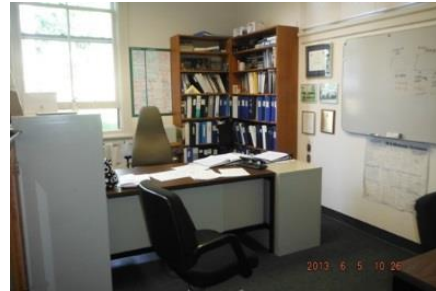
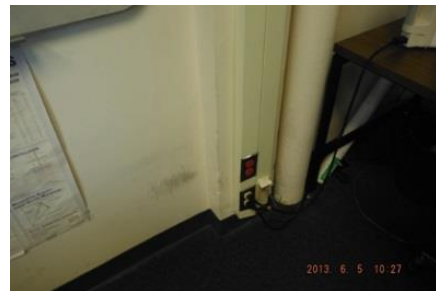
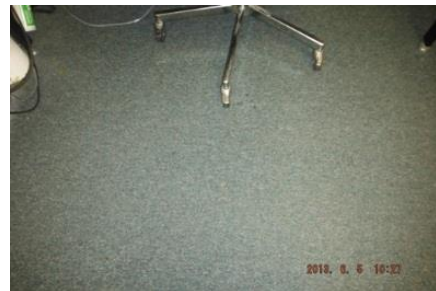
Fibreglass pipe insulation

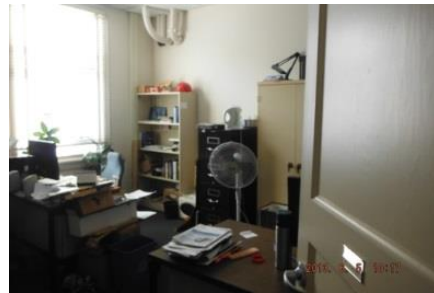
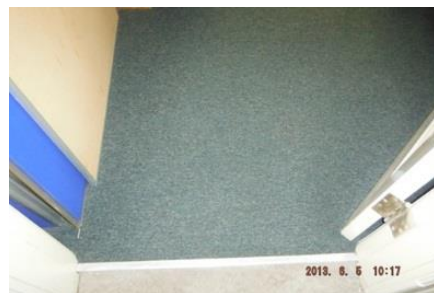
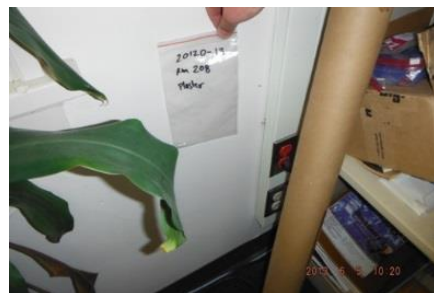
Fibreglass pipe insulation
