| | REMEDIATION ACTION PLAN FOR 7 ABANDONED MINE SITES, NT | | | | | |
| | JOON MINE: GENERAL SITE PLAN | | | | | |
| | PROJECT No. 122510933 | OFFICE OTT | DES DW | CKD FL | REV 0 | DRAWING |

| | JOON MINE - AREA 1: ESTIMATED VOLUMES FOR WASTE ROCK AND PHYSICAL HAZARDS | | | | | |

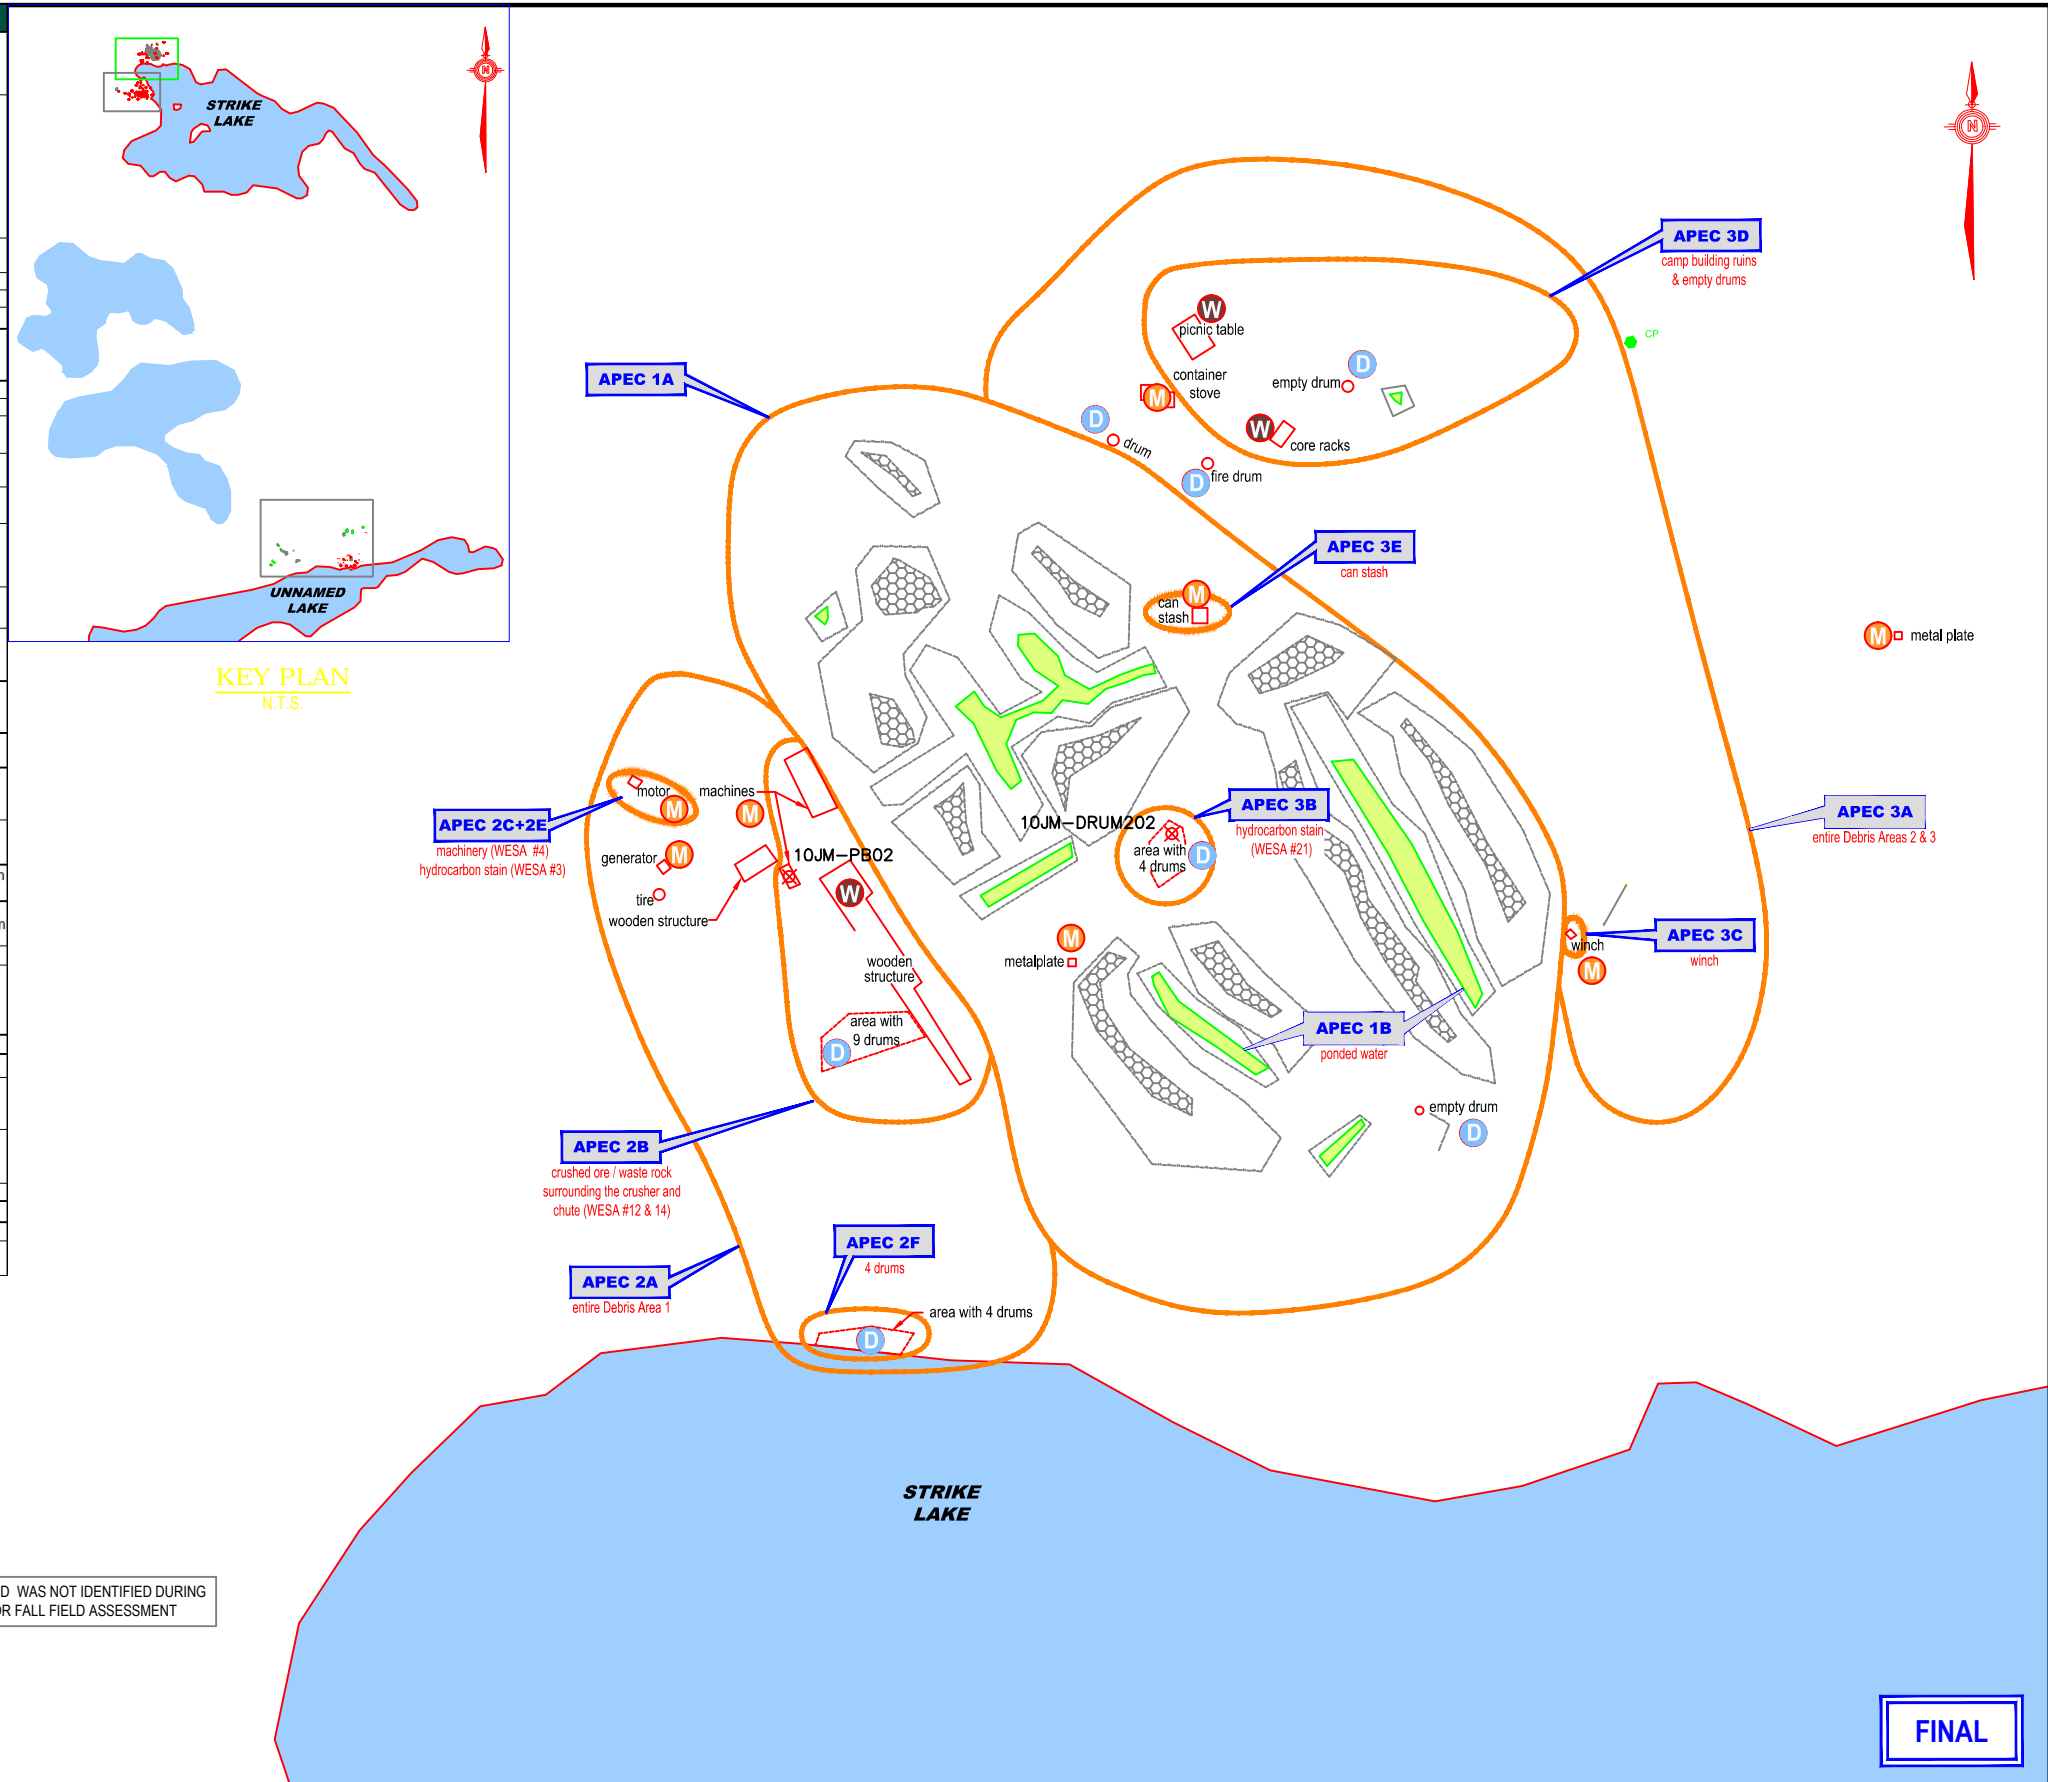
PROJECT No. 122510933 OFFICE OTT DES DW FL REV 0 DRAWING DATE: Mar 2015 SHEET No. - of - DWN APP STATUS - LC - - - - - FIGURE JM 3-1

JOON MINE - AREA 1: HAZARDOUS AND NON-HAZARDOUS MATERIALS

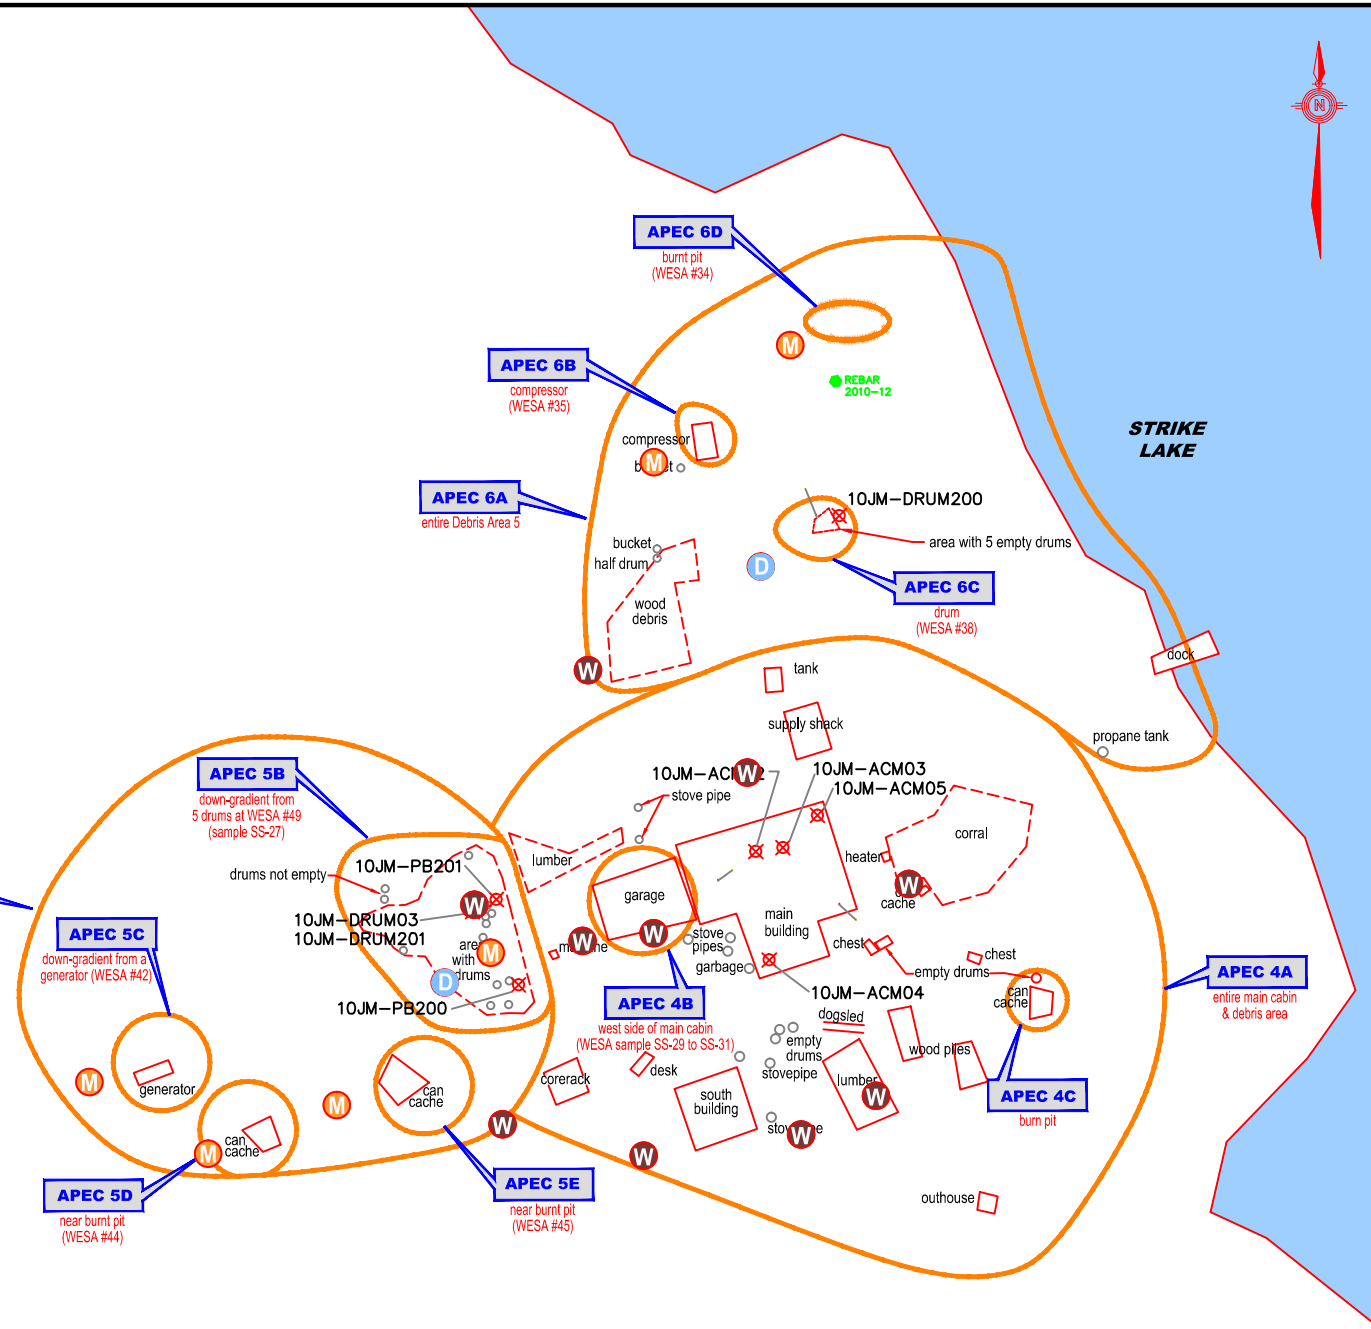
PROJECT No: 122510933 | OFFICE: OTT | DES: DW | CKD: FL | REV: 0 | DRAWING: FIGURE JM 3-2

APEC 5F
small trench

JOON MINE - AREA 2: HAZARDOUS AND NON-HAZARDOUS MATERIALS

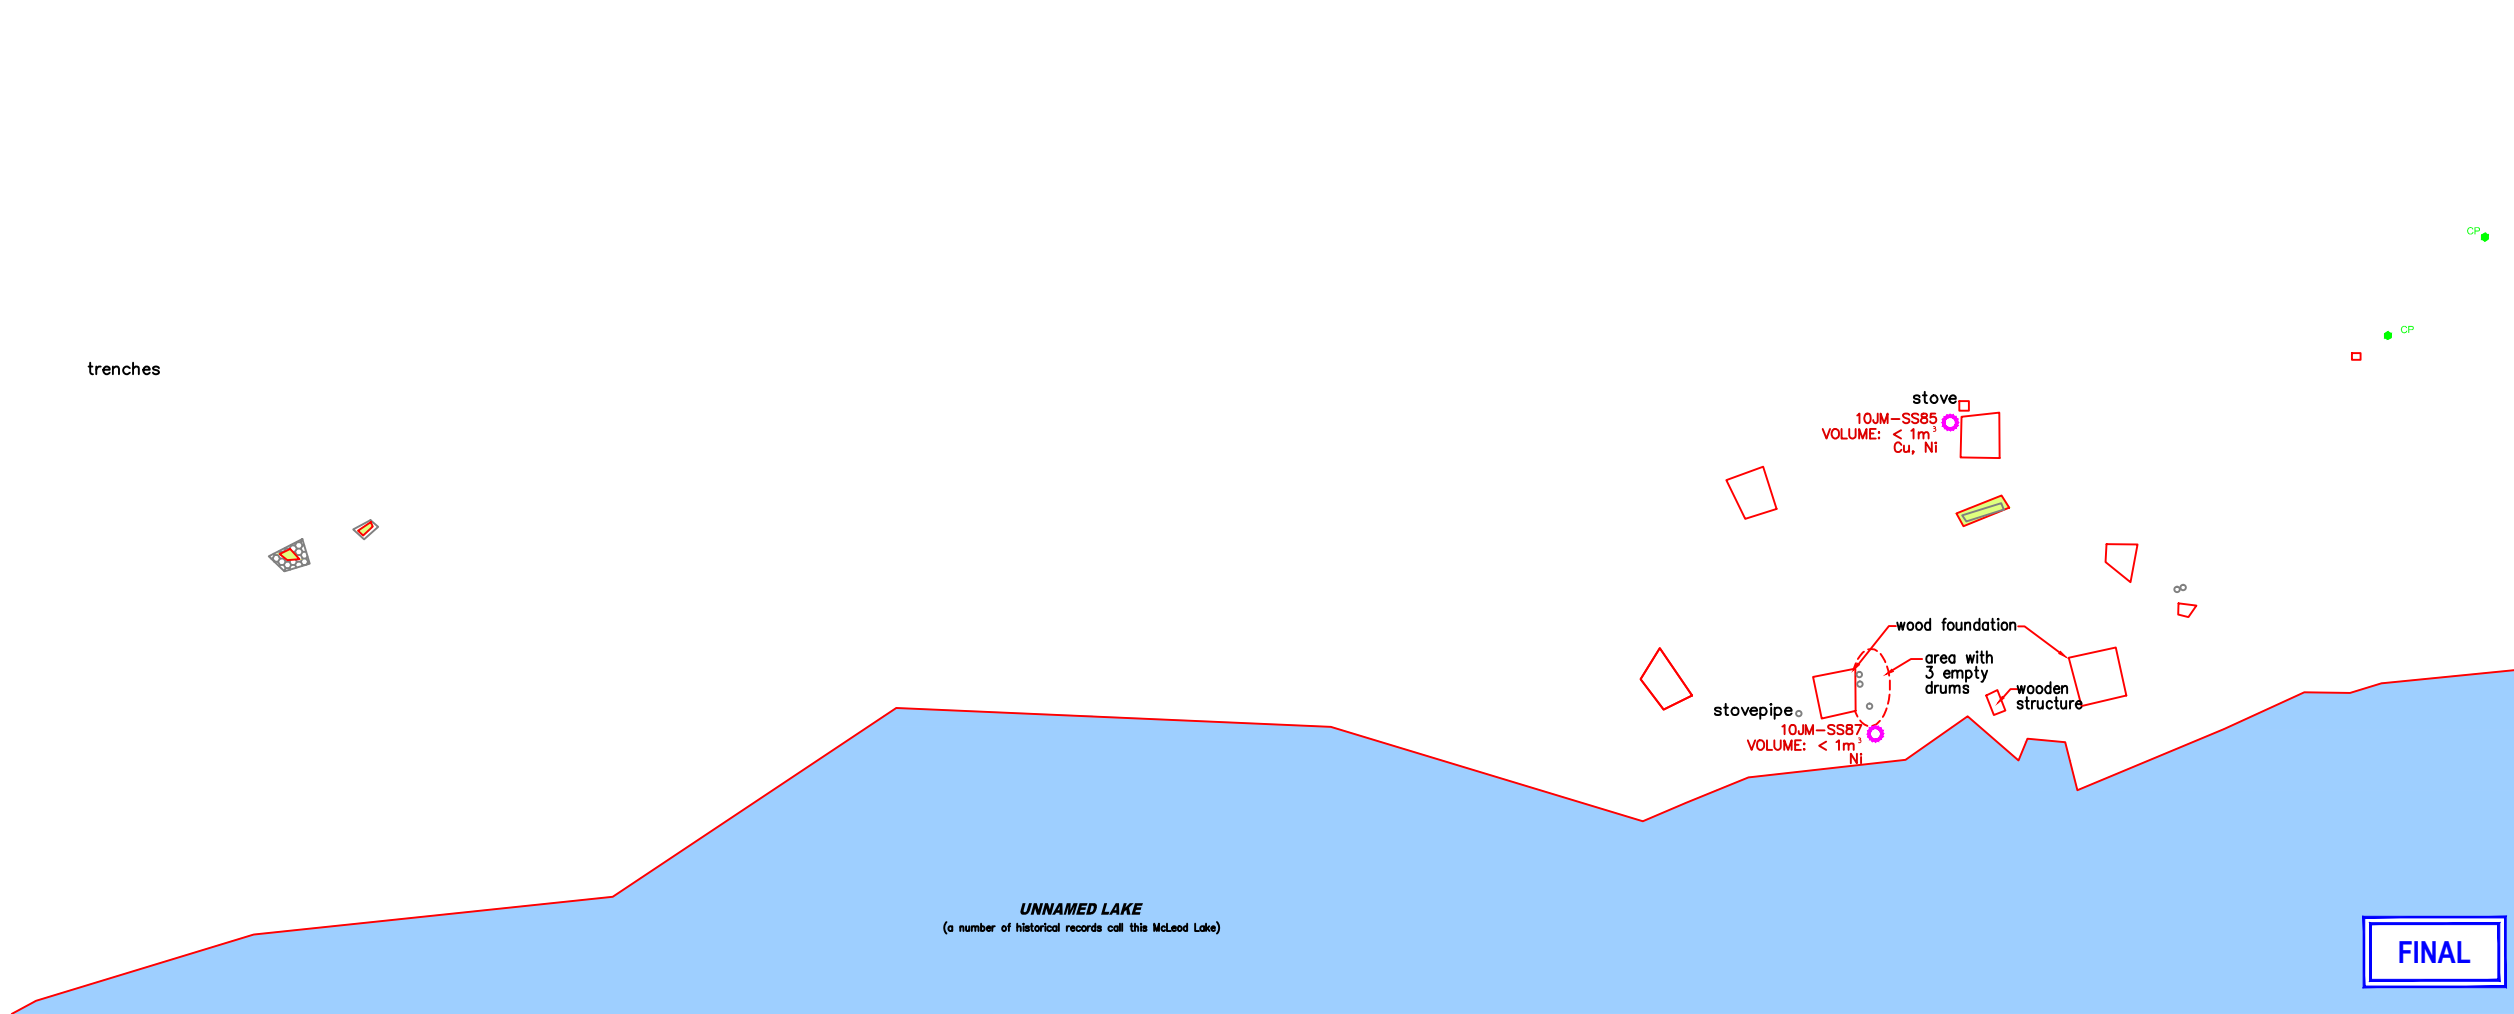
| DATE Mar 2015 | SHEET No. - of - | DWN APP | LC | STATUS - | DRAWING FIGURE JM 4-2 |

| | JOON MINE - AREA 3: SOIL CONTAMINATION AREAS | | | | |
