CHIPP LAKE

Public Works and Government Services Canada / Travaux publics et Services gouvernementaux Canada	REMEDATION ACTION PLAN FOR 7 ABANDONED MINE SITES, NT				
	CHIPP LAKE MINE: ESTIMATED VOLUMES FOR WASTE ROCK AND PHYSICAL HAZARDS				
	PROJECT No. 122510933	OFFICE OTT	DES DW	CKD FL	REV 0
DATE: Mar 2015	SHEET No. - of -	DWN APP	LC	STATUS -	DRAWING FIGURE CL 2

REMEDIACTION ACTION PLAN FOR 7 ABANDONED MINE SITES, NT

CHIPP LAKE MINE: HAZARDOUS AND NON-HAZARDOUS MATERIALS

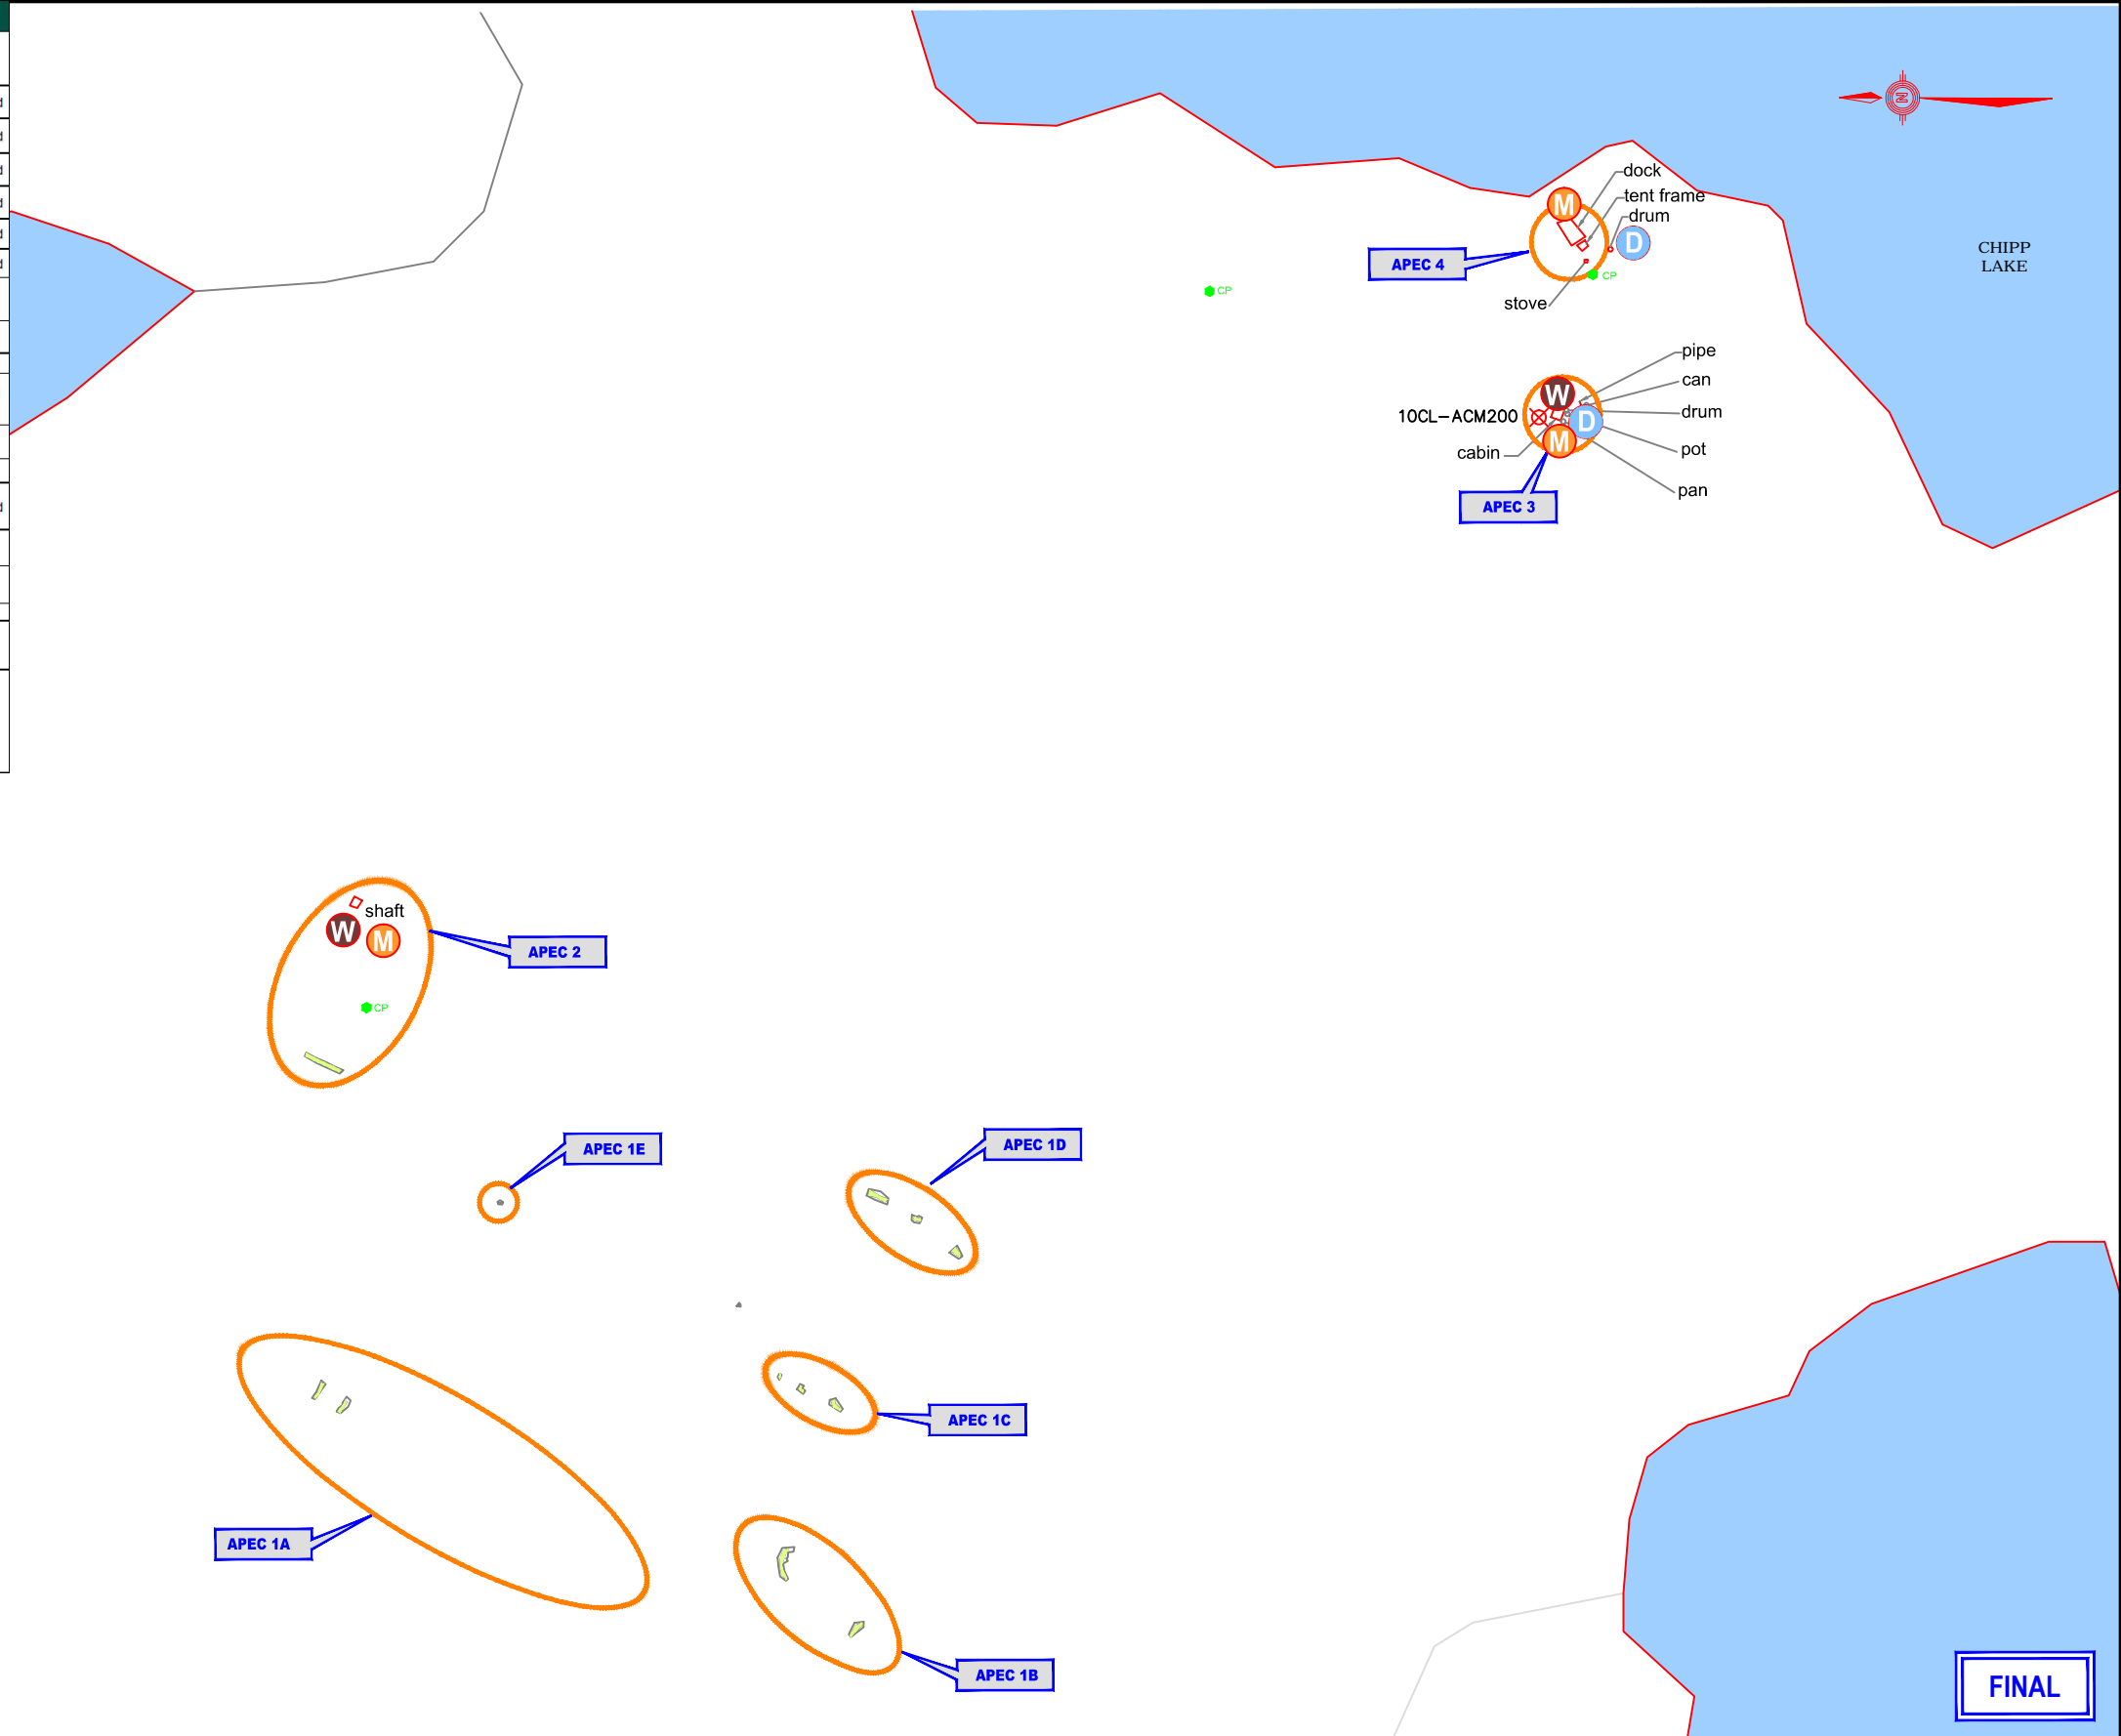
CHIPP HAZARDOUS AND NON-HAZARDOUS MATERIALS INVENTORY TABLE						
APEC #	APEC Description	Material Classification	Material Type	Volume (m³ and drums)¹	Material Description	Condition
1A	Trenches and loose waste rock	None Identified	None Identified	None Identified	None Identified	None Identified
1B	Trenches and loose waste rock	None Identified	None Identified	None Identified	None Identified	None Identified
1C	Trenches and loose waste rock	None Identified	None Identified	None Identified	None Identified	None Identified
1D	Trenches and loose waste rock	None Identified	None Identified	None Identified	None Identified	None Identified
1E	Trenches and loose waste rock	None Identified	None Identified	None Identified	None Identified	None Identified
1F	Trenches and loose waste rock	None Identified	None Identified	None Identified	None Identified	None Identified
2	Shaft with trenches and waste rock	Non-Hazardous	Wood Debris	2	Wood logs around shaft at unknown depth, logs scattered	Unpainted

Metal Debris	0.5	Metal stake: 2 m long, 2 cm thick, 6 core racks	Unpainted
			Core	0.5	Coresh	Broken
3	Cabin	Non-Hazardous	Wood Debris	4	Cabin: wood logs within. Made of wood logs, 2x4 frames, 21 logs high	Unpainted, no roof
			Metal Debris	0.5	Metal pipe, tin cans, empty drum (75 L), pot, pan	Rusted
			Plastic	0.5	1 inch black pvc pipe	Intact
			Roofing Material	0.5	Black shingles and felt scattered sampled and is not an ACM	Torn, scattered
4	Dock	Non-Hazardous	Wood Debris	2	Dock: wood and tent Frame: plywood, logs and 2x4s	Unpainted
			Metal Debris	0.5	Stove and vents, piles of cans and food containers	Rusted
			Plastic	1	1 inch black pvc pipe	Intact
		Hazardous (leachable lead paint)	Drum (75L)	1 drum	1 (75L) drum red and blue, empty	Intact
Totals (Uncrushed and m³)	Non-Hazardous	Wood Debris	8		Notes: 1. All volumes: uncrushed	
		Metal Debris	1.5			
		Core	0.5			
		Plastic	1.5			
		Roofing Material	0.5

Hazardous (Leachable lead paint)	Drums (75 L)	1 drum
