REMEDIATION ACTION PLAN FOR 7 ABANDONED MINE SITES, NT	
		BEAULIEU MINE: GENERAL SITE PLAN	
PROJECT NO: 122510933	OFFICE: OTT	DES: DW	OKD: FL
DATE: Mar 2015	SHEET NO.: - of -	APP: LC	REV: 0
			DRAWING: FIGURE BE 1

REMEDIAL ACTION PLAN FOR 7 ABANDONED MINE SITES, NT

BEAULIEU MINE - AREA 1: HAZARDOUS AND NON-HAZARDOUS MATERIALS

REMEDIATION ACTION PLAN FOR 7 ABANDONED MINES SITES, NT

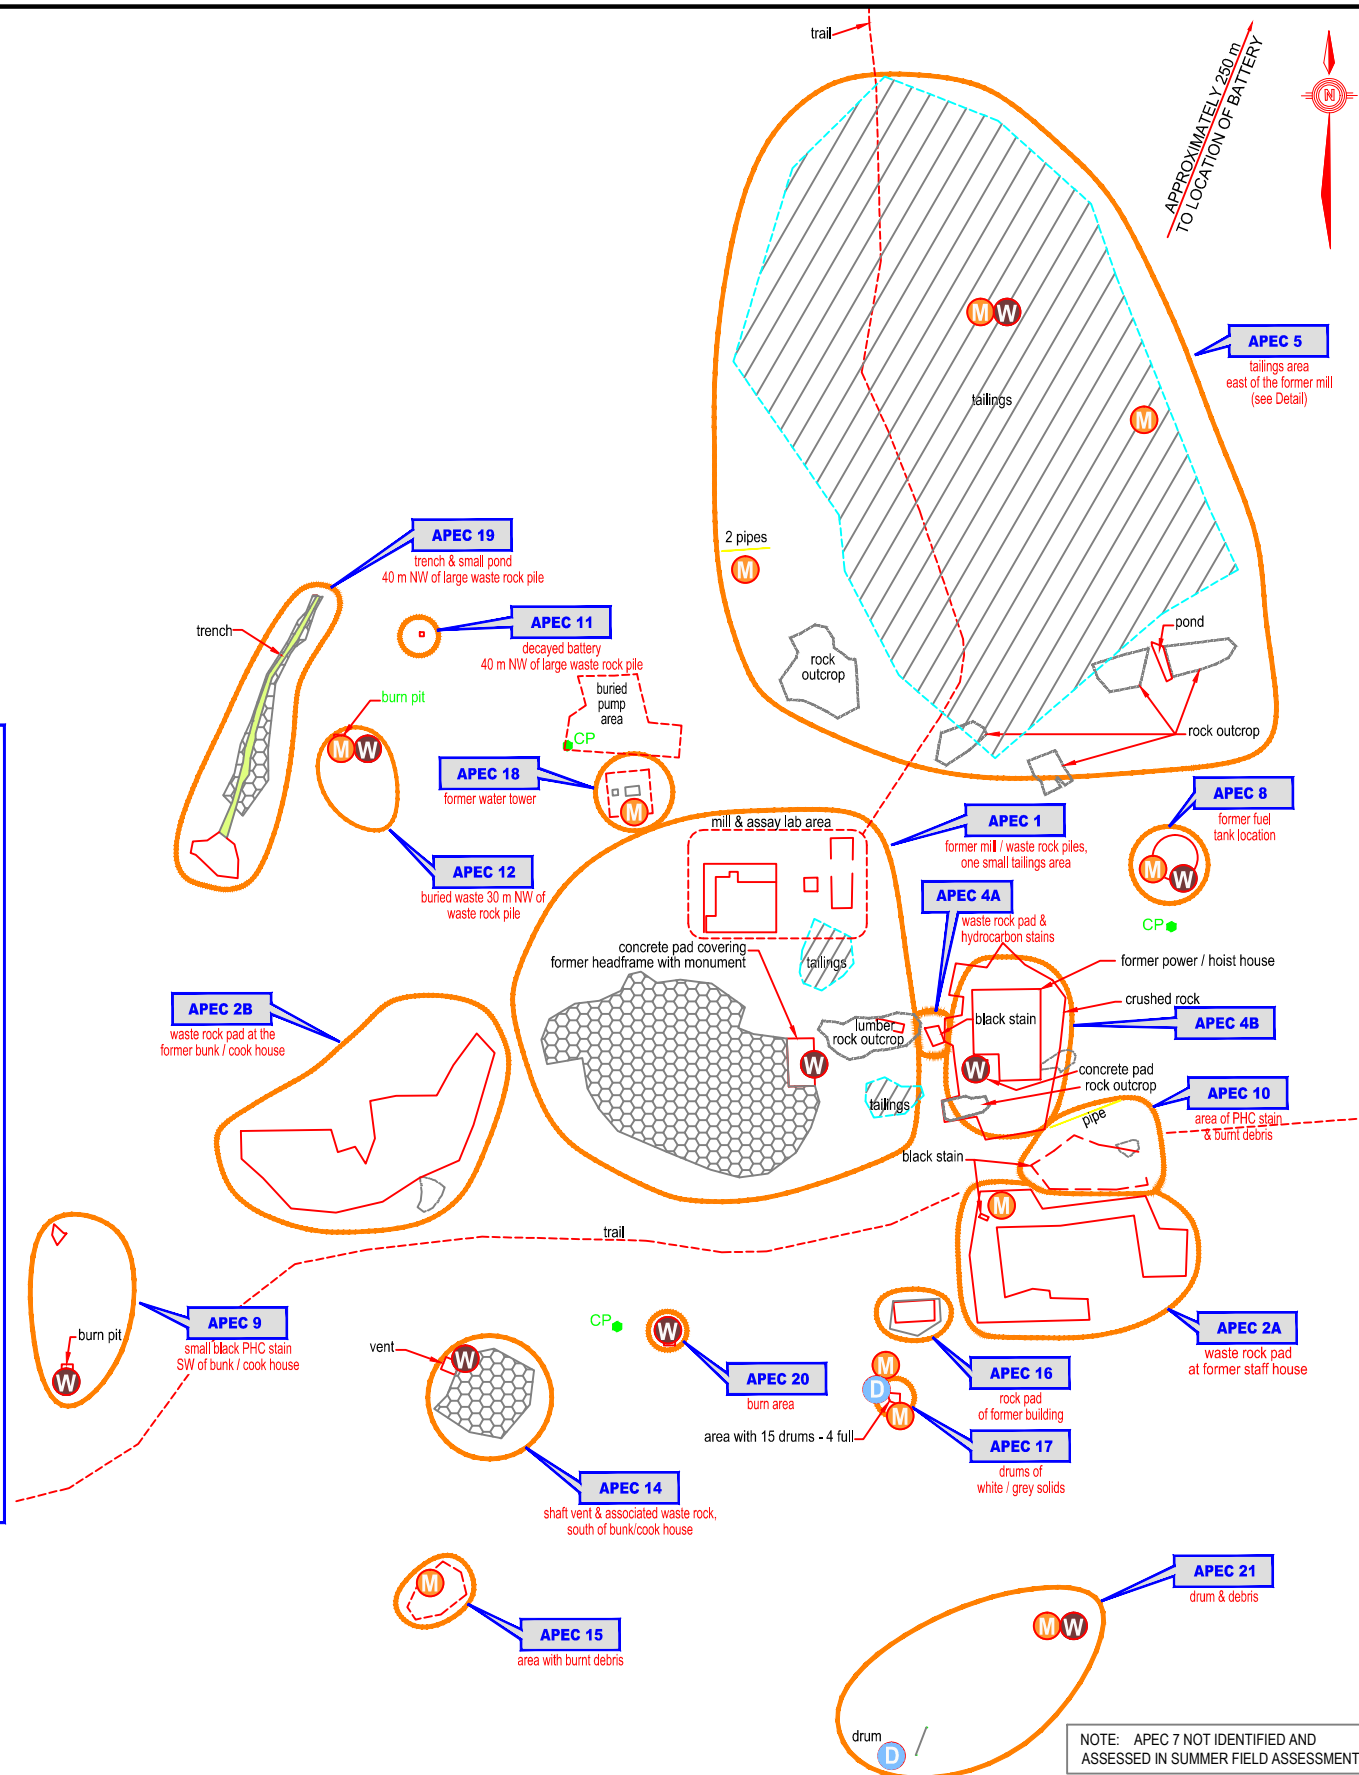
APEC #	APEC Description	Material Type	Volume (m ³) ^{1,2}	Material Description	Condition
1	Former mill/waste rock piles, and one small tailings area	Wood Debris	3	Wood posts around concrete pad with monument and lumber by rock outcrop	Unpainted
		Concrete	10	Concrete pads at the monument and mill and lab assay lab area.	Unpainted, screws rebar in the concrete
2A	Waste rock pad at the former staff house	Metal Debris	0.1	Loose nails and bit of wood	Rusted
2B	Waste rock pad at the former bunk/cook house	None Identified	None Identified	None Identified	None Identified
3	Large trench and waste rock northwest of the site	None Identified	None Identified	None Identified	None Identified
4A	Waste rock pad and hydrocarbon stains	None Identified	None Identified	None Identified	None Identified
4B	Former power/hoist house	Wood Debris	2	Wood posts around concrete pad	Unpainted
		Concrete	2	Concrete pad	Unpainted, screws in the concrete

5	Tailings area east of the former mill	Wood Debris	0.3	Bits of wood	Unpainted
		Metal Debris	2	Two Pipes, nails, ect	Rusted
		Roofing material	0.5	Shingles and tar paper scattered around wood and metal debris areas	Deteriorating
N/A	250 m North of APEC 5	Battery (Lead and sulphuric acid contents)	0.1	One battery	Broken apart
7	On-site landfill at the unknown location	Identified and re-named during fieldwork as APEC 13	Identified and re-named during fieldwork as APEC 13	Identified and re-named during fieldwork as APEC 13	Identified and re-named during fieldwork as APEC 13
8	Former fuel tank location	Wood Debris	0.1	Bits of wood	Unpainted
		Metal Debris	0.1	Cans	Rusted
9	Small black PHC stain SW of bunk/cook house and burn pit	Wood Debris	0.1	Bits of wood	Burnt, unpainted
10	Area of black PHC stain and burnt debris	Metal Debris	1	Pipe, cans, bolts, metal chain.	Rusted
11	Decayed battery, 40 m NW of large waste rock pile	Battery (Lead and sulphuric acid contents)	0.1	One battery	Decayed

12	Buried waste 30 NW of large waste rock pile	Metal Debris	0.1	Cans, metal bits	Rusted
13	Dump site with heavily rusted drums and tin cans, E of the site	Metal Debris	4	Five empty 205 L Drums, heater ducting and cans	Rusted, crushed
14	Shaft vent and associated waste rock, south of bunk/cook house	Wood Debris	0.1	Wood around concrete pad	Unpainted
		Concrete	2	Concrete pad	Unpainted
15	Burnt debris south of shaft vent	Metal Debris	0.1	Parts of cans	Rusted
16	Rock pad of a former building	None Identified	None Identified	None Identified	None Identified
		Metal Debris	2	Long object, track.	Rusted
17	Barrels of white/grey solids	Small Drums (75 L)	14 drums	12 Full of hard concrete, two empty	Rusted
		Drums (205 L)	1 drum	Empty	Rusted
		Metal Debris	1	Rebar, pipe	Rusted
18	Former water tower	Concrete	2	Water tower and pad	Crumbling
		Wood Debris	0.1	Logs	Unpainted
19	Trench and small pond 40 m NW of large waste rock pile	Metal Debris	0.3	Cans, metal bits	Rusted

Wood Debris	0.1	Pallet	Unpainted
20	Burn area	Metal Debris	1	Cans, parts of cans	Rusted
		Drum (Hazardous liquids 205 L)	1 drum	Half full of black, viscous liquid	Mostly rusted, tear in one end
Material Totals (Uncrushed in m ³)	Non-Hazardous	Wood Debris	7.8		
		Metal Debris	12.7		
		Concrete	16		
		Roofing material	0.5		
		Bombardier Snow Cat	18		
Hazardous (Lead and sulphuric acid contents)	Batteries	Small Drums (75 L)	14 drums		
		Drums (205 L)	2 drums		
Hazardous (Liquids)	Heavy oil	100 L

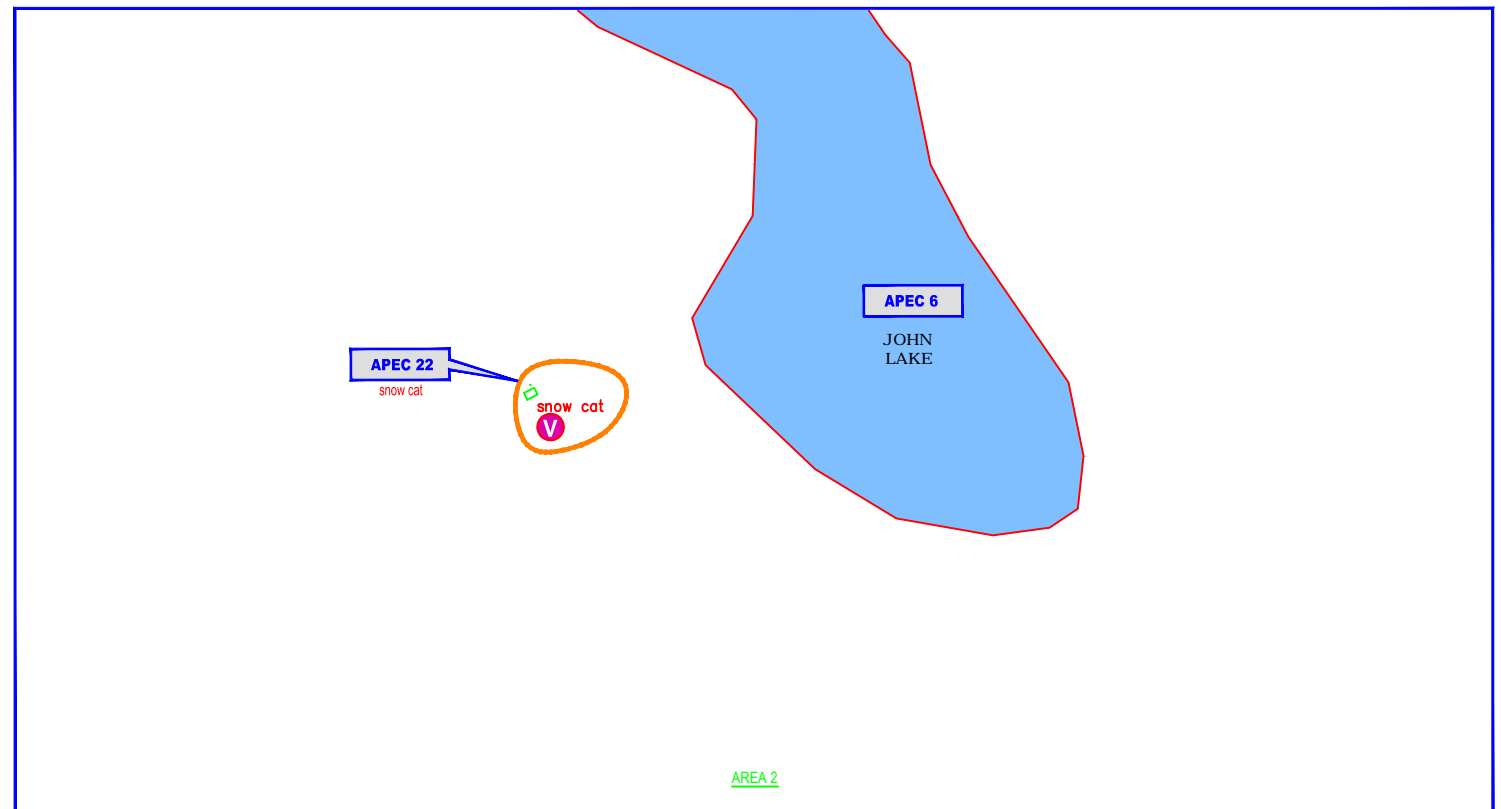
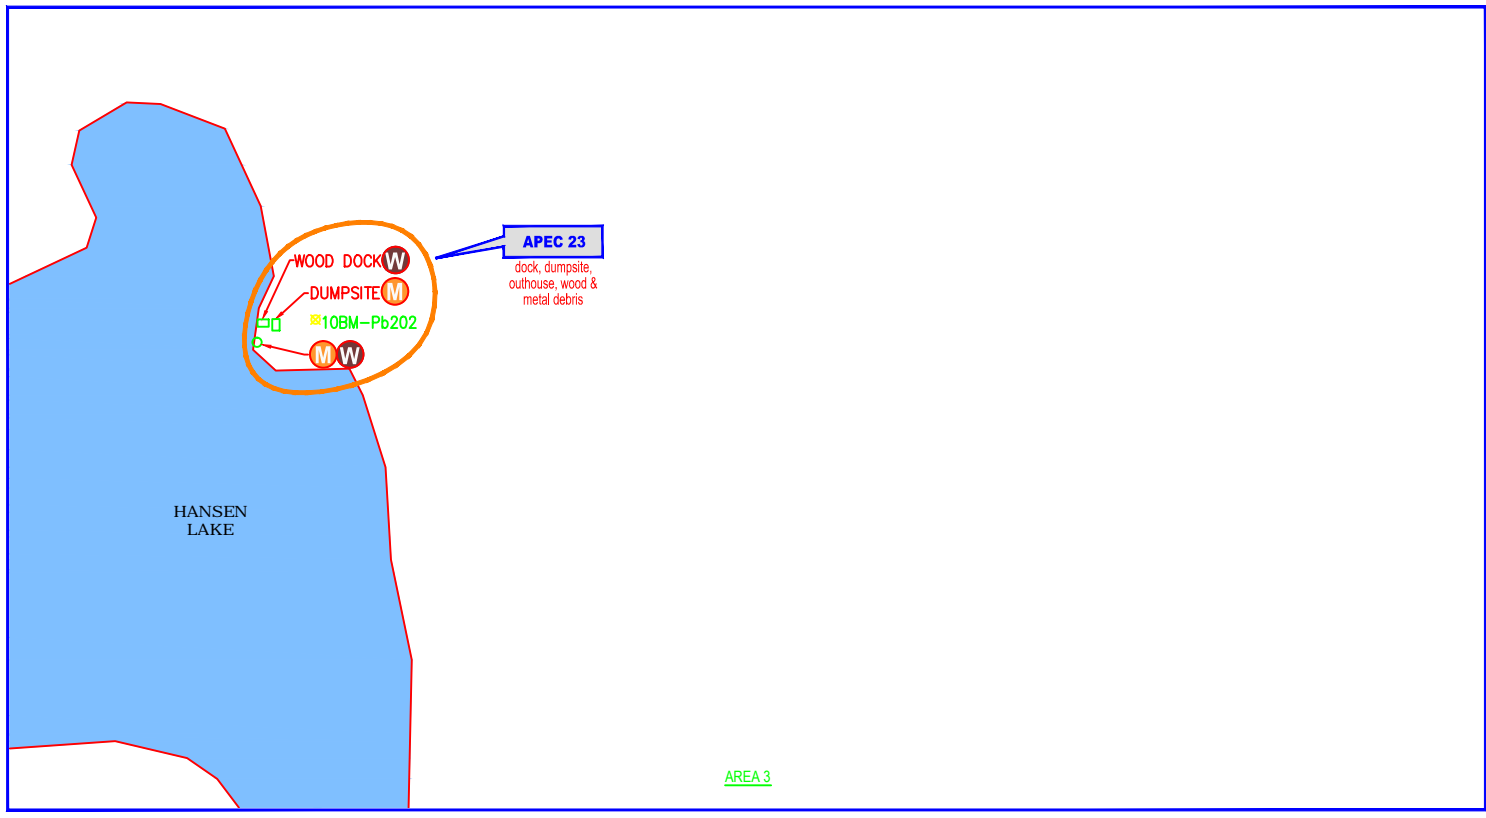
BEAULIEU HAZARDOUS AND NON-HAZARDOUS INVENTORY TABLE					
APEC #	APEC Description	Material Type	Volume (m ³) ^{1,2}	Material Description	Condition
22	Snow cat	Bombardier Snow Cat	18	All metal, rubber track, possibly hydrocarbon based liquids in tank on cat.	Partially rusted, missing roof.
23	Dock, dumpsite, outhouse and wood and metal debris at Hansen Lake	Wood debris	2	Benches, dock, outhouse, picnic table, table, ect.	Unpainted, except outhouse.
		Metal Debris	1	Bed springs, tools, cans, ect.	Rusted

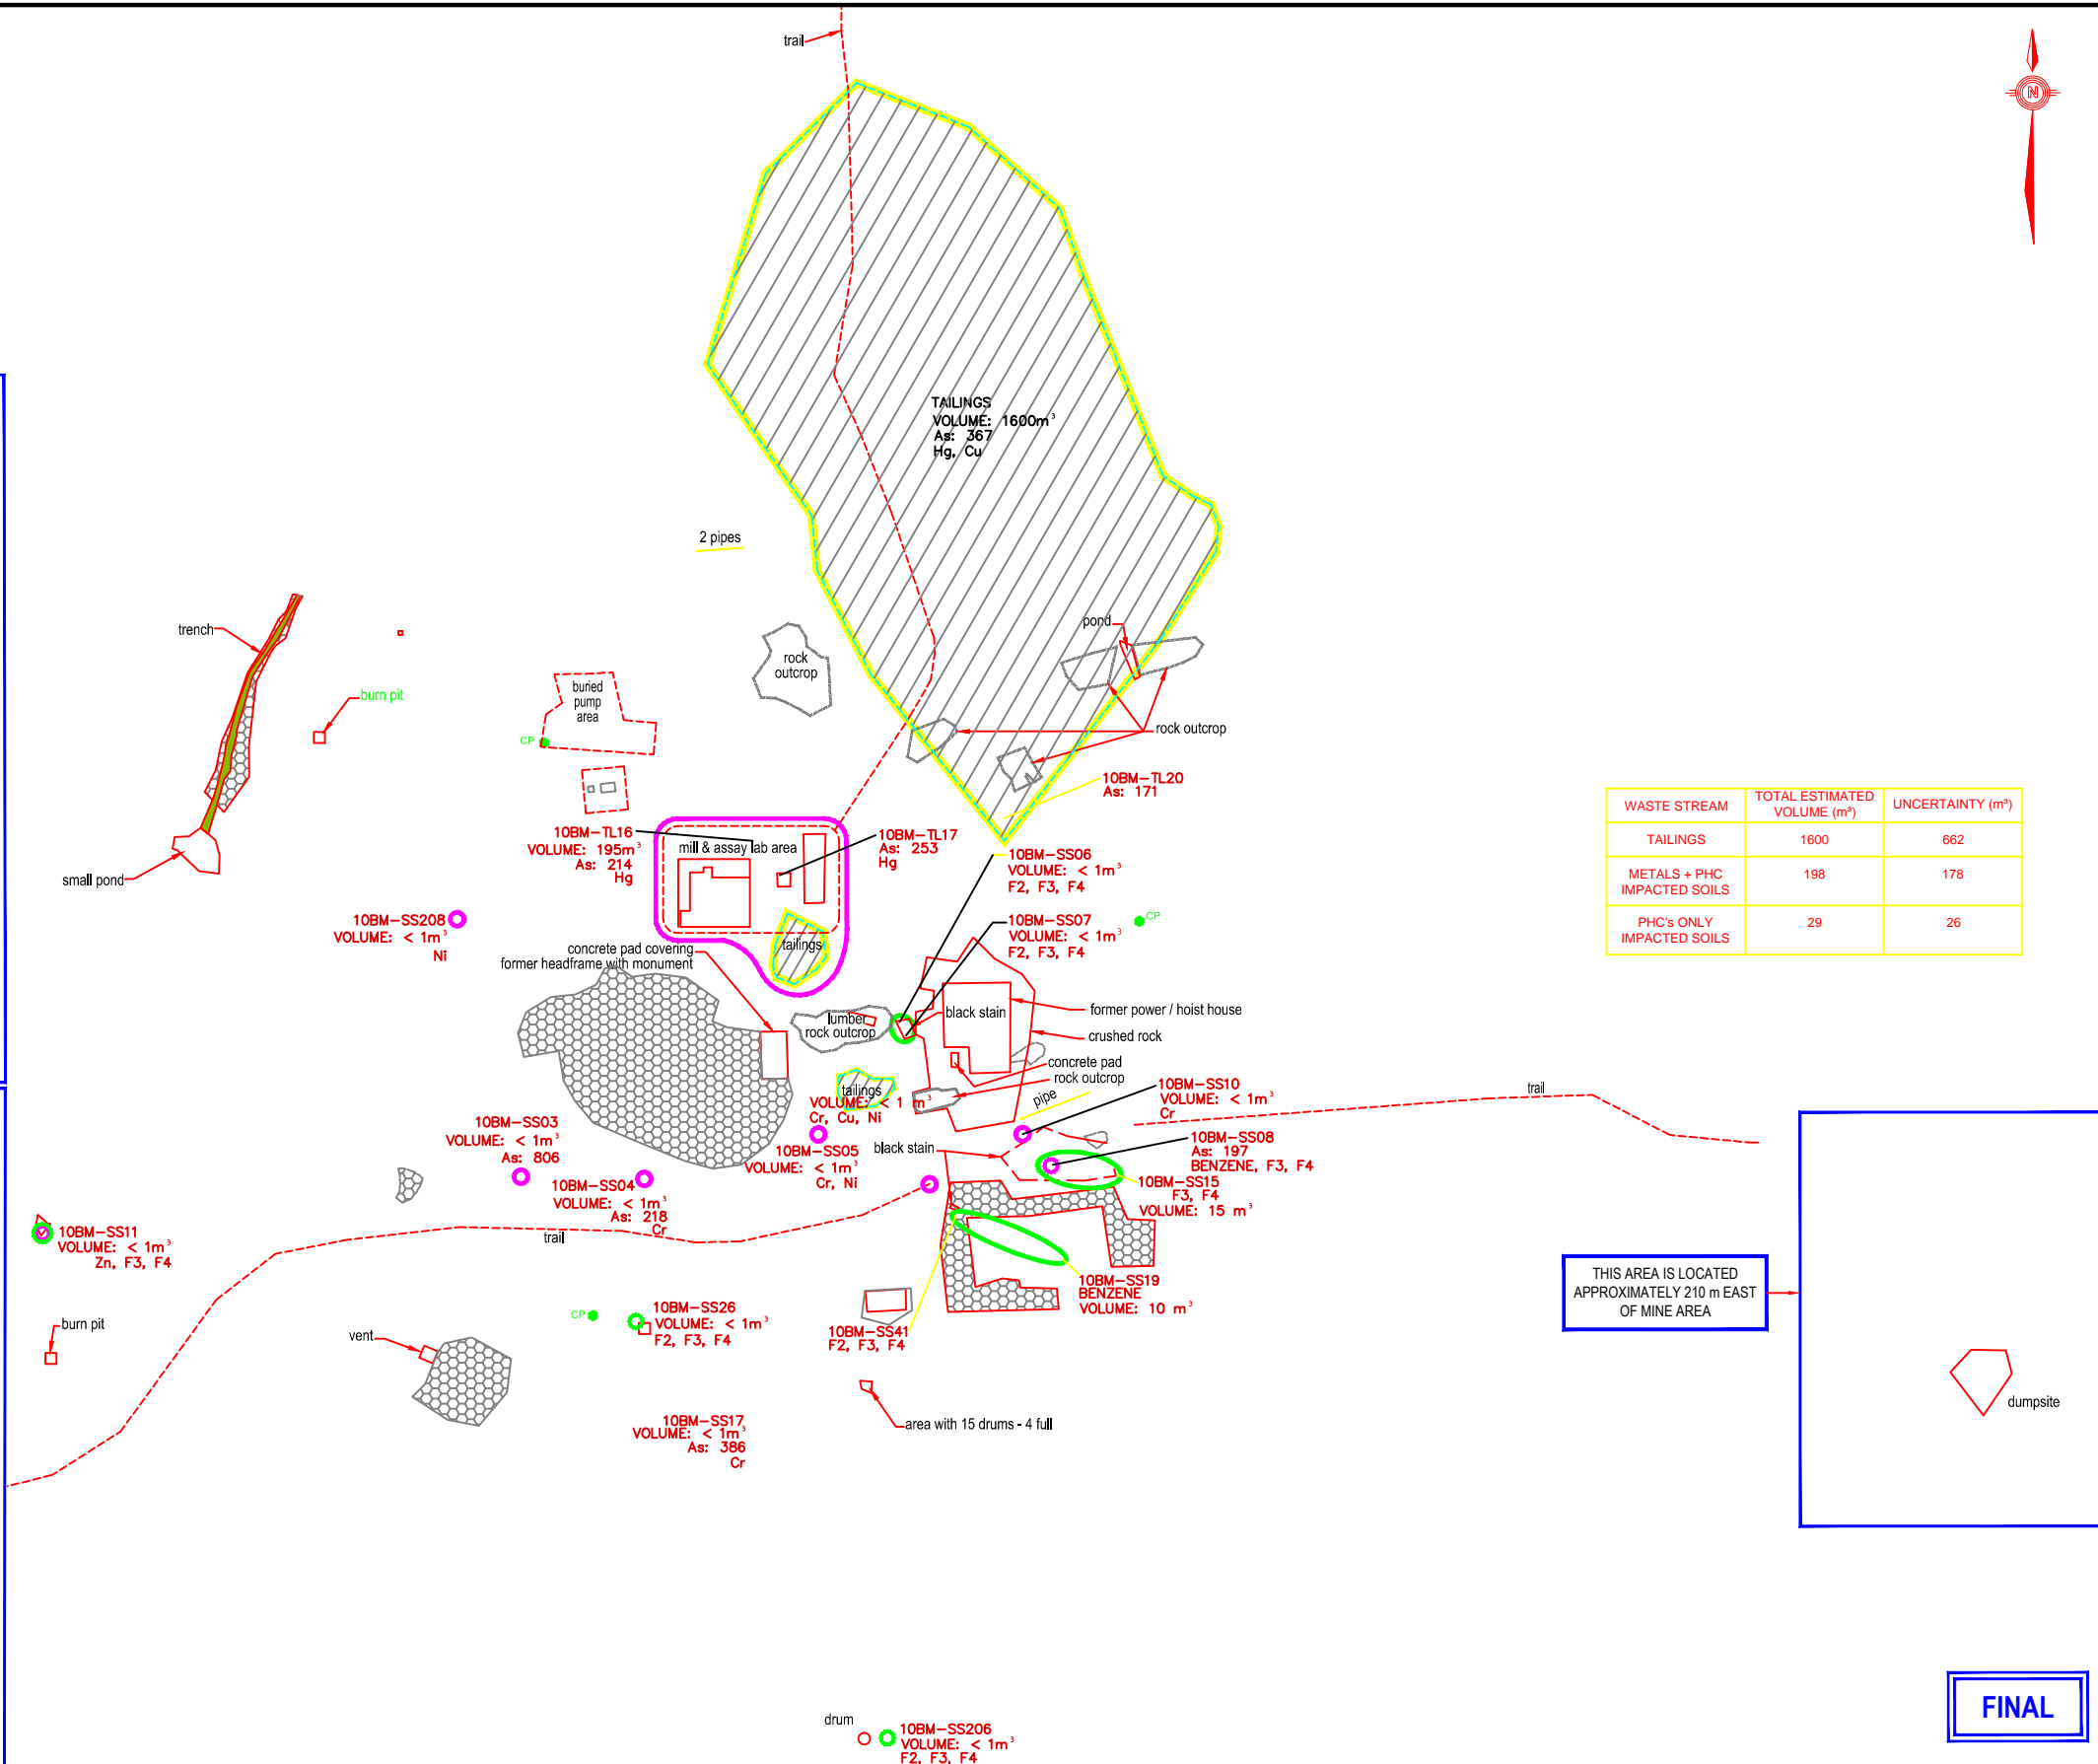
WASTE STREAM	TOTAL ESTIMATED VOLUME (m ³)	UNCERTAINTY (m ³)
TAILINGS	1600	662
METALS + PHC IMPACTED SOILS	198	178
PHC's ONLY IMPACTED SOILS	29	26

ARSENIC (As) CONCENTRATIONS ARE IN mg/Kg

AFTER REMOVAL OF WASTE ROCK, THE SOIL BELOW WILL BE SAMPLED AND TESTED TO CONFIRM IF IT IS CONTAMINATED, AND IF SO IT WILL BE REMOVED.
