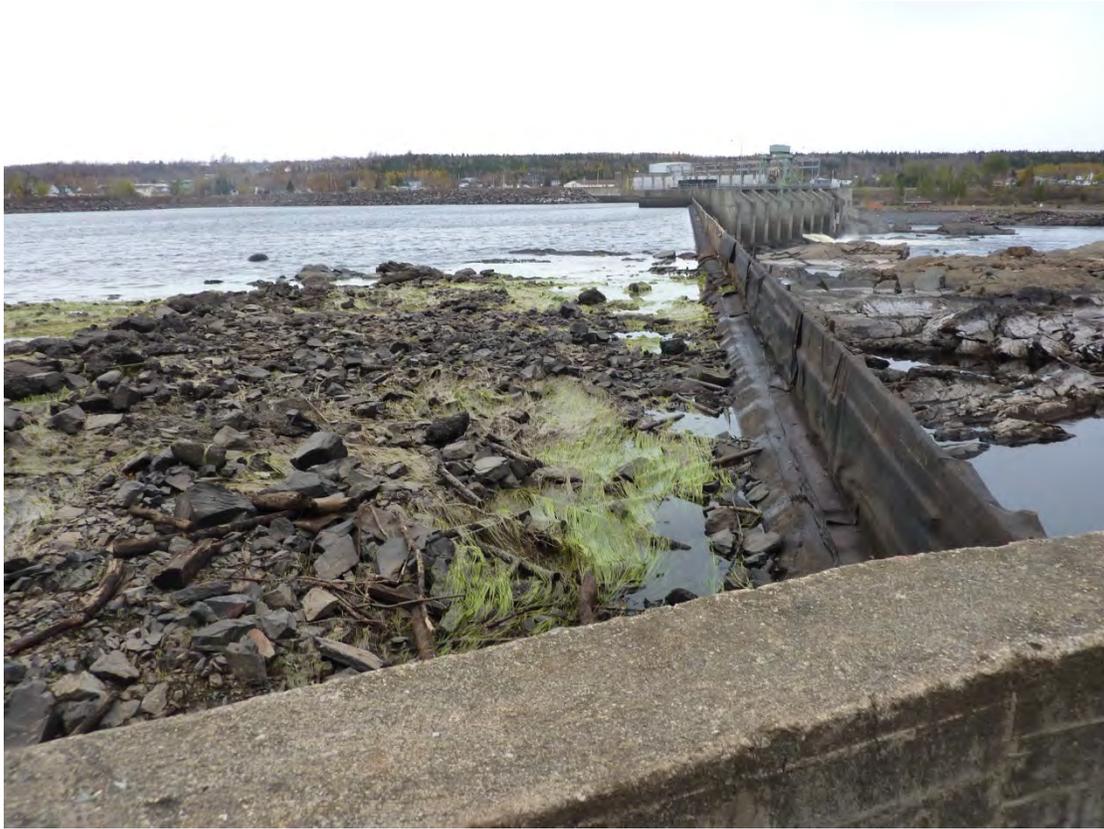
2009 – Upstream riverbed during low water conditions

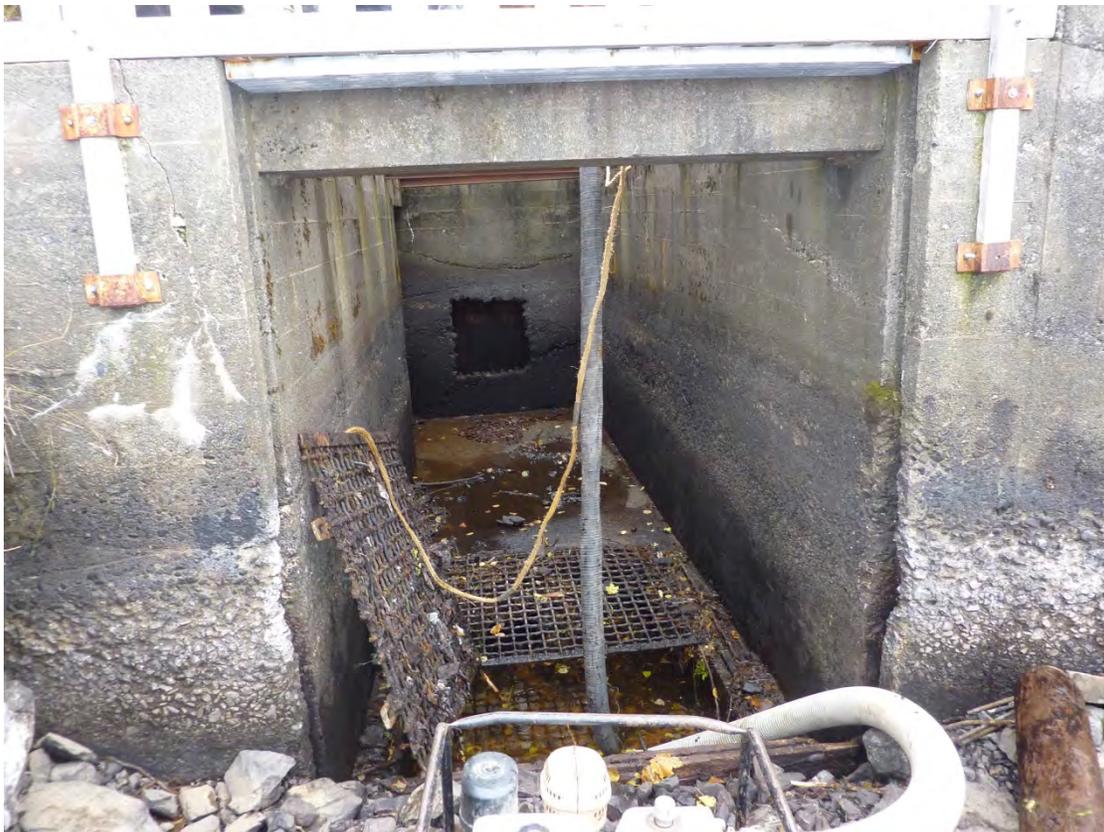
2009 – Pool No. 1 with attraction flow grating

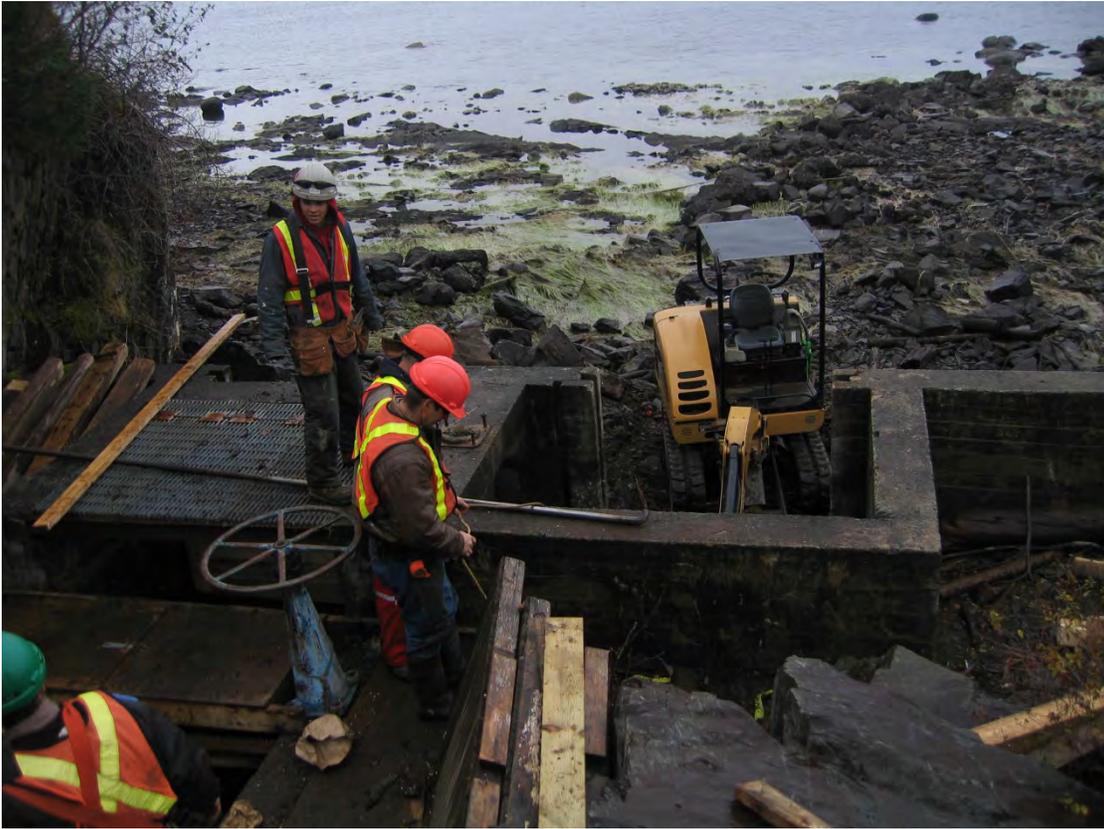
2009 – Repair work at Pool No. 6

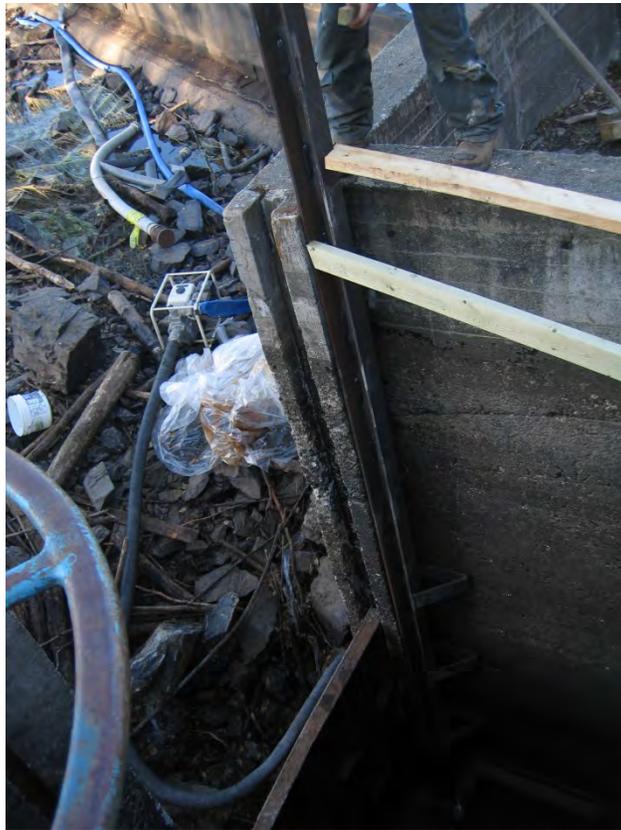
2009 – Inlet at Pool No. 6

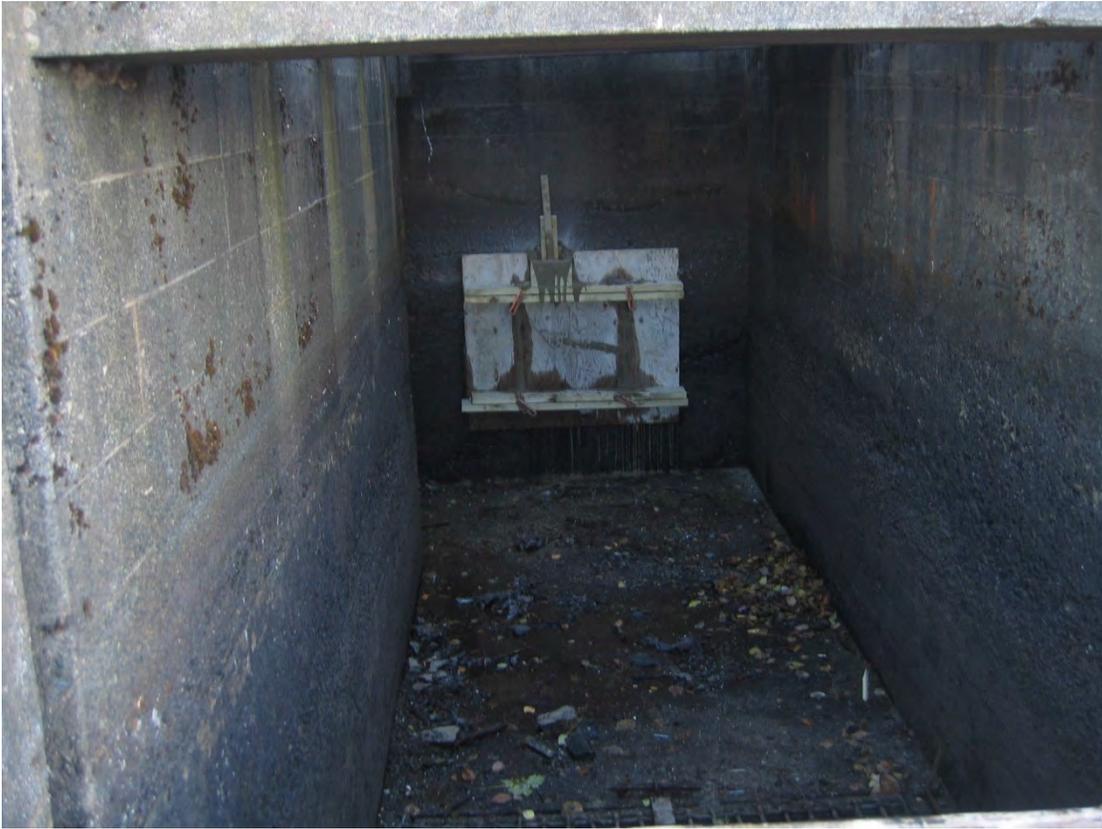
2009 – Wall repairs in Pool No. 1

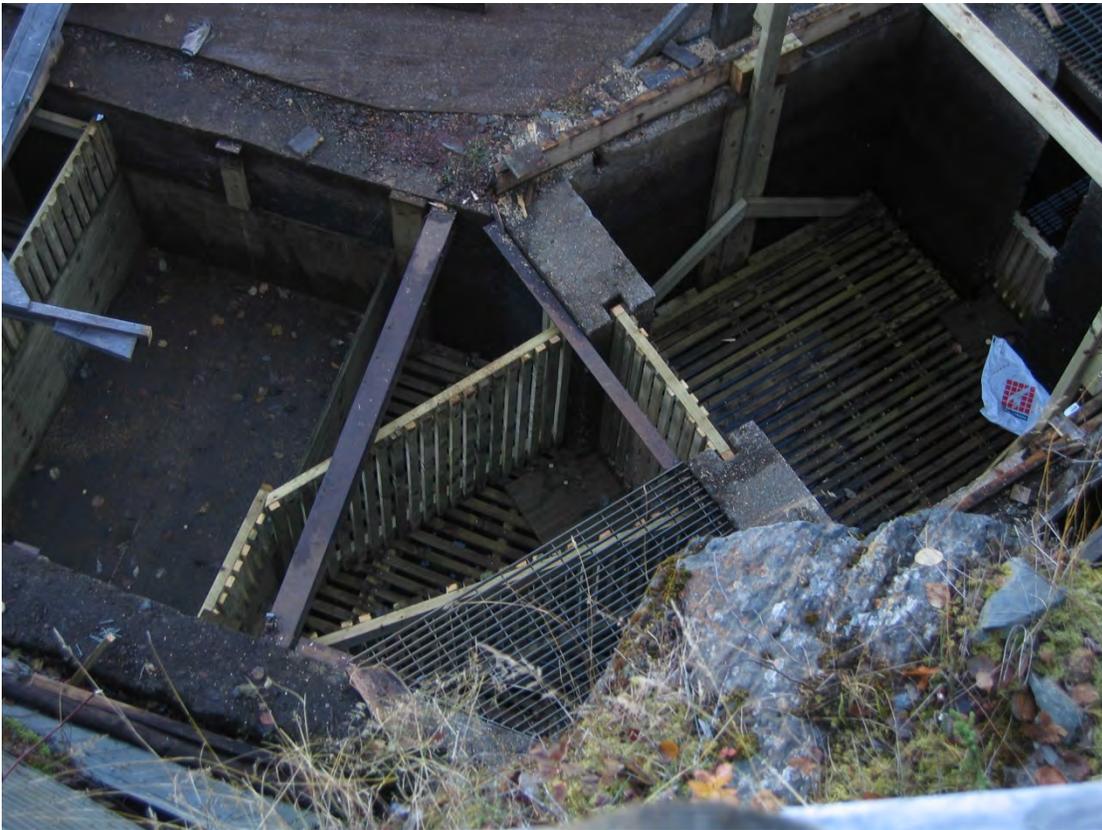
2009 – Wooden fish counting trap without above enclosure (Pools No. 4 and 5)

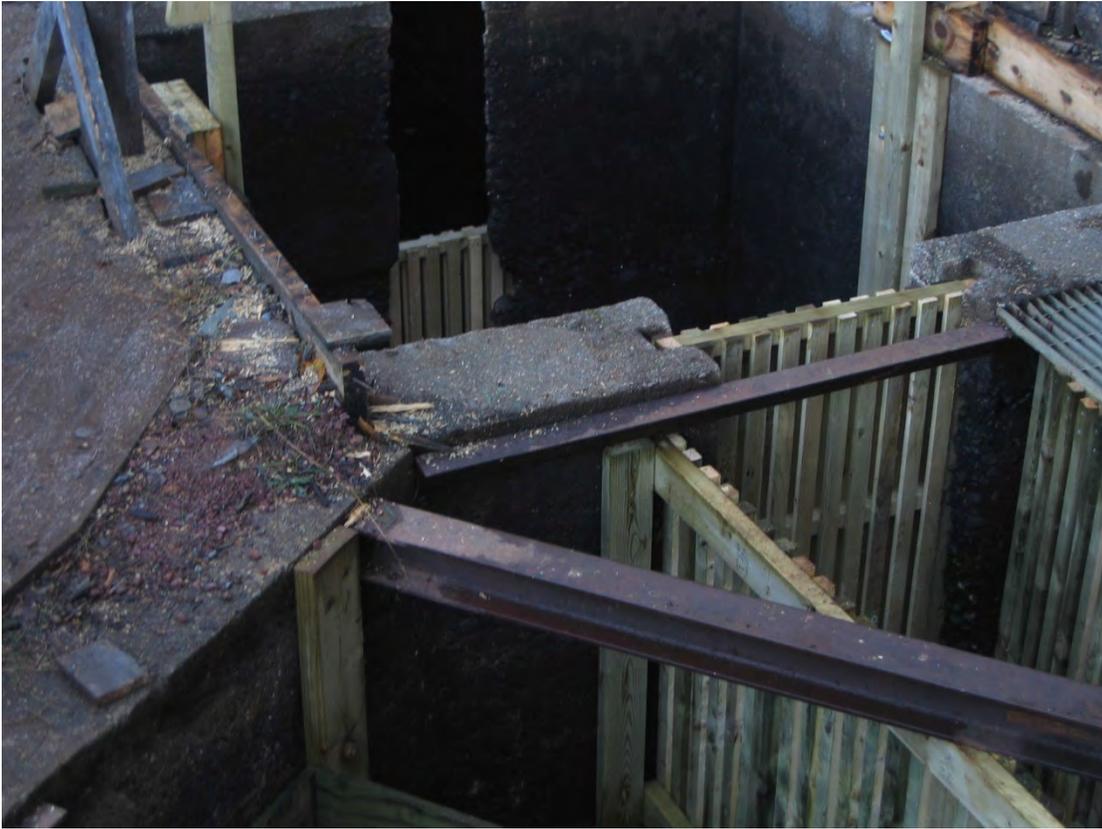
2009 – Wooden fish counting trap without above enclosure (Pools No. 4 & 5)

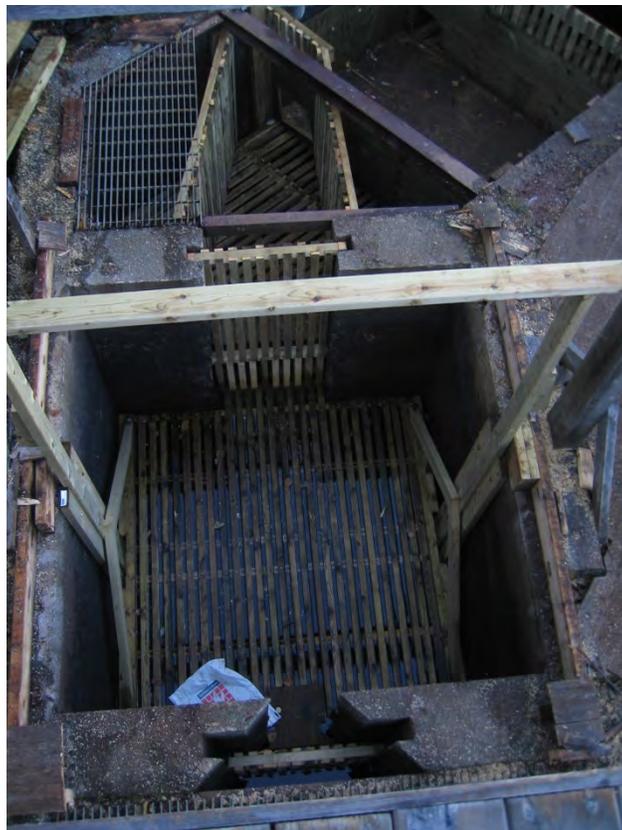
2009 – Wooden fish counting trap without above enclosure (Pool’s No. 4 & 5)

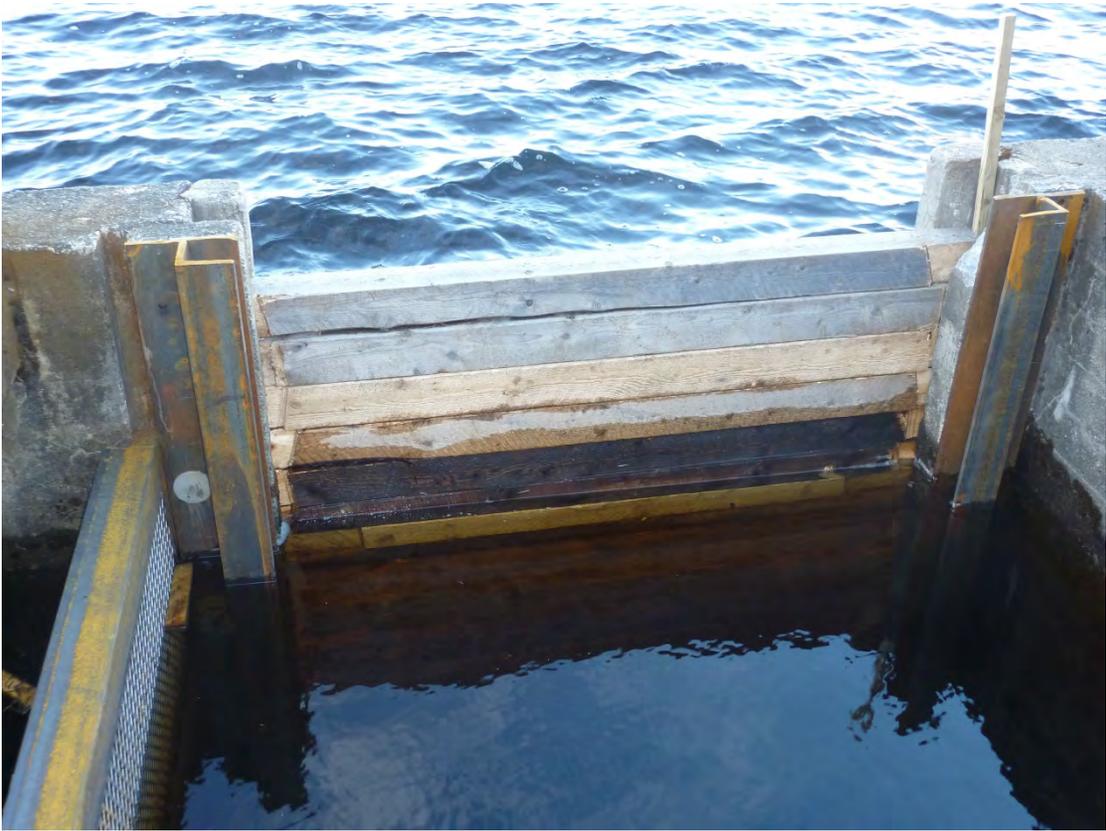
2009 – Stop logs and screen (on left) in Pool No. 6

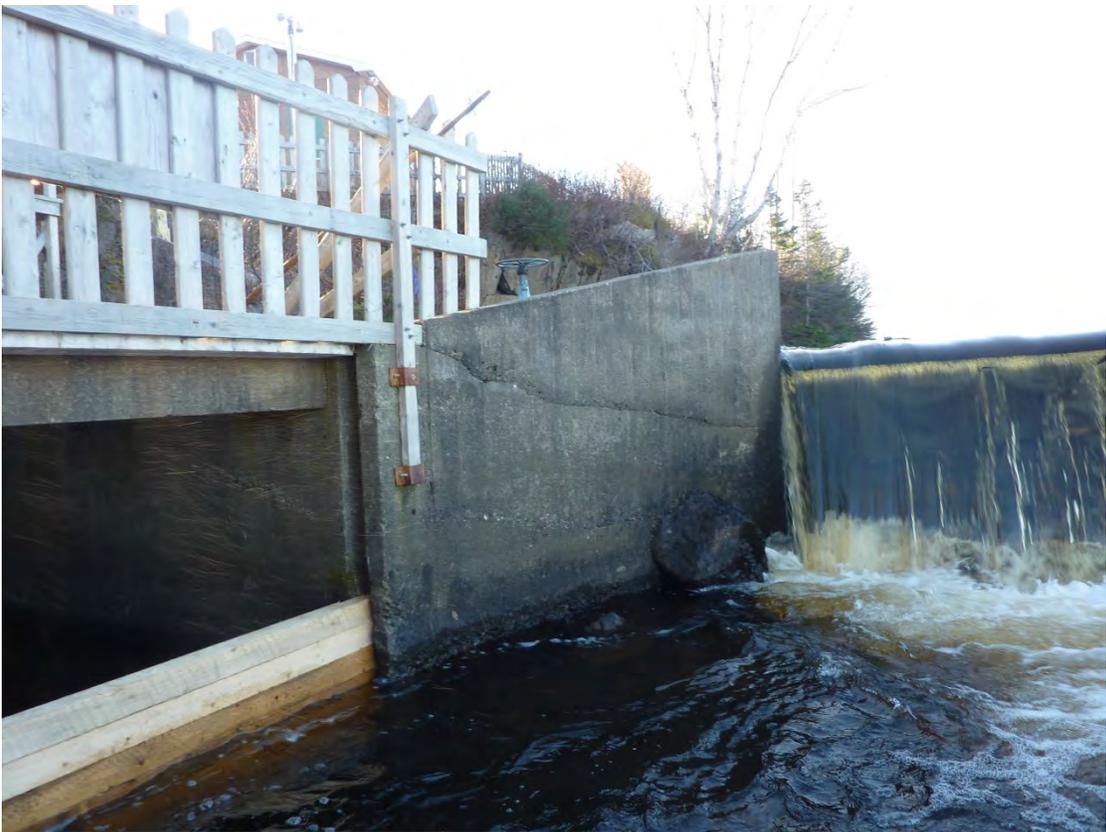
2009 – Retaining wall and inlet to Pool No. 1

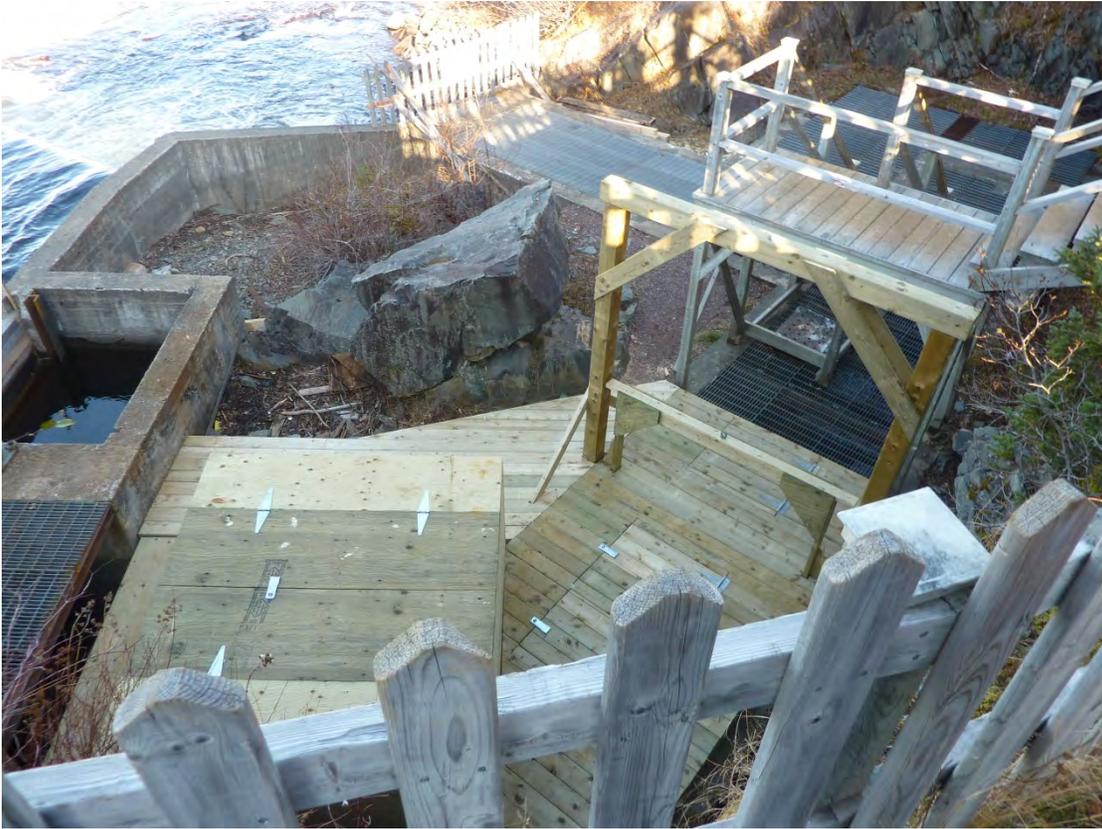
2009 – Overall fishway with timber enclosure over fish trap area

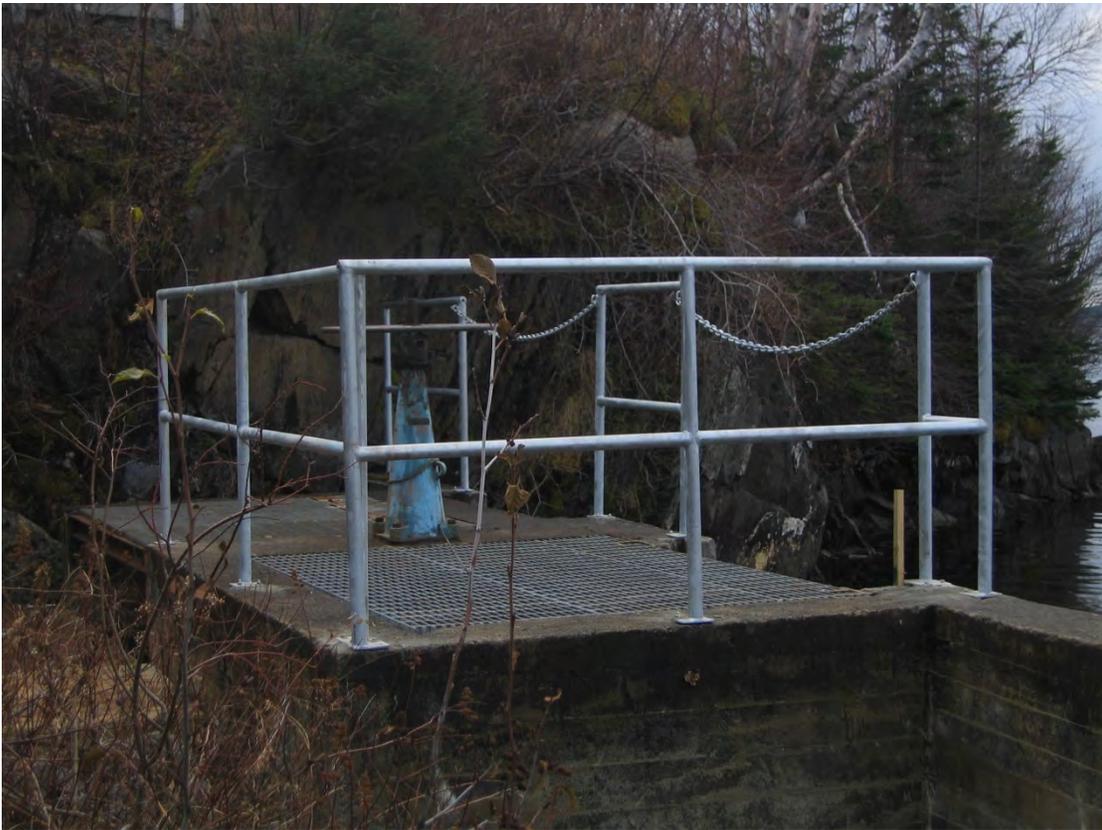
2009 – Steel pipe railing around Pool No. 5 & 6

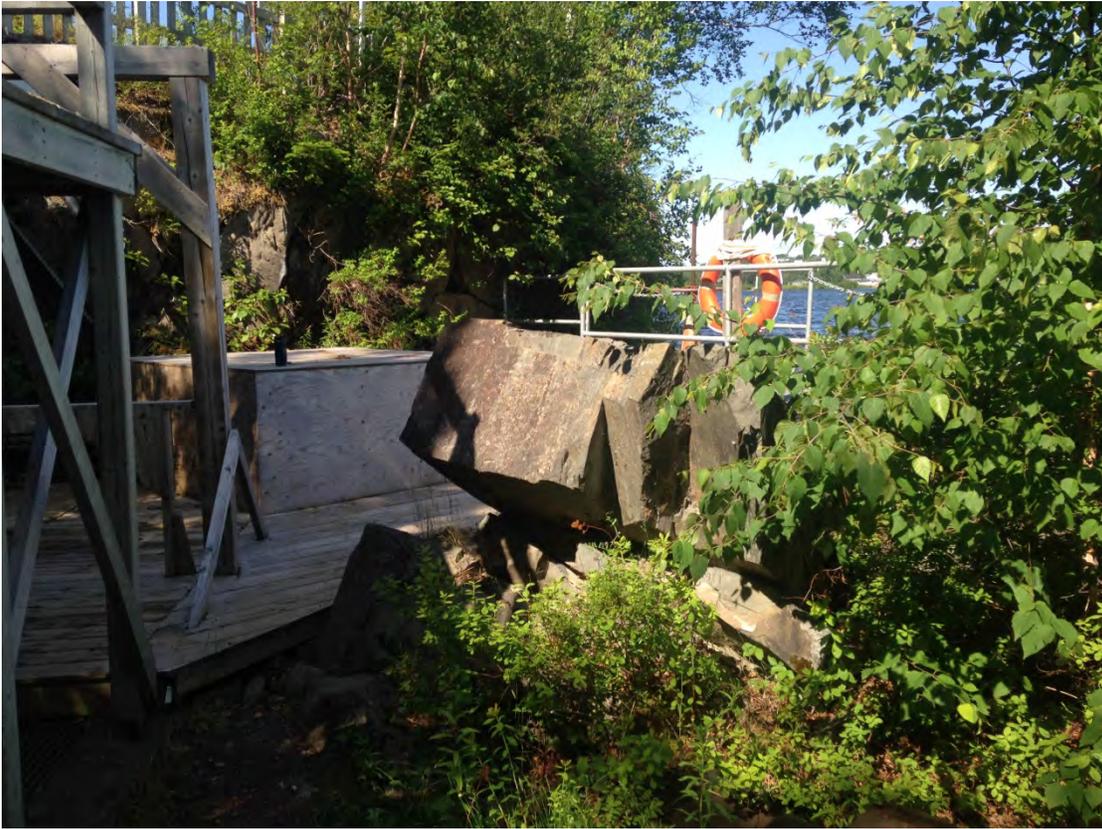
2015 – Rock outcrop in area of new staircase

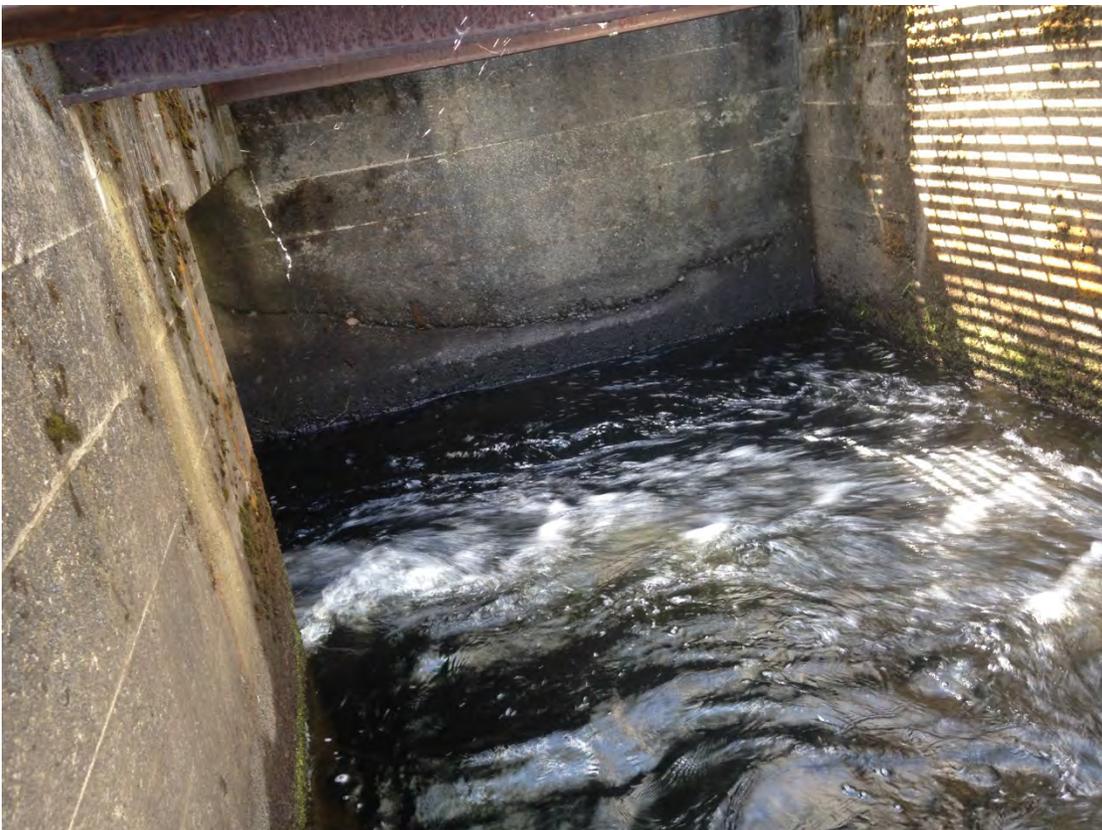
2015 – Concrete deterioration/cracks in far wall

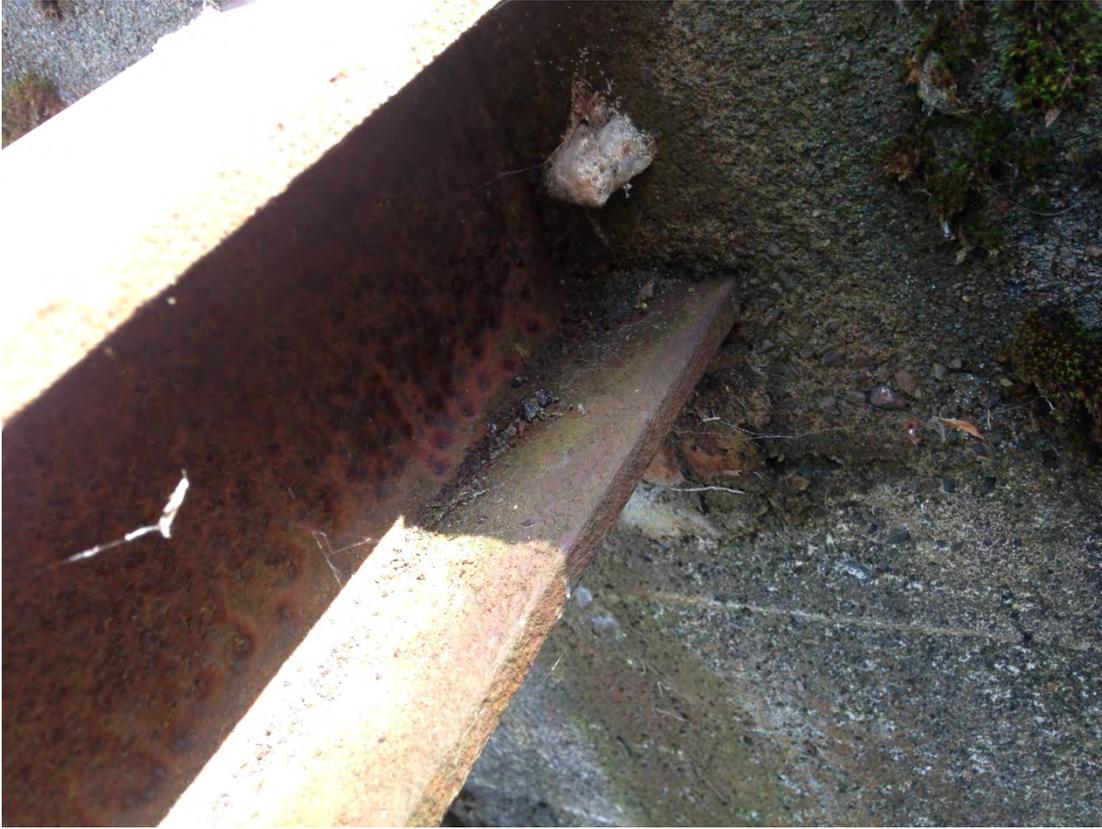
2015 – Embedded steel grating supports

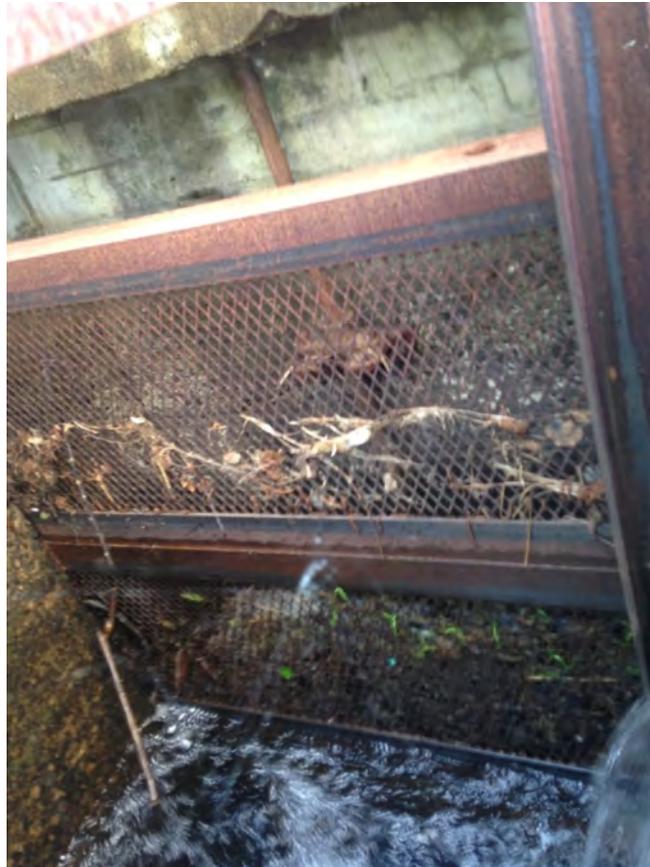
2015 – Debris on screen in Pool No. 6

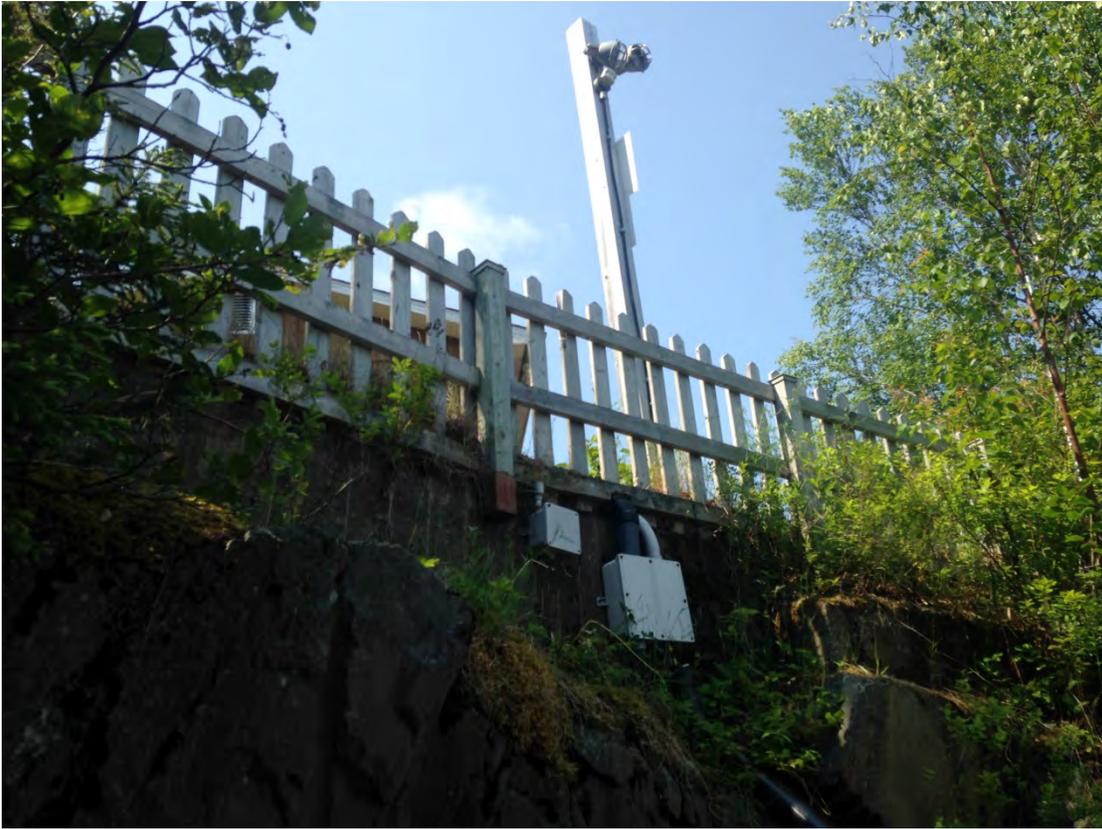
2015 – Uplands wooden fence/railing

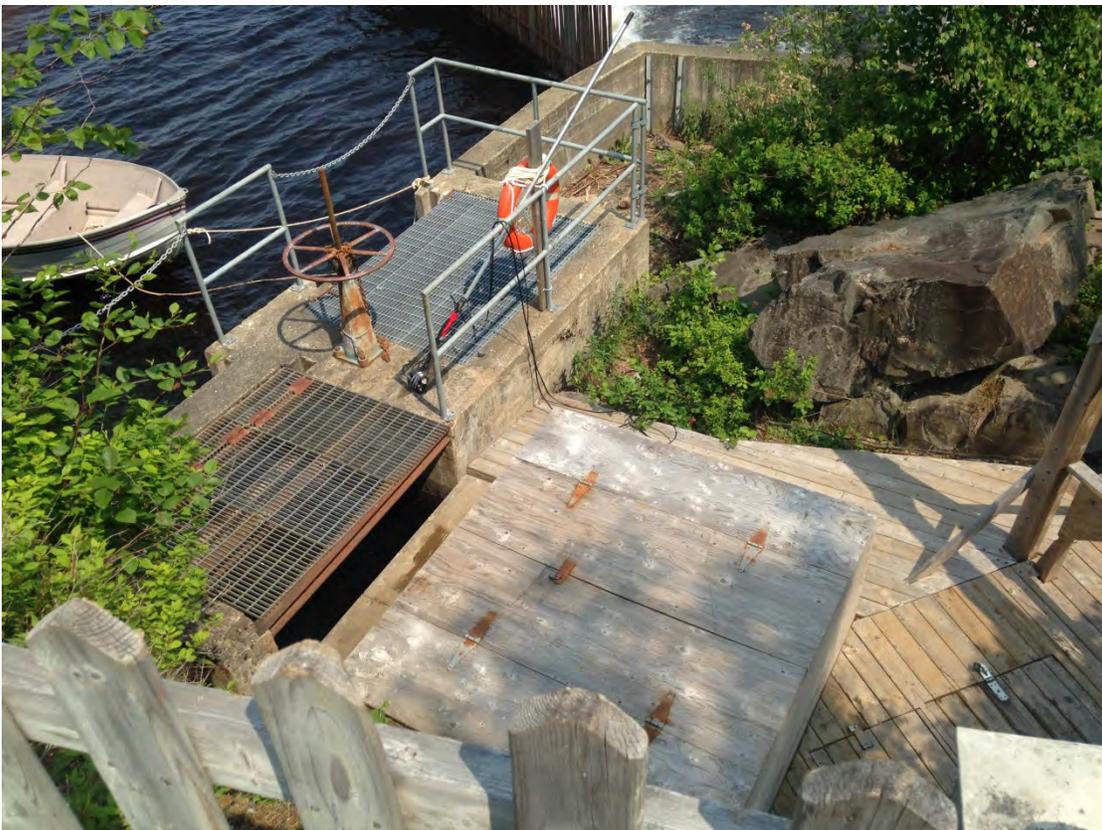
2015 – Fish trap enclosure indicating raised portion of Pool No. 5 and Pool No. 6

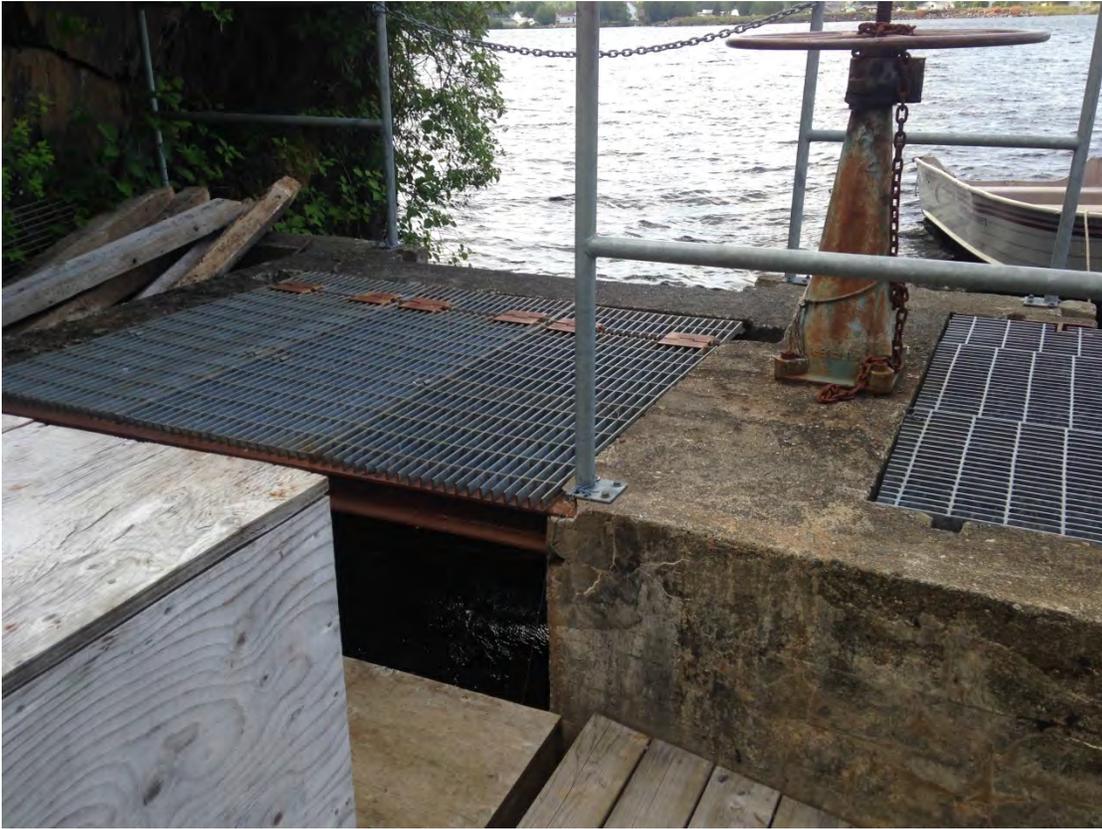
2015 – Raised portion of Pool No. 5

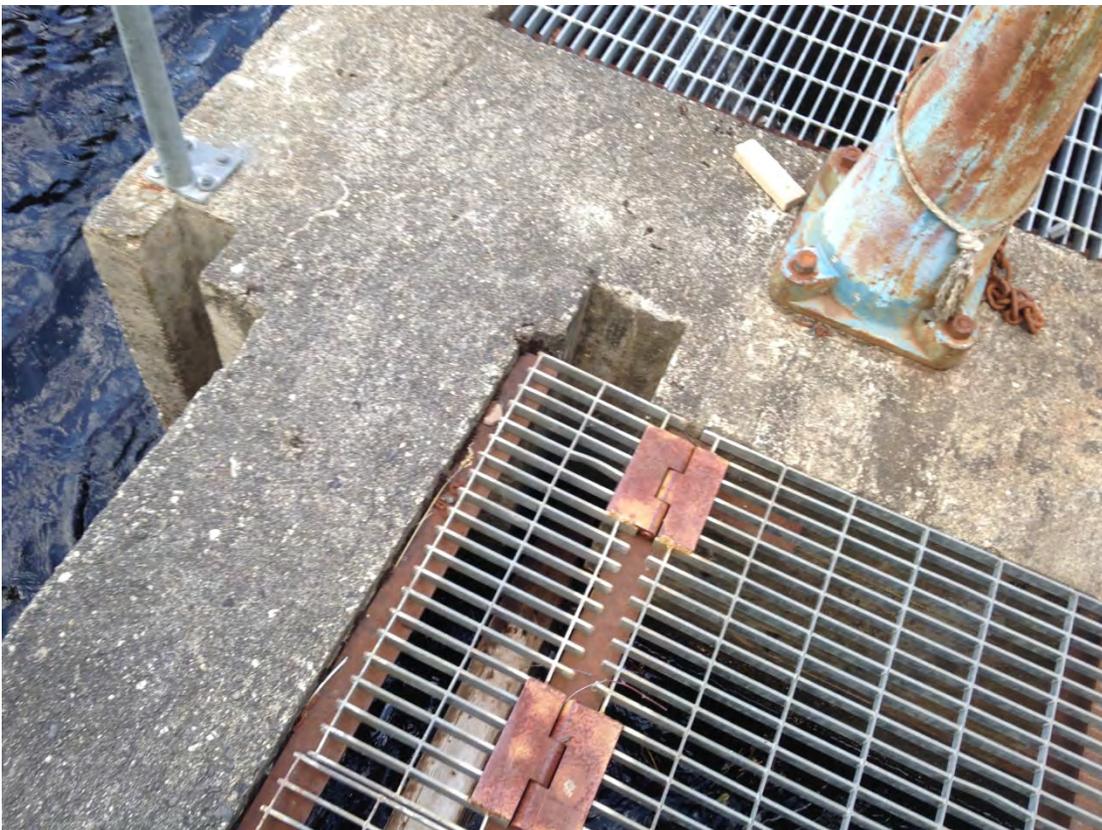
2015 – Stop logs at inlet to Pool No. 5

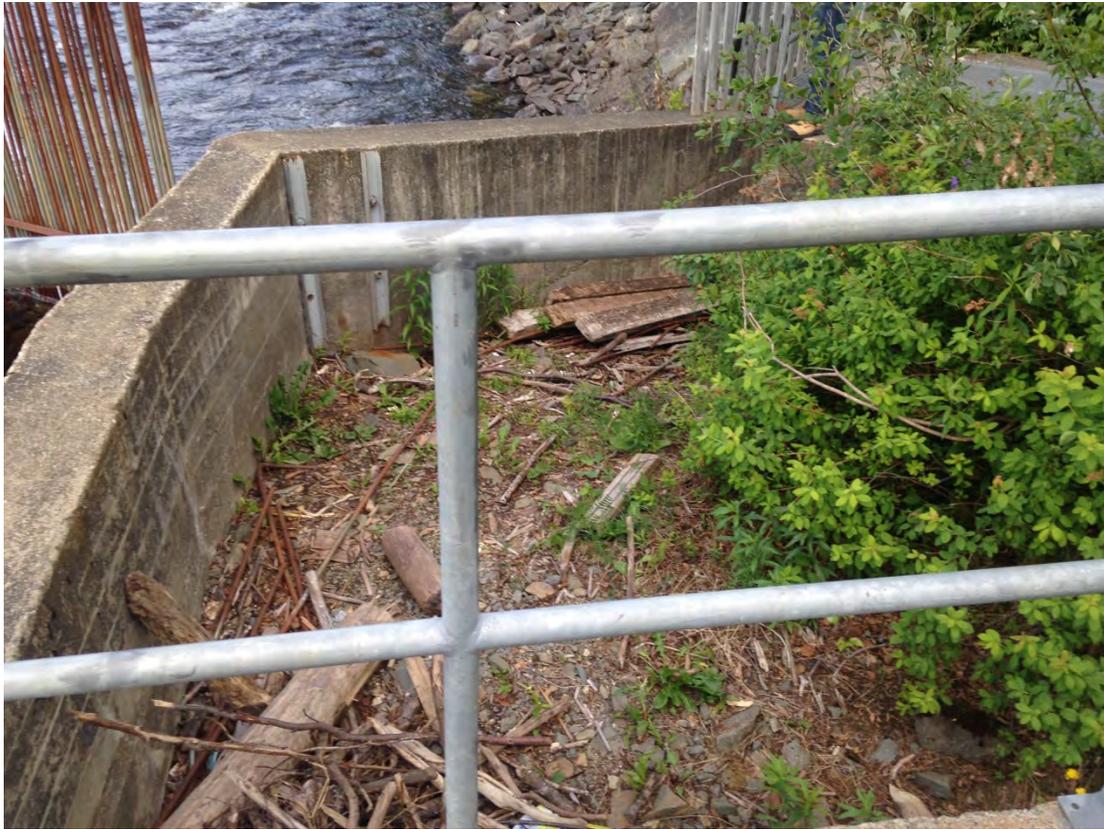
2015 – Retaining wall adjoining Pool No. 6 and No. 7

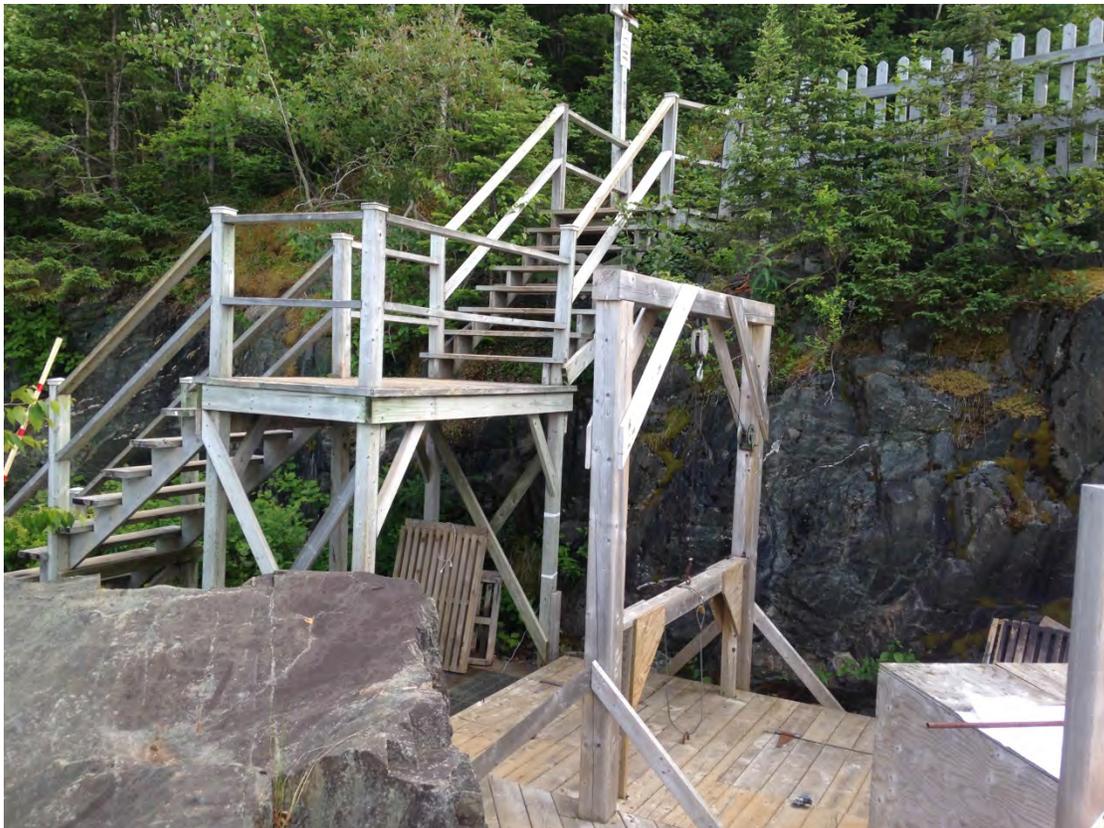
2015 – Staircase, rock outcrop, trap enclosure, wooden hoist and uplands wooden fence

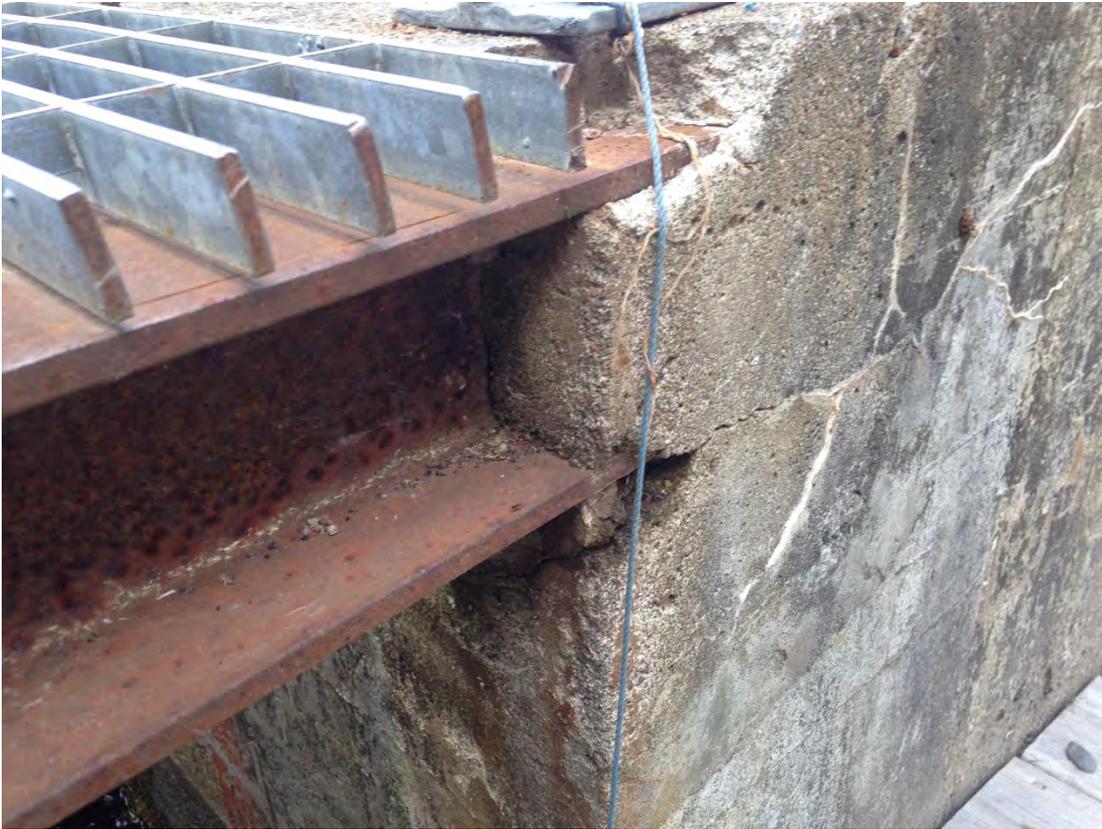
2015 – Embedded steel grating support with concrete damage

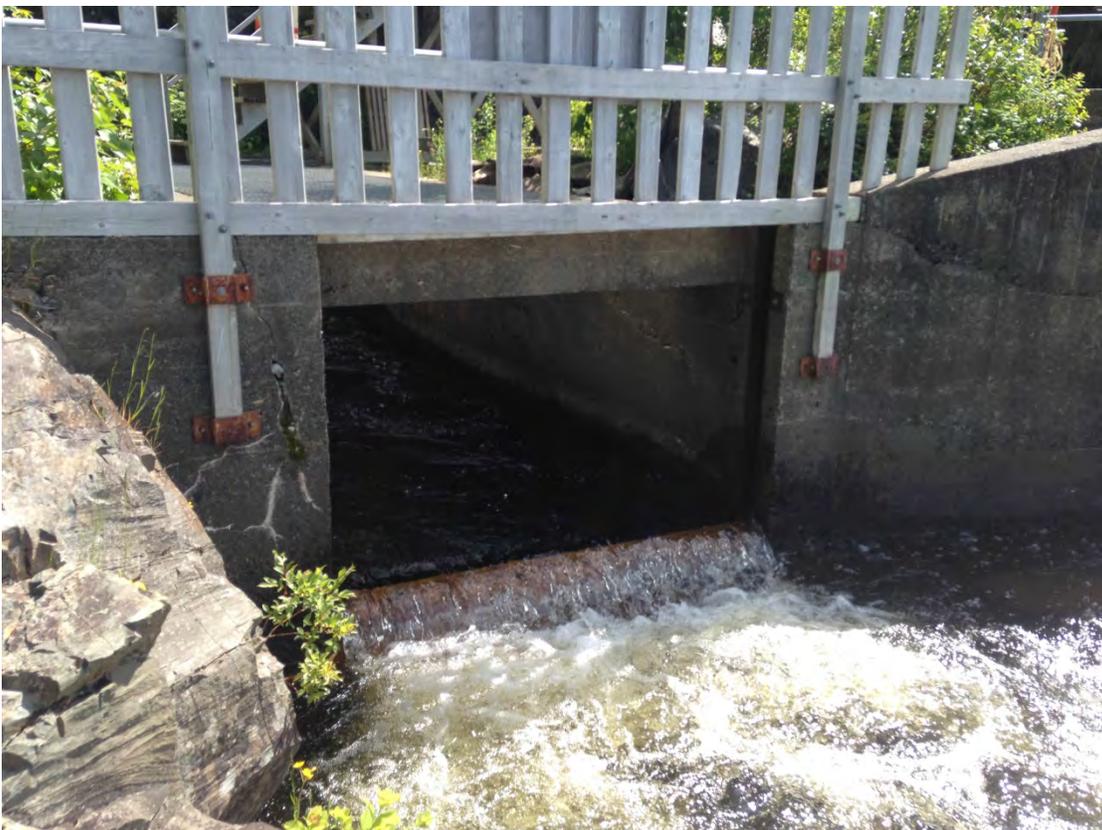
2015 – Inlet at Pool No. 1

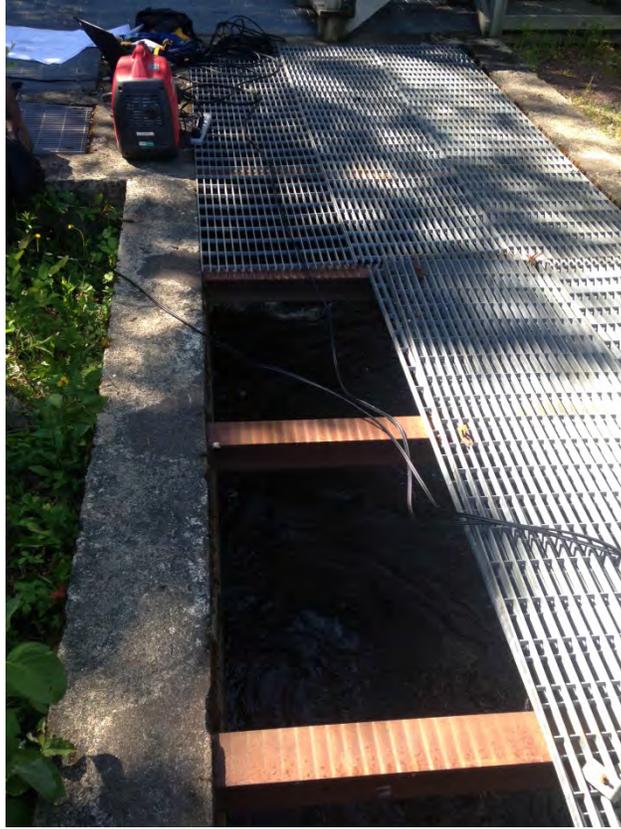
2015 – Pool No. 1 with partial section of grating removed exposing steel supports

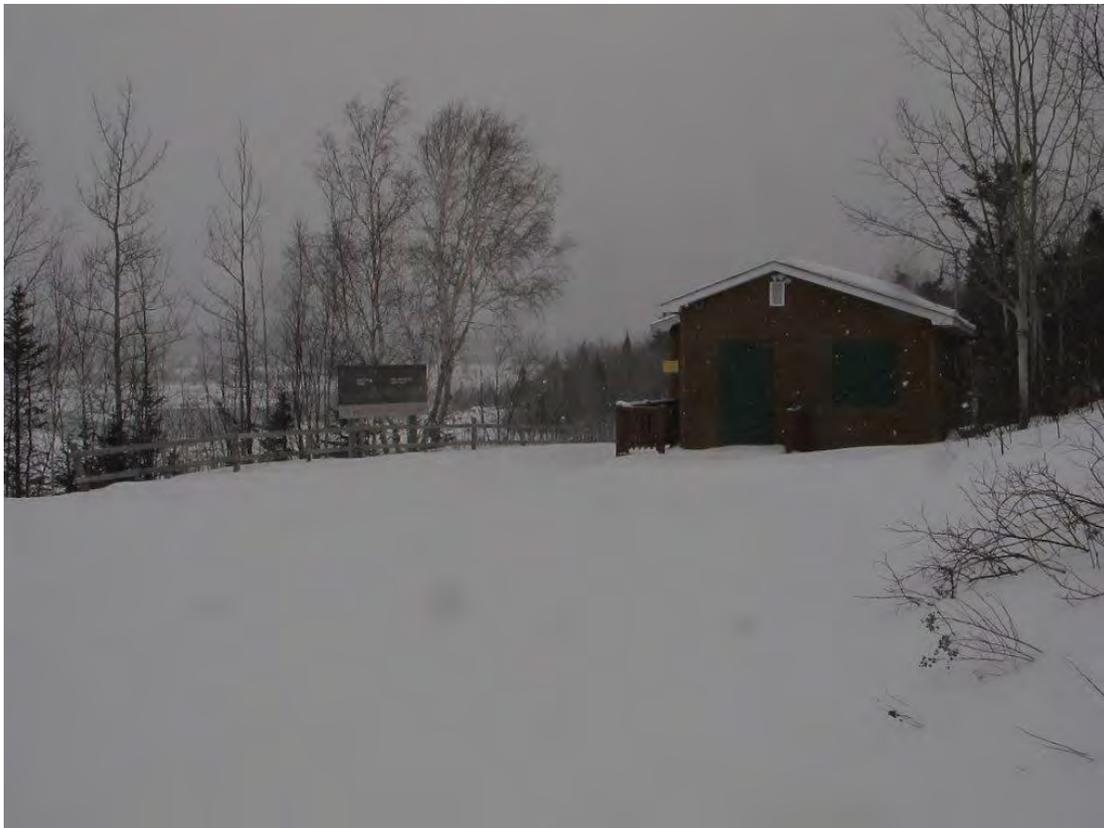
2015 – Site cabin during winter
