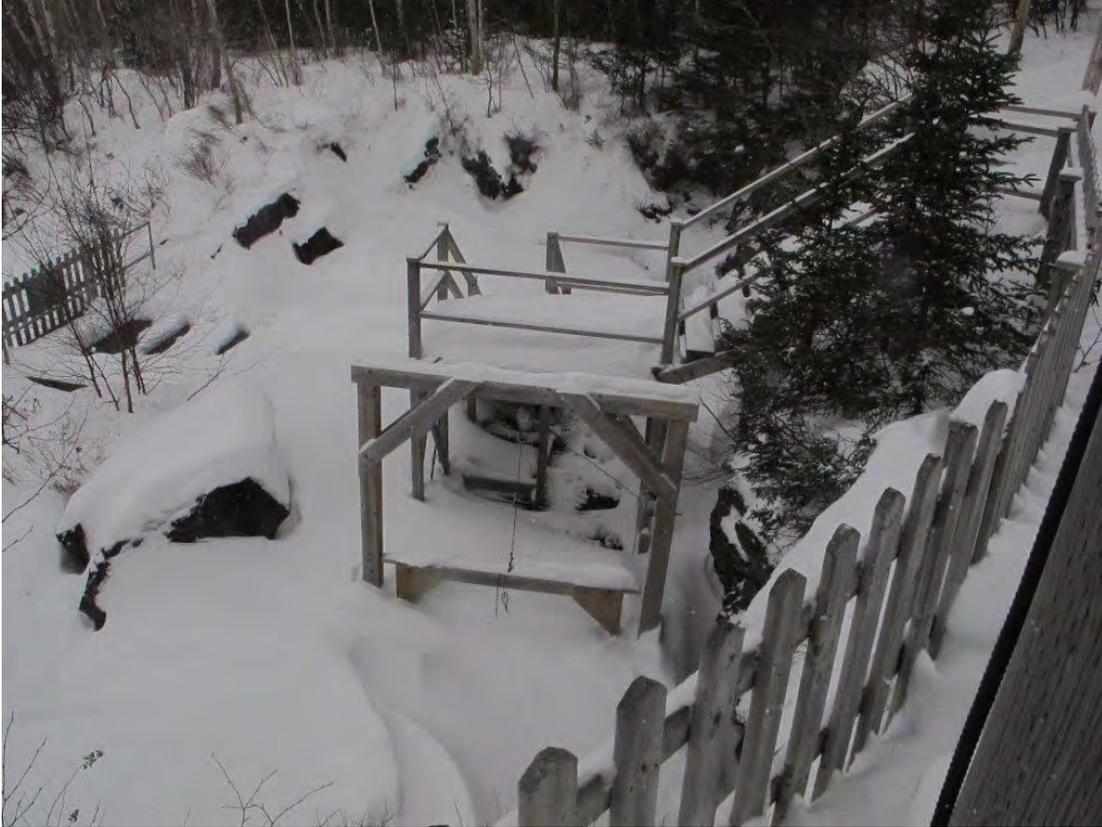
2015 – Fishway during winter

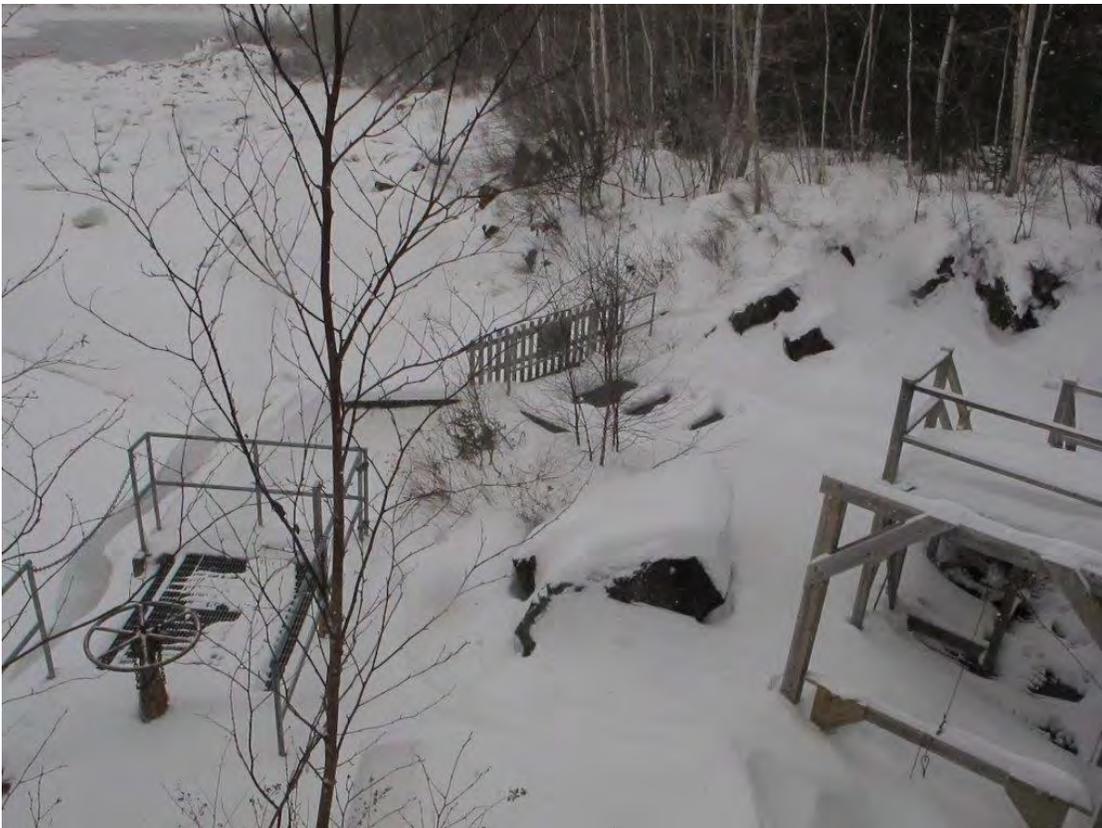
2015 – Fishway during winter

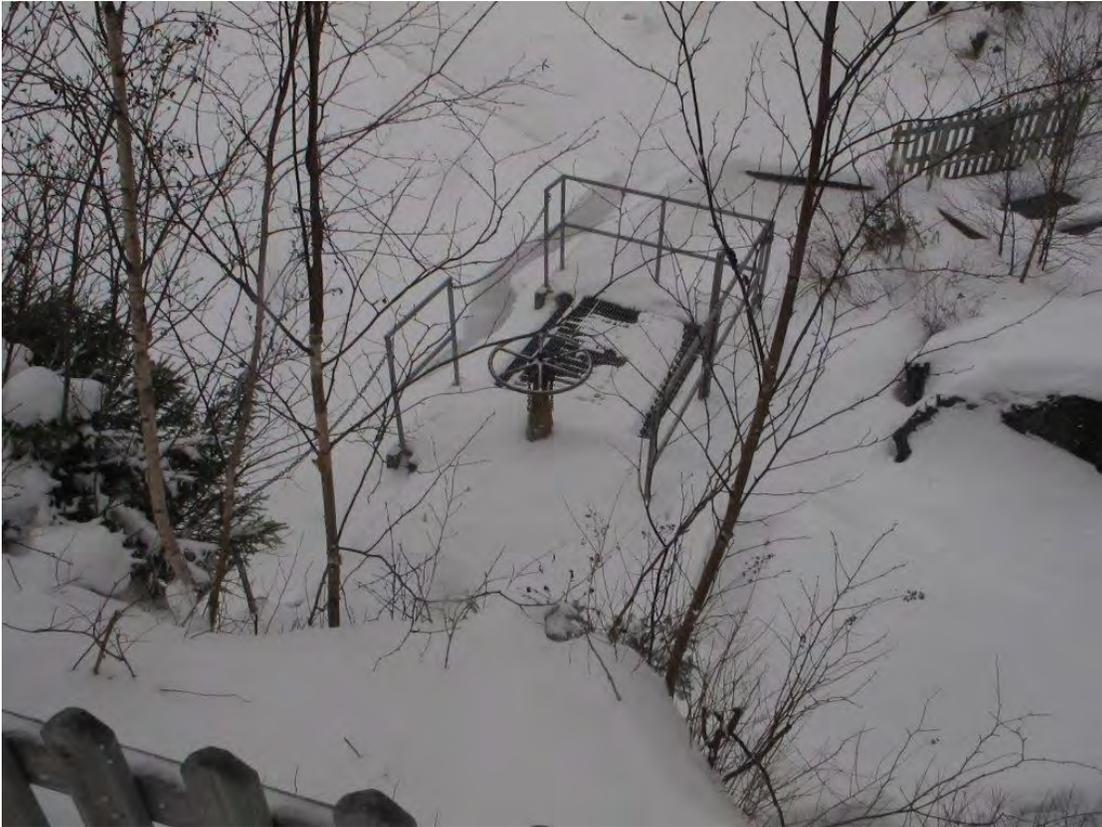
2015 – Fishway during winter, Pool No. 5 & 6

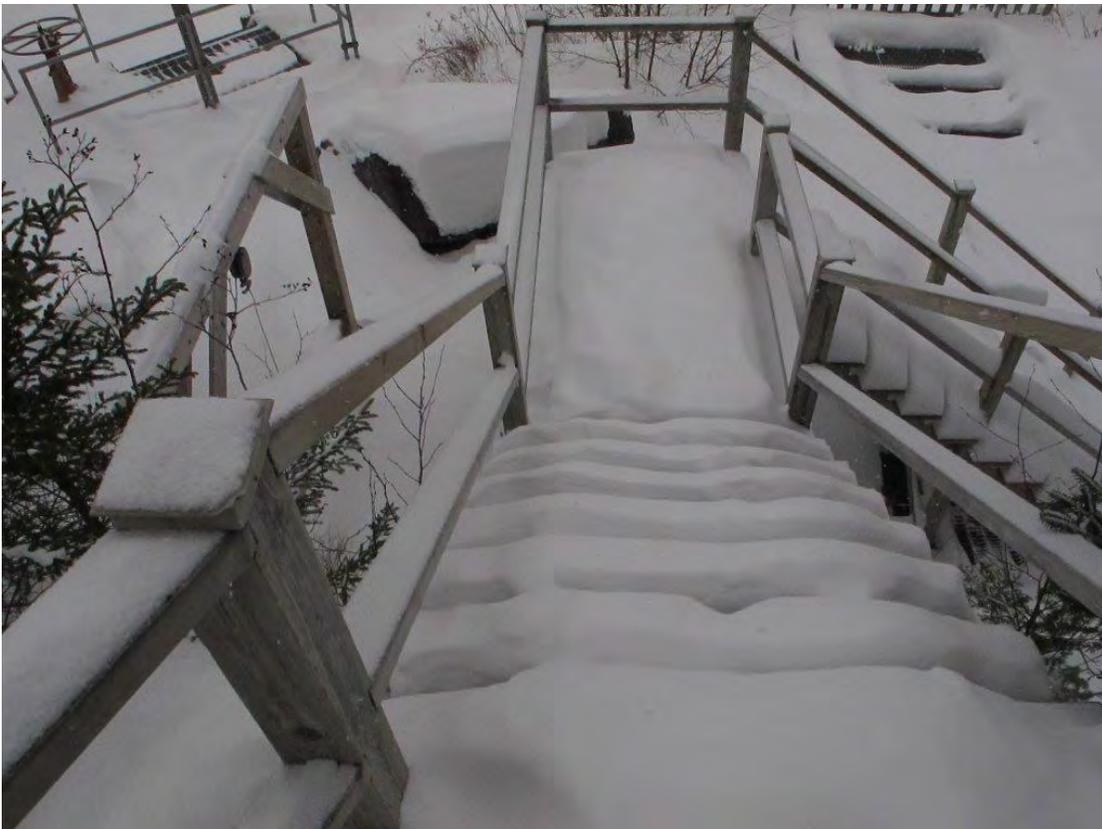
2015 – Staircase during winter

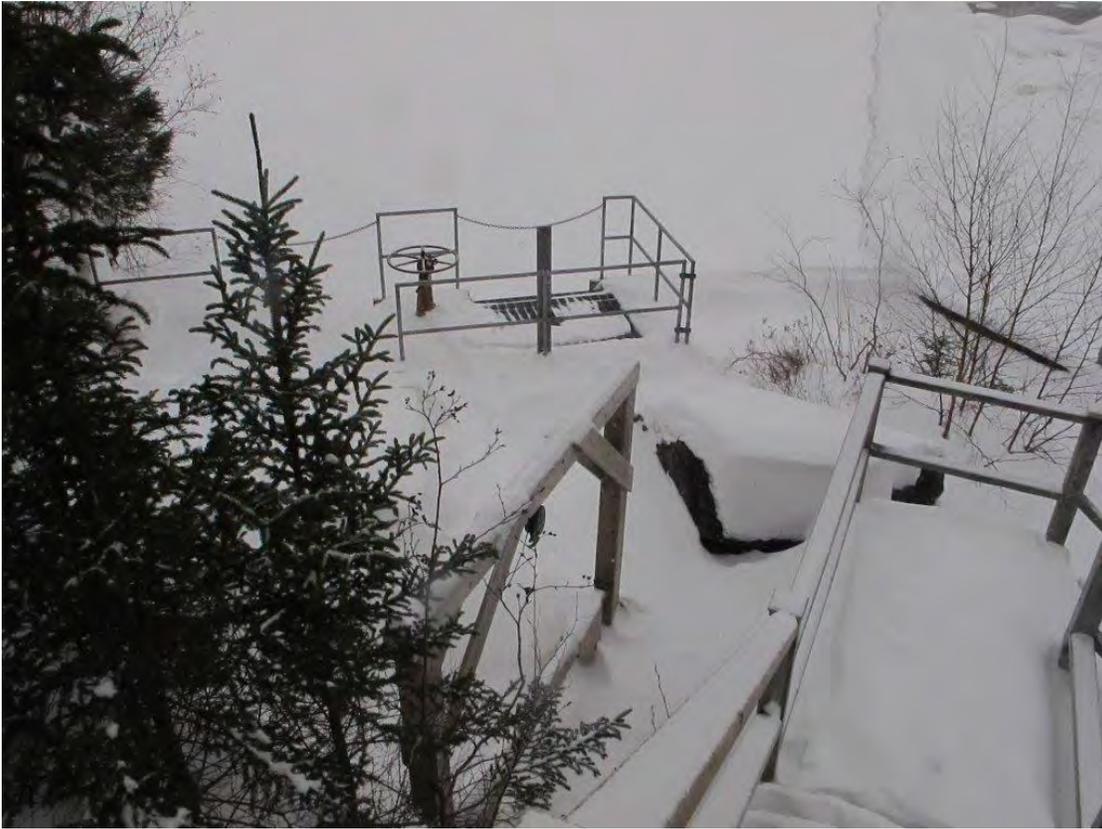
2015 – Fishway during winter, looking towards Pool No. 6

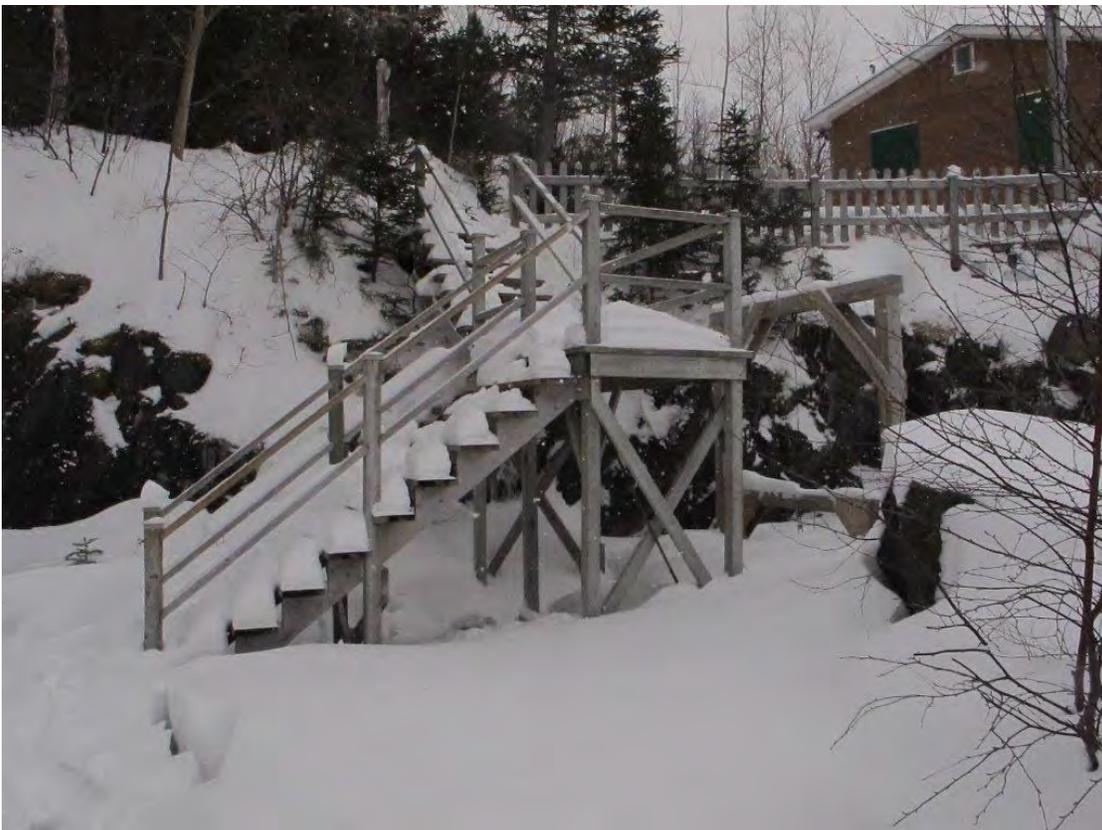
2015 – Fishway during winter
