project title
titre du projet
TORONTO

25/55 ST. CLAIR AVE., EAST

BUILDING WORKS

drawing title
titre du dessin
**ELEV. QUANTIFICATION NOTES.
ENLARGED ELEV. PLANS
ELEV. 5, 6, 7, & 8**

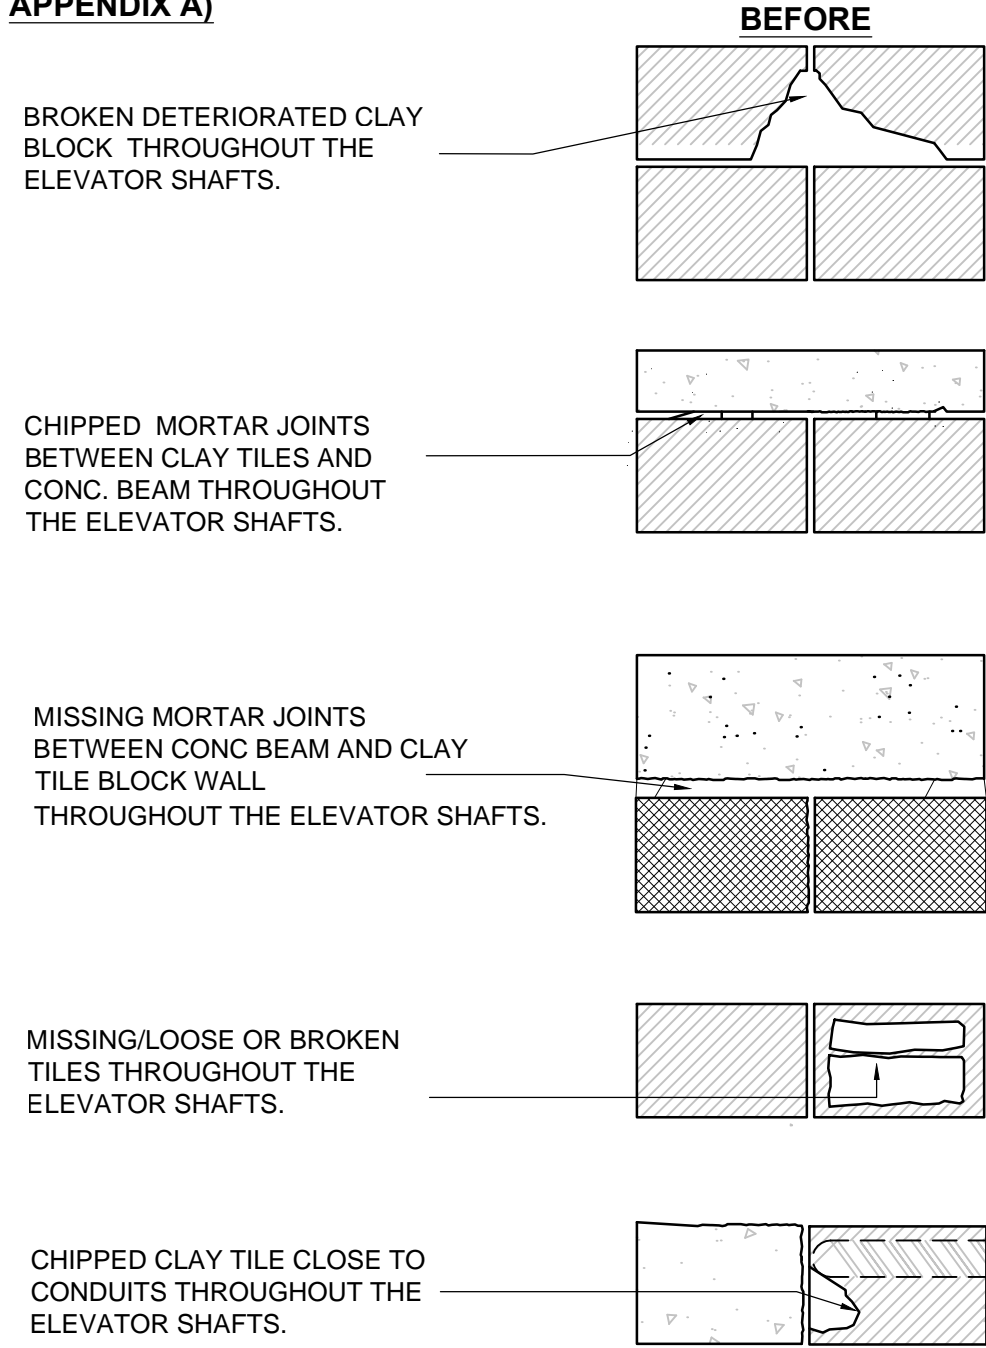
**EXISTING CONDITIONS FROM VISUAL REVIEW OF THE INTERIOR OF ALL
THE ELEVATOR SHAFTS (ELEV. 1-4, 5-7 AND 8) DESCRIBED IN THE
QUANTIFICATION REPORT. (SEE SPECIFICATIONS, SECTION 000111
APPENDIX A)**
