ADDENDUM NUMBER: TWO

ISSUED BY: SEPW Architecture Inc.
109 – 3725 Pasqua St., Regina, SK. S4S 6W8
PH. (306) 569-2255

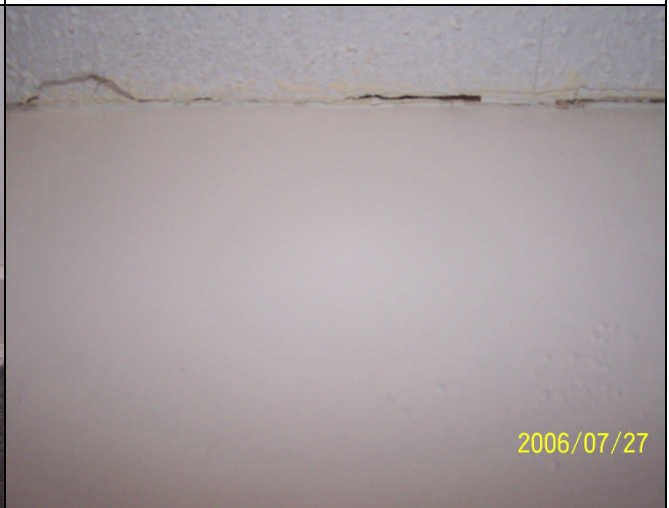
Figure 20: Second Floor Bedroom –
Water damaged ceiling and paint cracking on wall

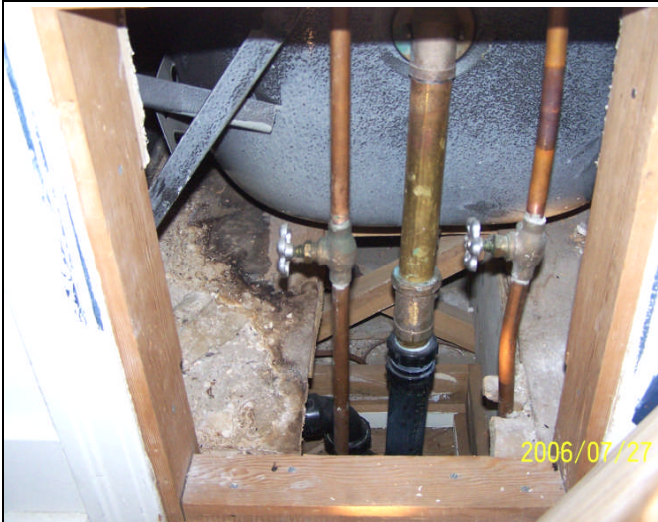
Figure 21: Second Floor Bedroom –
Access Hatch to bathtub plumbing

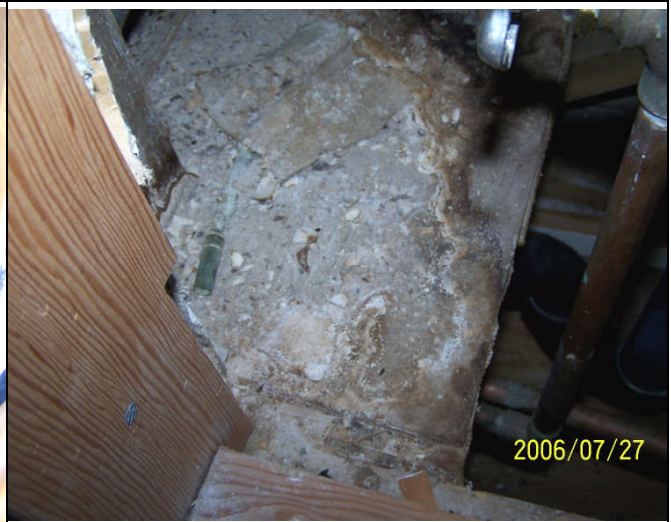
Figure 22: Second Floor Bedroom –
Access Hatch to bathtub plumbing shows
mould staining on floor from water damage.

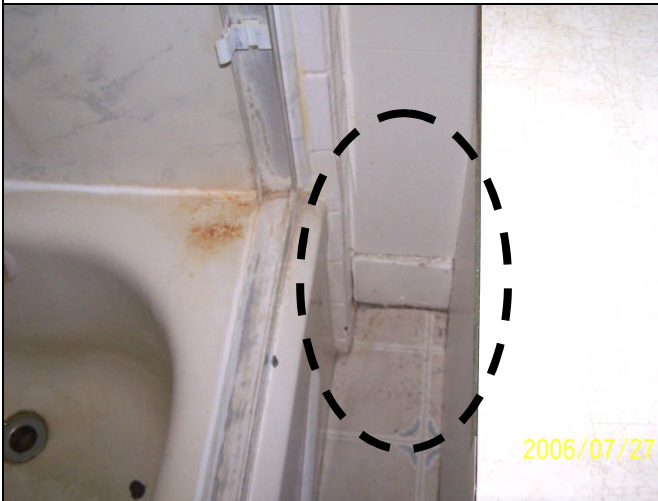
Figure 23: Second Floor Washroom –
Suspect mould growth beside bathtub.

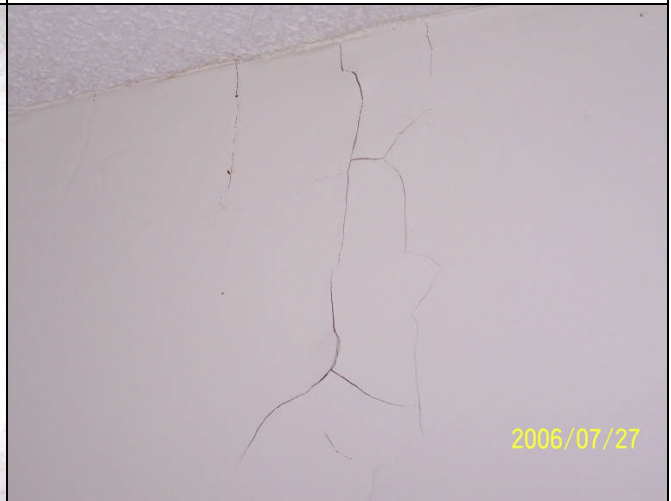
Figure 24: Second Floor Bedroom –
Moisture damage to wall causing paint and
plaster cracking

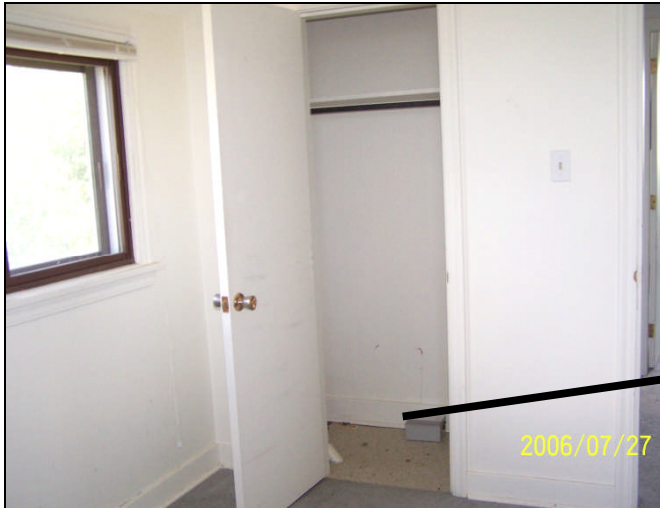
Figure 25: Second Floor Bedroom Closet –
Contained three mouse traps

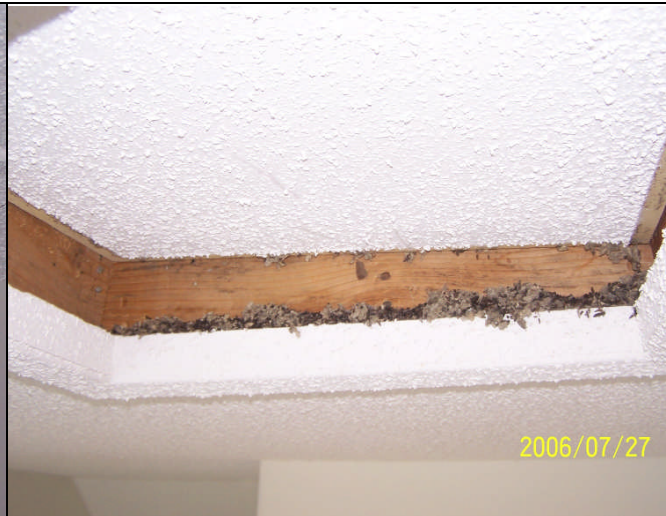
Figure 29: Second Level Hallway – Lifting of Access Hatch caused feces and insulation to fall from the Attic.

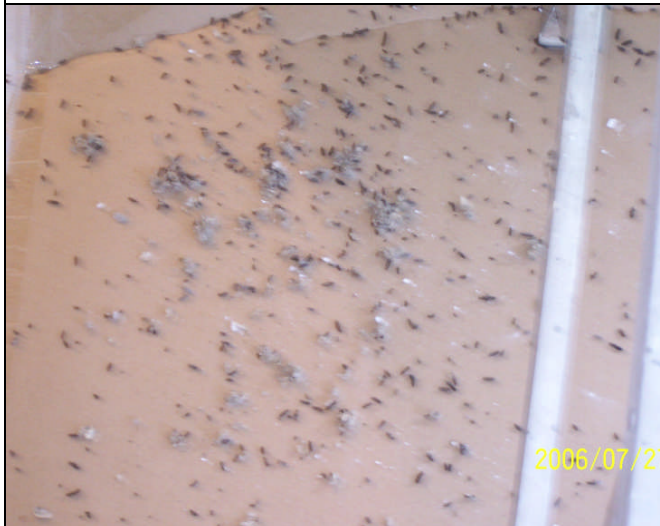
Figure 30: Second Level Hallway – Feces (mouse) fell from Attic onto barrier material when cover over Access Hatch was removed.

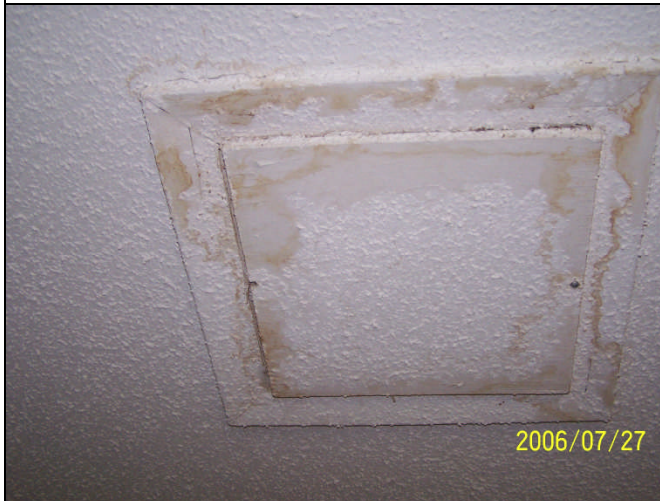
Figure 34: Living Room (Access Hatch) – Water reportedly poured from Access Hatch in Living Area below. Water staining evident on and around Access Hatch.

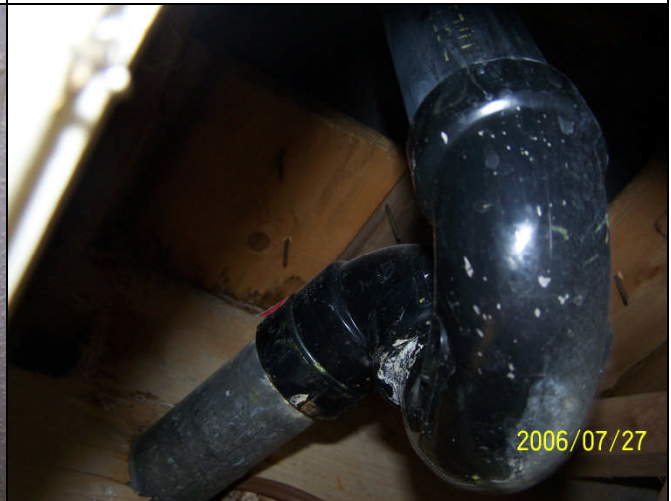
Figure 35: Living Room (Access Hatch) – Removal Access Panel identified trap for bathtub drain (second level).
