Statement of Work Foam Lake Production Wells

Background

On September 3 2015 a site visit was conducted by AAFC Rep. Kirk Brossart at Foam Lake Pasture to assess wells to be decommissioned. Kirk was taken to six well sites on a side by side ATV operated by pasture manager Steven Miller. Five (5) out of six (6) wells visited require decommissioning and one of the wells was found to have been previously decommissioned.

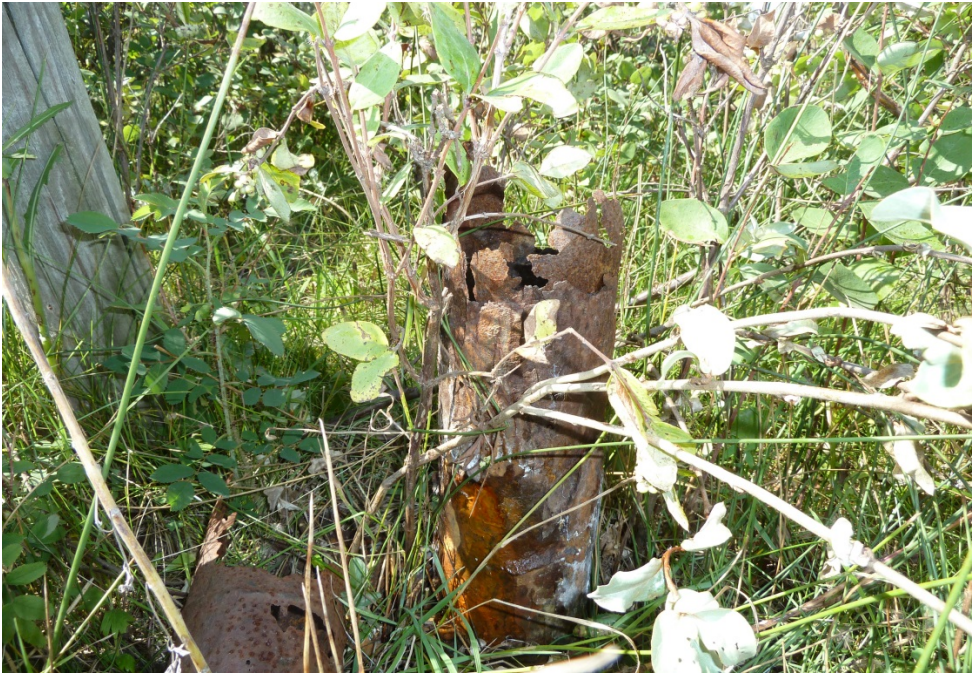
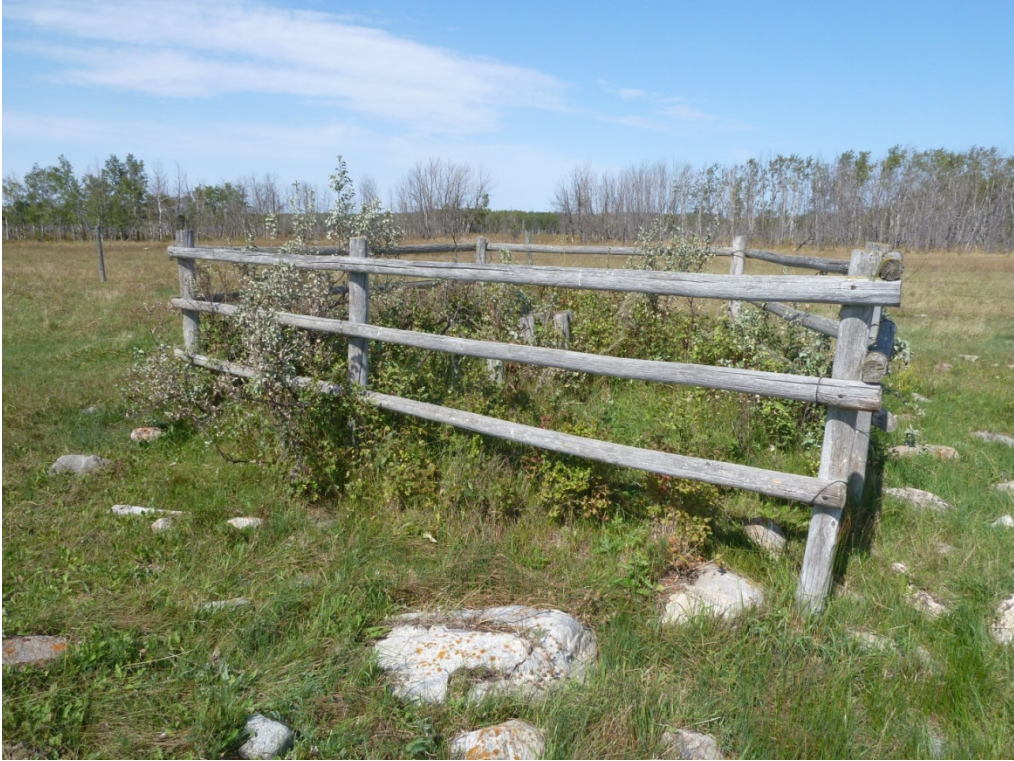
Foam 1 (2 pictures)

Foam 1 is located NW 14-32-10-w2 (GPS 13u 0615906e 5734118n)

It is a 4" steel casing flowing well located beside a dugout

AAFC was able to measure 18 ft. down the well. The water level was 1 ft. above ground in the casing.

To decommission this well, the existing well will have to be drilled out and be clear of debris so a cement grout with a specific gravity heavy enough to control the flowing water can then be pumped into the well close to the 102 ft. level from bottom to top.

The well should be cut off at or below ground and buried with local fill.

Fencing and related debris around well shall be cleaned up and disposed of off-site.

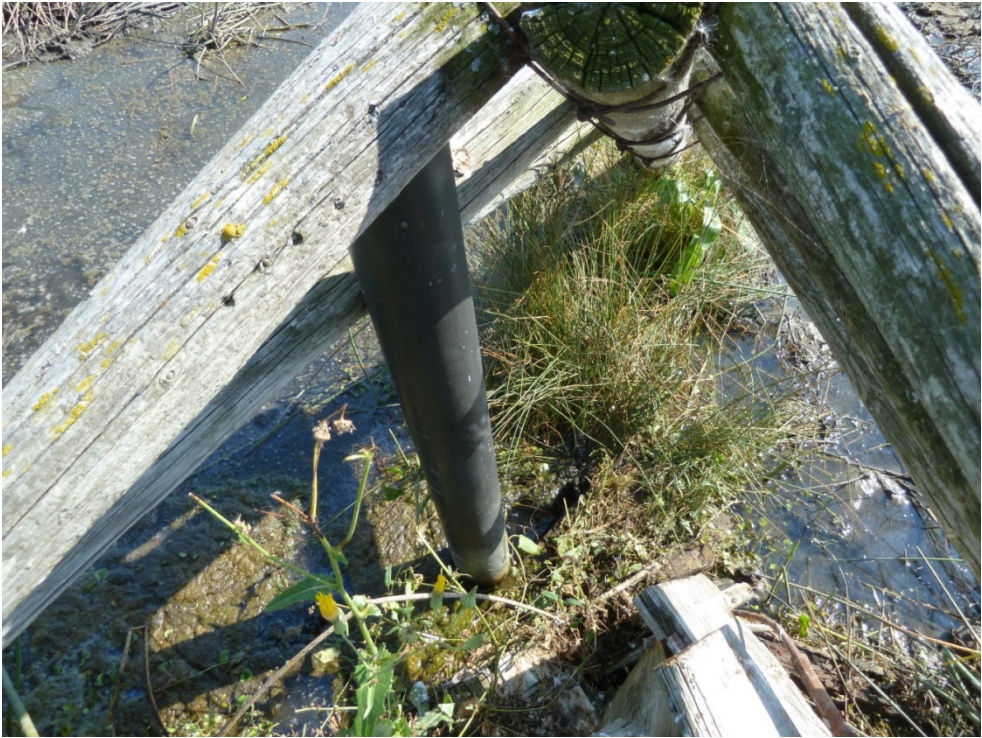
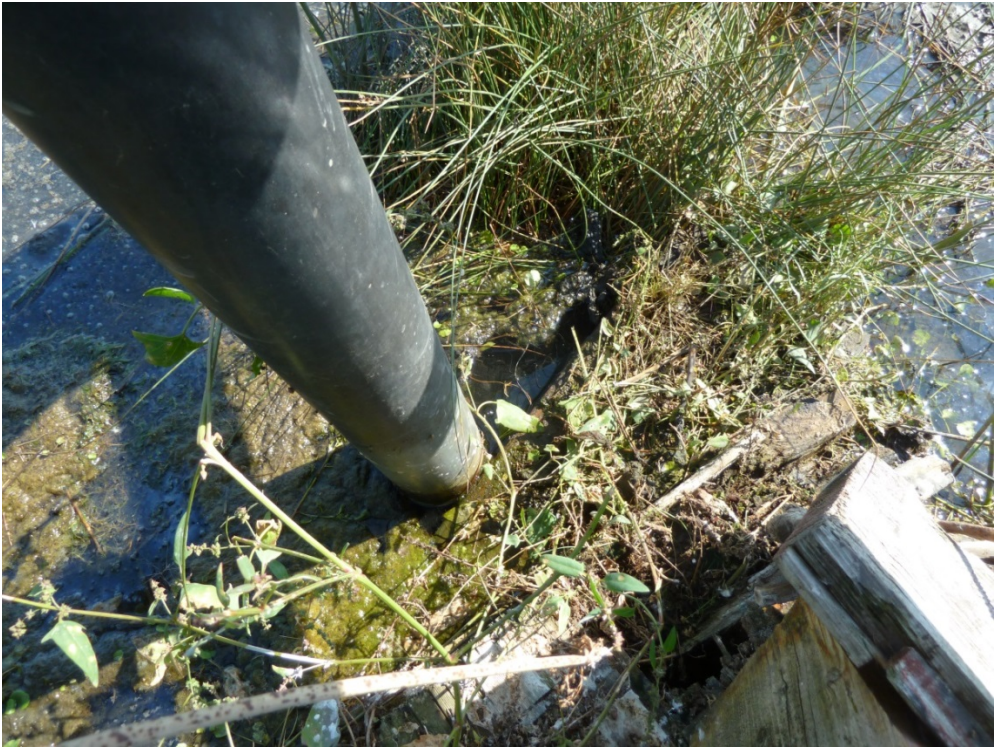
Foam 2 (2 pictures)

Foam 2 is located NE 11-32-10-w2 (GPS 13u 0616737e 5732757n)

It is a 4" steel casing flowing well that seems to have a plastic pipe inside

AAFC was able to measure 20 ft. down the well. The water was flowing out of and around the casing.

Access to this well is over rough terrain and wet conditions exist around the well.

To decommission this well, the existing well will have to be drilled out and be clear of debris so a cement grout with a specific gravity heavy enough to control the flowing water can then be pumped into the well close to the 143 ft. level from bottom to top.

The well should be cut off at or below ground and buried with local fill.

Fencing and related debris around well shall be cleaned up and disposed of off-site.

Wood fence around the well will have to be removed

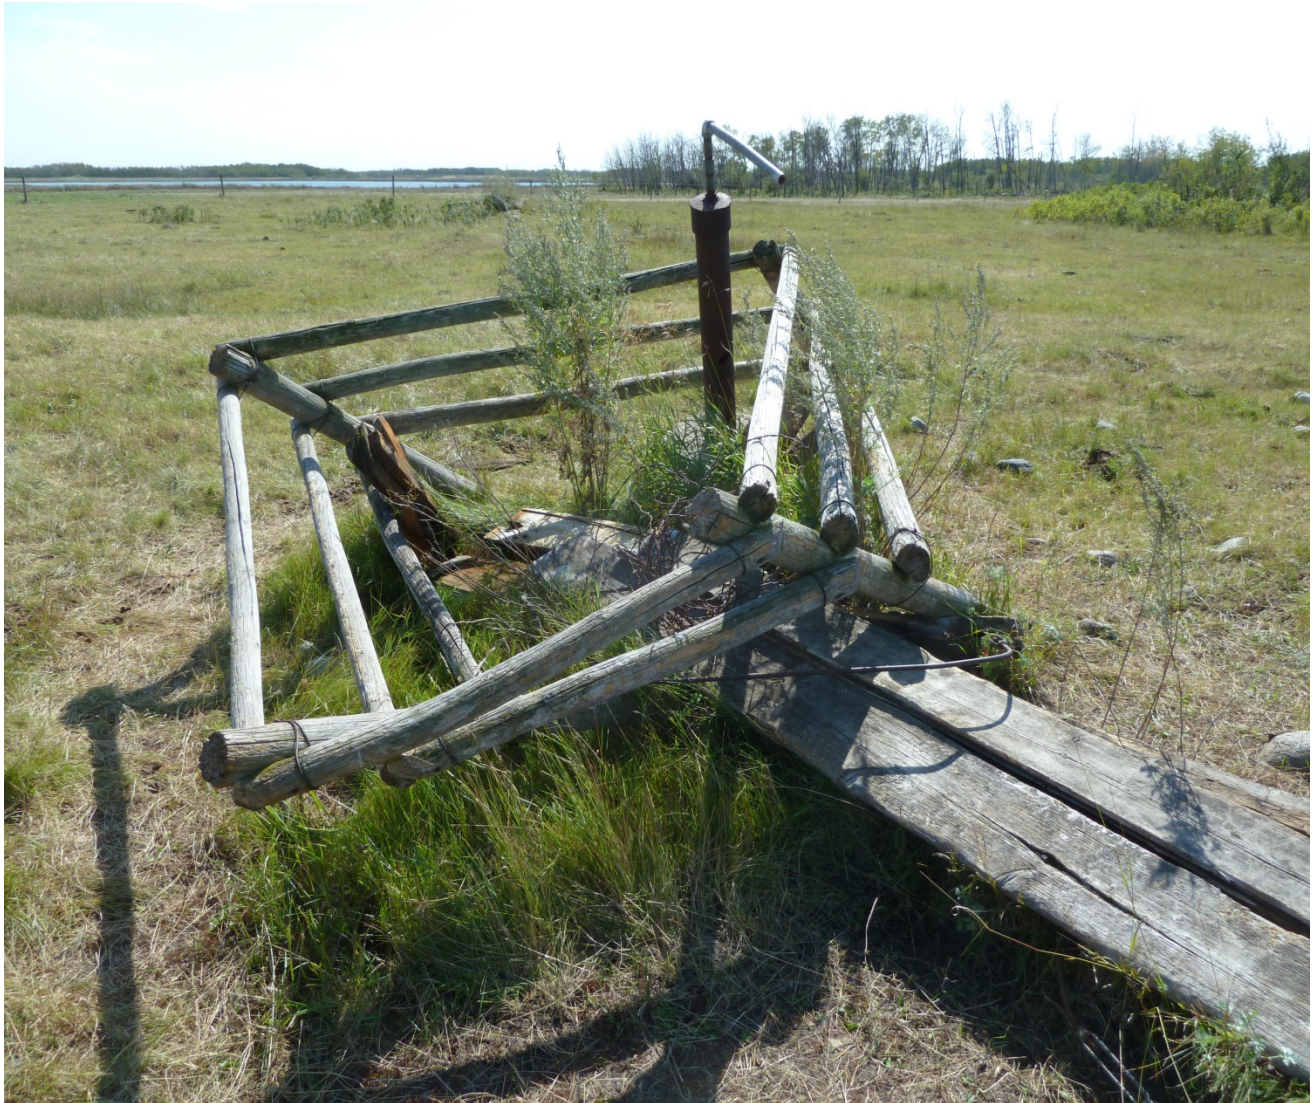
Foam 3

Was thought to be a well that needed to be decommissioned but when it was just a fenced area with and old pipe that was removed from the ground

This well has be previously decommissioned

No additional work required

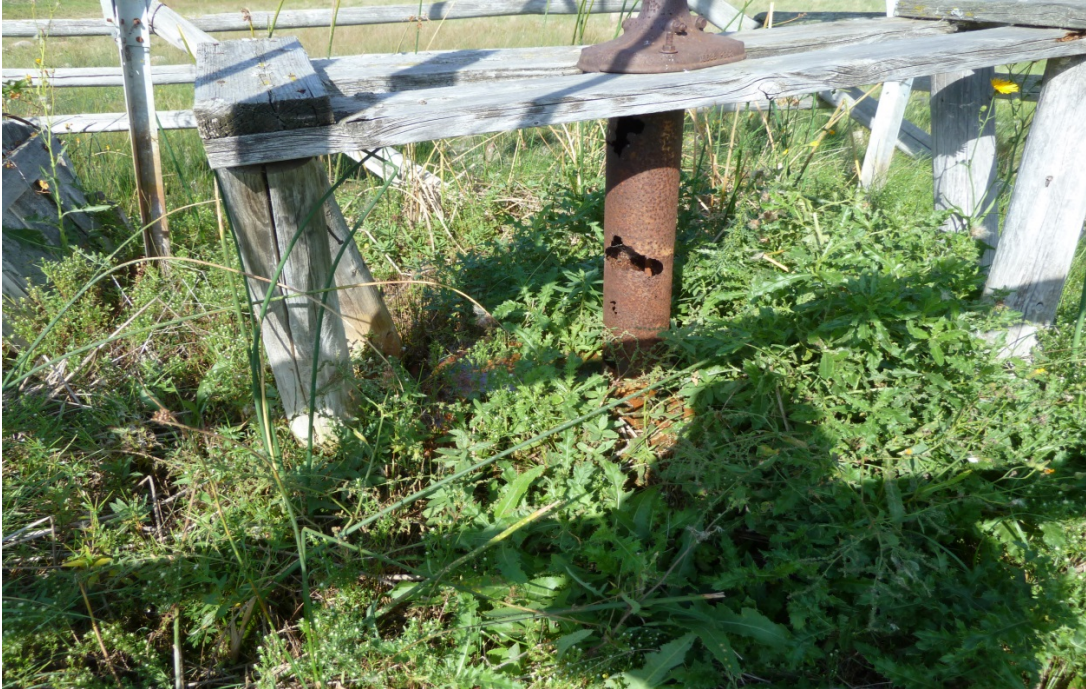
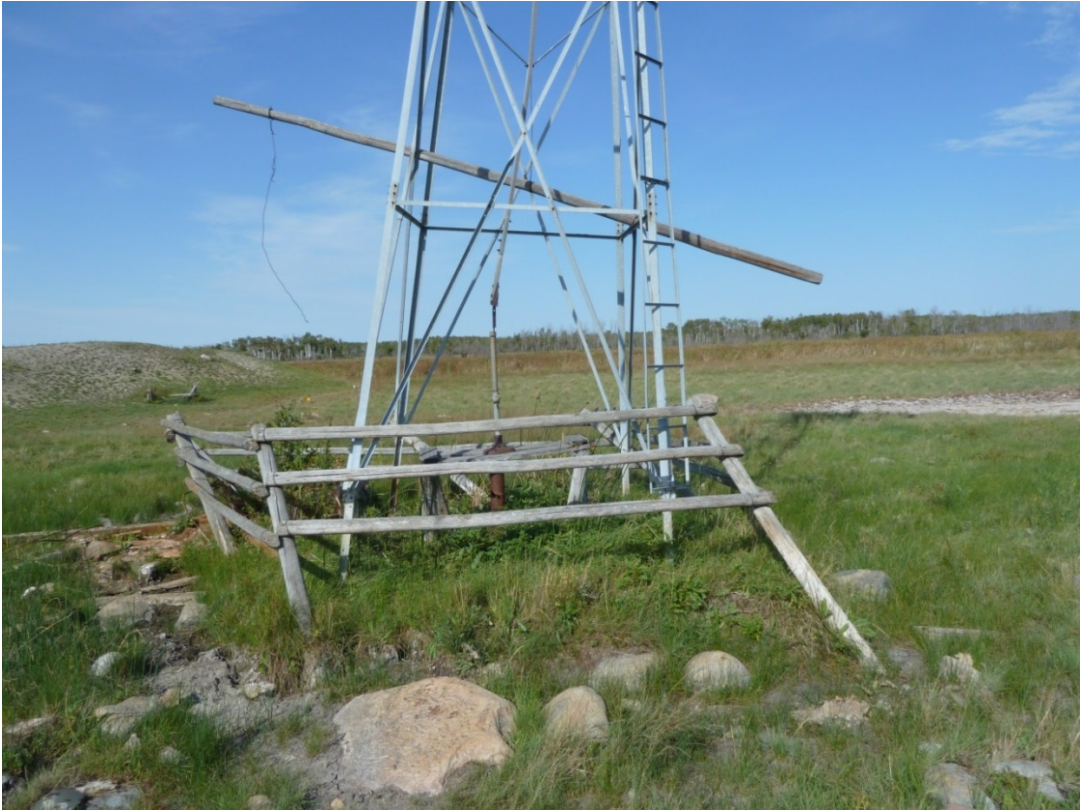
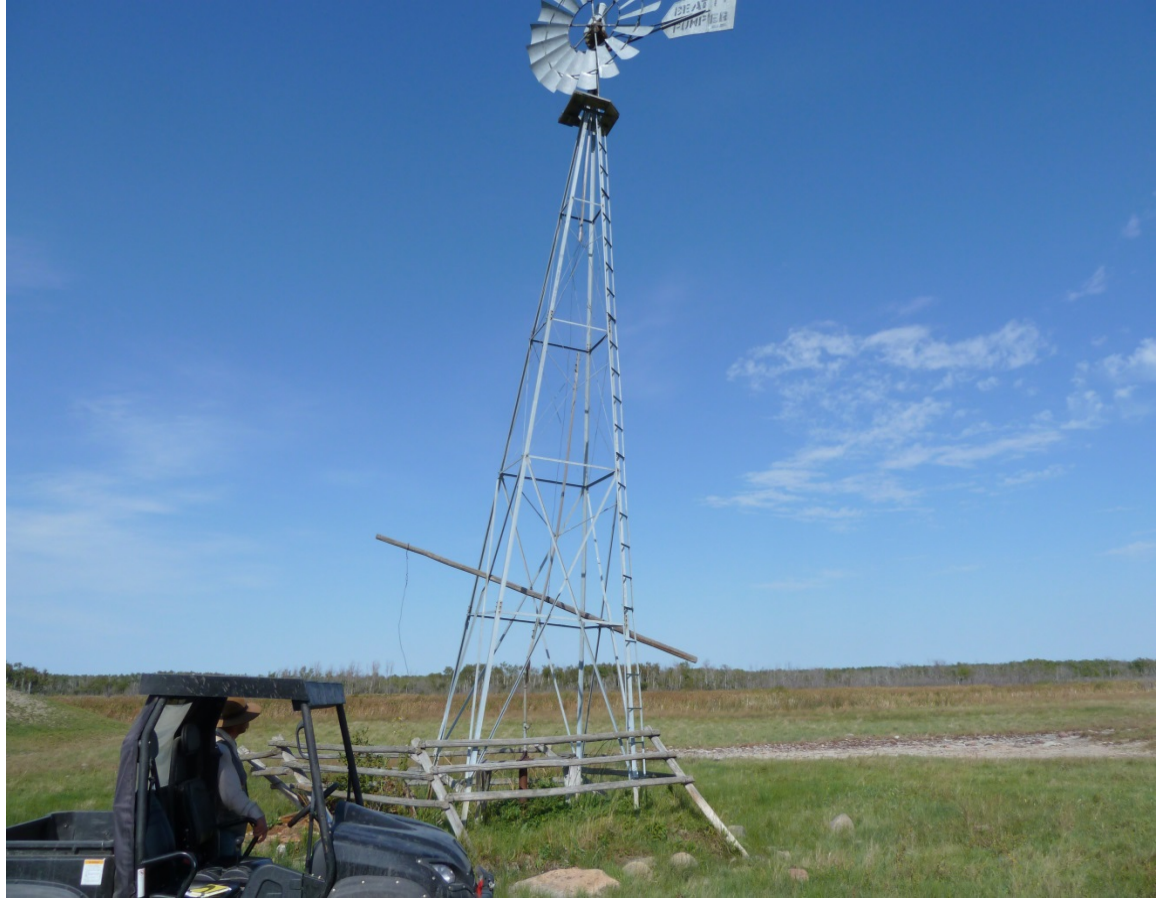
Foam 4 (3 Pictures)

Foam 4 is located SW 29-32-10-w2 (GPS 13u 06111056e 5736767n)

It is a 4" steel casing flowing well located under a windmill

AAFC was able to measure 5 ft. down the well. The water was flowing out of and around the casing.

Wet conditions exist around the well.

To decommission this well the windmill will have to be removed. The existing well will have to be drilled out and be clear of debris so a cement grout with a specific gravity heavy enough to control the flowing water can then be pumped into the well close to the 95 ft. level from bottom to top.

The well should be cut off at or below ground and buried with local fill.

Windmill, fencing, and related debris around well shall be cleaned up and disposed of off site

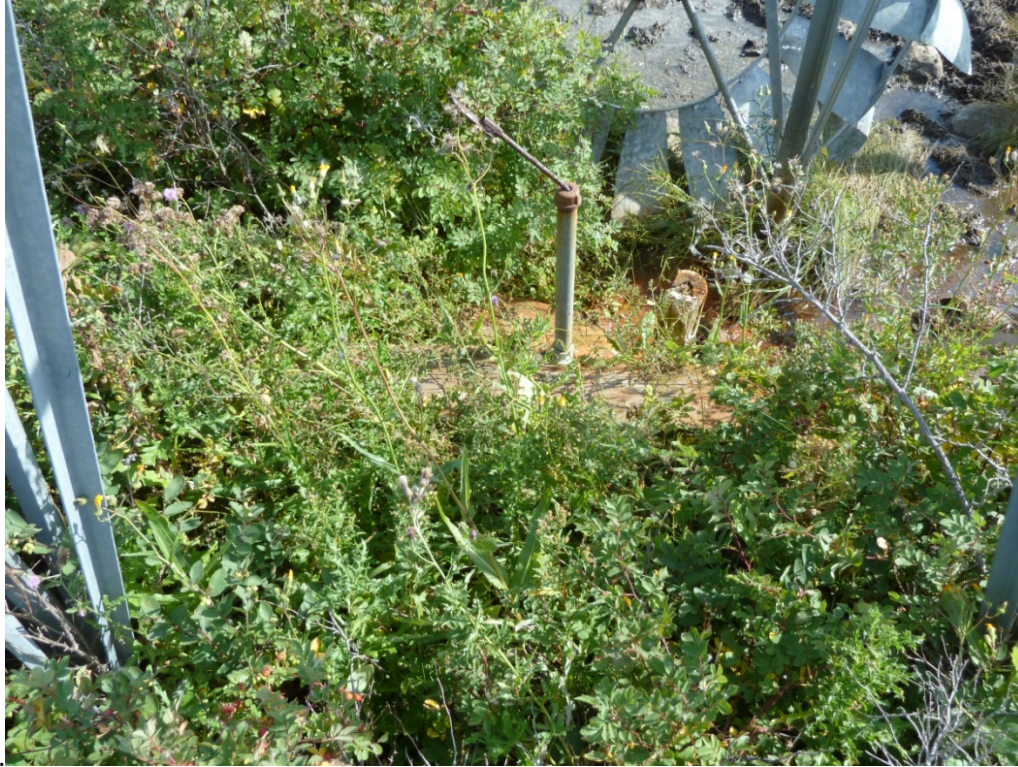
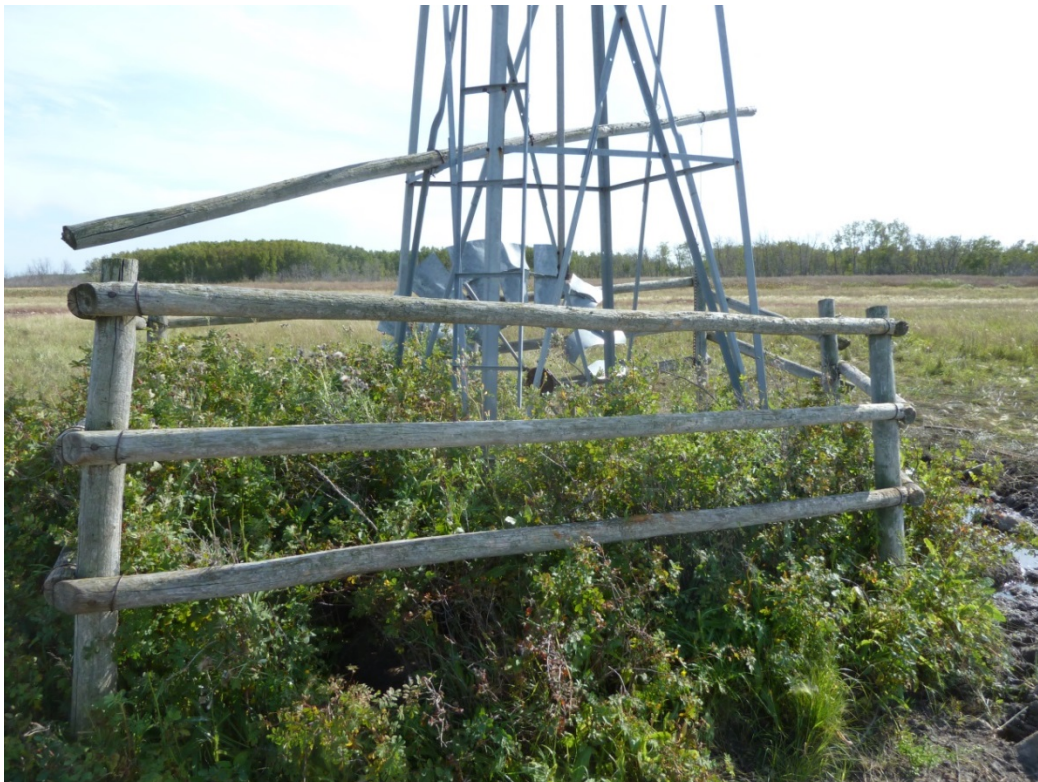
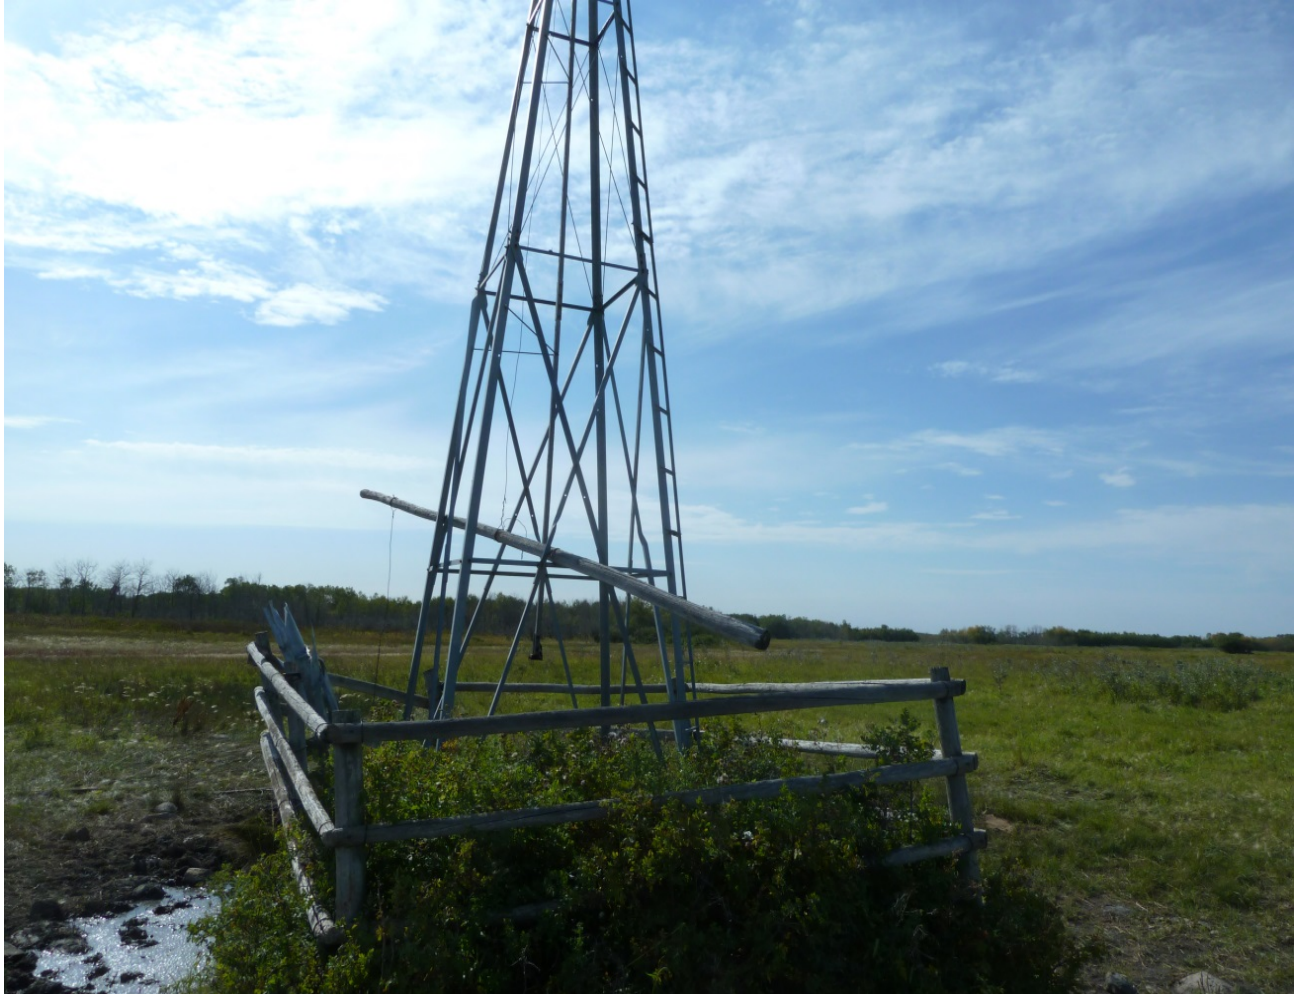
Foam 5 (3 pictures)

Foam 5 is located SW 30-32-10-w2 (GPS 13u 0609362e 5736158n)

It is a 4" steel casing well located under a windmill

AAFC was able to measure 22 ft. down the well. The water was flowing out of and around the casing.

Access to this site is over very rough terrain and through some narrow paths through trees. A dozer will be needed to push pathway wide enough for drill to access well. Wet conditions exist around the well.

To decommission this well the windmill will have to be removed. The existing well will have to be drilled out and be clear of debris so a cement grout with a specific gravity heavy enough to control the flowing water can then be pumped into the well close to the 140 ft. level from bottom to top.

The well should be cut off at or below ground and buried with local fill.

Windmill, fencing, and related debris around well shall be cleaned up and disposed of off-site.

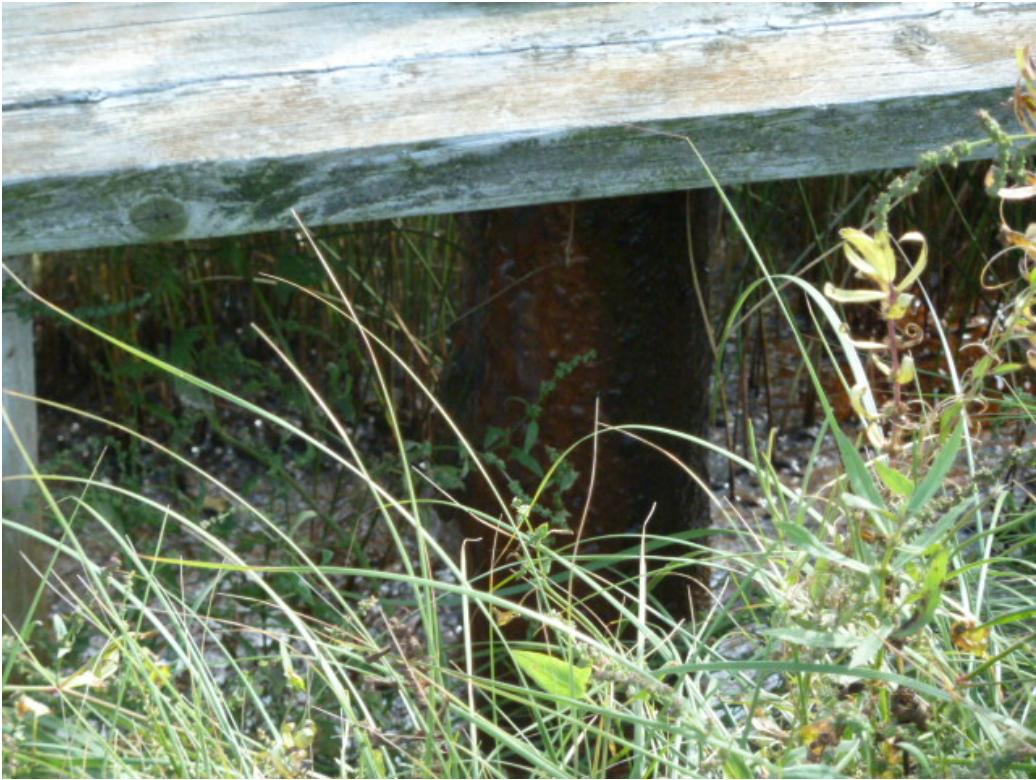
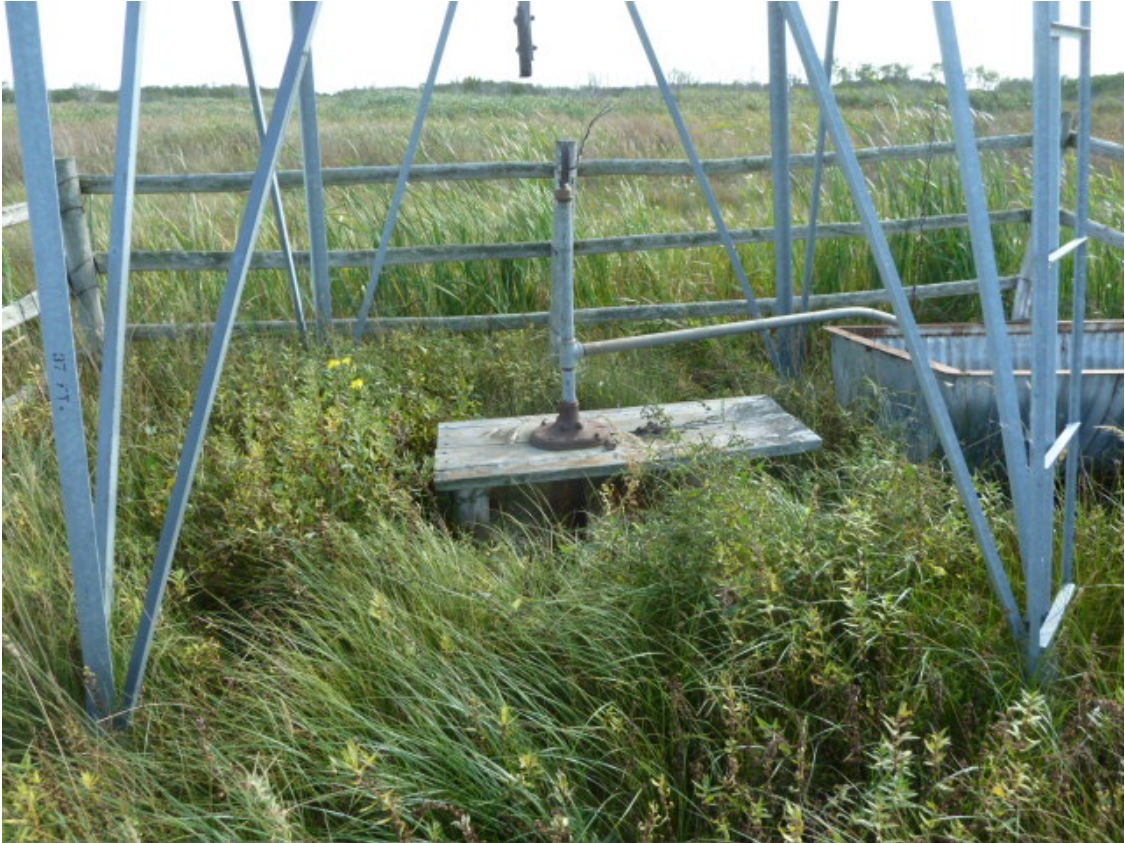
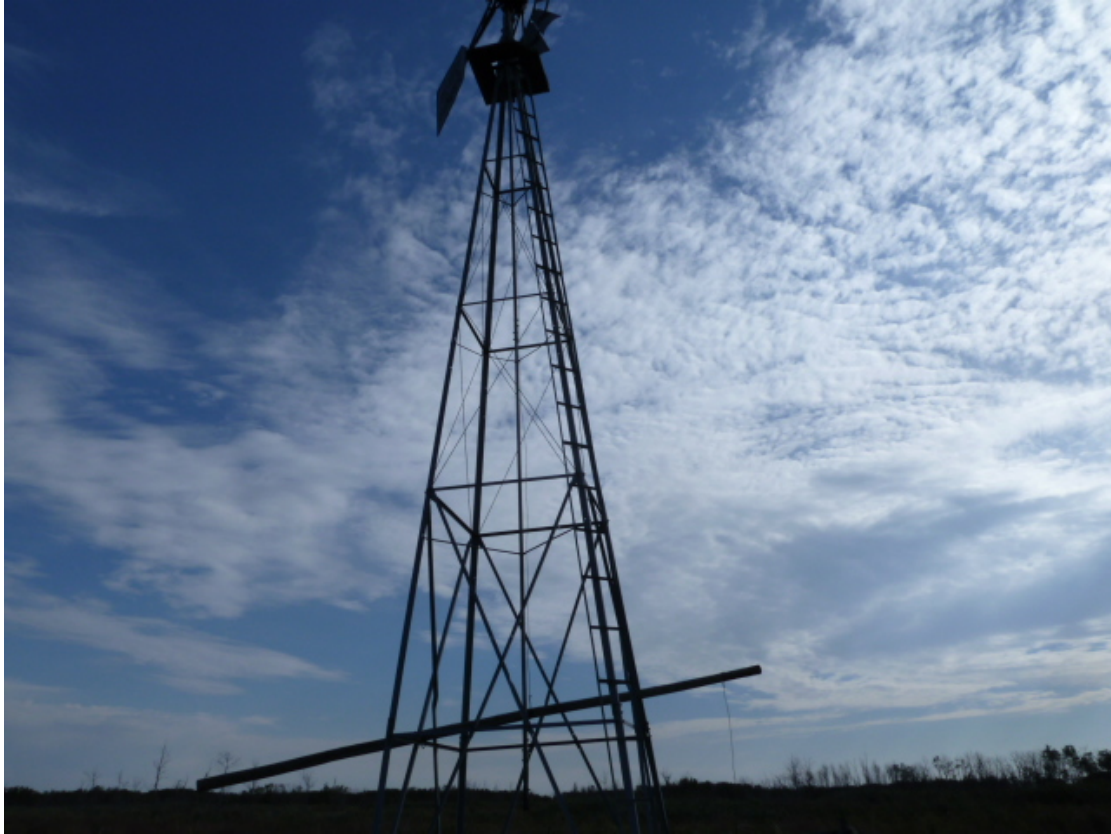
Foam 6 (3 Pictures)

Foam 6 is located SE 19-32-10-w2 (GPS 13u 0609705e 5734836n)

It is a 4" steel casing well located under a windmill

AAFC was not able to measure down the well. The water was flowing out of and around the casing.

Wet conditions exist around the well.

To decommission this well the windmill will have to be removed. The existing well will have to be drilled out and be clear of debris so a cement grout with a specific gravity heavy enough to control the flowing water can then be pumped into the well close to the 92 ft. level from bottom to top.

The well should be cut off at or below ground and buried with local fill.

Windmill, fencing, and related debris around well shall be cleaned up and disposed of off-site.
