Assessment Report
Canadian Rockies Hot Springs – Banff Upper Hot
Springs Bath House – Structural Review of Roof
Overhang for New Copper Gutter Assembly

AECOM: 60445999

October 19, 2015

Regarding: Banff Upper Hot Springs Bath House Roof Overhang—Assessment Report

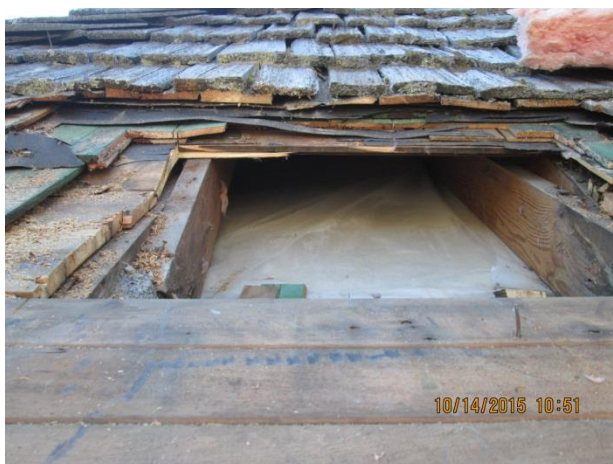
Figure 2: Cut-out and Exposed Portion of Roof

On October 14th, 2015, an AECOM representative conducted a site inspection wherein a portion of the roof cladding at the bathhouse was cut away to expose the structure below. It was observed that the roof structure is composed of 2" x 6" (38mm x 140mm) rafters and 2" by 6" (38mm x 140mm) outrigger rafters supporting the overhang both spaced at 2'-0" (610mm) o/c. See Figure 1 below for an overall view of the building and Figure 2 for the area of the roof that was cut away.

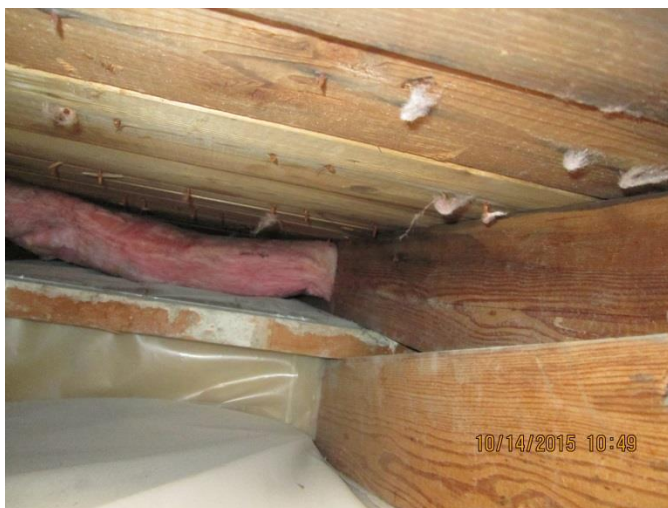
Figure 3: Close-up View of Roof Rafter (Upper Beam) and Outrigger Rafter (Lower Beam)

Upon inspection of the roof beams from the cut-out portion of the roof (see Figure 3 below) and from the upper level crawl space (see Figure 4 below), it was observed that the outrigger rafters are continuous over the block wall support and tie into the main rafters inside the building. A diagram of the presumed geometry of the roof overhang is presented in figure 5.

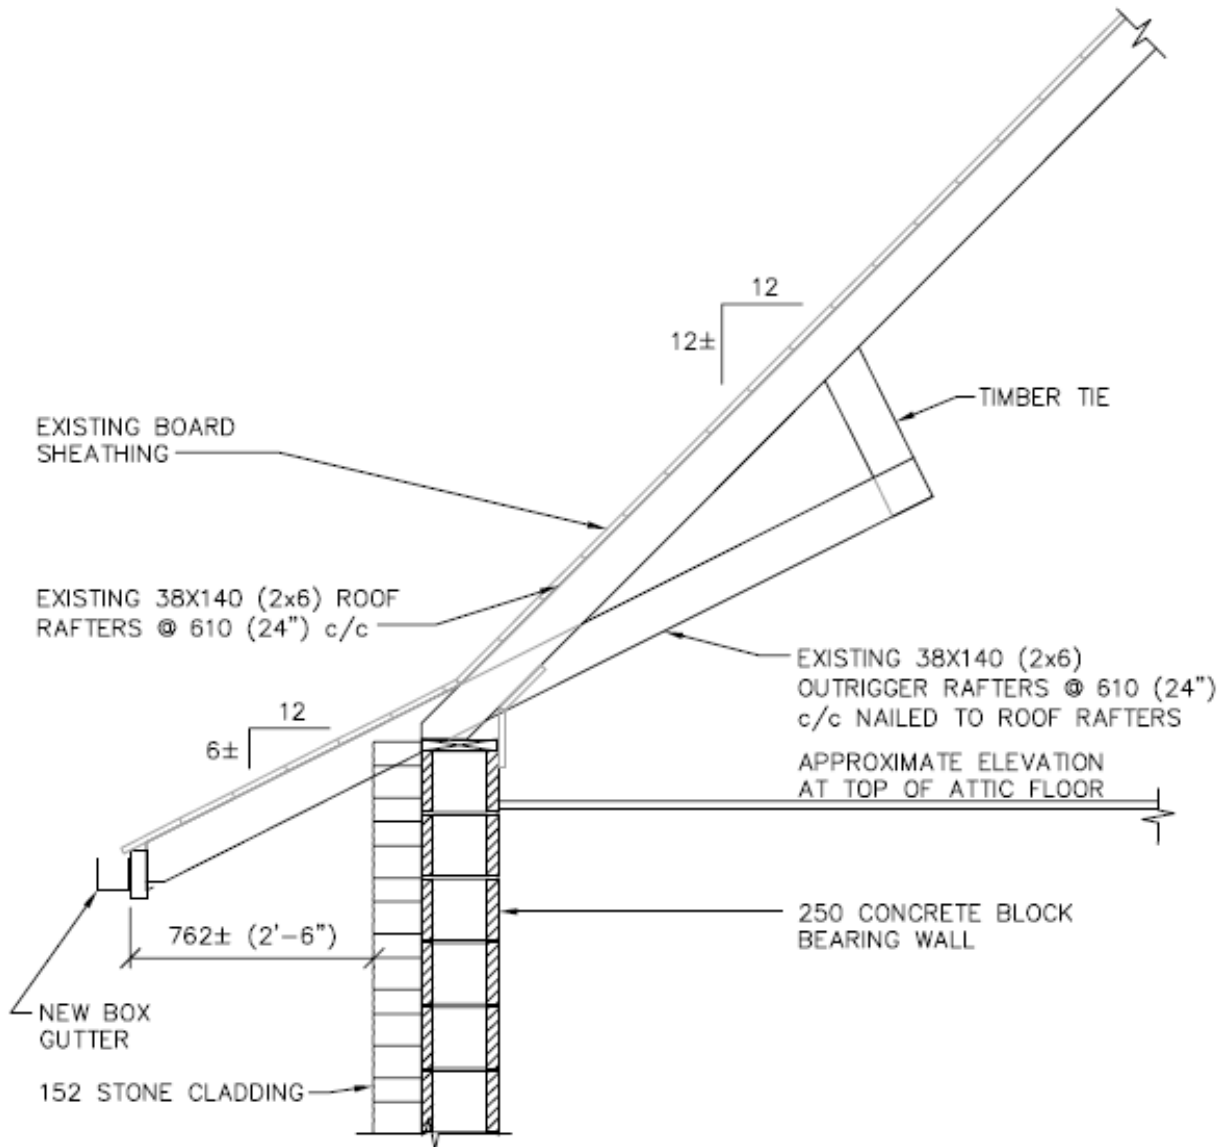
Figure 5: Presumed Existing Roof Framing Geometry at Bearing Wall

Based on the geometry presented in Figure 5, the roof overhang joists were checked for the latest snow loading (according to Alberta Building Code 2014) with the addition of the new copper gutter. It was assumed that the roof overhang joists are S-P-F No. 2 sawn lumber.

The beams were found to be adequate to support the additional loads and, based on a visual assessment of the timber rafters, no additional support or retrofit is needed. See Table 1 below for a summary of the analysis results.

1. No additional support is required for the roof rafters to support the loads from the gutter system based on the presumed geometry. It is AECOM's recommendation that, before construction, more of the roof structure is exposed so that the geometry shown in Figure 5 can be confirmed at each rafter.
2. The timber rafters appeared to be in good condition based on the portion of the roof that was exposed. It is AECOM's recommendation that the condition of all of the rafters that will support the new gutter system be confirmed before construction.
