Hamlet Bridge (Bridge 57) Comprehensive Detailed Inspection and Structure Evaluation Report (PCA Project No. 2011-4650-20027340)

Comprehensive Detailed Inspection and Structure Evaluation Report

Parks Canada Project No. 2011-4650-20027340

Delcan Corporation

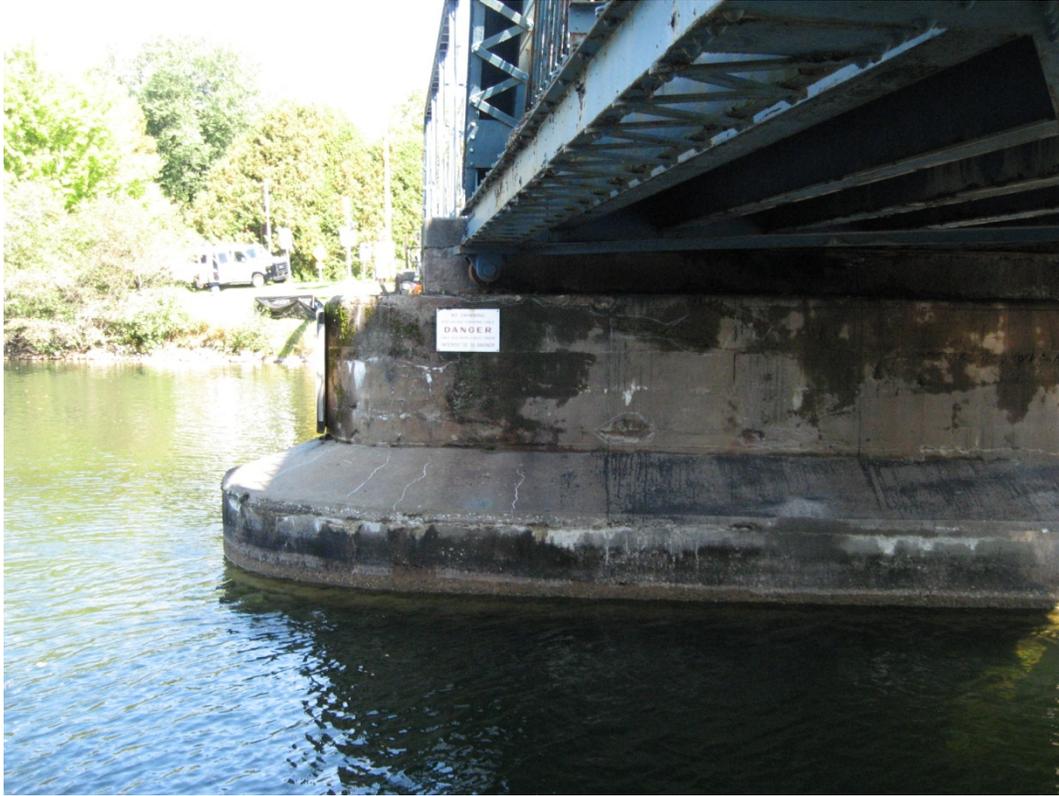
Photo S7: East pier. Note the typical cracks with efflorescence and areas of spalling and disintegration.

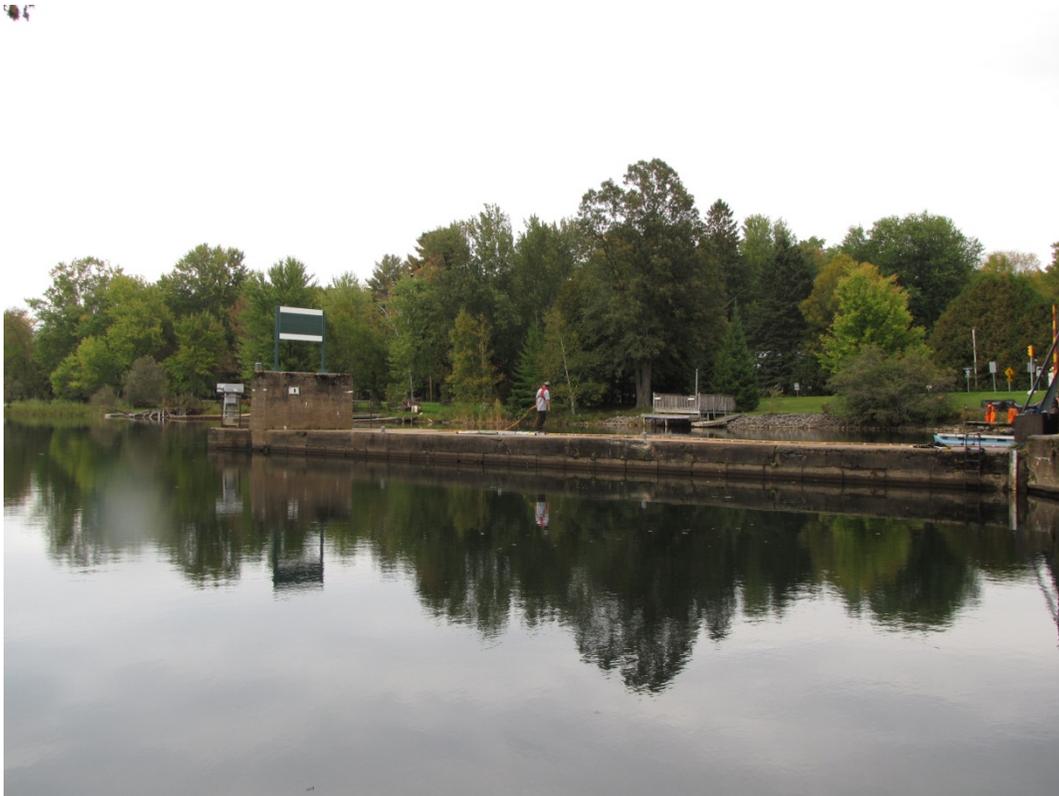
Photo S8: West elevation of the north section of the rest pier.

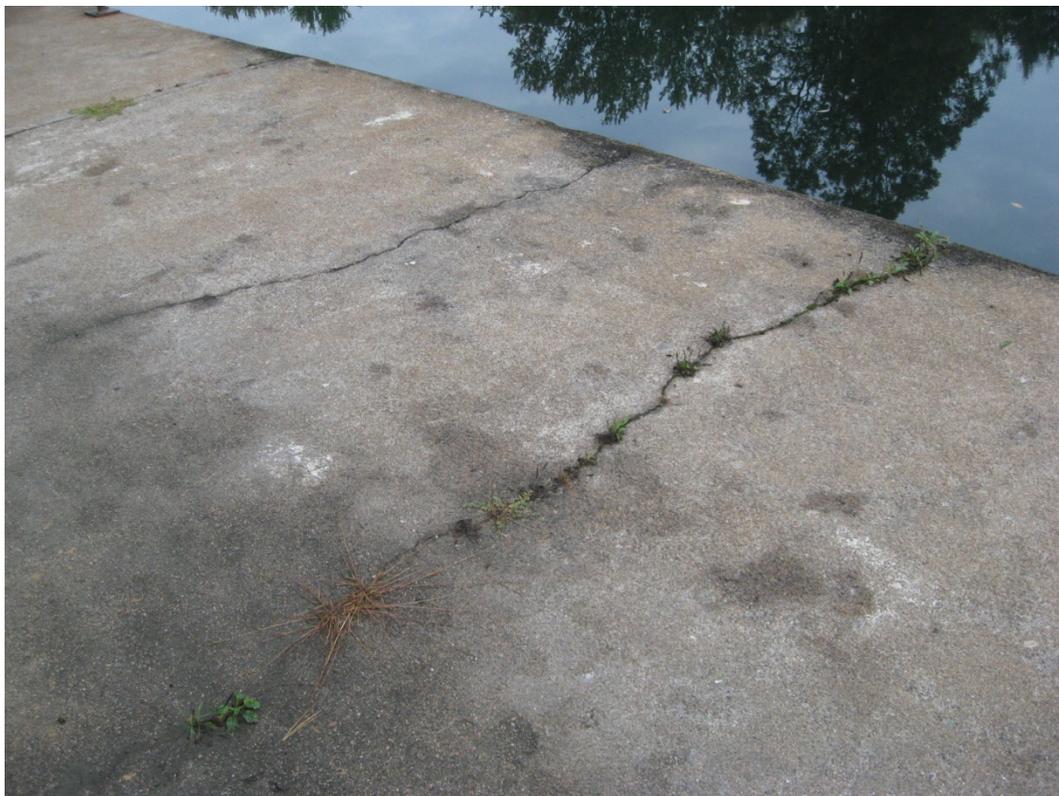
Photo S12: Typical wide transverse cracks in the top of the rest pier concrete cap.

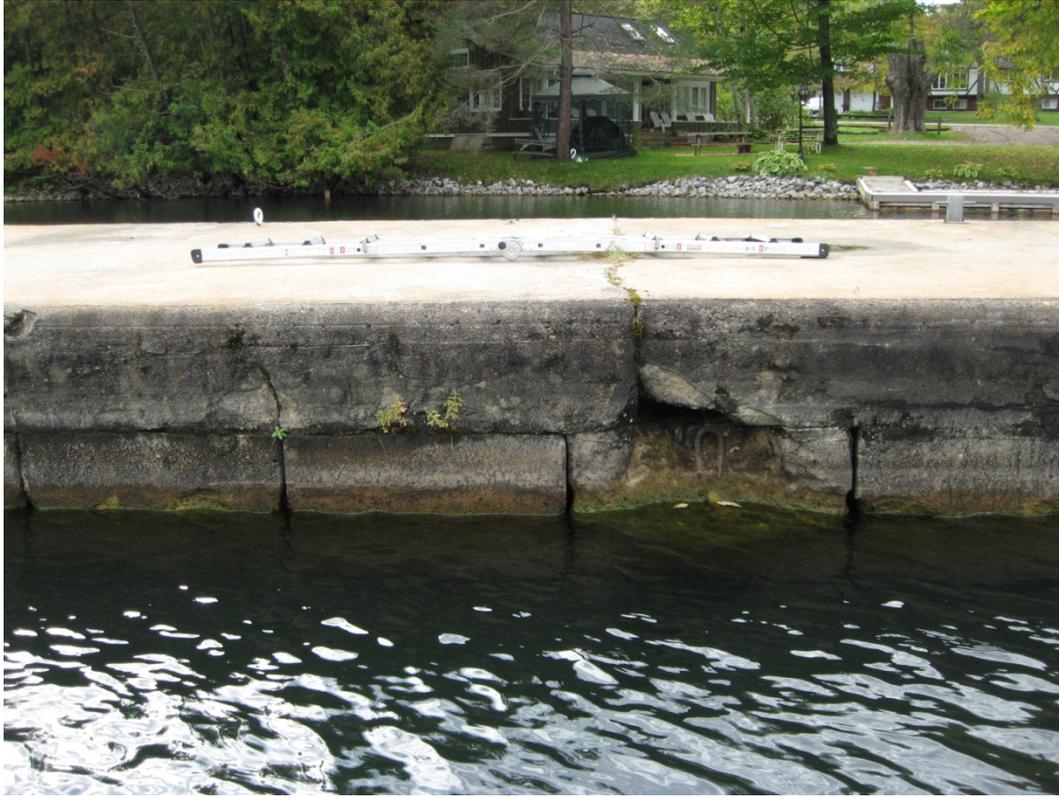
Photo S13: East side of the south section of the rest pier. Typical wide cracks and large spalled areas in the concrete cap and blocks.

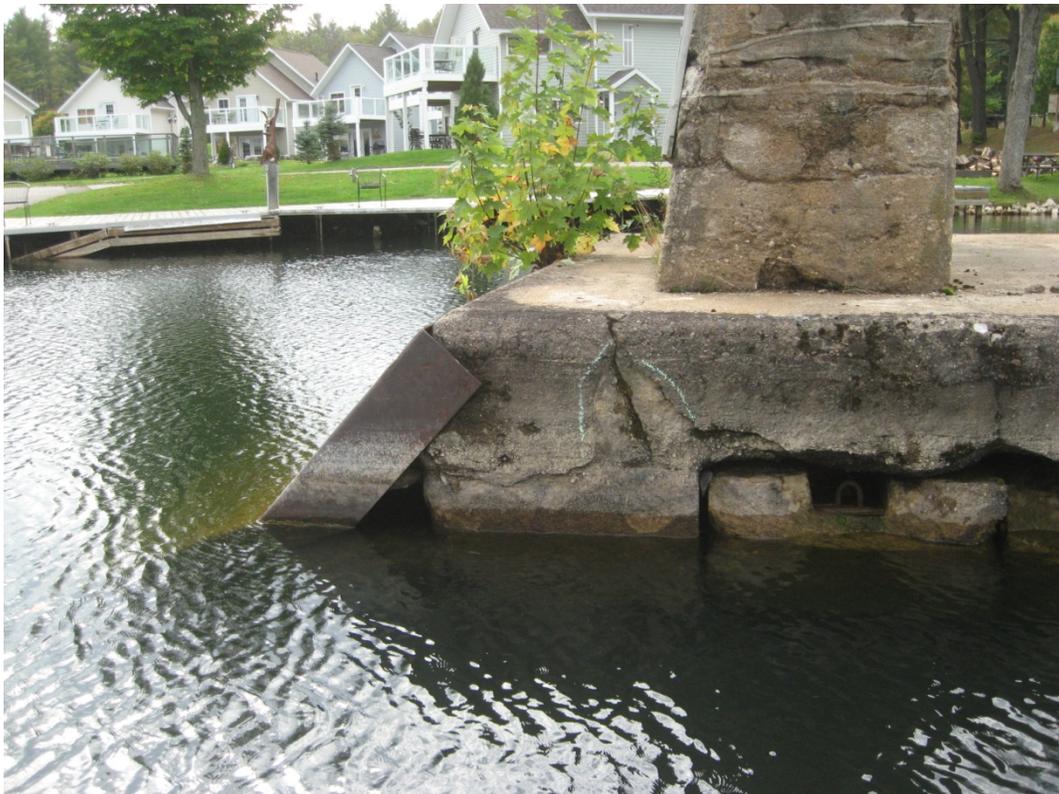
Photo S14: South-east corner of the rest pier. Typical wide cracks and large spalled areas in the concrete cap and blocks. Note the void beneath the steel plates.

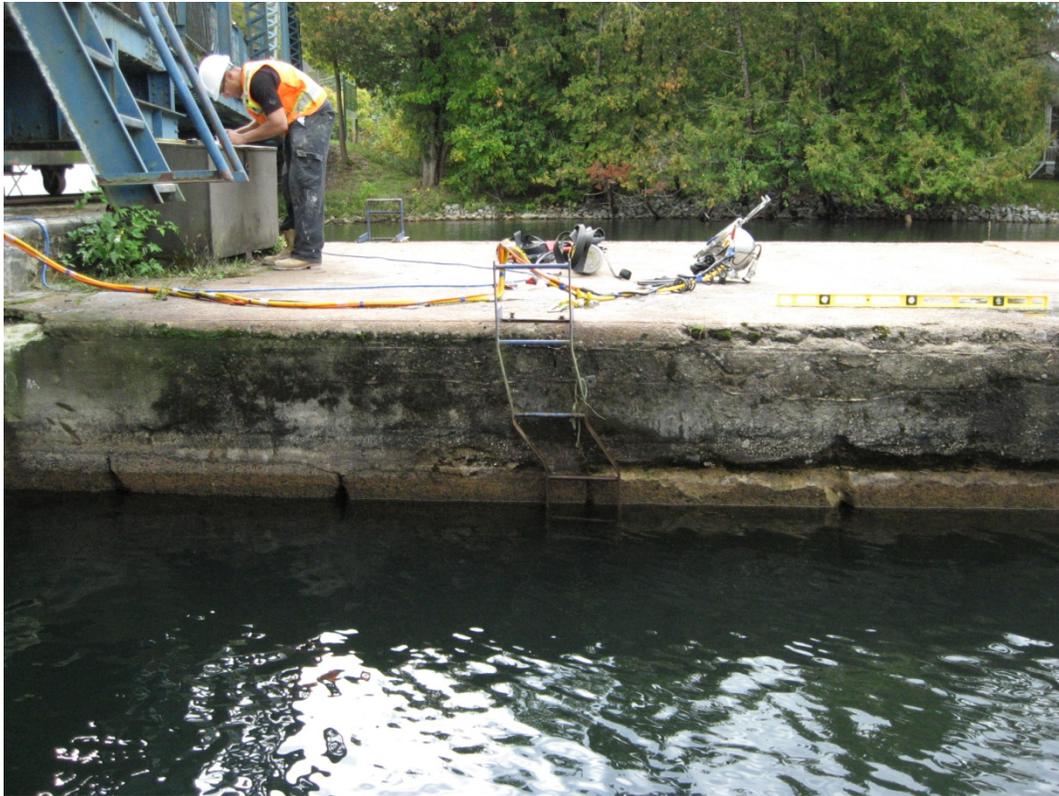
Photo S15: The ladder on the east side of the north section of the rest pier is bent in the downstream direction.

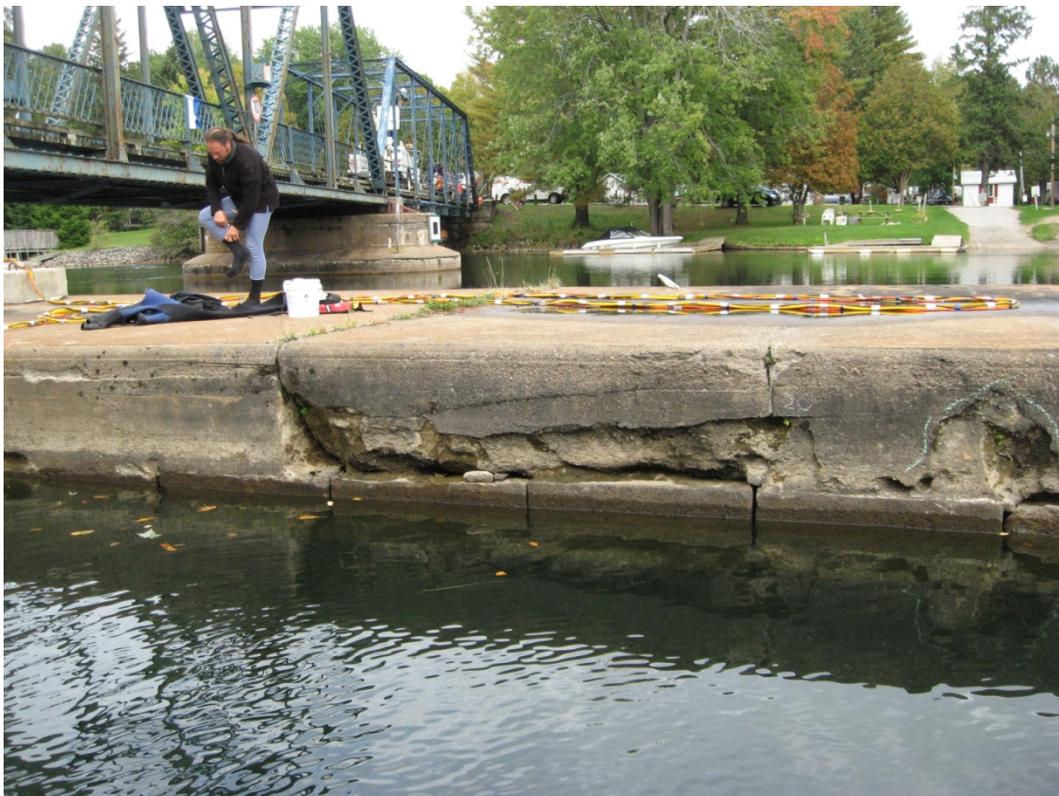
Photo S16: Large spalled section in the concrete cap on the west side of the south section of the rest pier.

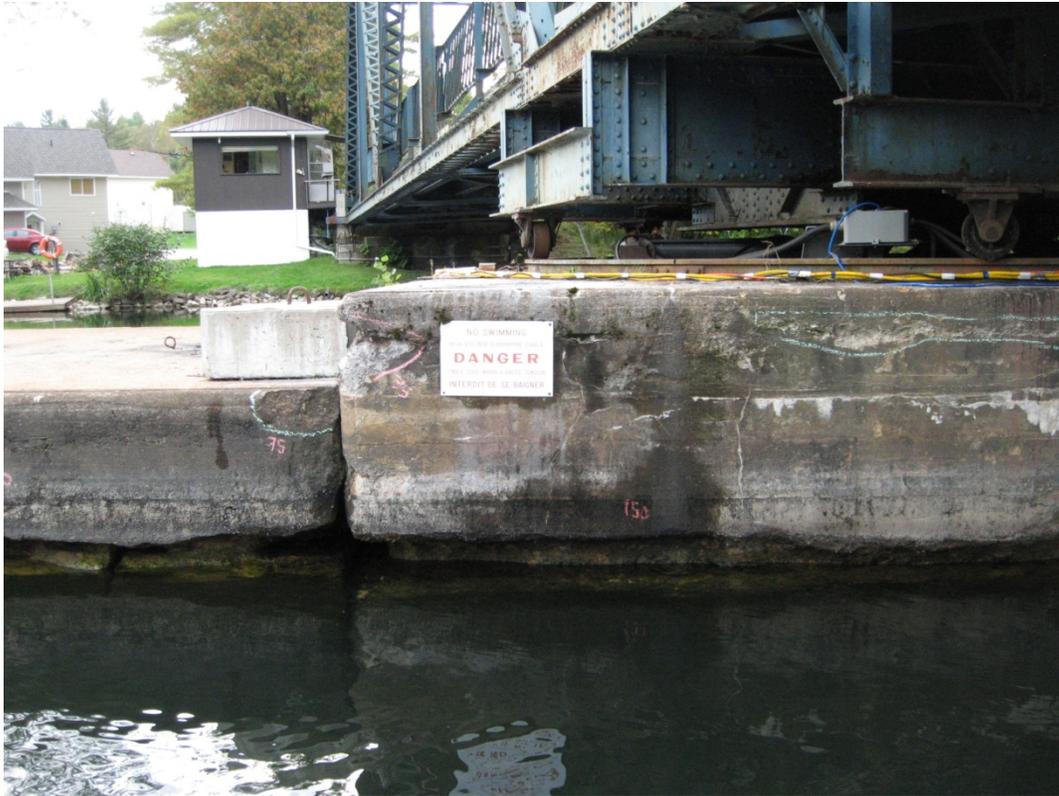
Photo S17: South-east corner of the central swing pier. Very severe erosion of the walls at the waterline.

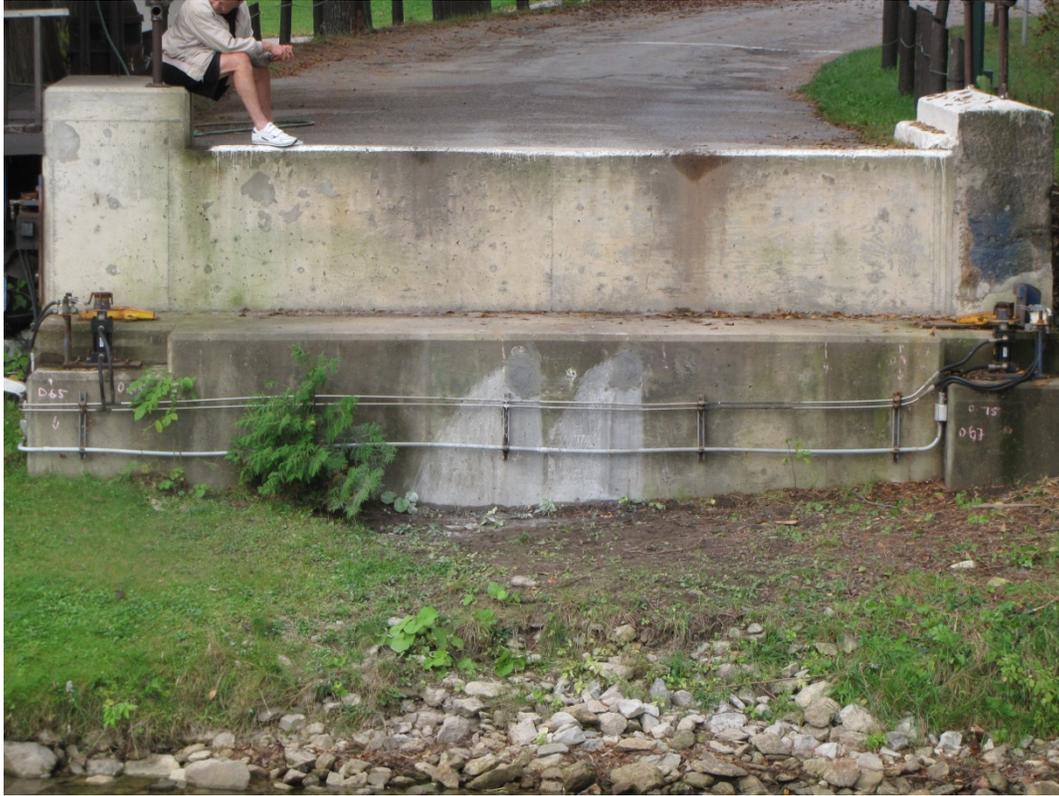
Photo S19: The west abutment is in good condition. Note the minor erosion of the embankment.

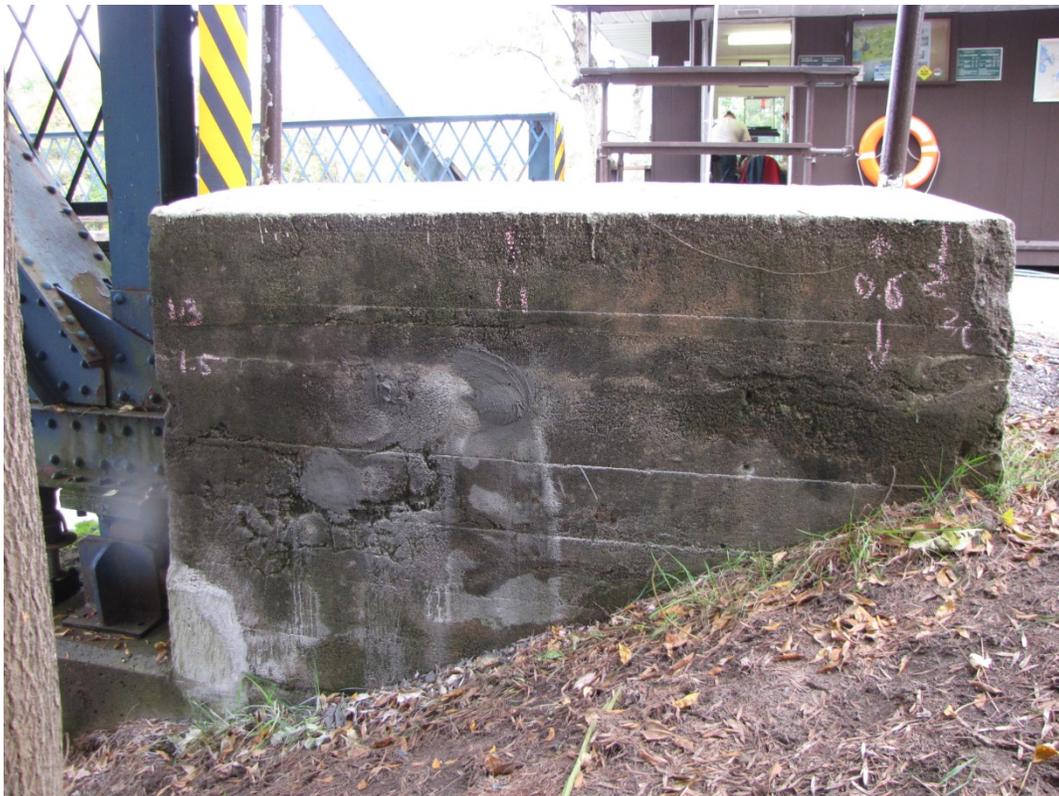
Photo S20: The north-west wingwall exhibits areas of honeycombing and scaling.

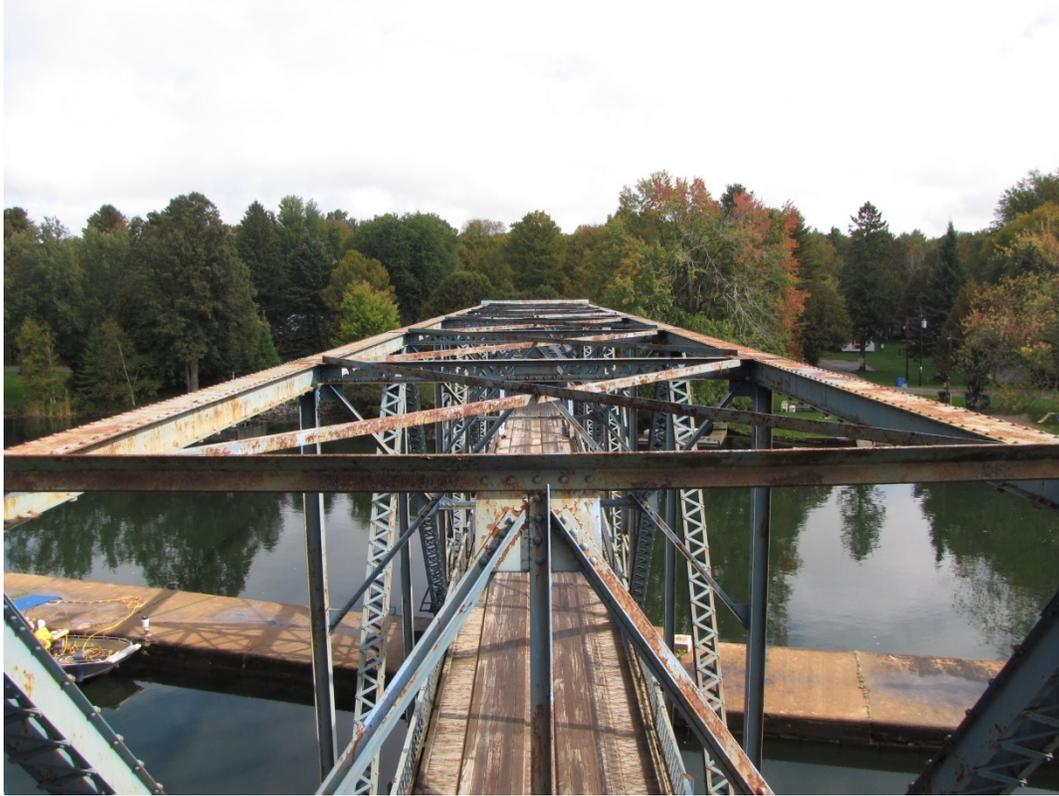
Photo S21: Looking east. The truss and bracing members typically have extensive areas of coating failure and light corrosion.

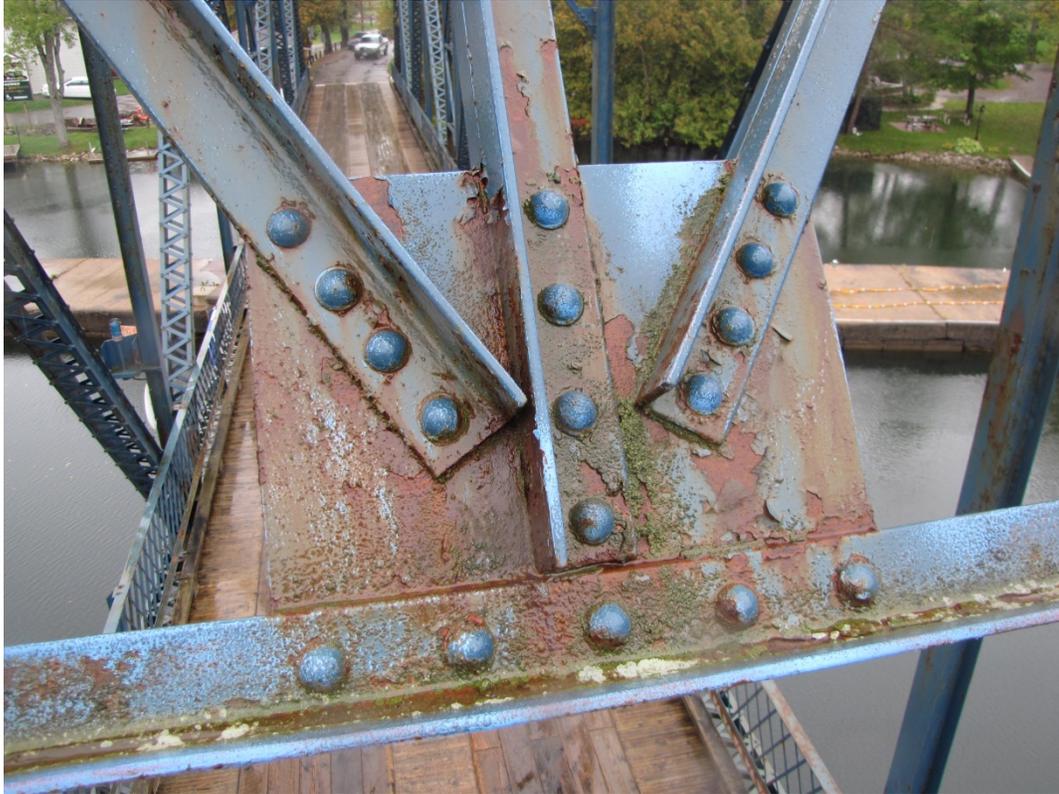
Photo S23: The east portal frame members exhibit the typical coating loss and light corrosion. Note the water collecting in the bottom member.

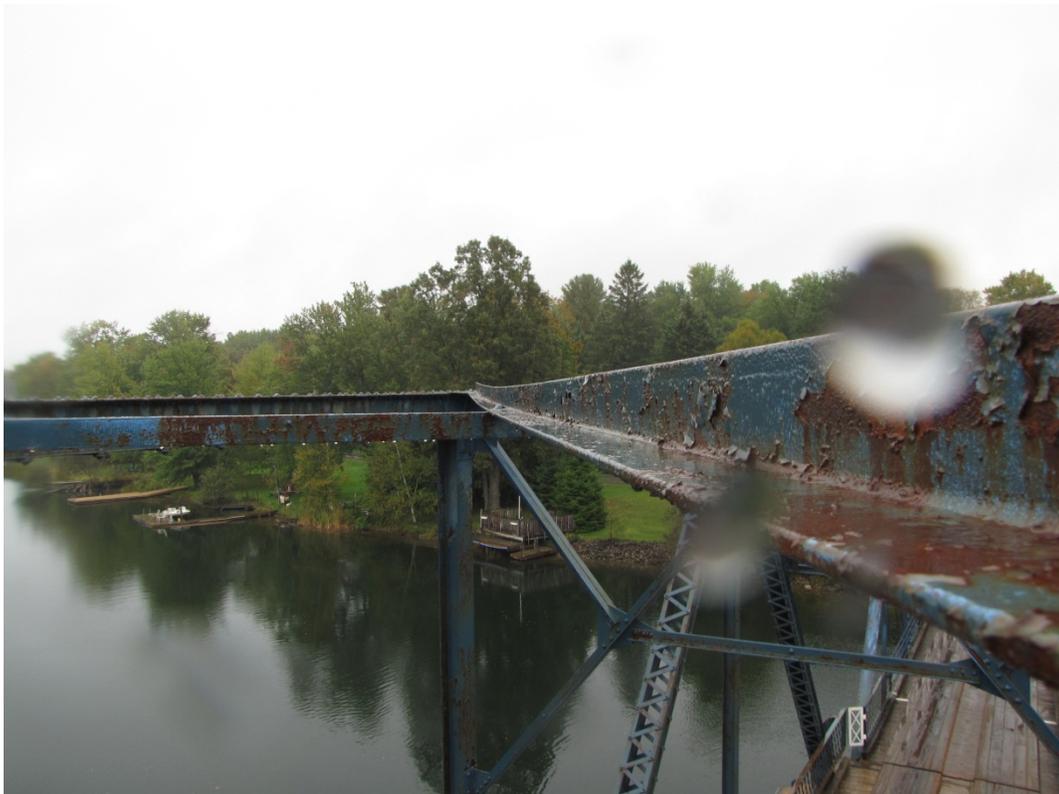
Photo S24: The upper lateral bracing members are typically bent.

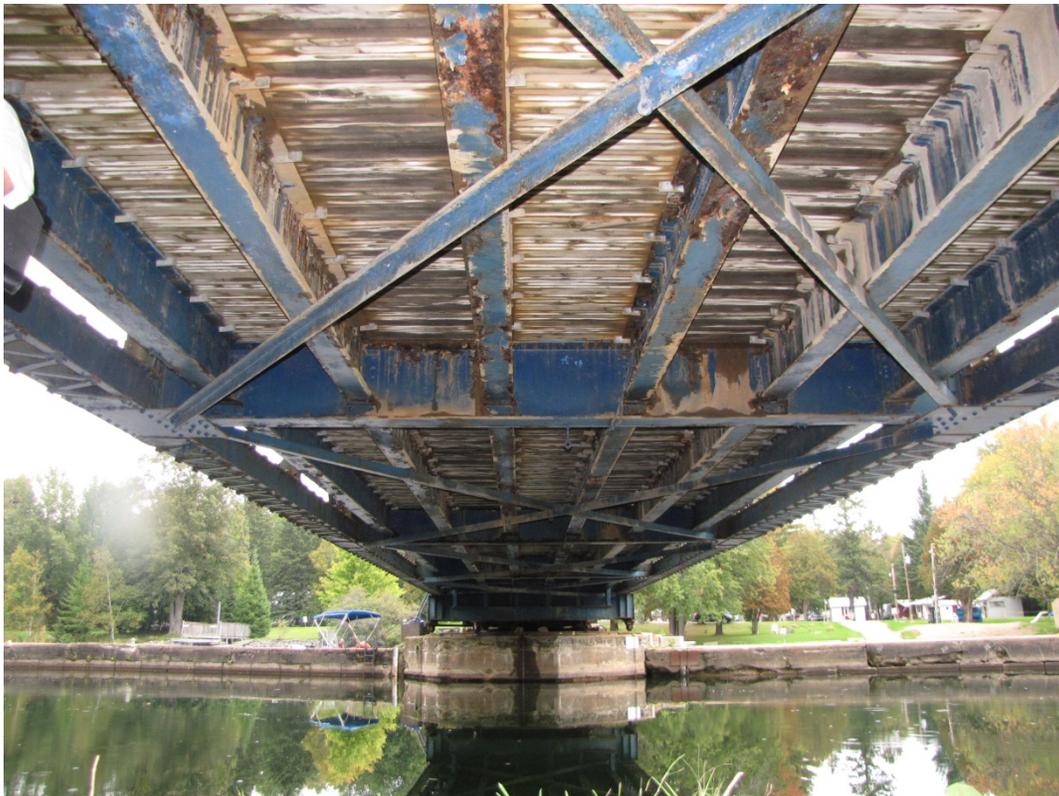
Photo S26: Looking east from the west embankment. Note the typical condition of the floor system and deck members.

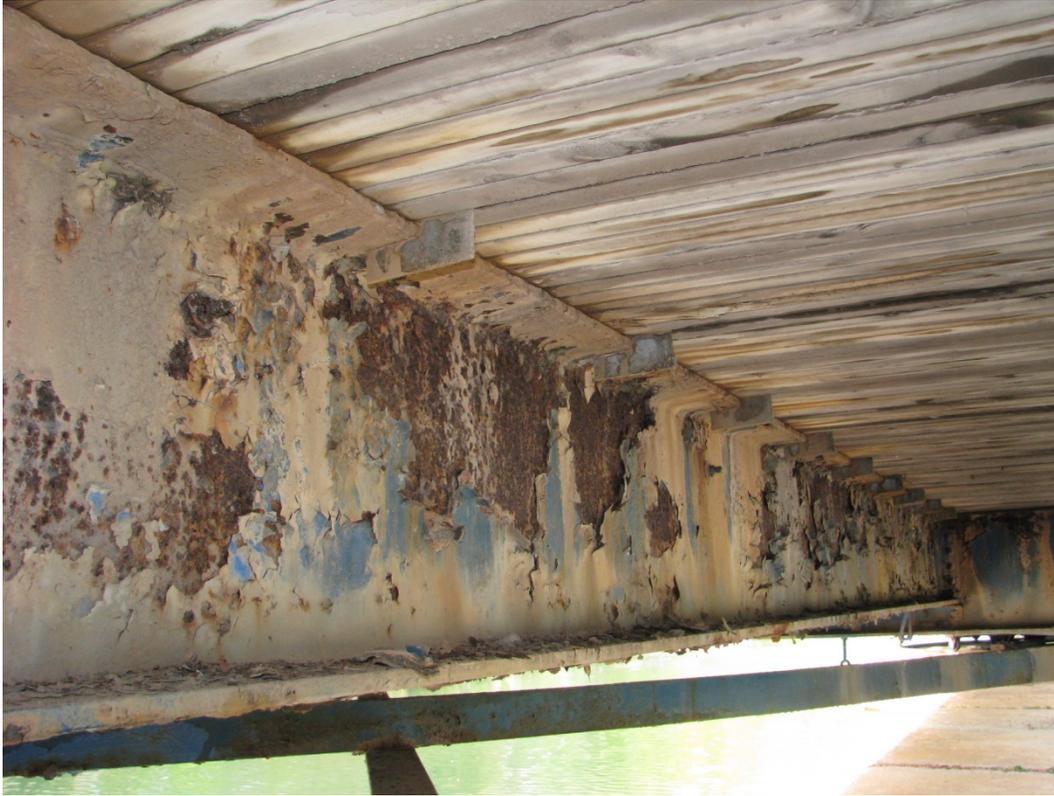
Photo S27: South side of stringer S0-3 between F0 and FB1. Typical condition of stringers with coating loss and light to medium corrosion.

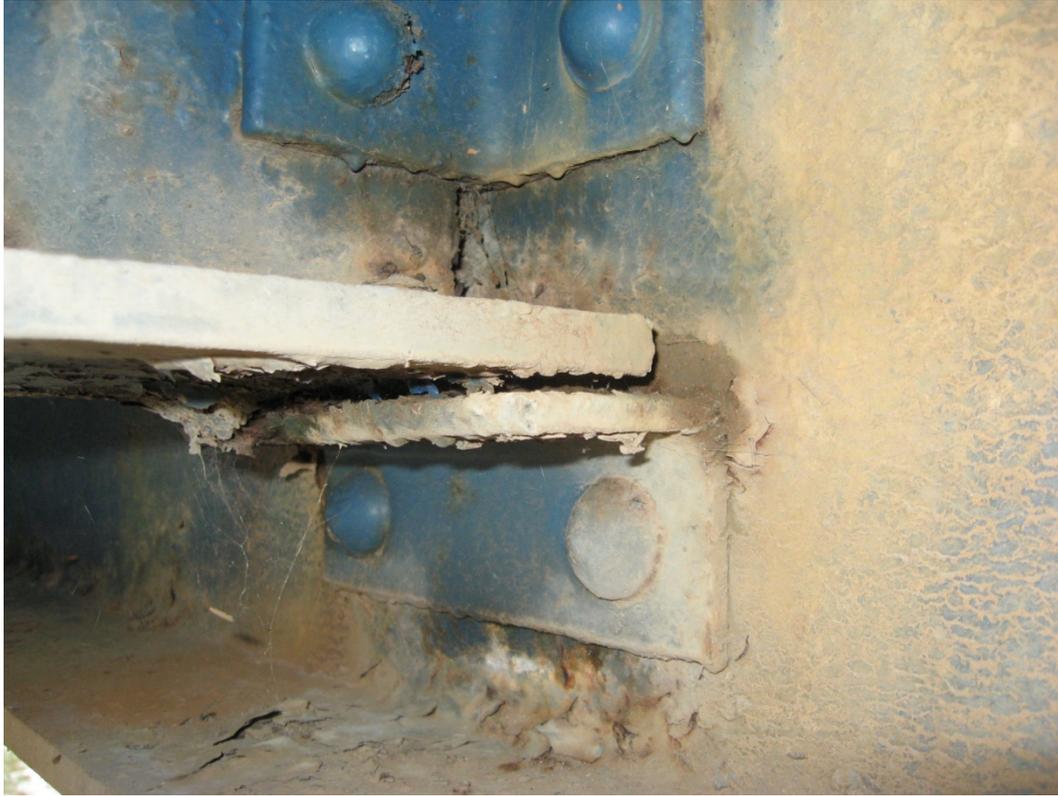
Photo S29: Typical gap between the supporting angle and the stringer bottom flange.

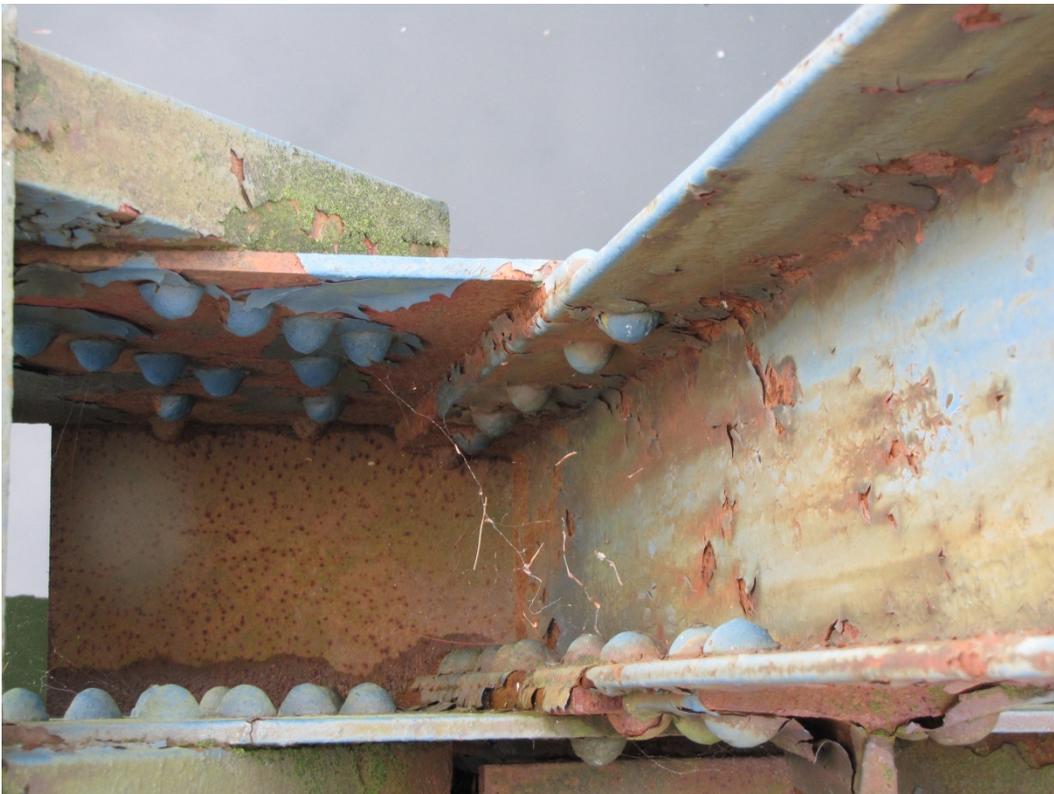
Photo S34: Typical condition of the coating system and truss members at the lower connections.

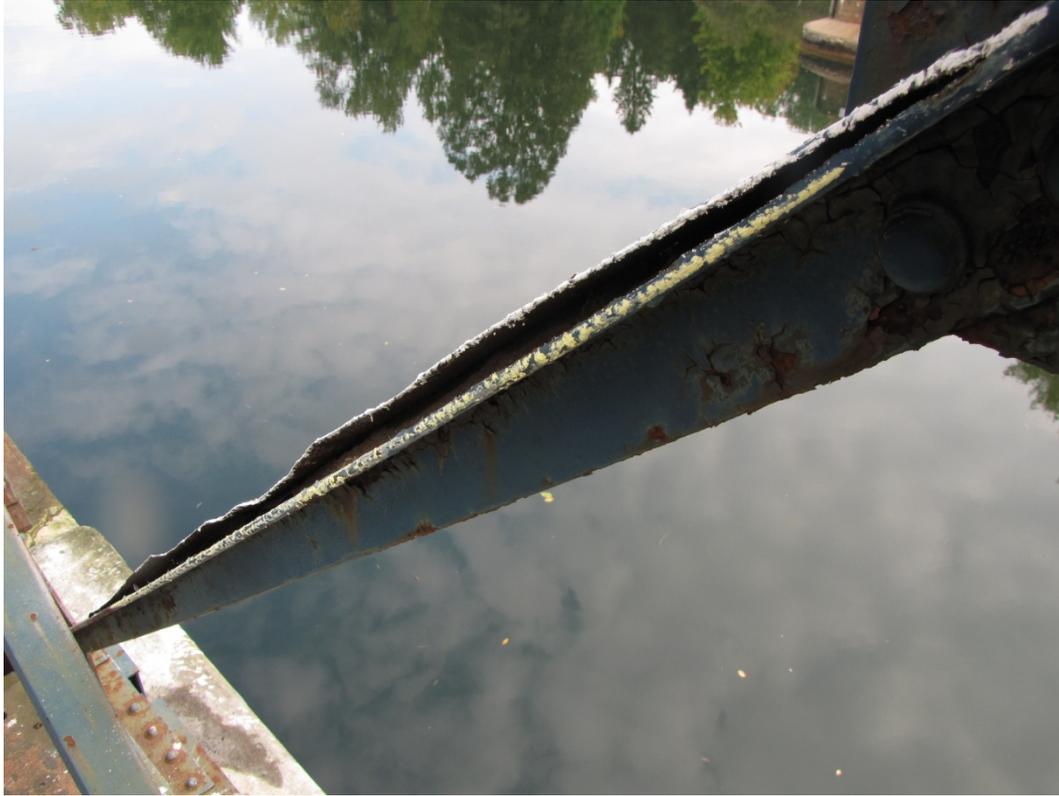
Photo S35: The top layers of steel of the bottom section of vertical bracing between V4S and V5S have delaminated.

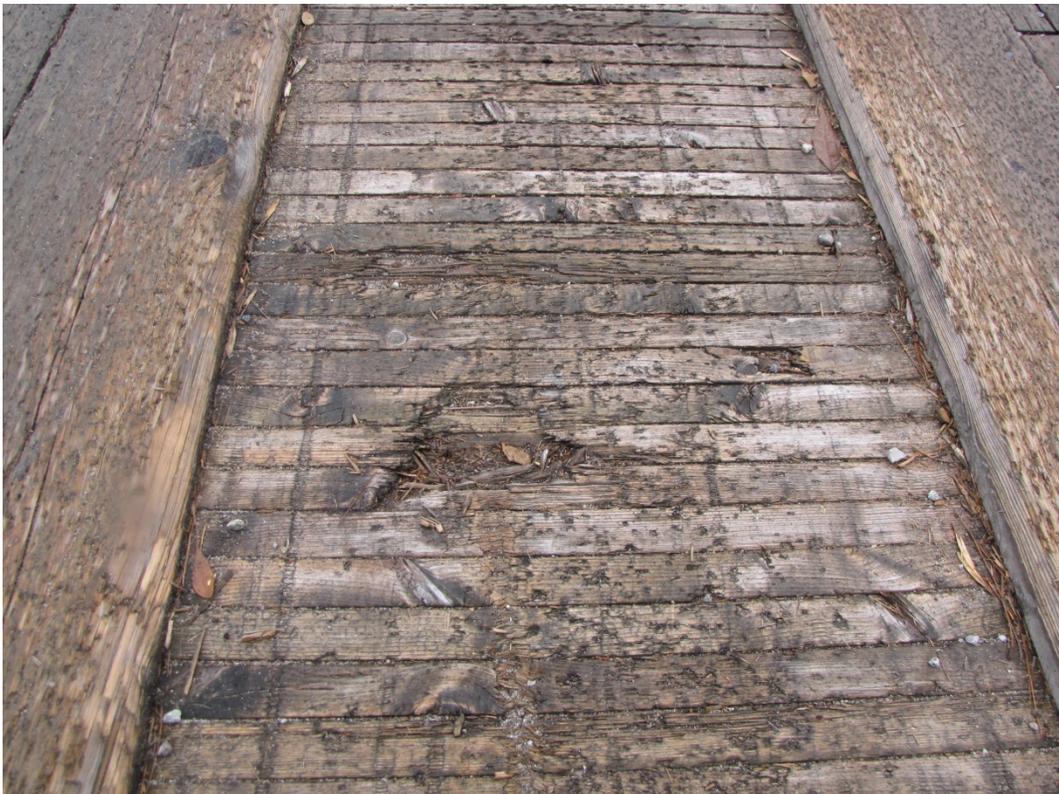
Photo S40: Central section of exposed deck between FB0 and FB1. Several deck members have areas of rotting. Note the typical small rot holes throughout and the abrasion on the edges of the inside wearing surface members.

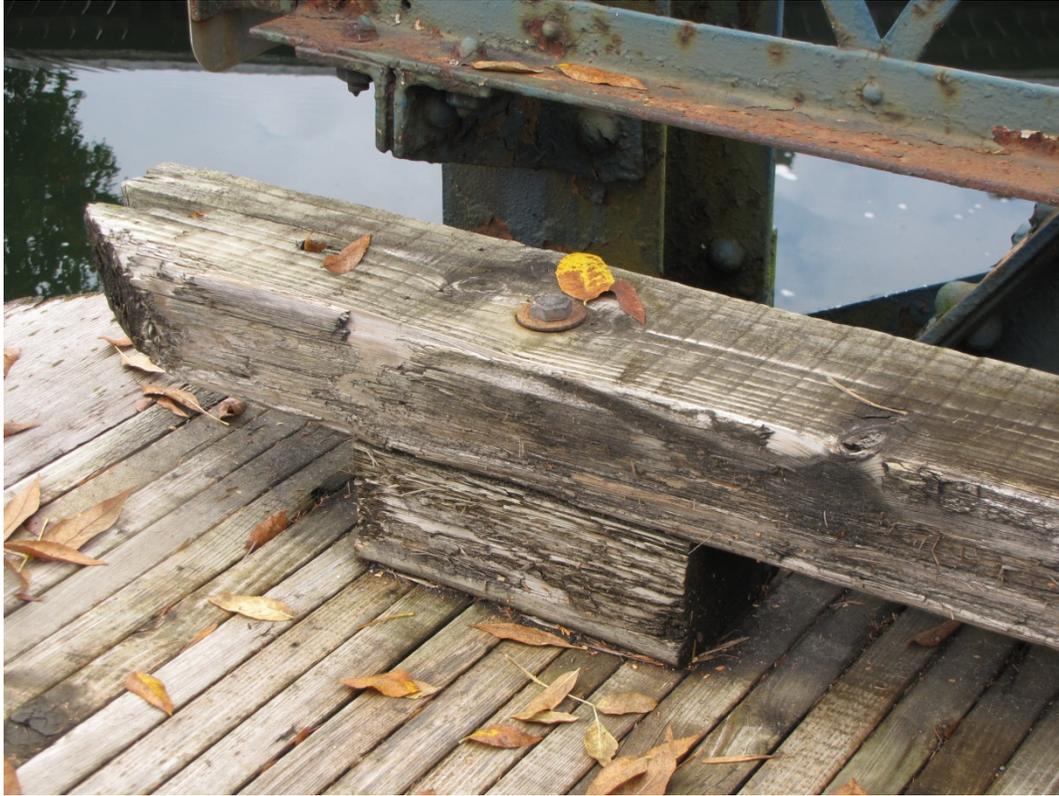
Photo S43: West end of north curb. The curb is loose and is starting to split from the west end.

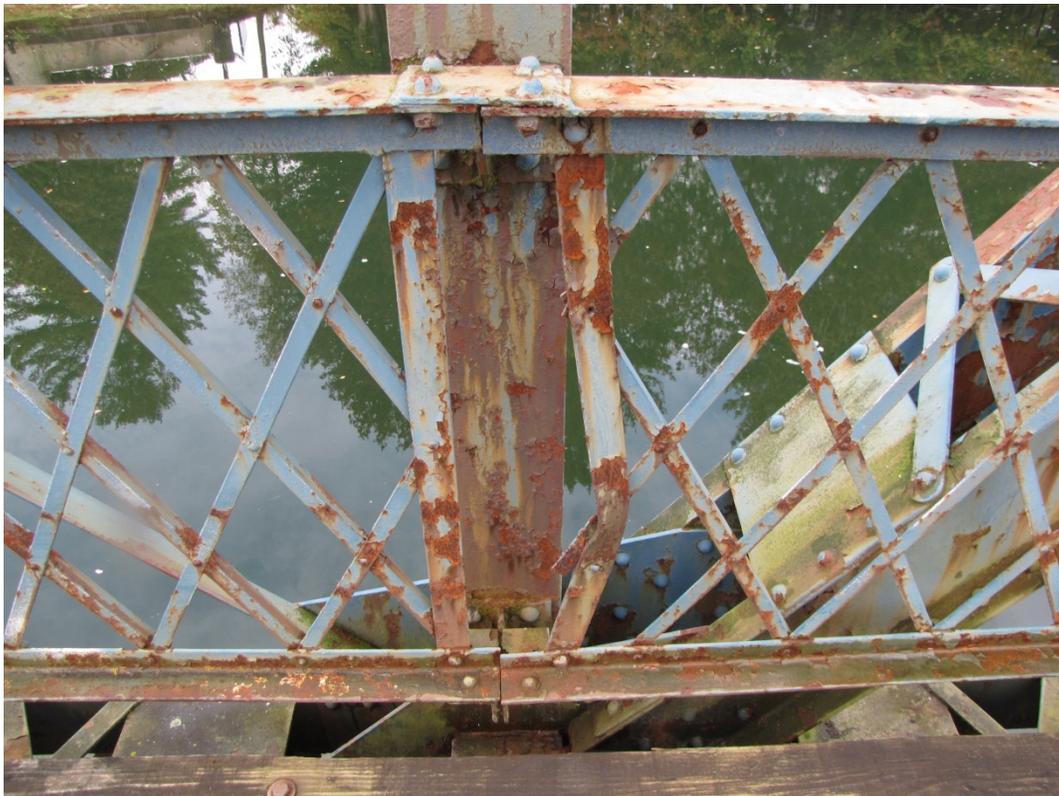
Photo S44: North railing at FB5. Impact damage to end baluster and lattice. The bolt in the lower connection is loose. Note typical coating system condition.

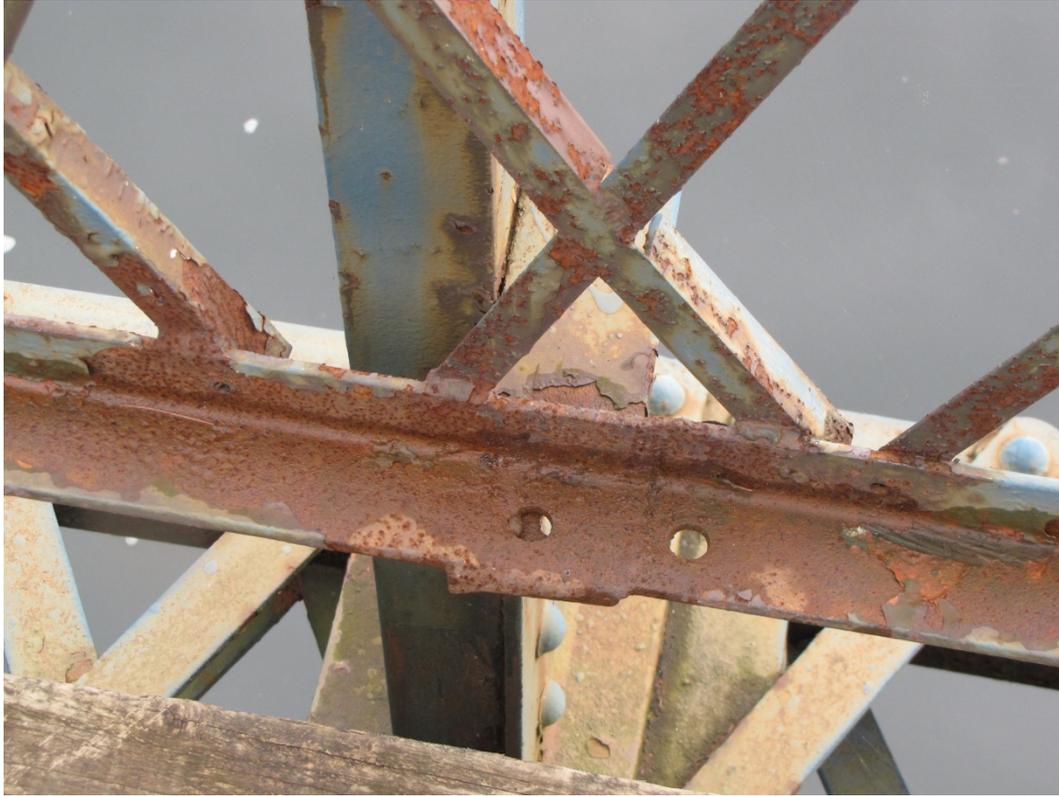
Photo S45: Missing bolt in bottom south rail between FB8 and FB9.

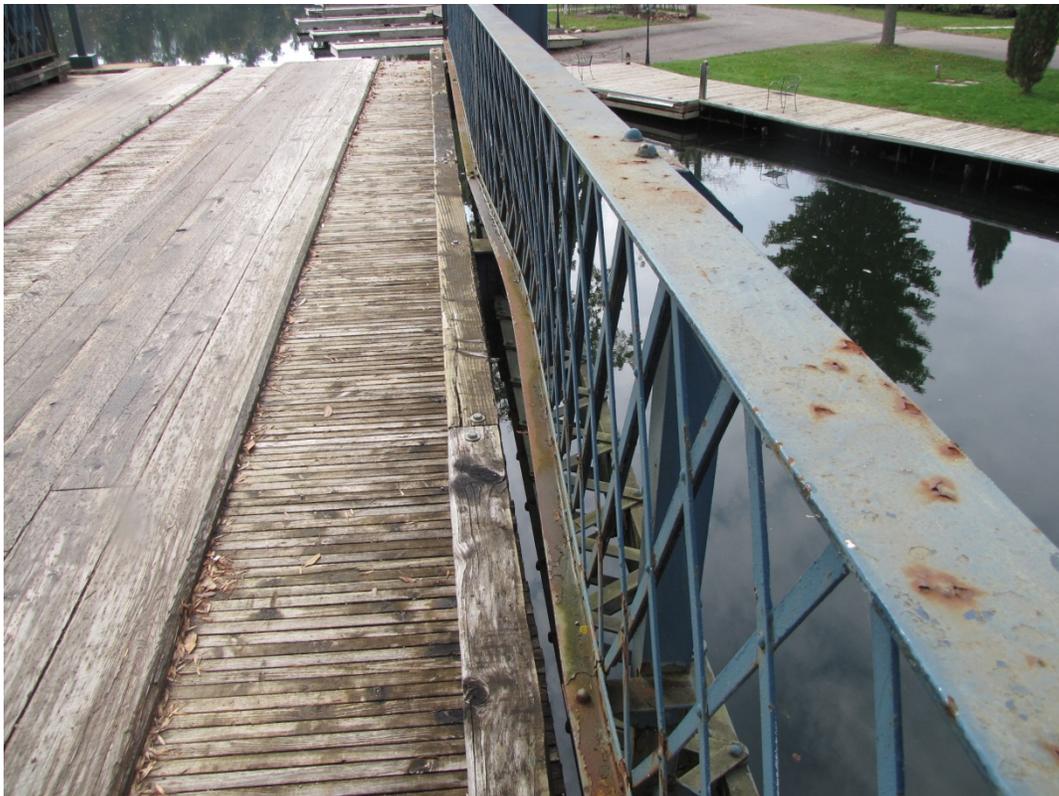
Photo S46: Impact damage to bottom rail on north railing between FB1 and FB2.

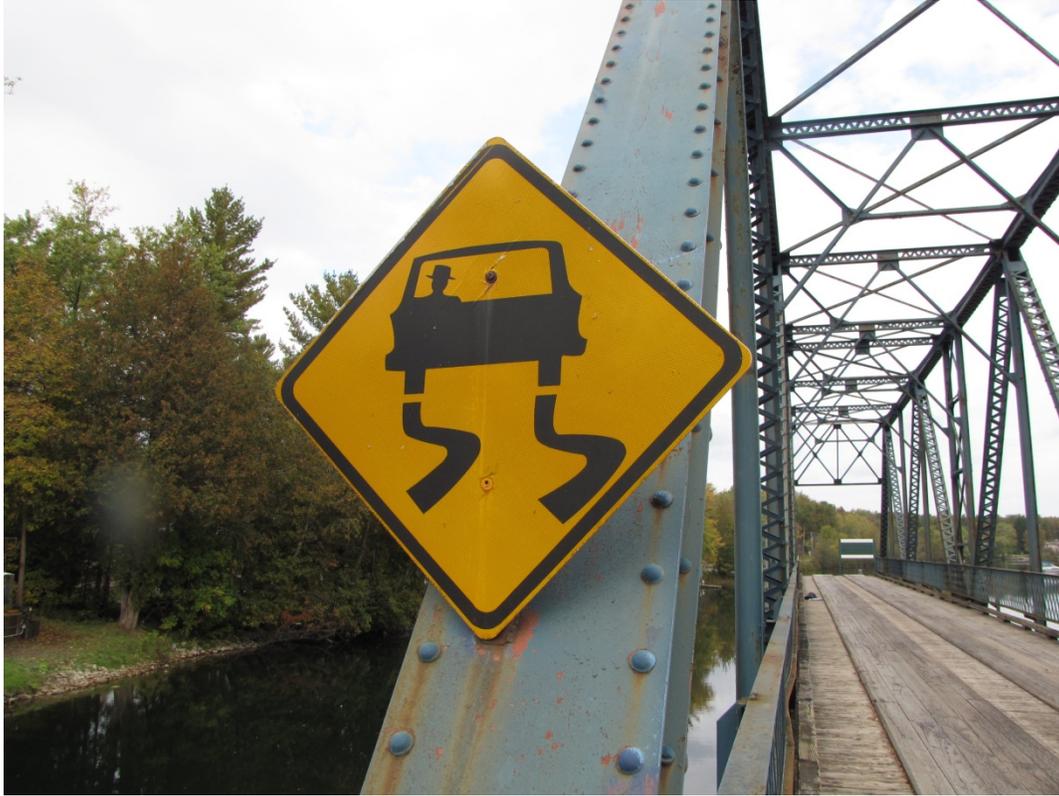
Photo S51: The sign on the west end of the north truss is missing a bolt.

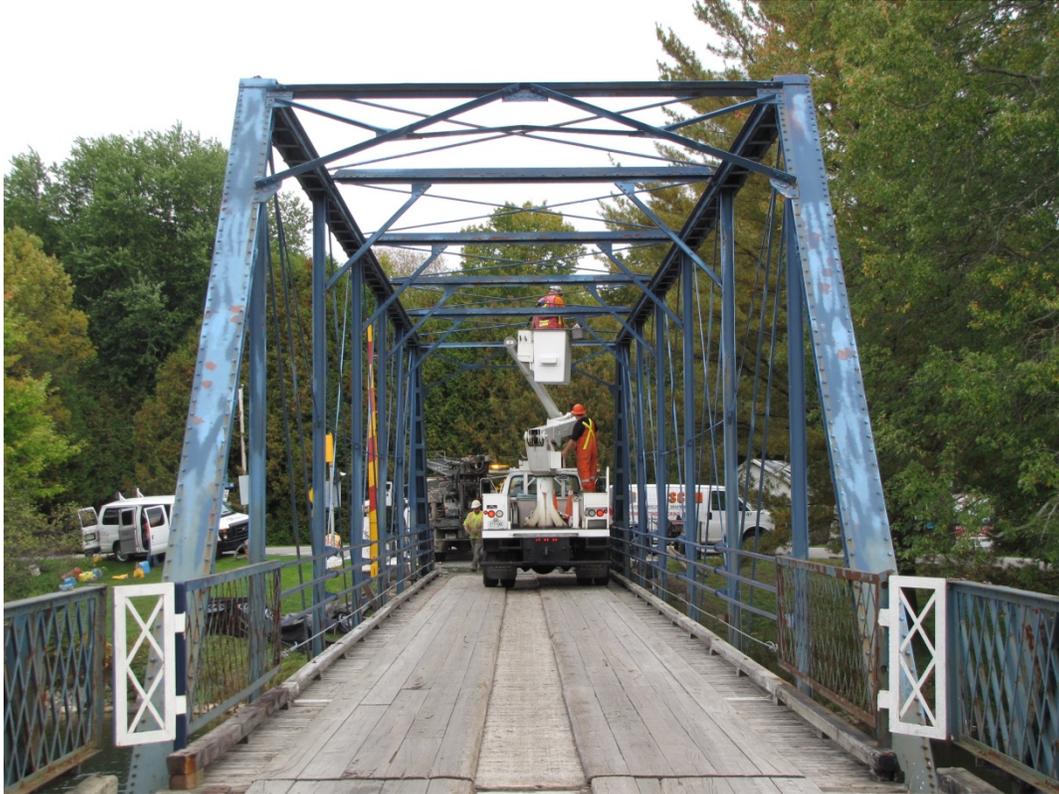
Photo F3: Looking east. Note the typical condition of the coating on the end top chord members.

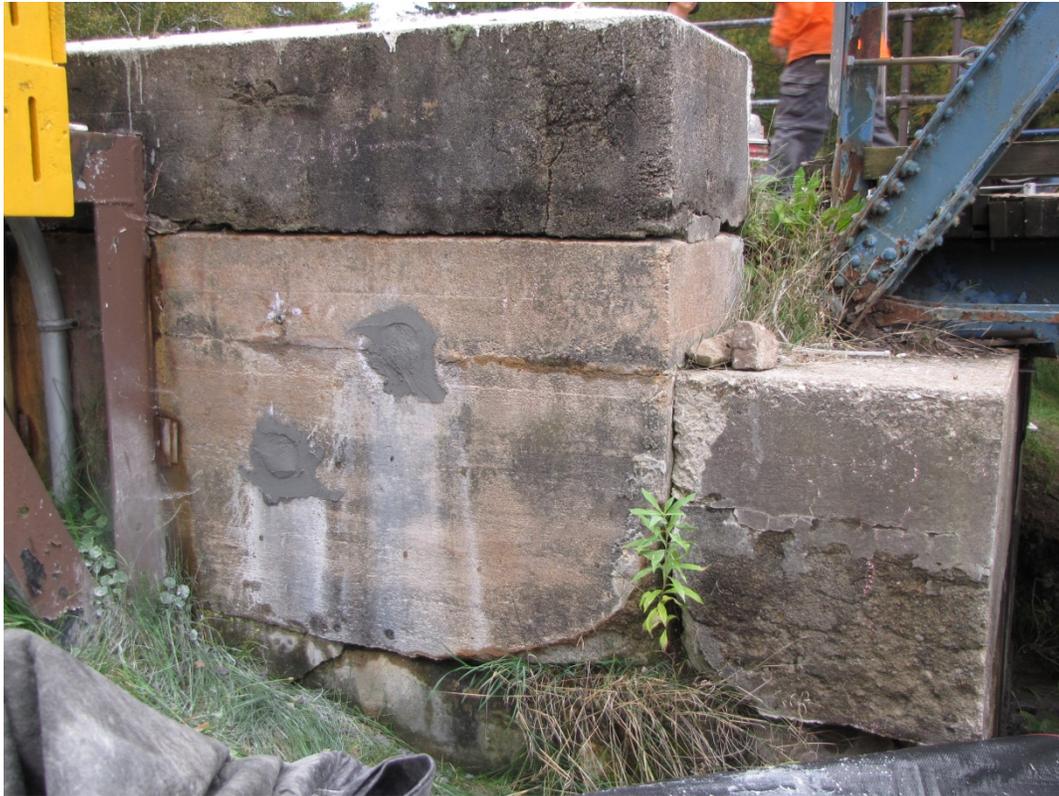
Photo F5: The north-east wingwall has wide gaps at the construction joints plus areas of spalling and disintegration.
