Hamlet Bridge (Bridge 57) Comprehensive Detailed Inspection and Structure Evaluation Report (PCA Project No. 2011-4650-20027340)

Comprehensive Detailed Inspection and Structure Evaluation Report

Parks Canada Project No. 2011-4650-20027340

Delcan Corporation

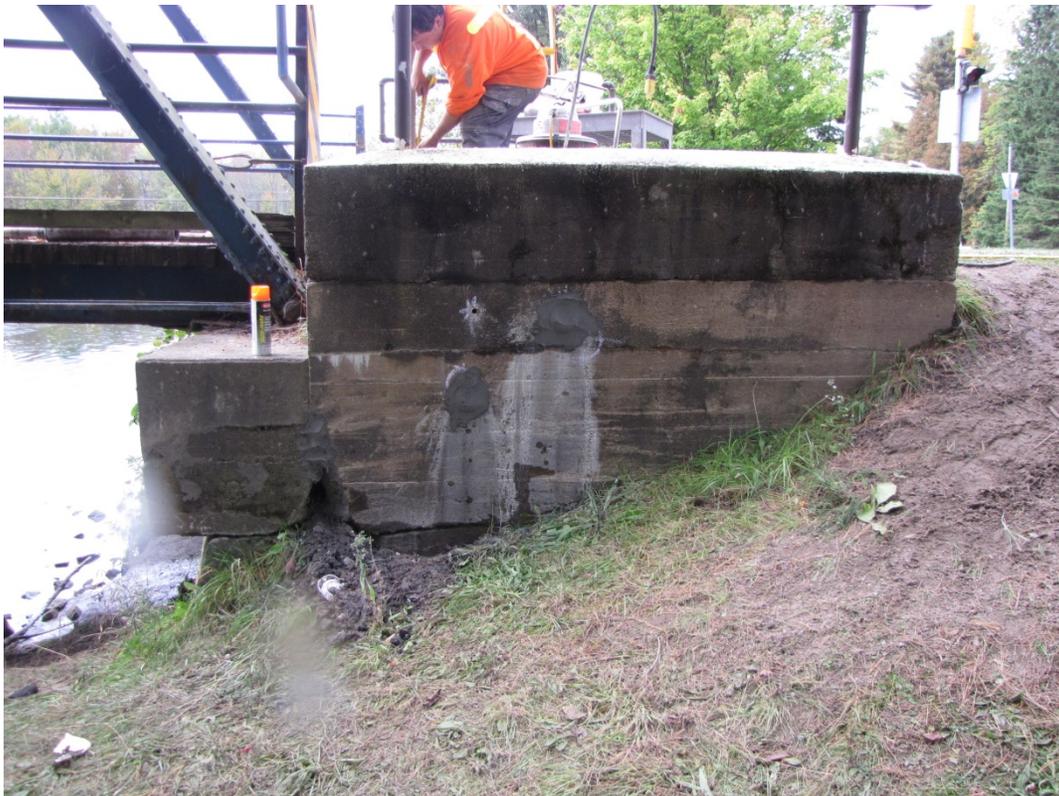
Photo F6: The south-east wingwall has wide gaps at the construction joints plus areas of spalling and disintegration. The wall is leaning to the south.

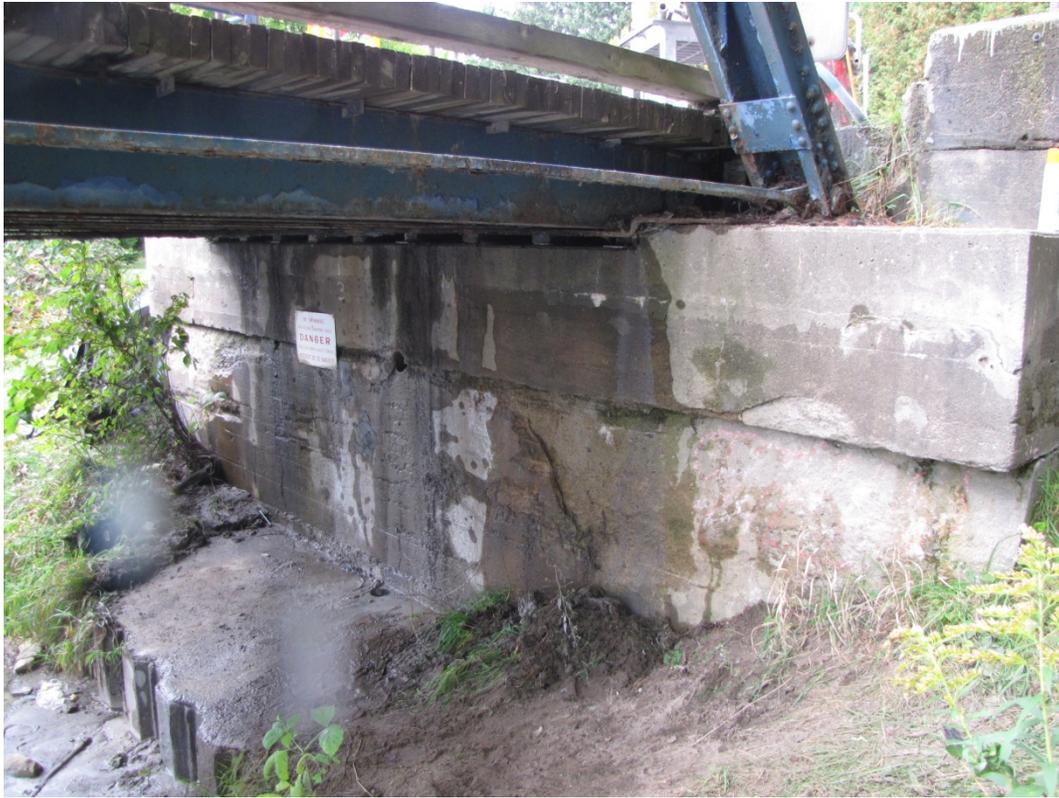
Photo F7: East abutment exhibits large areas of spalling and severe scaling. The wall is leaning to the west.

Recommended rehabilitation work (within 5 years) on the span includes: Cleaning and re-painting of the steelwork and minor steel repairs; Repair/replacement of the roller bearings; Replacement of deteriorated areas of timber curbs and decking; Replacement of the timber running boards on the deck; Repair of the damaged portal frame members; Concrete repairs to the east pier; Replacement of the steel connection pins at L7; and underpinning and re-facing of the east abutment.

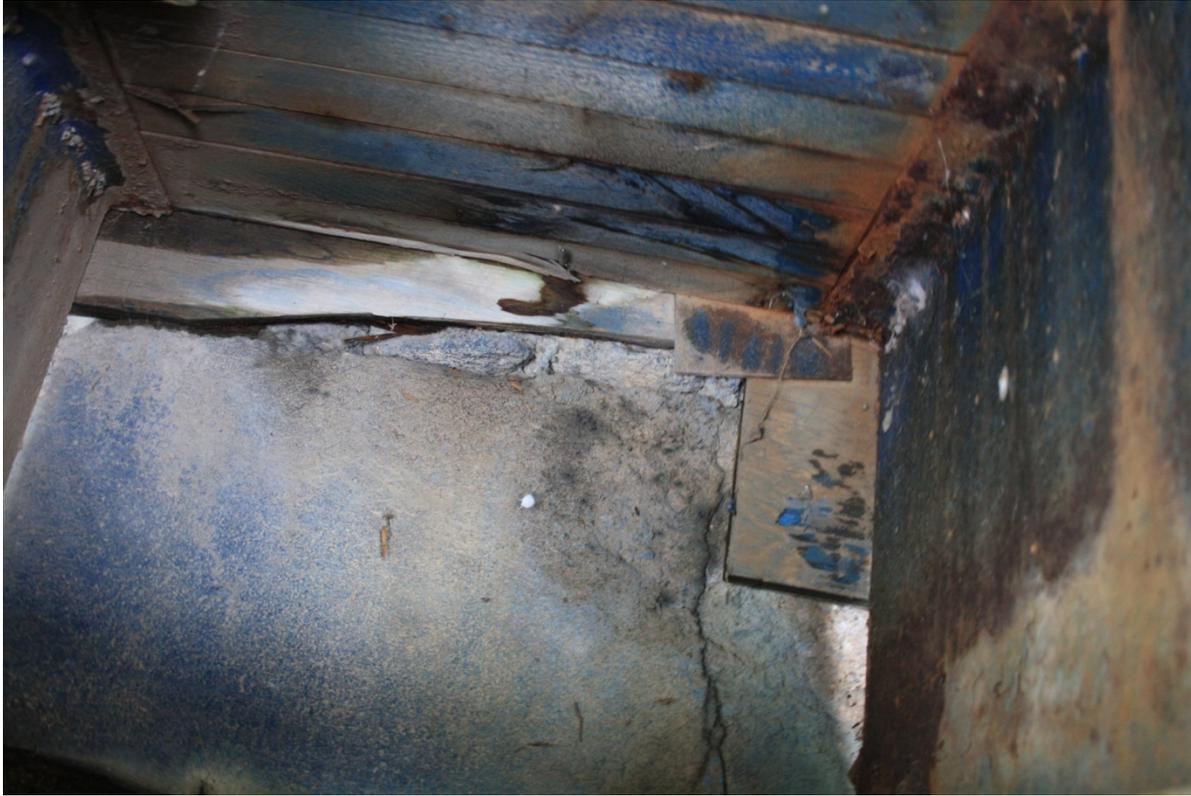
Photo F9: The east ballast wall has several vertical cracks.

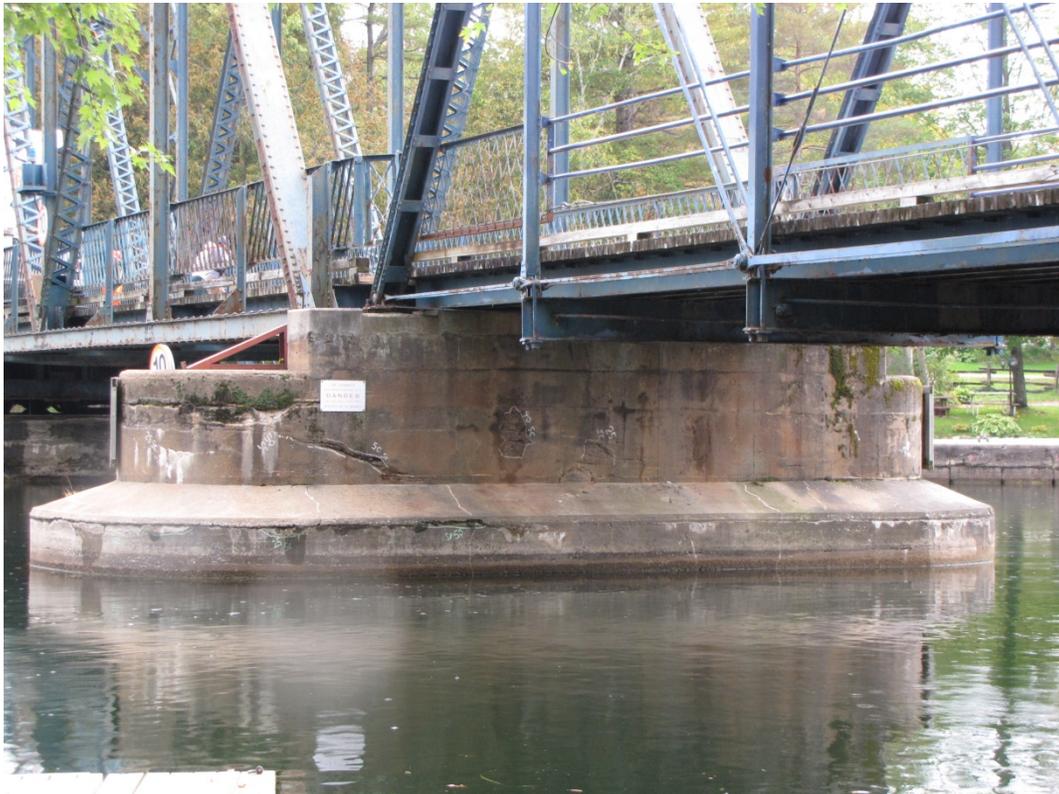
Photo F10: East face of the pier – numerous cracks, spalls and areas of disintegration noted.

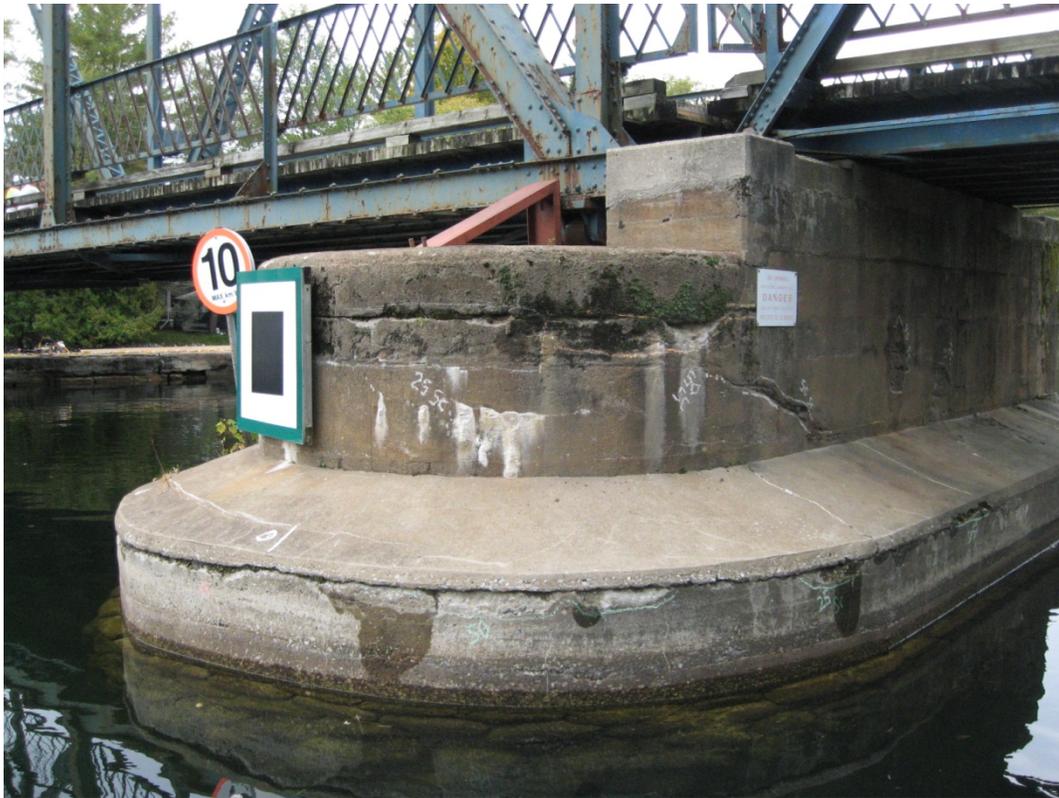
Photo F11: Typical very wide cracks, efflorescence and spalls in the south end of the pier.

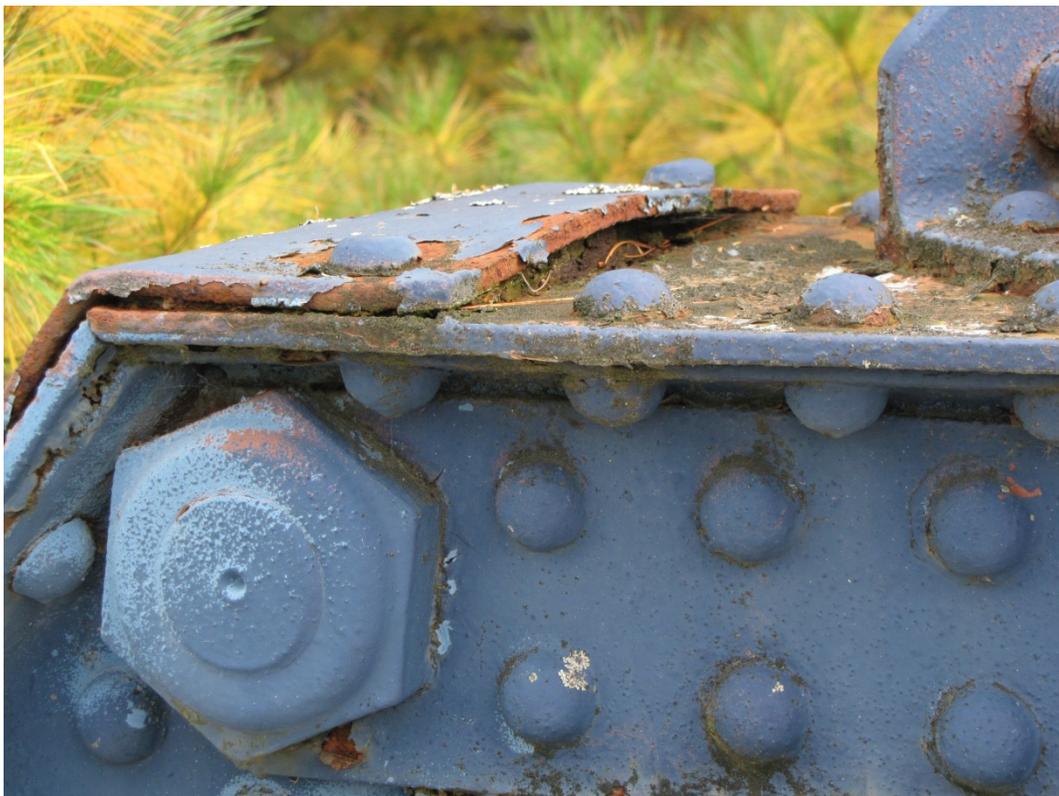
Photo F12: Severe rust jacking of the top chord cover plate at U6S.

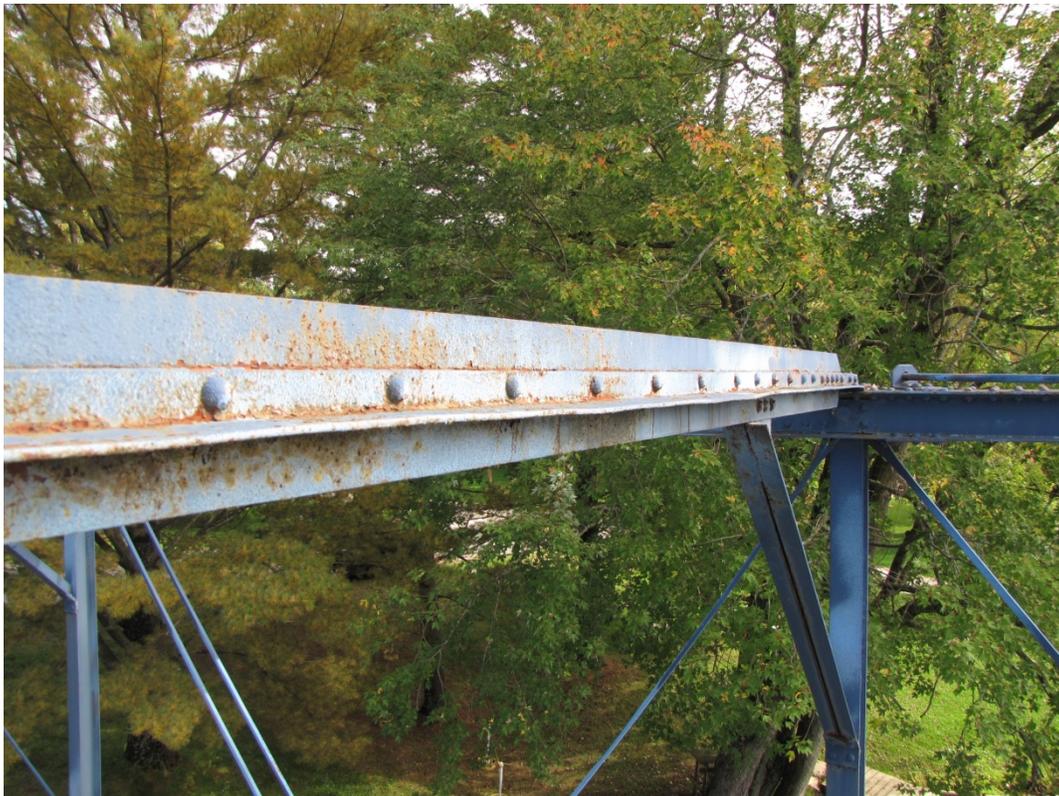
Photo F13: West horizontal flange of the lateral bracing member 4S-4N is deformed along its length.

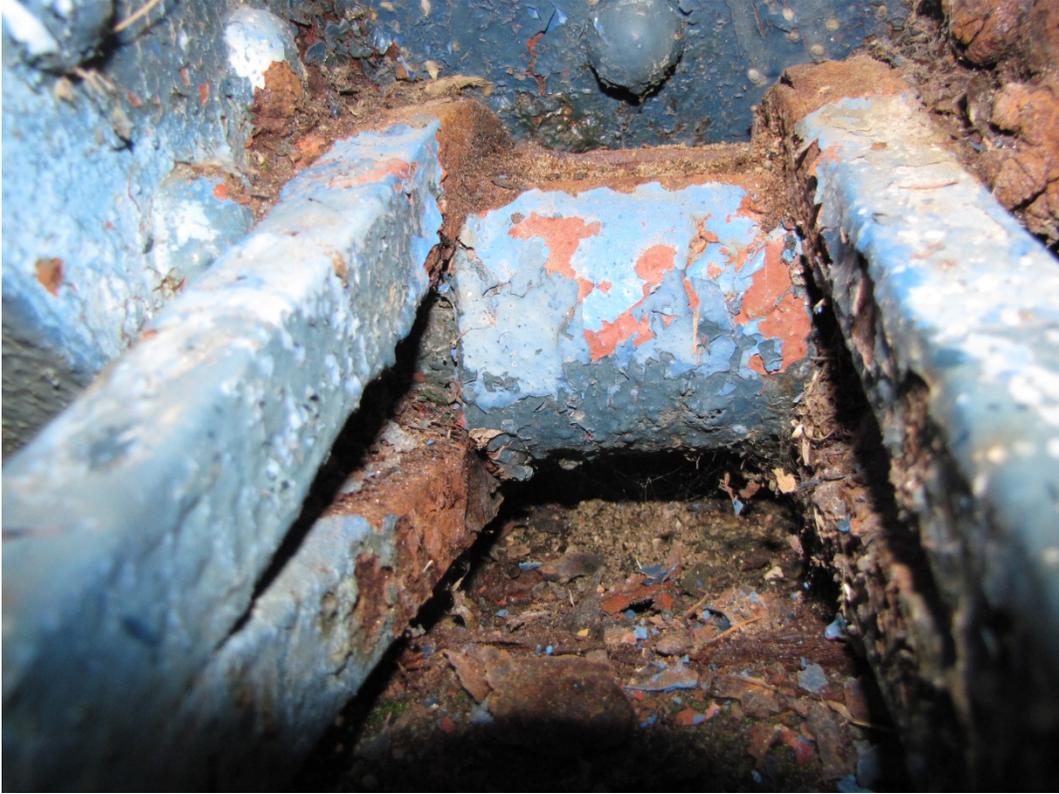
Photo F21: Severe corrosion and rust jacking of the north bottom chord I-bars at the west end of bridge.

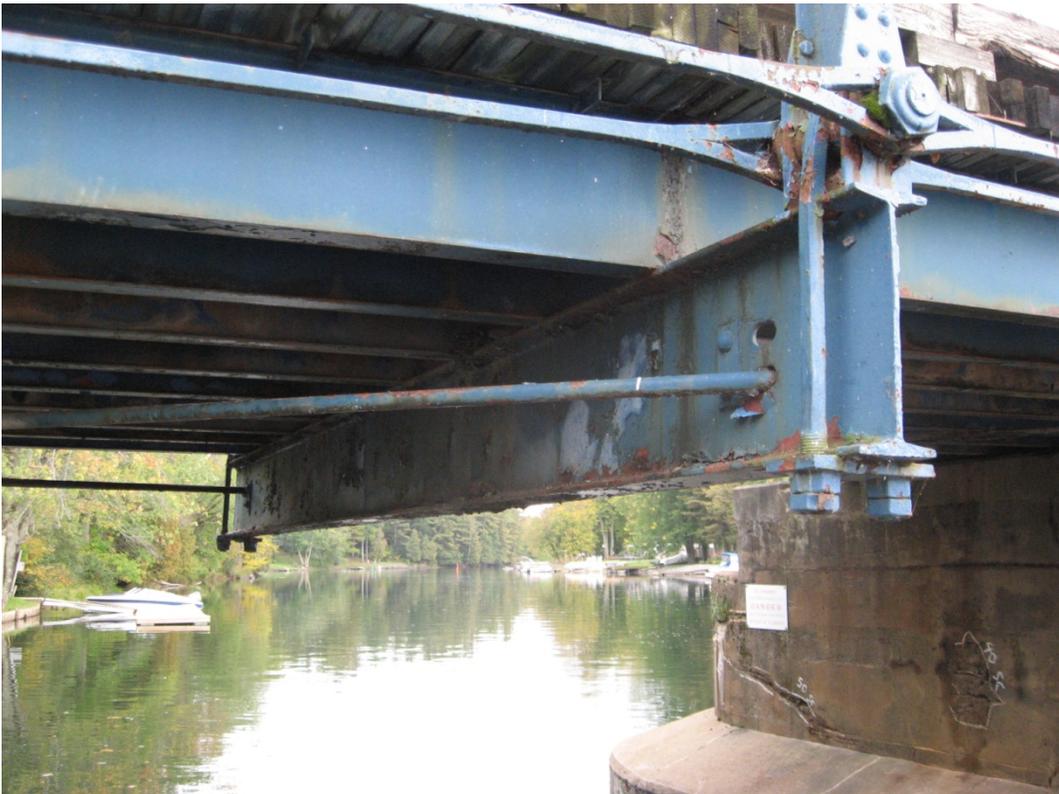
Photo F22: Typical condition of the lower truss connections and floor beams.

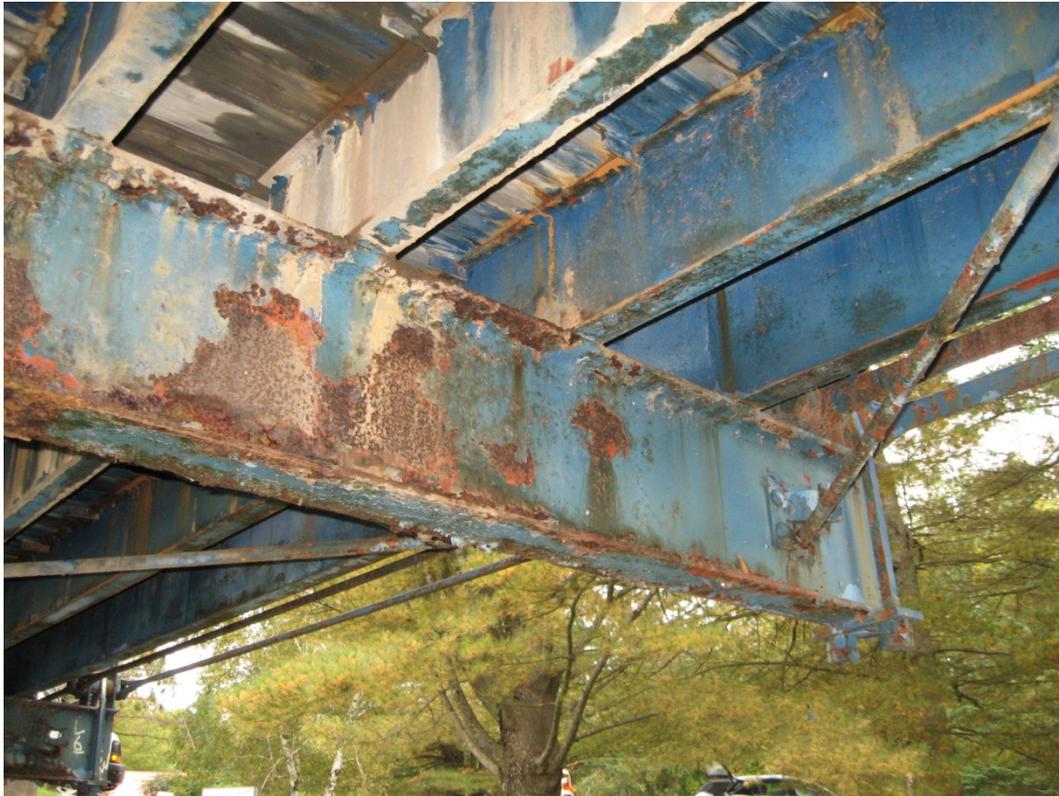
Photo F23: Typical condition of the floor beams, stringers and bottom lateral bracing.

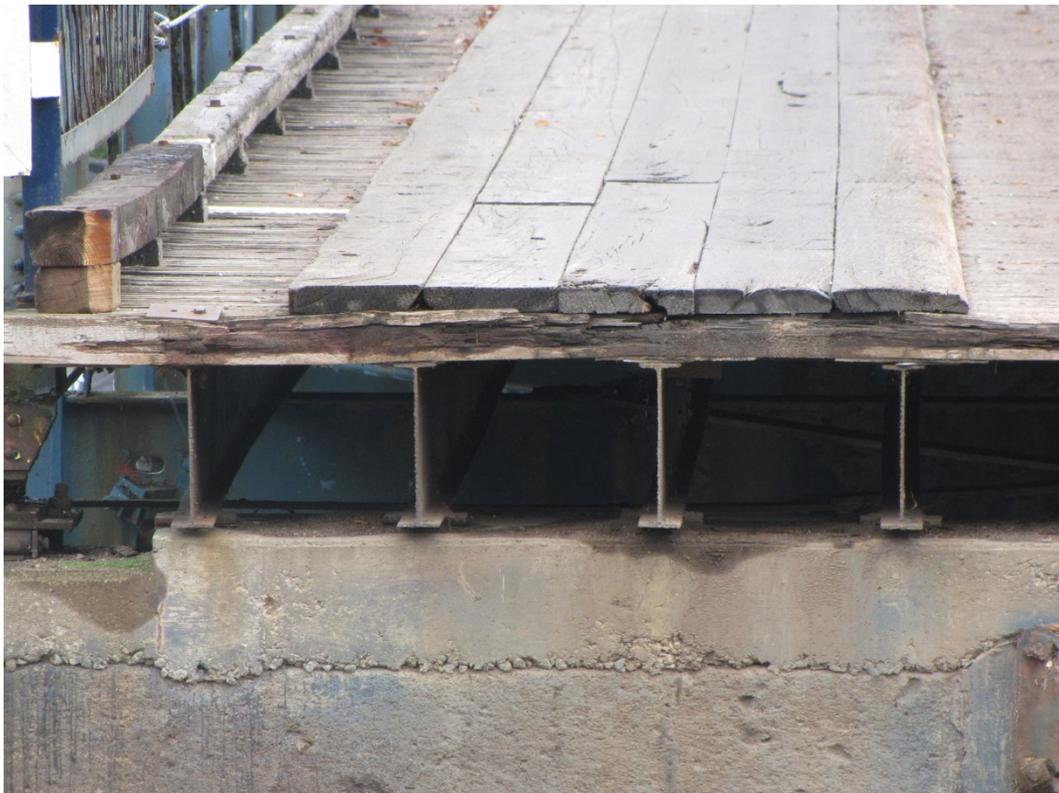
Photo F24: West end of the fixed span. Note the deteriorated timber deck member.

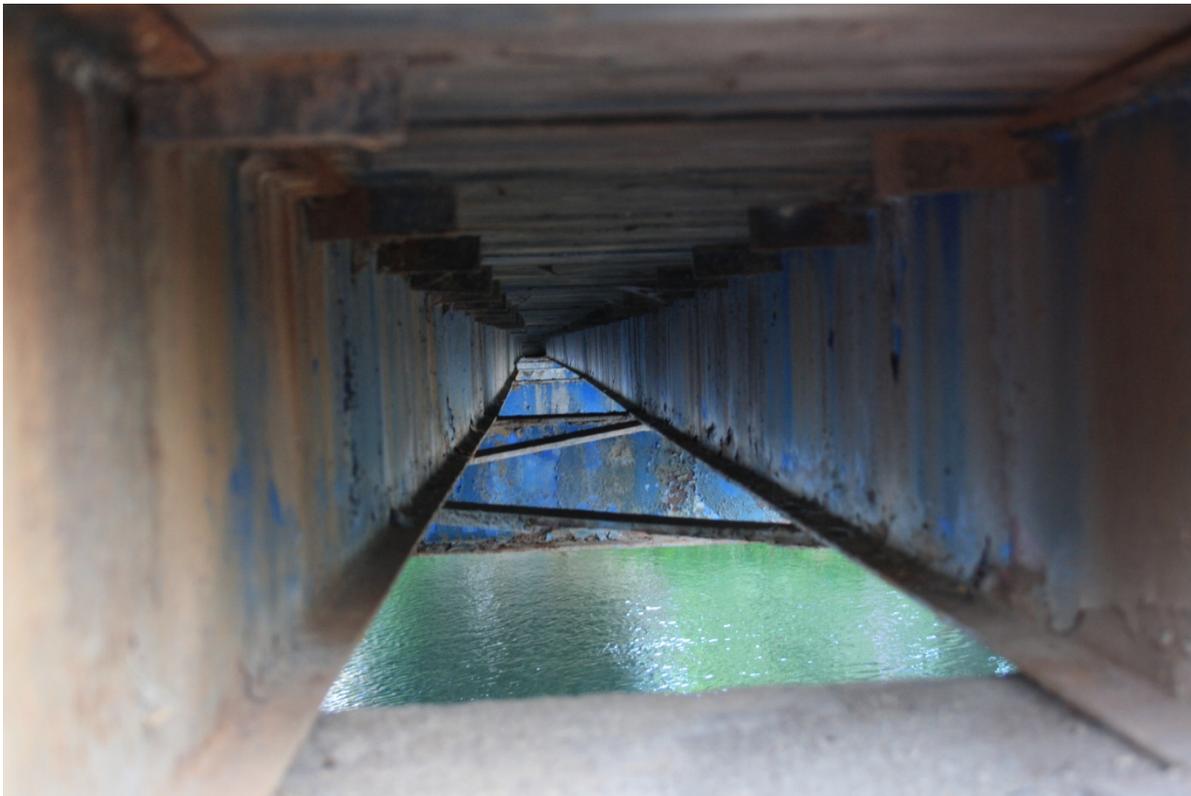
Photo F25: Looking east along the stringers. Some stringer out-of-straightness observed.

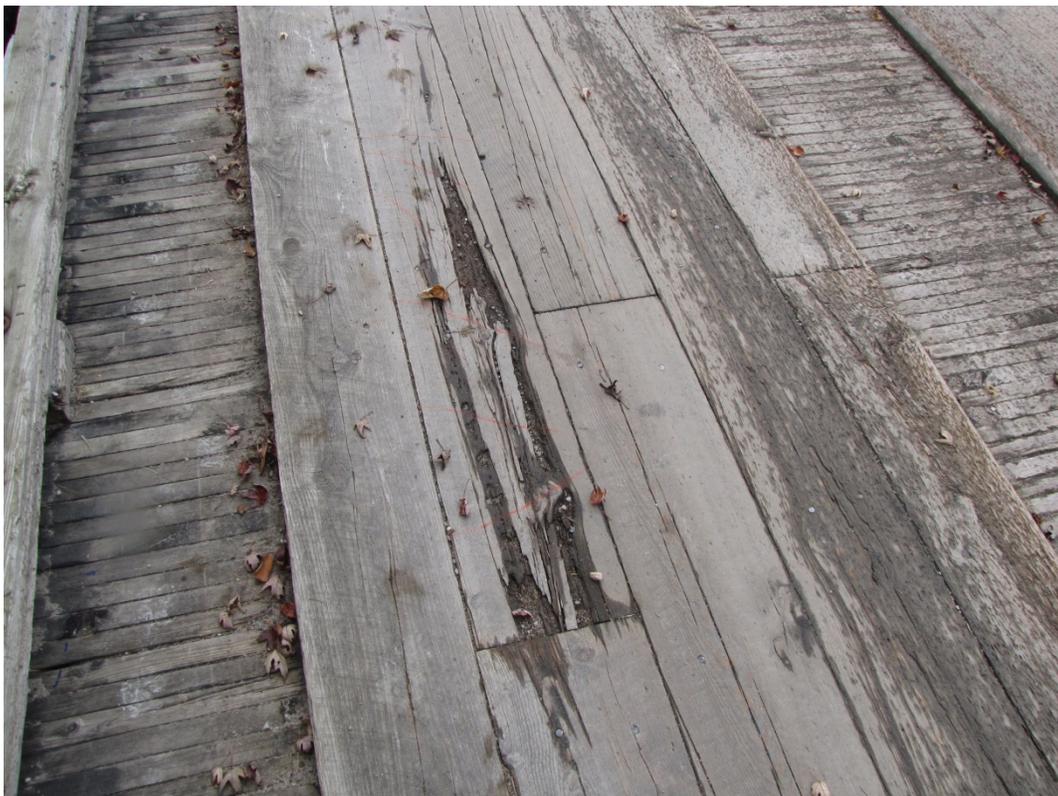
Photo F26: Typical area of rotting and checking in the timber wearing surface.

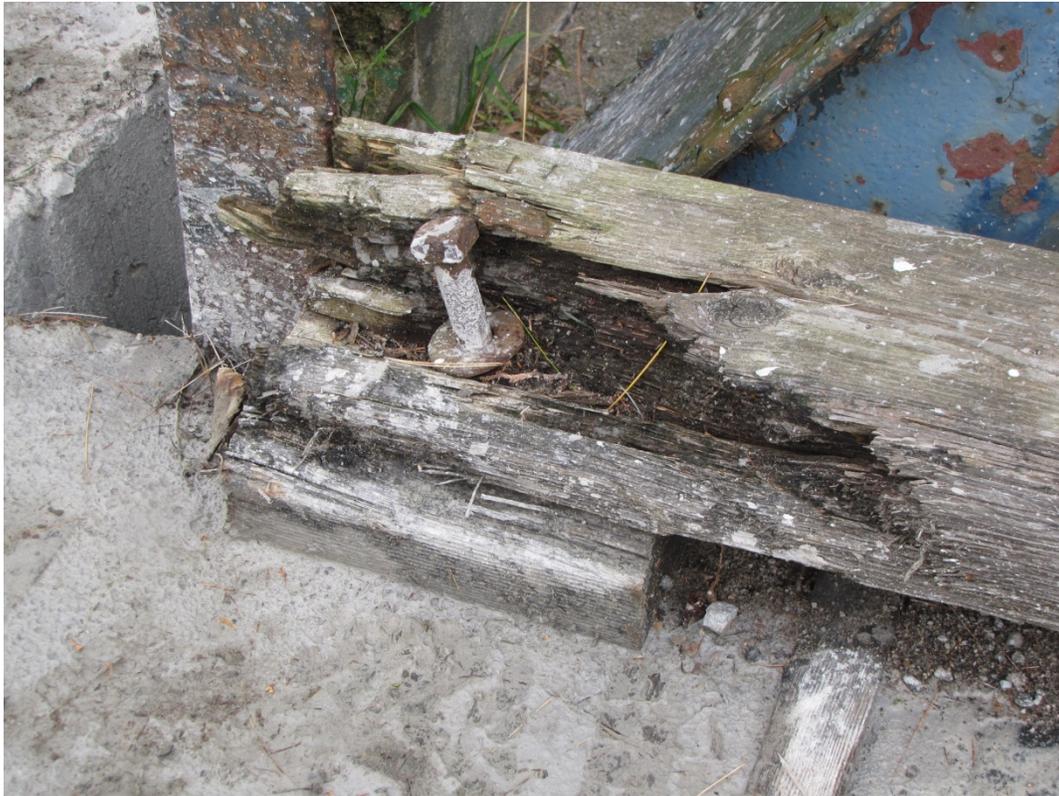
Photo F27: Severe rotting of the east end of the south curb.

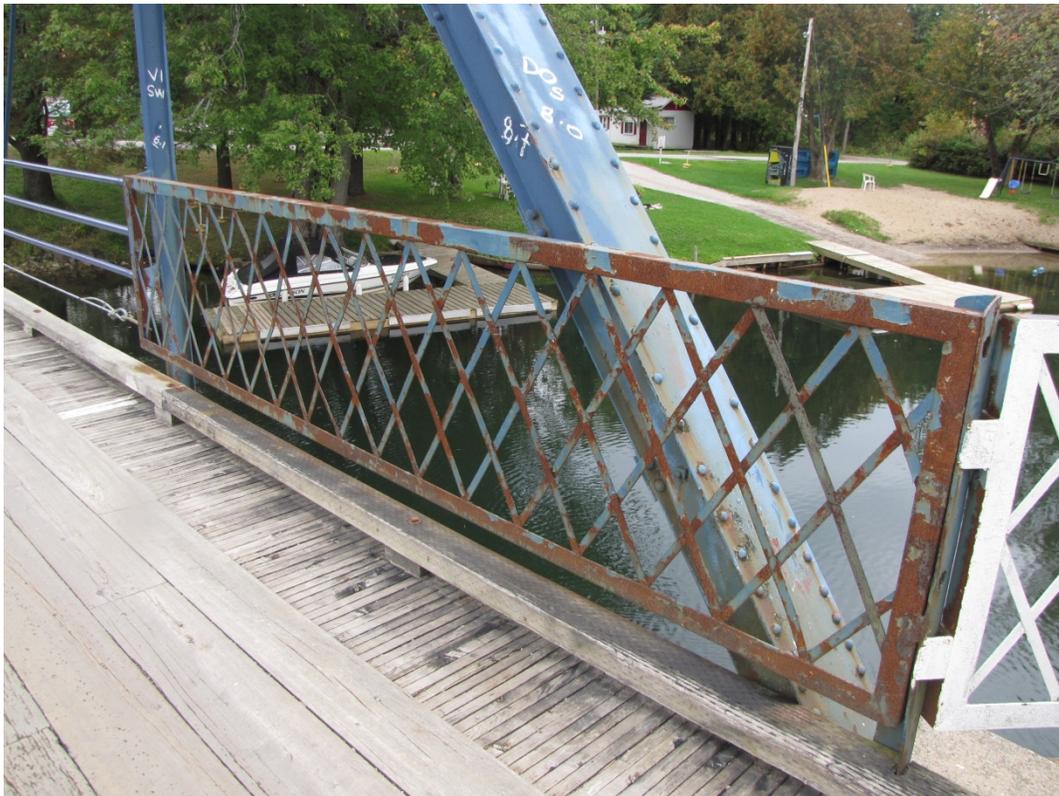
Photo F33: Typical extensive coating failure and light corrosion on the decorative railing panels

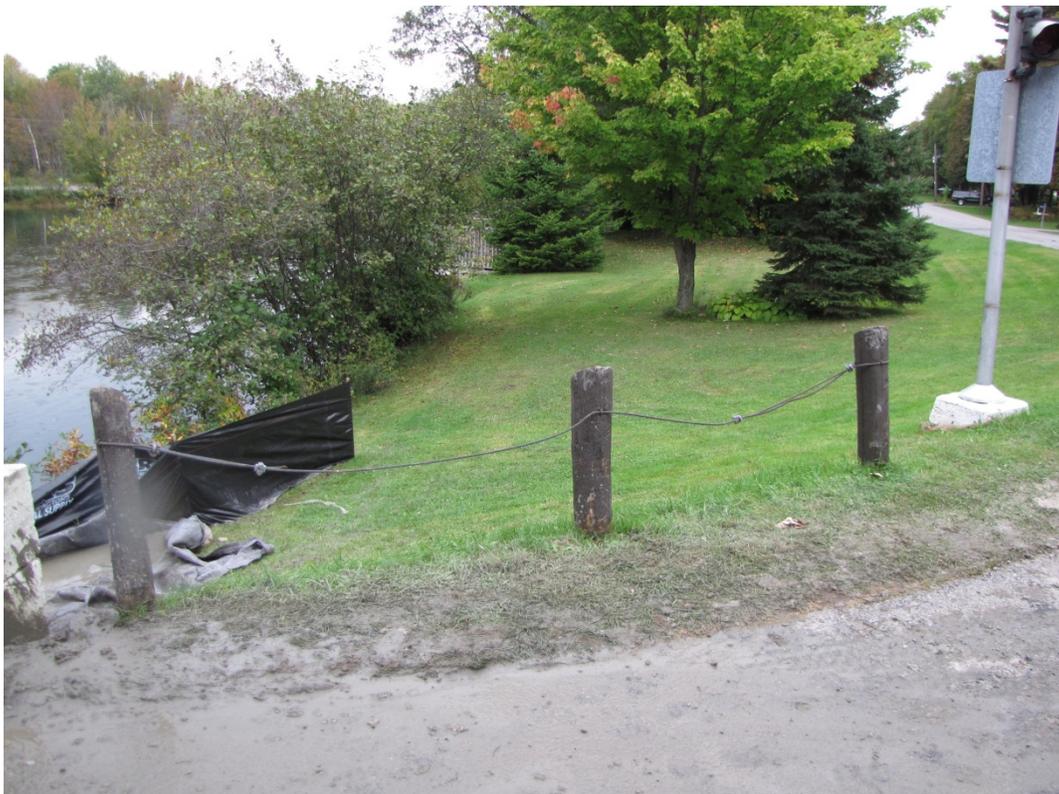
Photo F34: The two end posts of the north-east guide rail are rotten.

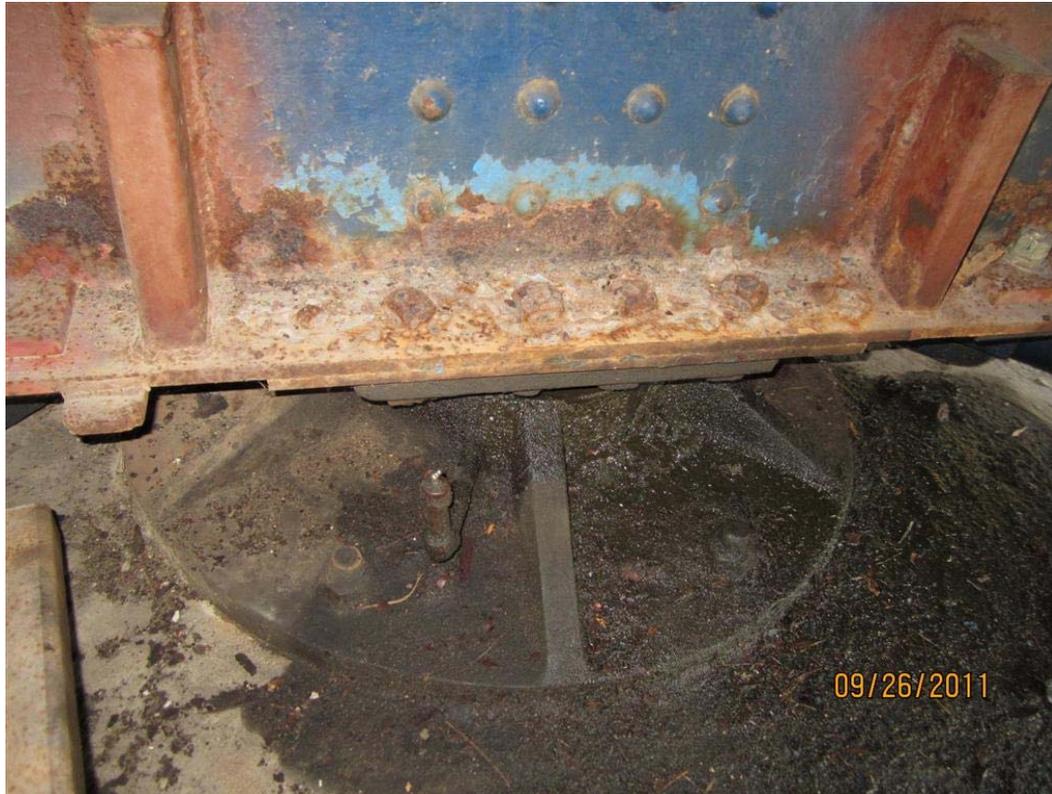
Photo M1: The center pivot top plate mounting bolts exhibit moderate corrosion with moderate section loss.

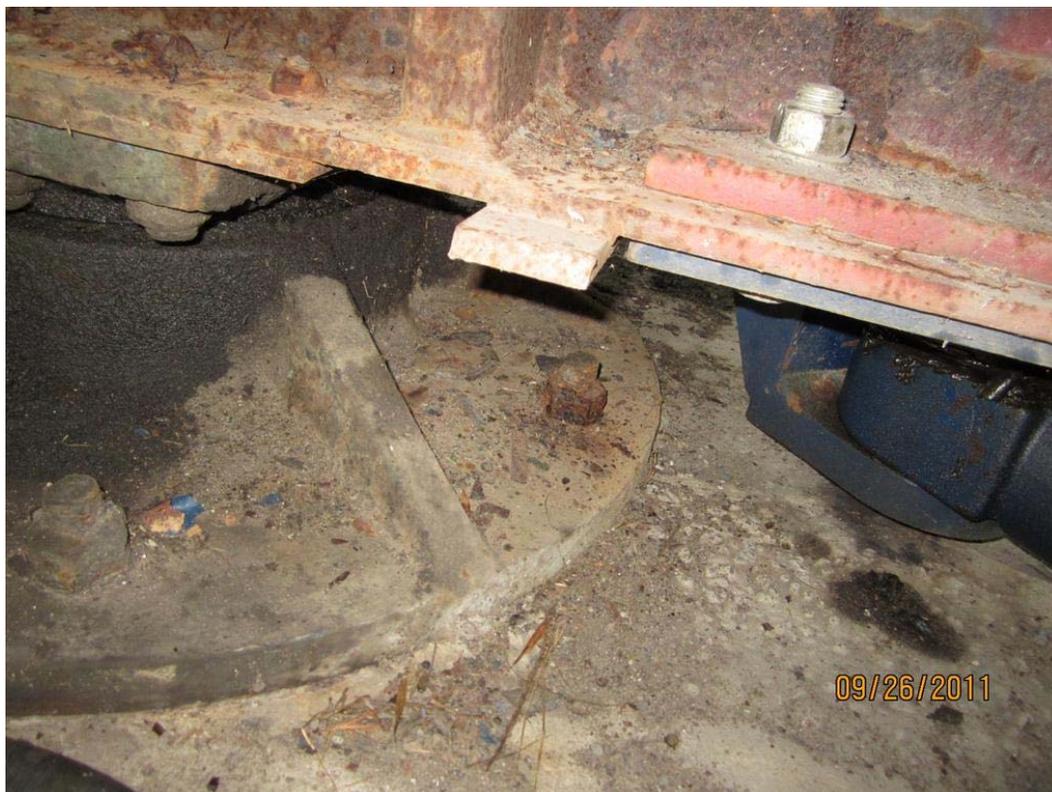
Photo M2: One of six anchor bolts exhibits corrosion and light section loss.

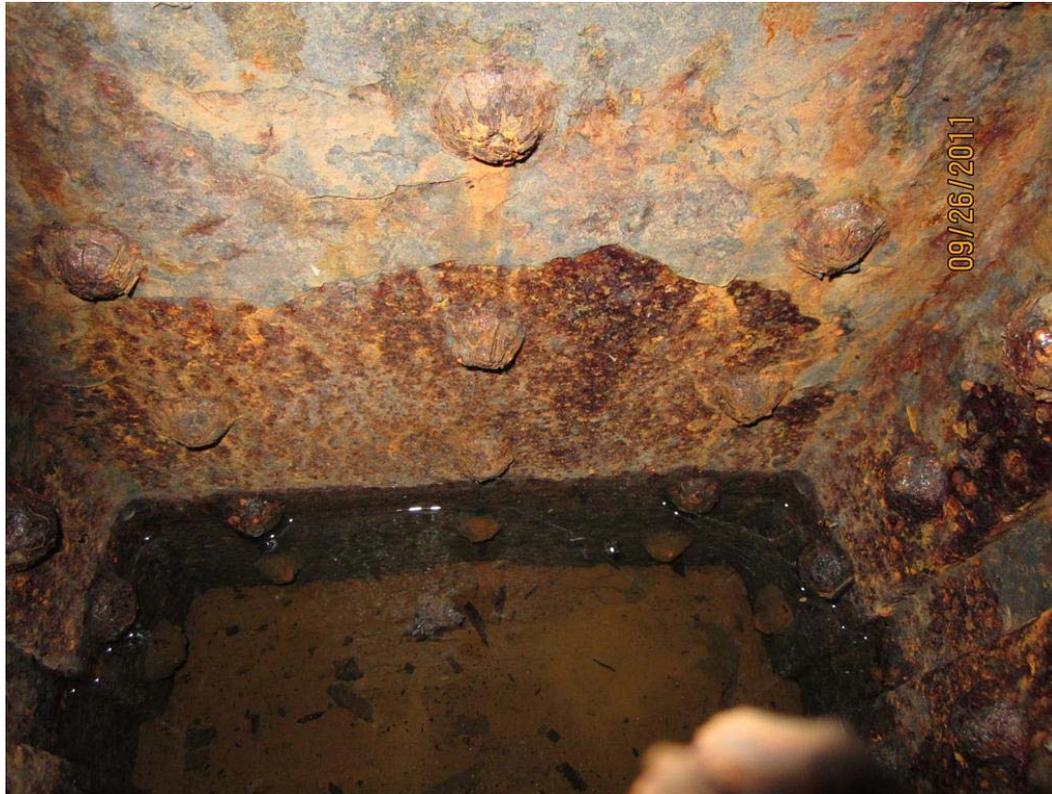
Photo M3: The interior of the pivot girder collects debris and standing water.

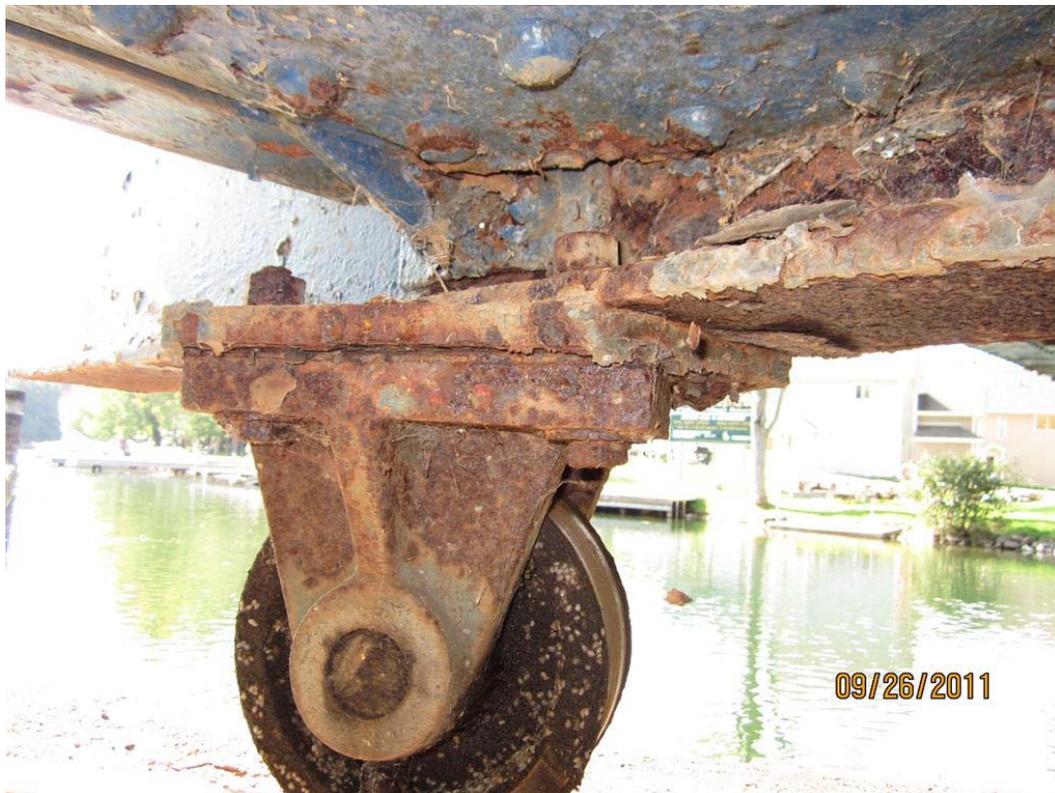
Photo M6: The balance wheel assembly and mounting bolts exhibit moderate corrosion and light section loss.

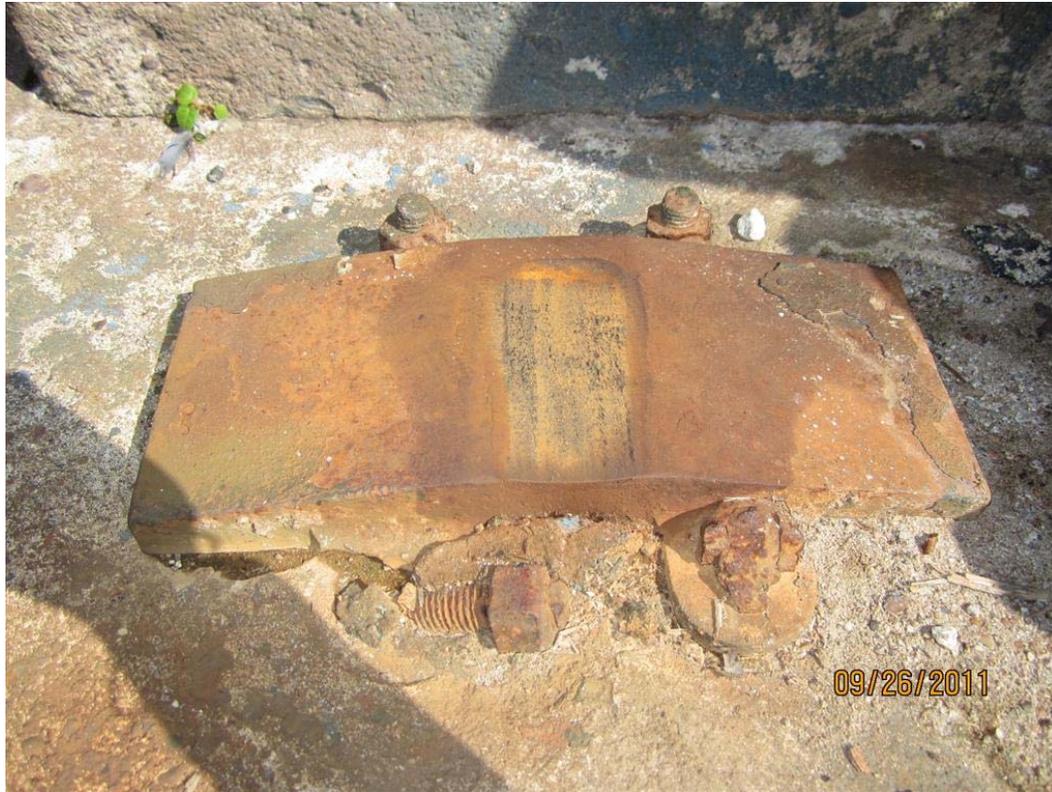
Photo M7: Northeast End Castor Rest Plate. Slight movement was noted between both end rest plates and the pier. One of the four north rest plate anchor bolts is bent. Also note the heavy wear on the rest plate due to contact with the roller.

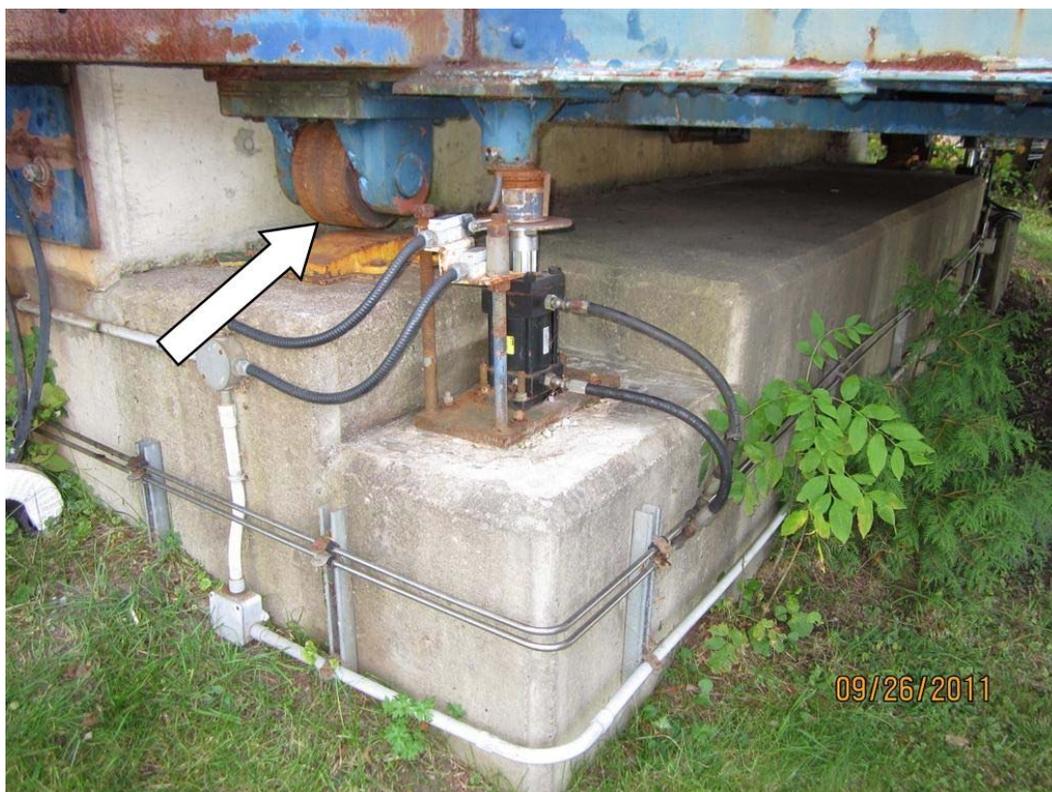
Photo M8: The west end castors are no longer utilized to support the swing span. The end lift cylinder body, base plates, and anchor bolts exhibit light corrosion.

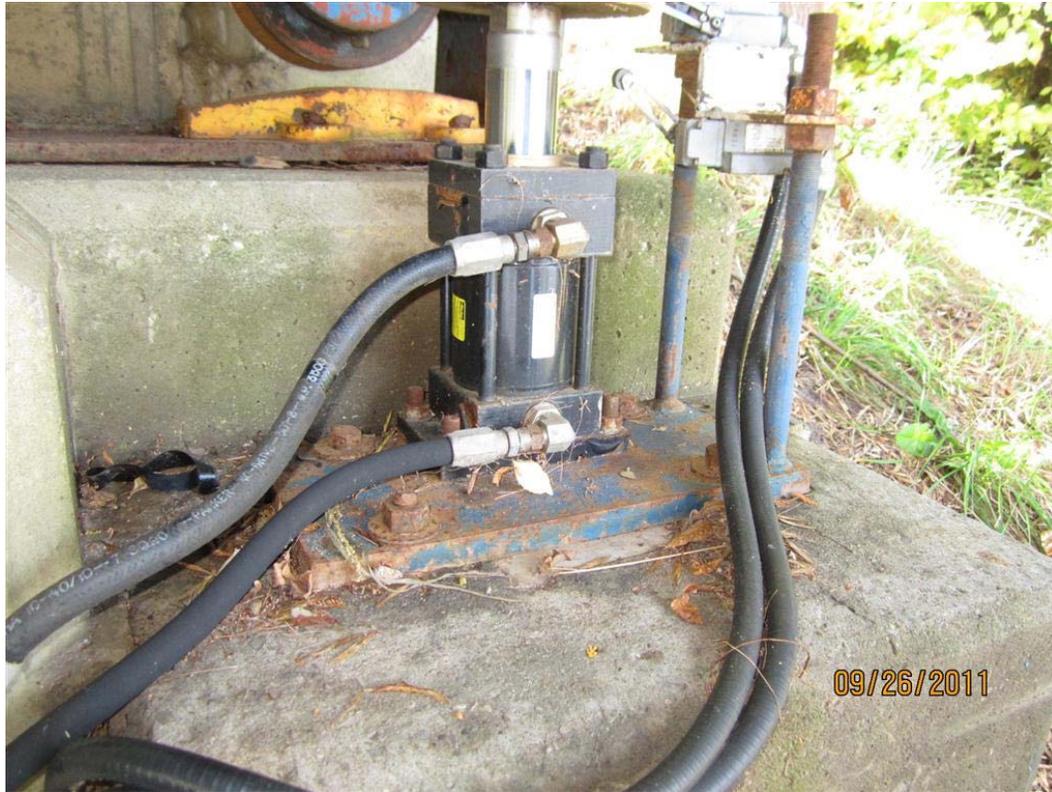
Photo M9: North End Lift. The base plate anchor bolts are not properly tightened.

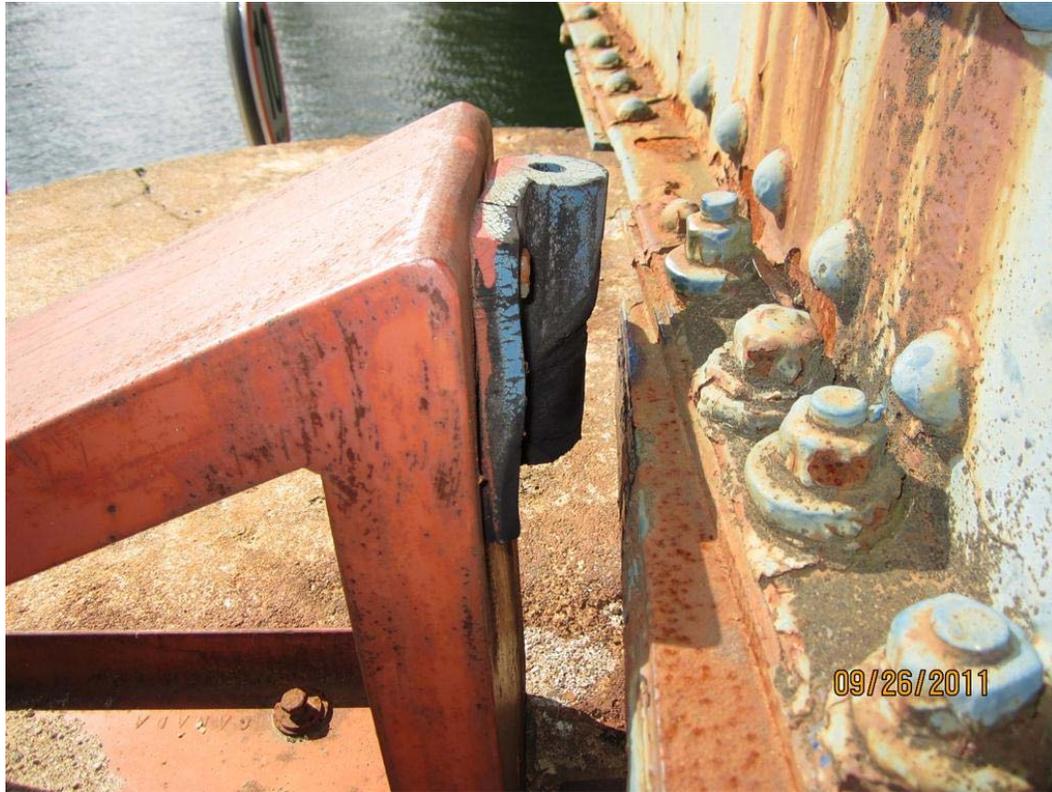
Photo M13: The east end of travel stop is installed with an energy absorbing pad that is in poor condition.

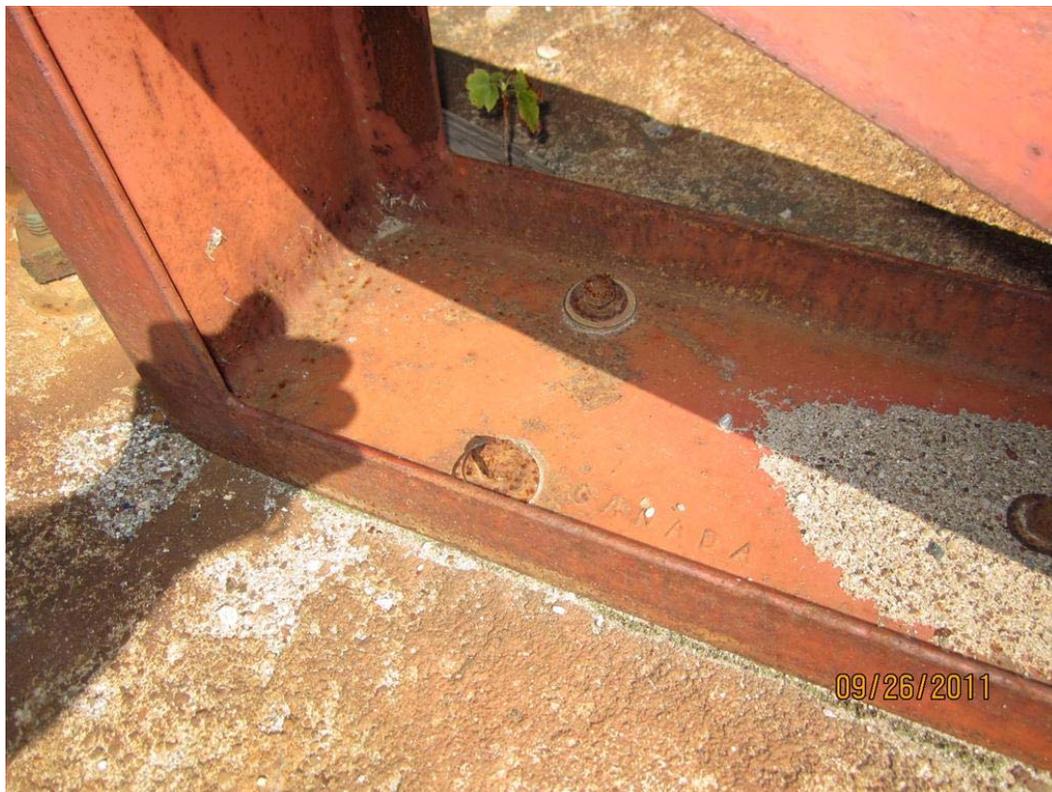
Photo M14: The east end of travel stop anchor bolts are in poor condition and exhibit evidence that the stop was impacted resulting in the anchors being slightly pulled out.

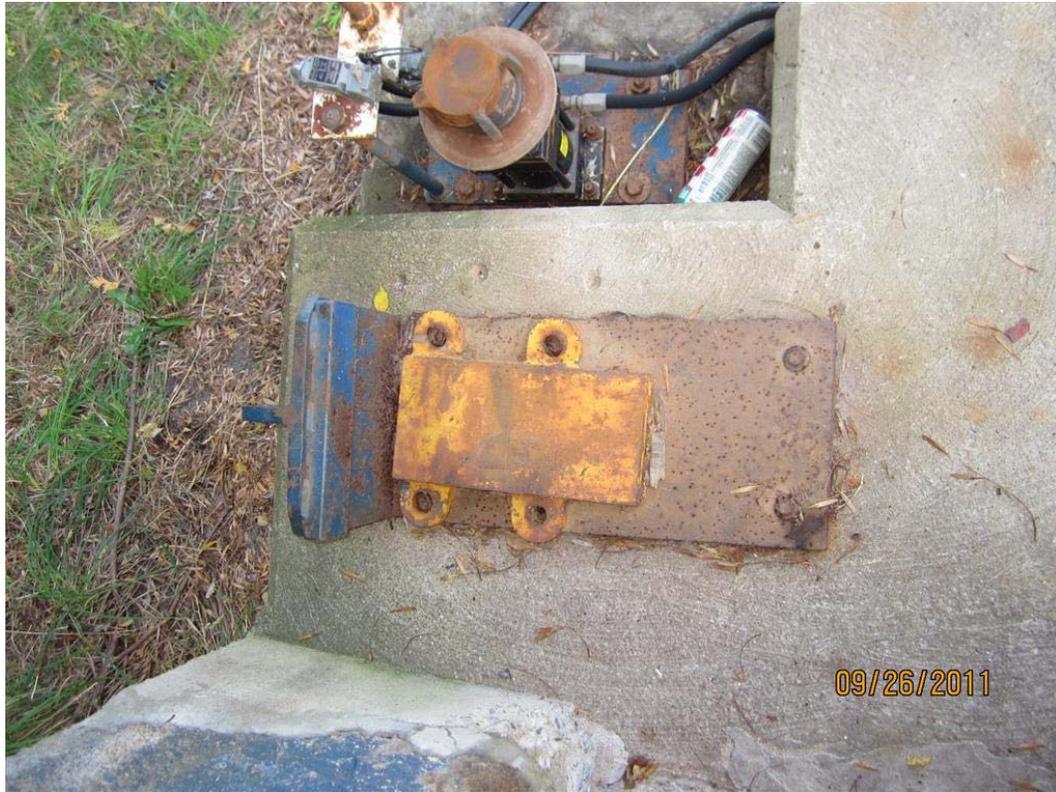
Photo M15: West end of travel stop. The rest plate anchor bolt heads are cut off and do not secure the rest plate to the pier.
