Hamlet Bridge (Bridge 57) Comprehensive Detailed Inspection and Structure Evaluation Report (PCA Project No. 2011-4650-20027340)

Comprehensive Detailed Inspection and Structure Evaluation Report

Parks Canada Project No. 2011-4650-20027340

Delcan Corporation

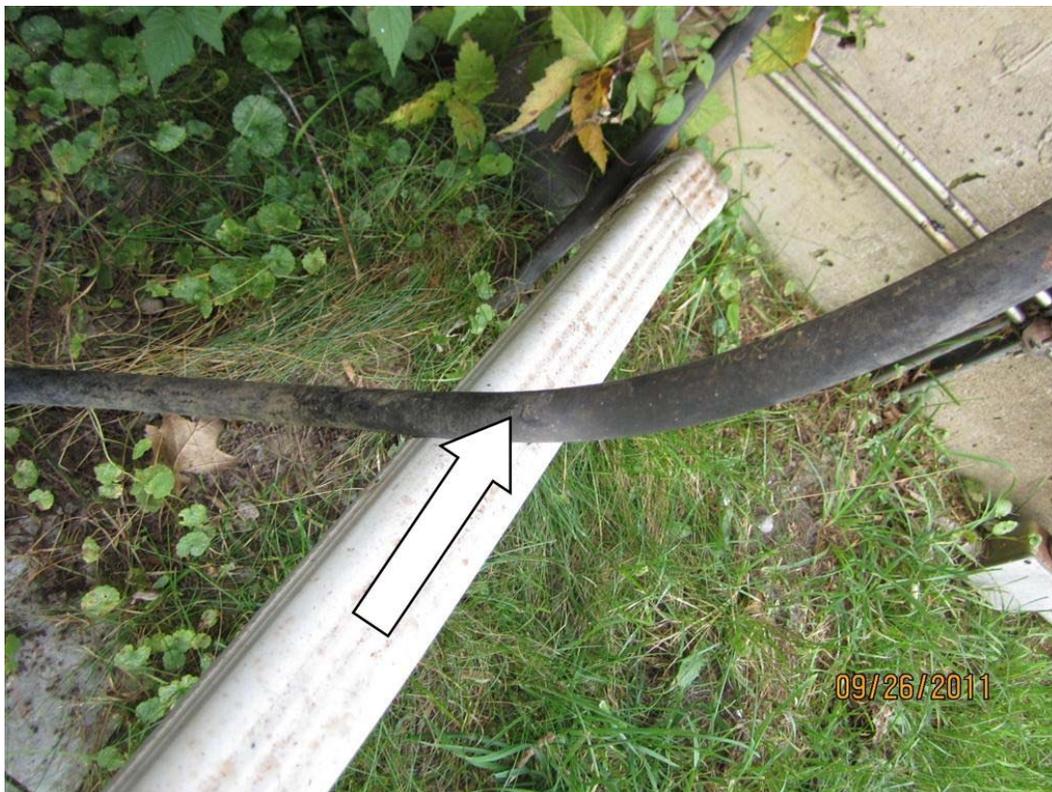
Photo M20: The west locking pin hydraulic cylinder blind end hose (arrow) is damaged.

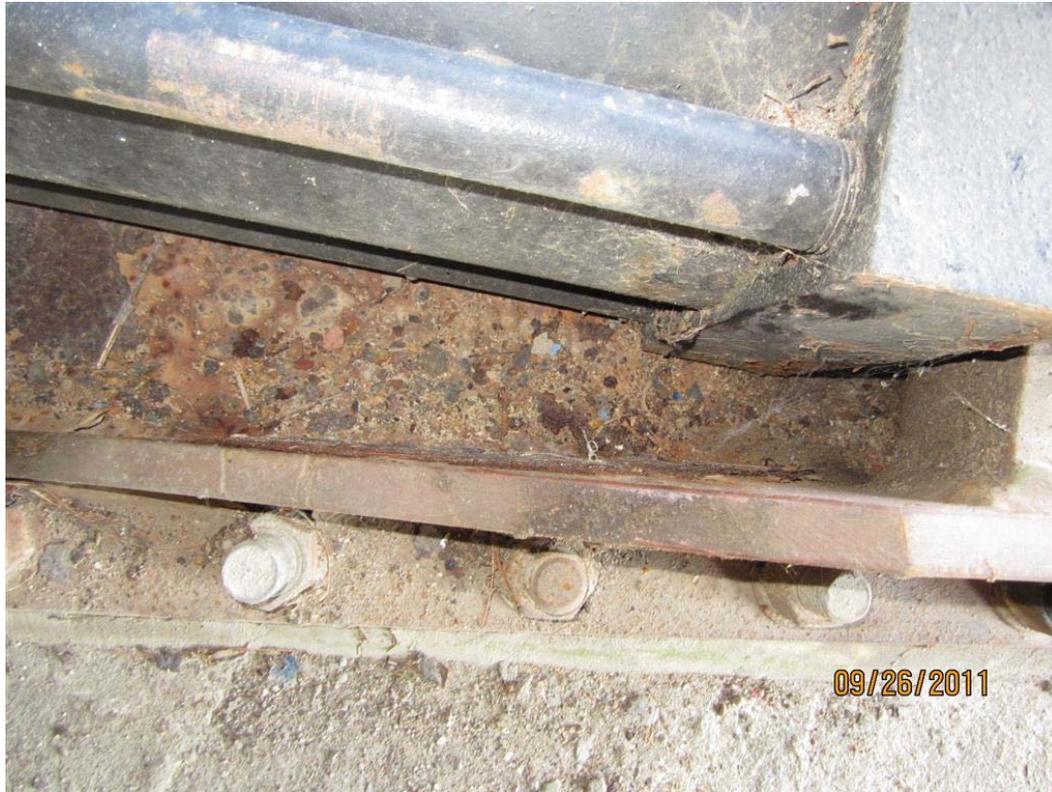
Photo M21: The blind end clevis and bracket for the span drive cylinder collects debris and exhibits light corrosion.

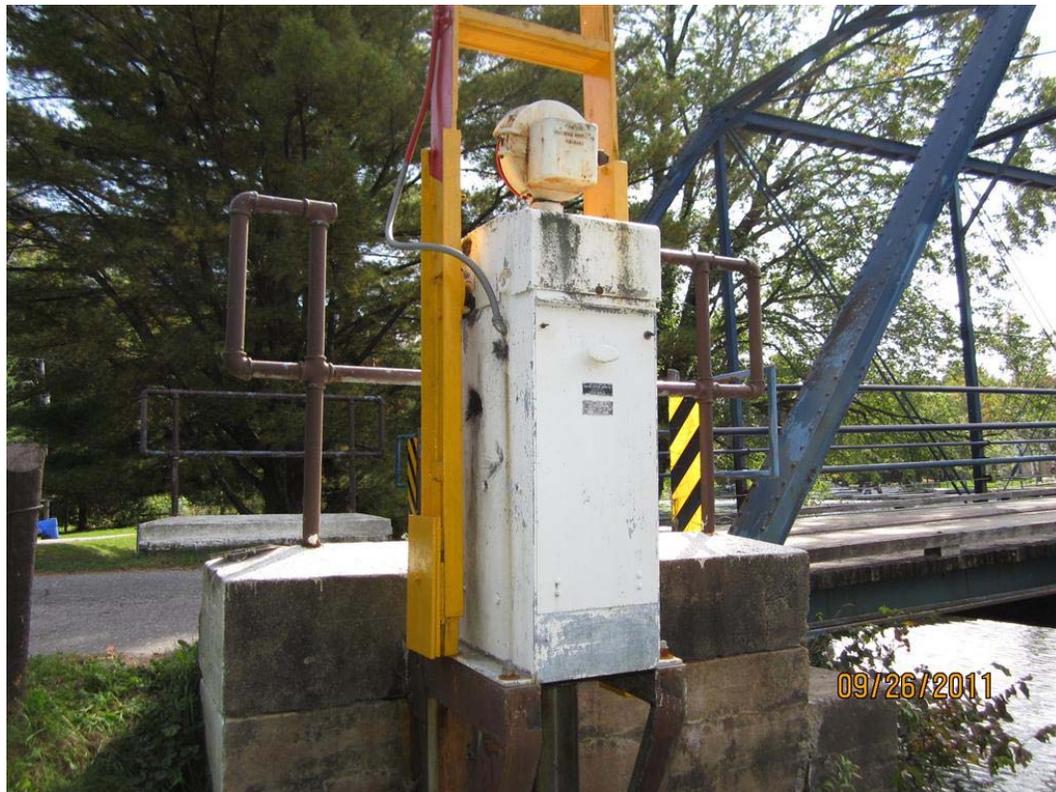
Photo M22: East Traffic Gate. The gate housings are in fair condition.

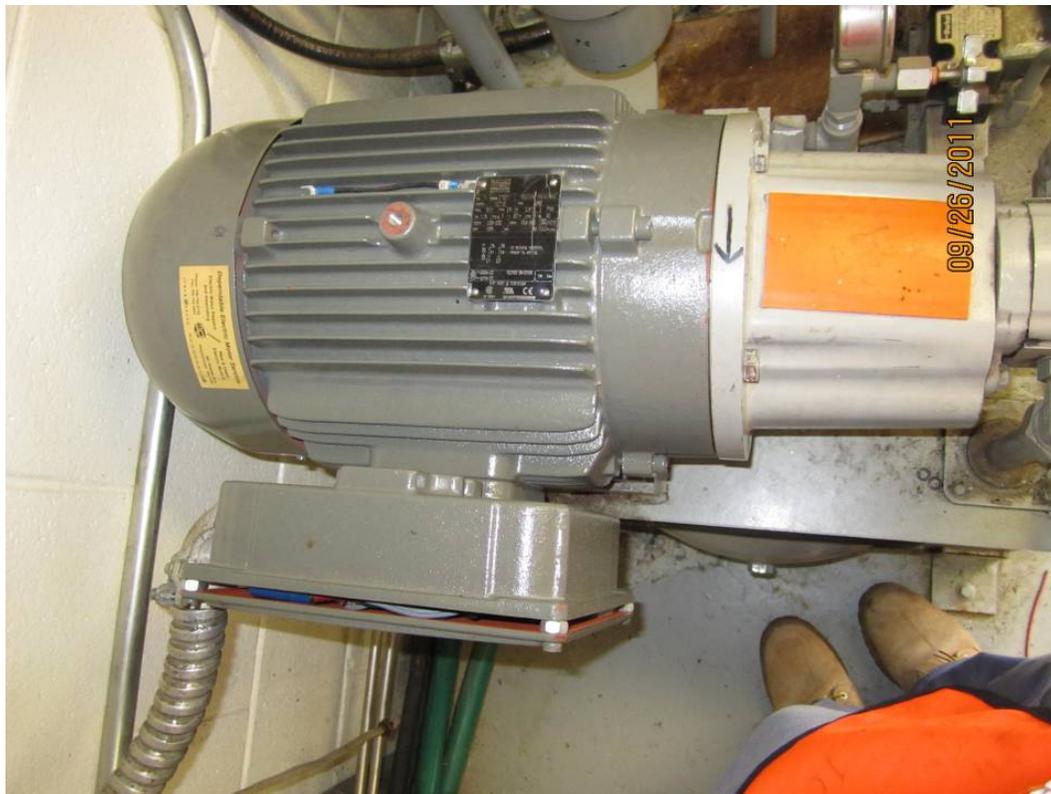
Photo E4: Swing Span Hydraulic Pump Motor. Note the gap in the motor power junction box.
