ROYAL CANADIAN MOUNTED POLICE
2020 9th Avenue West, Prince Albert

ASBESTOS HAZARD ASSESSMENT
SURVEY REPORT

April 2009

Prepared by: Bersch & Associates Ltd.
Prepared for: Kadam Developments
Project No. B01.09

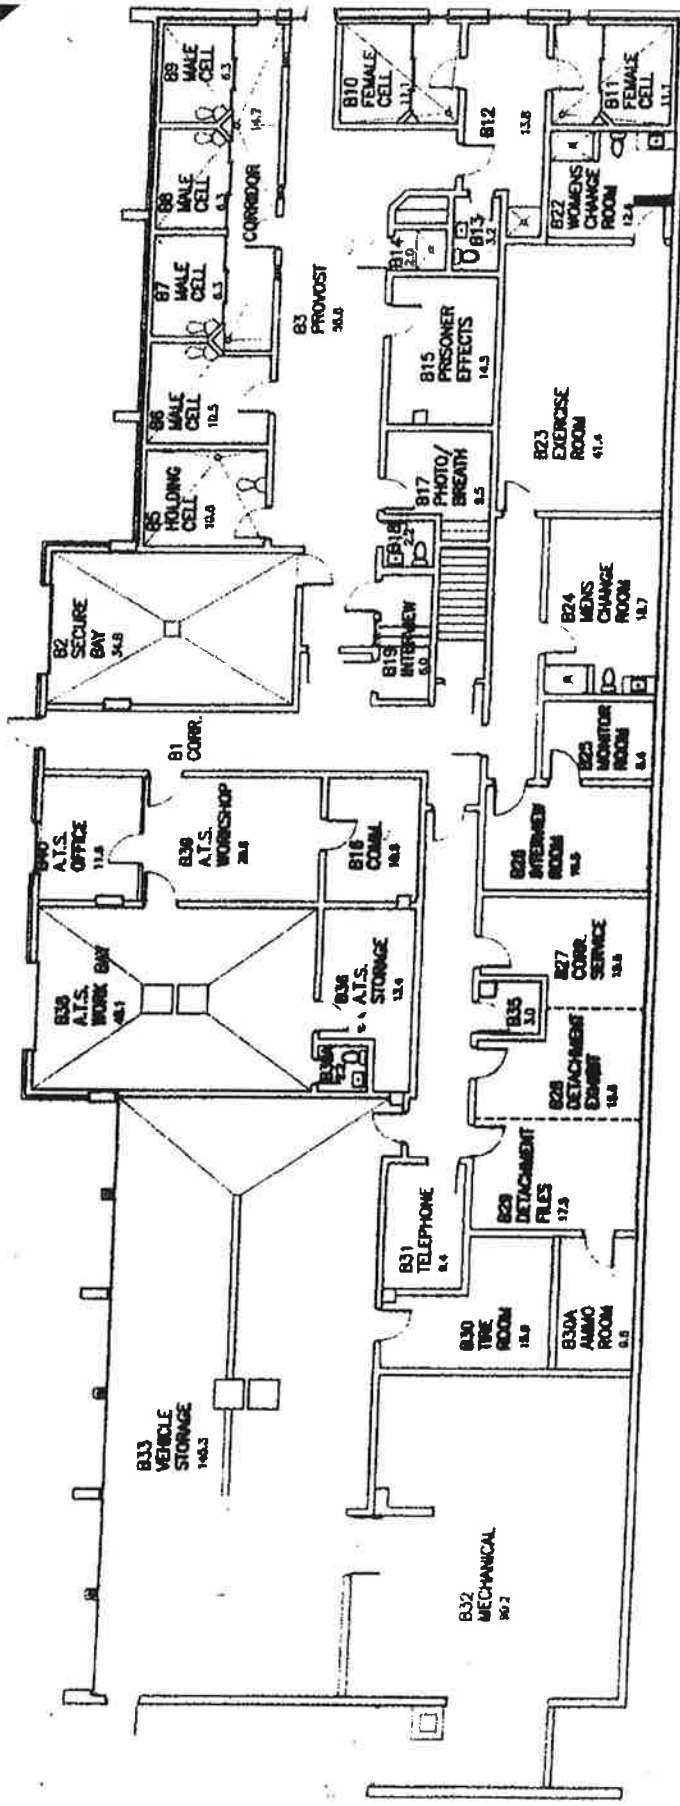
RCMP PRINCE ALBERT Basement - Existing

2. a) **Asbestos Sheet Floor Covering** - Vinyl asbestos sheet floor covering is present within rooms: B1, B22, B23, B24, B25, B26, B27, B28, B29, B30, B31, B36, B38A, B39, B40, Corridor adj. B24, Corridor adj. B35, Refer to bulk samples B12 and B22 (appendix I).

ASBESTOS SHEET FLOORING

PRIORITY:	THREE
CONDITION:	GOOD
POTENTIAL FOR DISTURBANCE:	LOW
ACTION:	MANAGE

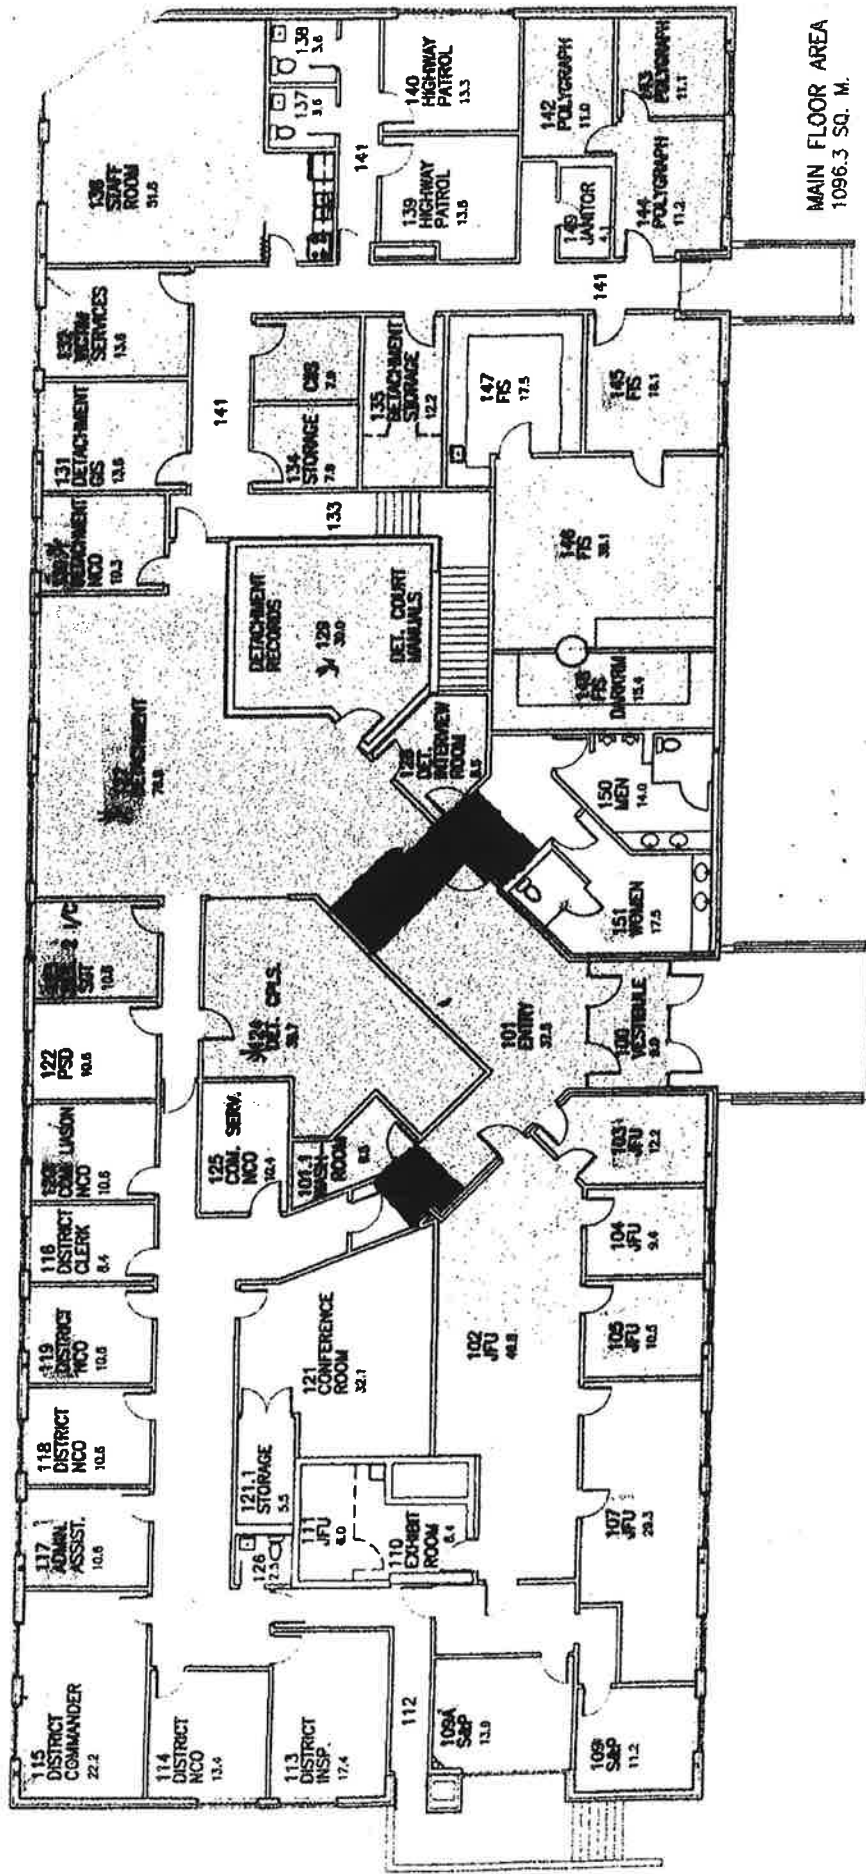
RCMP PRINCE ALBERT Main Floor - Existing

3. **Asbestos Sheet Flooring** – Vinyl sheet floor covering was identified as ACM. The sheet flooring exists within rooms 110, 111, 126, 133 stairway landing, 136, 137, 138 and 147. The sheet floor covering is identified on the floor plan (appendix III). Refer to bulk sample B12 and B22 (appendix I).

ASBESTOS SHEET FLOORING

PRIORITY: THREE
CONDITION: GOOD
POTENTIAL FOR DISTURBANCE: LOW
ACTION: MANAGE

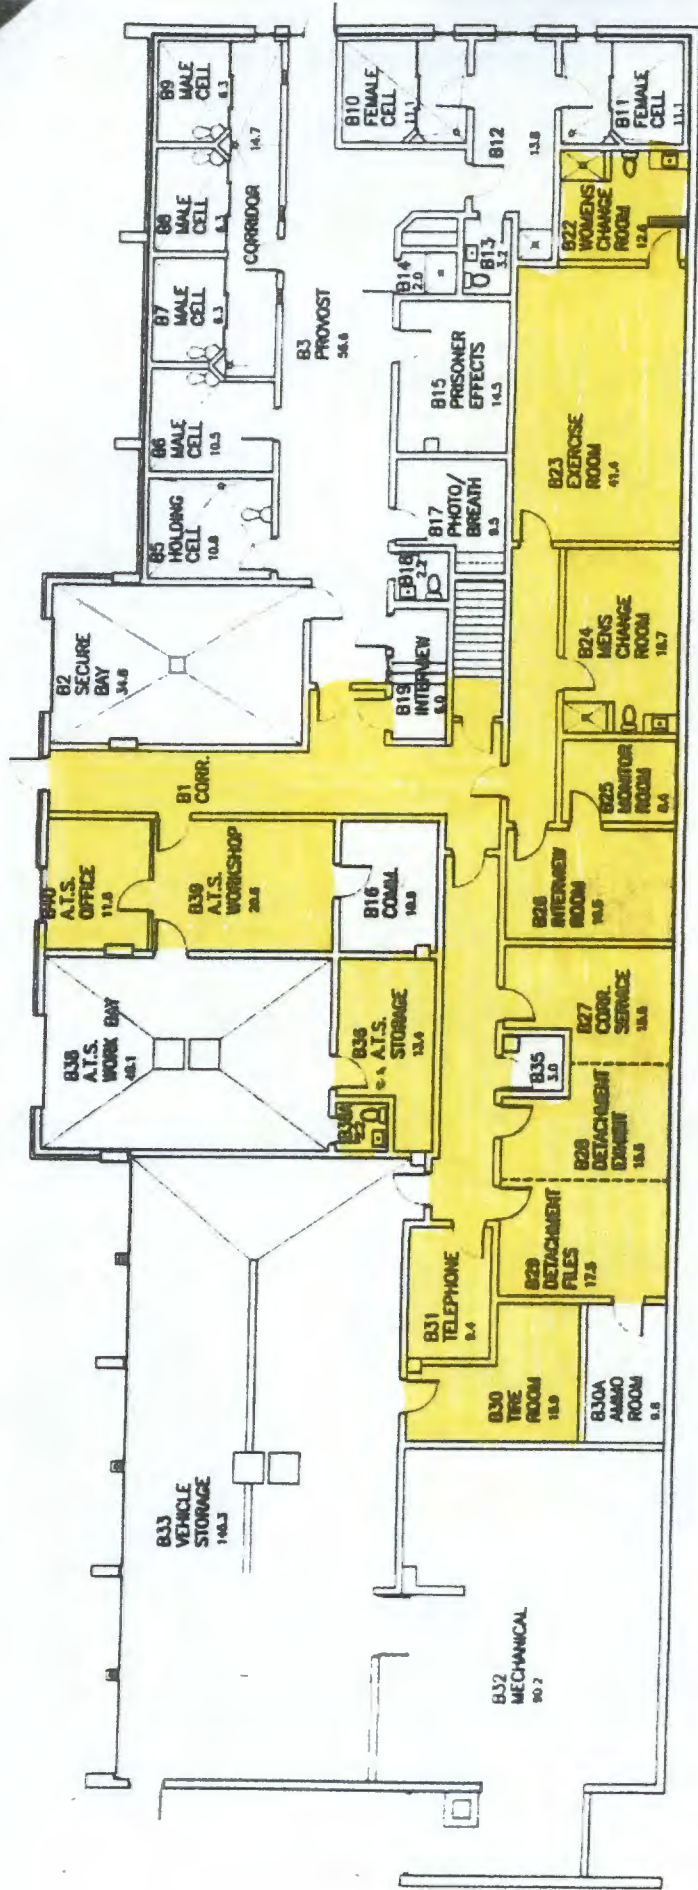
RCMP PRINCE ALBERT Basement - Existing

ASBESTOS SHEET FLOORING
