Title - Sujet Concrete Wharf Repairs	
Solicitation No. - N° de l'invitation F1700-150940/A	Amendment No. - N° modif. 001
Client Reference No. - N° de référence du client	Date 2016-02-02
GETS Reference No. - N° de référence de SEAG PW-\$PWY-019-7728	
File No. - N° de dossier PWY-5-38353 (019)	CCC No./N° CCC - FMS No./N° VME
Solicitation Closes - L'invitation prend fin at - à 02:00 PM on - le 2016-02-12	
F.O.B. - F.A.B. Plant-Usine: <input type="checkbox"/> Destination: <input checked="" type="checkbox"/> Other-Autre: <input type="checkbox"/>	
Address Enquiries to: - Adresser toutes questions à: Ngan, Ken (PWY)	Buyer Id - Id de l'acheteur pwy019
Telephone No. - N° de téléphone (604) 658-2755 ()	FAX No. - N° de FAX (604) 775-6633
Destination - of Goods, Services, and Construction: Destination - des biens, services et construction: DFO - Institute of Ocean Sciences Wharf - Patricia Bay, BC

**Re: Institute of Ocean Sciences Wharf Structure
Diving Inspection Report.**

An investigation has been completed to assess the present condition of the Main wharf located at the Institute of Ocean Sciences in Sidney, British Columbia. The investigation was performed February 2015 by Greg Ovstaas,

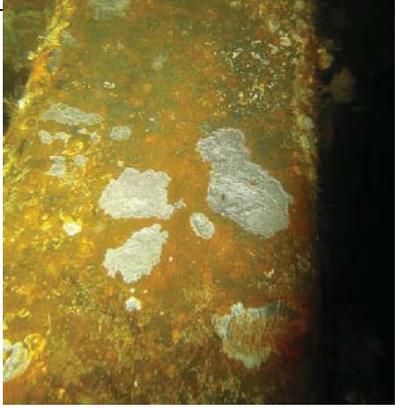
Bent No.	Octagonal Pile	Diagonal Brace	Tension Anchor	Column or Crib
3 Approach Pier	Concrete OK. No photo available	Galvanizing is consumed. Pitting depth is approx. 3 mm.

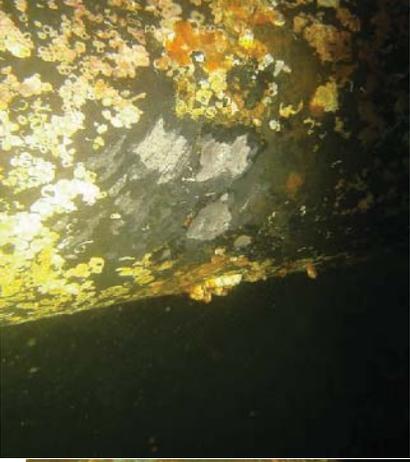
Coating has failed. Pitting is visible.

Based on the observations from this diving inspection, it is now also recommended that Bulk Anodes be installed on the various steel elements including the following.

- The tension anchors
- The Fender bracing,
- The camels
- The camel piles

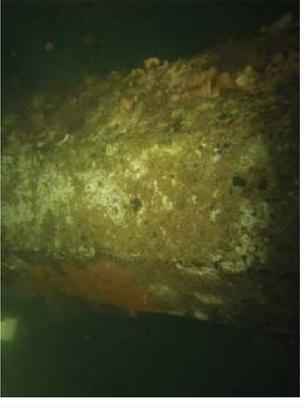
Minimal spalling at base. No photo available.
6 Approach pier	Concrete OK

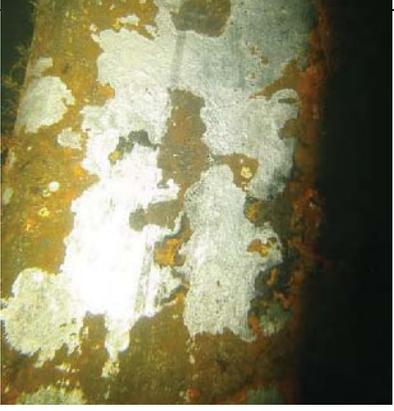
Possible Exposed steel

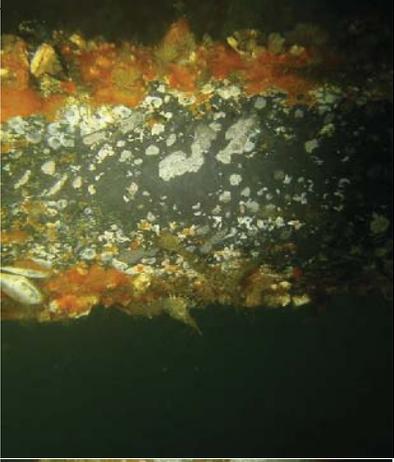
Coating is damaged

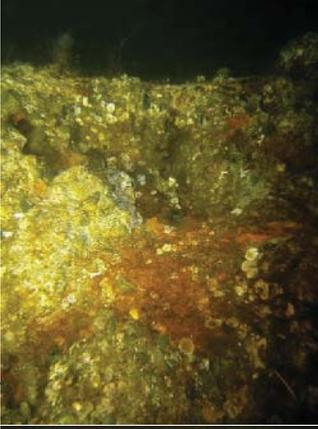
Spalling at SW corner 75 to 100 mm deep.

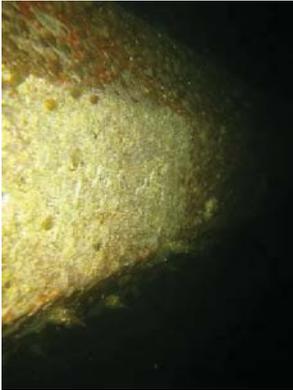
<p>9 Approach Pier</p>	<p>Concrete OK. Some surface damage at 5 m above mudline</p>

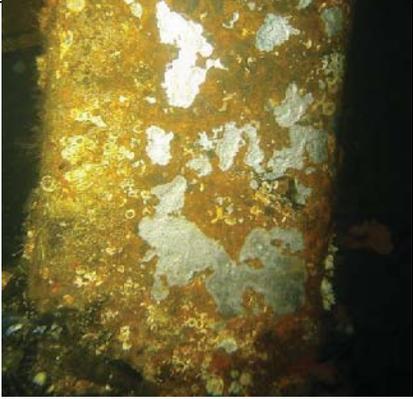
<p>Surface Pitting ~ 3 mm deep</p>

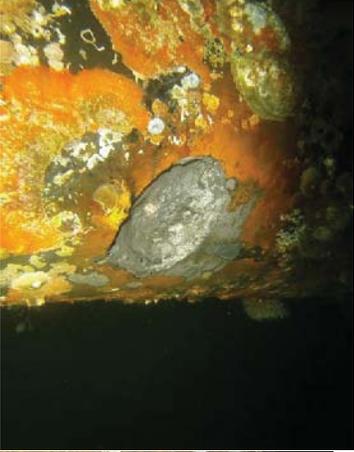
1. The coating on the tension anchors is failing and corrosion pitting has commenced. Typically the pitting appears to be a maximum of 3 mm. The large pit observed on the anchor at Bent 9 is likely the result of physical damage since it is unlikely that corrosion could progress that rapidly.

<p>Large Pit near base of anchor ~ 10 mm deep x 80 mm wide The Pit may be the result of physical damage.</p>

These are rough costs only. The bulk anode system must be designed by an experienced designer and accurate budgets determined. It is recommended that the cathodic protection of these steel elements be implemented sooner rather than later as corrosion has initiated and if no action is taken soon there may be physical damage that must be repaired. Currently, the only visible damage that requires repair is the hole in the tension anchor at Bent 9.

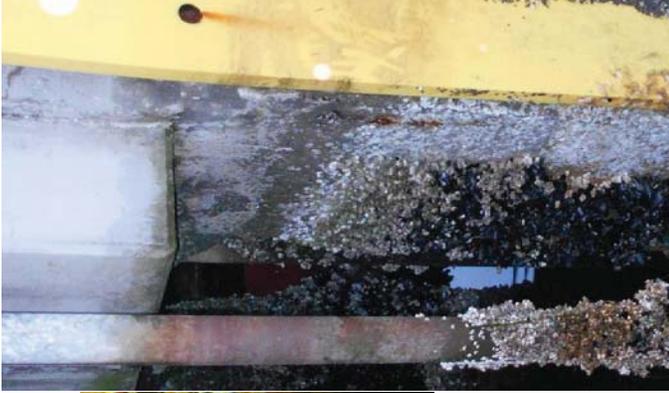
2. There is significant corrosion occurring on the camels - which is clearly visible above water. This suggests that the coating is failing at these locations and requires remedial action be implemented both on the camels and on the piles to which some are attached.

<p>Delamination in corner by UHMW panel above water. Note also the corrosion that has initiated in the Camel Locator Pole.</p>

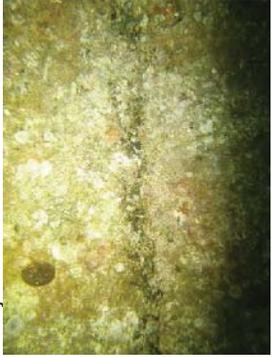
<p>12 to 13 crib Pier 1</p>	<p>NA</p>	<p>NA</p>	<p>NA</p>	<p>Concrete OK – Old form tie holes and cold joint visible.</p>

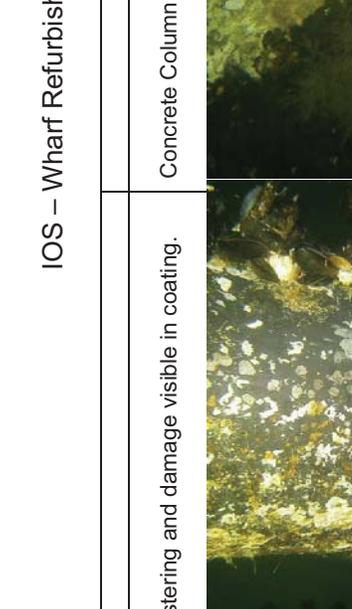
<p>Concrete Column condition OK.</p>

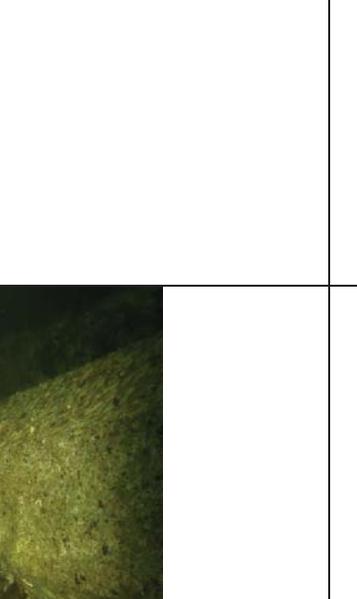
<p>Not Present at this Bent</p>	<p>Severe damage to coating and visible pitting in steel. Note also erosion on surface of octagonal pile</p>

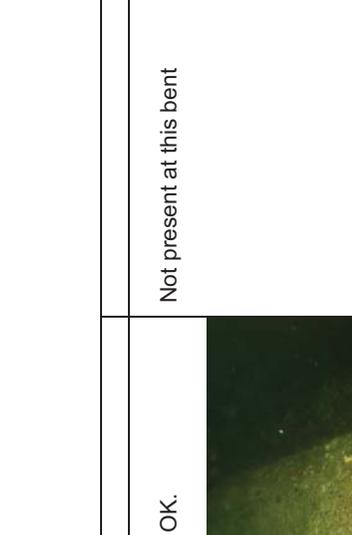
<p>Corrosion staining and erosion on concrete surface.</p>

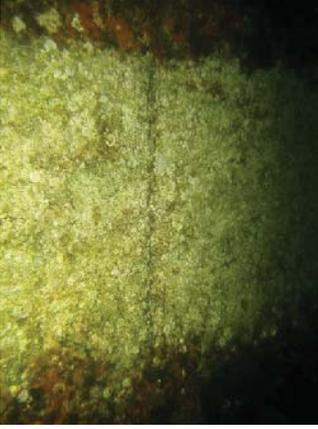
<p>24 to 25 crib</p>	<p>NA</p>	<p>NA</p>	<p>NA</p>	<p>Concrete Condition OK – minor bug holes.</p>

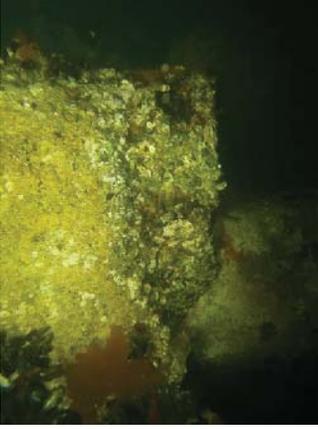
<p>C Cross pier</p>	<p>Concrete Condition OK</p>

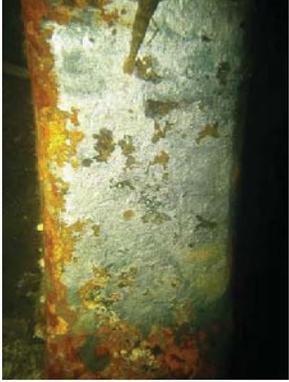
<p>Galvanizing appears to be consumed and pitting visible.</p>

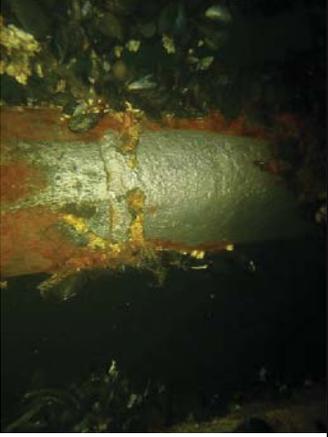
<p>Significant coating damage. Visible pitting.</p>

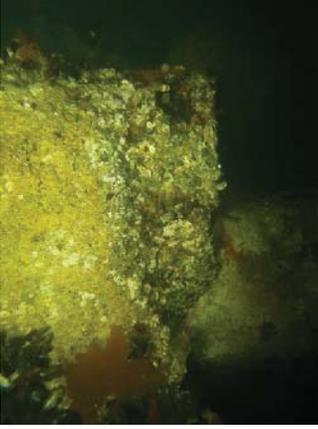
<p>Concrete damage at base.</p>
<p>E Cross pier</p>	<p>Concrete Condition OK.</p>

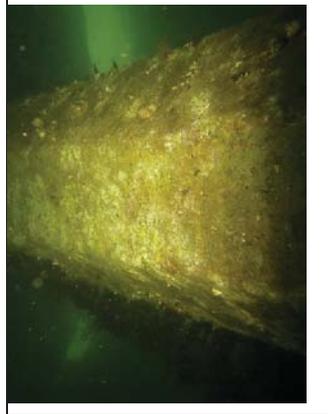
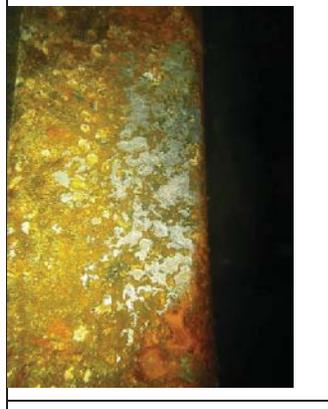
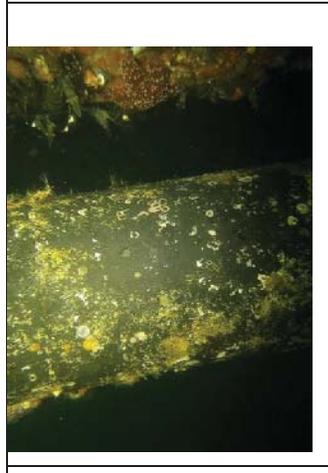
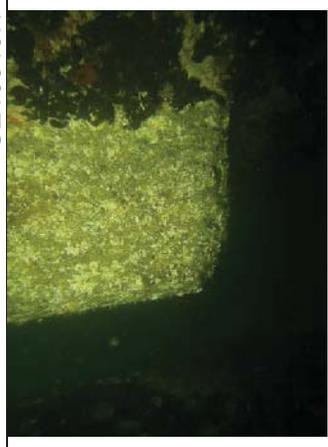
<p>Galvanizing appears consumed. Some surface pitting.</p>	<p>Coating condition reasonable, but some bubbling. Visible.</p>	<p>Concrete Condition OK but some erosion at edges.</p>

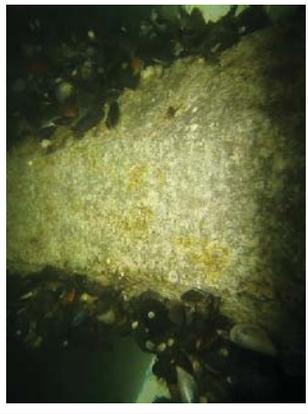
<p>12 to 13 inshore crib Pier 2</p>	<p>NA</p>	<p>NA</p>	<p>NA</p>	<p>Form Tie Holes visible.</p>
<p>14 Pier 2</p>	<p>Concrete Condition OK</p>

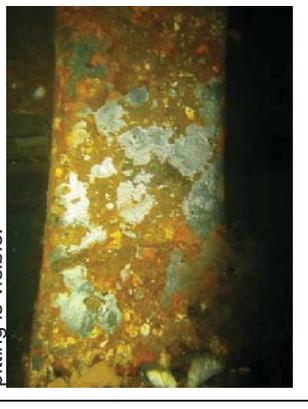
<p>Galvanizing appears consumed and pitting is visible.</p>

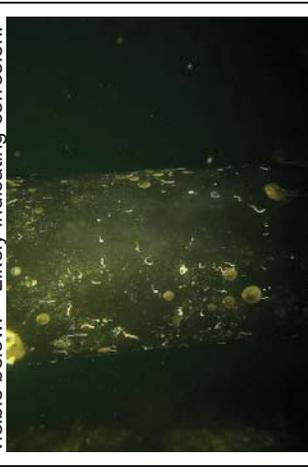
<p>Coating is still complete but bubbling visible below. – Likely indicating corrosion.</p>

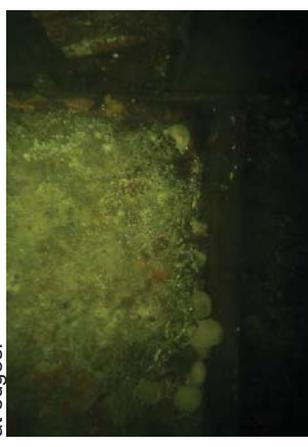
<p>Concrete condition OK but some erosion at edges.</p>

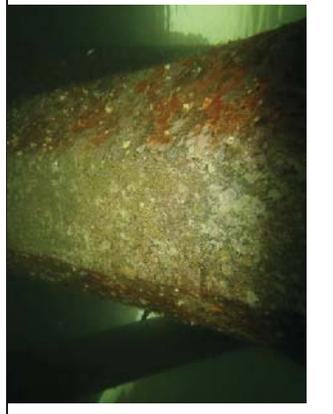
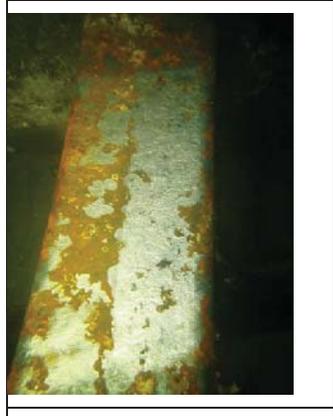
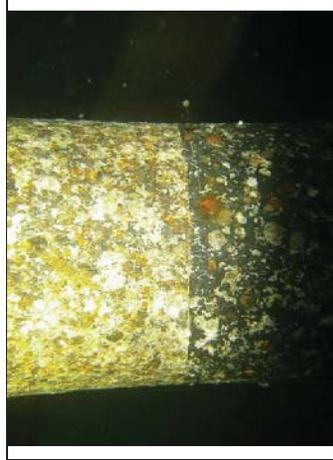
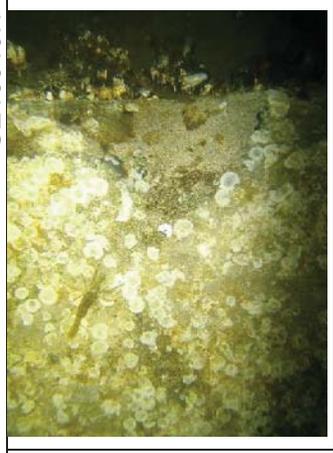
<p>20 Pier 2</p>	<p>Concrete Condition OK.</p>	<p>Galvanizing appears consumed. Pitting visible.</p>	<p>Pipe only appears to be partially coated and coating is damaged.</p>	<p>Some damage to column corner. Old repair is visible.</p>

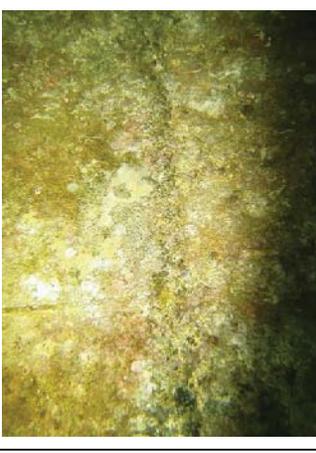
<p>21 to 23 Crib Pier 2</p>	<p>NA</p>	<p>NA</p>	<p>NA</p>	<p>Concrete condition OK. Form tie holes visible. Minor erosion at cold joints.</p>
