Voyageur Pathway Leamy Creek Bridge Gatineau, QC

Final Design Study Report

Date: 2013-12-16
O/Ref.: P-0001957

Re: Leamy Creek Bridge Diving Inspection

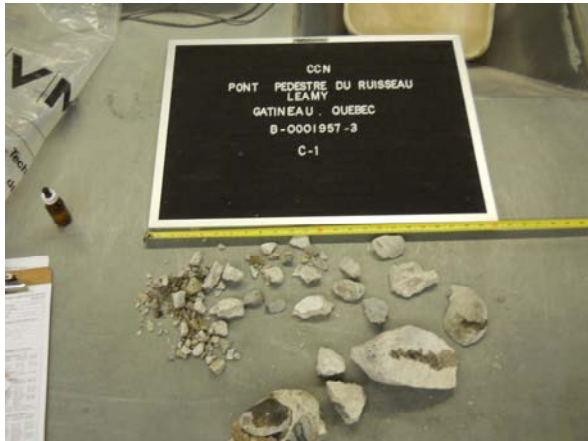
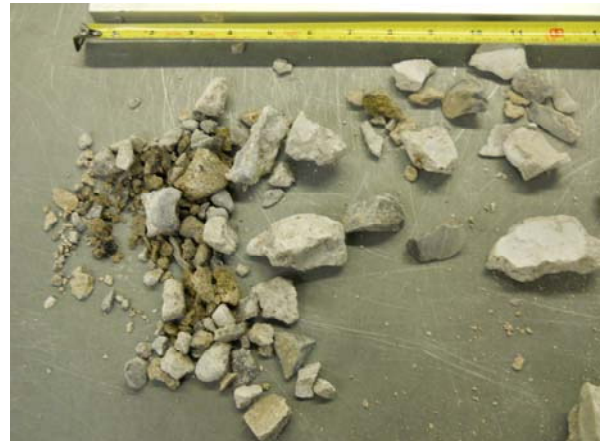
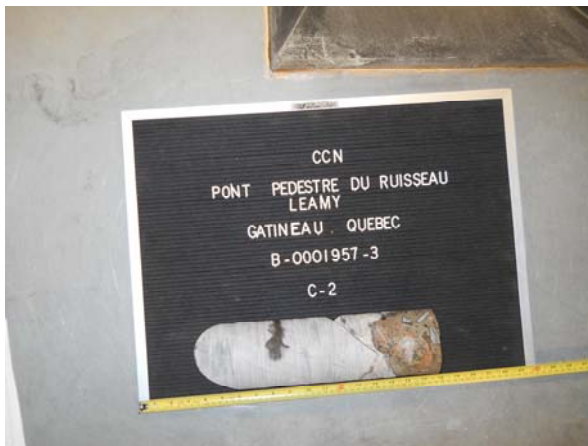
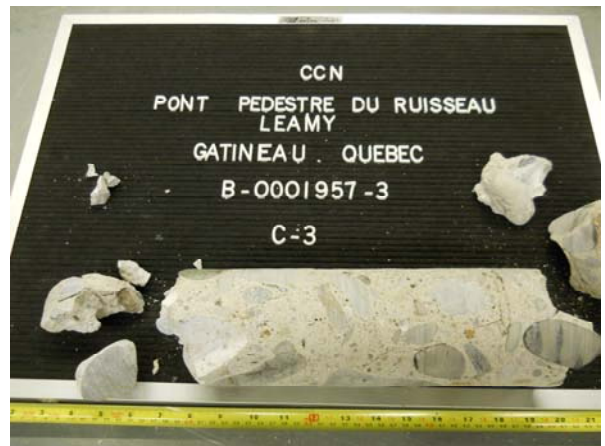
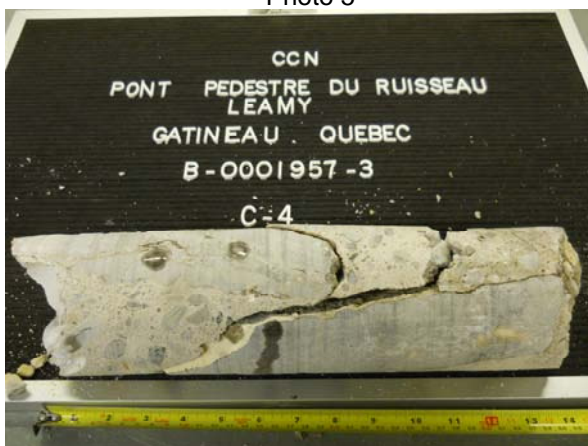
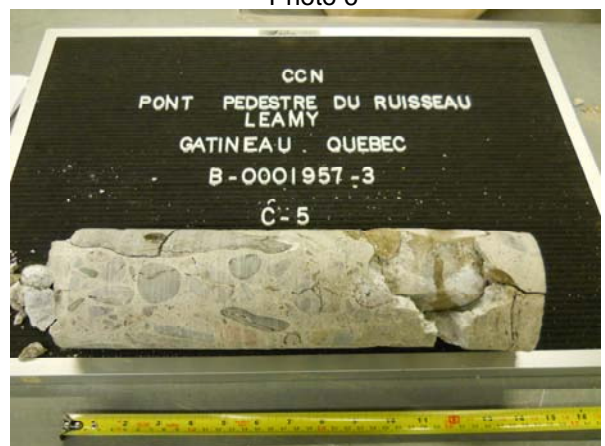
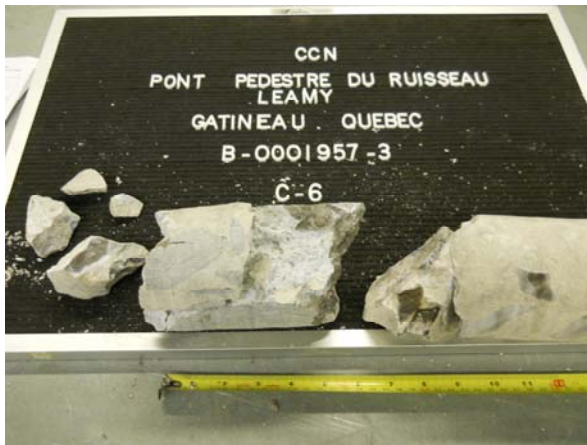
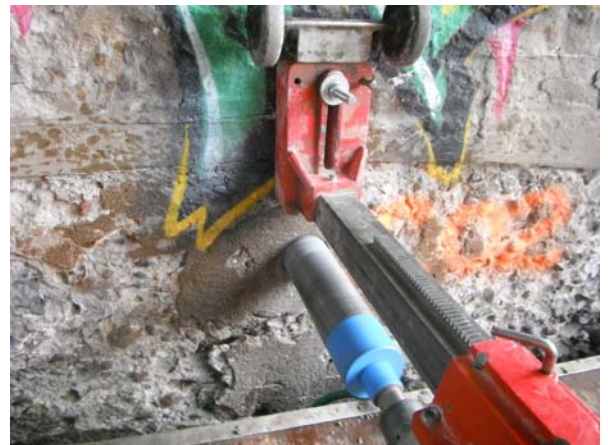
The work confirmed that the concrete was in extremely poor condition. Six concrete samples were taken from the piers and, of those six, only two were sufficiently sound to allow compression testing. The other four samples disintegrated during the core sampling. The granular material used in the formulation of the concrete was extremely coarse and did not appear to contain any reinforcing steel. Concrete defects akin to alkali-aggregate reaction were observed. The condition of the samples is shown in the photos below.

Analysis of the concrete samples provided an assessment of the advanced state of concrete deterioration. On the underside of the piers, the aggregate is very coarse and we noted a lack of adhesion between the grout mix and the aggregate. Of the six concrete samples taken, only two could be used for compression testing, as the others were too heavily damaged to withstand this type of test. On the upper part of the pier, the concrete appeared to be in better condition. The footings were also in a very advanced state of disrepair. During the underwater investigations, large pieces broke off from the concrete mass. The compression strength levels obtained for the two samples tested were extremely variable. We obtained 20 MPa for one sample and 48.4 MPa for the other. As for the foundation footings, the concrete is heavily damaged.

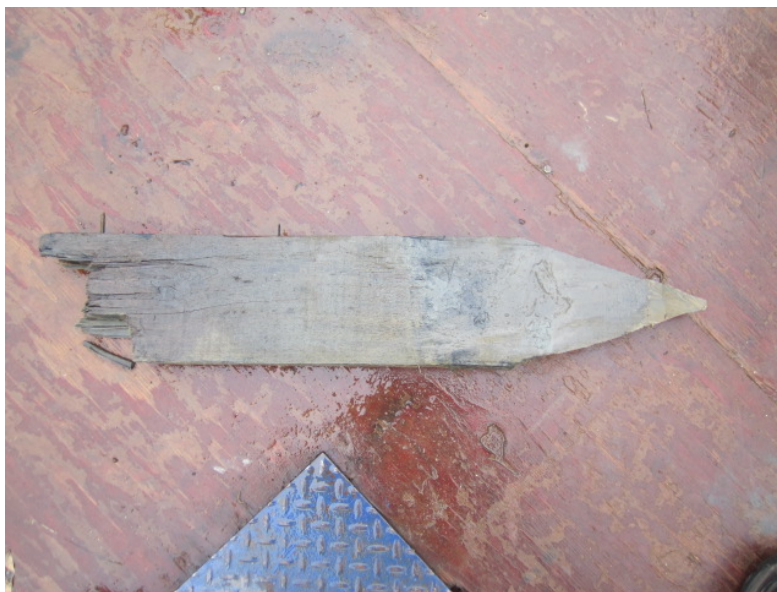
Vertical form work

The material being excavated next to the footing was a mix of rock, concrete, mud and wood debris. The divers used water jets to help move the material away to create a large enough hole to reach the base of the footing. The base of the footing was located and the current height of the footing was 43". The footing from top to bottom was heavily deteriorated with no noticeable square edges. Form work from the original construction was removed at the face of the footing which allowed the diver to excavate further under the footing.

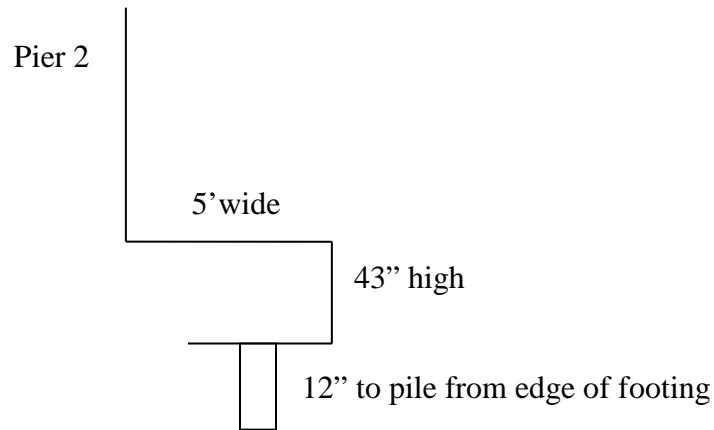
A pile was located under the footing approximately 12" from the face of the footing. The pile was a round wood pile measuring approximately 12" in diameter. We were unable to excavate a large enough hole to get any images of the pile but it was confirmed by the diver that the pile was firmly planted into the river bottom and the top had been poured into the footing of the pier. The diver also confirmed that we had reached the base of the footing by excavating 28" laterally under the footing.

Note: Drawing is not to scale and the current condition of the concrete is not square.

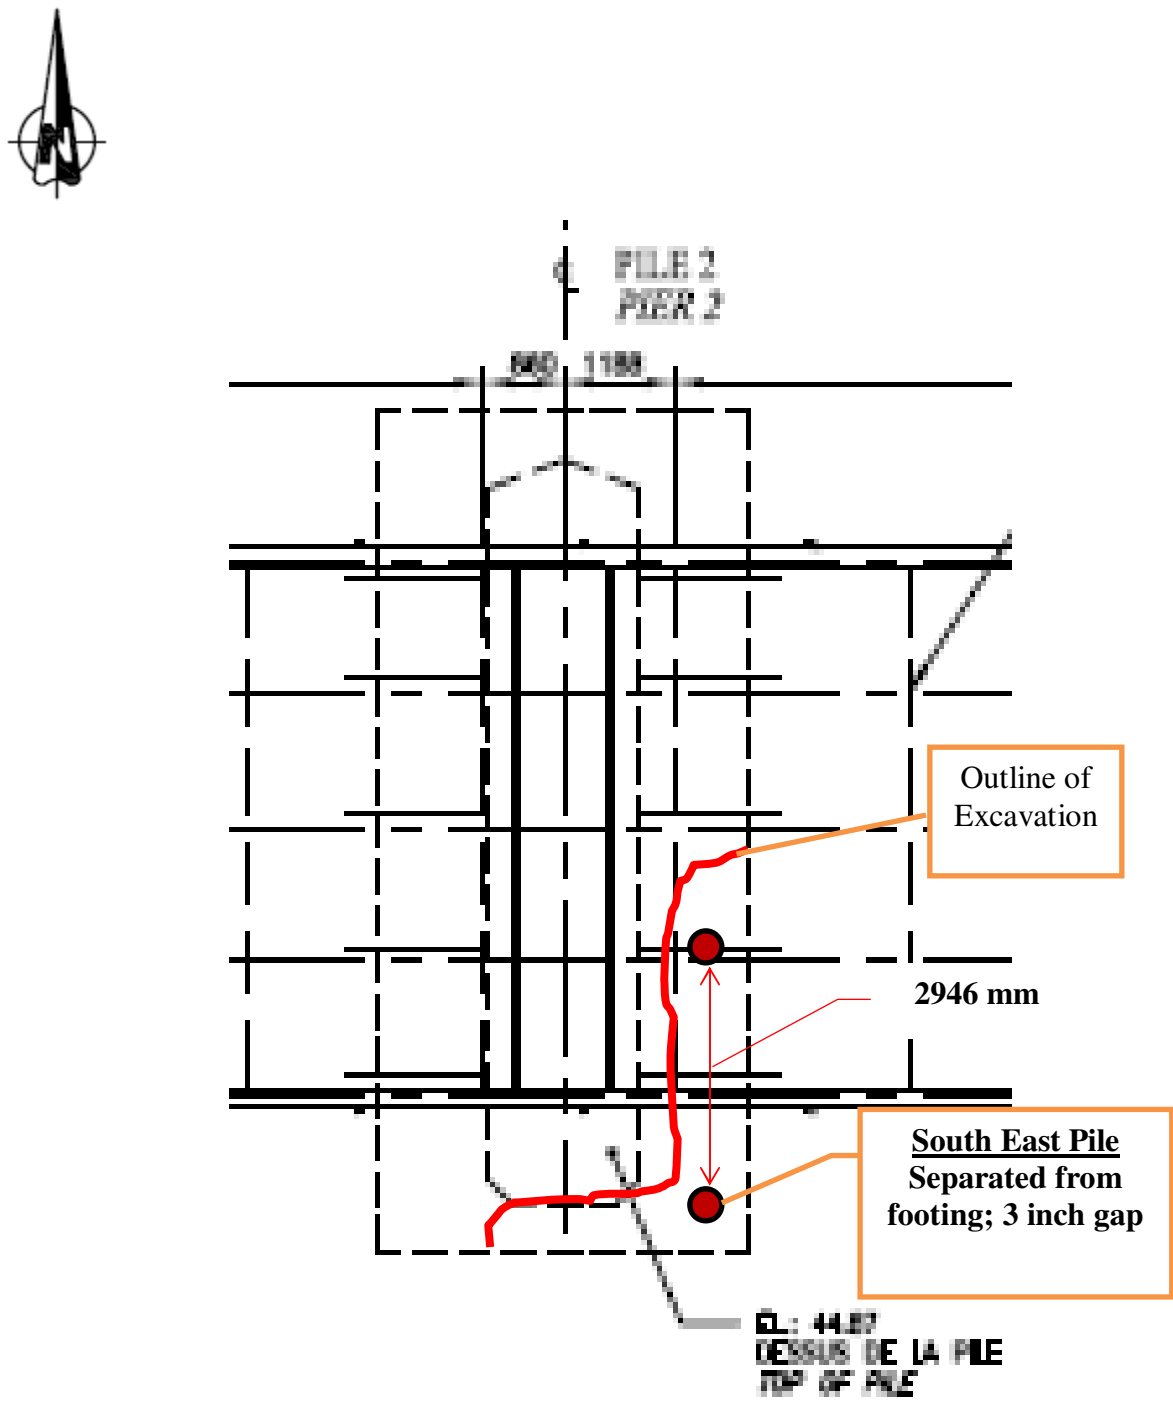
- Very severe disintegration of concrete
- No evidence of rebar
- Concrete was falling off footing during excavation with a noteworthy 24" x 24" x 6" section of the concrete face delaminated and fell off on the diver. The diver moved it aside and continued with the excavation.

- Severe concrete loss with no evidence of structural steel critically affecting the strength of the footing. An evaluation of the overall footing is required to determine the extent of strength reduction.

- 2 – 12 inch diameter vertical wooden piles were exposed under the footing on the east side of the pier
- Positioned approximately 116 inches apart with no evidence of piles located between.
- Sounding returns on the wood were excellent.
- Core sample of wood pile supplied to client.
- South east corner pile has 3 inch separation from footing; no bearing load on the pile in this location

Performance Deficiency – Load carrying capacity; Continuation of disintegration of concrete footing to pile interface.

Note: due to the conditions found any further investigation work to be conducted under footing will require shoring to ensure the safety of the diver.
