**APPENDIX A**  
**PHOTOGRAPHES**

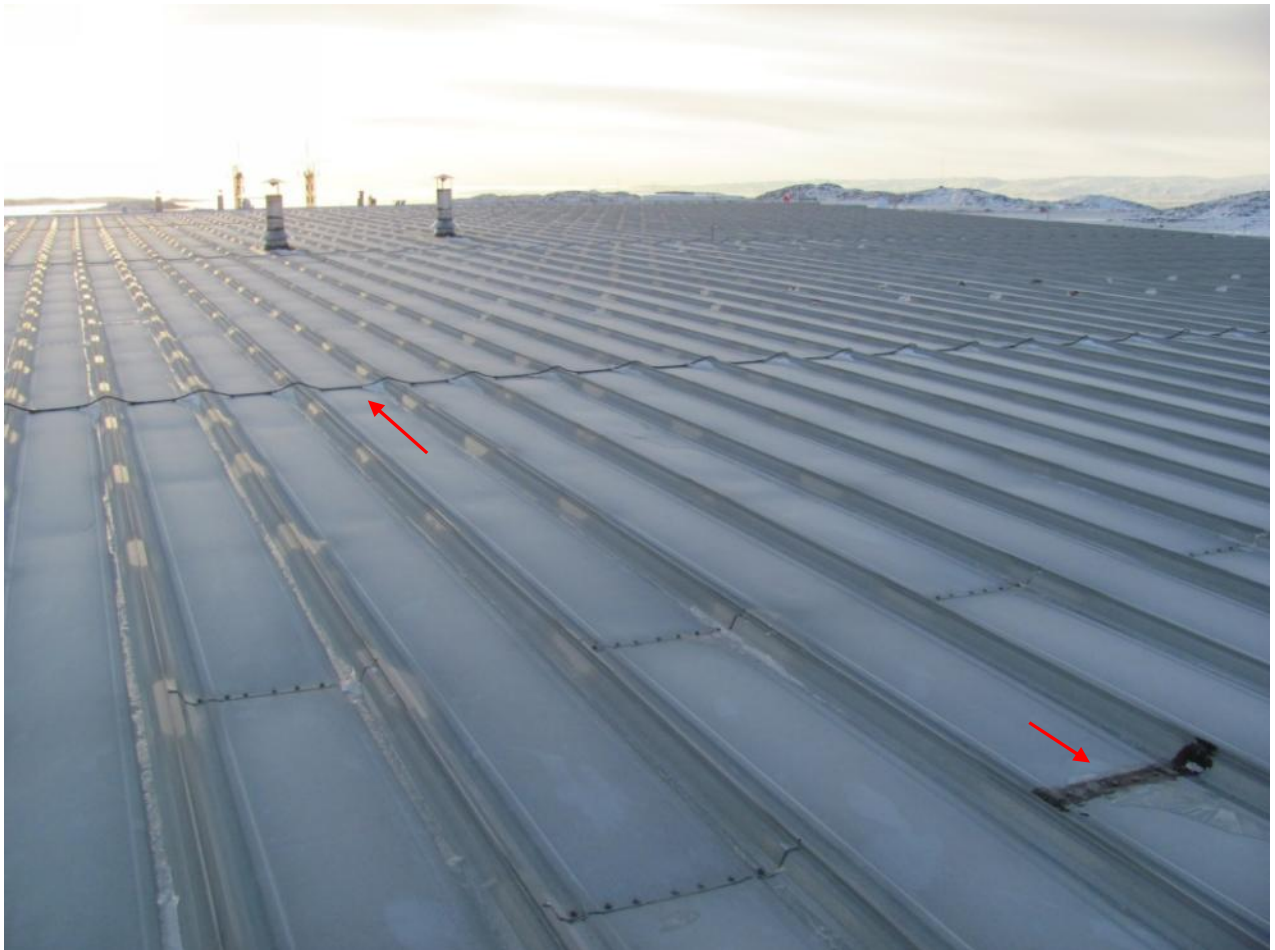
**Photo 2:** Typical view of the main roof deck, photograph taken from the mid-section of the roof deck with a view of the south half of the hanger roof assembly. Note the lighting arrest system that spans the length and width of the roof deck and the bitumen mastic.

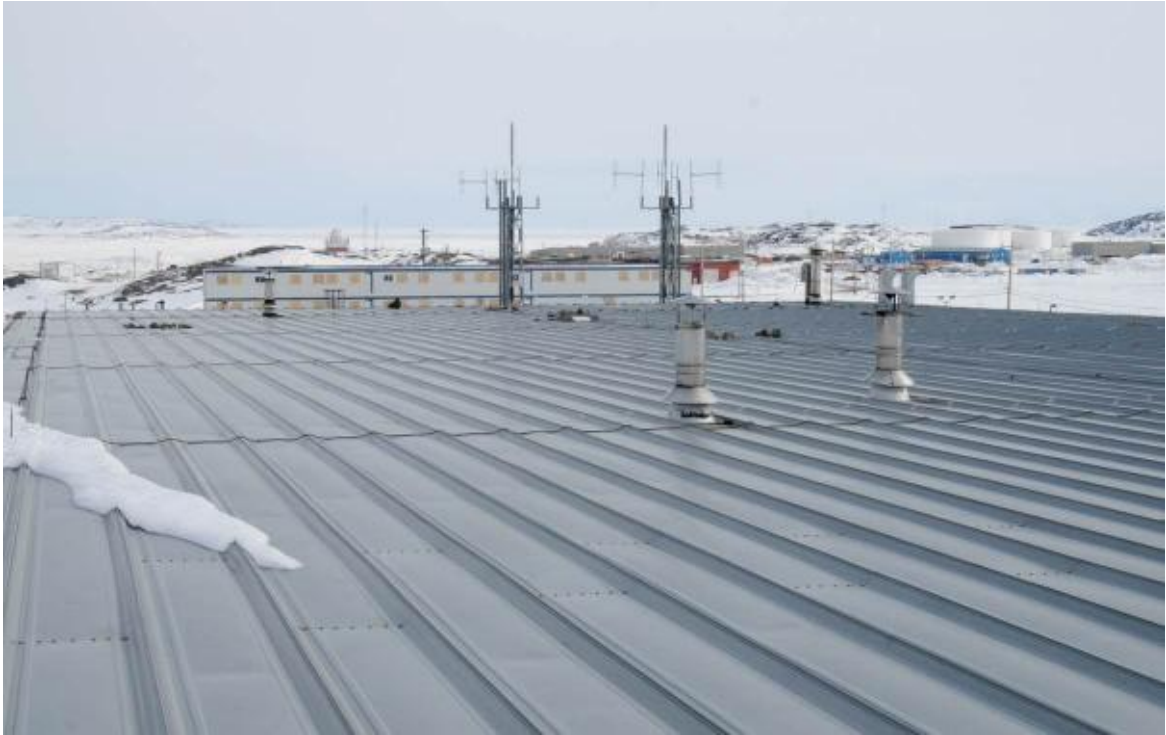
**Photo 3:** Photo of the south end of the roof deck.

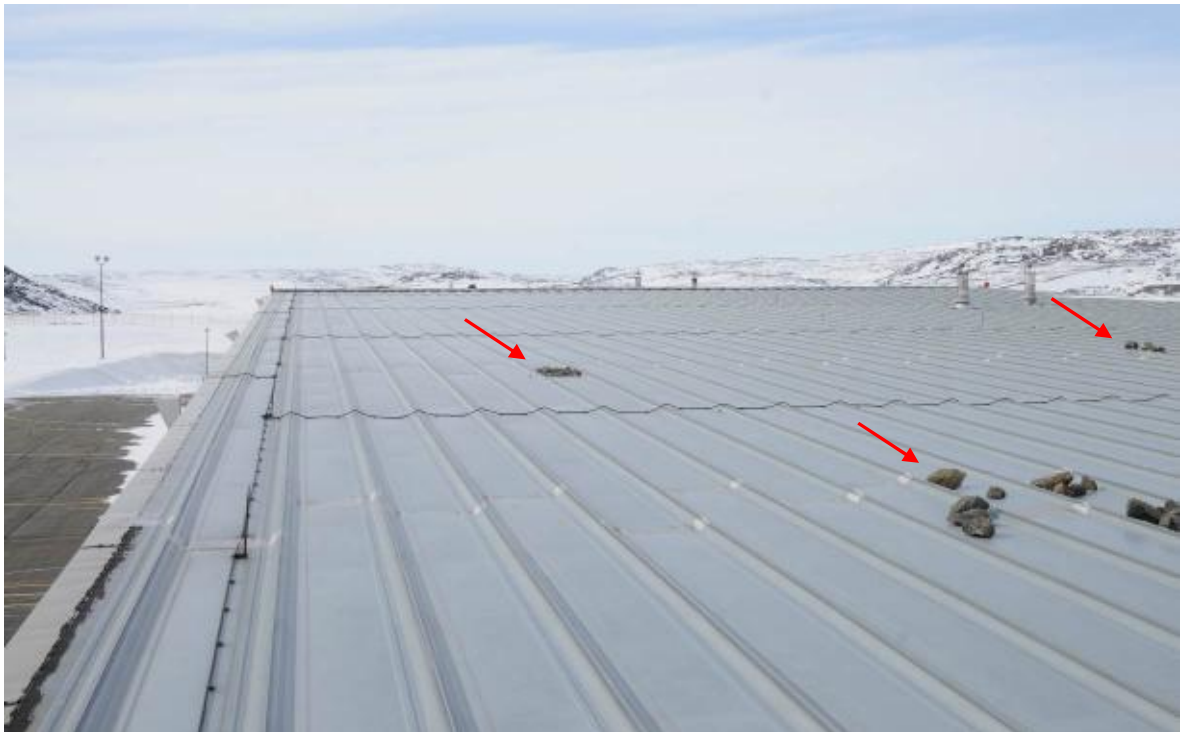
**Photo 4:** Photo of the north end of the roof deck, note the rock on the roof deck (to be removed).

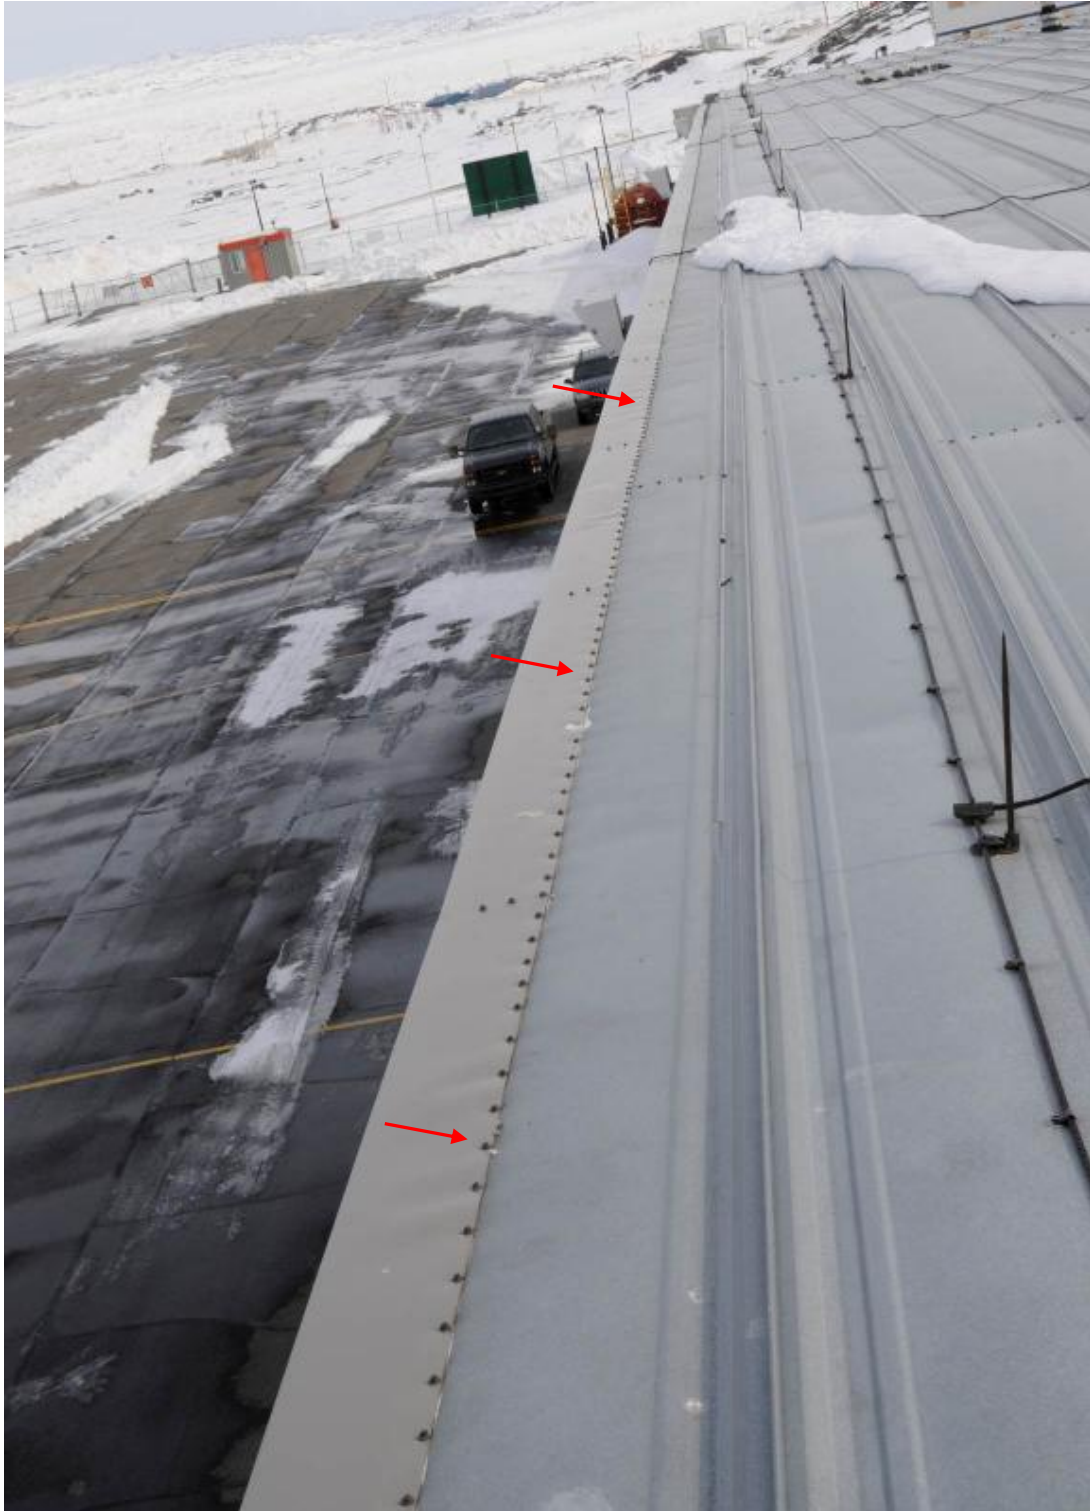
**Photo 5:** Photo at the eve of the roof deck along the east elevation of the building, viewing towards the south end of the roof deck. Joint between metal roof panel and sheet metal flashing to be repaired along the entire length of the east and west elevations.

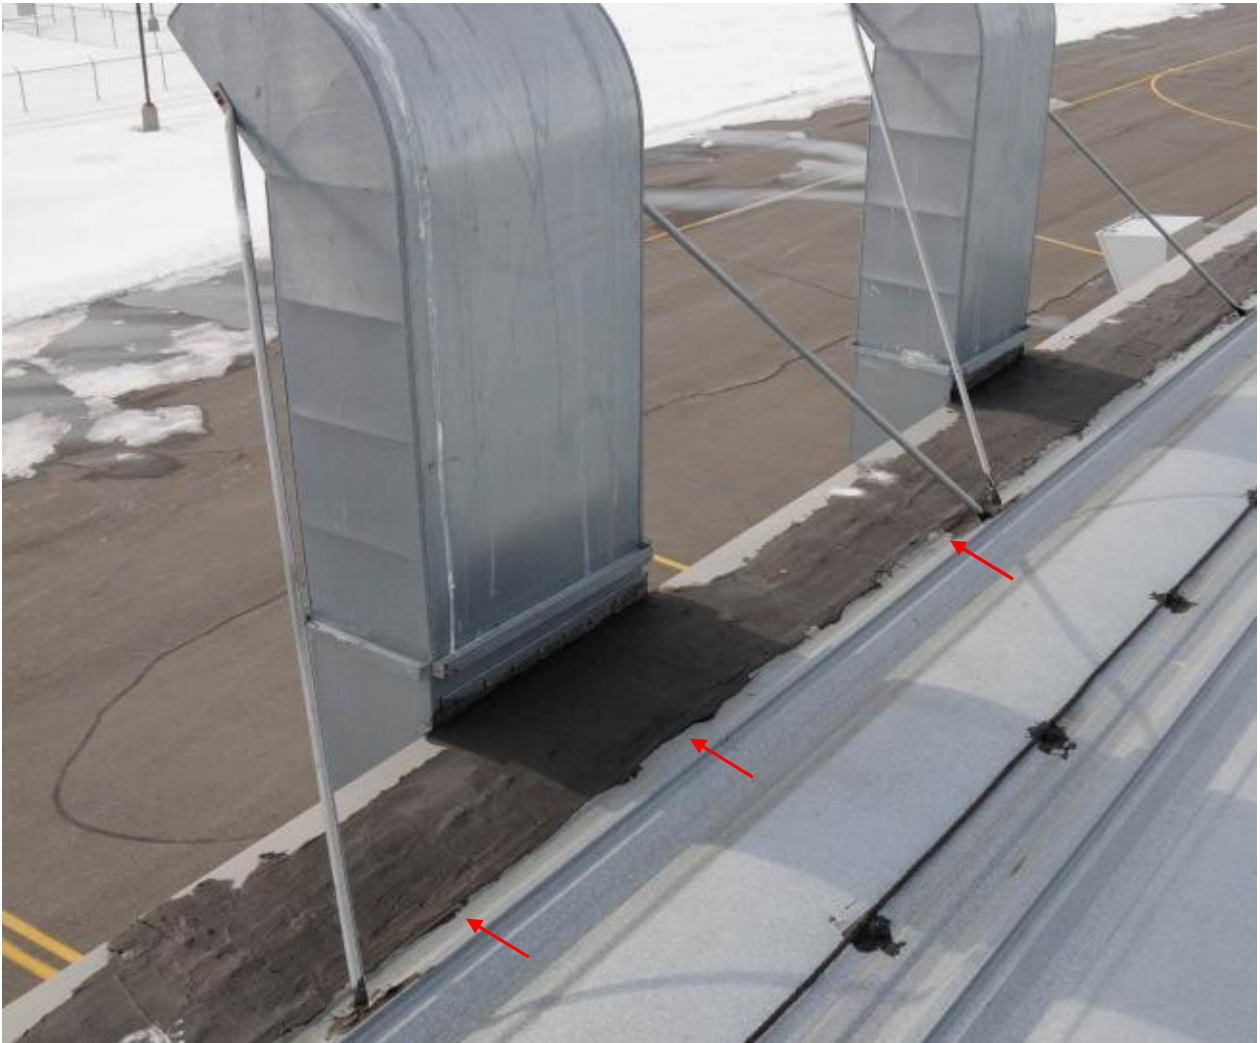
**Photo 6:** Typical asphalt mastic application at the interface between the sheet metal flashings along the eave of the roof system and metal roof panels on the east and west elevations. Photo taken along west elevation. All asphalt material to be removed prior to installation of new micro-sealant tape material along the joint between the metal pan and the sheet metal flashings along the east and west elevations.

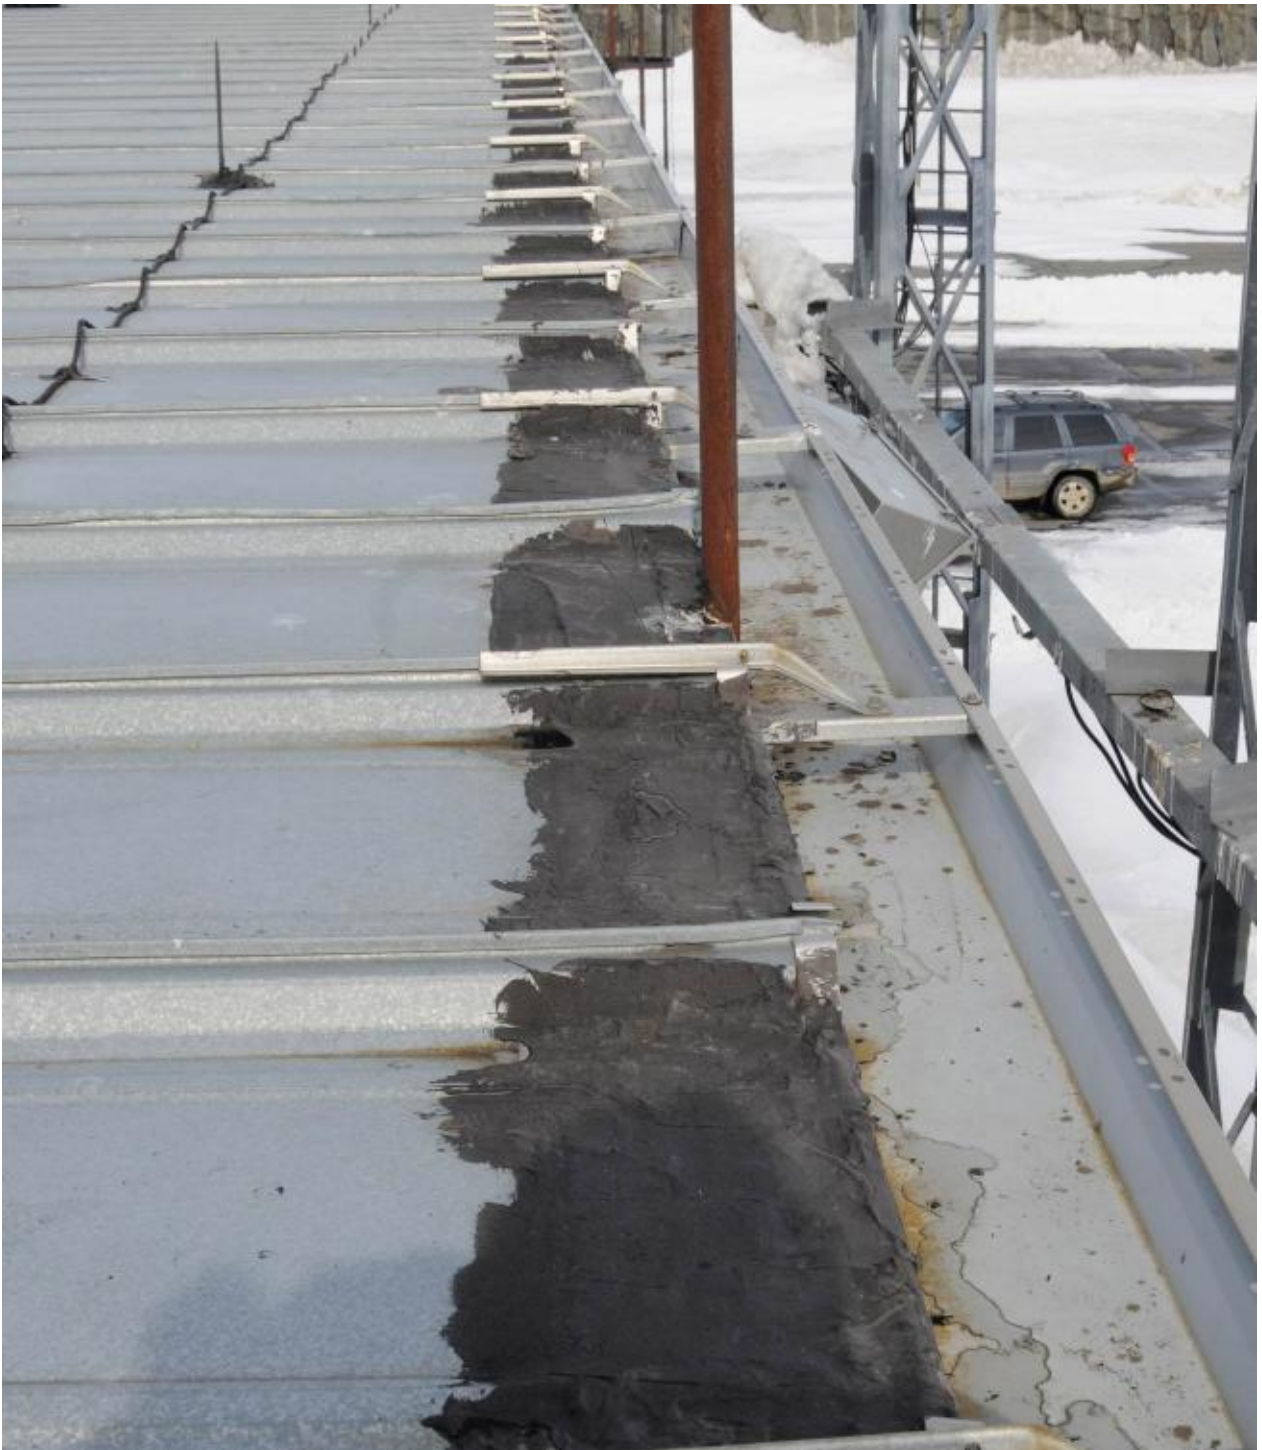
**Photo 7:** Typical asphalt mastic application at the interface between the sheet metal flashings along the eve of the roof system and metal roof panel on the north and south elevations. Photo taken at south elevation. All asphalt material to be removed prior to installation of new micro-sealant tape material

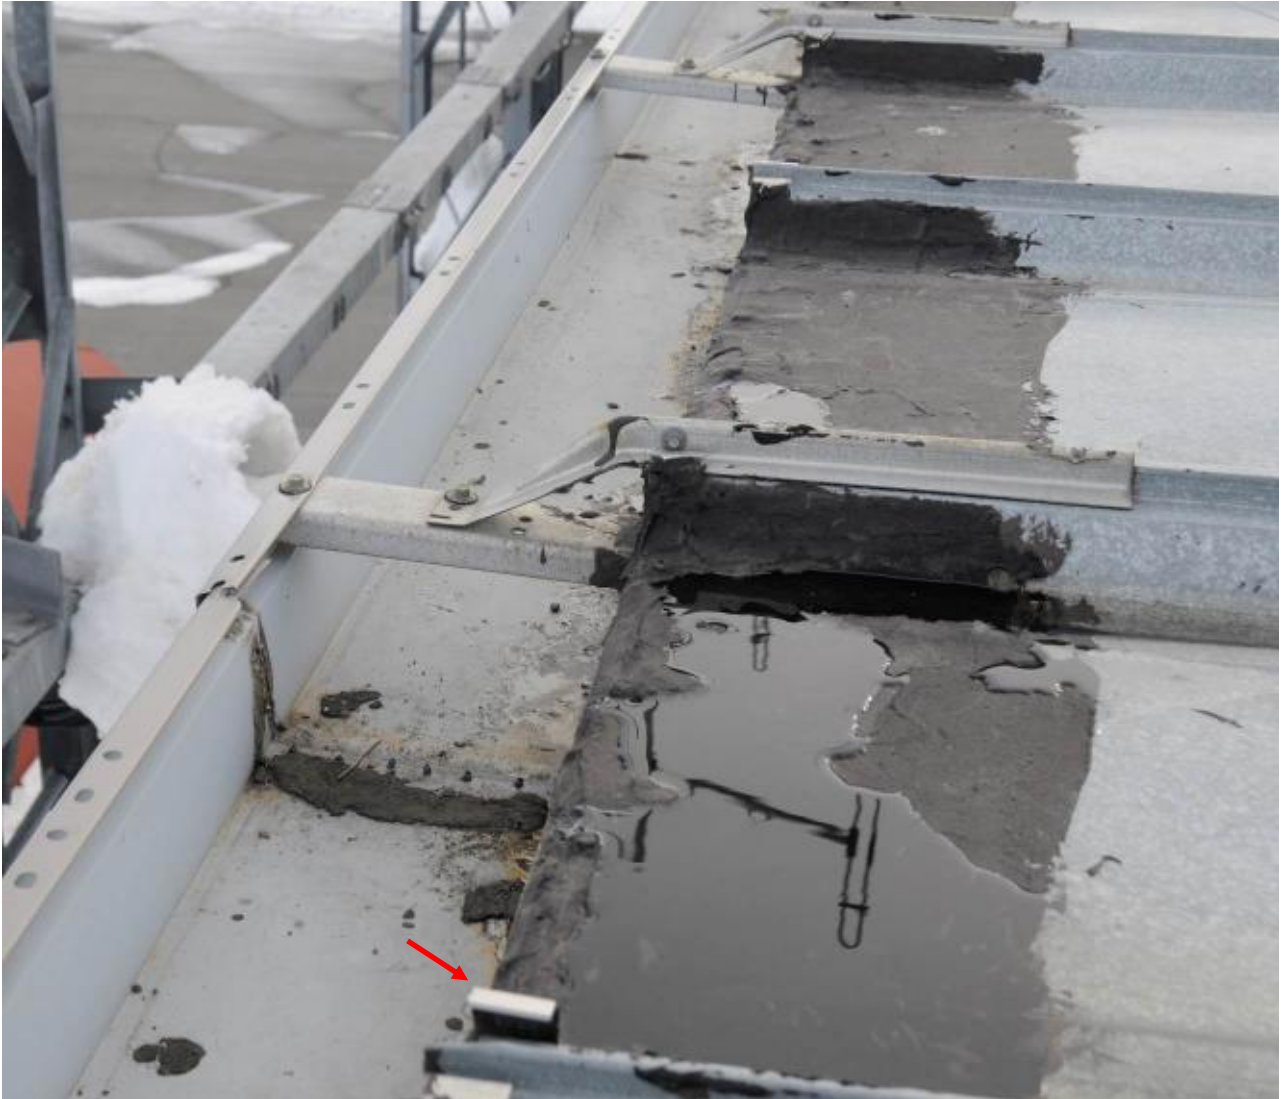
**Photo 8:** Typical end lap at the north / south elevations of the roof system. Note the installation of the rain gutter at these locations. All asphalt, metallic paint material and surface corrosion to be removed prior to installation of new material. Contractor to re-install existing rain gutter support brackets and end lap clamp where existing brackets and clamps are loose or dislodged.

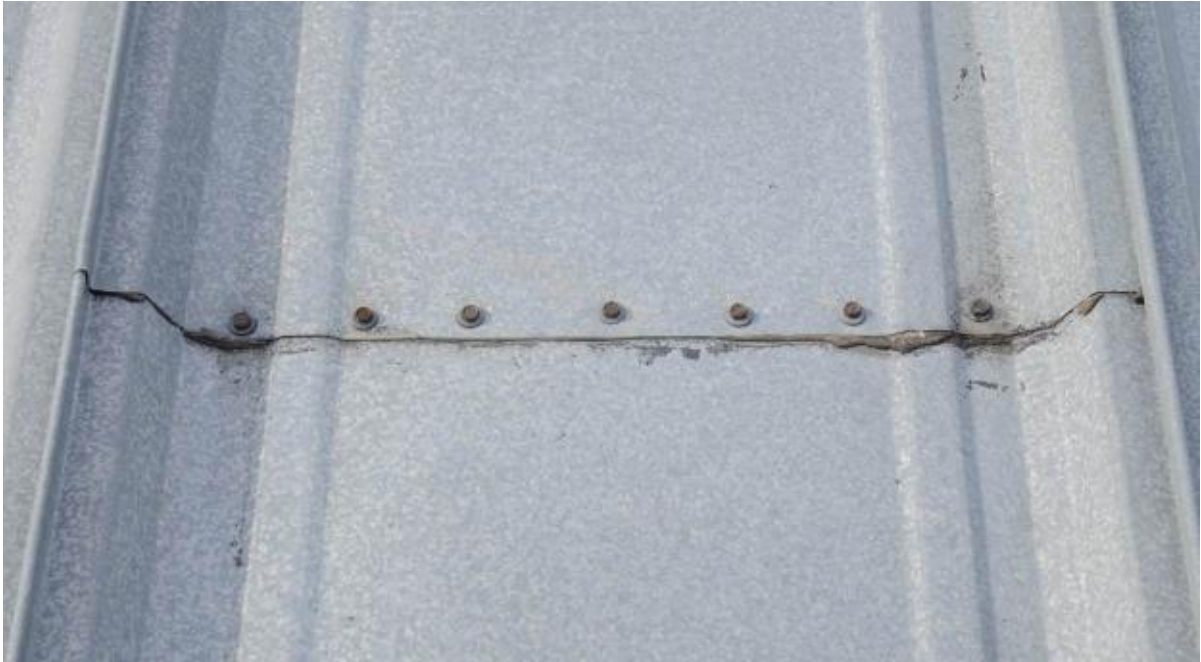
**Photo 9:** Typical head / end lap seam in the metal roof system.

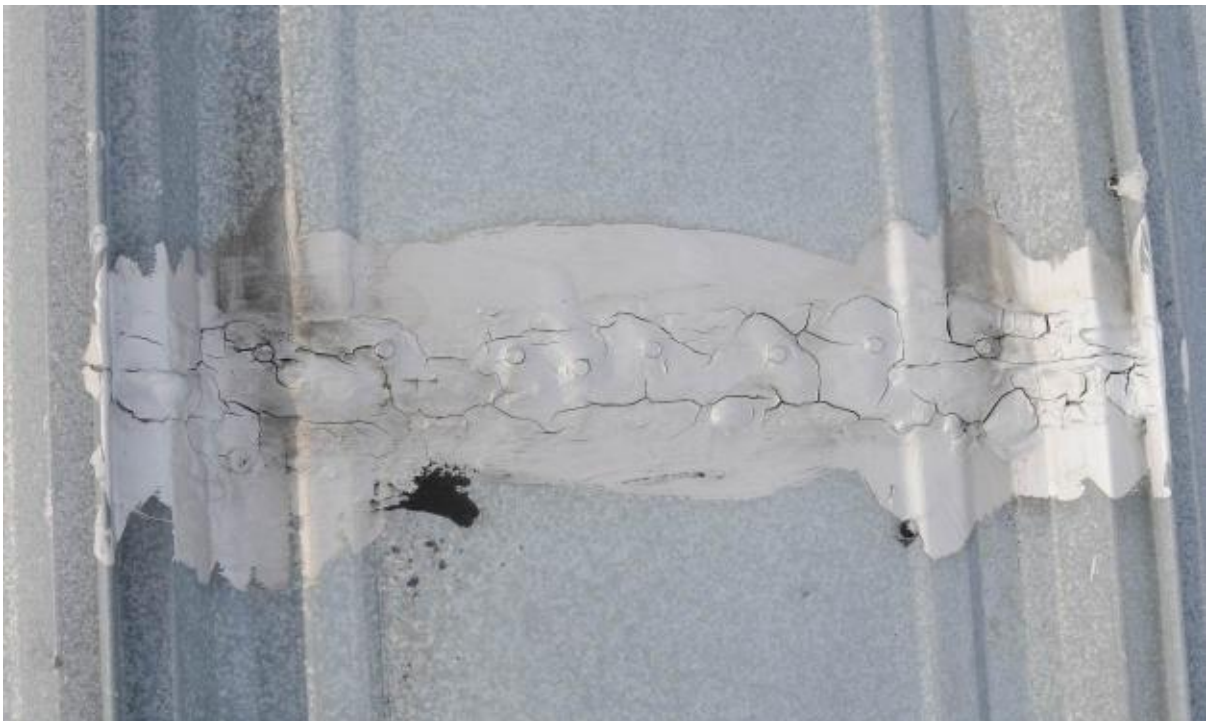
**Photo 10:** Typical metallic paint applied at the head / end laps between metal roof panels. All metallic paint (and asphalt) material to be removed prior to installation of new micro-sealant tape material

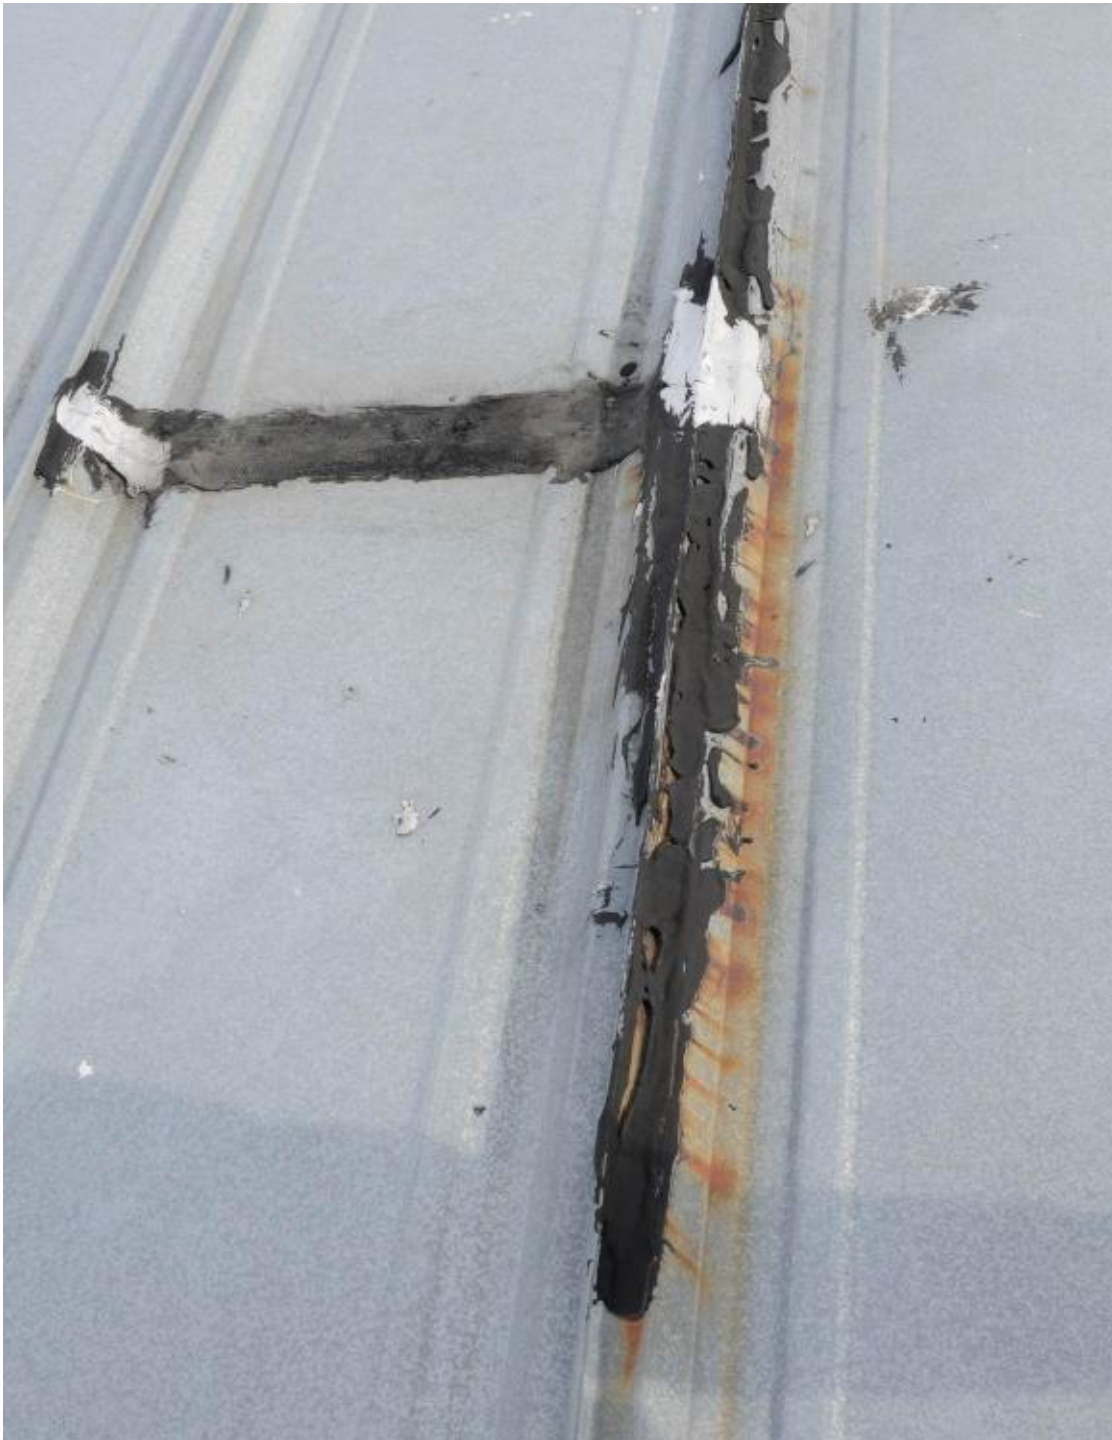
**Photo 11:** Typical metallic paint and asphalt mastic applied at the standing seam and head / end laps in the metal roof system. All asphalt, metallic paint material and surface corrosion to be removed prior to installation of new micro-sealant tape material

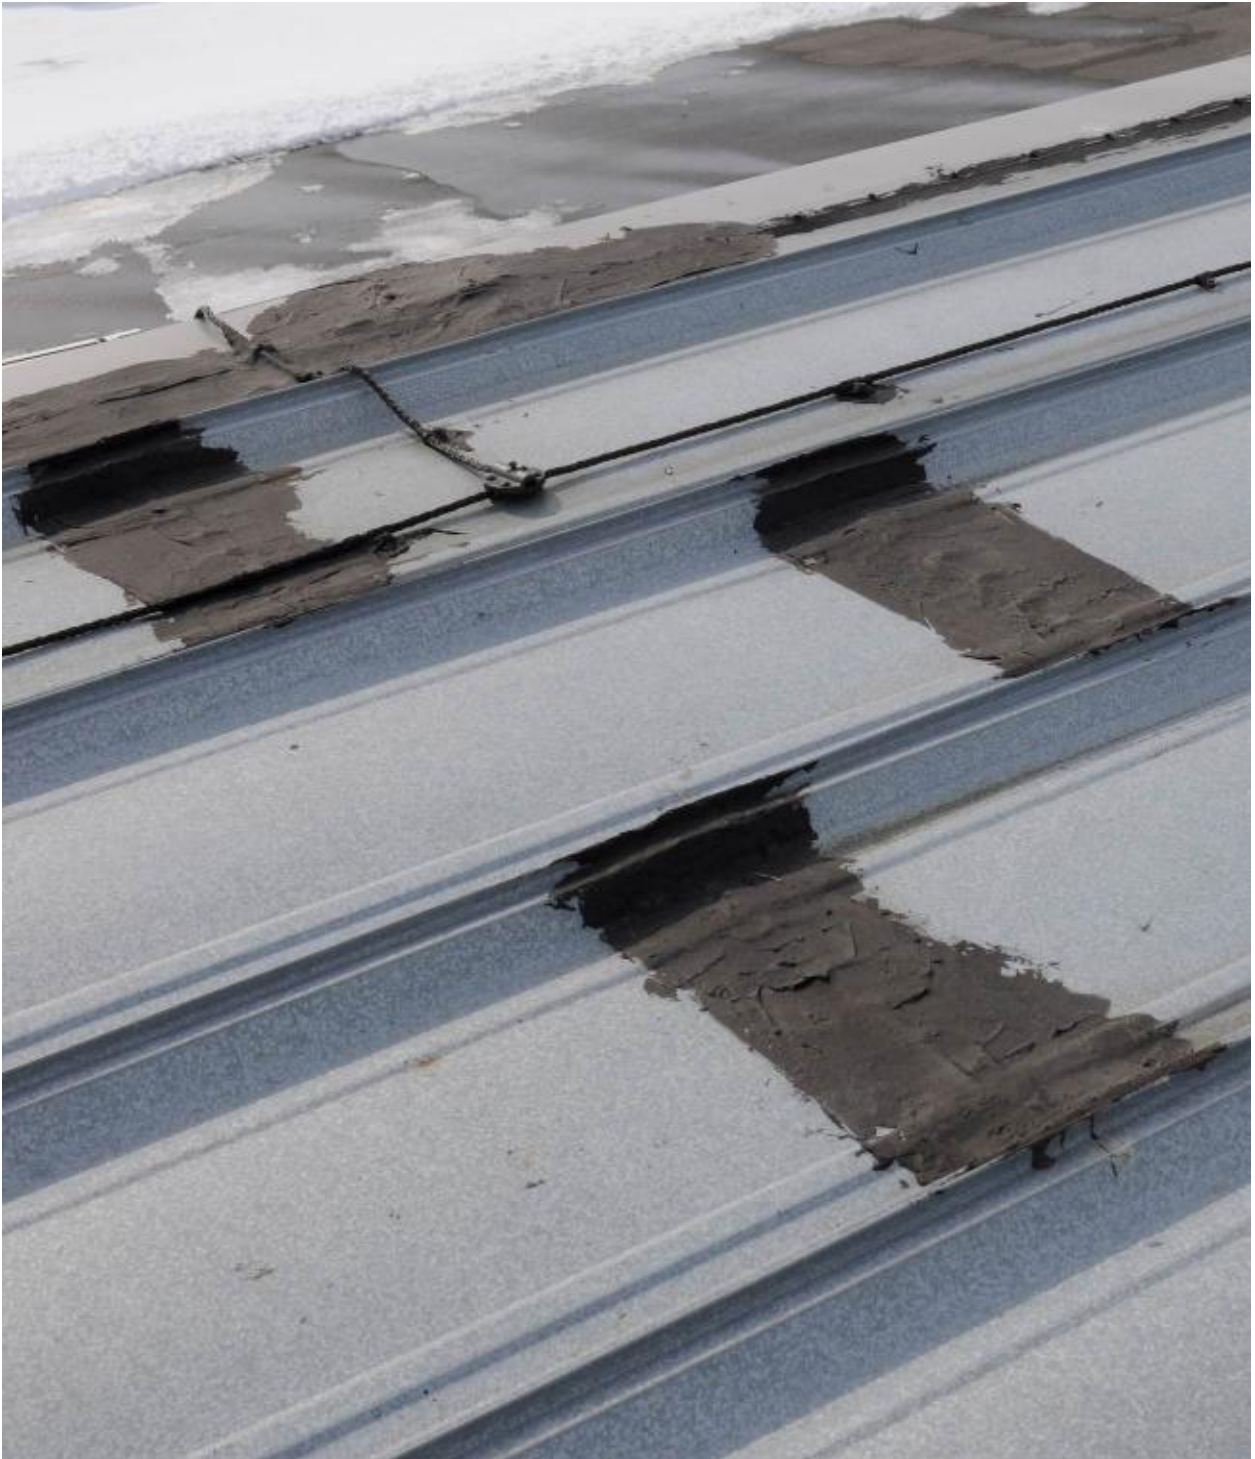
**Photo 12:** Typical asphalt mastic application at the head / end laps between metal roof panels.  
All asphalt material to be removed prior to installation of new micro-sealant tape material

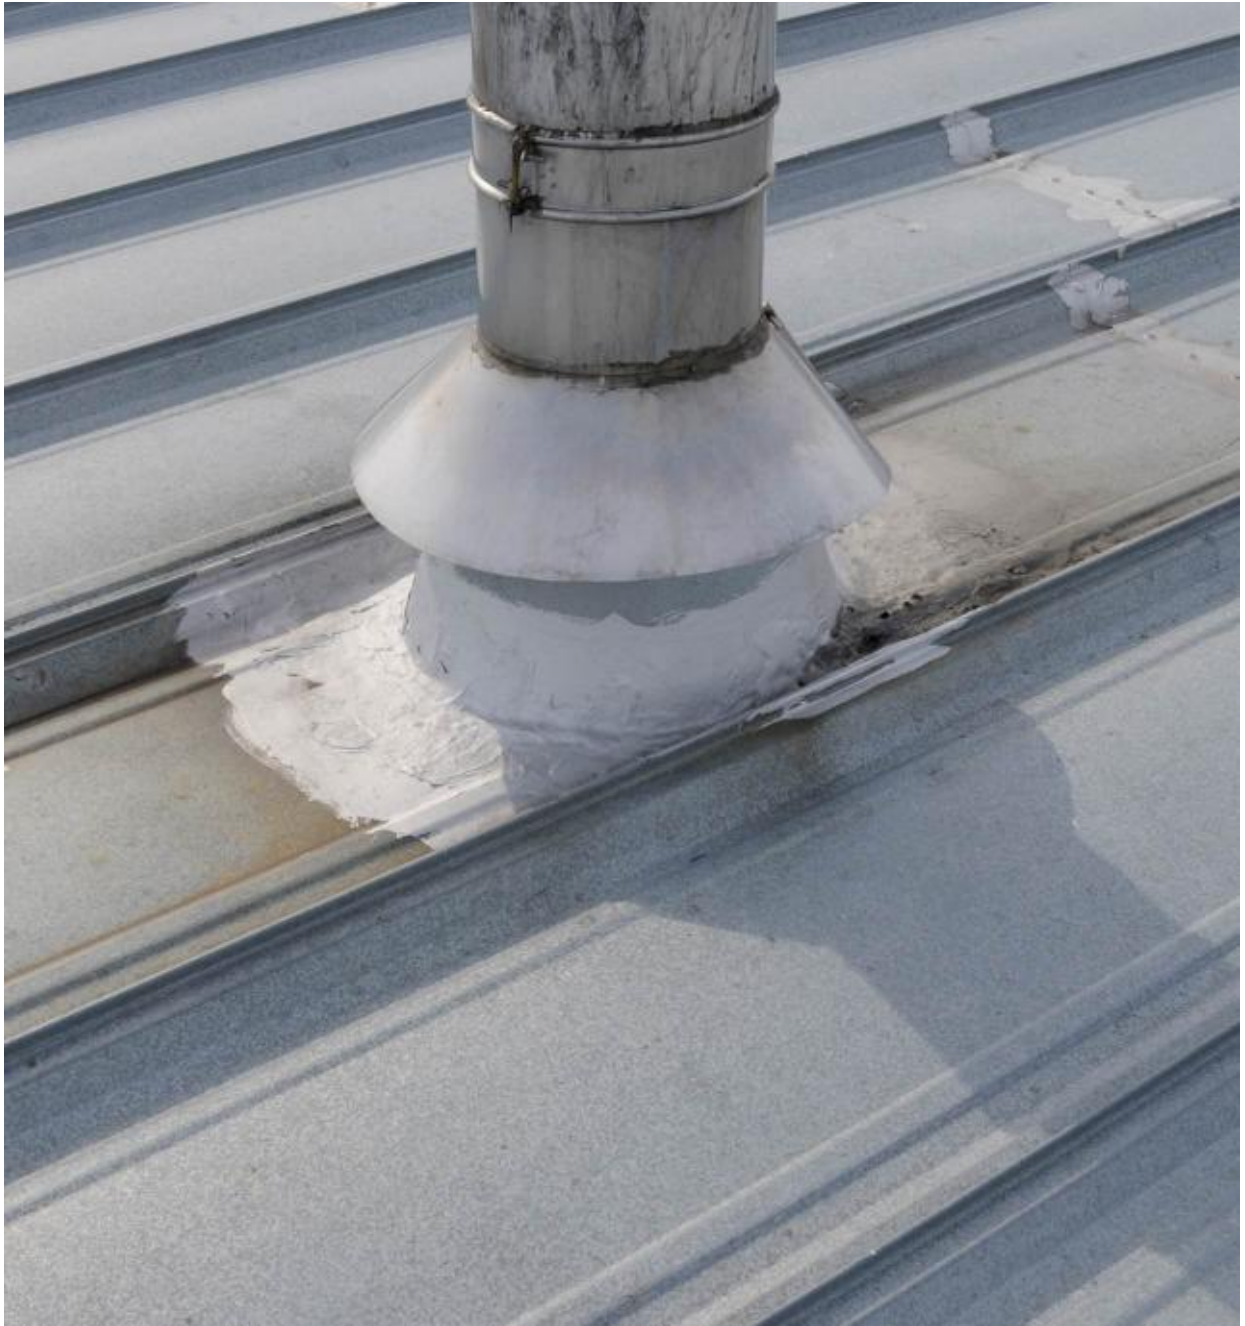
**Photo 13:** Typical metallic paint applied at the base of a exhaust stack. All metallic paint (and asphalt) material to be removed prior to installation of new bituminous membrane flashings.

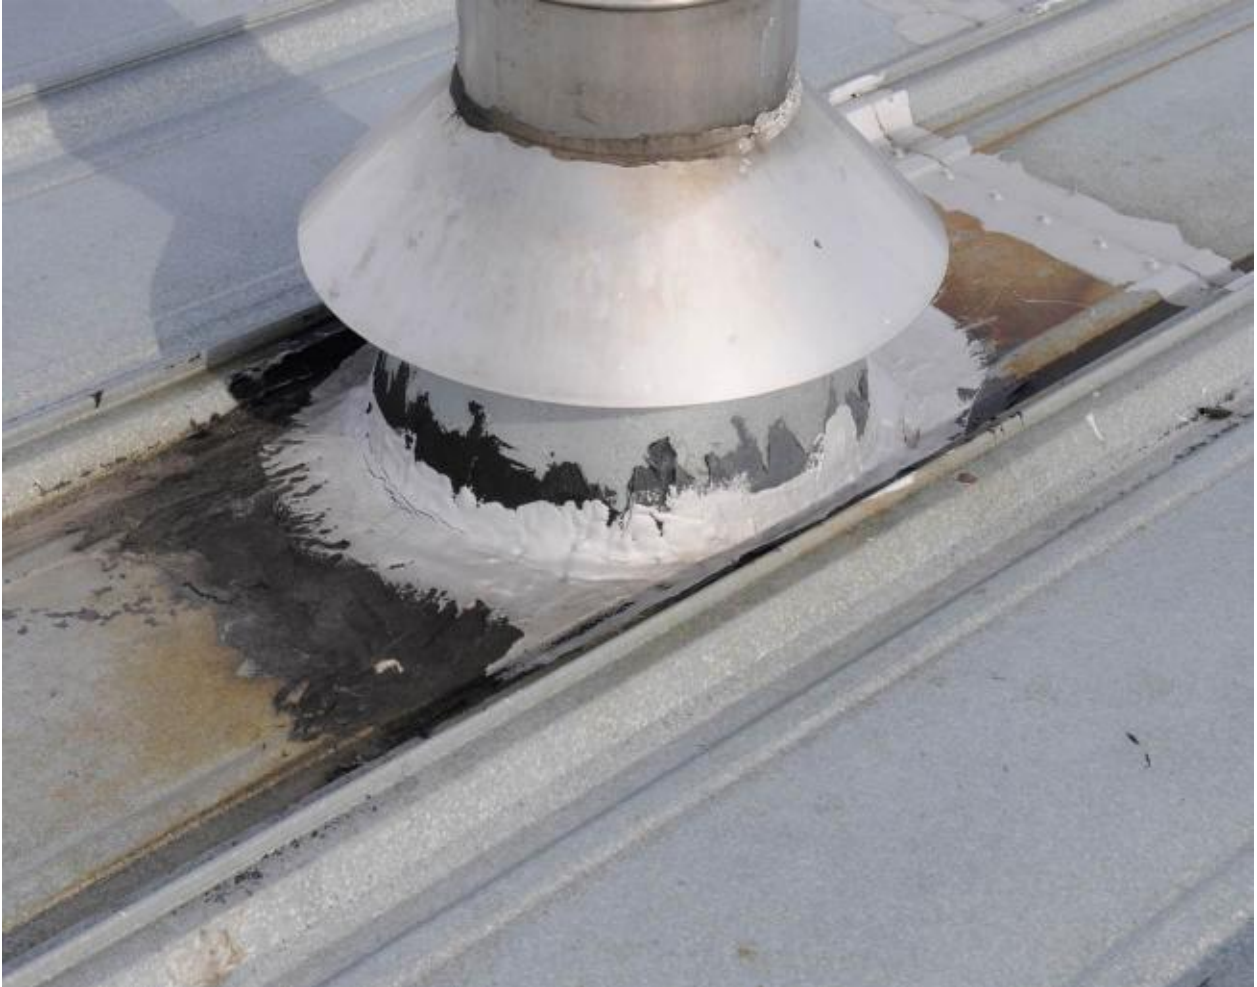
**Photo 14:** Typical metallic paint and asphalt mastic applied at the base of an exhaust stack. All asphalt and metallic paint material to be removed prior to installation of new bituminous membrane flashings.

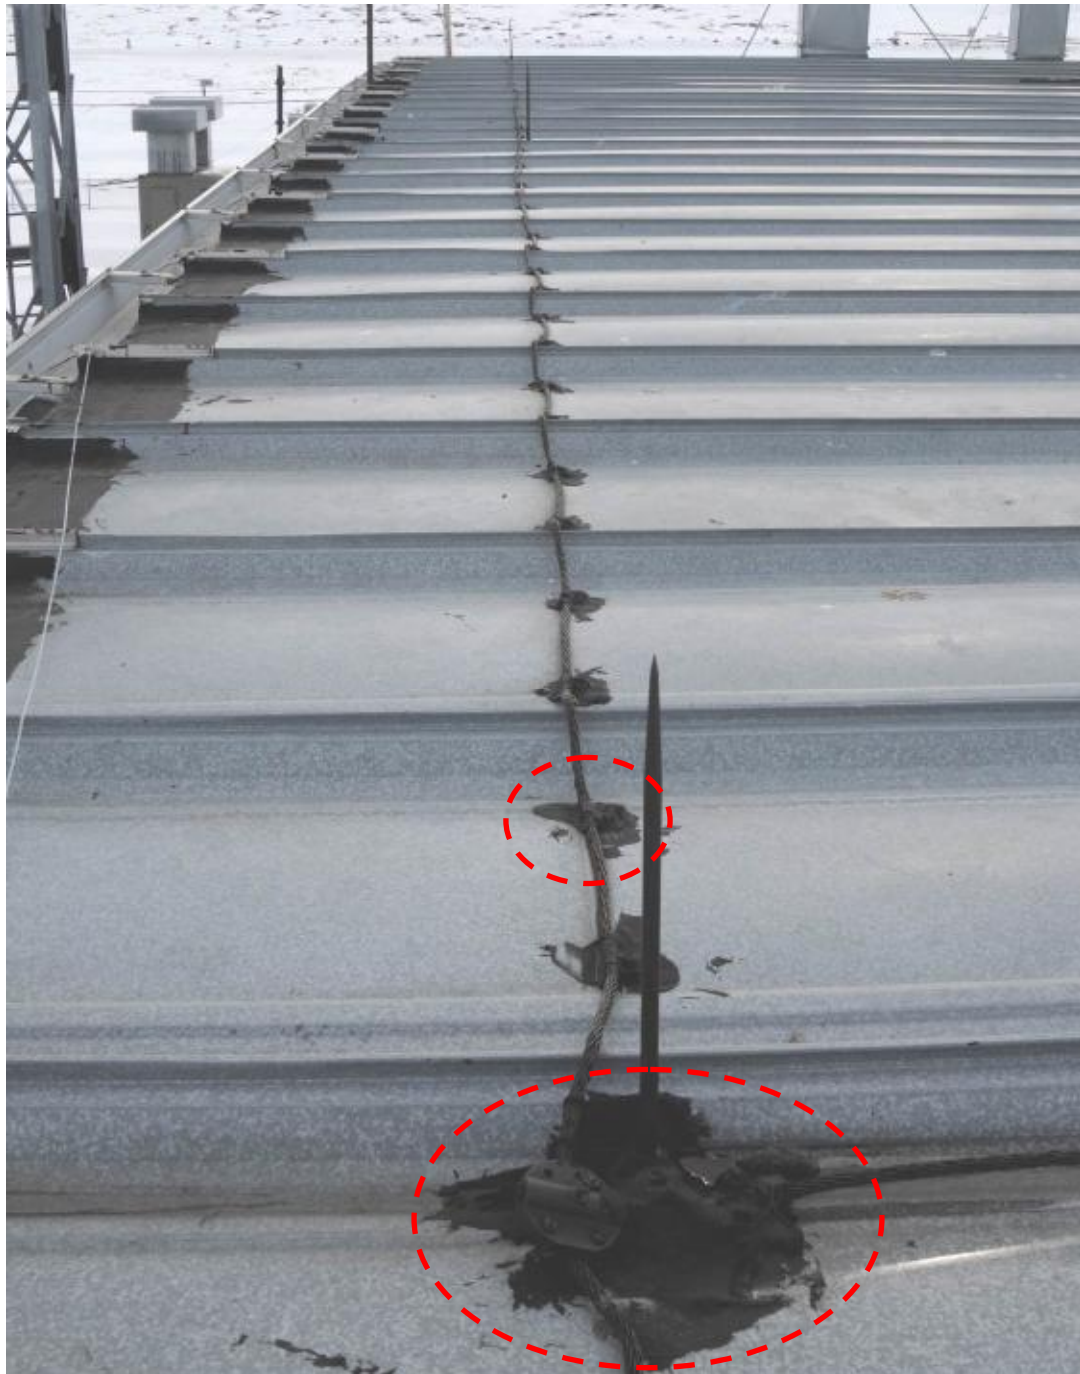
**Photo 15:** Typical lightning arrest system installation and (previous) repair. All asphalt, metallic paint material and surface corrosion to be removed prior to re-installation of lightning arrest anchor base support brackets and cable ties. Photo along the south elevation, viewing to the west.

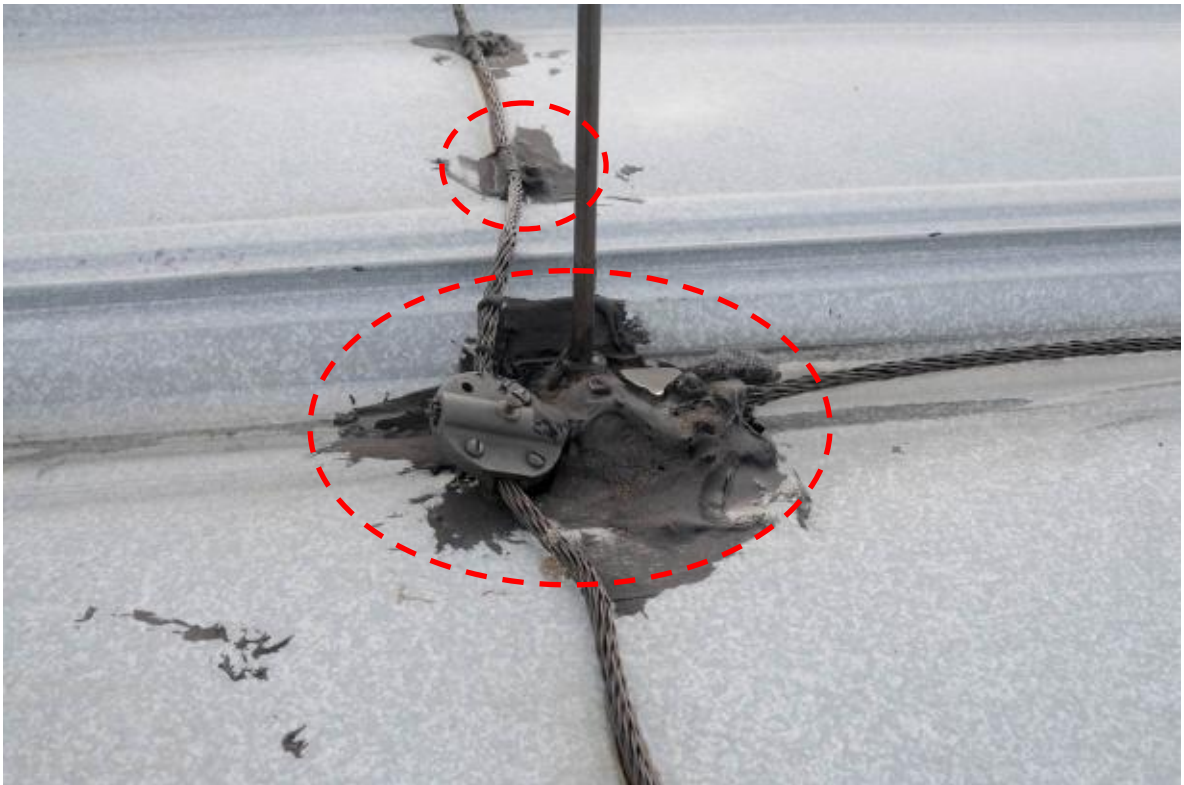
**Photo 16:** Typical lightning arrest system installation and (previous) repair. All asphalt, metallic paint material and surface corrosion to be removed prior to re-installation of lightning arrest anchor base support brackets and wire ties. .

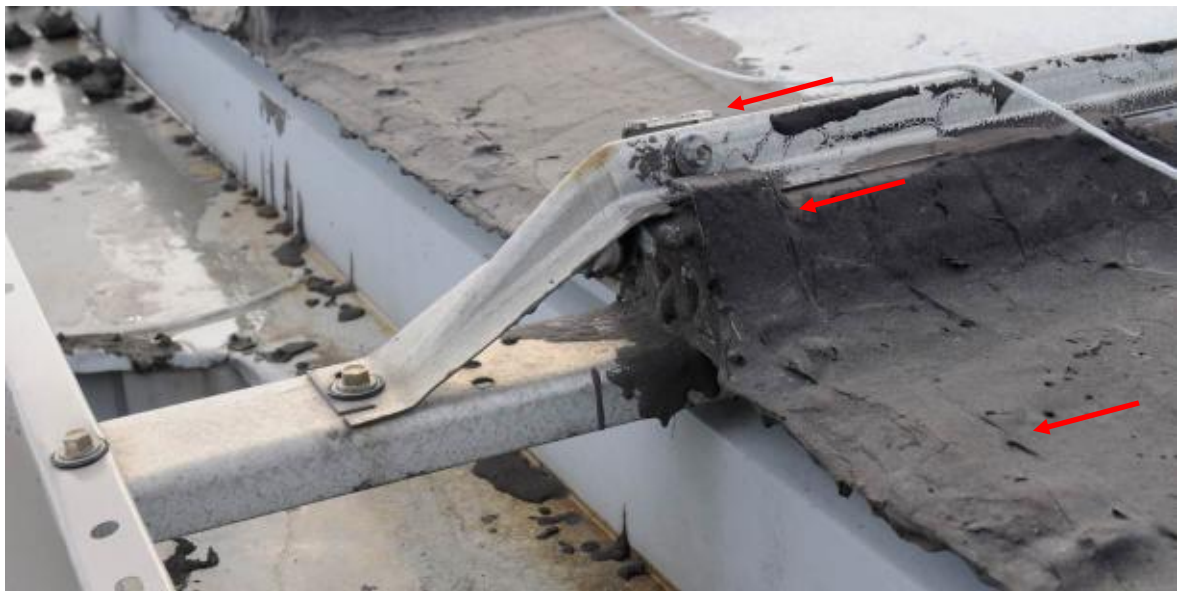
**Photo 17:** Typical Installation of asphalt mastic at the north and south ends of the roof deck. Note the installation of the rain gutter support bracket and end lap securement strap.
