PROJECT ADDRESS:  
HANGAR 6M- FORWARD OPERATION LOCATION, IQALUIT NUNAVUT

PROJECT NAME:  
ROOF REPAIR, FOL HANGER IQALUIT

DRAWING TITLE:  
PHOTOS OF EXISTING CONDITIONS

SHEET No.  
**R2**

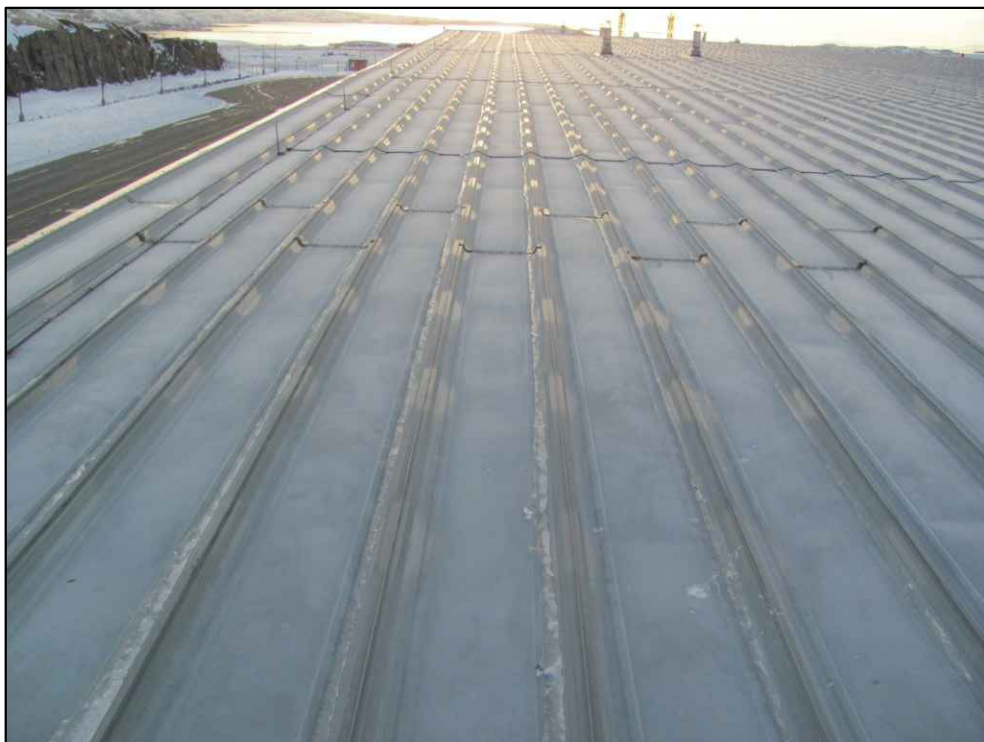
PHOTO\_1: VIEW OF METAL ROOF DECK (SOUTH)

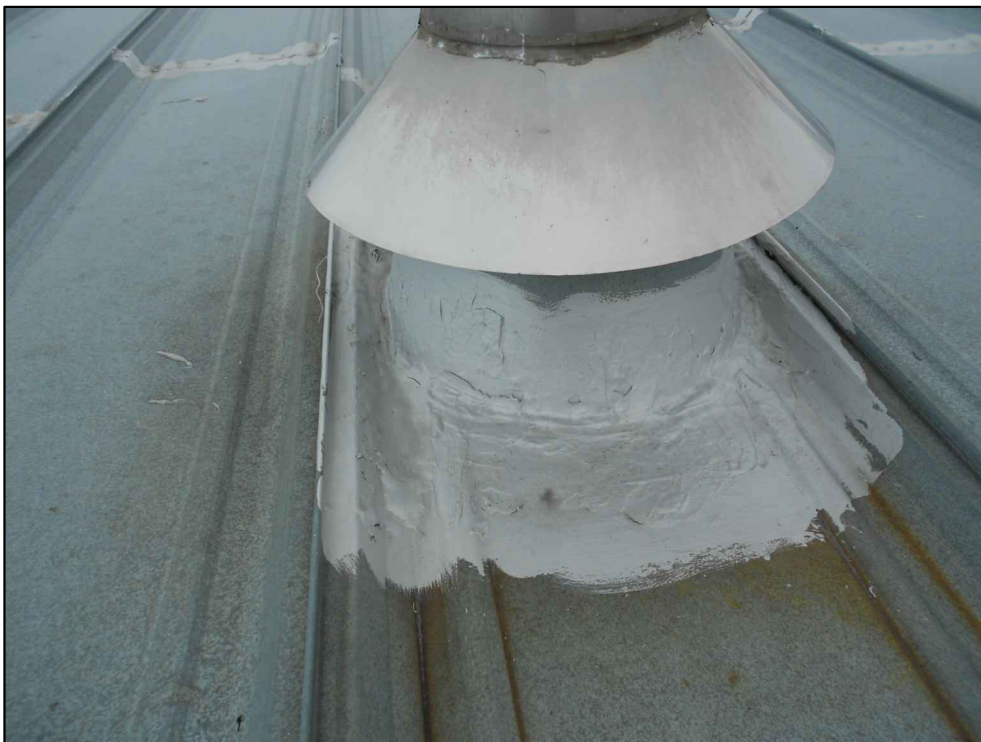
PHOTO\_3: TYPICAL EXHAUST STACK (QTY 8)

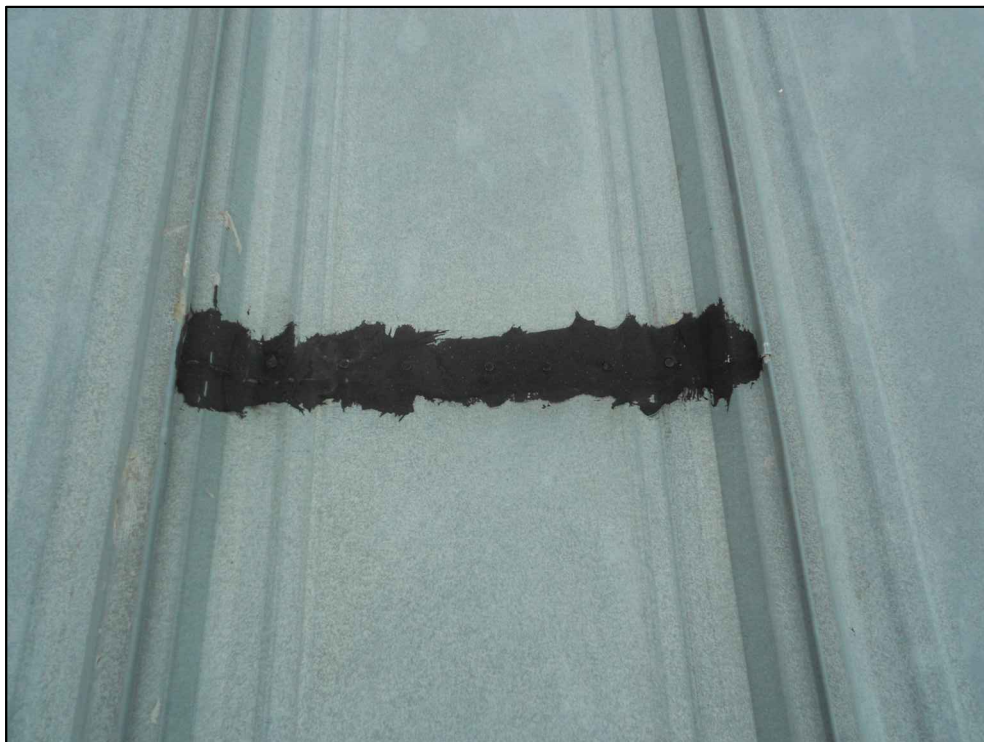
PHOTO\_5: TYPICAL END LAP WITH ASPHALT MASTIC

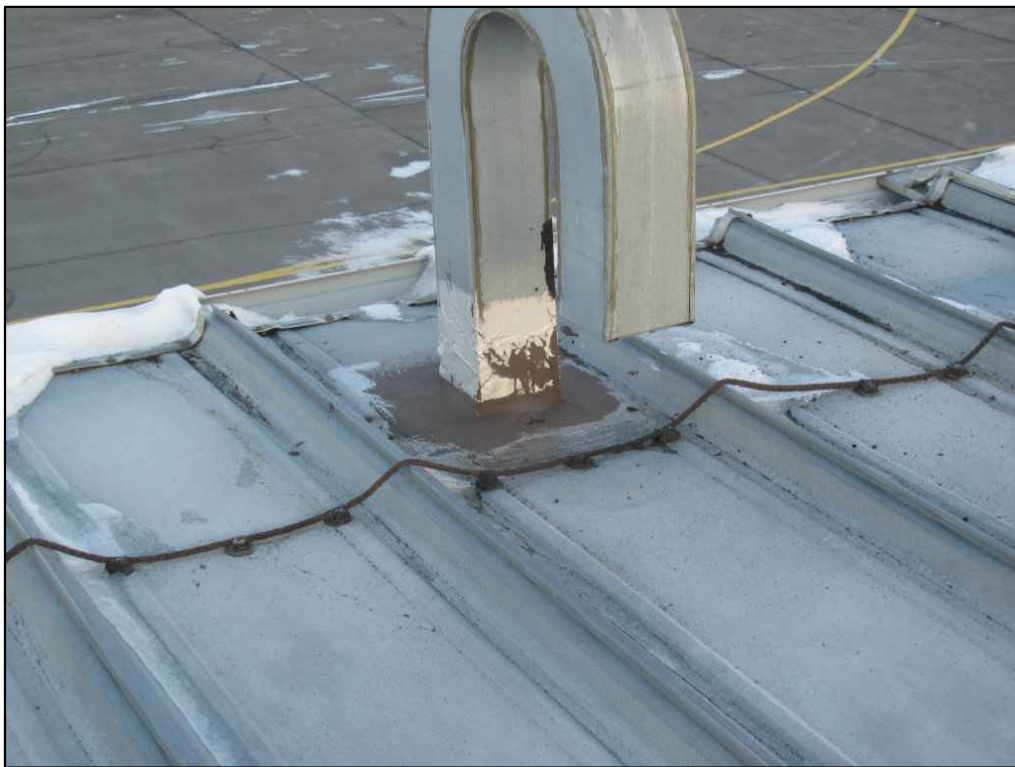
PHOTO\_7: TYPICAL EXHAUST HOOD (QTY 4)

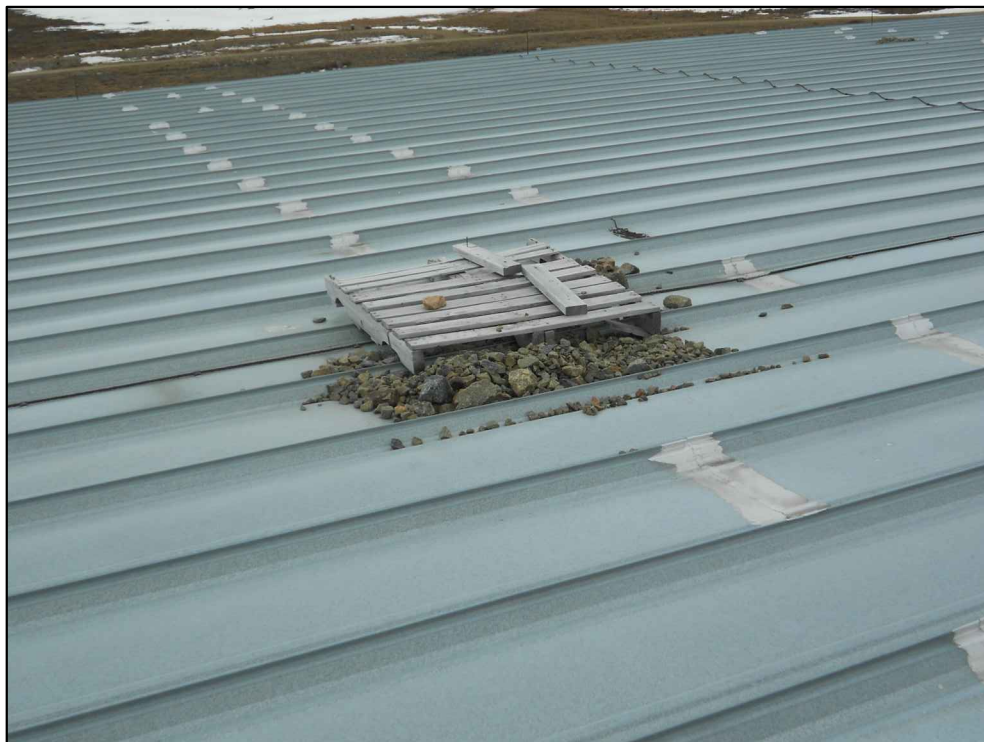
PHOTO\_9: TYPICAL STONE PILE ON ROOF DECK (4 LOCATIONS)

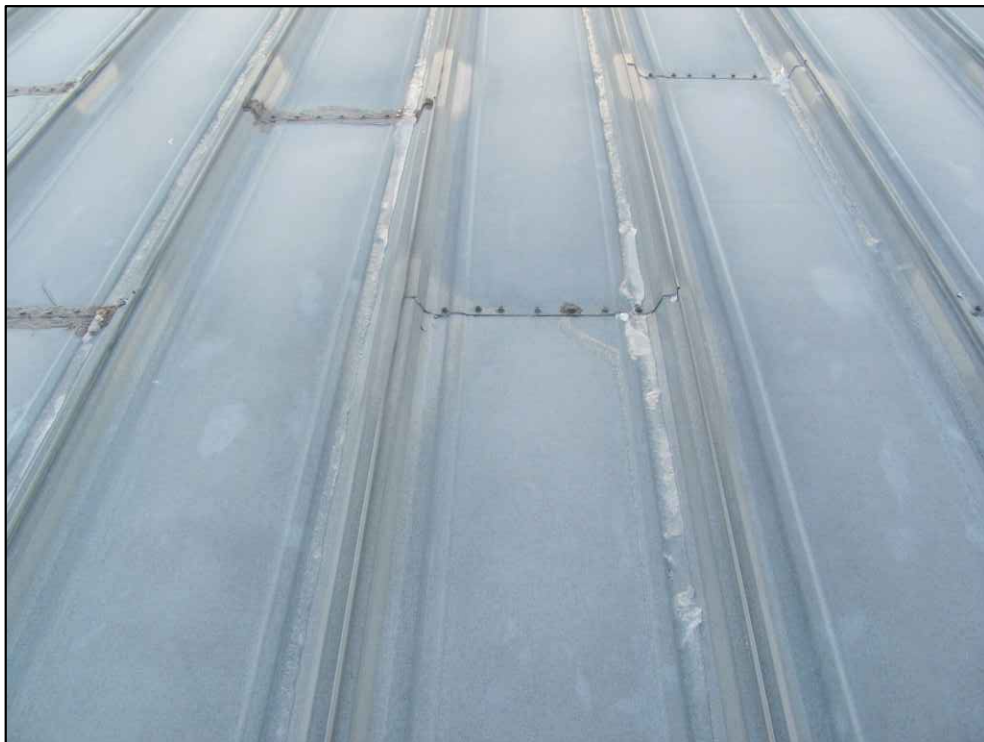
PHOTO\_2: TYPICAL METAL ROOF DECK AT END LAP LAYOUT

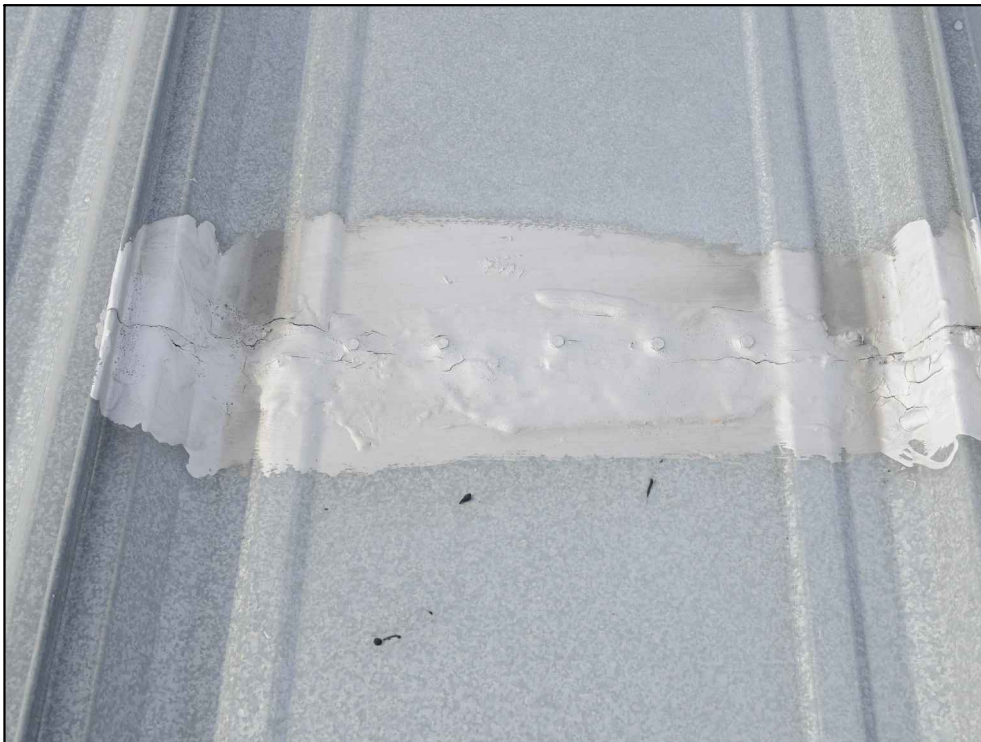
PHOTO\_4: TYPICAL END LAP WITH ALUMINUM PAINT

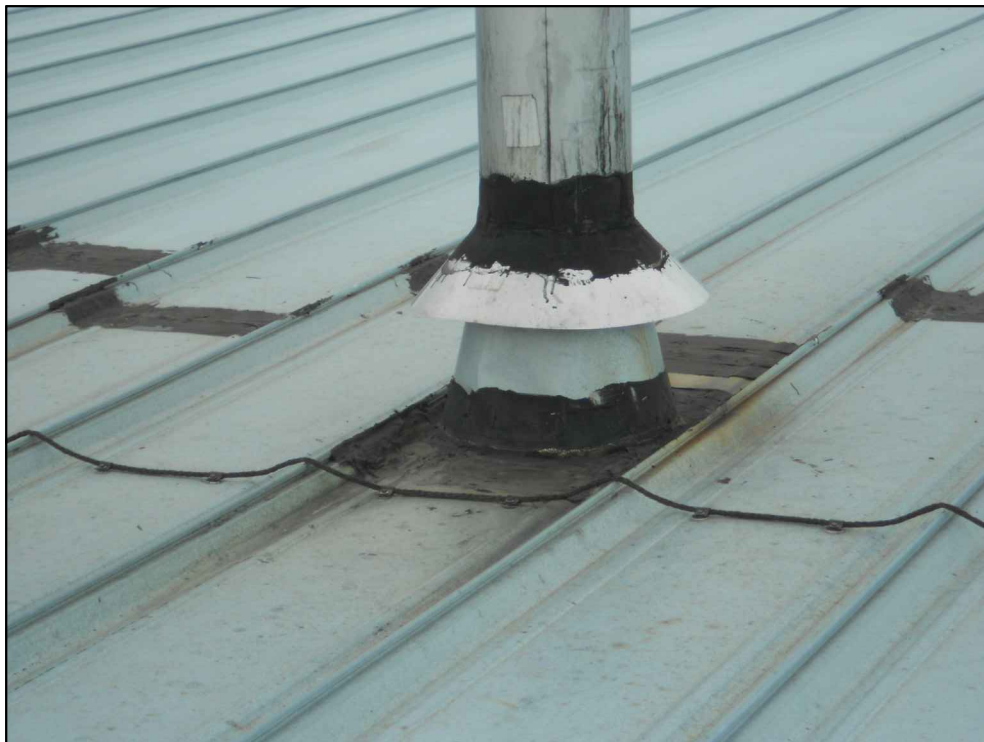
PHOTO\_6: TYPICAL EXHAUST STACK (QTY 8)

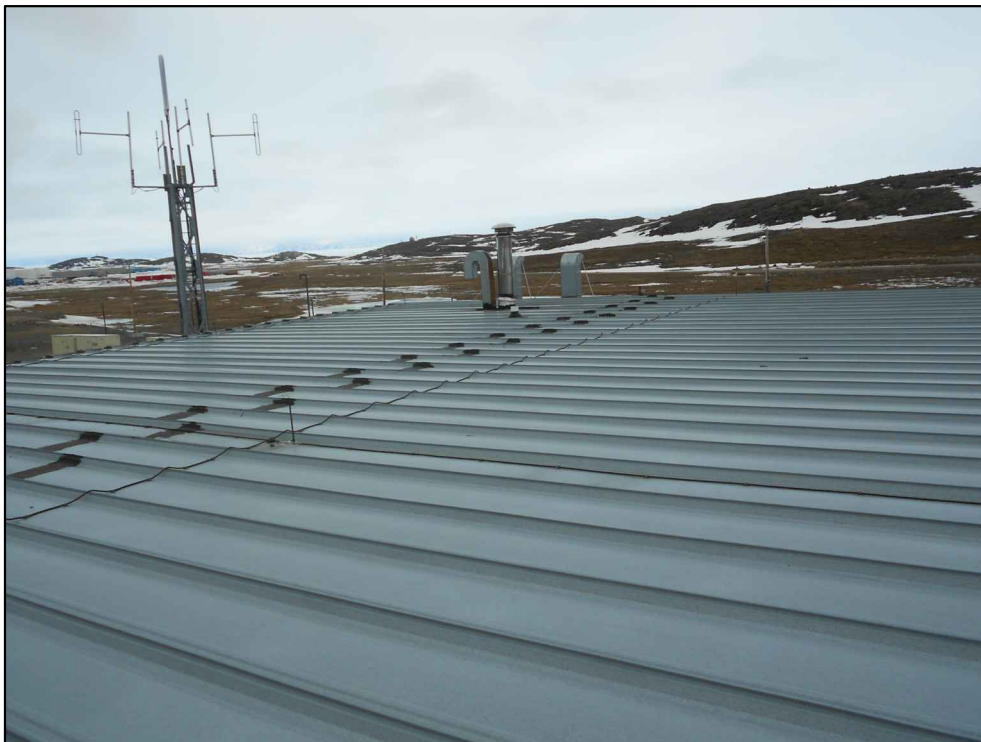
PHOTO\_8: VIEW OF ROOF DECK AND ROOF TOP EQUIPMENT

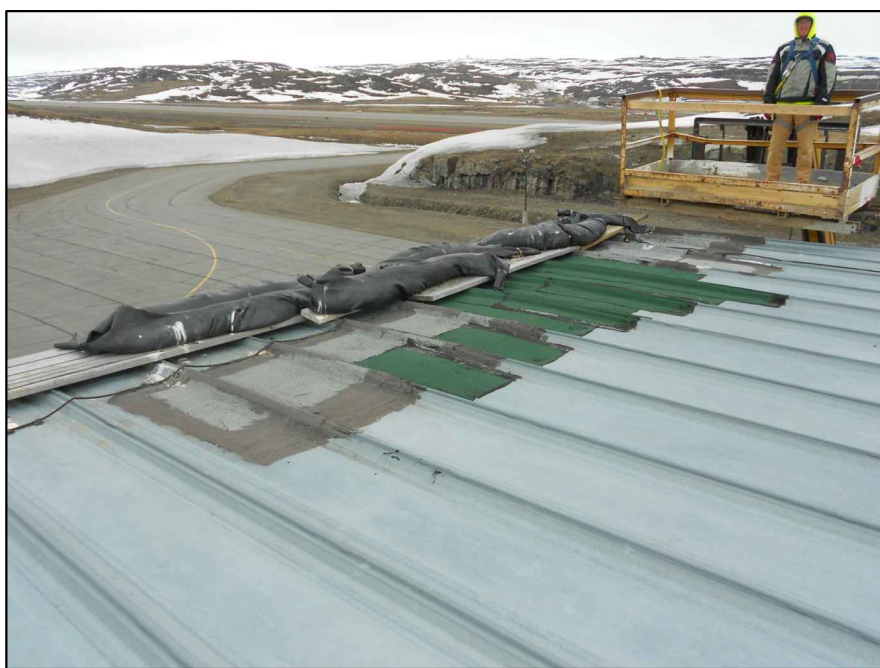
PHOTO\_10: AREA OF DAMAGED ROOF DECK, NORTH EAST CORNER OF ROOF DECK

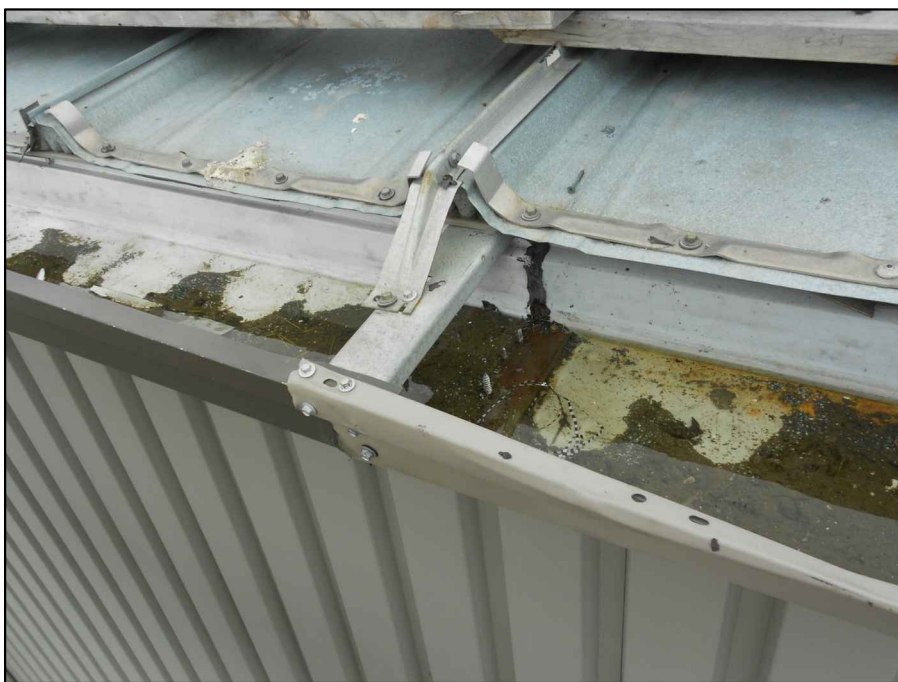
PHOTO\_12: TYPICAL RAIN GUTTER SUPPORT BRACKET, NOTE DAMAGE AT TOP OF STANDING SEAM

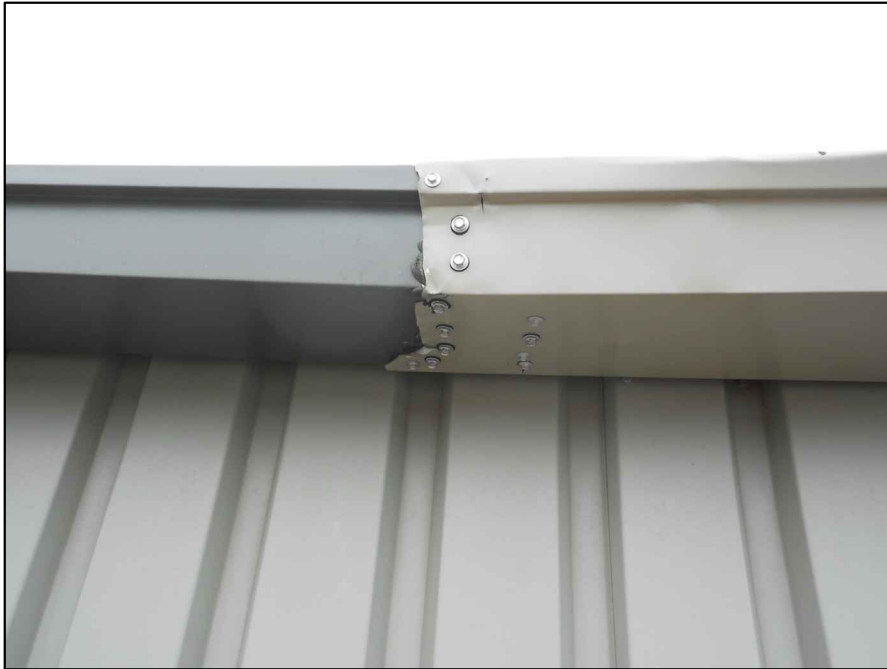
PHOTO\_15: VIEW OF DAMAGED GUTTER TEMPORARY REPAIR

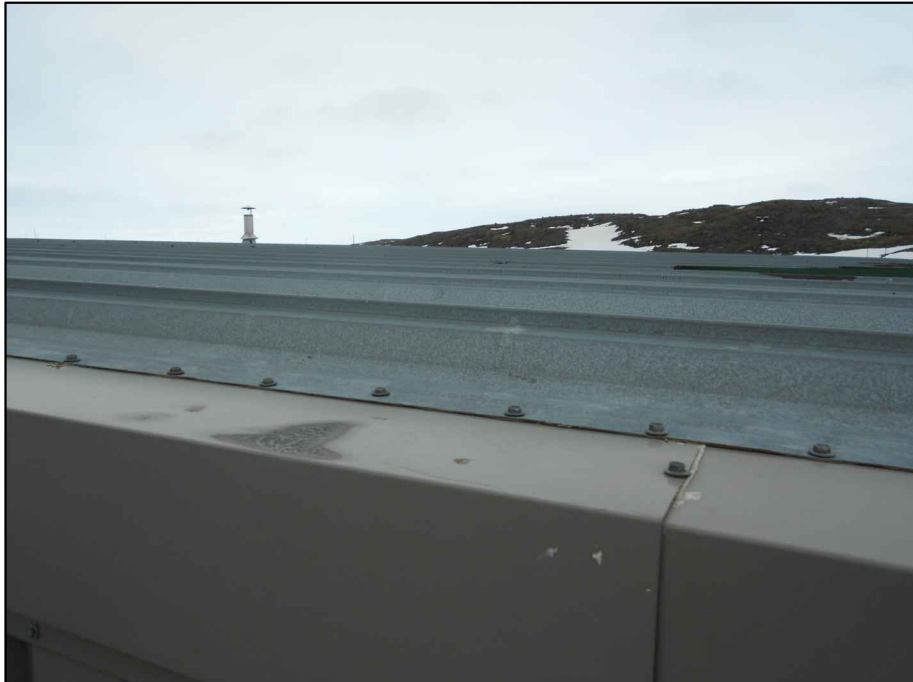
PHOTO\_17: TYPICAL ROOF INSTALLATION AT (EAST/WEST SIDE) PERIMETER OF ROOF DECK. SEE DETAIL 2/R1

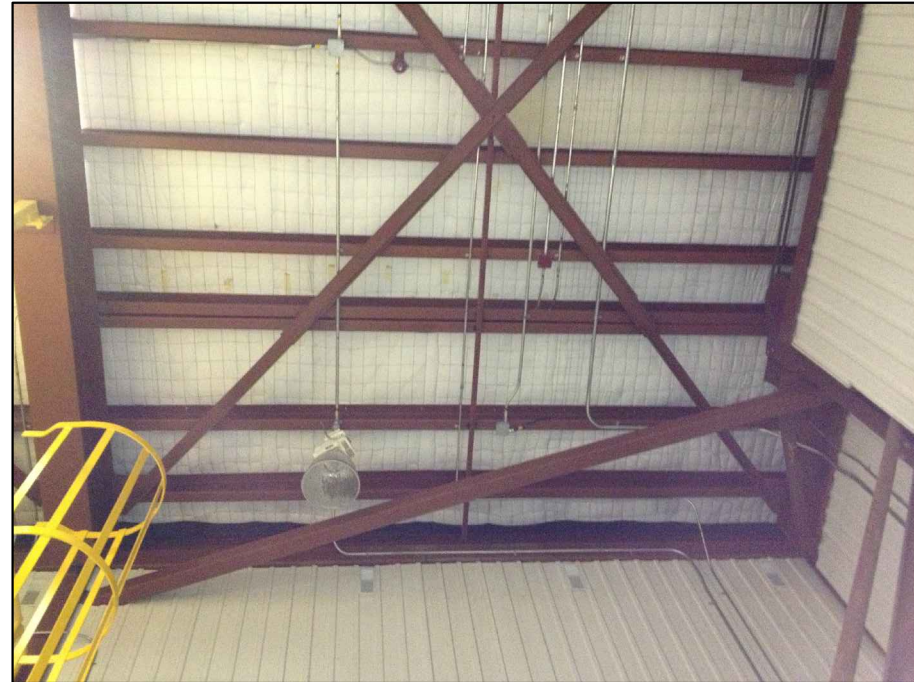
PHOTO\_19: UNDERSIDE OF DAMAGED CORNER OF ROOF DECK AT NORTH/EAST CORNER OF ROOF SYSTEM

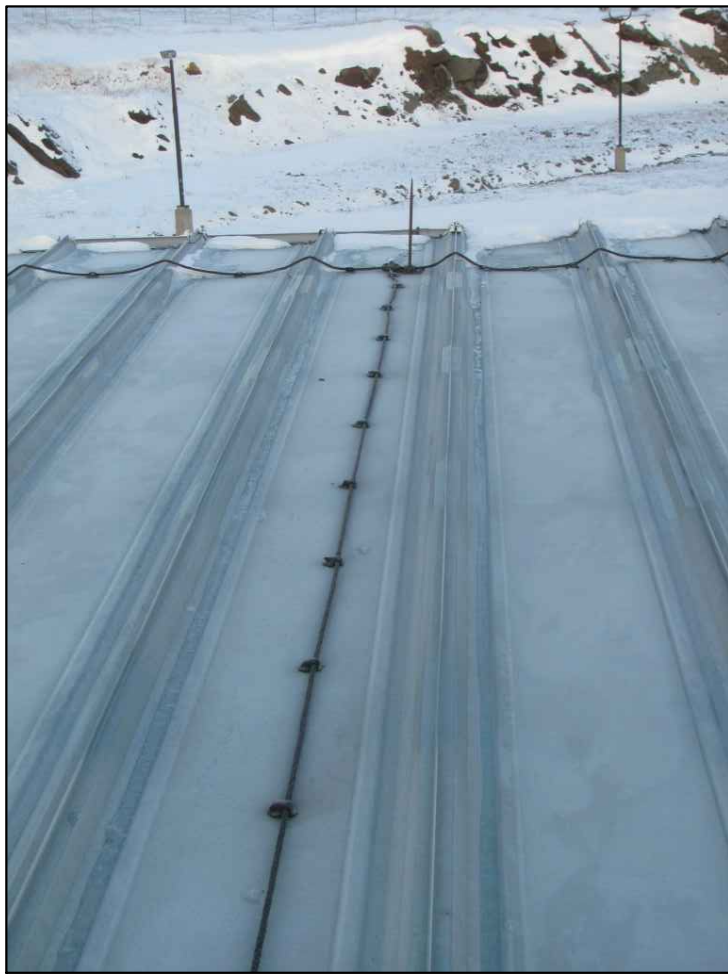
PHOTO\_11: TYPICAL LIGHTNING ARREST SYSTEM

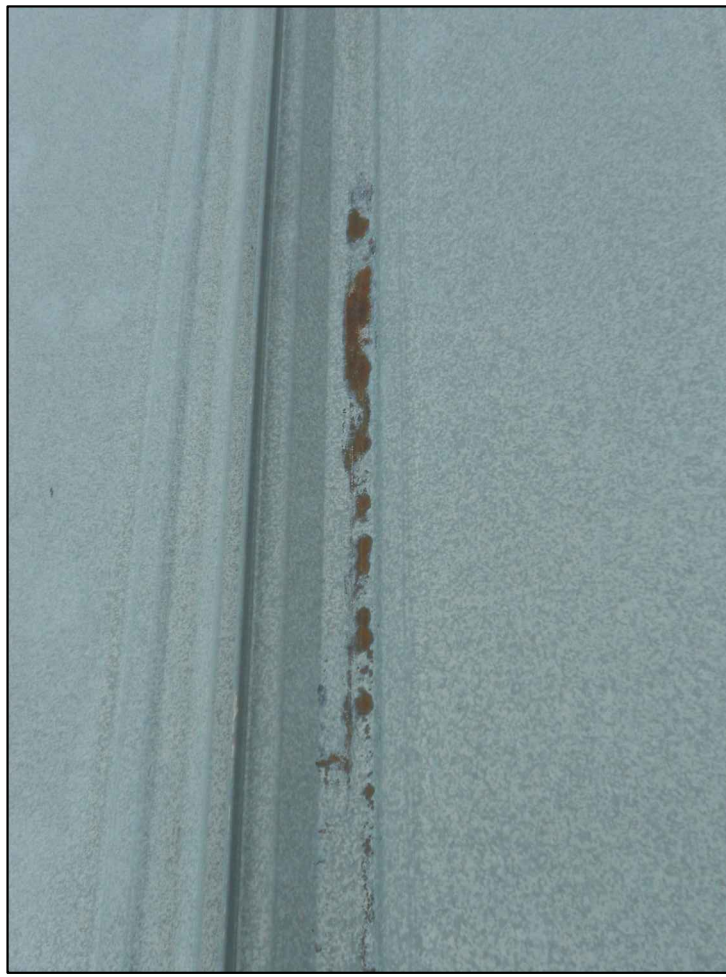
PHOTO\_13: TYPICAL ROOF DECK CORROSION

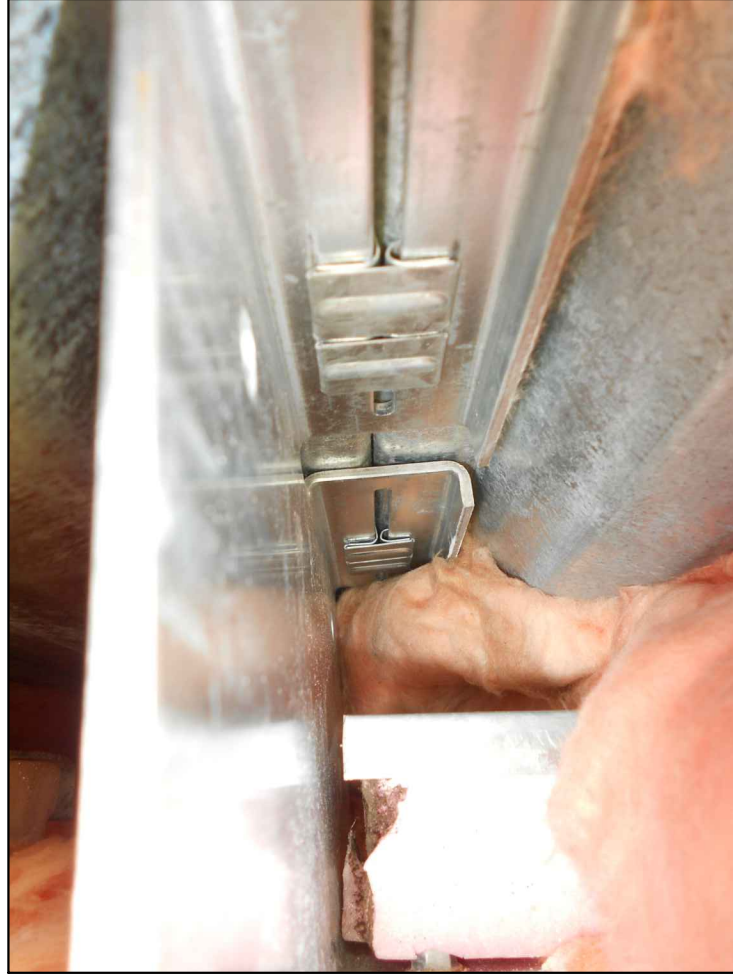
PHOTO\_14: VIEW OF EXISTING PANEL CUT FROM THE UNDERSIDE OF THE ROOF SYSTEM

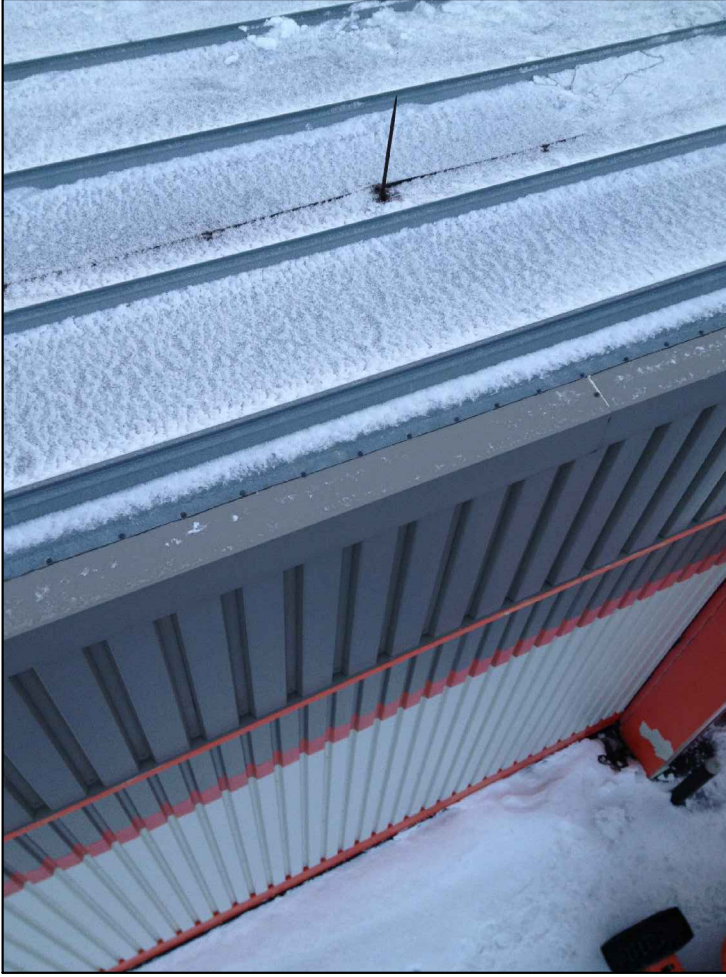
PHOTO\_16: TYPICAL ROOF INSTALLATION AT (SIDE) PERIMETER OF ROOF DECK. SEE 3/R1.

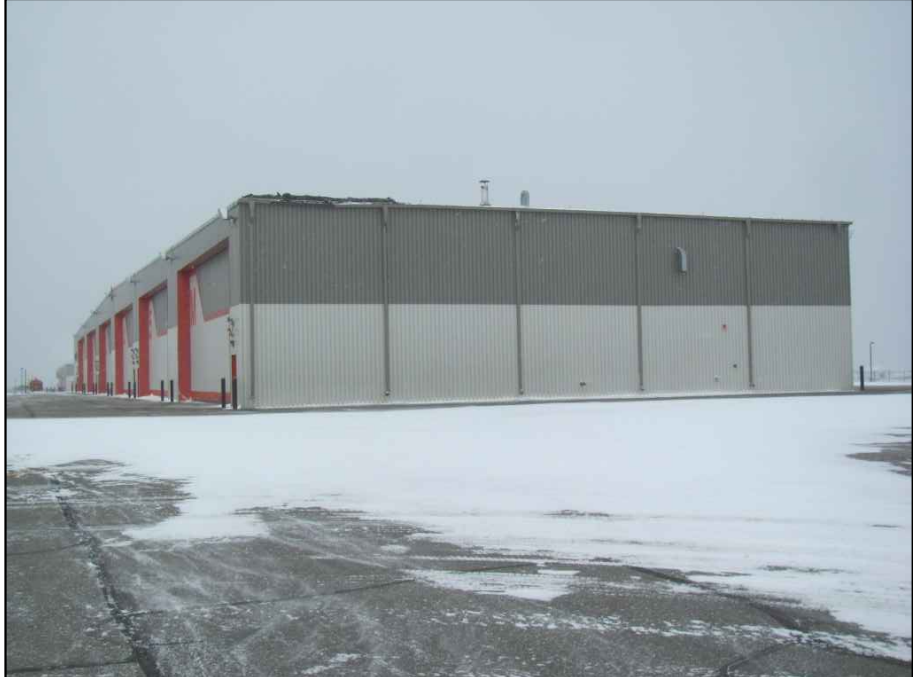
PHOTO\_18: VIEW OF NORTH ELEVATION OF BUILDING

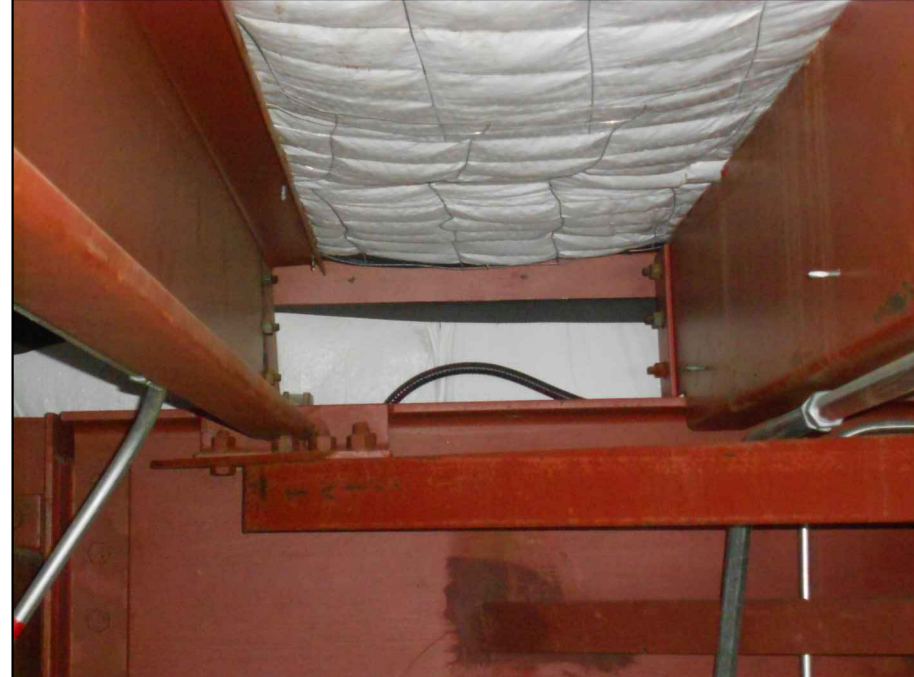
PHOTO\_20: TYPICAL VIEW OF ROOF SYSTEM UNDERSIDE
