Tetsa Creek Bridge-Culvert No. 4

Alaska Highway km 595.3

Significant Inspection Concerns	<ol style="list-style-type: none"> Both barrels are in poor condition with significant distortion and significant cracking along plate seams. The south barrel has a maximum of 15.4% vertical distortion and 10 of 15 rings cracked with as little as 50 mm remaining steel plate between cracks. The north barrel has a maximum of 12.7% vertical distortion and 7 of 15 rings cracked with as little as 23 mm remaining steel plate between cracks (down from 35 mm in 2005 but unchanged from 2009) (see Photo P17). Both barrels have historically cantilevered (gun barreled) out of the highway embankment a few metres. The eroded gap below the outlet barrels has been backfilled periodically over the years and cycles between the backfilled and scoured state. The barrels are currently well backfilled with riprap at the outlet. Both barrels have drooped at the outlets with the bottom plates in the last few rings dropping as much as 400 mm. There are two large (200 mm) dents in roof the south barrel at rings 5 and 14. The bottom corrugations are flattened by rock flow in both barrels. These barrels (particularly th

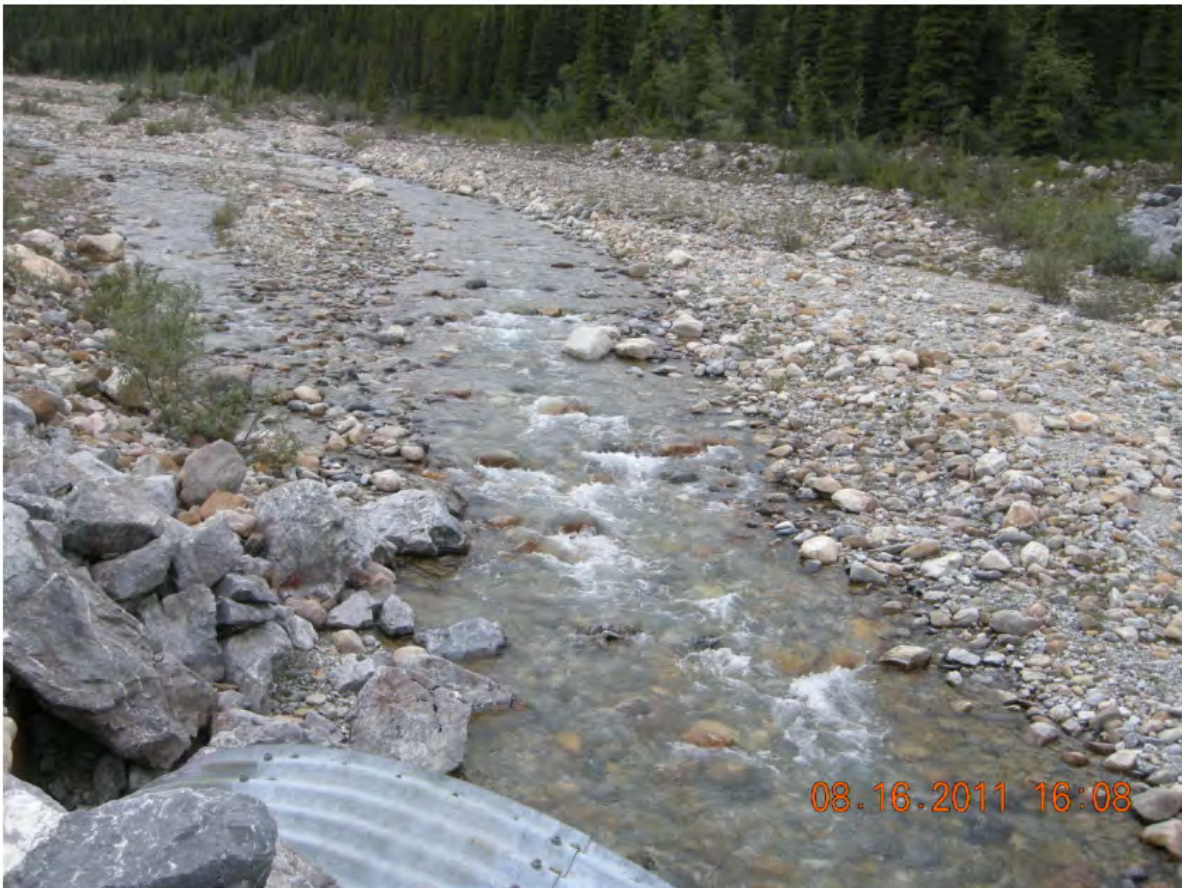
P02 - Upstream Watercourse to the East

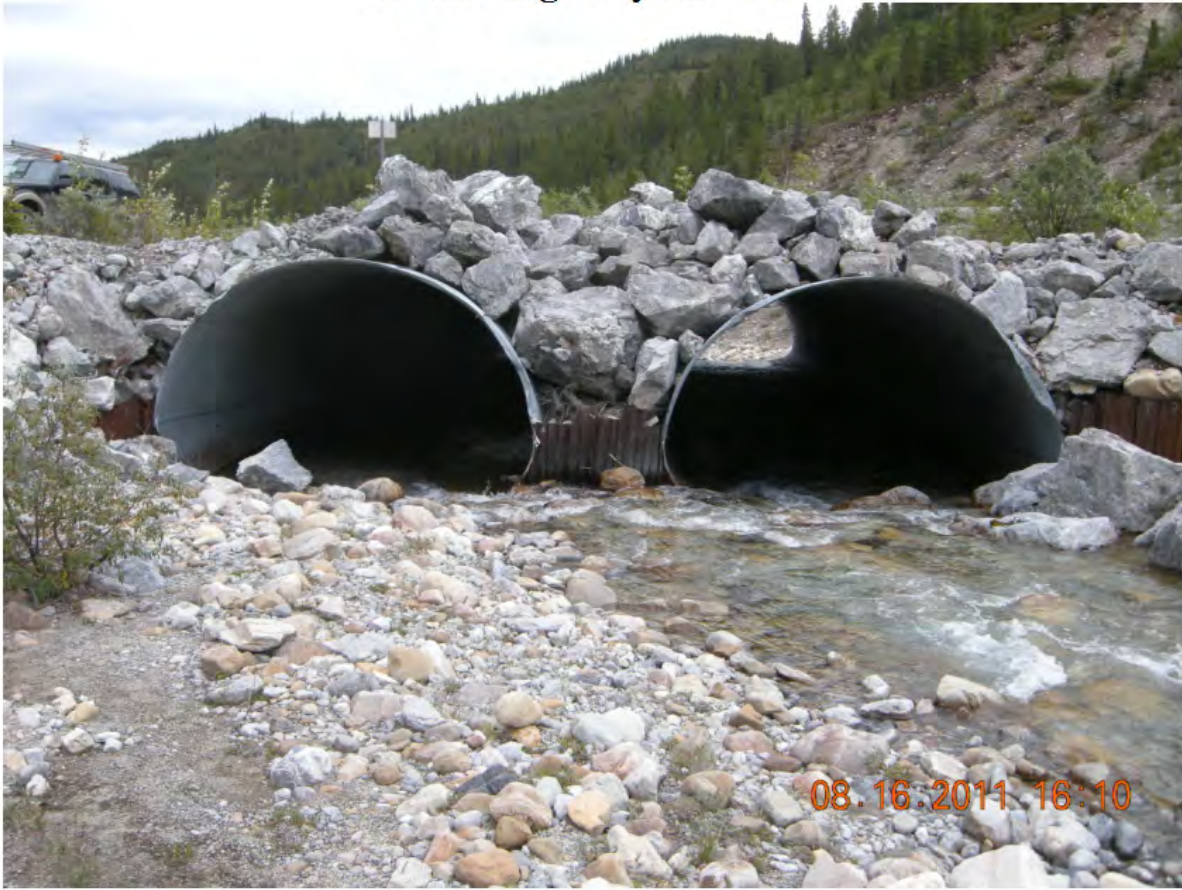
Element	2009			2011			Observations	Photo References
	MCR	PCR	Priority	MCR	PCR	Priority		
Slope Protection	5	5	D	5	5	D	Embankments are well covered with river rock and there is little evidence of erosion. A berm of heavy riprap protects the SE inlet embankment and diverts the stream into the twin barrels.	3,18
Signs	5	5	D	5	5	D	Creek name signs present on both approaches.	1

P03 - Inlets and East Embankment

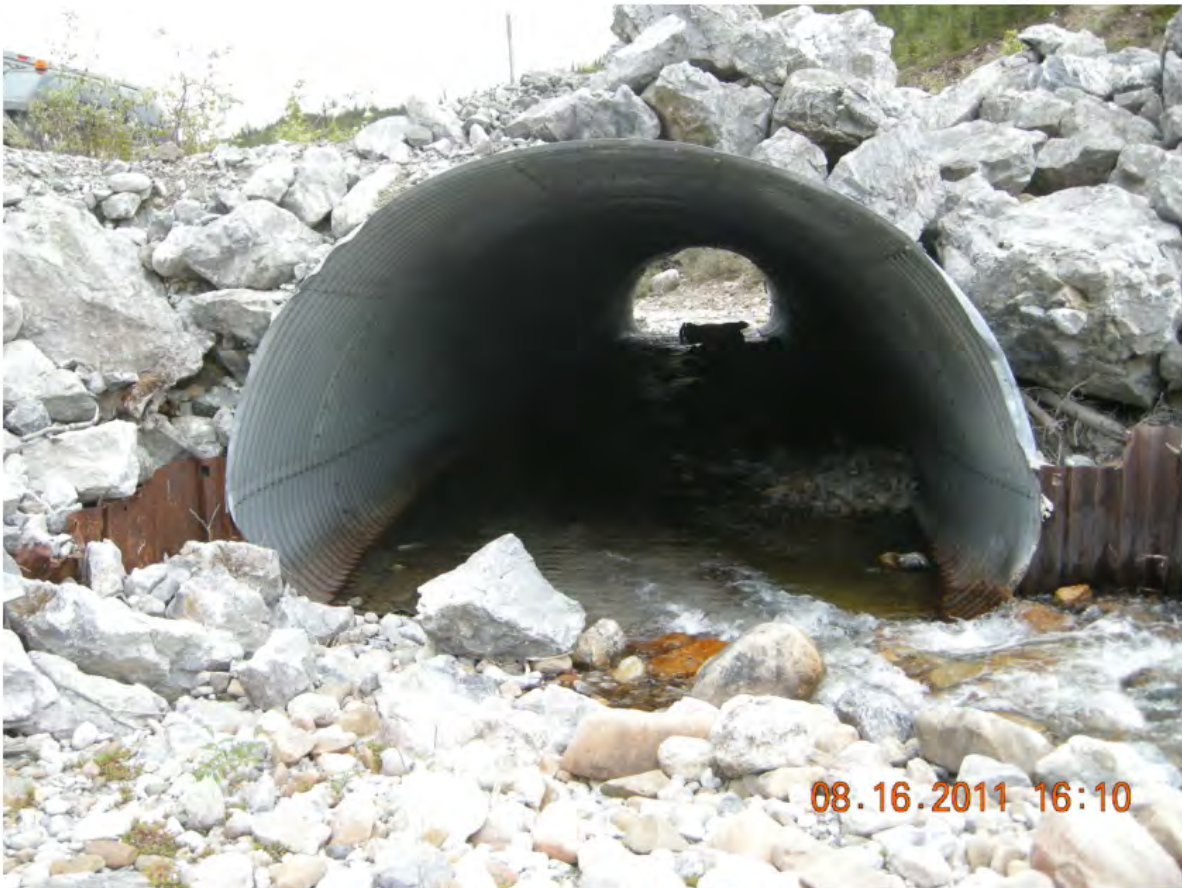
Element	2009			2011			Observations	Photo References
	MCR	PCR	Priority	MCR	PCR	Priority		
							the outlet barrels has been backfilled periodically over the years and cycles between the backfilled and scoured state. The barrels are currently well backfilled with riprap at the outlet. Both barrels have drooped at the outlets with the bottom plates in the last few rings dropping as much as 400 mm. There are two large (200 mm) dents in roof the south barrel at rings 5 and 14. The bottom corrugations are flattened by rock flow in both barrels. These barrels (particularly the north barrel) have a relatively short 10 years of estimated remaining life, therefore, an investment in floor armouring probably doesn't make sense prior to lining or replacement.	
Inlet	4	4	A	4	4	A	The inlets both have minor collision damage. There are some large rocks blocking the north barrel inlet. Some flow is piping below the south barrel inlet and squirting in through bolt holes in ring 1.	3,4

P04 - South Barrel - Inlet and East Embankment

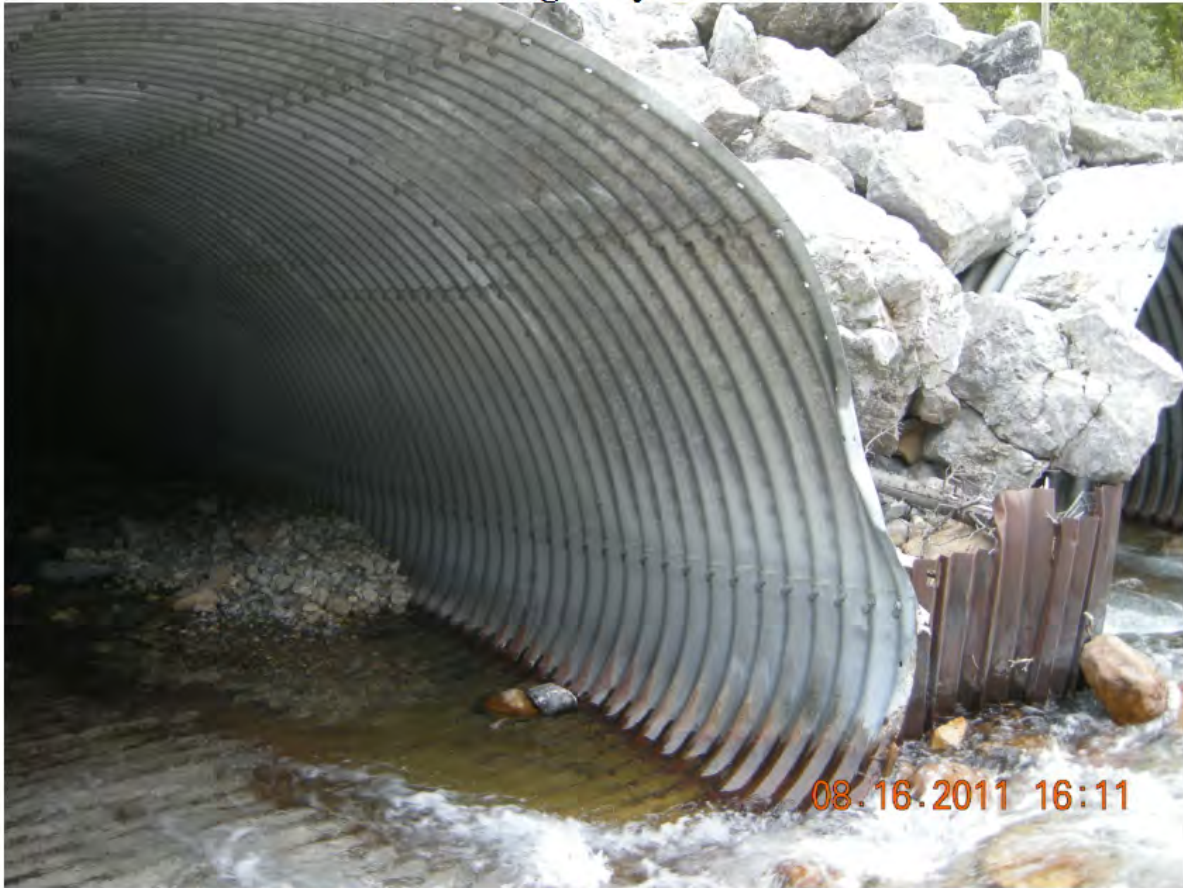
P05 - South Barrel - Minor Collision Damage both Sides of Inlet Rim

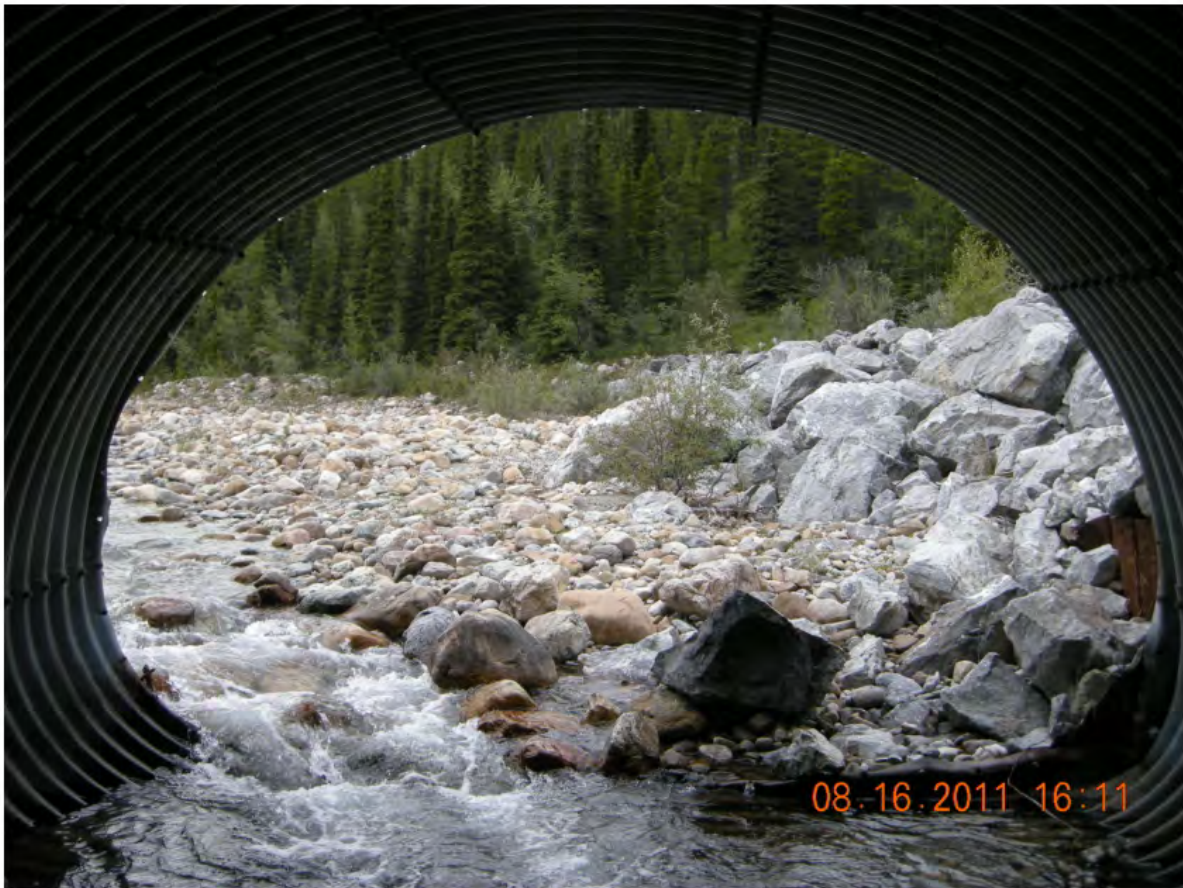
P06 - South Barrel - Inlet Watercourse to North of Inlet

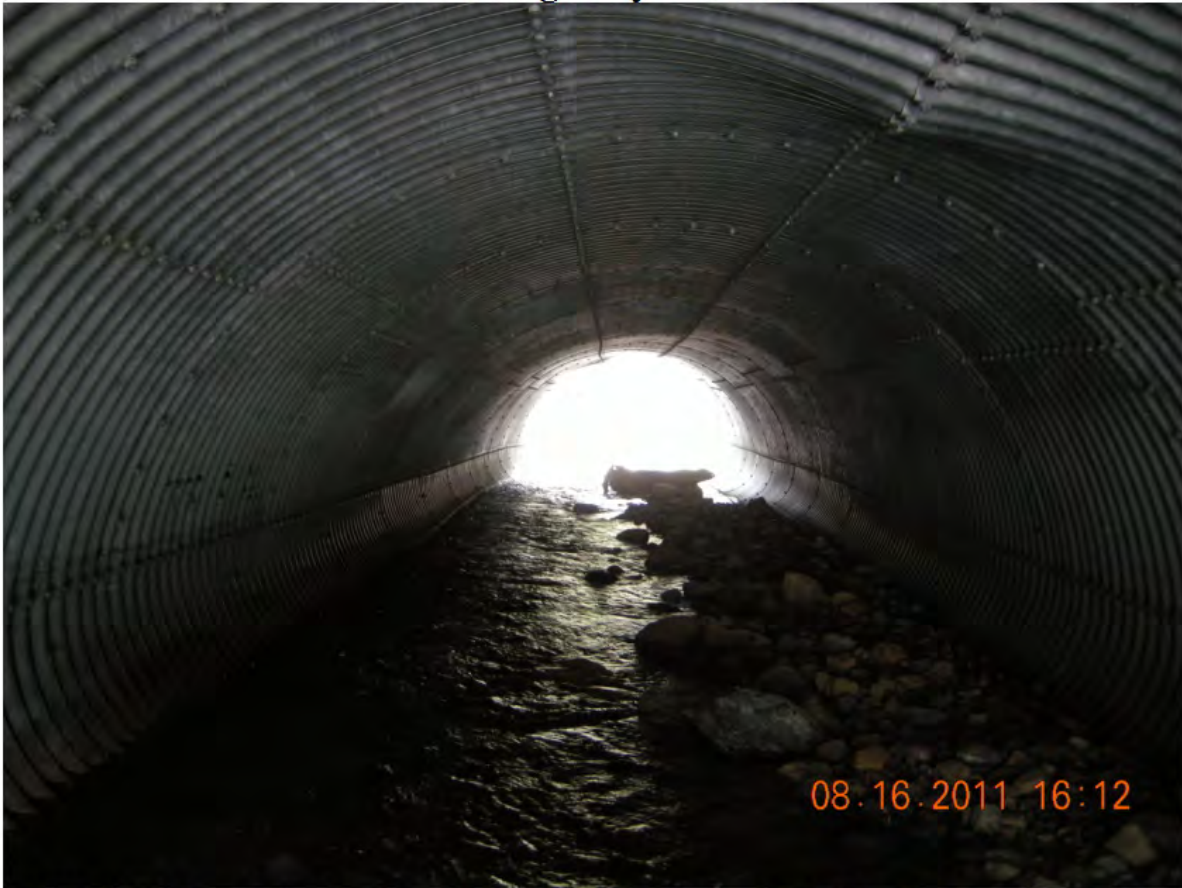
P07 - South Barrel - Looking Towards Outlet - Most Flow on South Side - Debris on North Side

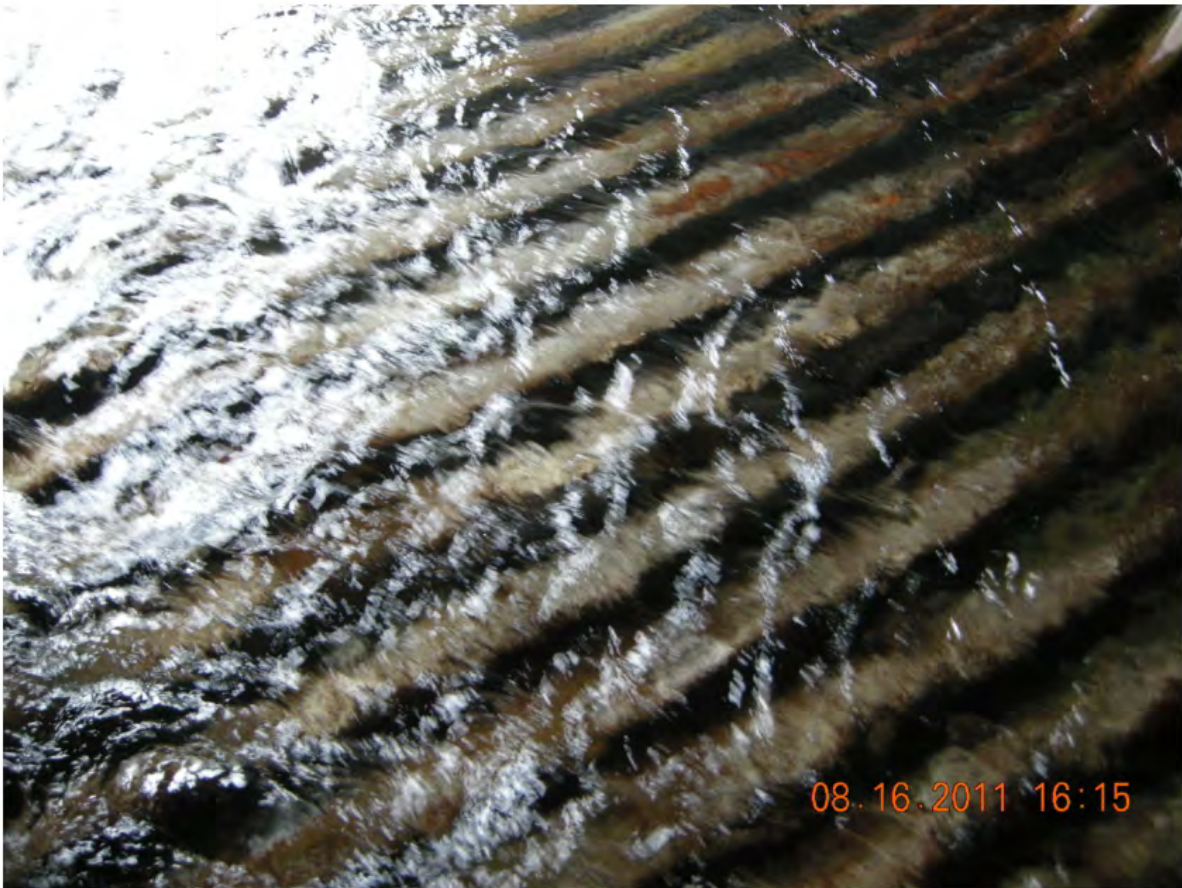
P08 - South Barrel - Bottom Corrugations Folded Over Due to Rock Impact in Both Barrels

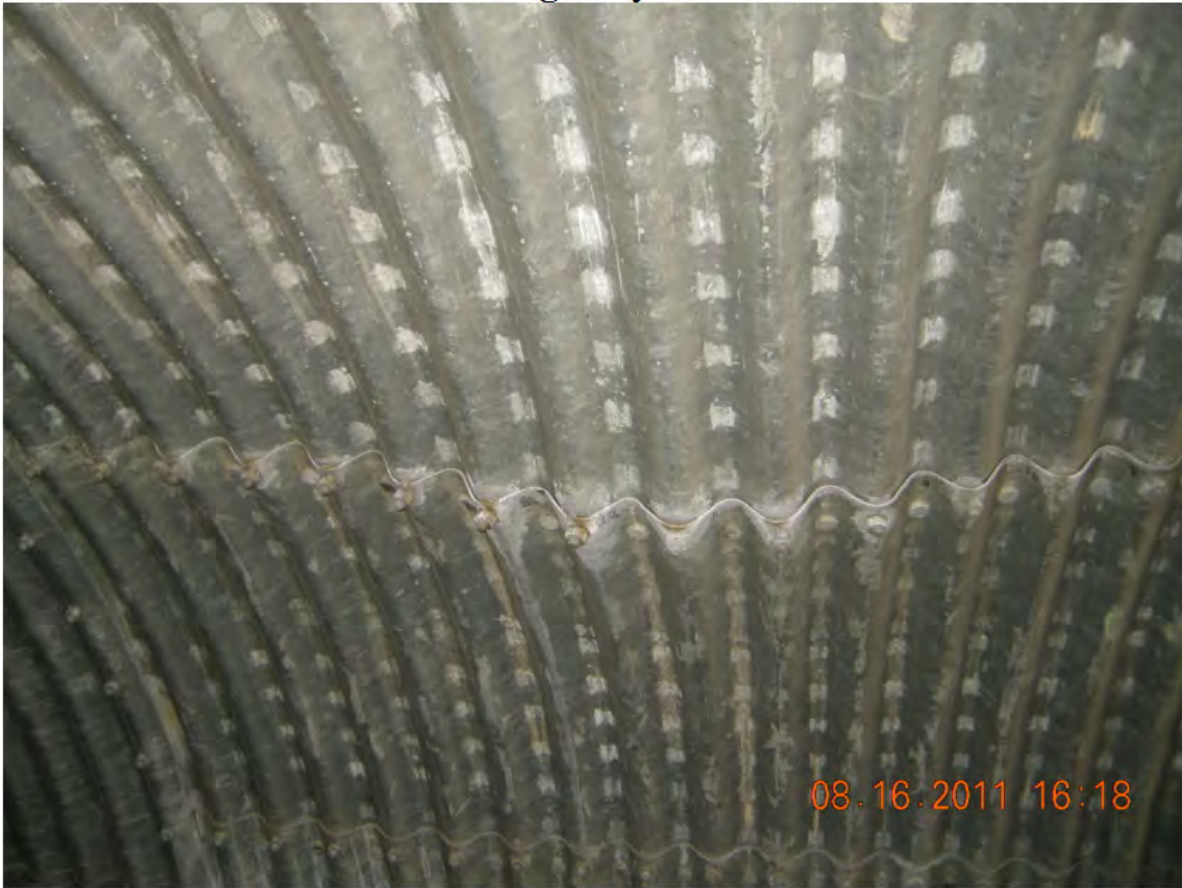
P09 - South Barrel - Ring 5 - Roof Kinked Down ~150 mm

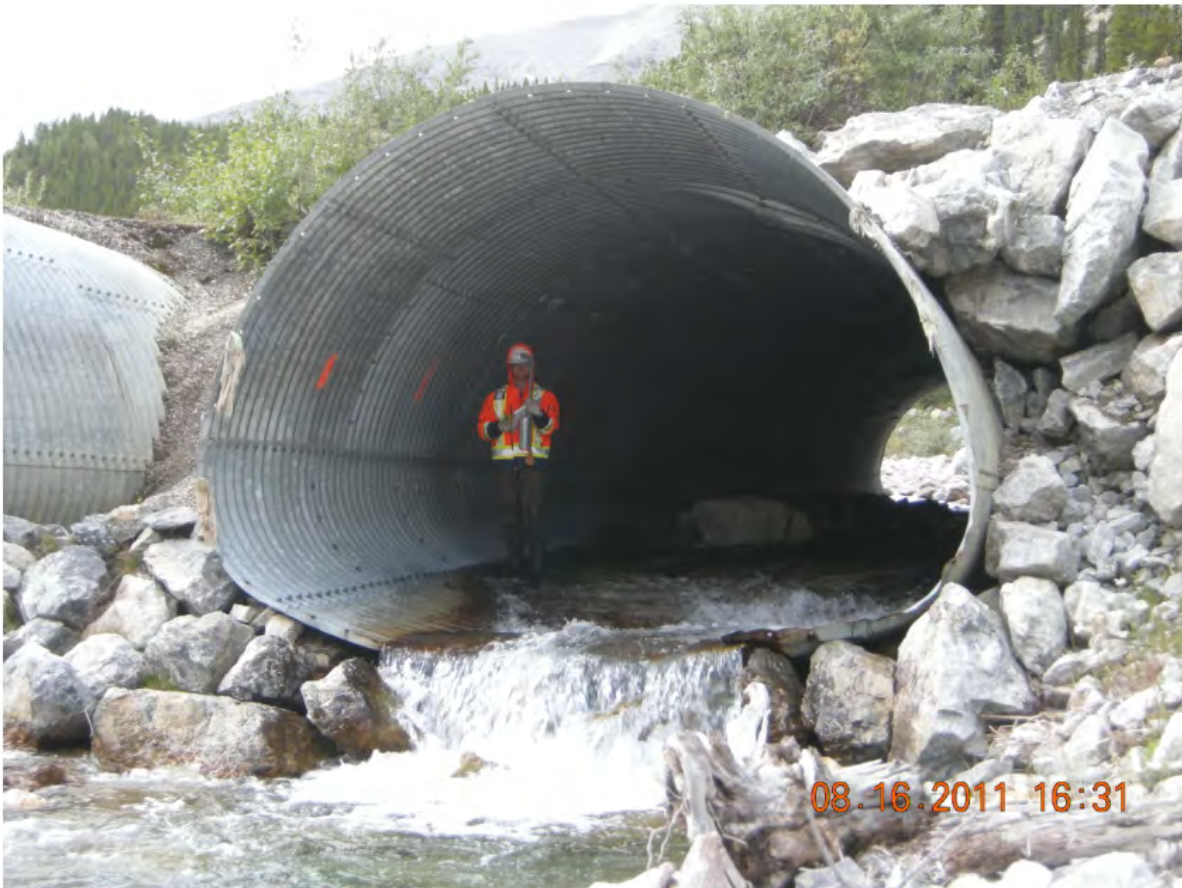
P10 - South Barrel - Floor has Drooped Down ~400 mm in Both Barrels - Collision Damage Kink in Roof at Ring 14

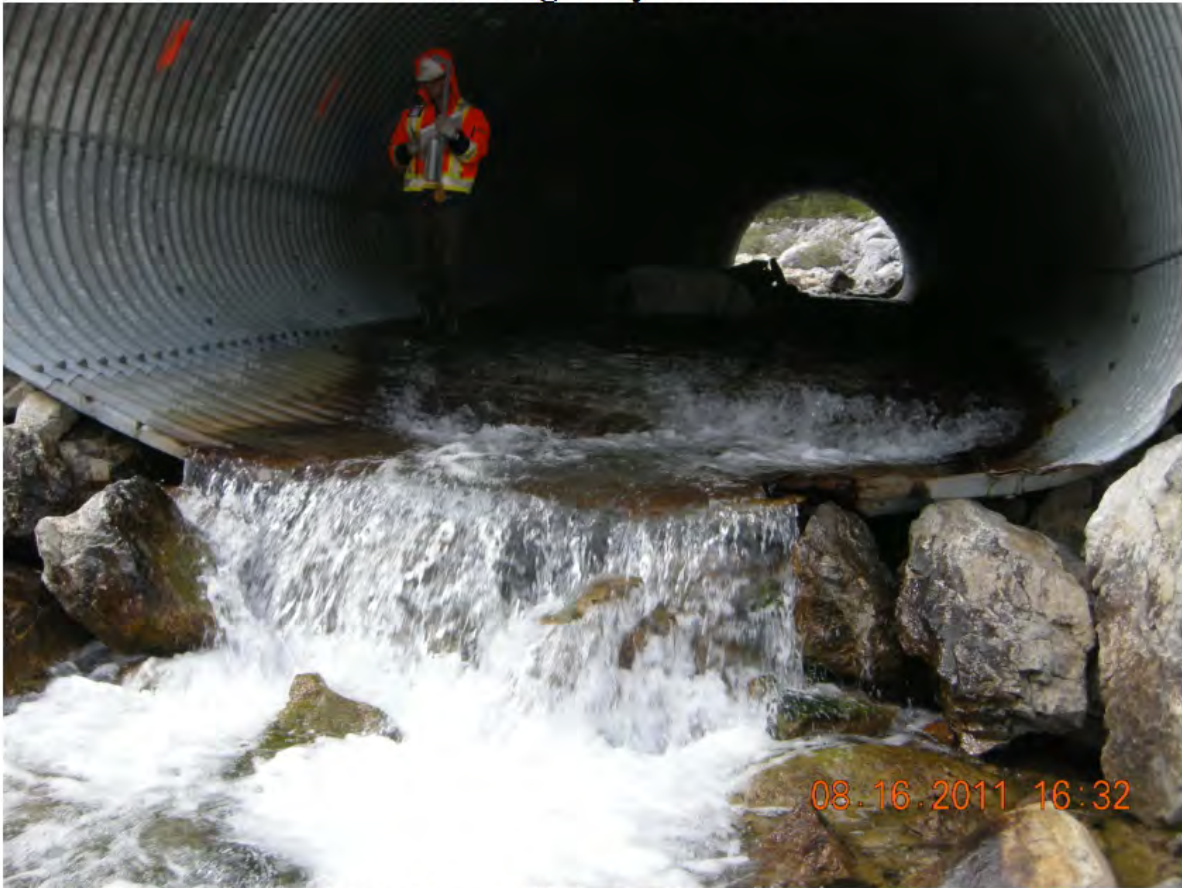
P11 - South Barrel - Outlet - Floor has Drooped Down ~400 mm in Both Barrels Due to Erosion of Supporting Material Below Outlet in Past

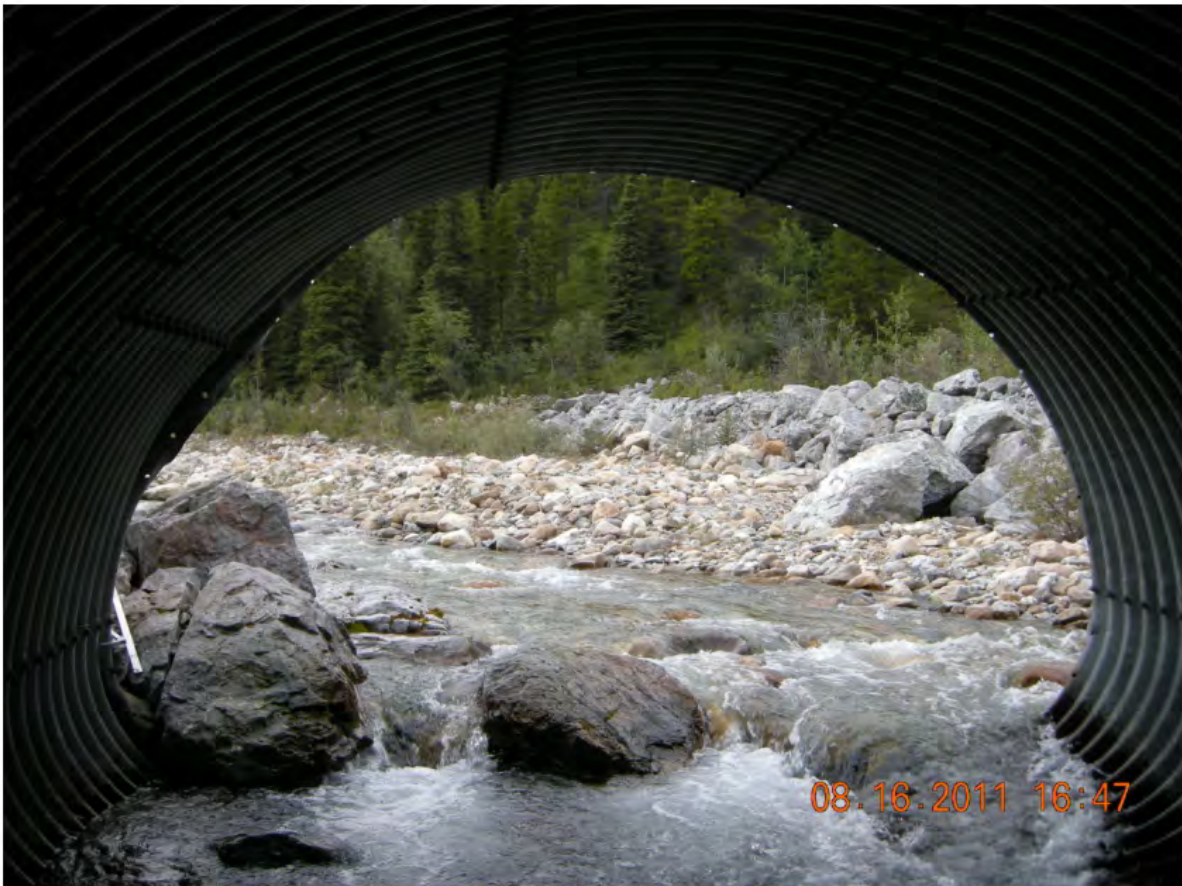
P12 - North Barrel - Inlet Watercourse - Large Riprap in Watercourse

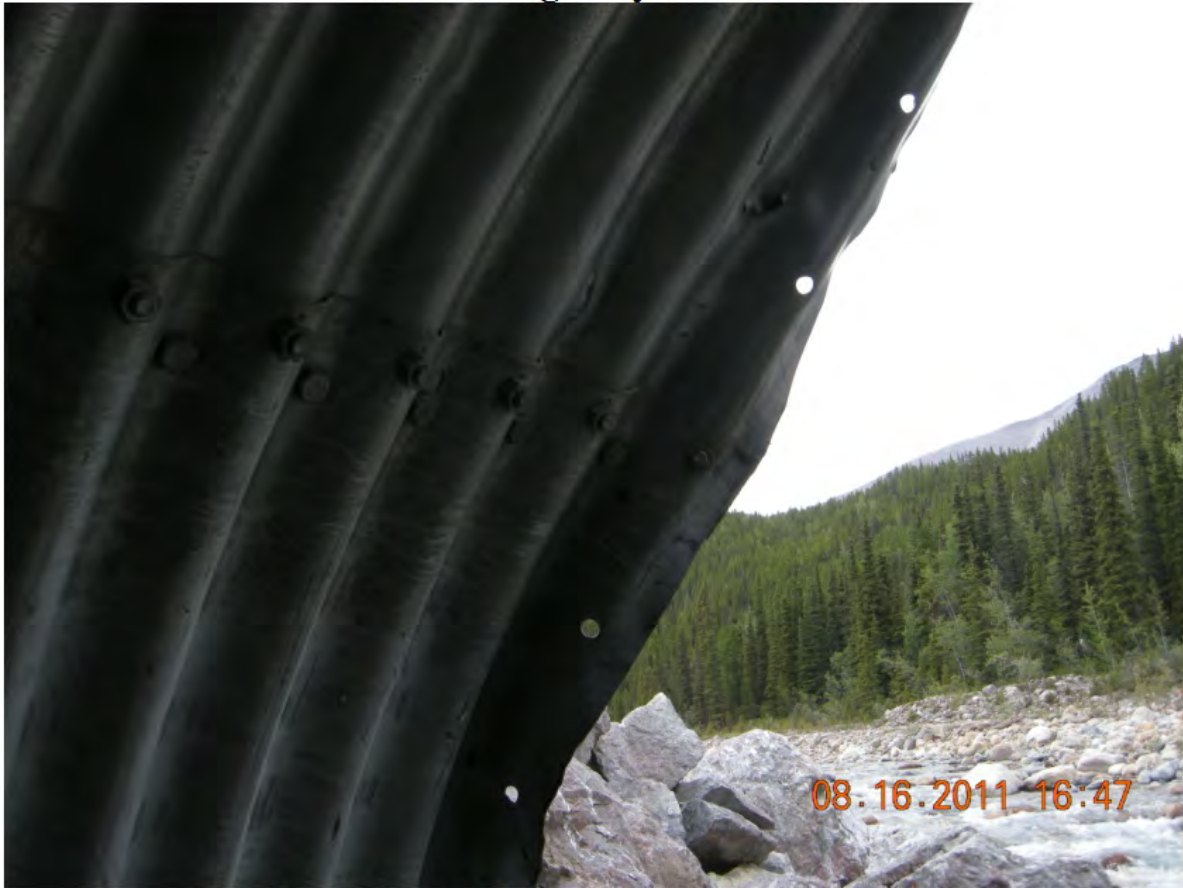
P13 - North Barrel - Minor Collision Damage to Inlet Rim

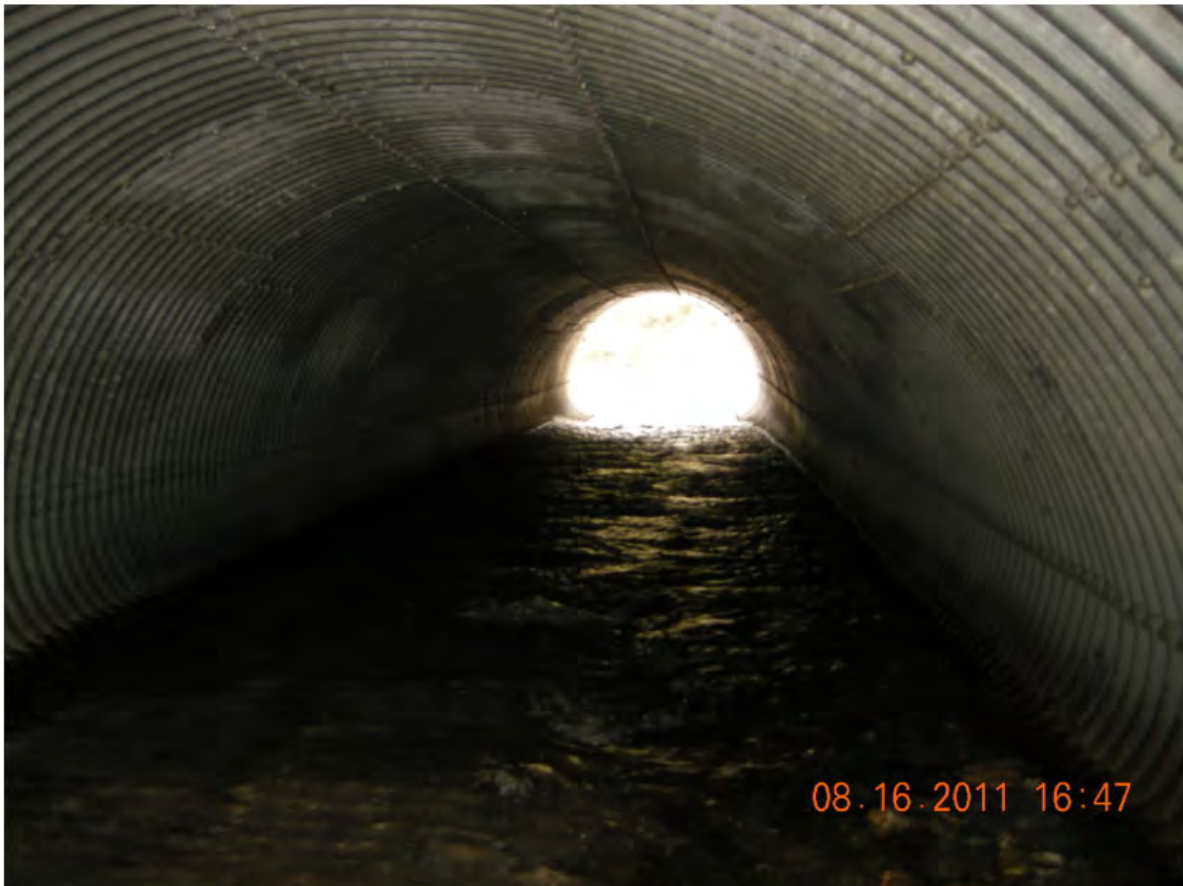
P14 - North Barrel - Looking Towards Outlet

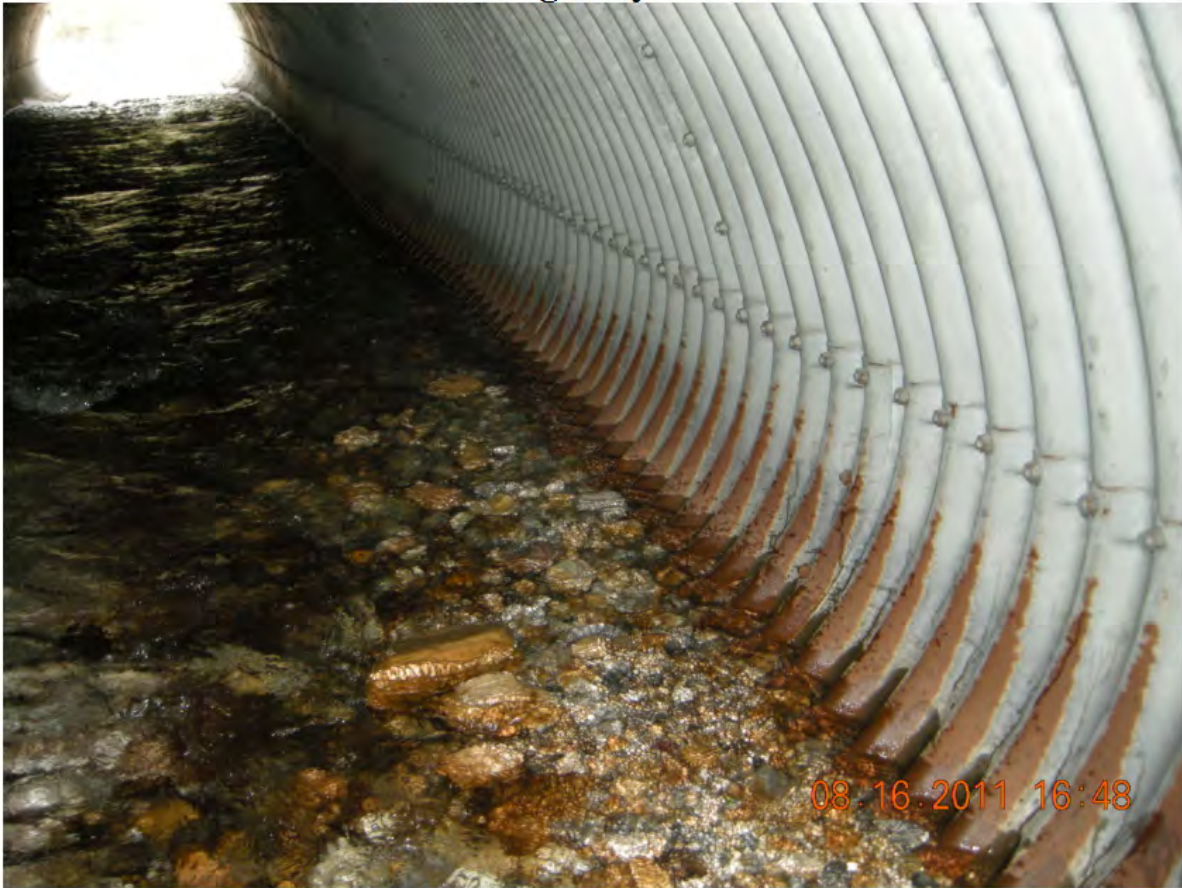
Galvanizing	5	5	D	5	5	D	The galvanizing is in surprisingly good condition with corrosion limited to the bottom of both barrels where galvanizing has been largely removed by stream abrasion.	5-17
Auxiliary Components

P15 - North Barrel - Light Surface Corrosion to High Water Level

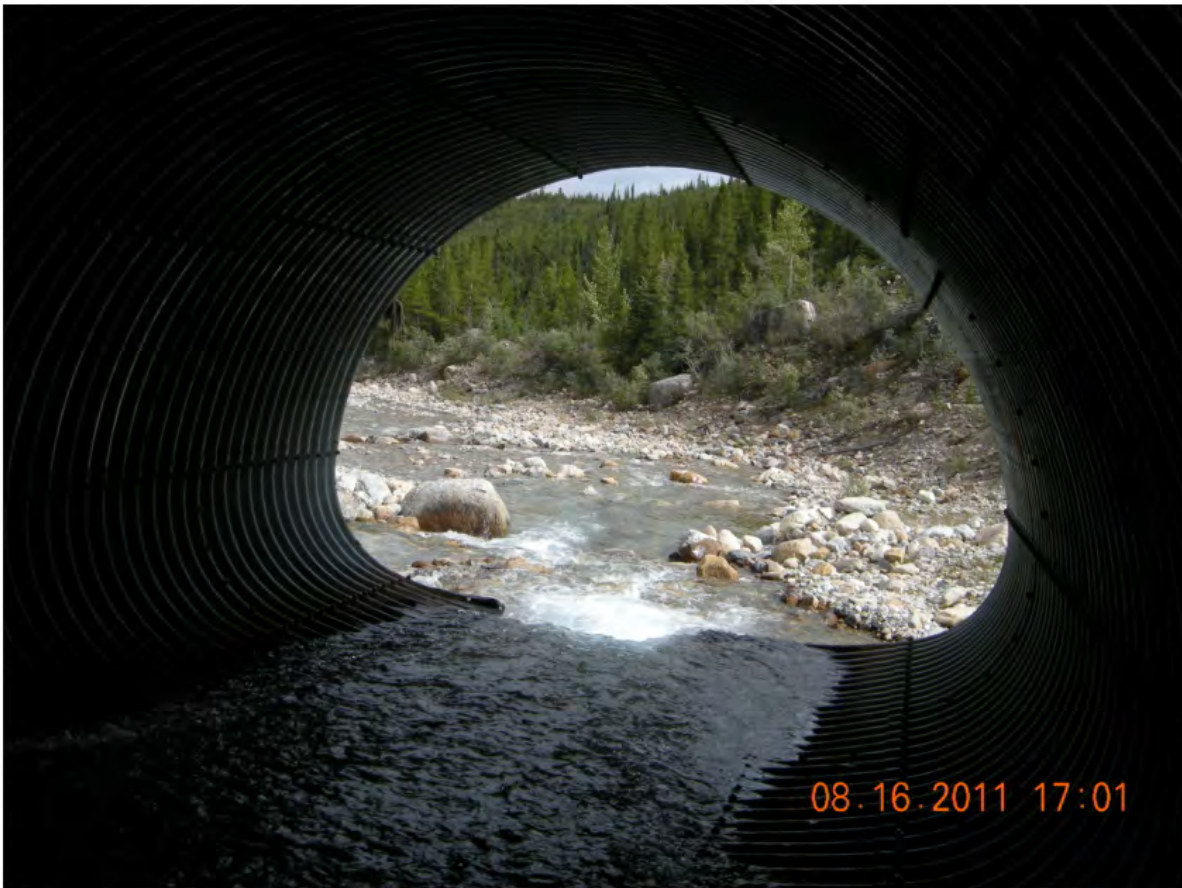
P16 - North Barrel - Floor has Dropped Down ~400 mm in Both Barrels

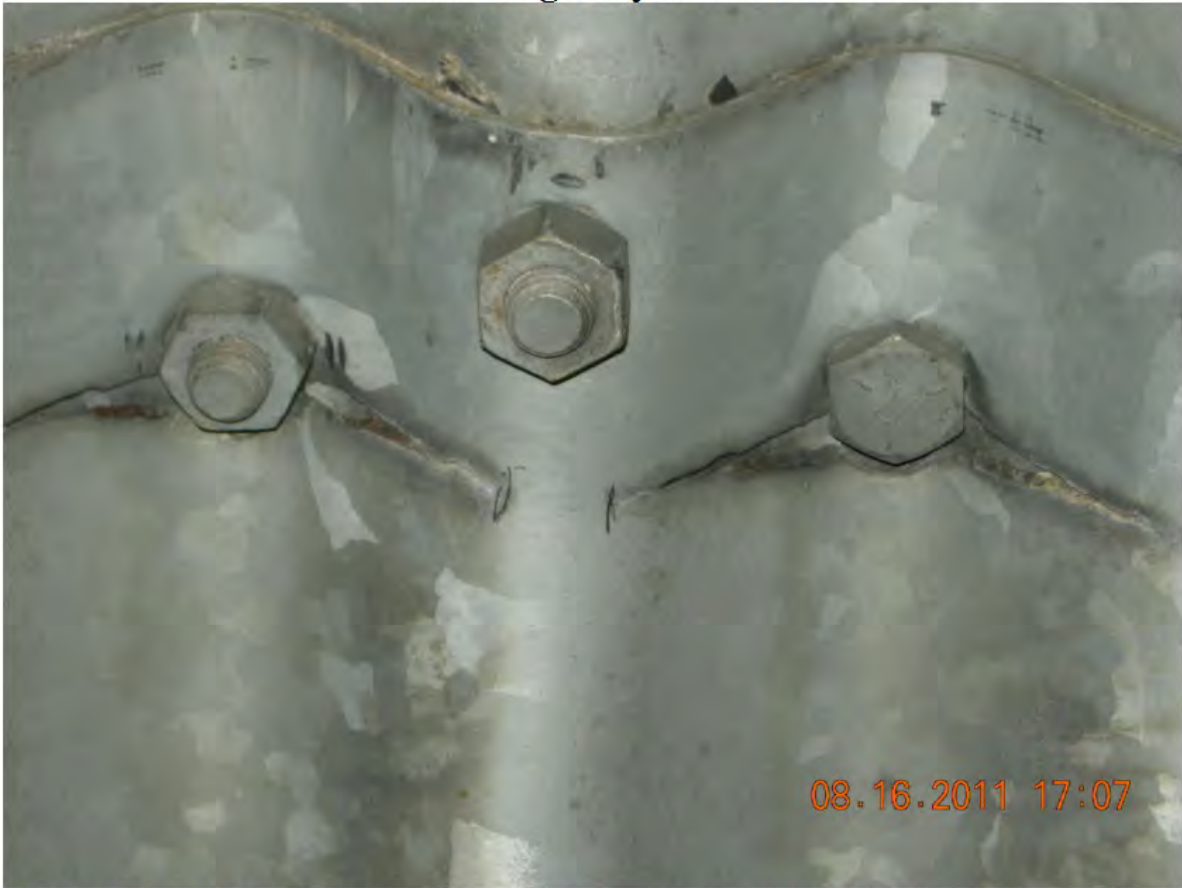
P17 - North Barrel - Longitudinal Cracking in Both Barrels - Ring 4 @ 4:30 - 23 mm Remaining Section

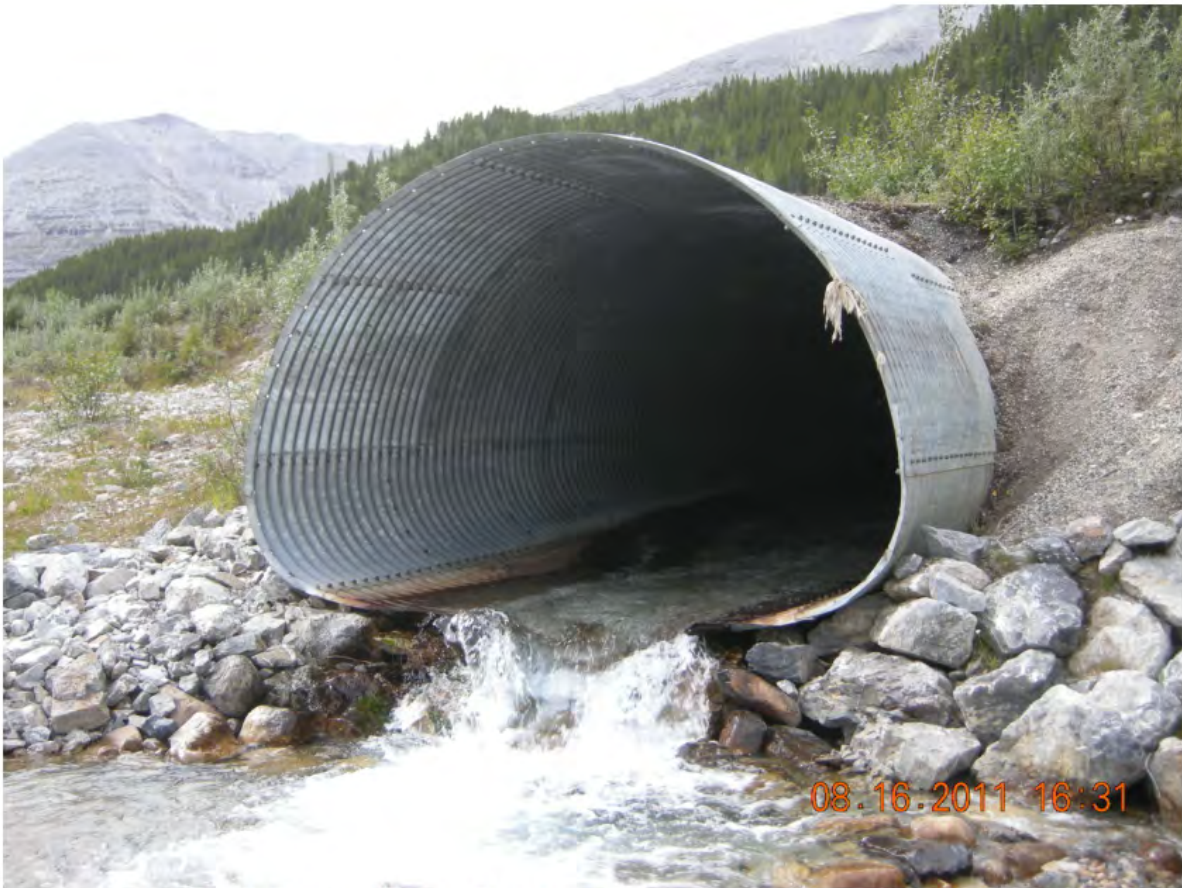
P18 - North Barrel - Outlet - Floor has Drooped Down ~400 mm in Both Barrels

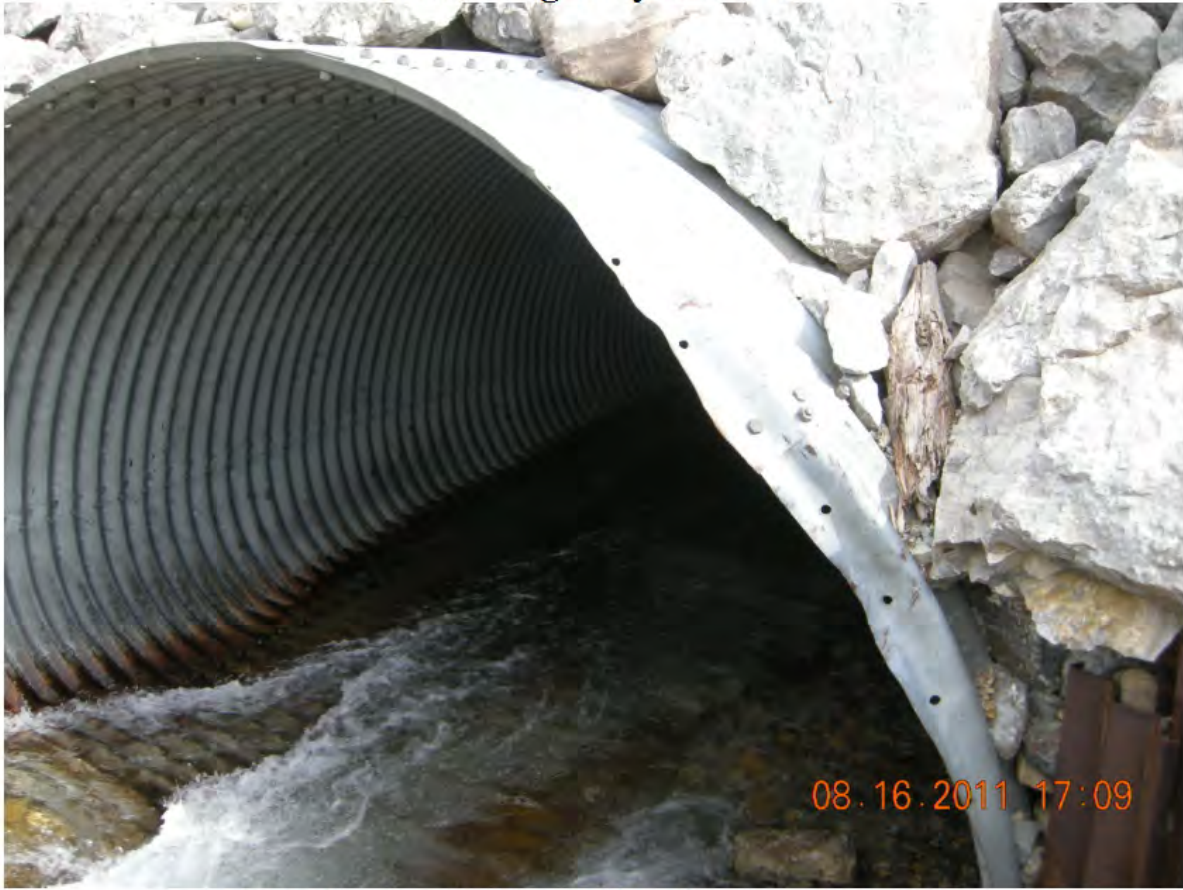
P19 - North Barrel - Minor Collision Damage to Outlet Rim

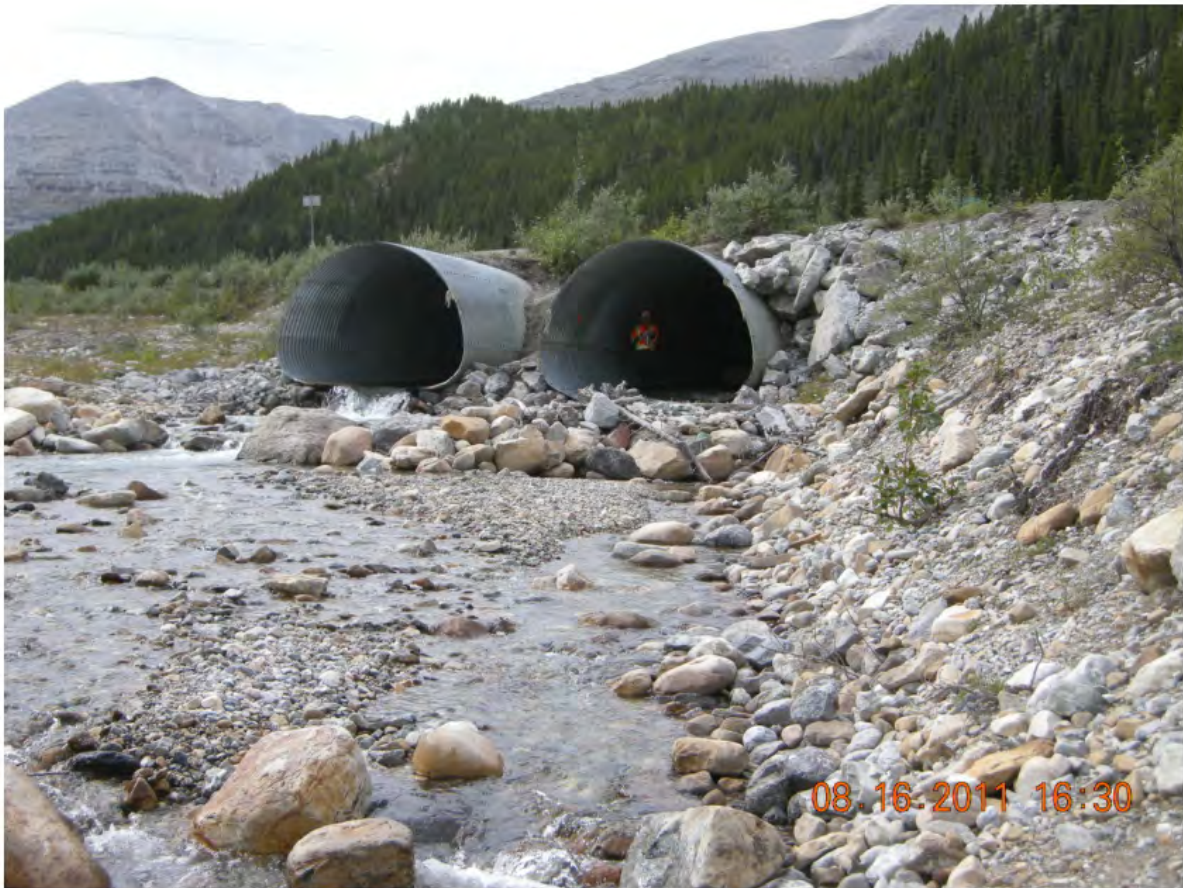
P20 - Outlets and West Embankment

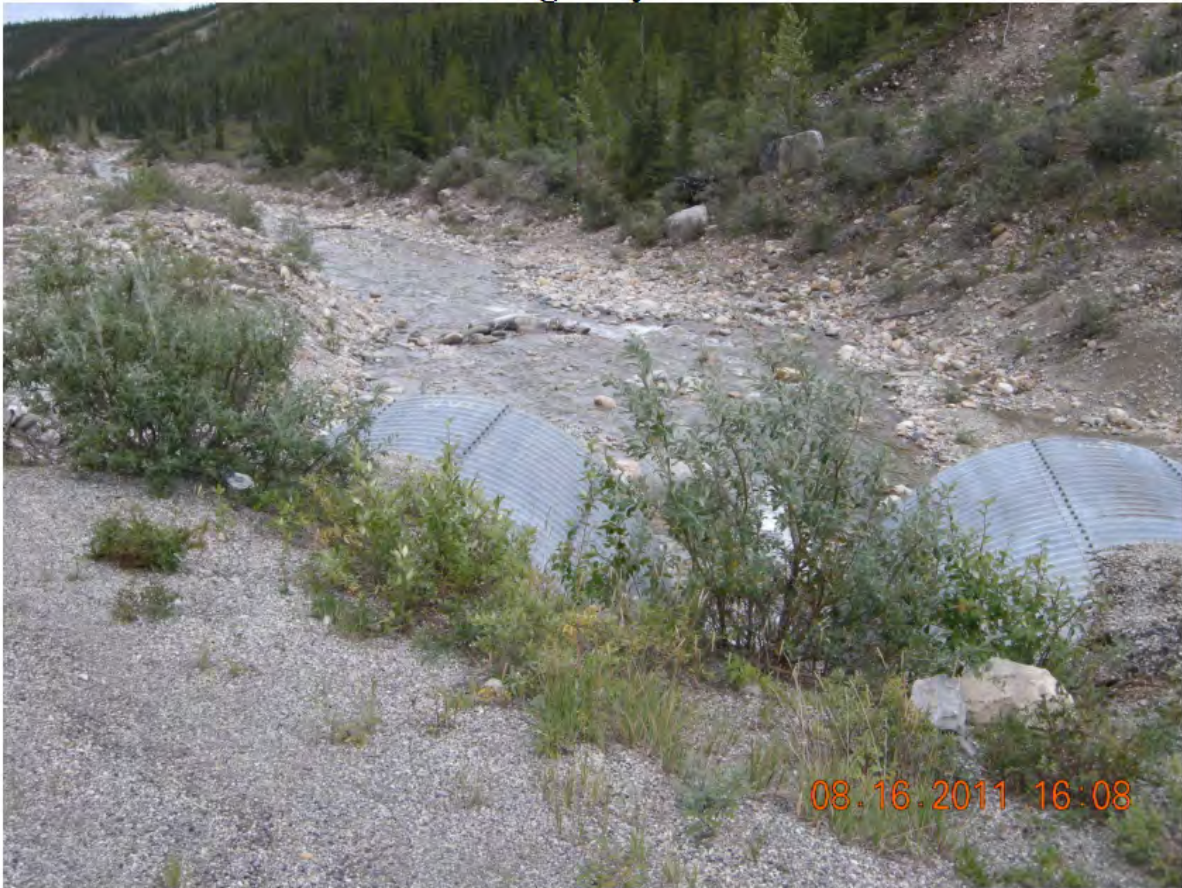
P21 - Downstream Watercourse to the West
