EXECUTIVE SUMMARY

Delcan Corporation (Delcan) has been retained by Public Works and Government Services Canada to conduct visual evaluations of 56 bridge structures and 6 culvert structures along the British Columbian portion of the Alaska Highway in both 2009 and 2011. Also, as part of this contract, Delcan was to complete live load capacity factor structural evaluations for 11 of the Alaska Highway bridge structures. In 2009, Delcan performed 6 of these live load capacity factor structural evaluations: Beaton River at km 232.8, Sikanni Chief River at km 256.1, Buckinghorse River at km 277.6, Bougie Creek at km 357.4, Adsett Creek at km 366.0, and Jackfish Creek at km 424.8. Enclosed in this submission are the live load capacity factor structural evaluations performed for the 5 other bridge structures: Kledo River at km 509.1, Steamboat Creek at km 515.3, Tetsa River 1 at km 584.6, Toad River at km 671.7, and Peterson Creek at km 678.6. Also enclosed are the 2009 condition inspection reports for these 5 bridges.

Kledo River Bridge, Alaska Highway, km 509.1 Live Load Capacity Factor Structural Evaluation

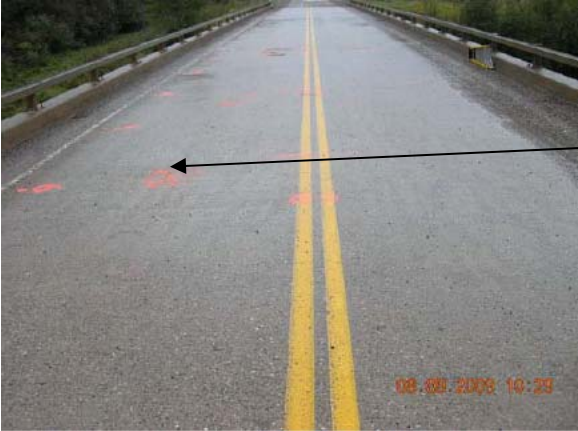
Figure 4: Deck.

Locations of Deck
Delaminations (Typical).

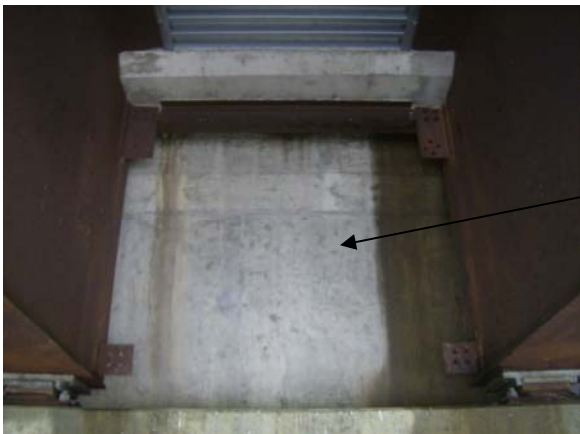
Figure 9: End Bracing.

It is important to point out that Kledo River Bridge's end diaphragm cross-bracing between its two box girders at each end of this bridge has been improperly removed and should be replaced. Delcan modeled this bridge in its current (existing) condition with the end diaphragm cross-bracings removed.

Improperly Removed Transverse End Bracing from Between Box Girders (Similar at Each End of Span).

There are no major load capacity issues with Kledo River Bridge and no posting is required. No LLCFs for Kledo River Bridge are less than 1 for the ultimate limit state. The existing end transverse bracing between the box girders is not as shown on the original structural drawings (i.e. it is missing). It is important that this bracing be added in the field as soon as possible. Part of the 2009/2011 contract that Delcan has with PWGSC is to prepare sketches for the addition of these secondary members.

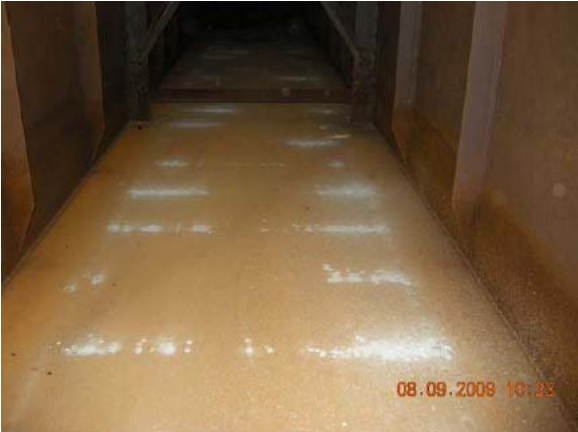
Figure 12: Efflorescence Staining Inside of Both Box Girders.

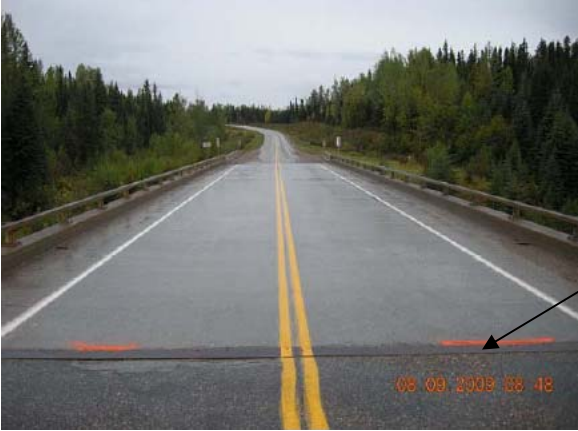
Figure 4: Deck.

Locations of Deck
Delaminations (Typical).

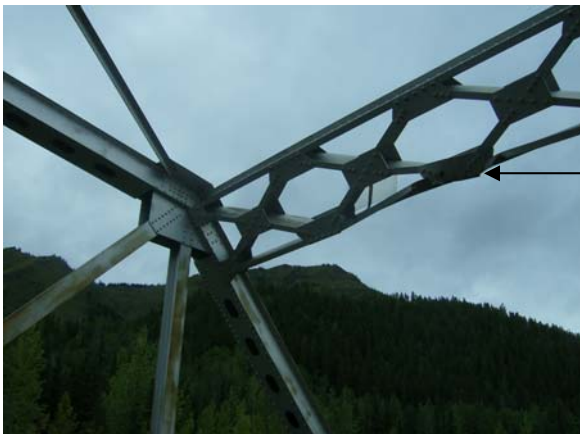
Figure 16: Typical End Portal Lateral Bracing.

Damaged Members Caused
by Vehicle Collision.

- **Tetsa River Bridge #1:** There are no major load capacity issues with Tetsa River Bridge #1 and no posting is required. No LLCFs for Tetsa River Bridge #1 are less than 1 for the ultimate limit state. The damaged portal and sway frame through-truss top chord lateral bracing should be repaired/replaced in the field as soon as possible. Part of the 2009/2011 contract that Delcan has with PWGSC is to prepare repair sketches for these damaged secondary members.

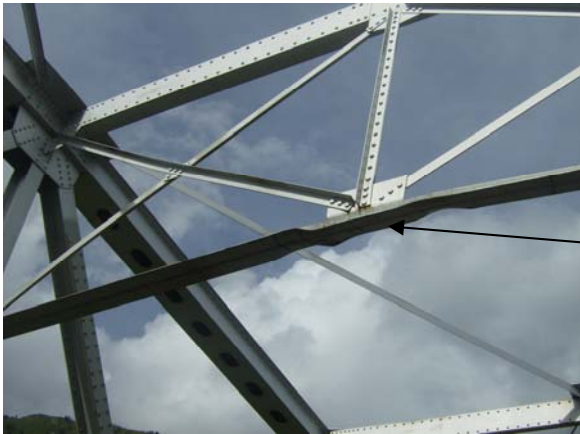
Figure 17: Typical Intermediate Sway Frame Lateral Bracing.

Damaged Members Caused
by Vehicle Collision.

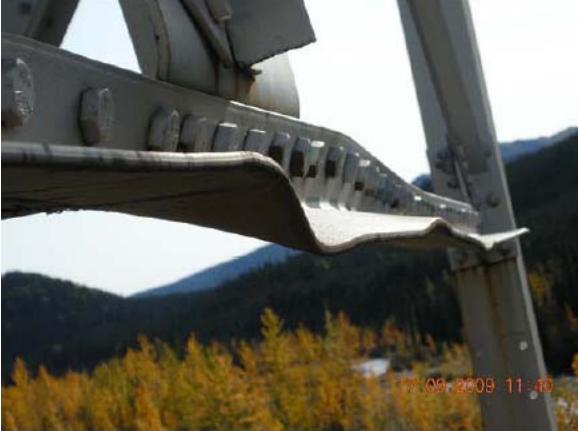
Figure 18: Example of Typical Vehicle Collision Damage to Truss Lateral Bracing.

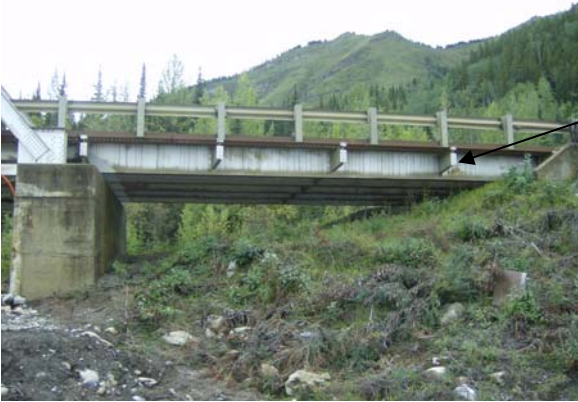
Figure 19: Jackspan.

Unused Steel Brackets Still Attached to Exterior Sides of Exterior Jackspan Girders.

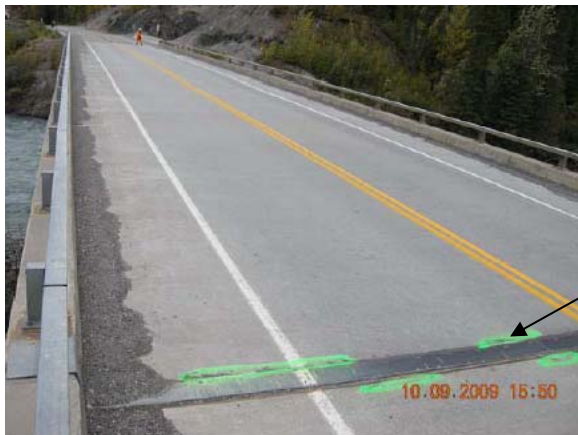
Figure 4: Deck.

Locations of Deck
Delaminations (Typical).

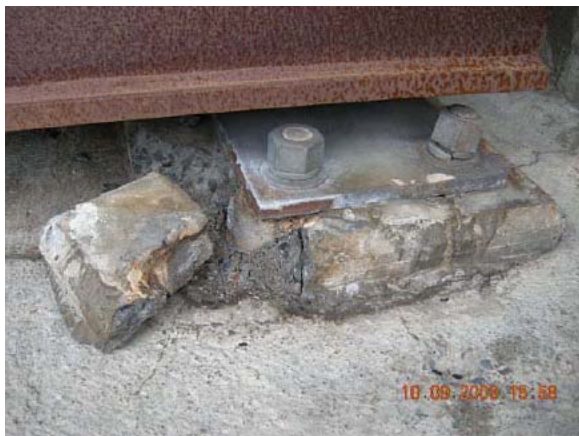
Figure 14: Typical Spalling of Bearing Seats.

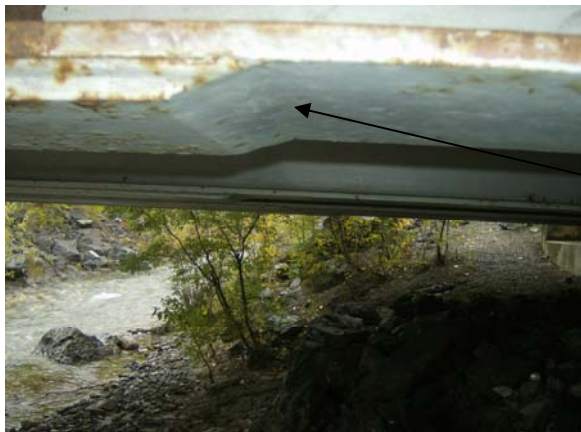
Figure 6: Plates Welded to Girder Bottom Flanges.

Stiffening Plates Welded Along Centre Portions of Girders' Bottom Flanges (from the Time of Original Construction).
