# Muskwa River Bridge Alaska Highway km 451.8

**ELEVATION**

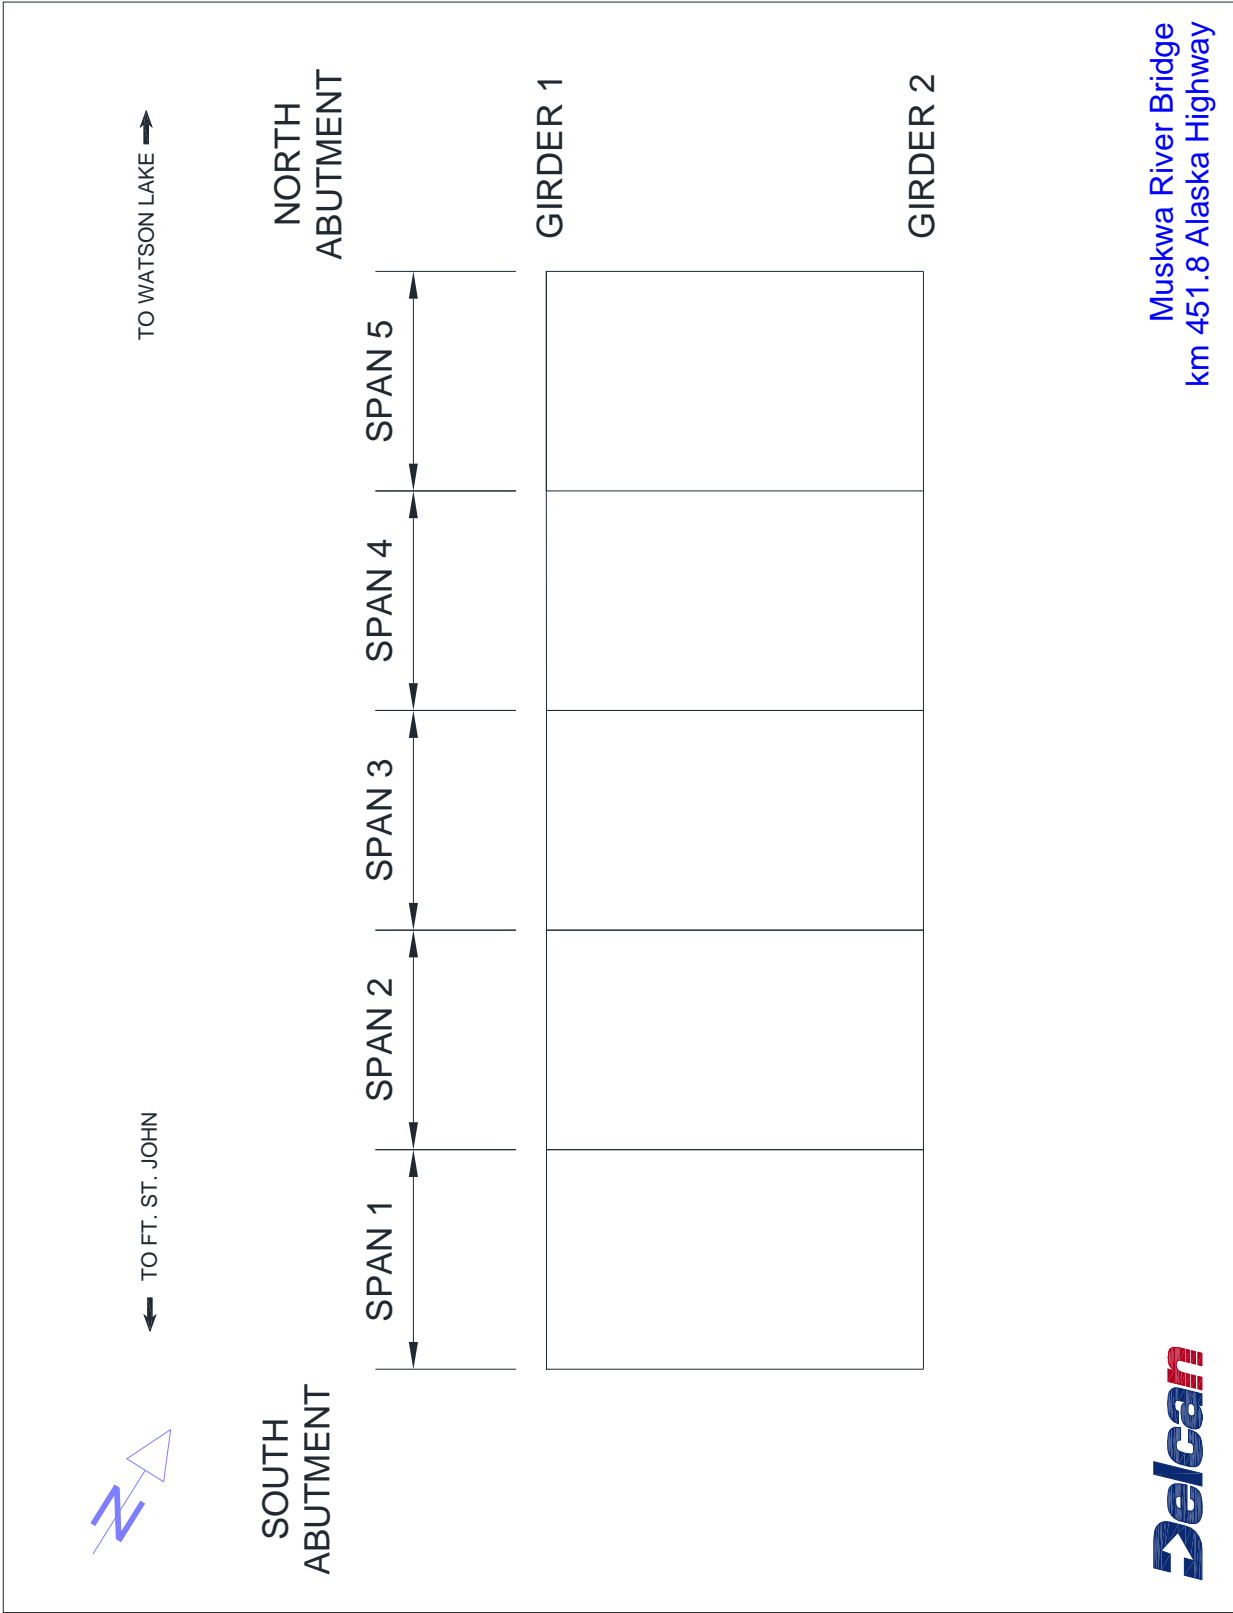
# Muskwa River Bridge

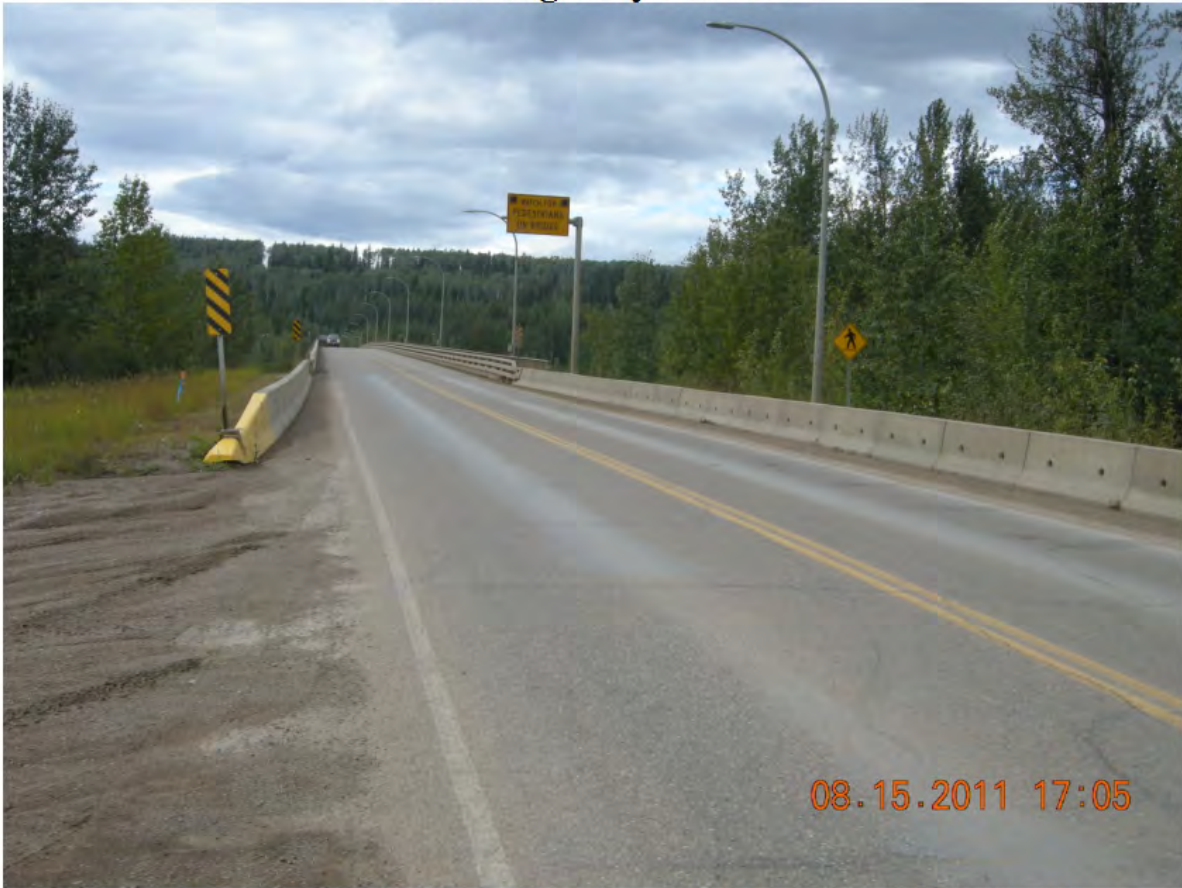
**P01 - South Approach - Looking North - 3 Delineators in Place but River Name Sign Missing**

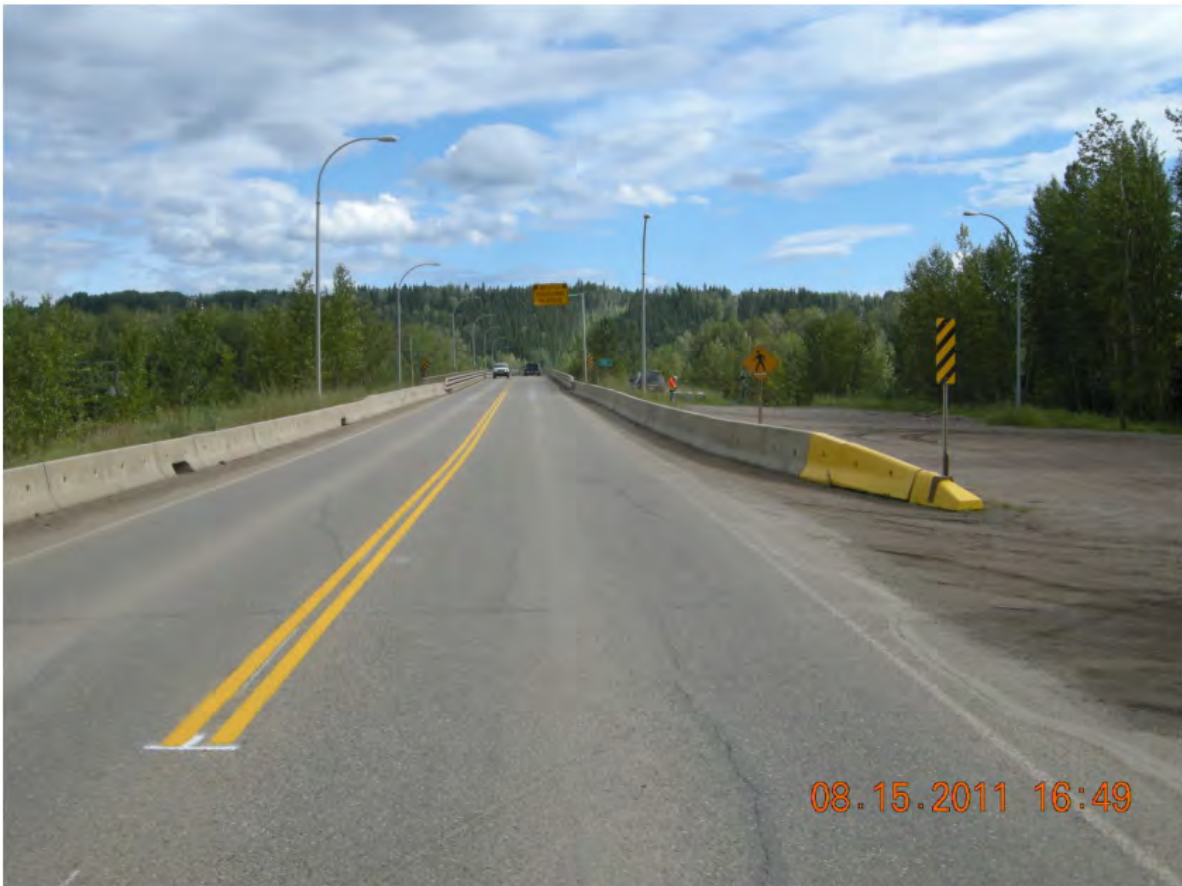
**P02 - North Approach - Looking South - All Delineators and River Name Sign in Place**

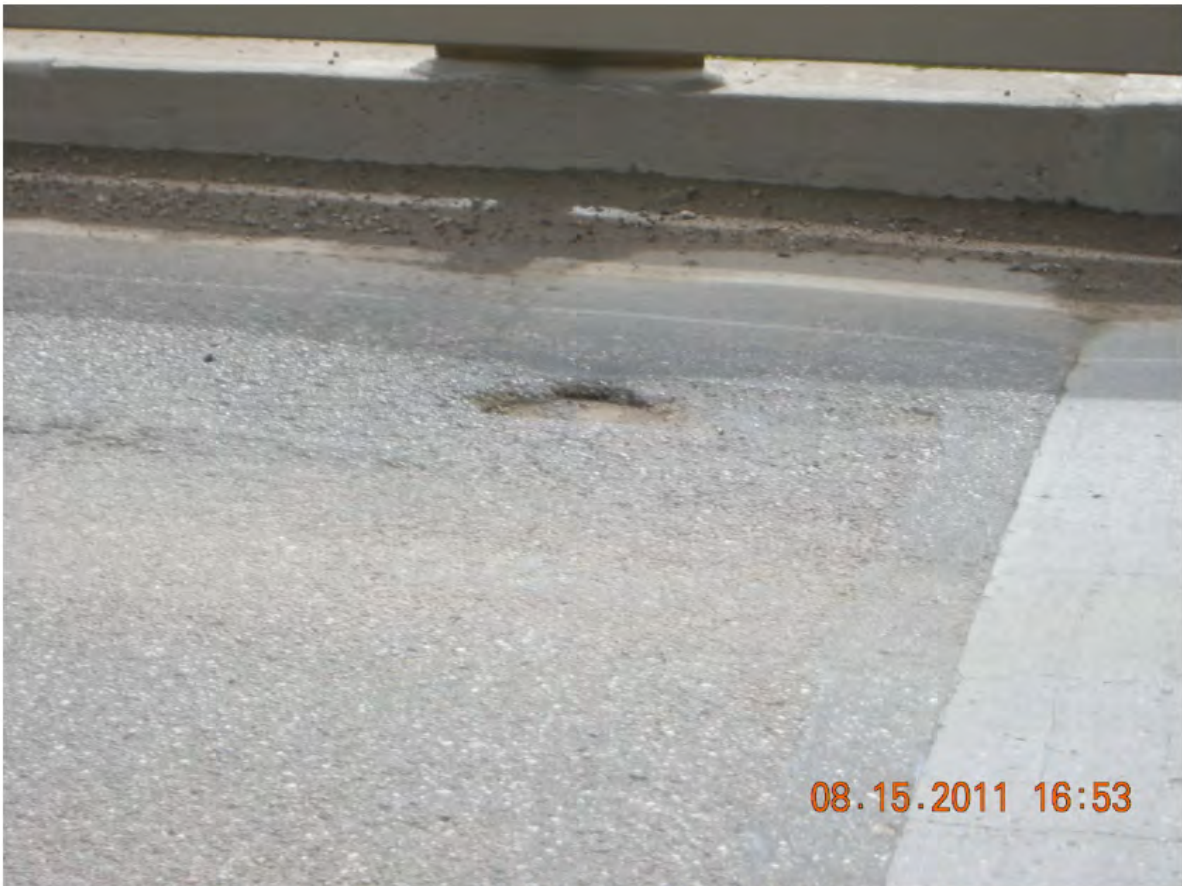
**P14 - Small Pothole in Asphalt Wearing Surface at NW Corner of Bridge**

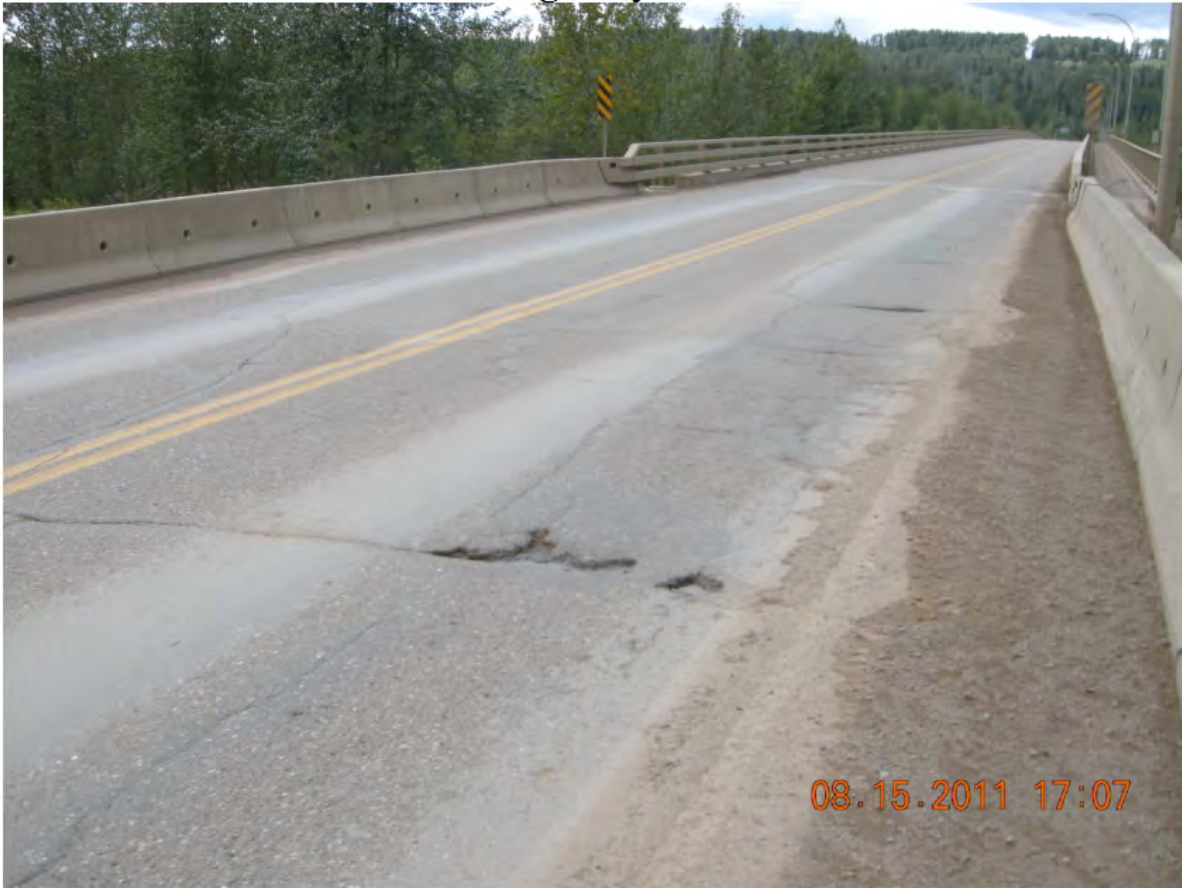
**P15 - South Approach - Wide Transverse Cracks and Pot Holes in Asphalt**

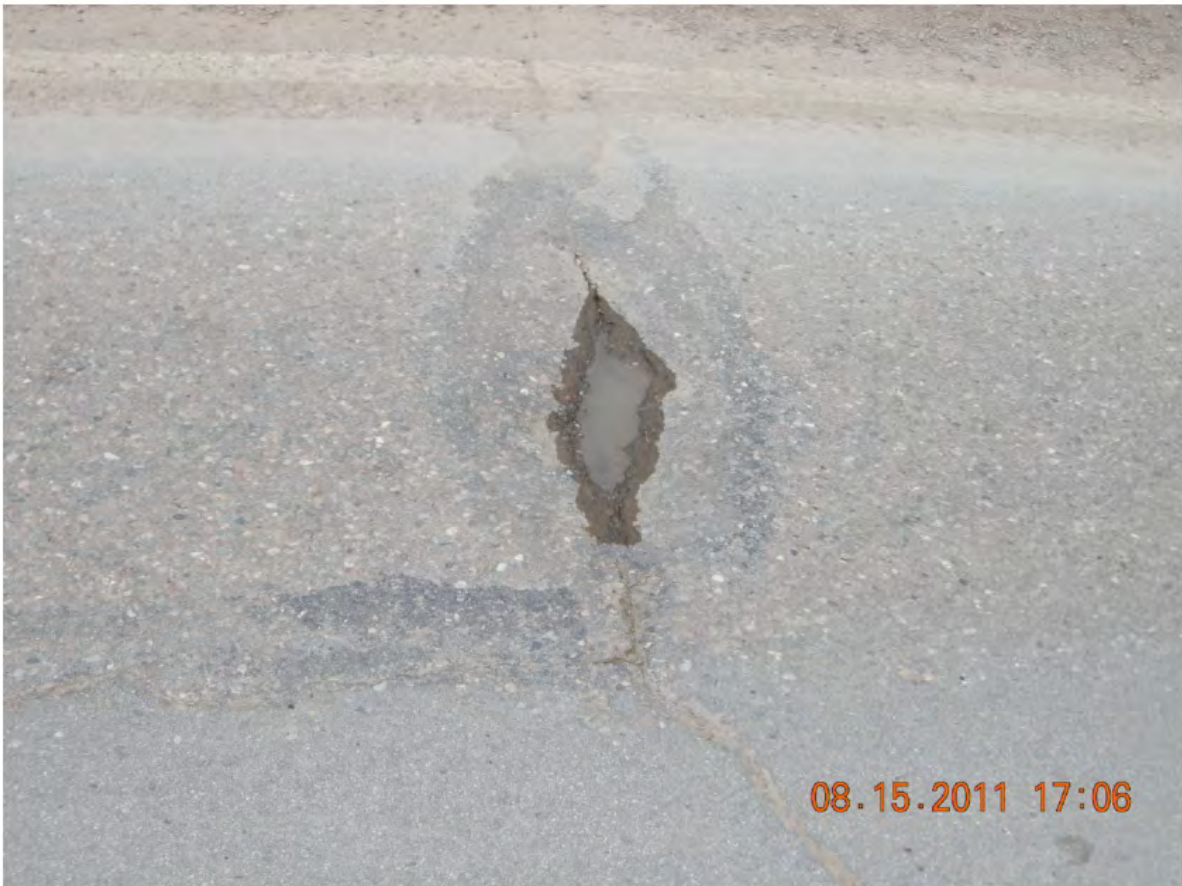
**P16 - South Approach - Wide Transverse Cracks and Pot Holes in Asphalt**

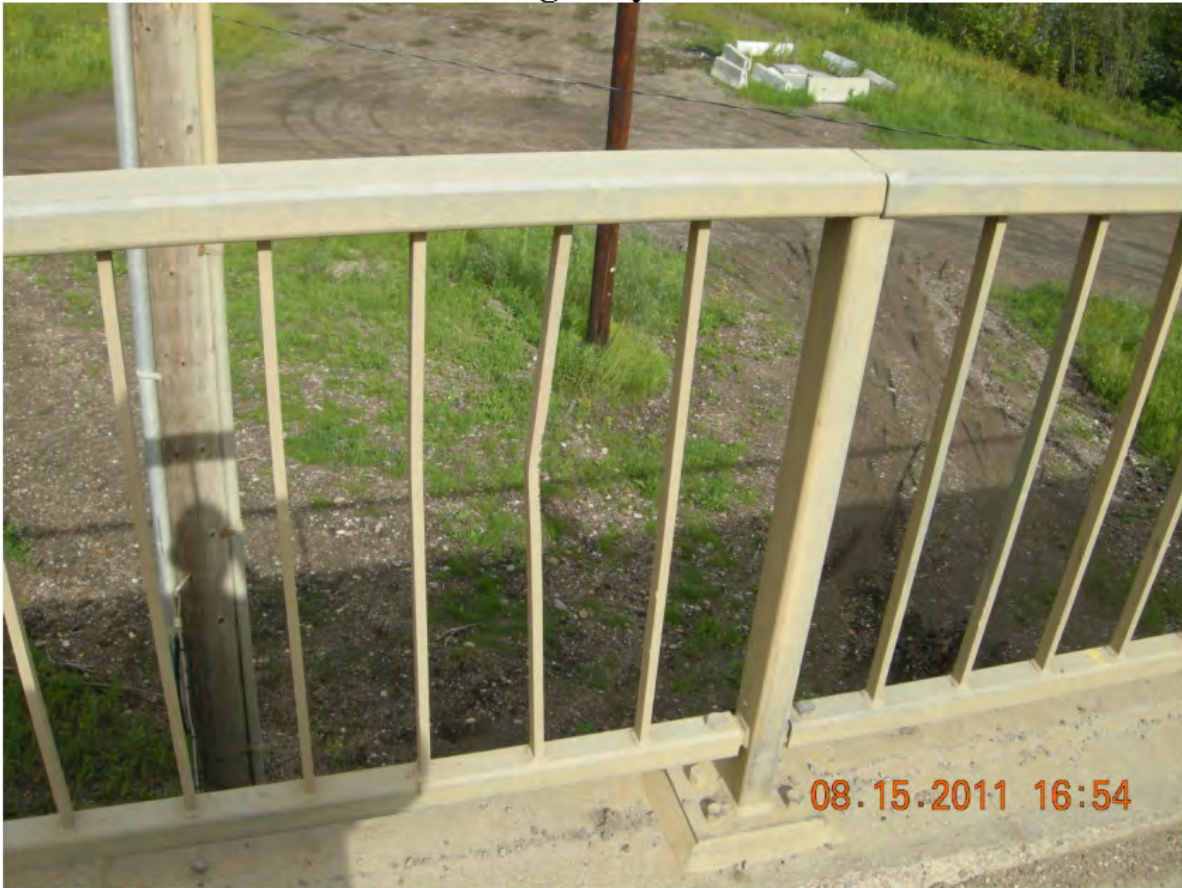
**P17 - Galvanized Steel Pedestrian Railing on East Side - Minor Collision Damage in Several Locations**

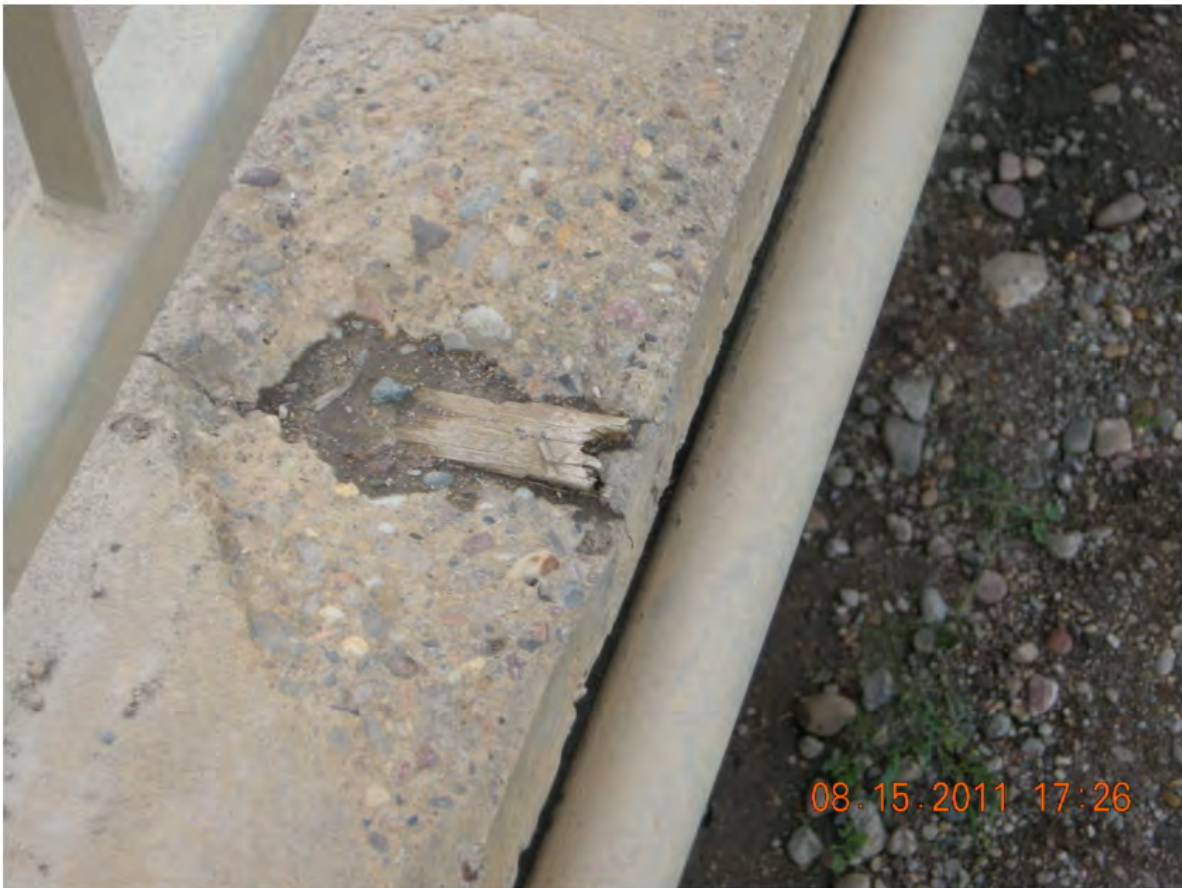
**P18 - Span 5 - East Curb Spalled ~60 mm Deep with Timber Formwork Embedded**

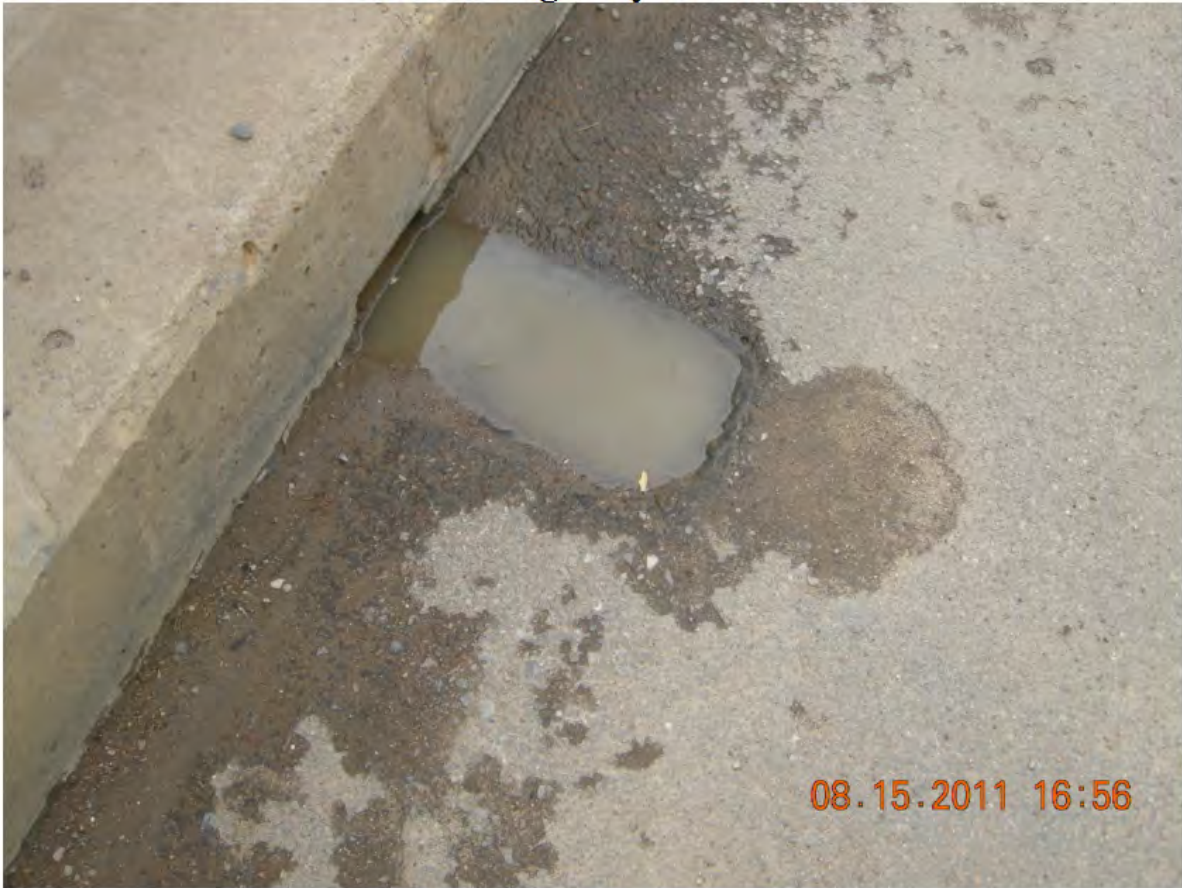
**P19 - Some Deck Drains Plugged**

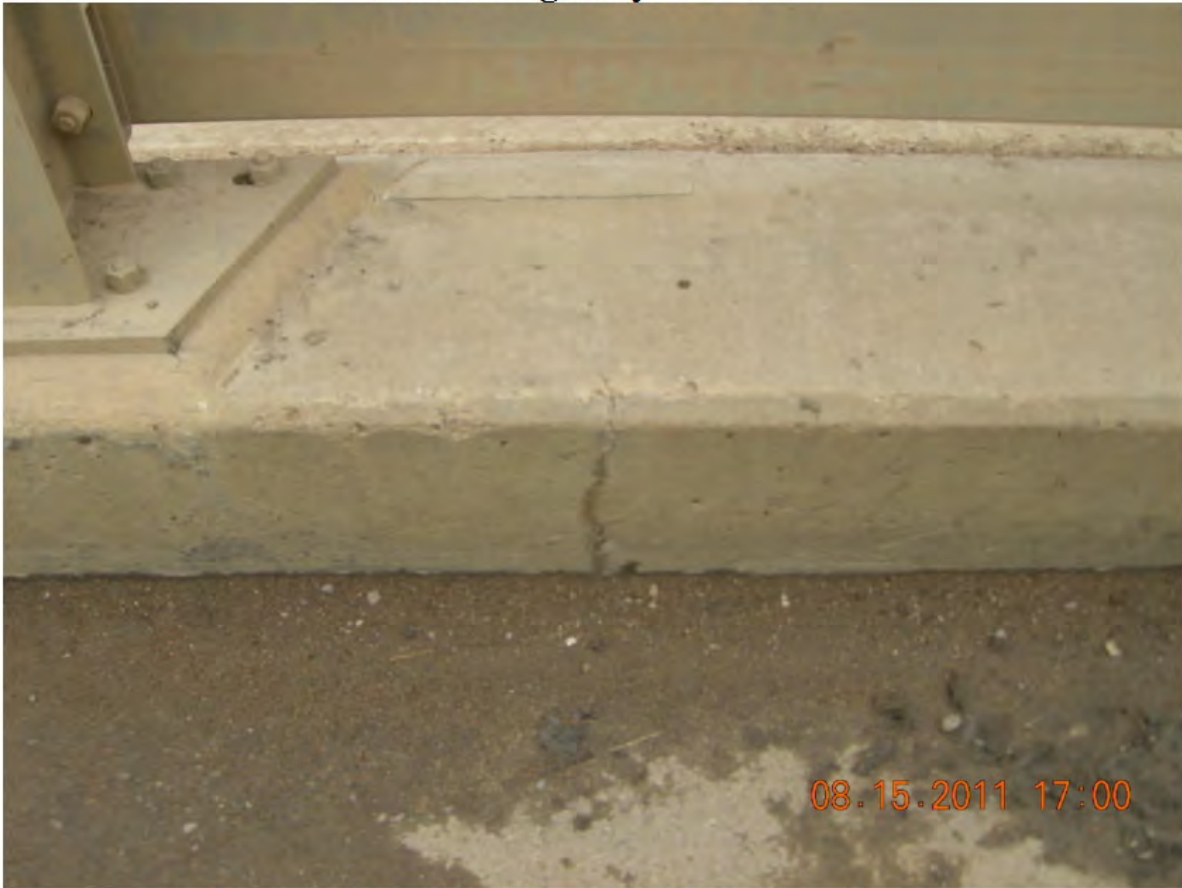
**P21 - East Curb - Random Narrow Shrinkage Cracks Throughout**

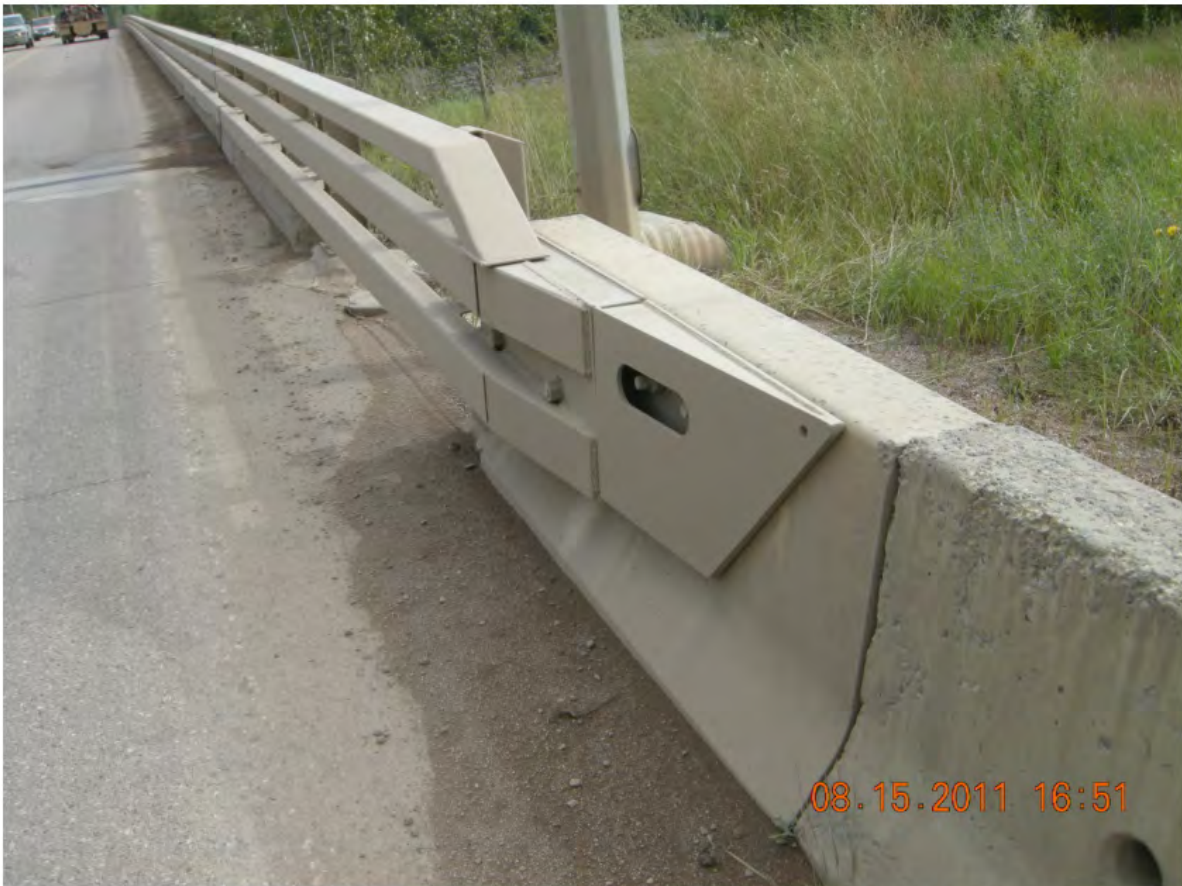
**P22 - NW Bridge Railing - Concrete Approach Barrier Transition**

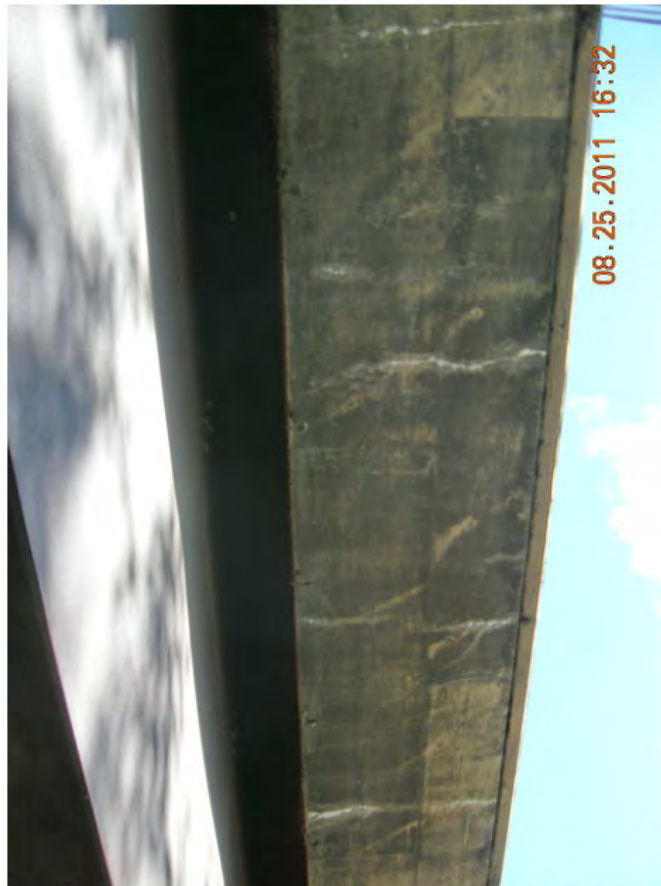
**P28 - Span 2 - Narrow Transverse Cracks in Cantilevers - Typical - No Sign of Recent Moisture Staining**

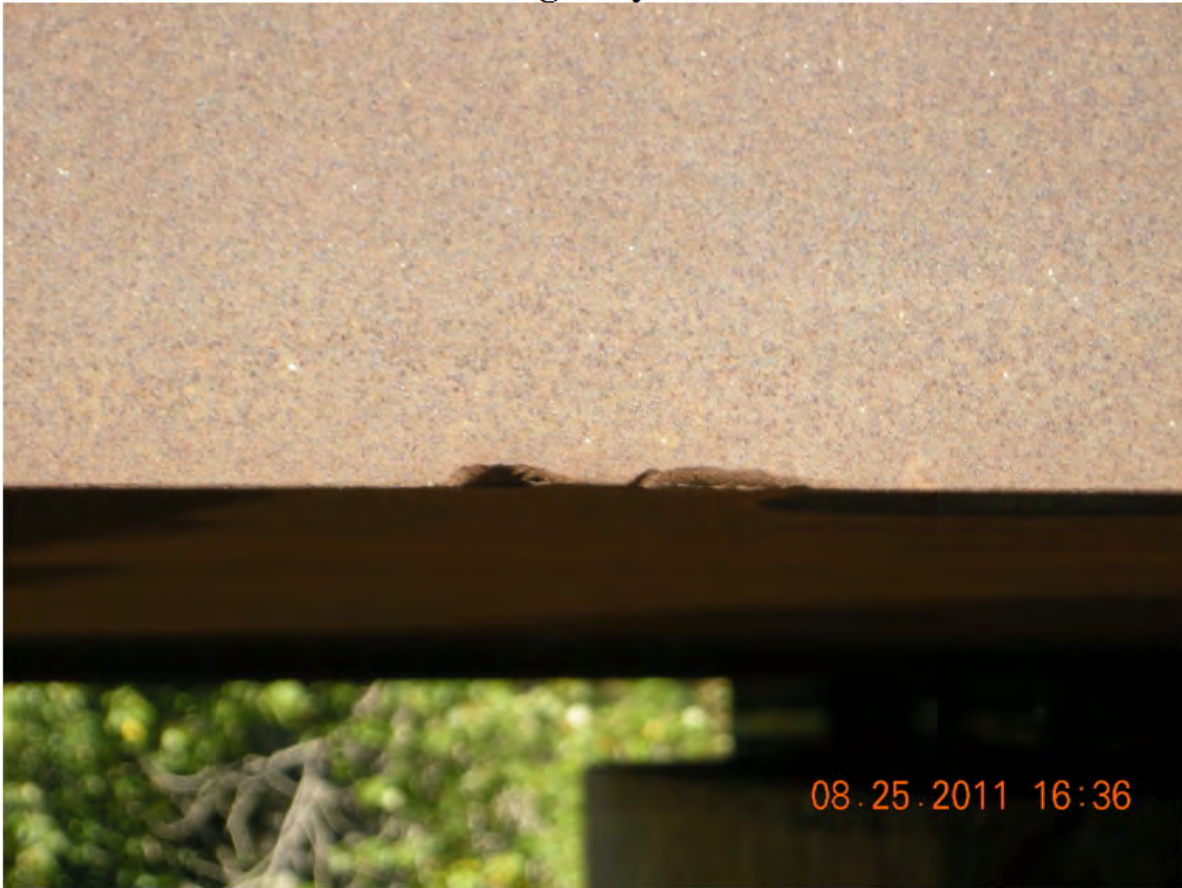
**Muskwa River Bridge  
Alaska Highway km 451.8**

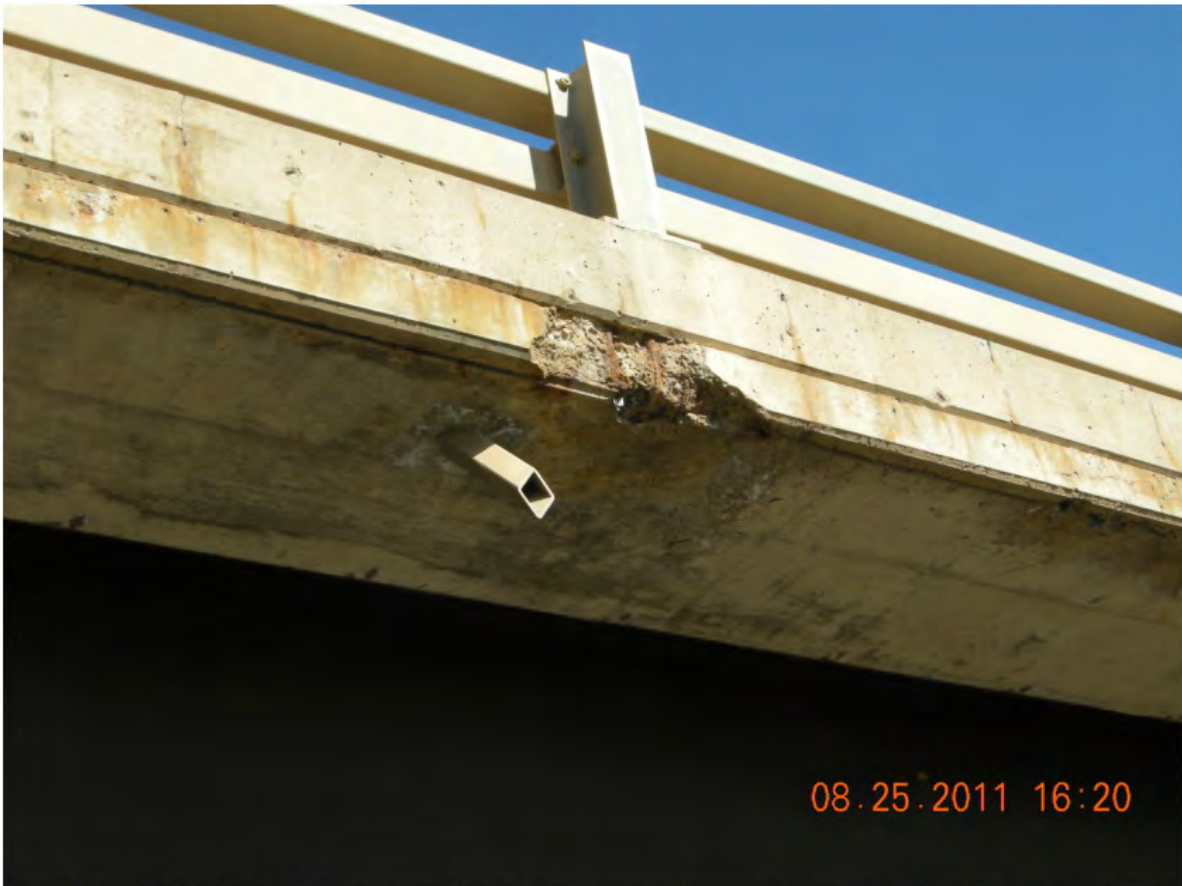
**P32 - Span 3 - Spall in West Cantilever Facia ~60 mm Deep with Exposed Rebar at Midspan**

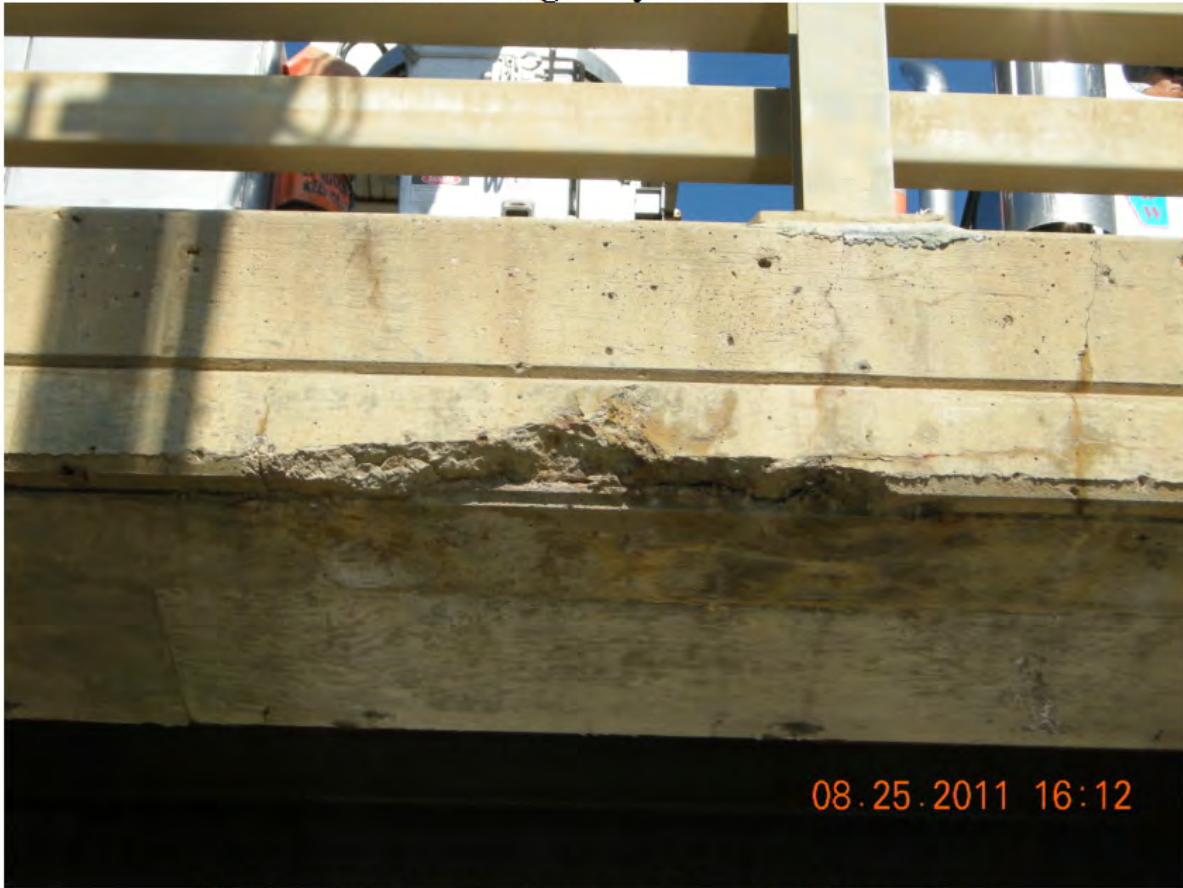
**P33 - Span 3 - Spall in West Cantilever Fascia ~40 mm Deep at Pier 3**

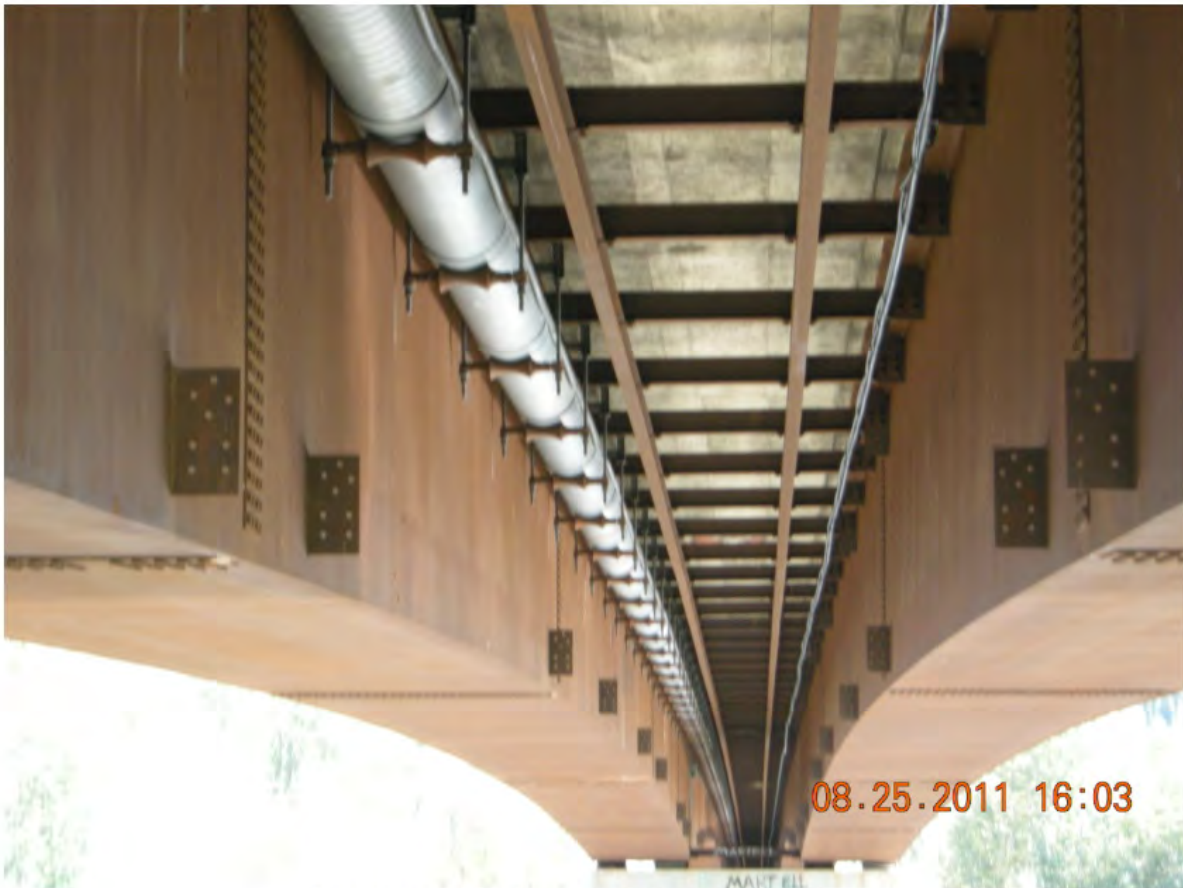
**P34 - Span 4 Girders and Soffit - Looking South**

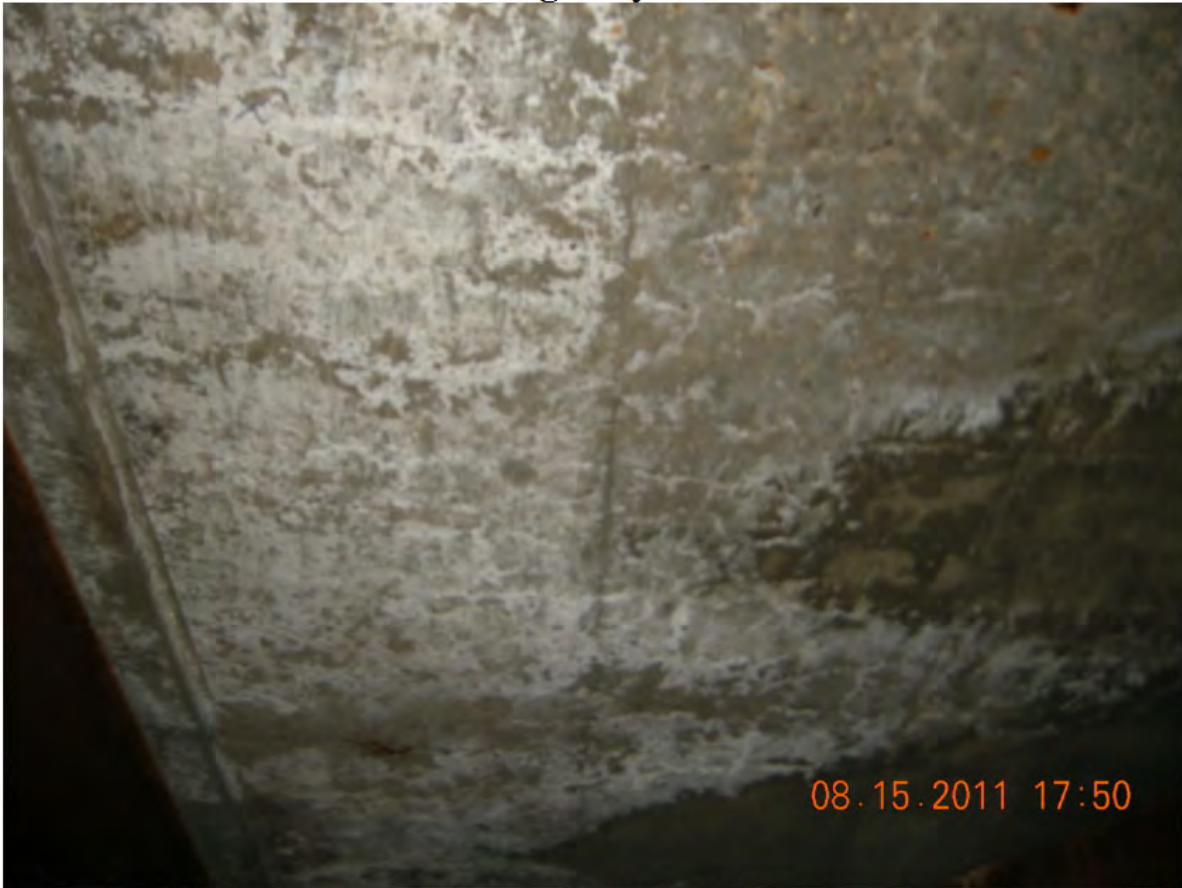
**P41 - East Girder - Span 2 Soffit - Leaching Hairline Map Cracks - Typical - No Sign of Recent Seepage - No Delamination**

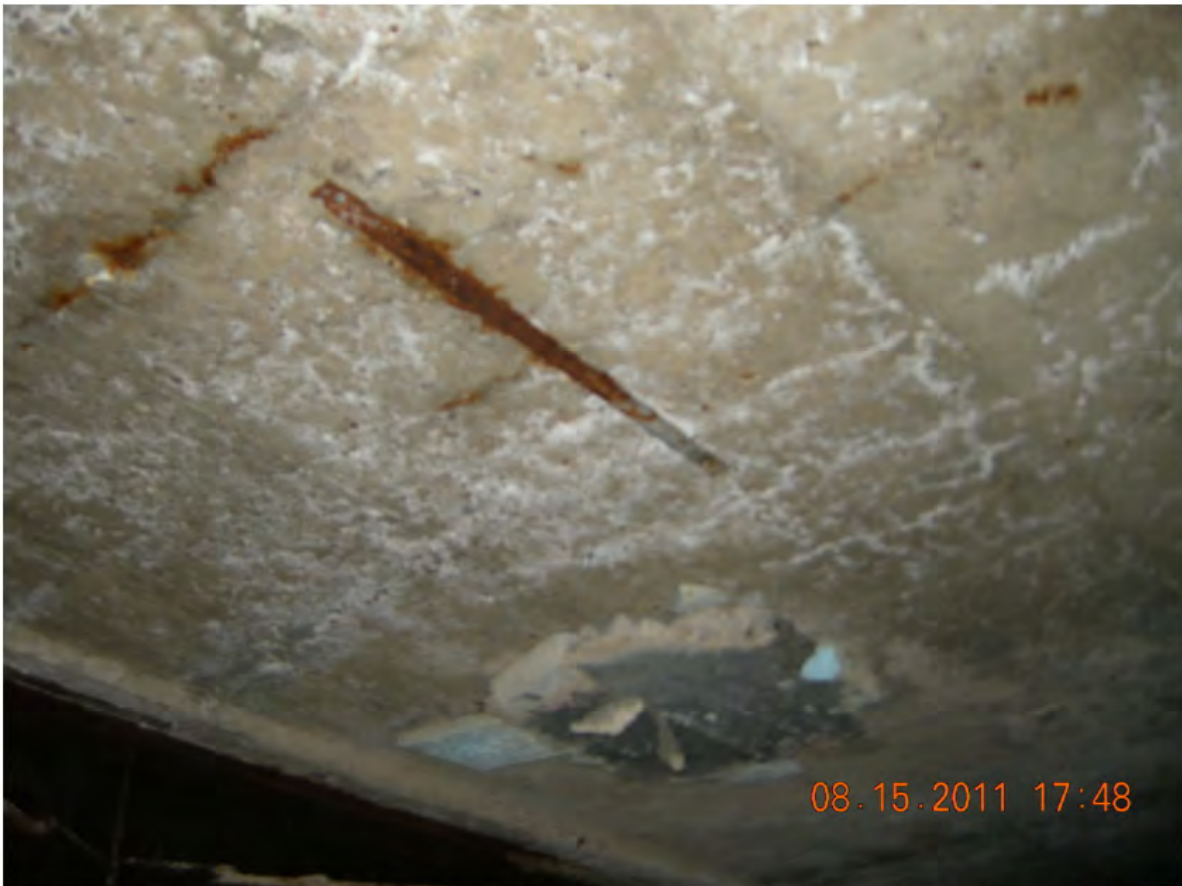
**P42 - East Girder - Span 3 - Soffit Patch and Rust Staining Near Midspan - Formwork Left in - No Delaminations**

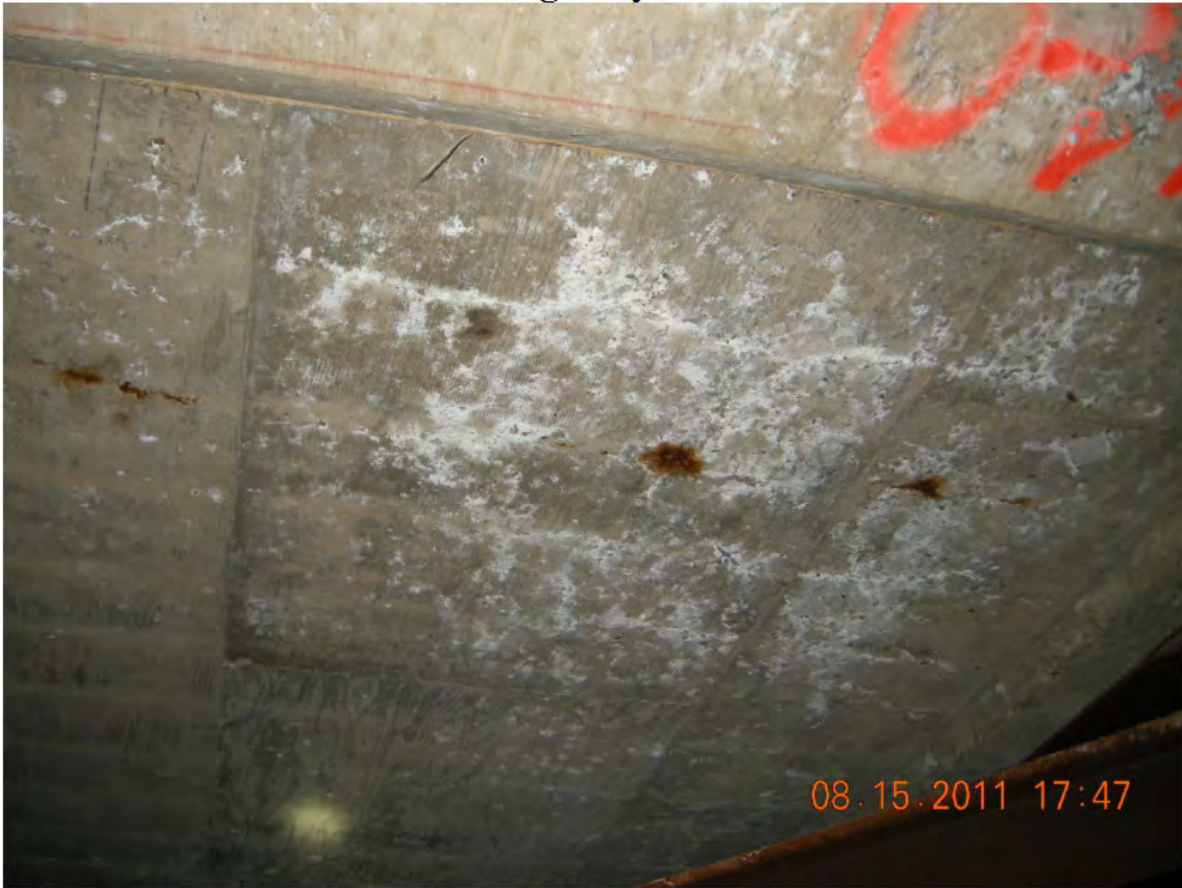
**P43 - East Girder - Span 3 Soffit - Random Rust Staining - No Recent Moisture Staining**

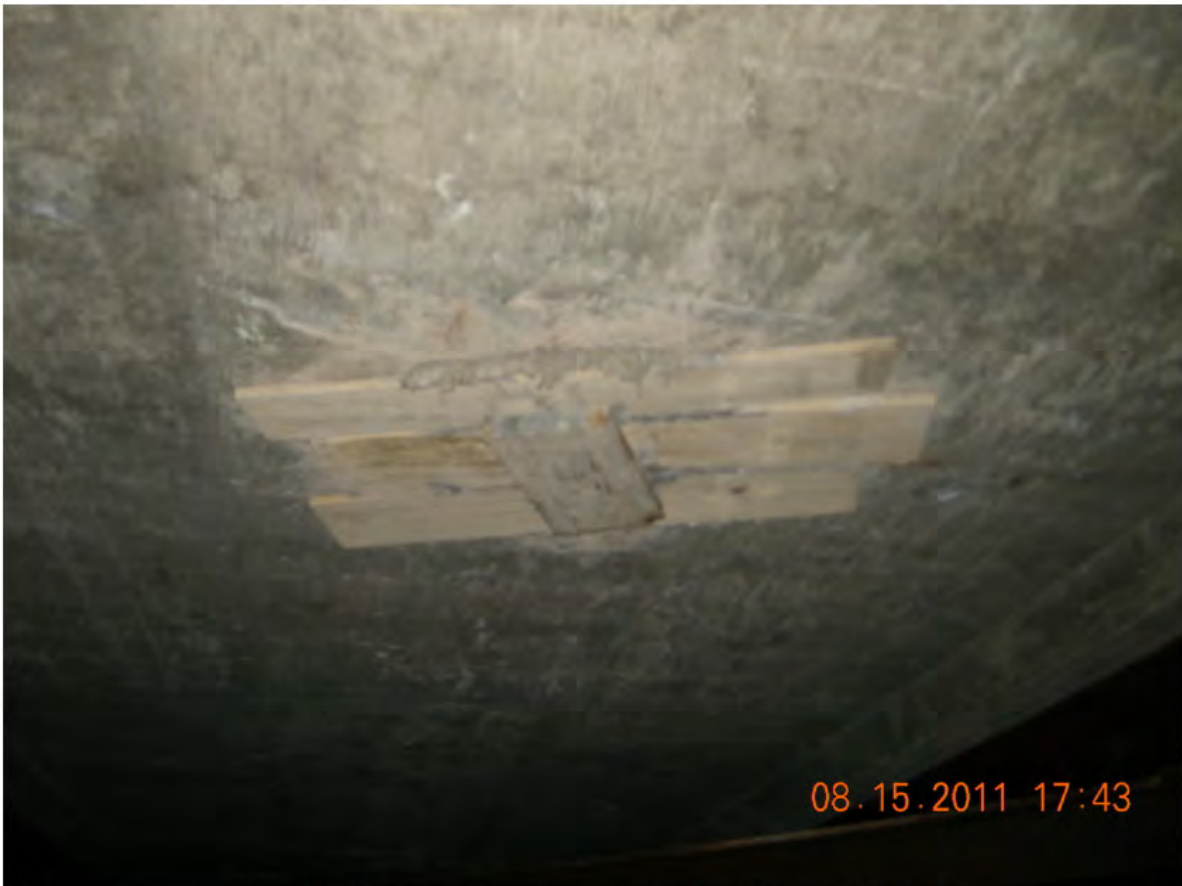
**P44 - East Girder - Span 4 - Soffit Patch - Formwork Left In**

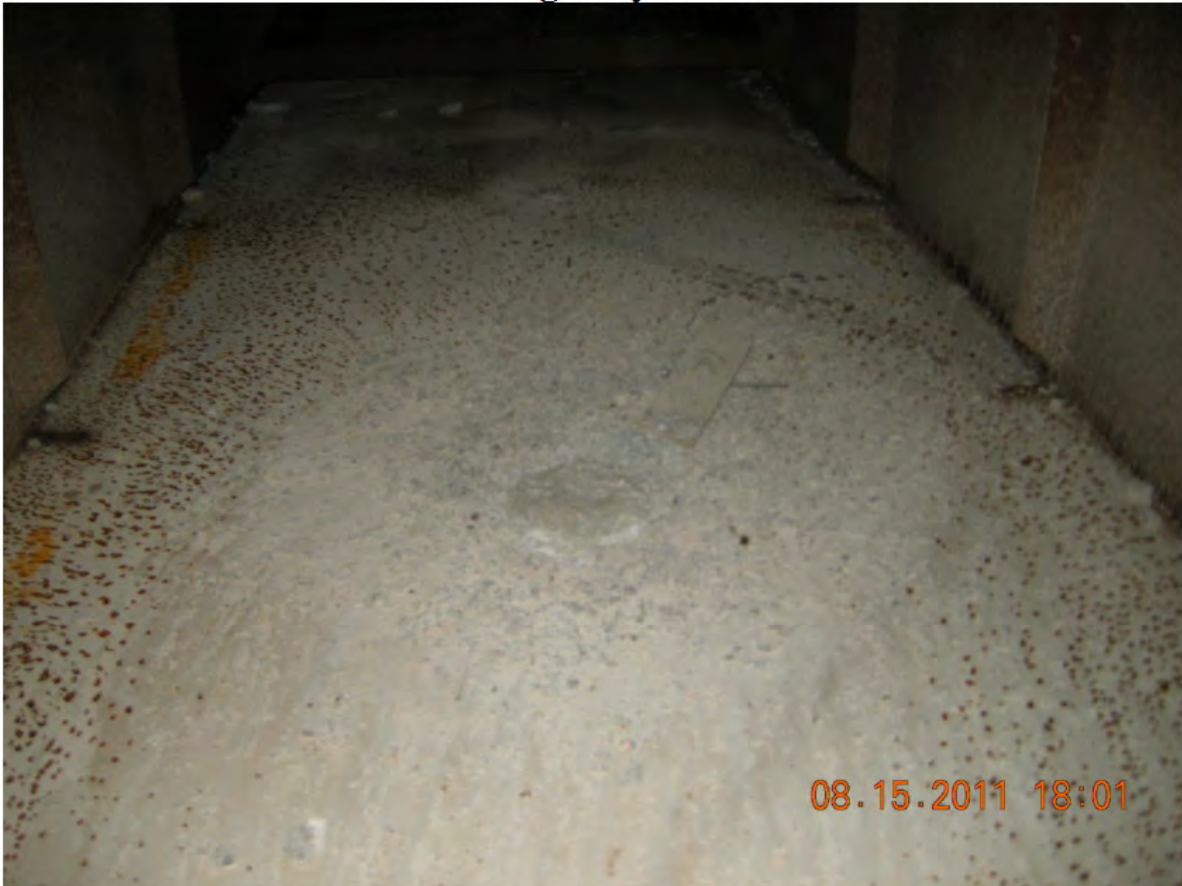
**P45 - East Girder - Span 4 - Concrete on Bottom Flange below Deck Patch from Deck Repairs**
