# Muskwa River Bridge Alaska Highway km 451.8

**ELEVATION**

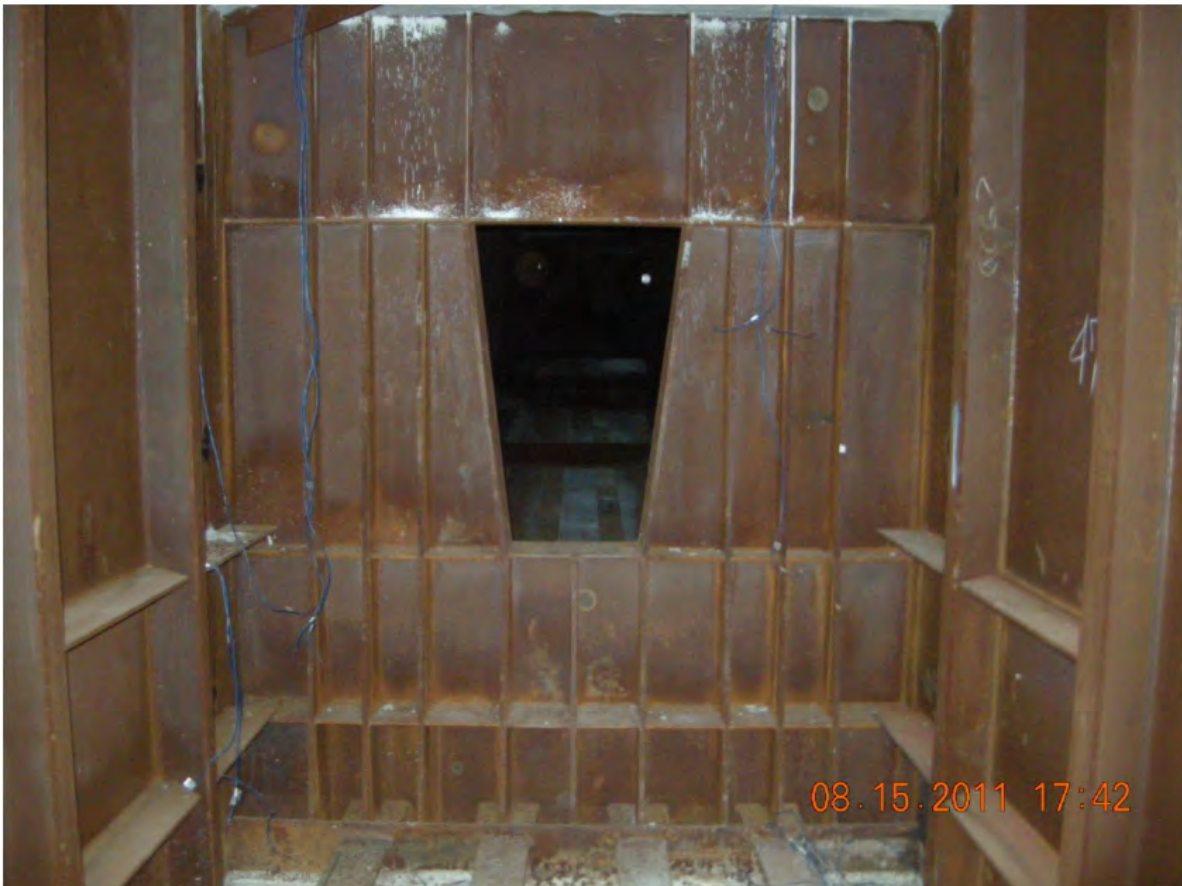
**P46 - East Girder - Pier 4 Diaphragm**

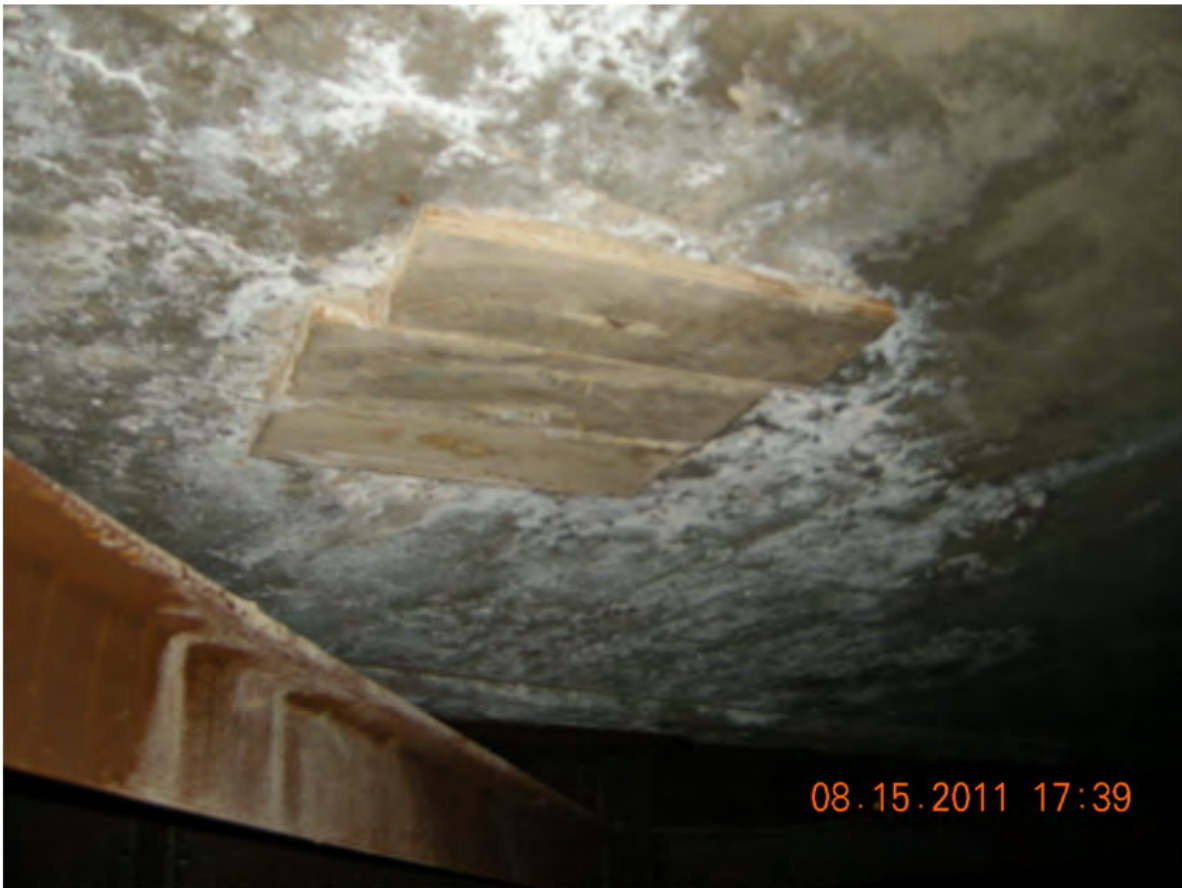
**P48 - East Girder - Span 5 - Soffit Patch at Midspan - Formwork Left In - Leaching Narrow Map Cracks - No Delaminations**

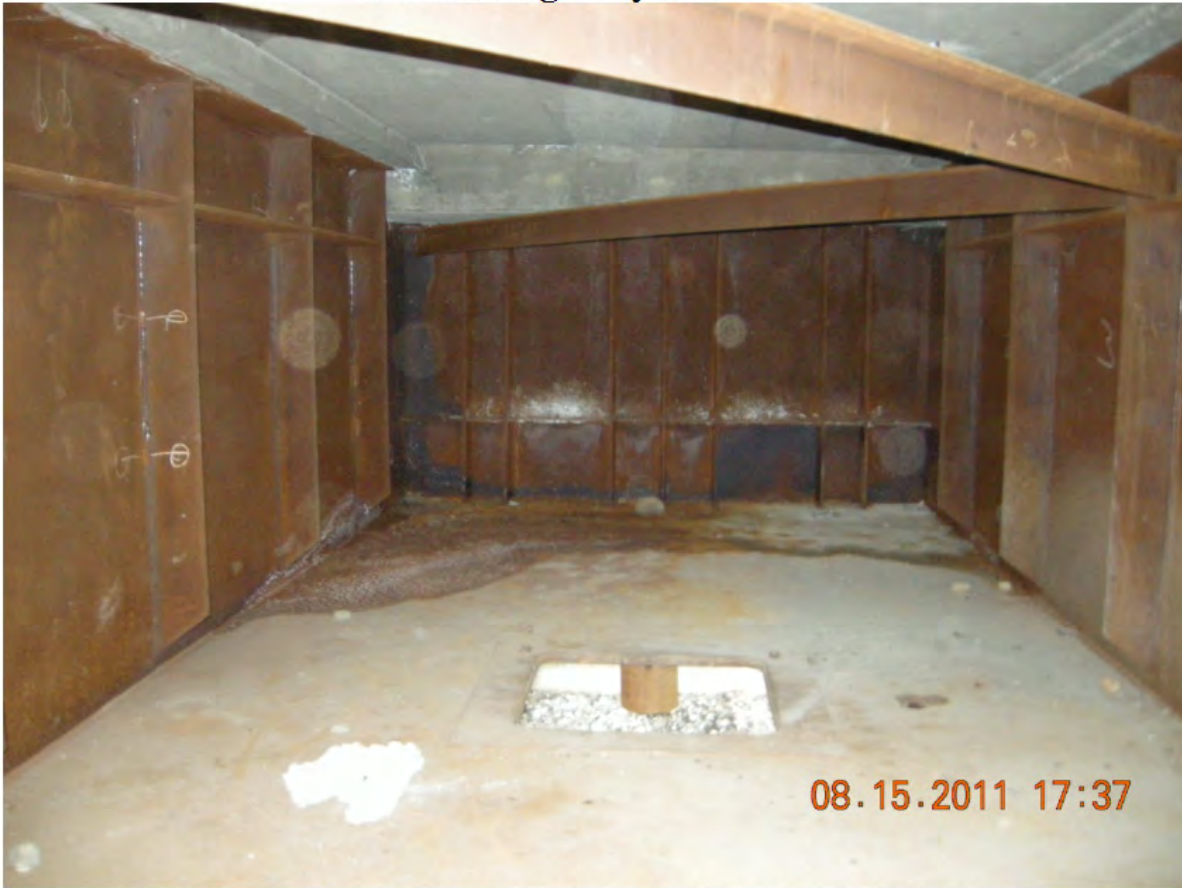
**P49 - East Girder - Span 5 - North End - Moisture Staining in Bottom Flange**

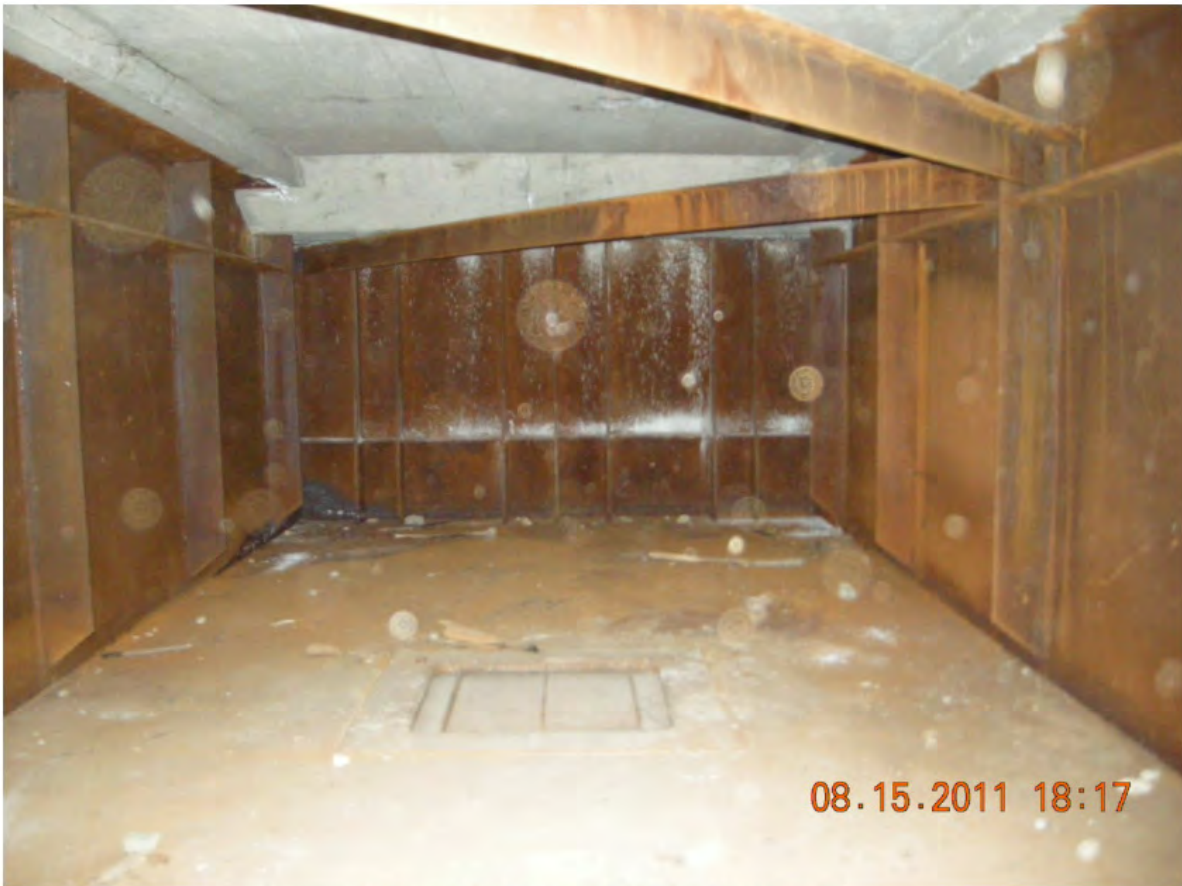
**P50 - West Girder - Span 1 - South End**

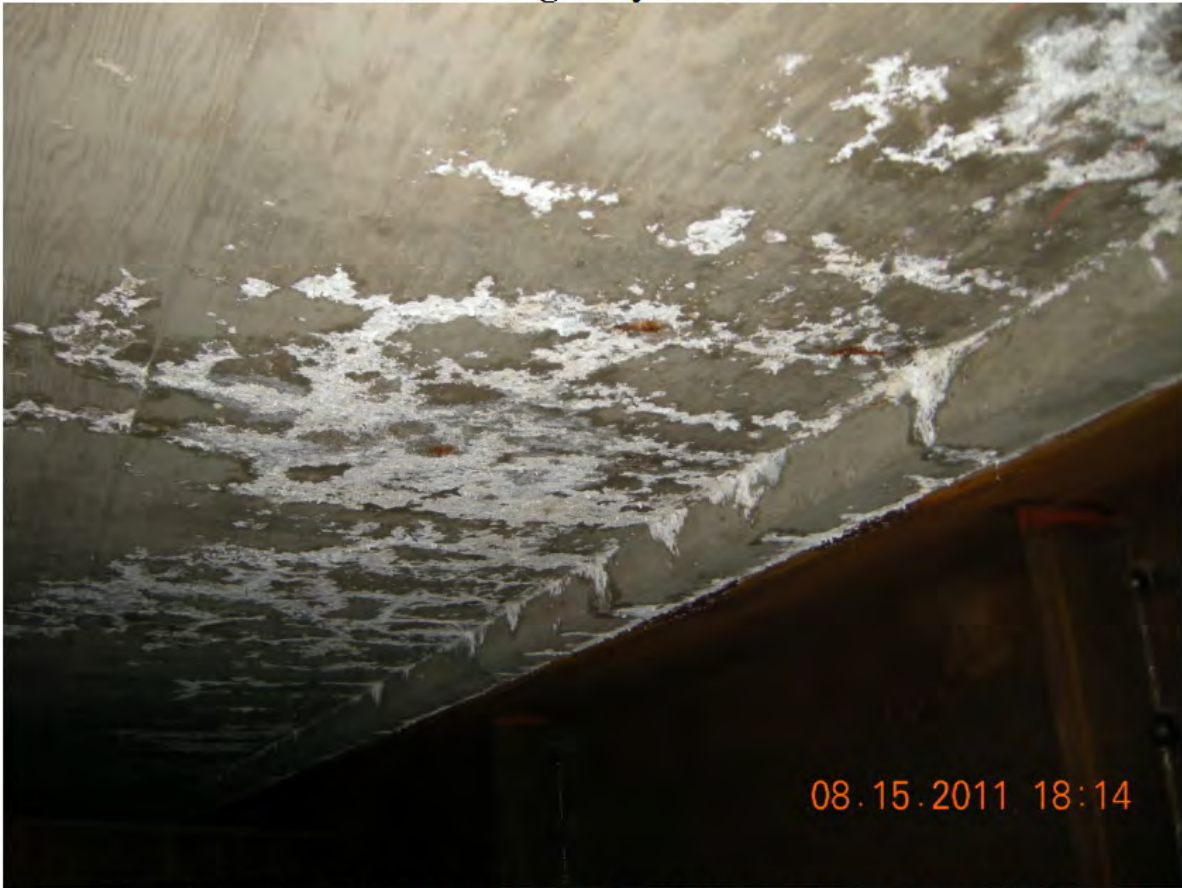
**P51 - West Girder - Span 2 Soffit - Leaching Hairline Map Cracks - No Signs of Recent Moisture Staining - No Delaminations**

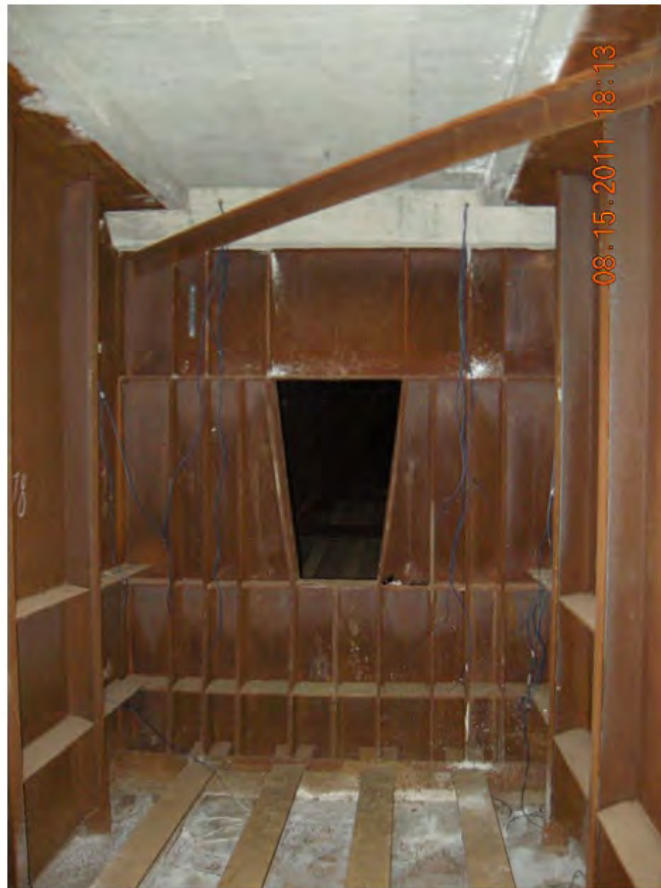
**P52 - West Girder - Pier 2 Diaphragm**

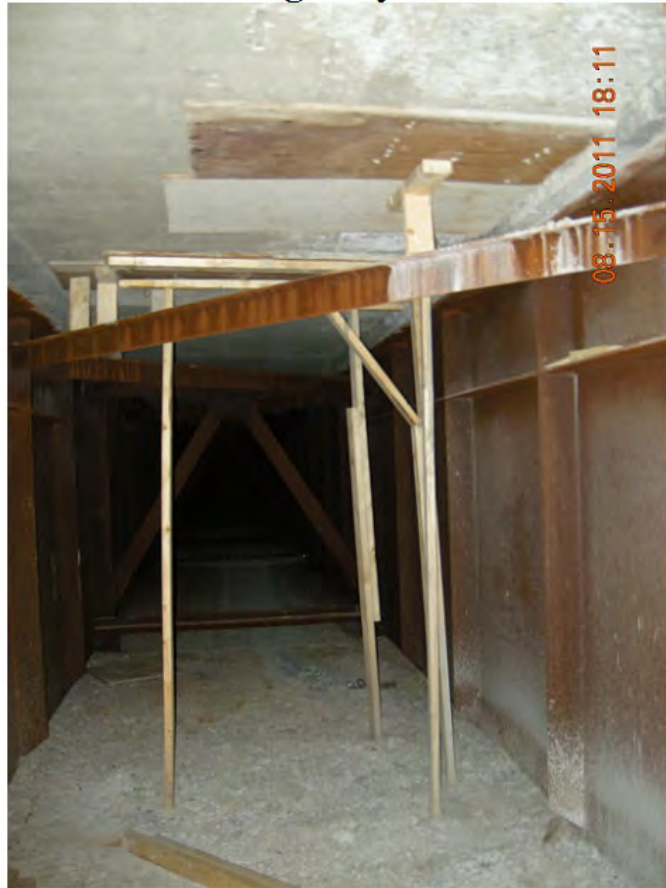
**P53 - West Girder - Span 3 - 3 Soffit Patches near Midspan - Formwork Left in Place - Leaked Concrete on Bottom Flange**

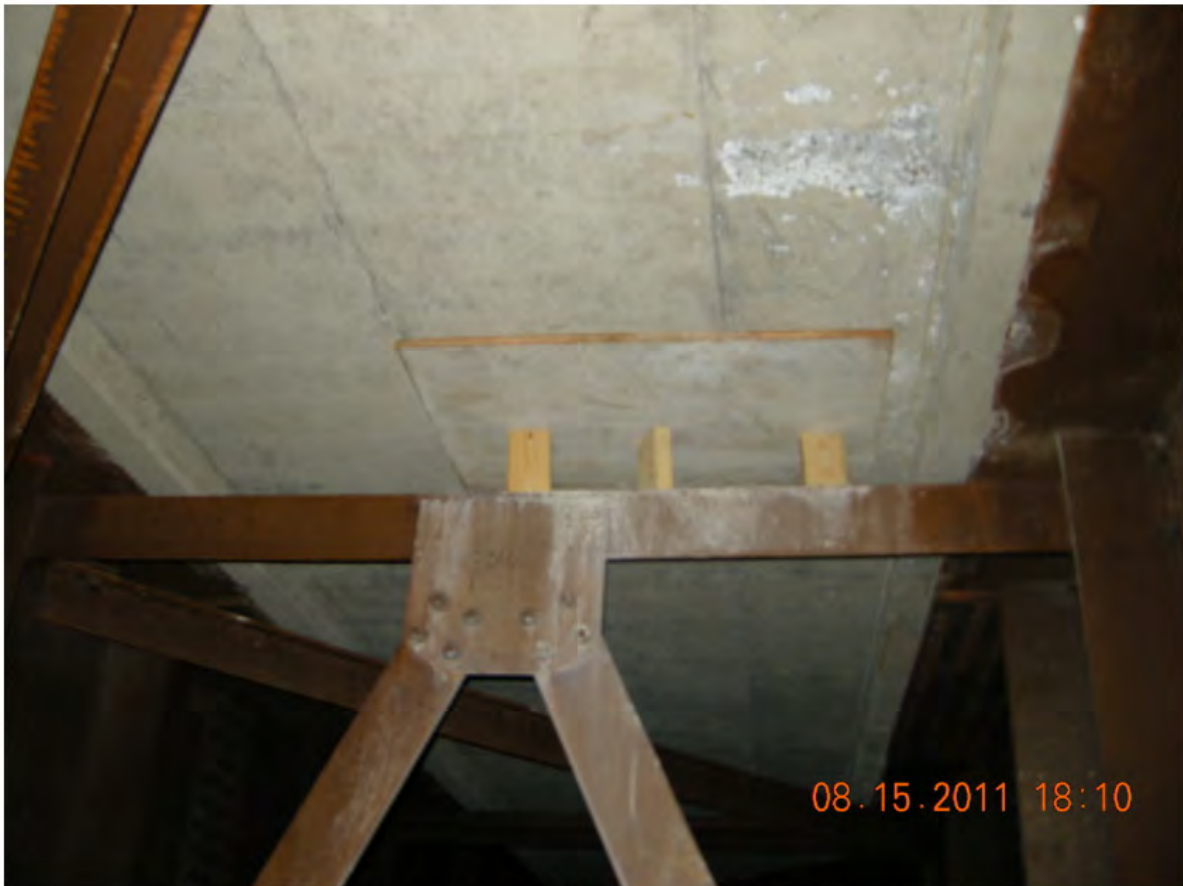
**P54 - West Girder - Span 3 - Patch in Soffit with Formwork Still in Place**

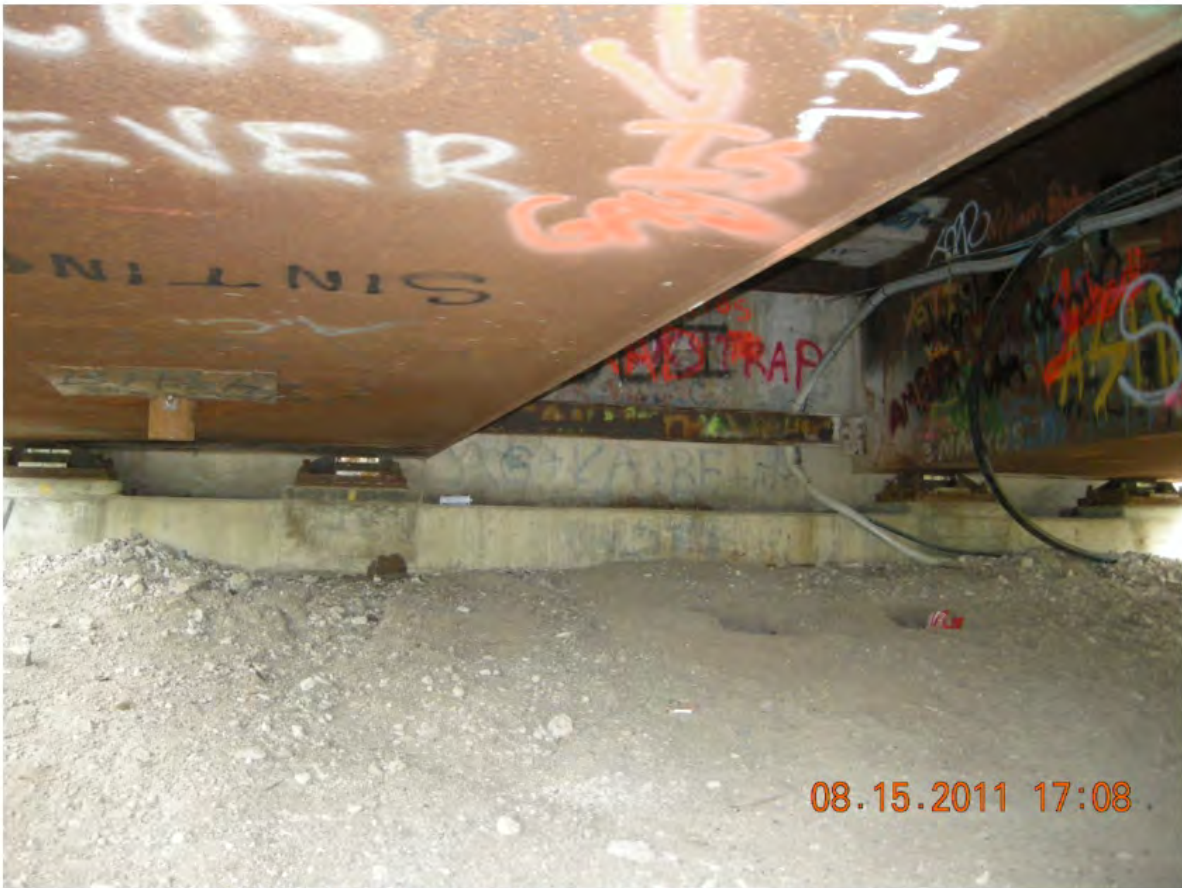
**P58 - South Abutment - Cladding Missing on All Bearings**

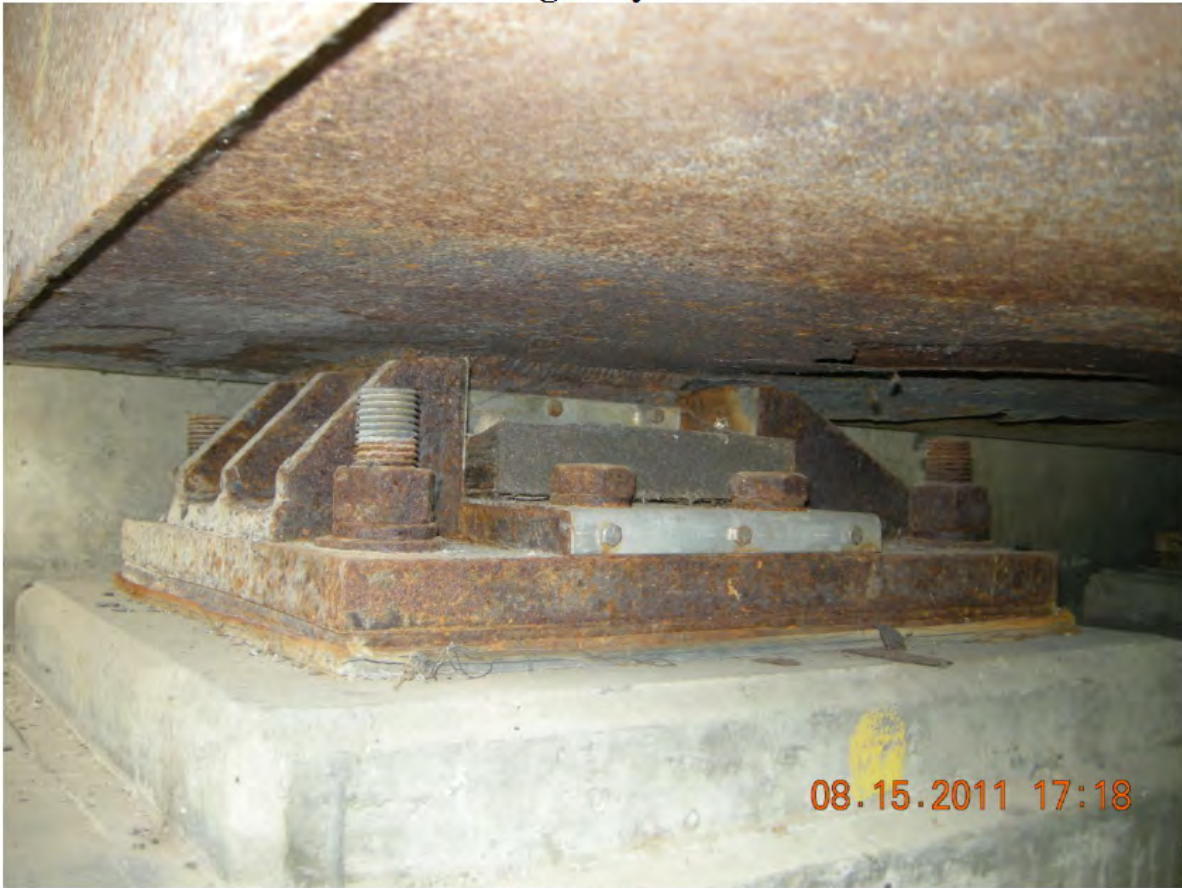
**P59 - South Abutment - East Girder - East Expansion Bearing**

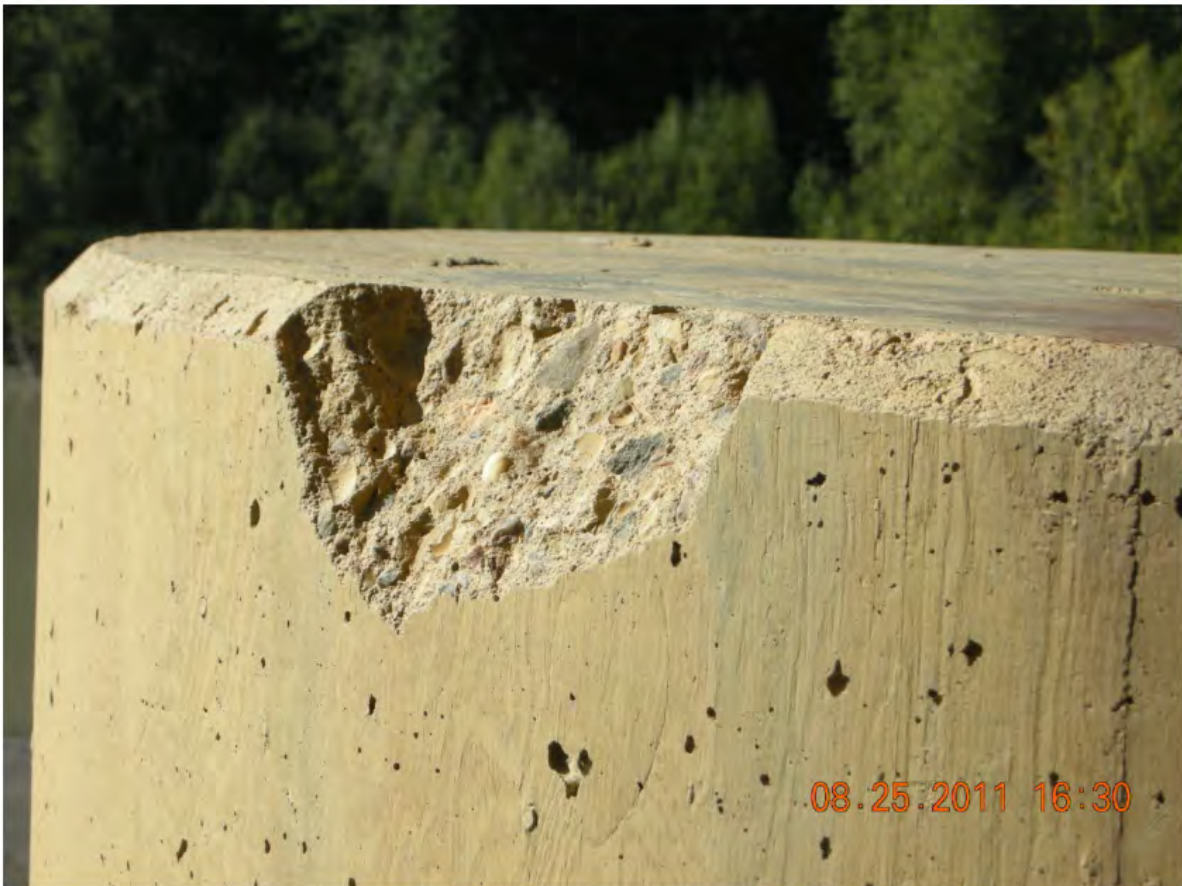
**P66 - Pier 2 Bearing Seat - Minor Spall 30 mm Deep at West End**

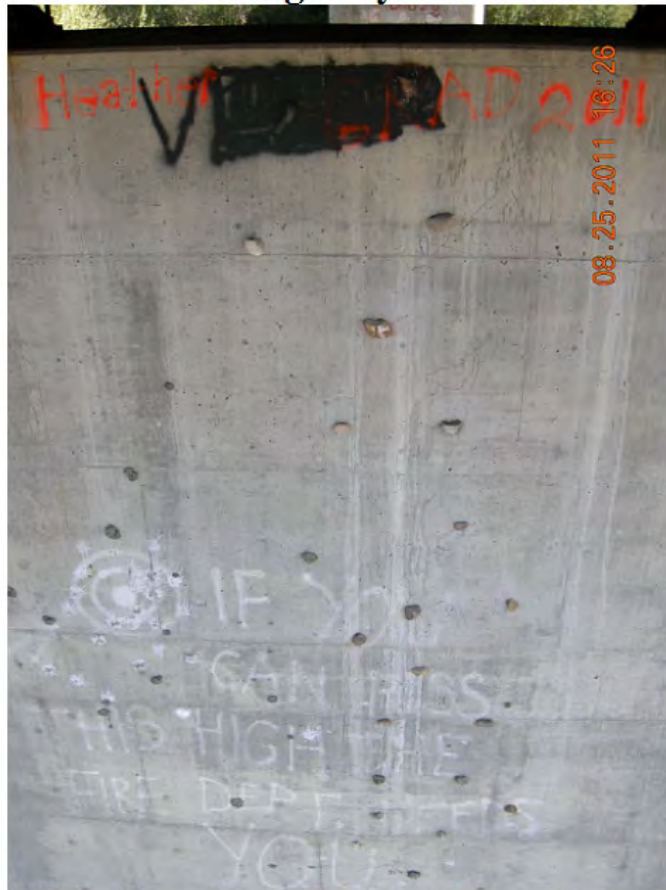
**P67 - Pier 2 - North Face - Stones Epoxied to Pier Face Likely for Climbing**

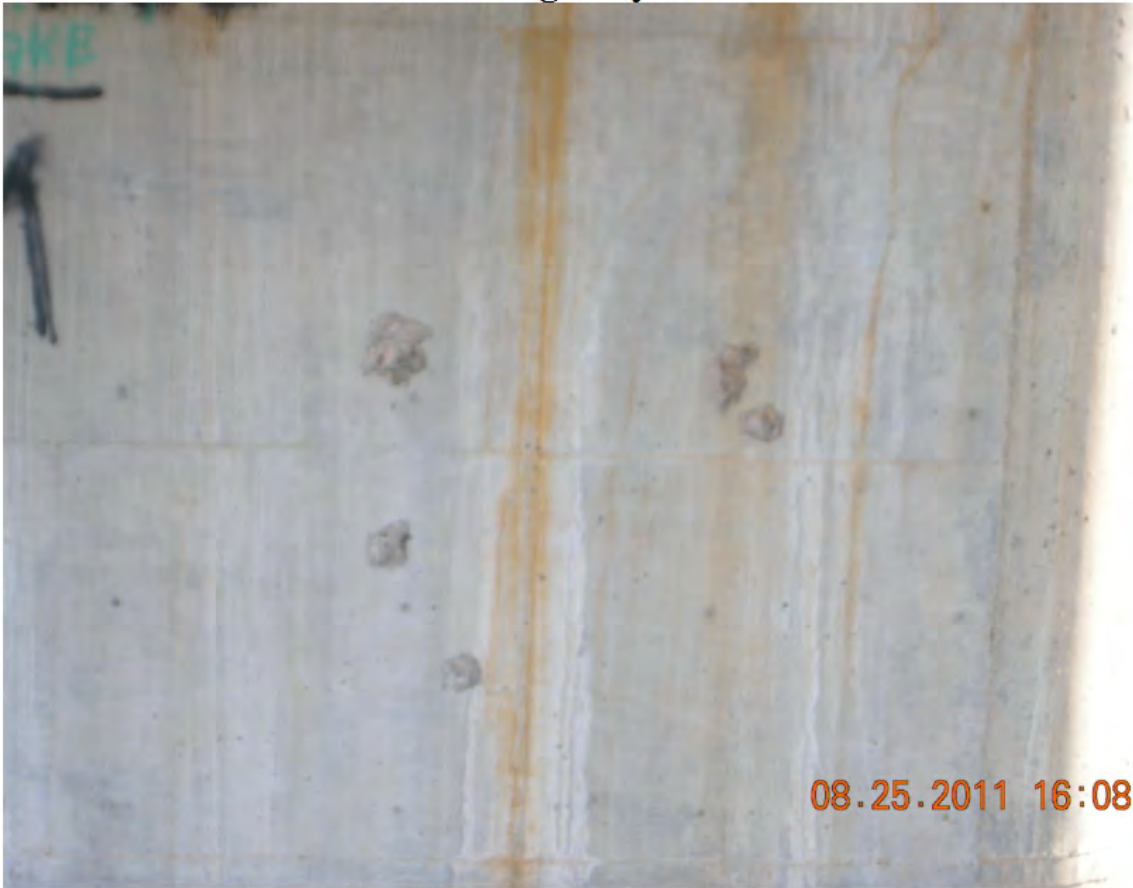
**P71 - Pier 3 - North Face - Rifle Shot Spalls**

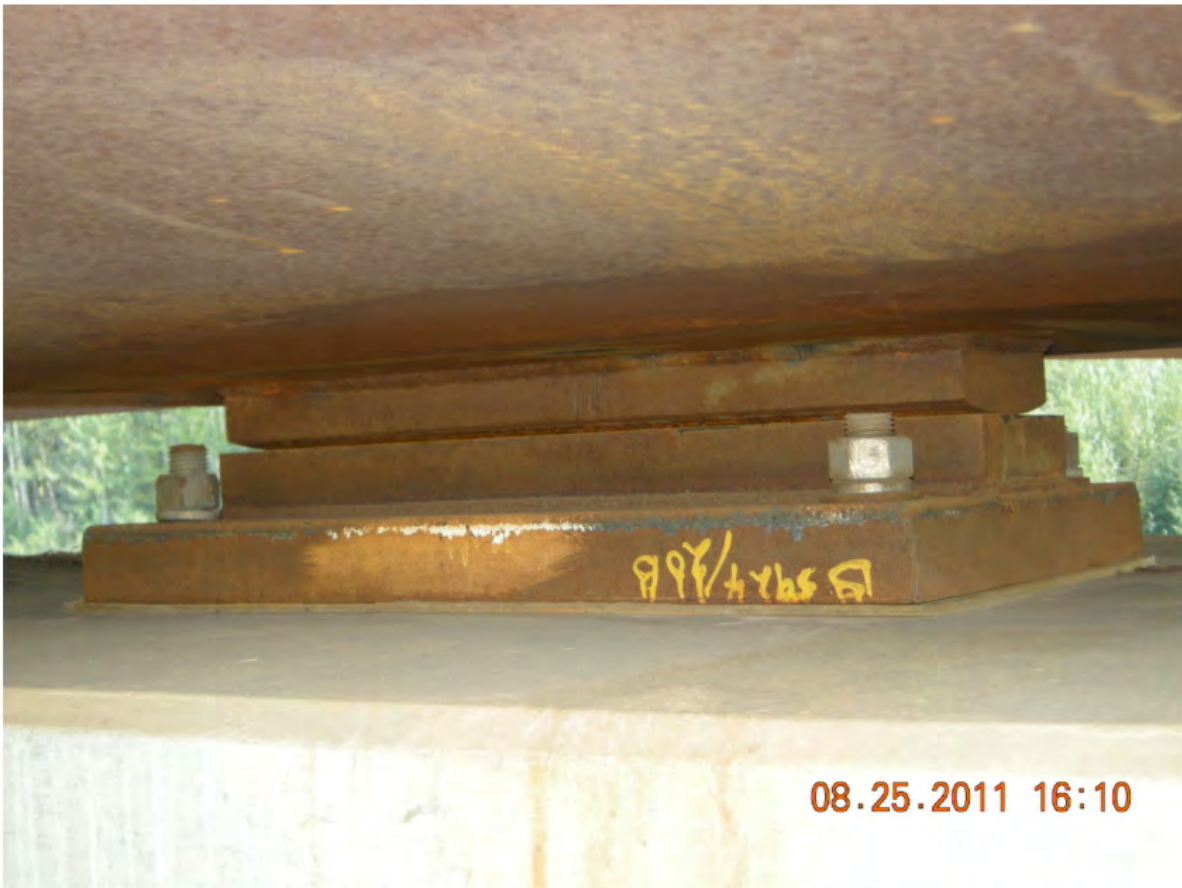
**P72 - Pier 3 - West Girder - East Fixed Bearing - Fixed Bearings on Pier 3 Only**
