# Lower Liard River Bridge Alaska Highway km 763.3

**ELEVATION**

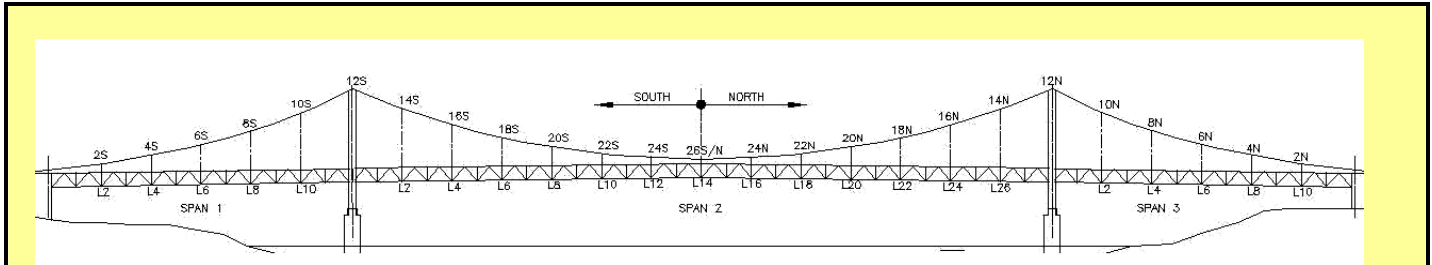
# Lower Liard River Bridge Alaska Highway km 763.3

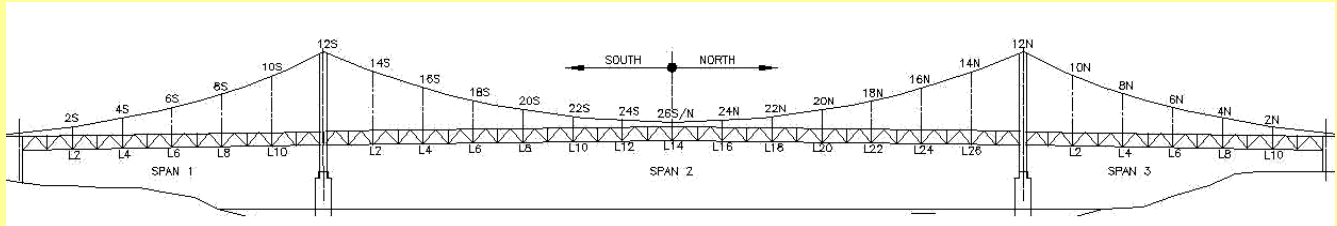
# Lower Liard River Bridge Alaska Highway km 763.3

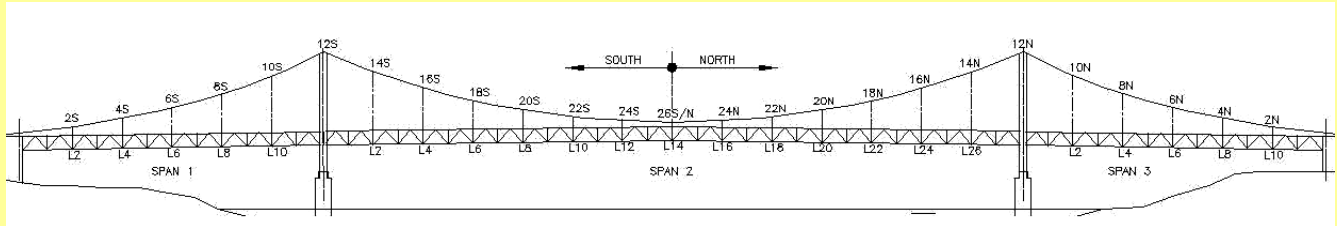
# Lower Liard River Bridge Alaska Highway km 763.3

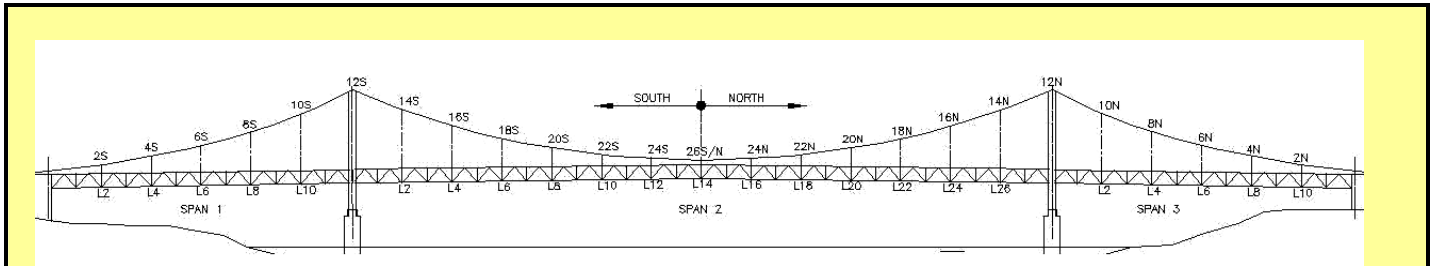
# Lower Liard River Bridge Alaska Highway km 763.3

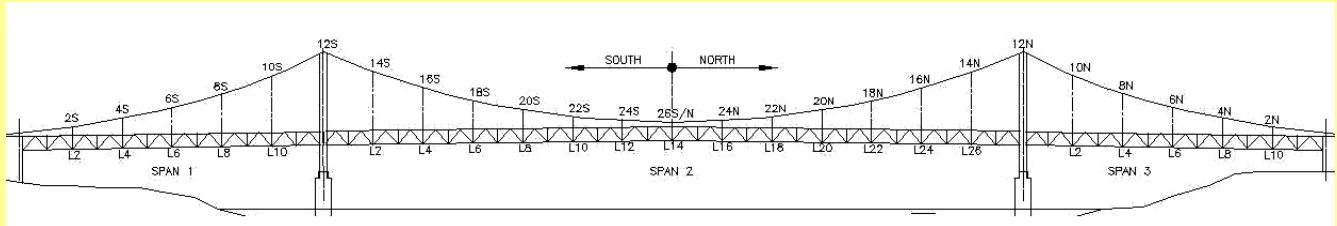
# Lower Liard River Bridge Alaska Highway km 763.3

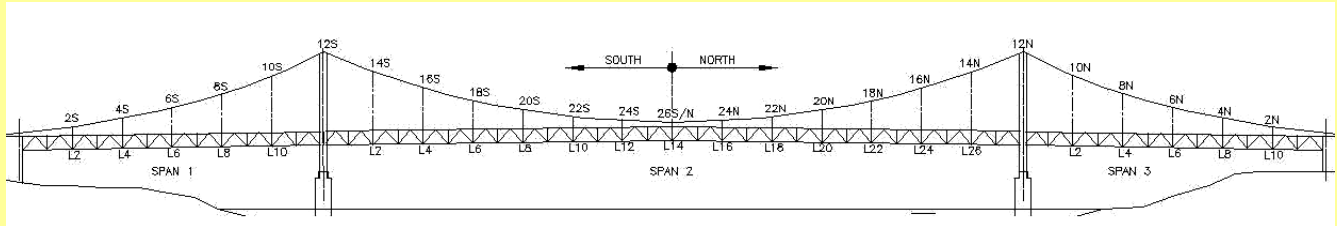
# Lower Liard River Bridge Alaska Highway km 763.3

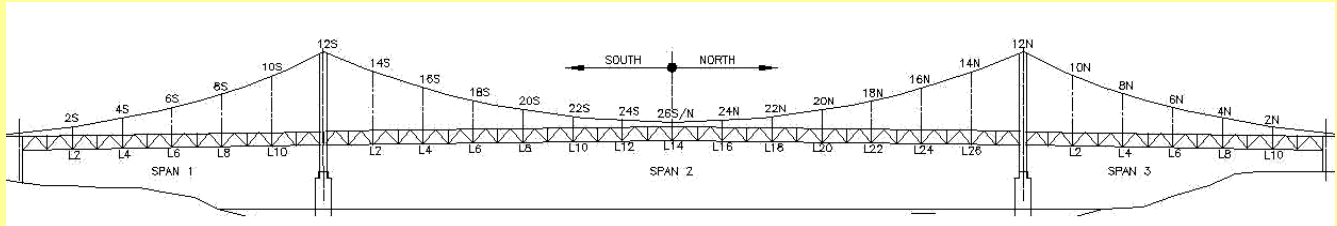
# Lower Liard River Bridge Alaska Highway km 763.3

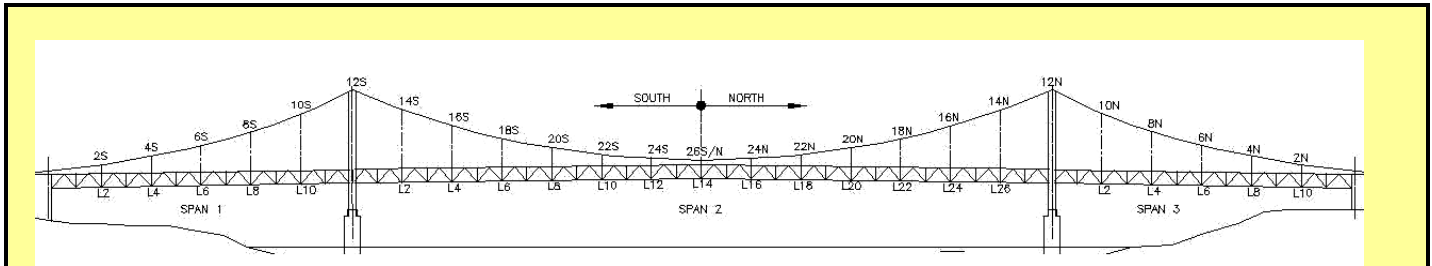
# Lower Liard River Bridge Alaska Highway km 763.3

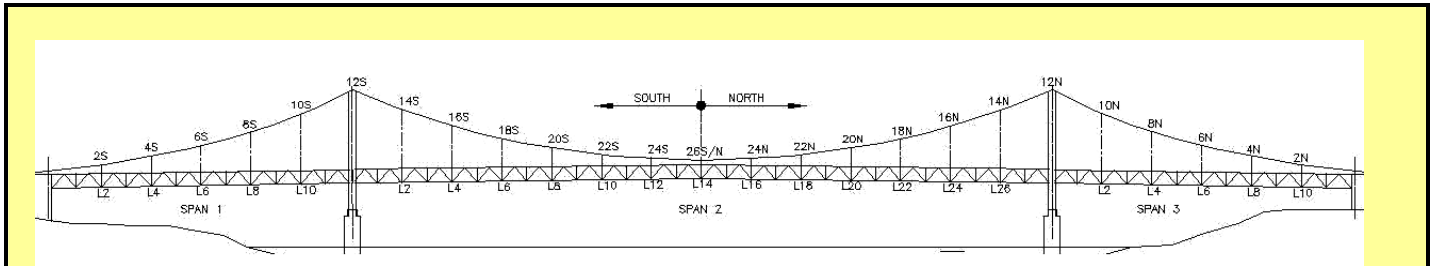
# Lower Liard River Bridge Alaska Highway km 763.3

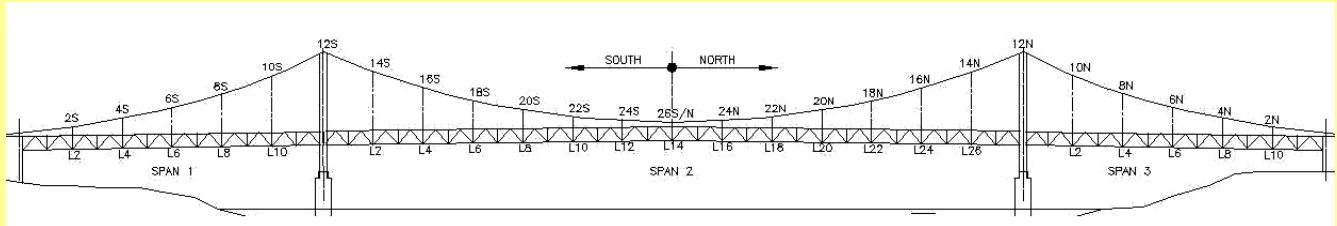
# Lower Liard River Bridge Alaska Highway km 763.3

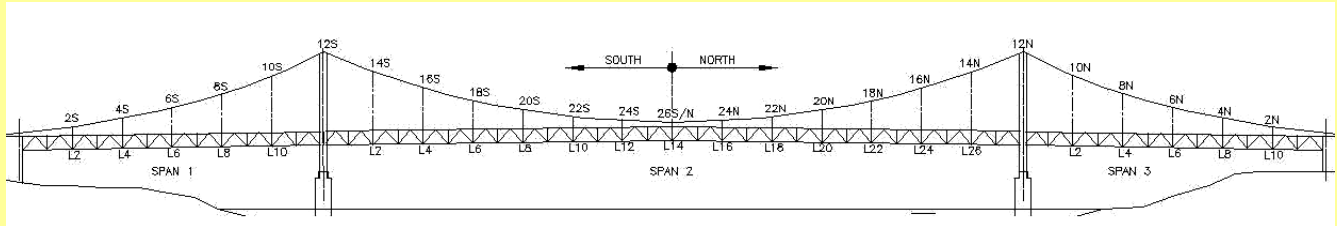
# Lower Liard River Bridge Alaska Highway km 763.3

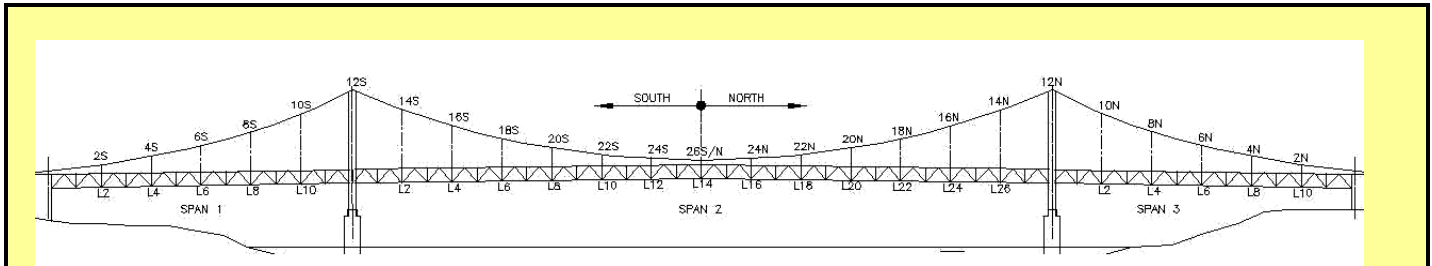
# Lower Liard River Bridge Alaska Highway km 763.3

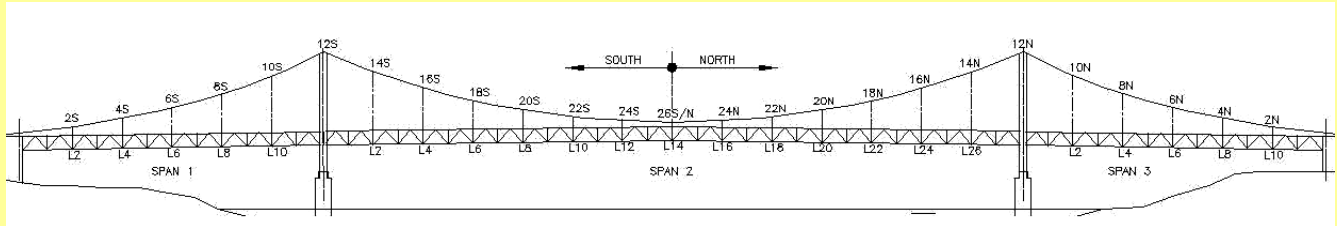
# Lower Liard River Bridge Alaska Highway km 763.3

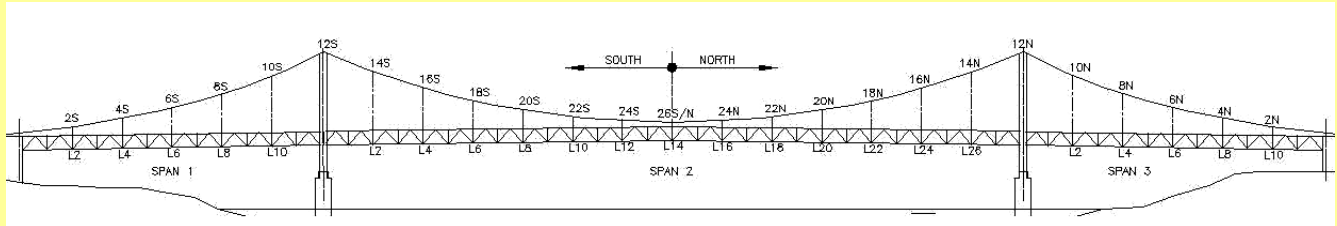
# Lower Liard River Bridge Alaska Highway km 763.3

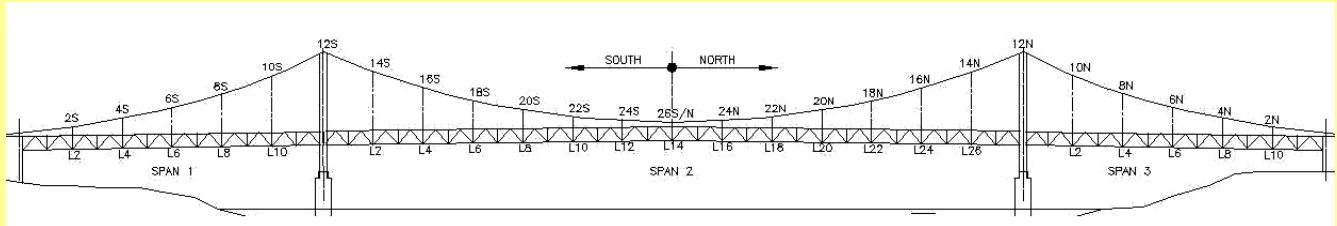
# Lower Liard River Bridge Alaska Highway km 763.3

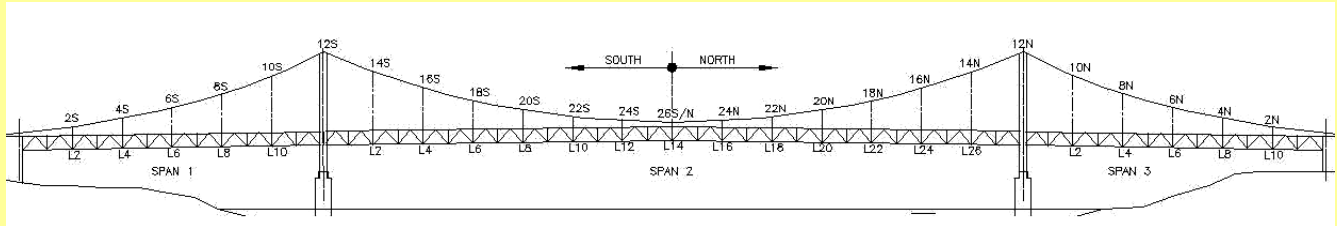
# Lower Liard River Bridge Alaska Highway km 763.3

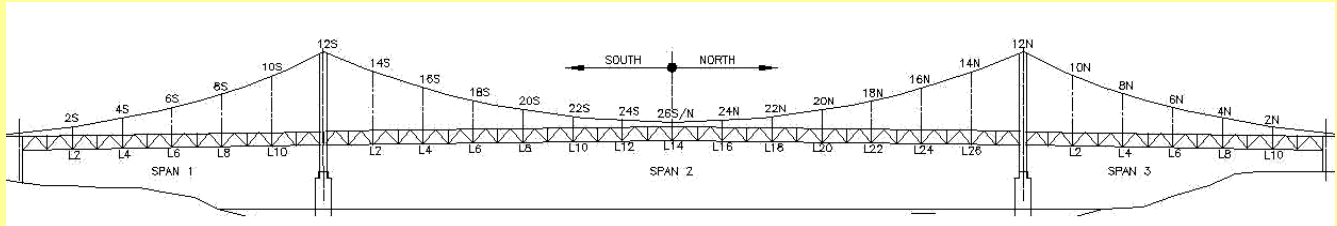
# Lower Liard River Bridge Alaska Highway km 763.3

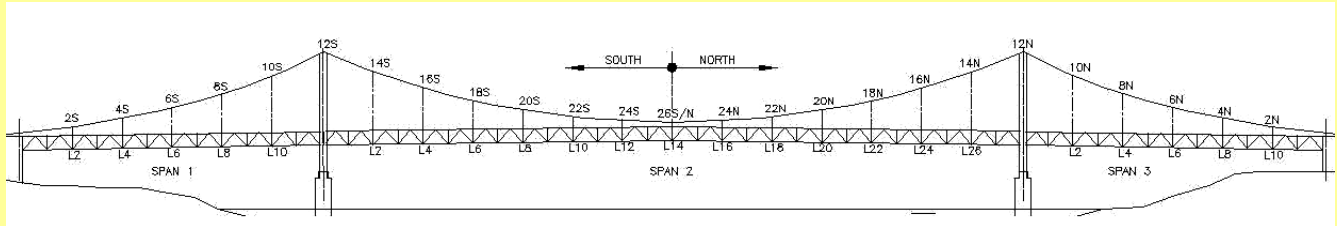
# Lower Liard River Bridge Alaska Highway km 763.3

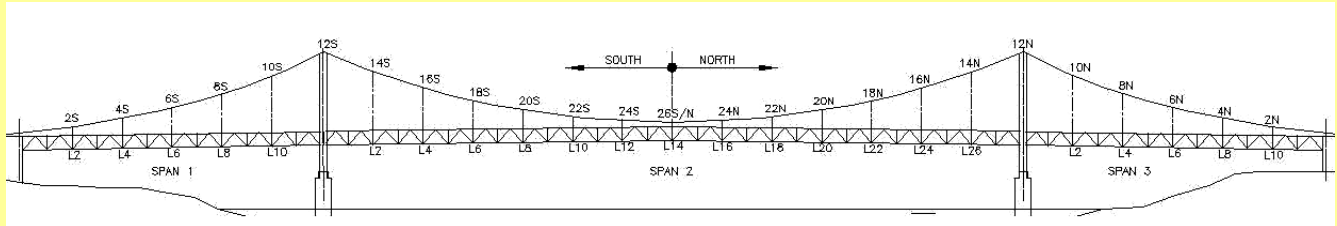
# Lower Liard River Bridge Alaska Highway km 763.3

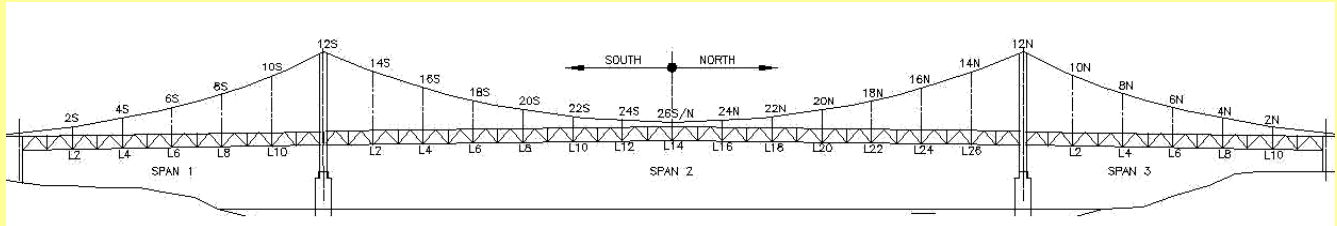
# Lower Liard River Bridge Alaska Highway km 763.3

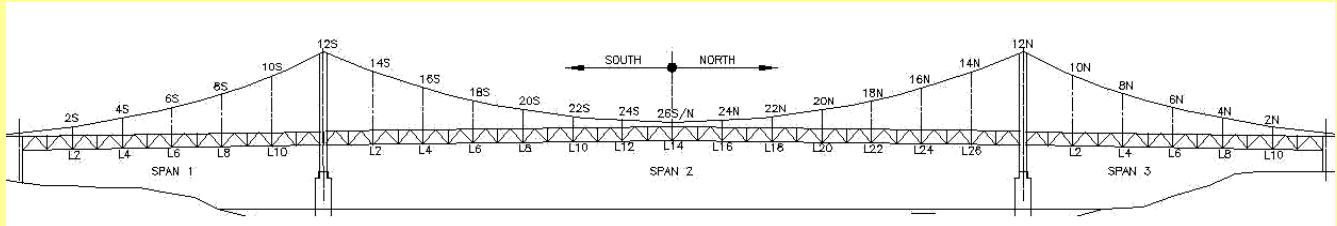
# Lower Liard River Bridge Alaska Highway km 763.3

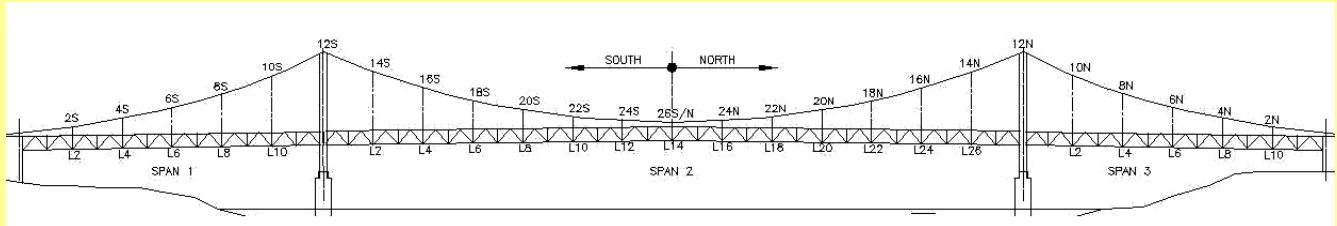
# Lower Liard River Bridge Alaska Highway km 763.3

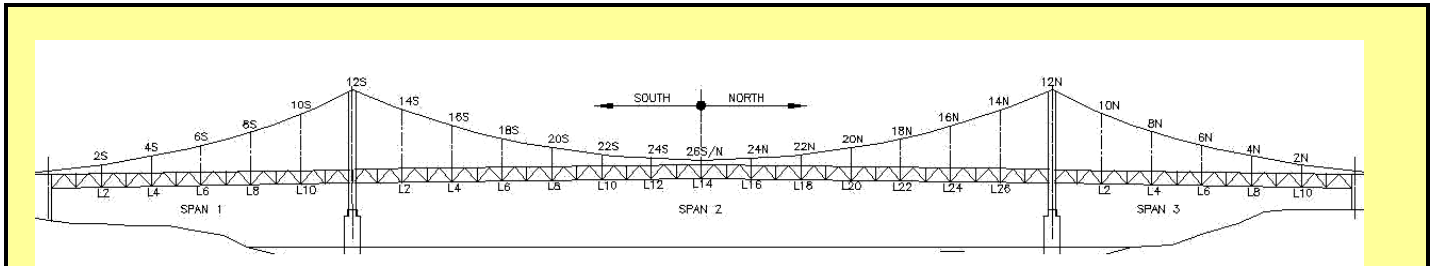
# Lower Liard River Bridge Alaska Highway km 763.3

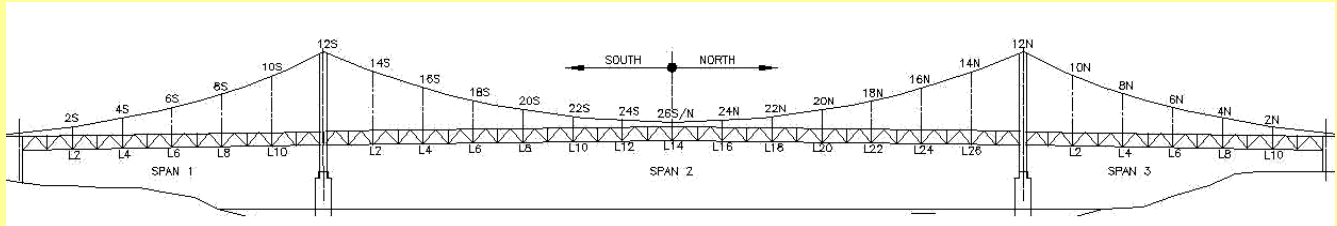
# Lower Liard River Bridge Alaska Highway km 763.3

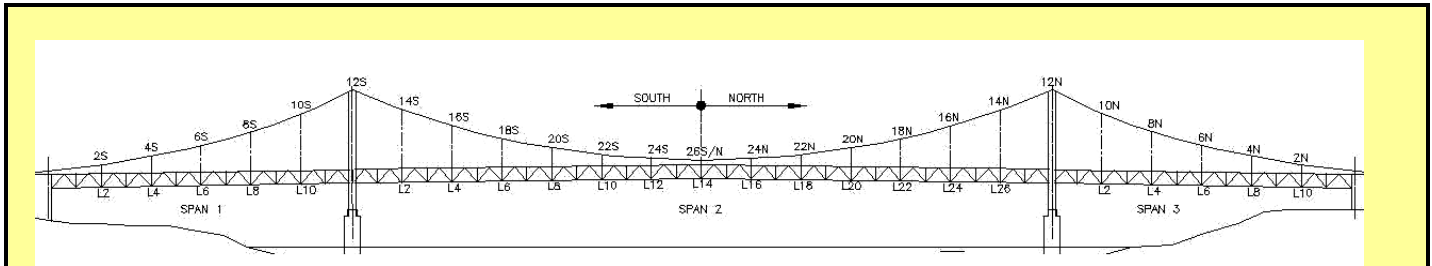
# Lower Liard River Bridge Alaska Highway km 763.3

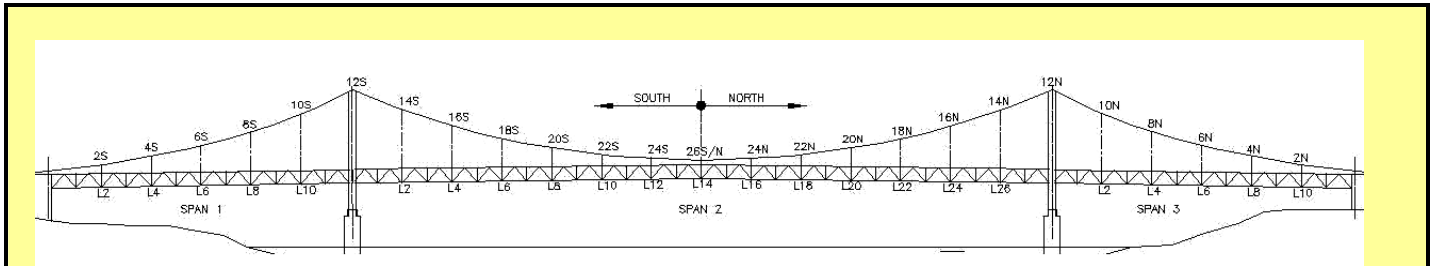
# Lower Liard River Bridge Alaska Highway km 763.3

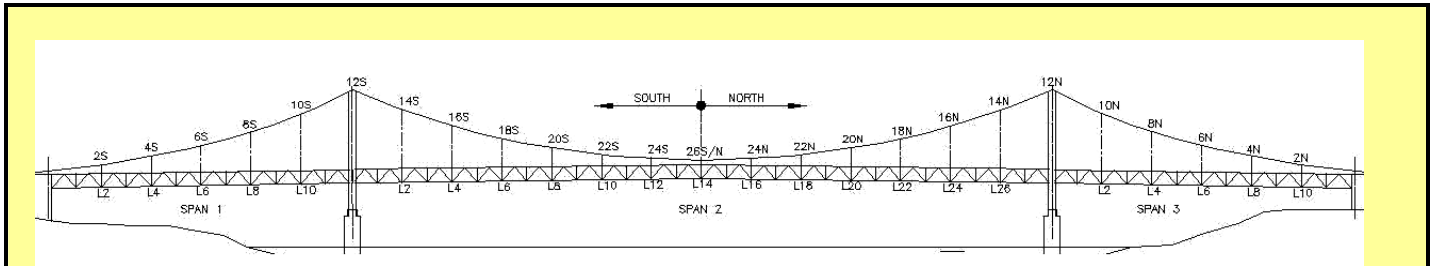
# Lower Liard River Bridge Alaska Highway km 763.3

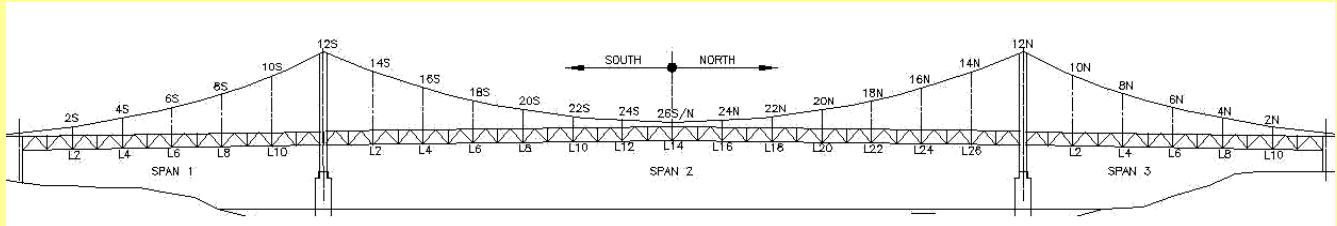
# Lower Liard River Bridge Alaska Highway km 763.3

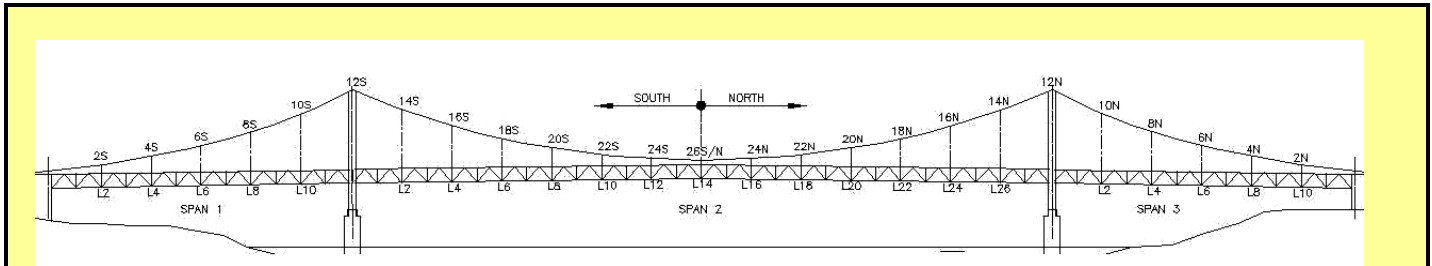
# Lower Liard River Bridge Alaska Highway km 763.3

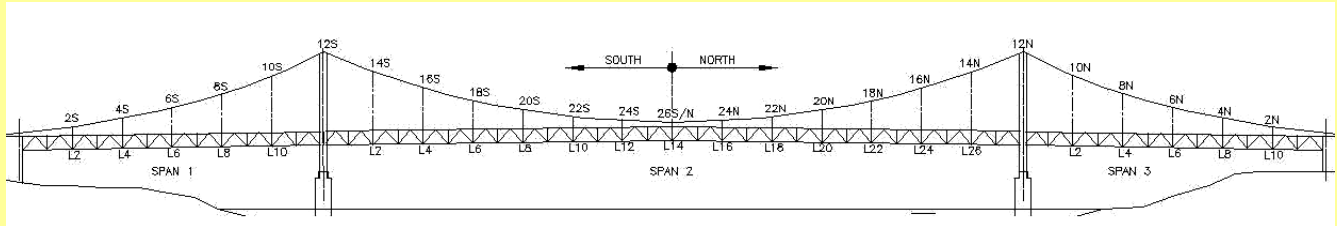
# Lower Liard River Bridge Alaska Highway km 763.3

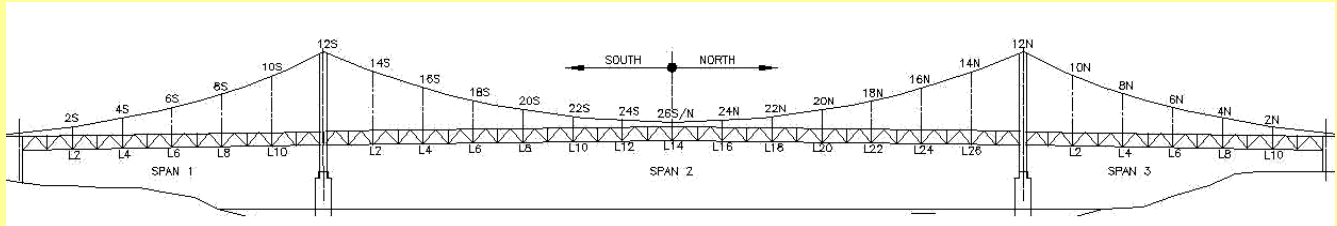
# Lower Liard River Bridge Alaska Highway km 763.3

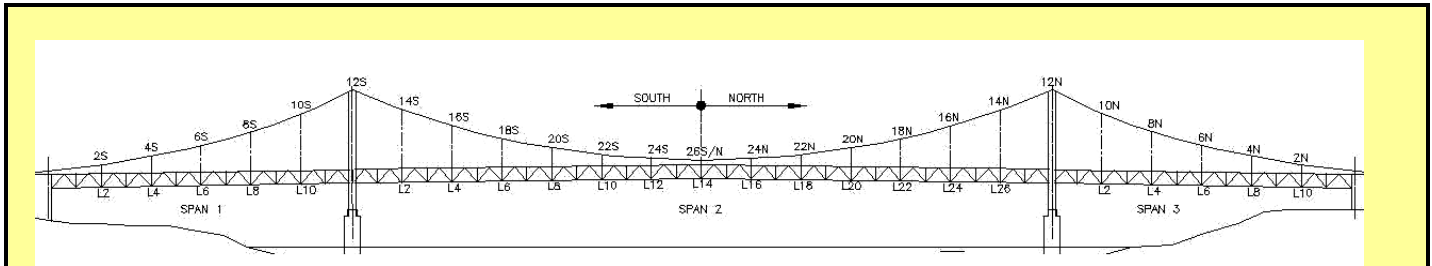
# Lower Liard River Bridge Alaska Highway km 763.3

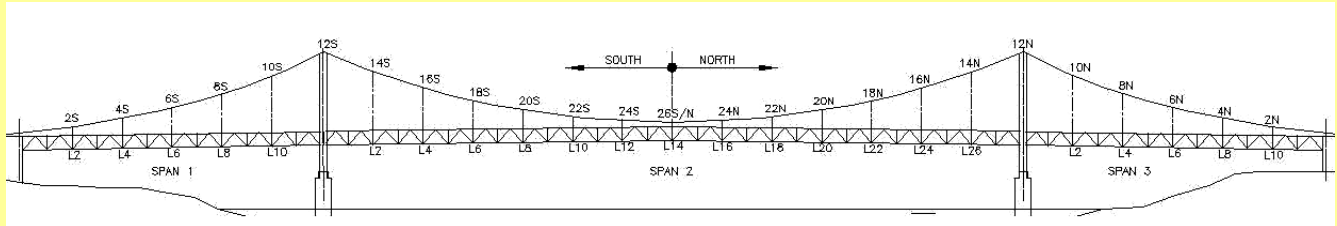
# Lower Liard River Bridge Alaska Highway km 763.3

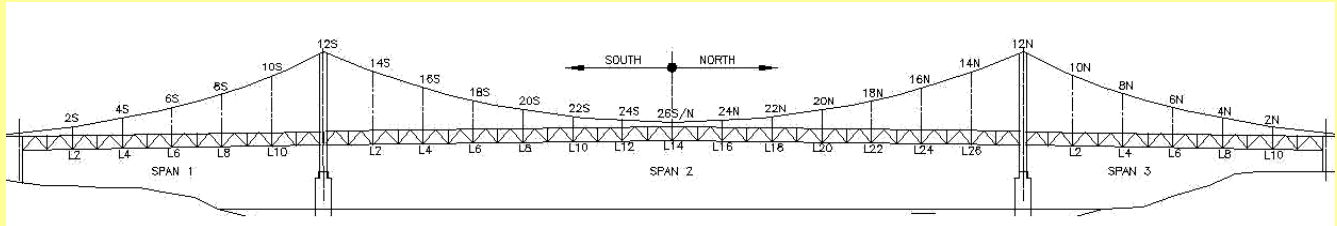
# Lower Liard River Bridge Alaska Highway km 763.3

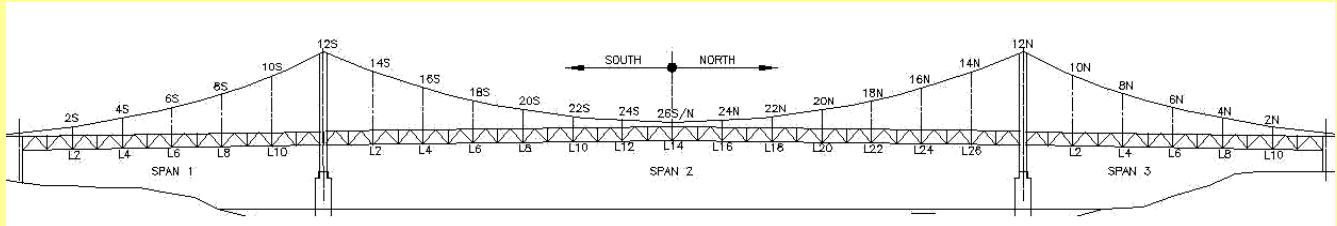
# Lower Liard River Bridge Alaska Highway km 763.3

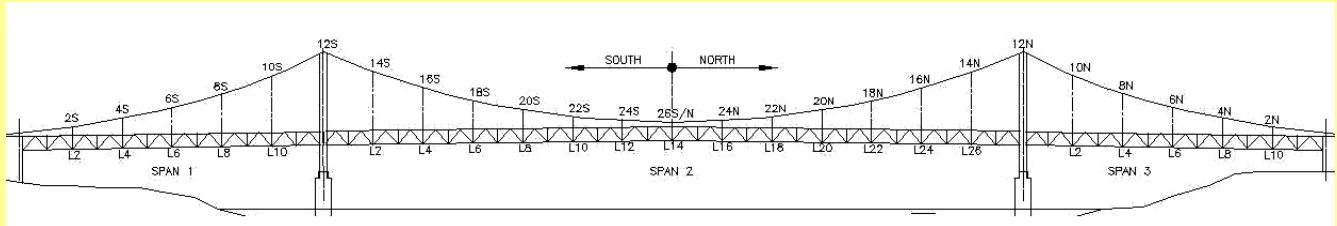
# Lower Liard River Bridge Alaska Highway km 763.3

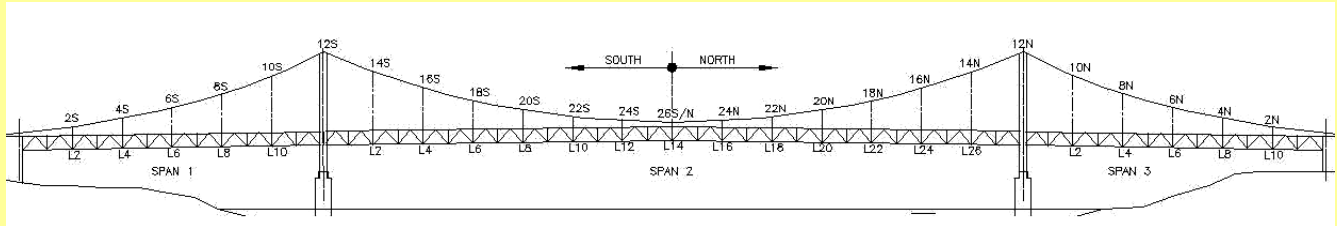
# Lower Liard River Bridge Alaska Highway km 763.3

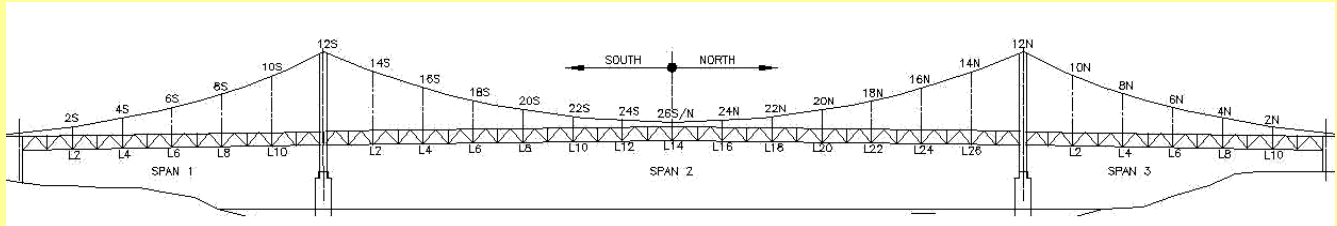
# Lower Liard River Bridge Alaska Highway km 763.3

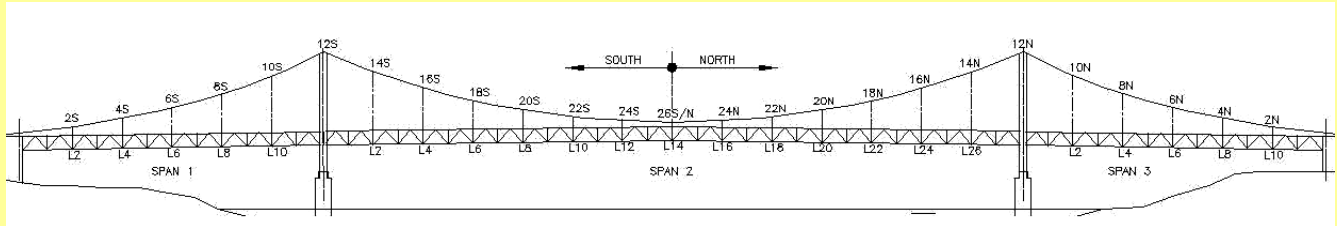
# Lower Liard River Bridge Alaska Highway km 763.3

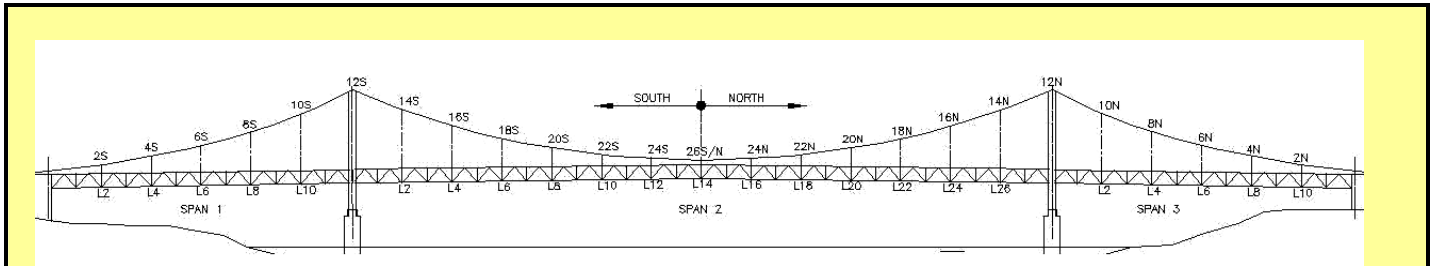
# Lower Liard River Bridge Alaska Highway km 763.3

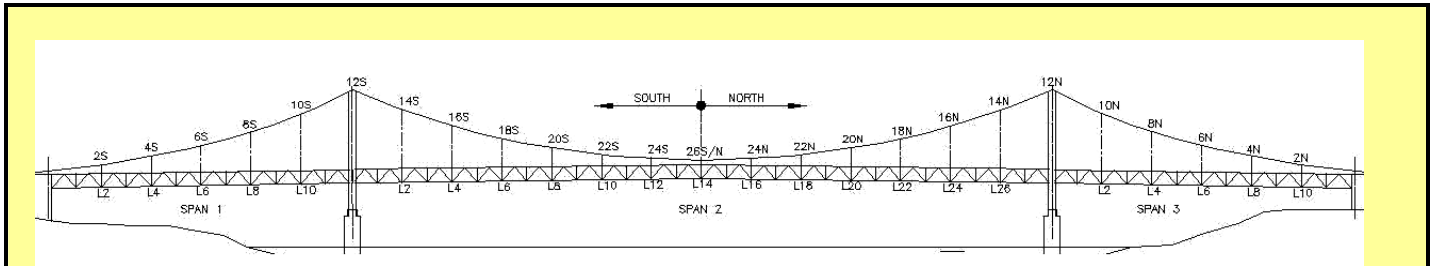
# Lower Liard River Bridge Alaska Highway km 763.3

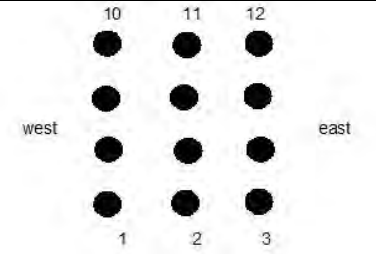
</div> <div style="background-color: #ffff00; width: 50%;"></div> </div>								
Element	2009			2011			Observations	Photo References
	MCR	PCR	Priority	MCR	PCR	Priority		
<b>Main Suspension Cables – East</b>								
Note: Naming convention identical to as-built drawings and previous reports								
<b>South Abutment</b>								
0S-2S	5	5	D	5	5	D	No visible defects.	
2S-4S	5	5	D	5	5	D	No visible defects.	
4S-6S	5	5	D	5	5	D	No visible defects.	
6S-8S	5	5	D	5	5	D	1 #7 and 3 #8 broken wires clamped – 3 clamps on #8, rust under clamps	56,57
8S-10S	5	5	D	5	5	D	1 #5 broken wire clamped	58
10S-12S	5	5	D	5	5	D	3 #1 broken wires double clamped	59
<b>South Tower</b>								
12S-14S	5	5	D	5	5	D	No visible defects.	
14S-16S	5	5	D	5	5	D	1 #5, 2 #9 and 2 #8 broken wires clamped	67,68,69
16S-18S	5	5	D	5	5	D	1 #8, 1 #10 and 1 #11 broken wires clamped	70,71,72

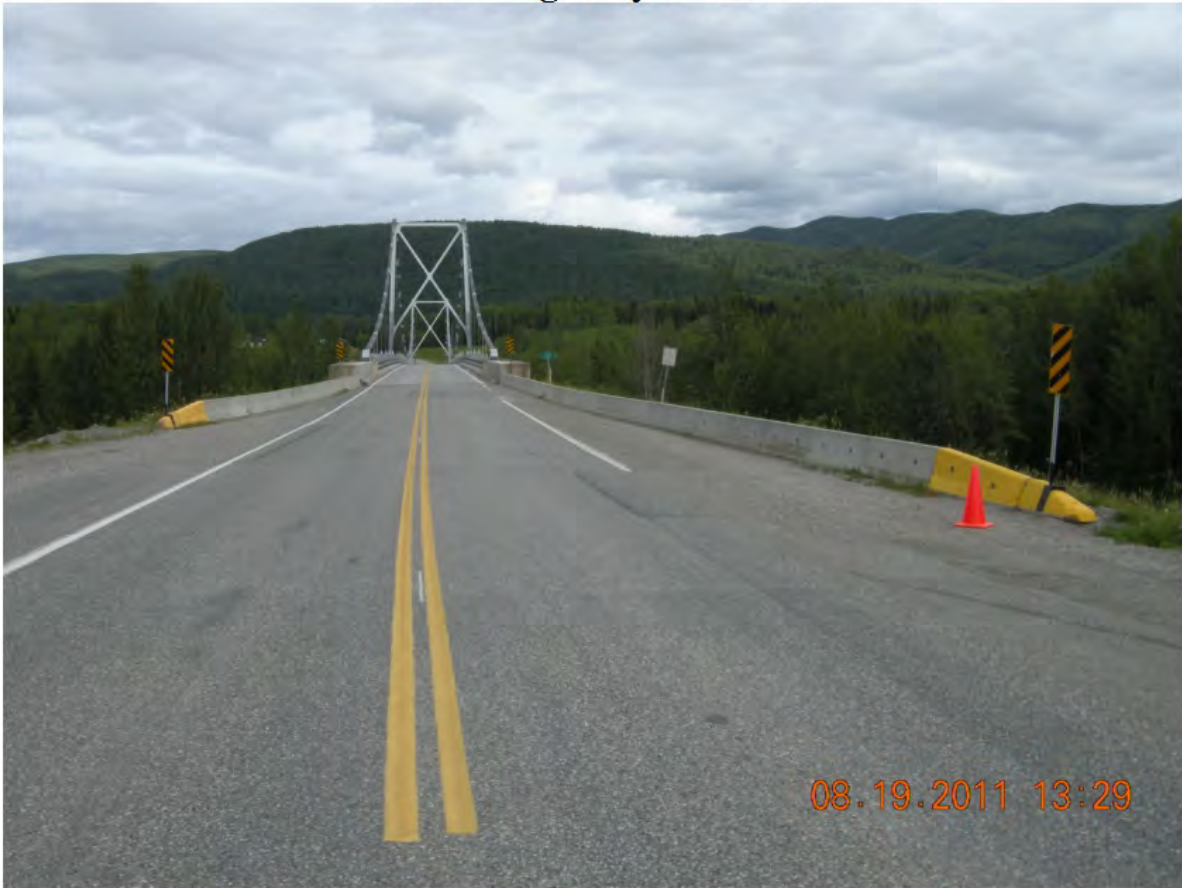
**P01 - South Approach - All 4 Delineators and River Name Sign in Place**

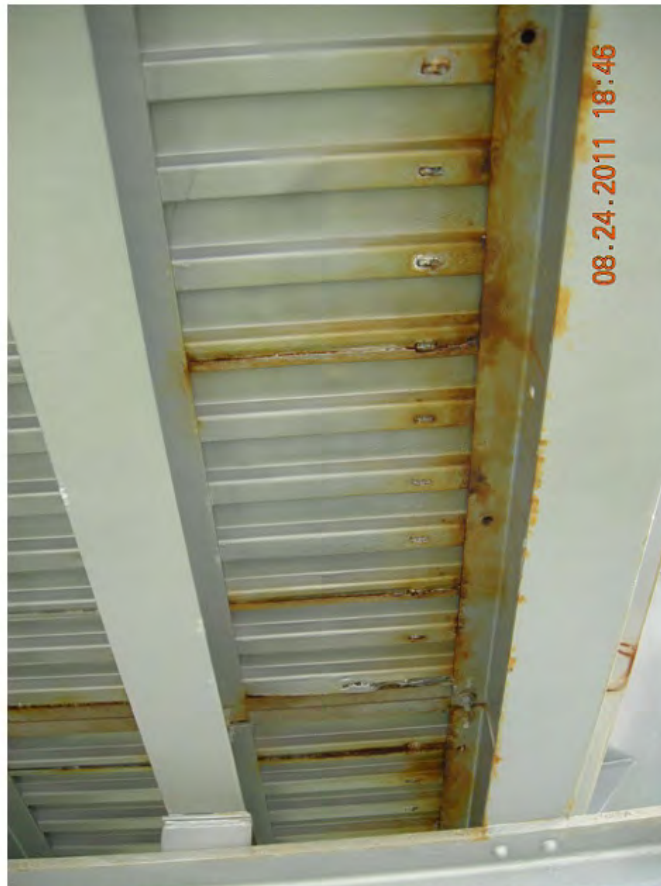
**P26 - Span 1 - Corrosion Staining of Permanent Soffit Formwork and West Stringer Top Flange Near Midspan on West Side of Deck**

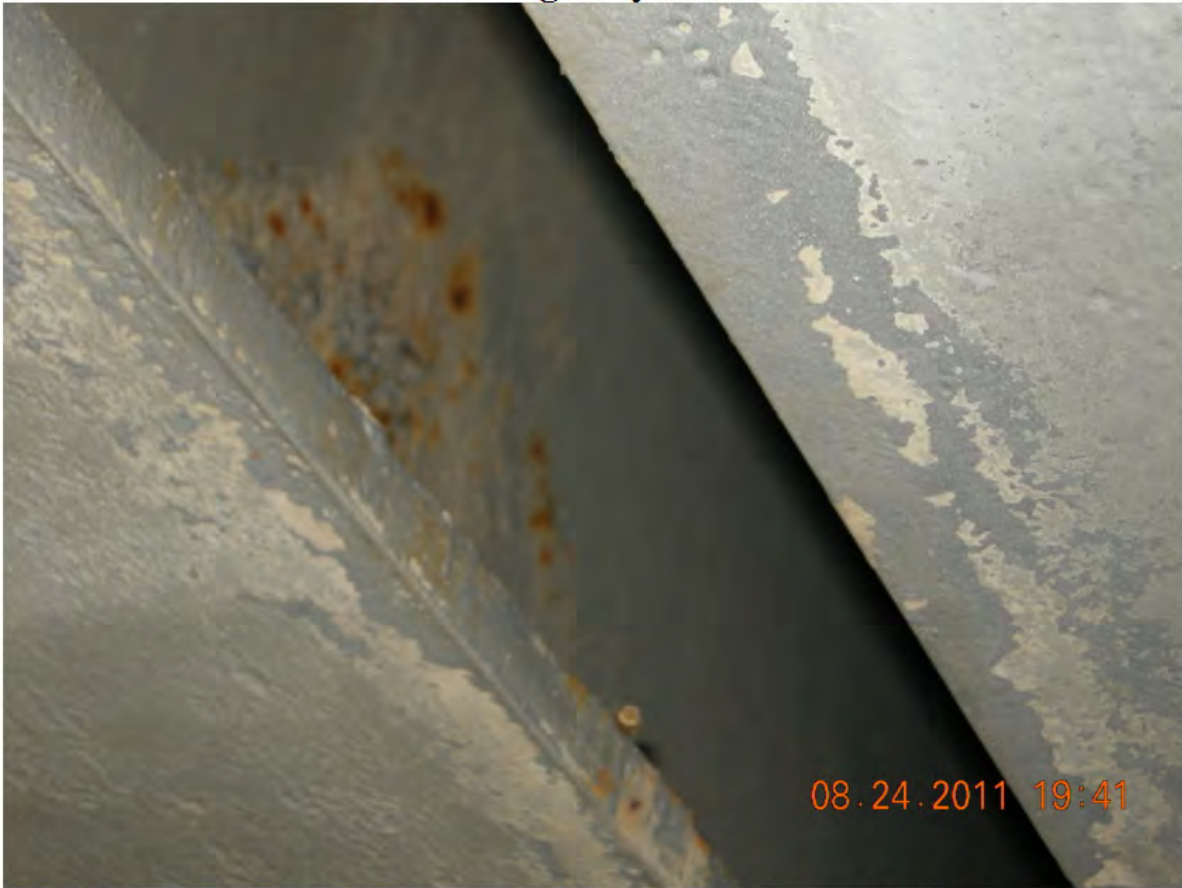
**P27 - Span 1 - South Tower Floorbeams at L12 - Corrosion on Floorbeam Web below Finger Joint**

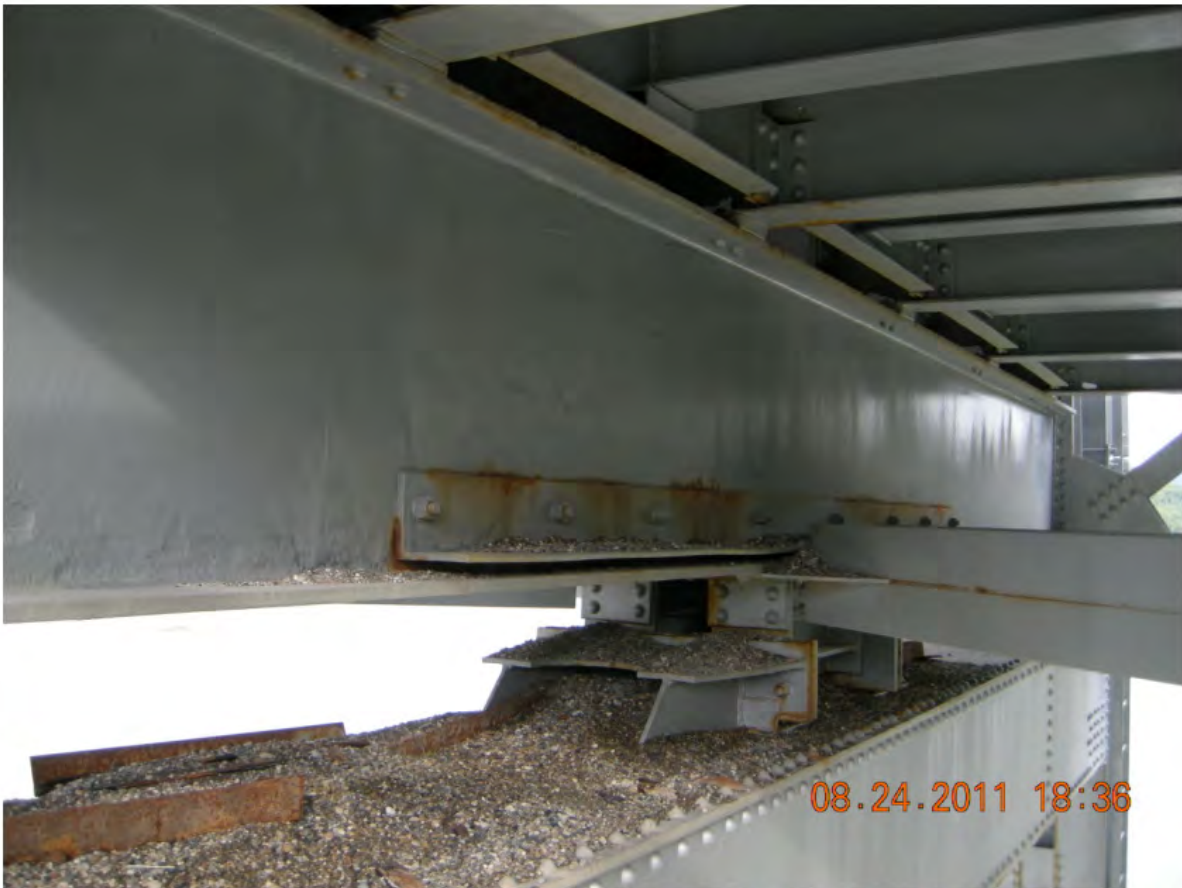
**P28 - South Tower - Gravel Leaking through Finger Joint onto Horizontal Surfaces - Rust Staining from Unpainted Surfaces**

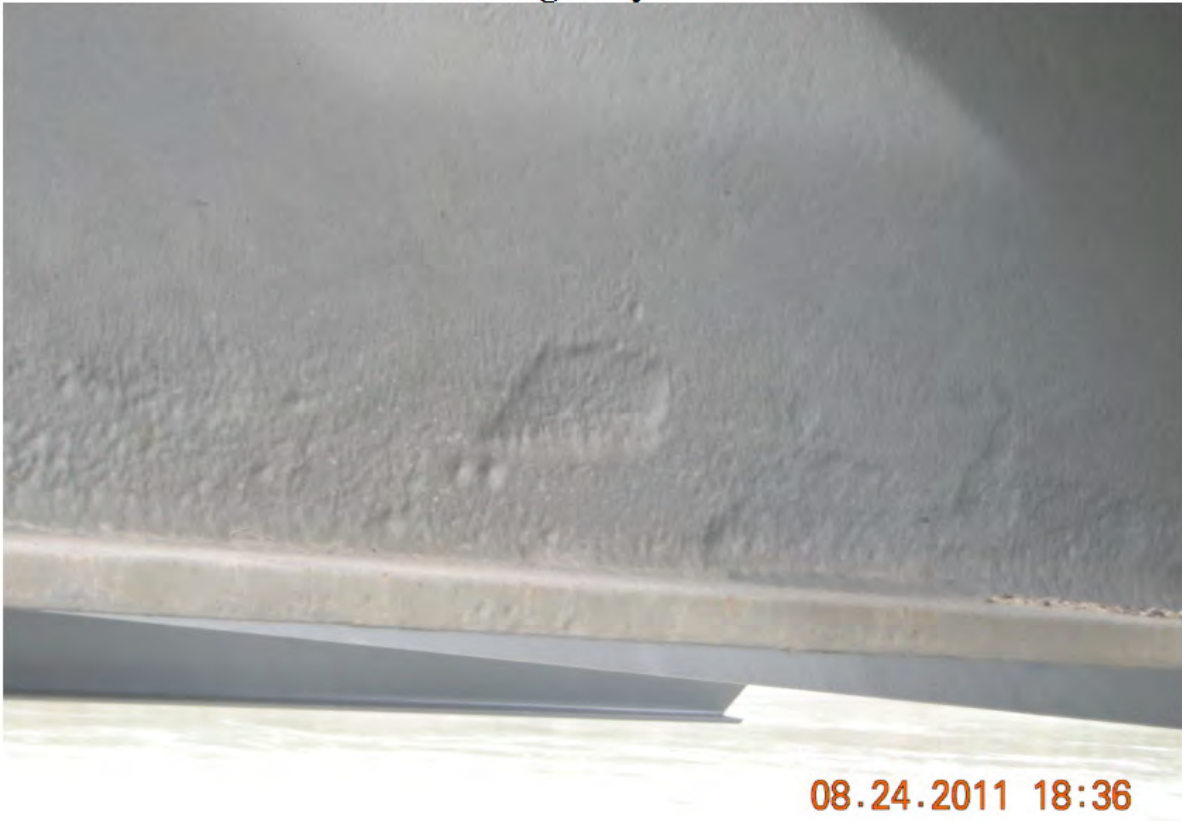
**Lower Liard River Bridge  
Alaska Highway km 763.3**

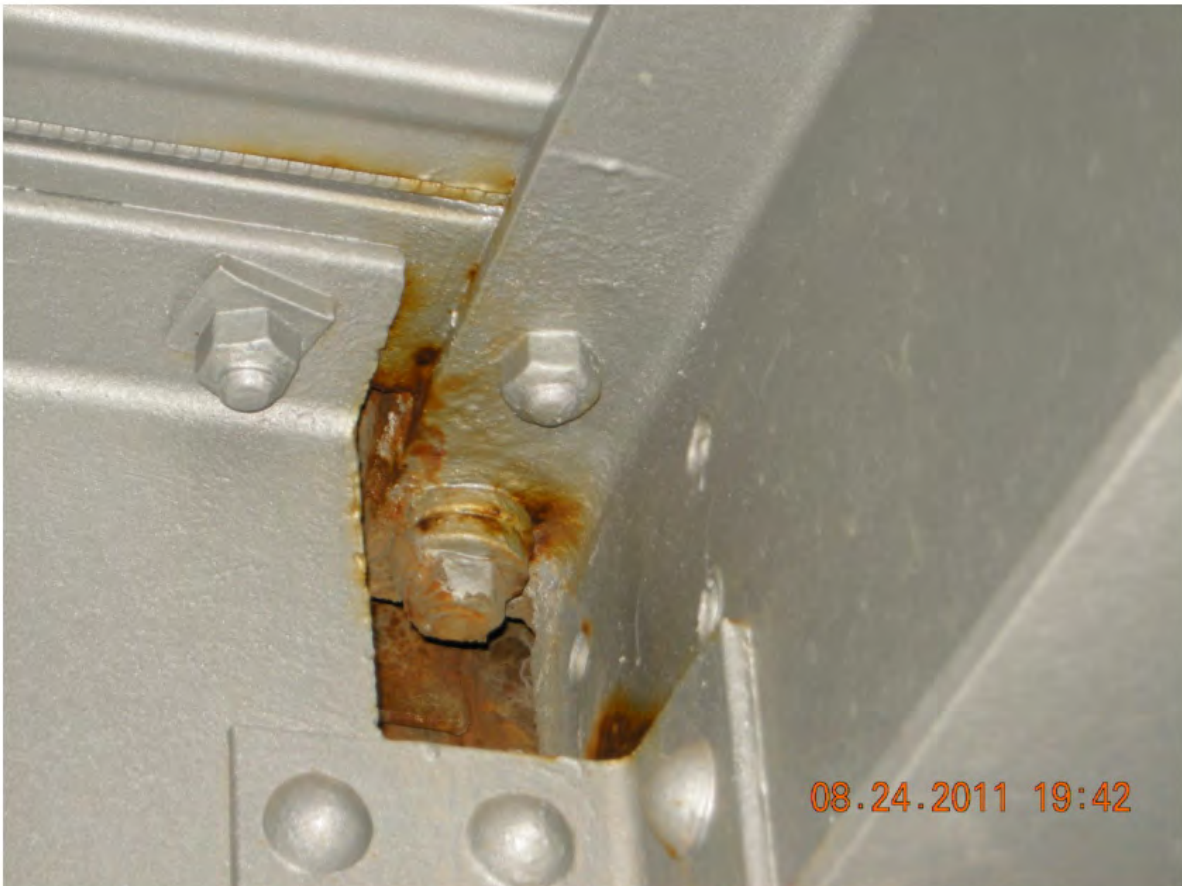
**P29 - Span 1 - Floorbeam L12 - Pitting up to 2 mm Deep in Web**

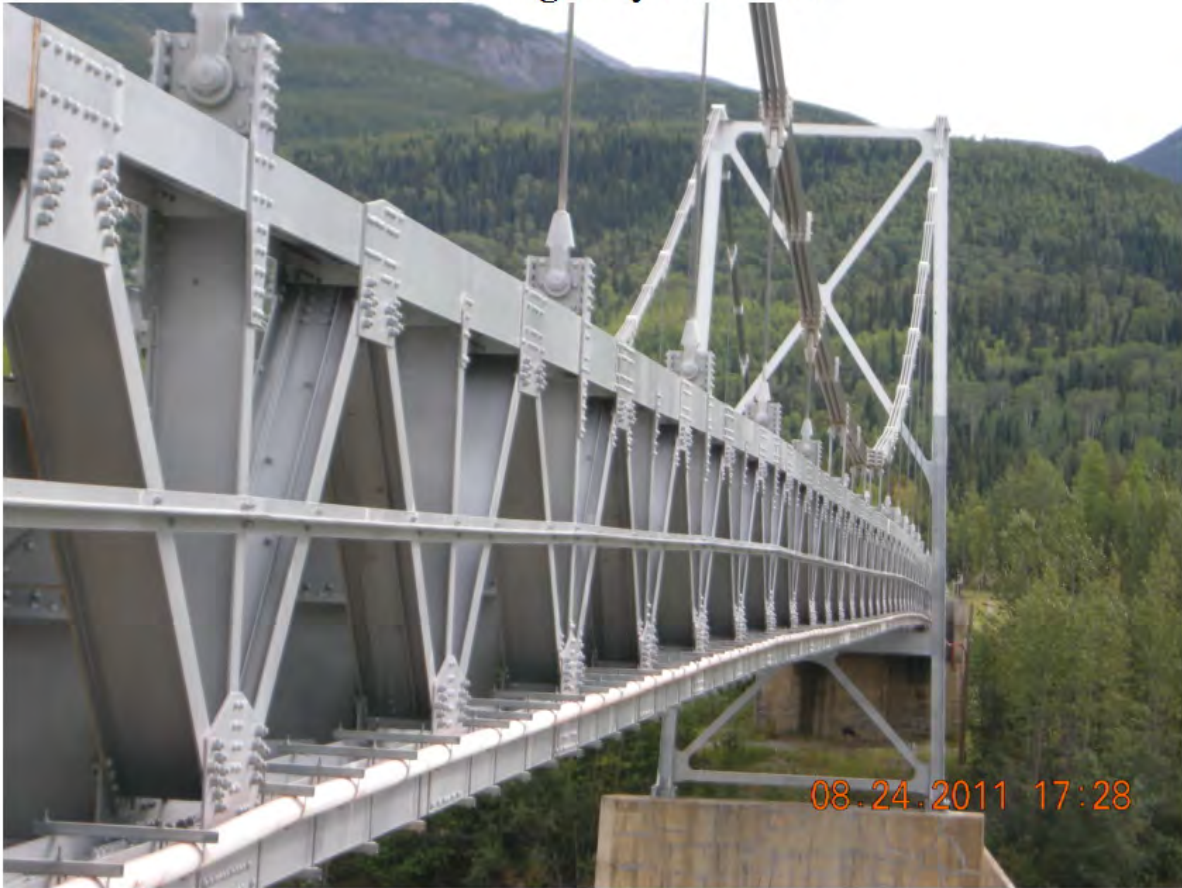
**P31 - Span 2 - West Truss - Looking South - Fibre Optic Cable along Bottom Chord - Profile Flattens out Near Midspan**

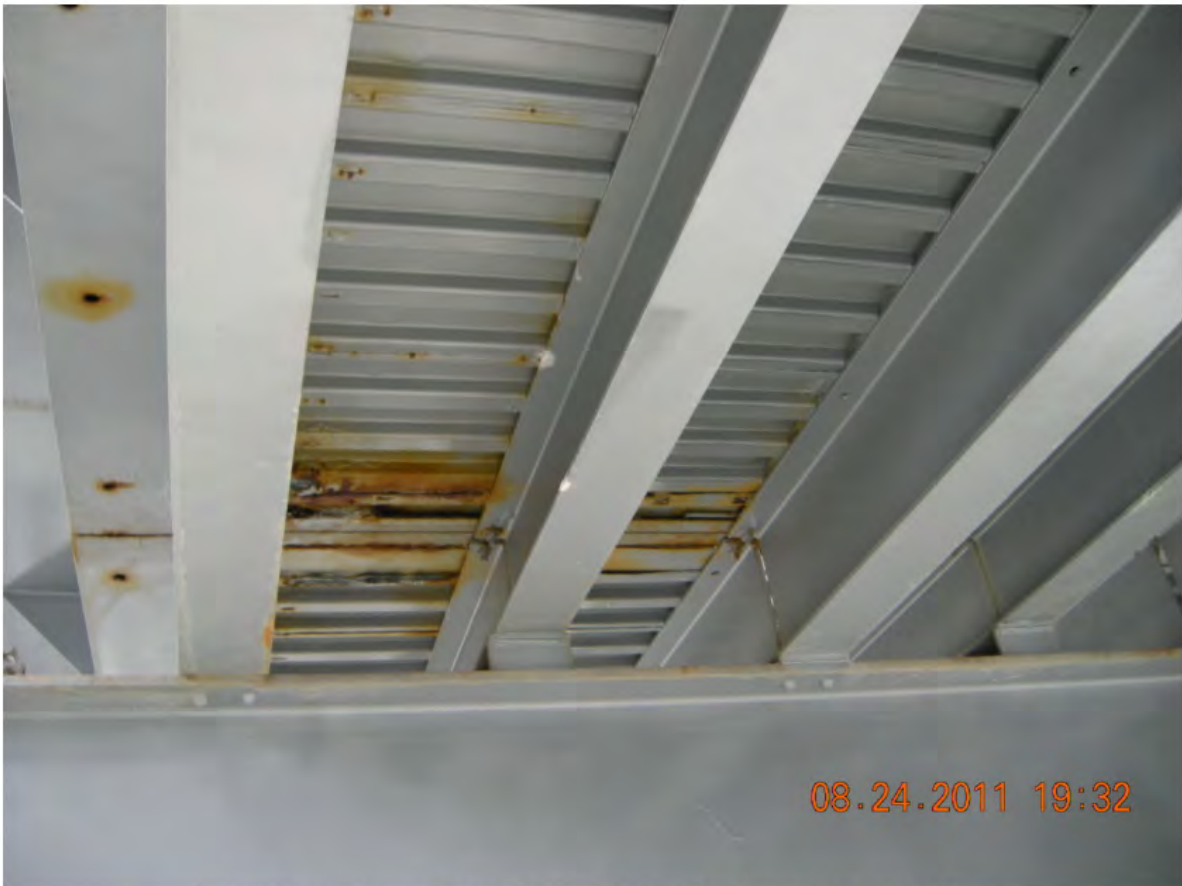
**P35 - Span 2 - Floorbeam L0**

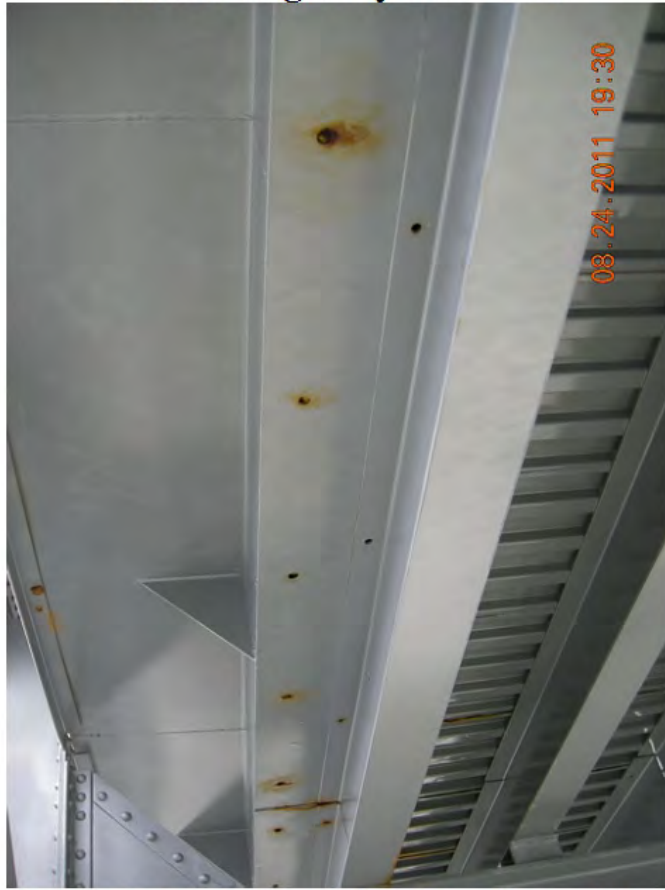
**P37 - Span 2 - Rust Staining in East Sidewalk near Midspan**
