# Lower Liard River Bridge Alaska Highway km 763.3

**ELEVATION**

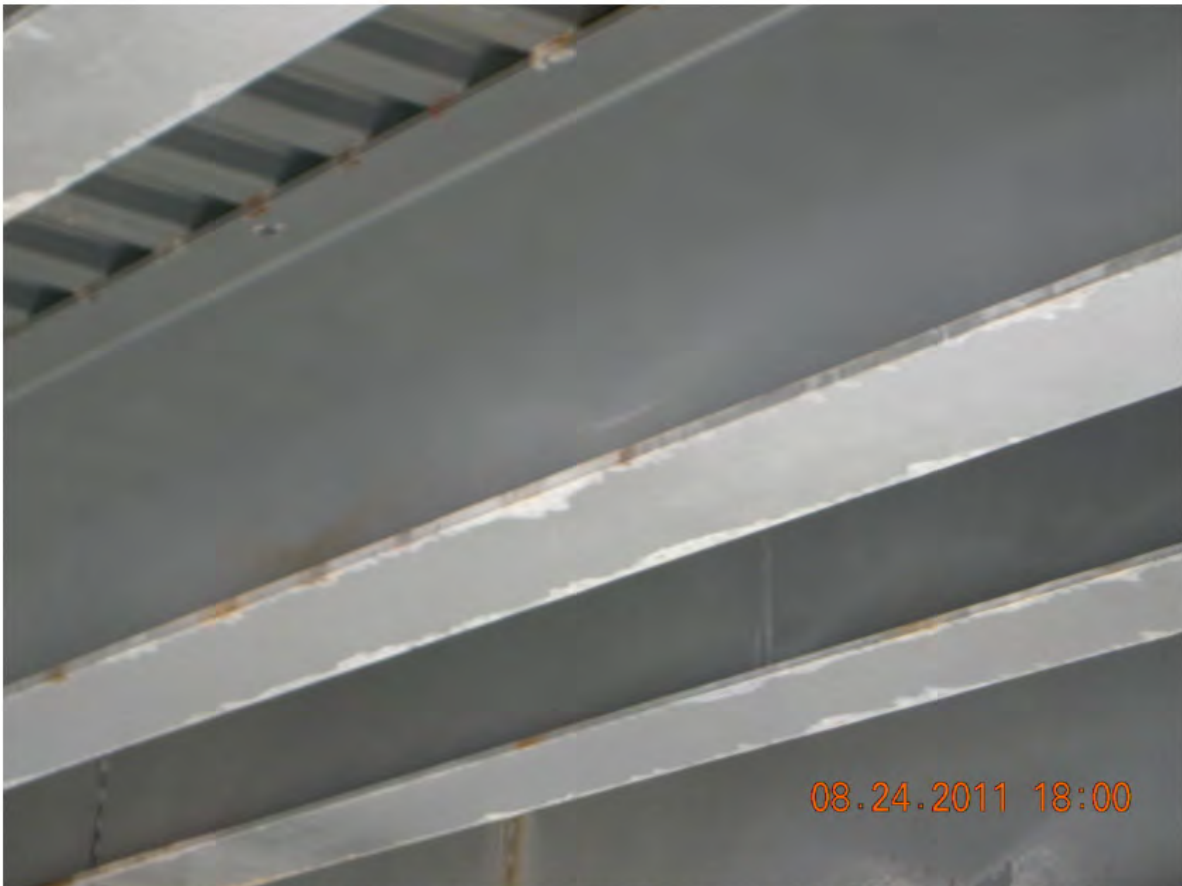
**P38 - Span 2 - Near Midspan - Stringer Bottom Chords - Top Coat of Paint Flaking off**

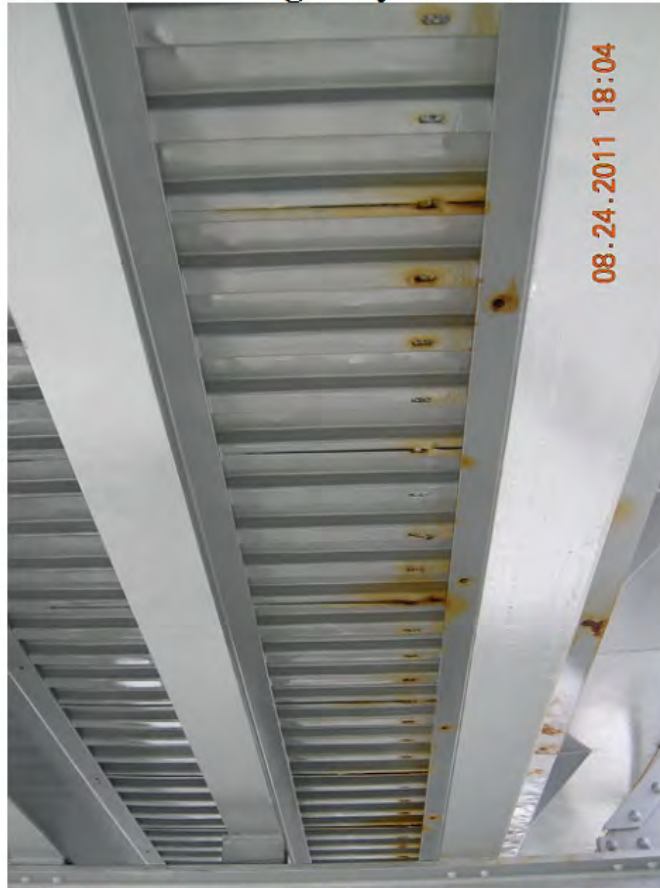
**P39 - Span 2 - Corrosion Staining of Permanent Soffit Formwork near Midspan on West Side of Deck**

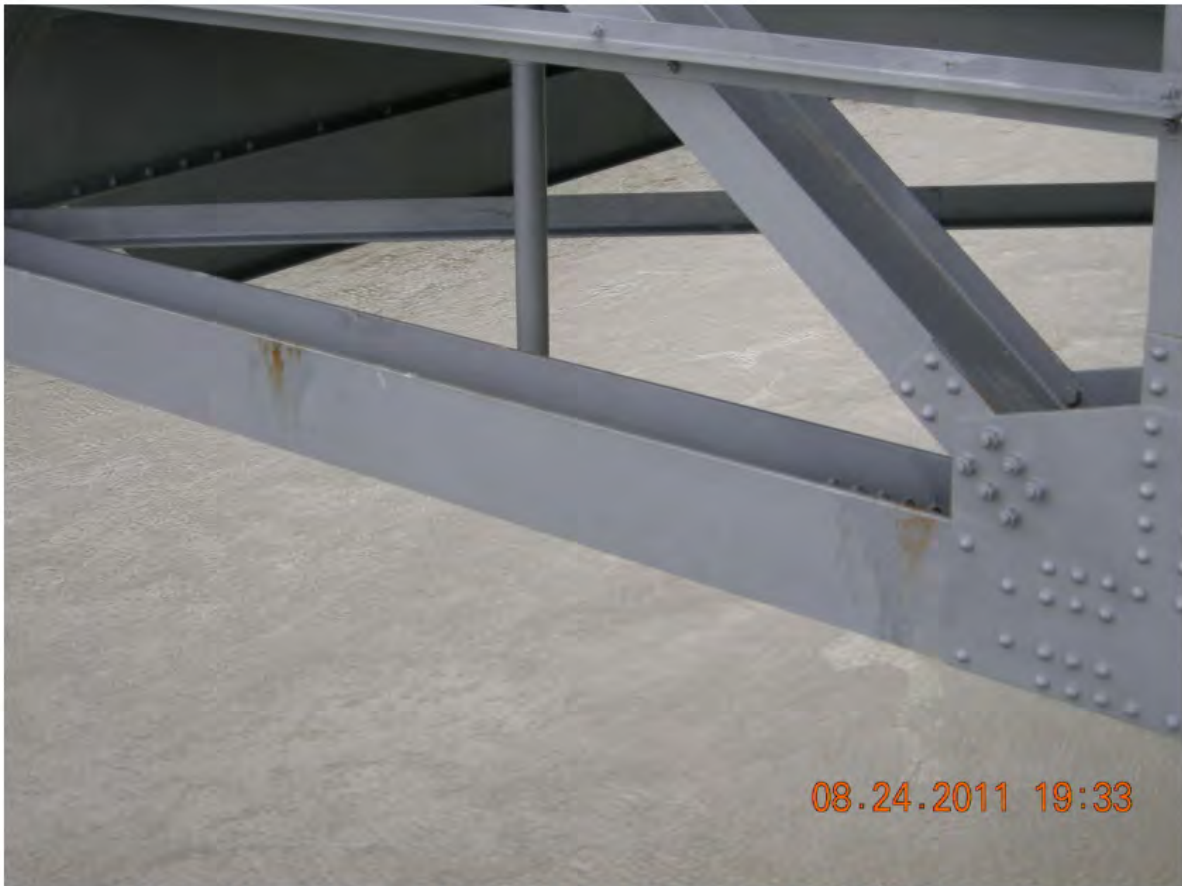
**P40 - Span 2 - Bottom East Chord at L9-L10 - Localized Light Surface Corrosion**

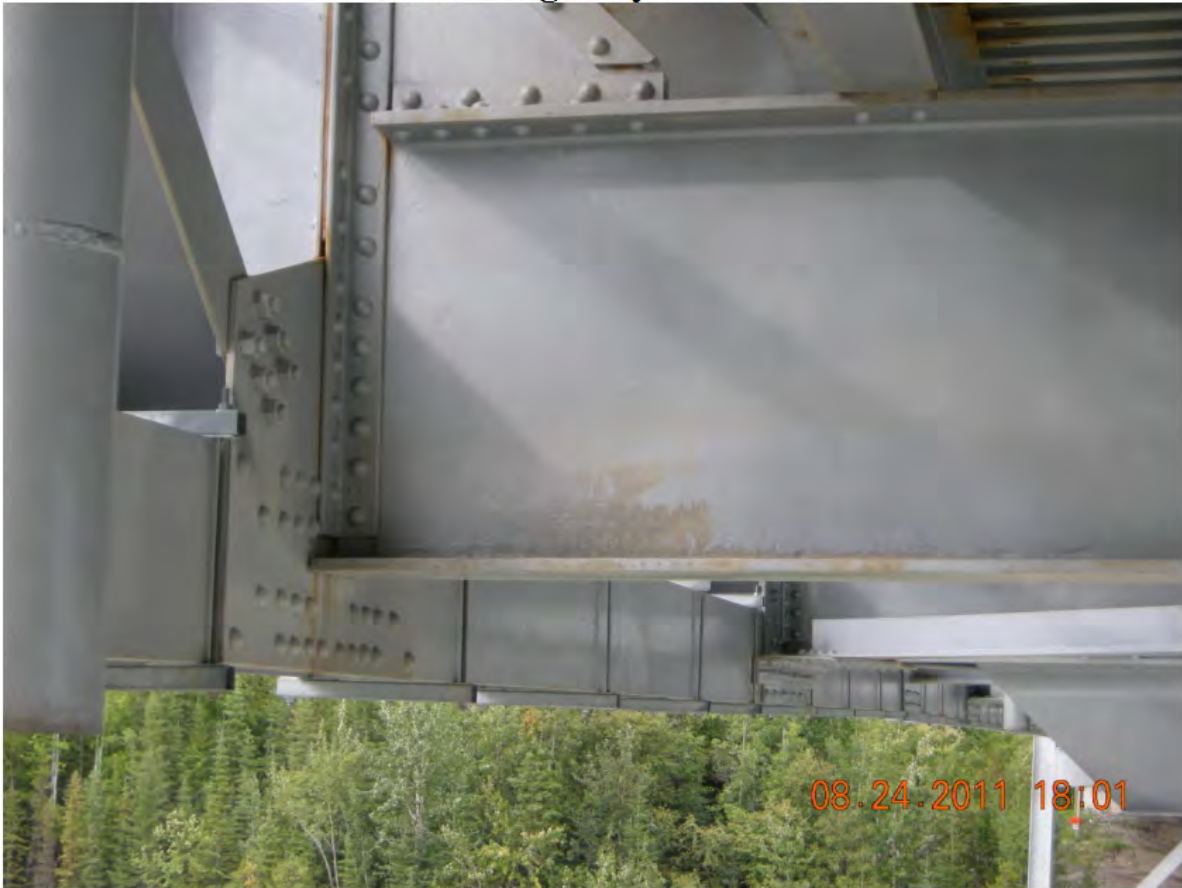
**P41 - Span 2 - Floorbeam L10 - Top Coat of Paint Incomplete at West End**

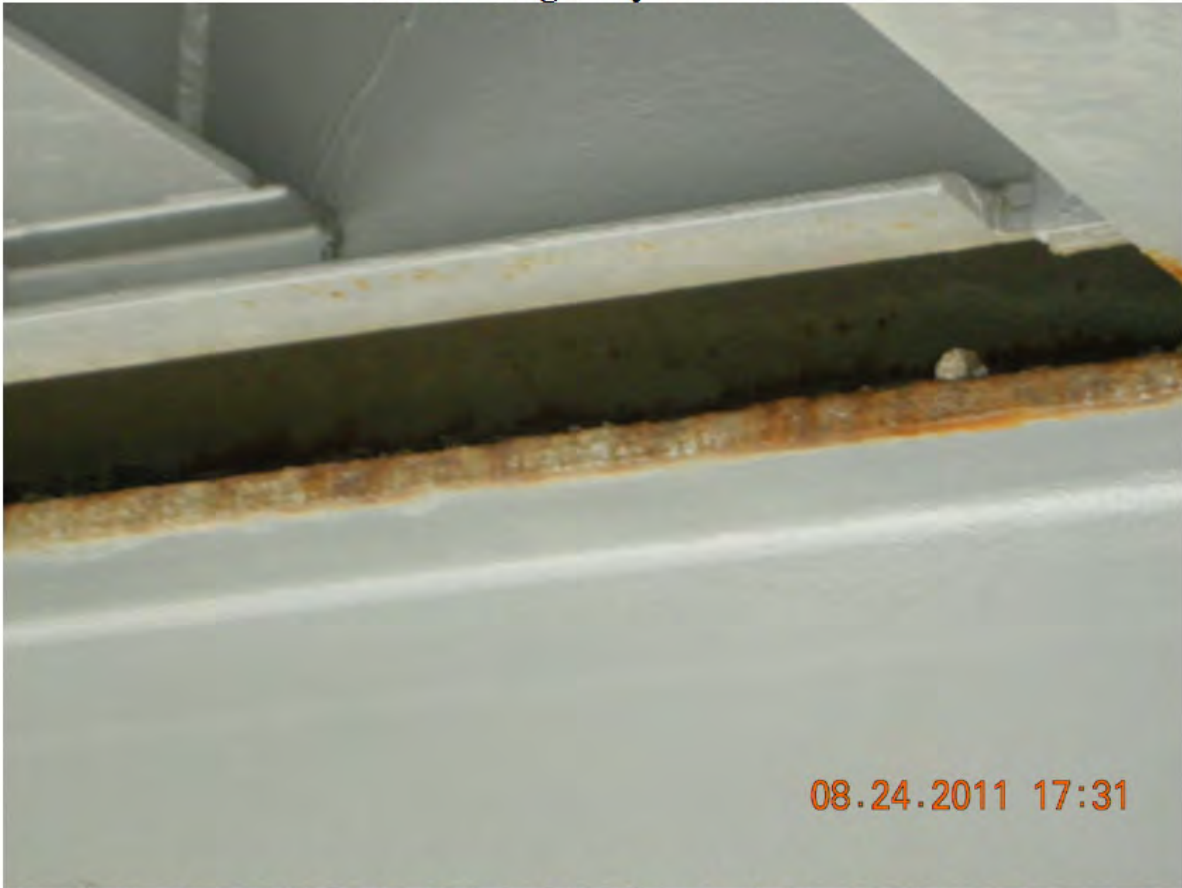
**Lower Liard River Bridge  
Alaska Highway km 763.3**

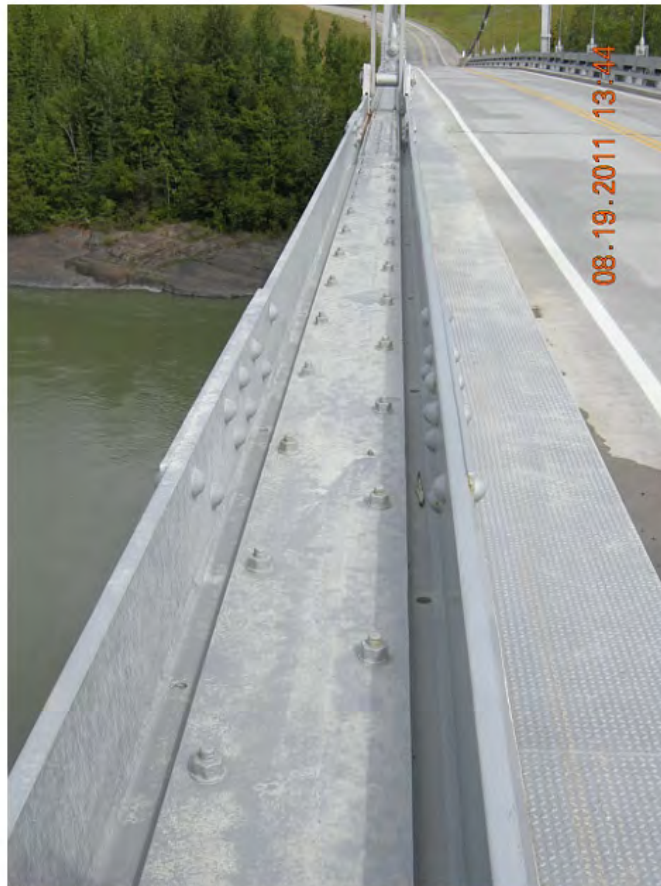
**P43 - Span 2 - Floorbeam L28 below North Finger Joint - Corrosion Staining from Unpainted areas below Joint**

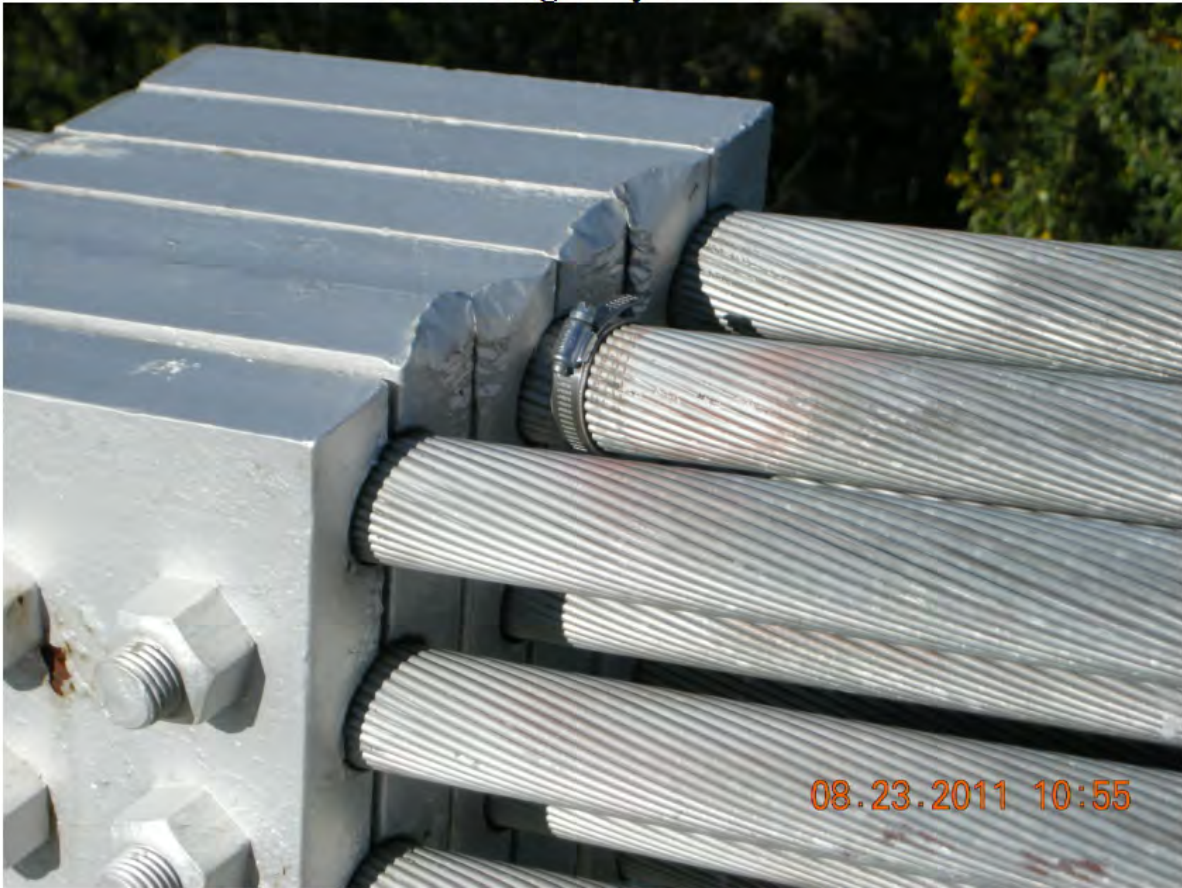
**P53 - Span 1 - West Cables 6S to 8S - 1 #11 Broken Wire Clamped**

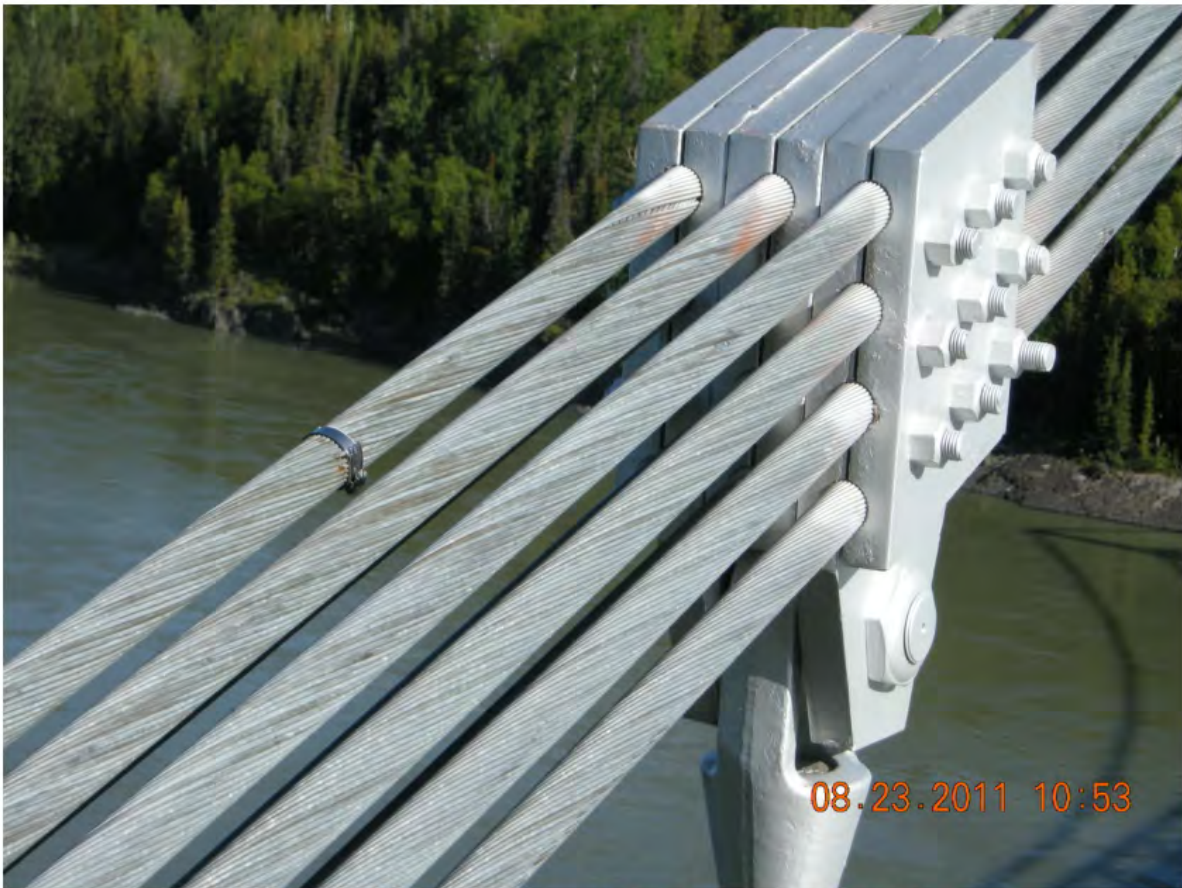
**P54 - Span 1 - West Cables 8S to 10S - 1 #10 Broken Wire Clamped**

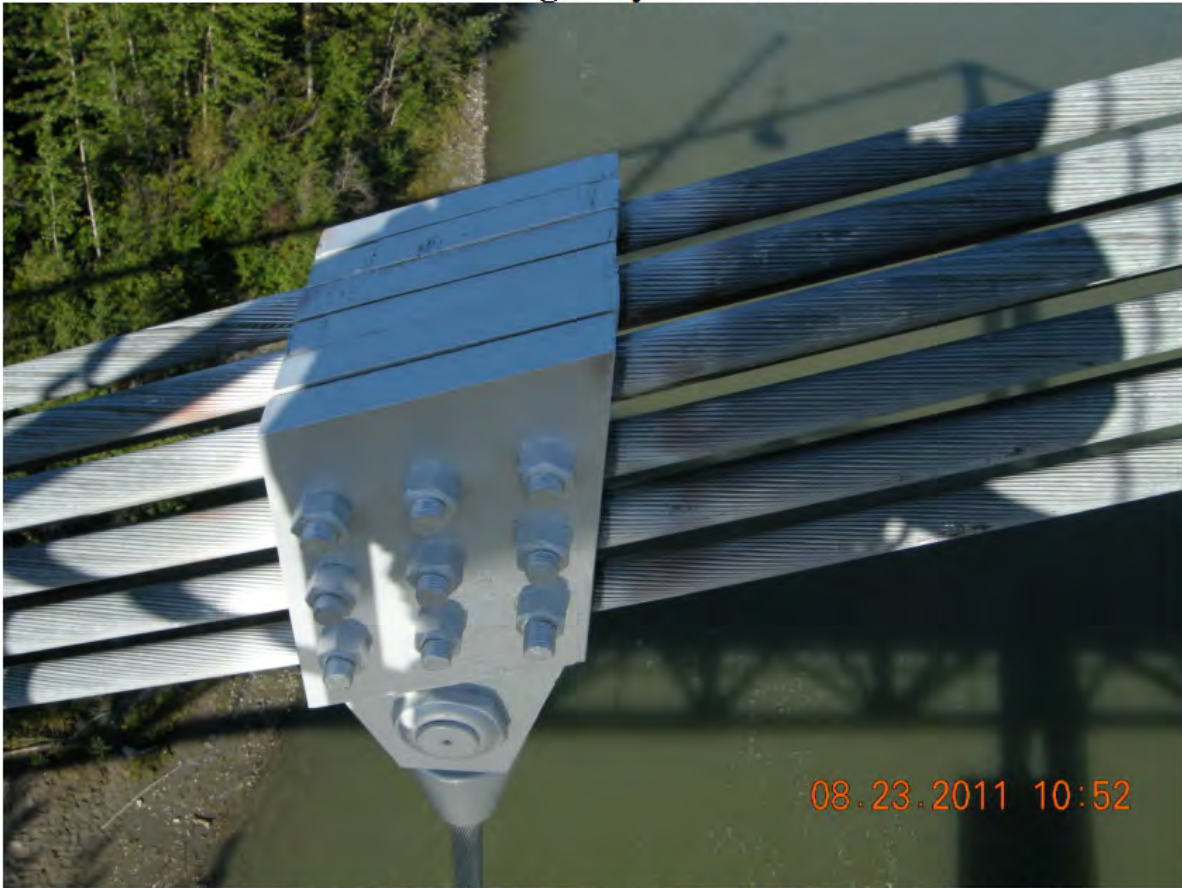
**P55 - Span 1 - West Hanger 10S - Slipped 5 mm as Previously Noted - No Additional Slippage**

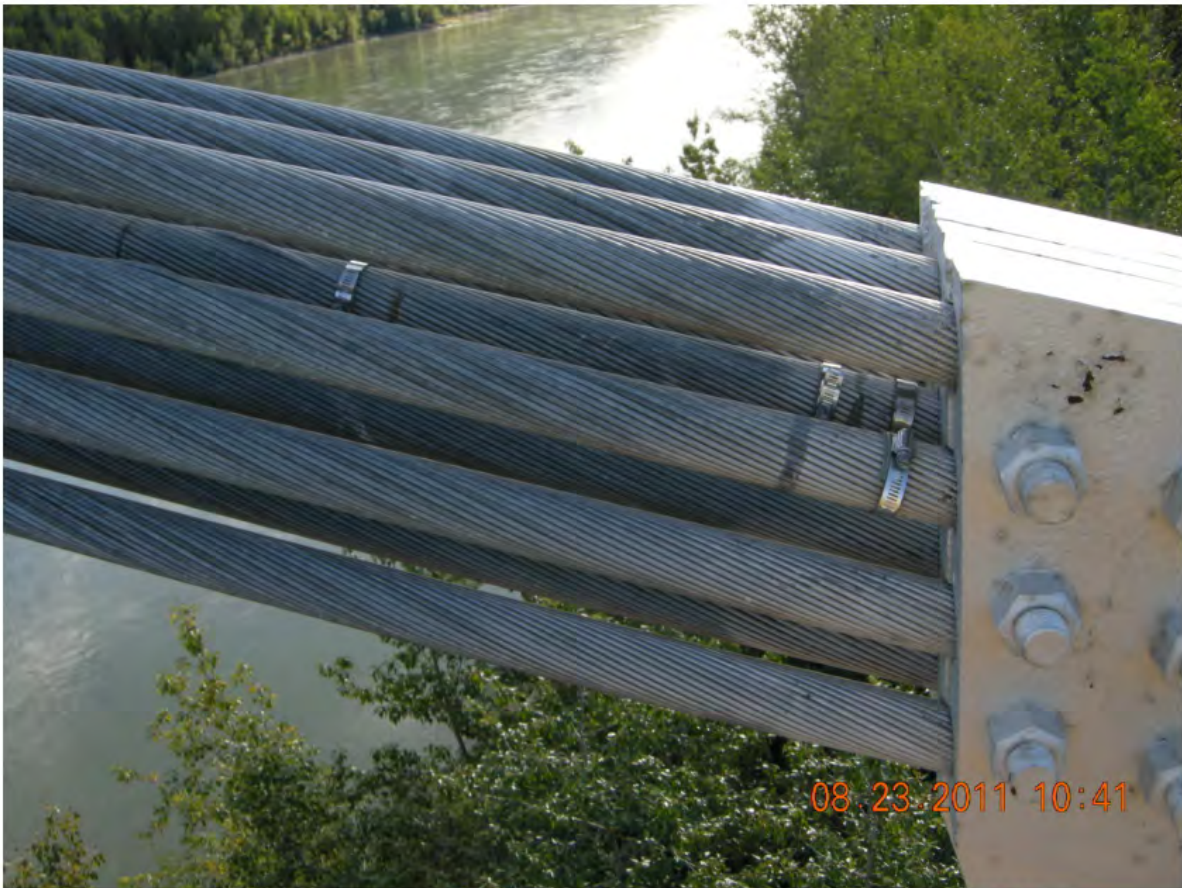
**P56 - Span 1 - East Cables 6S to 8S - 1 #7 and 3 #8 Broken Wires Clamped**

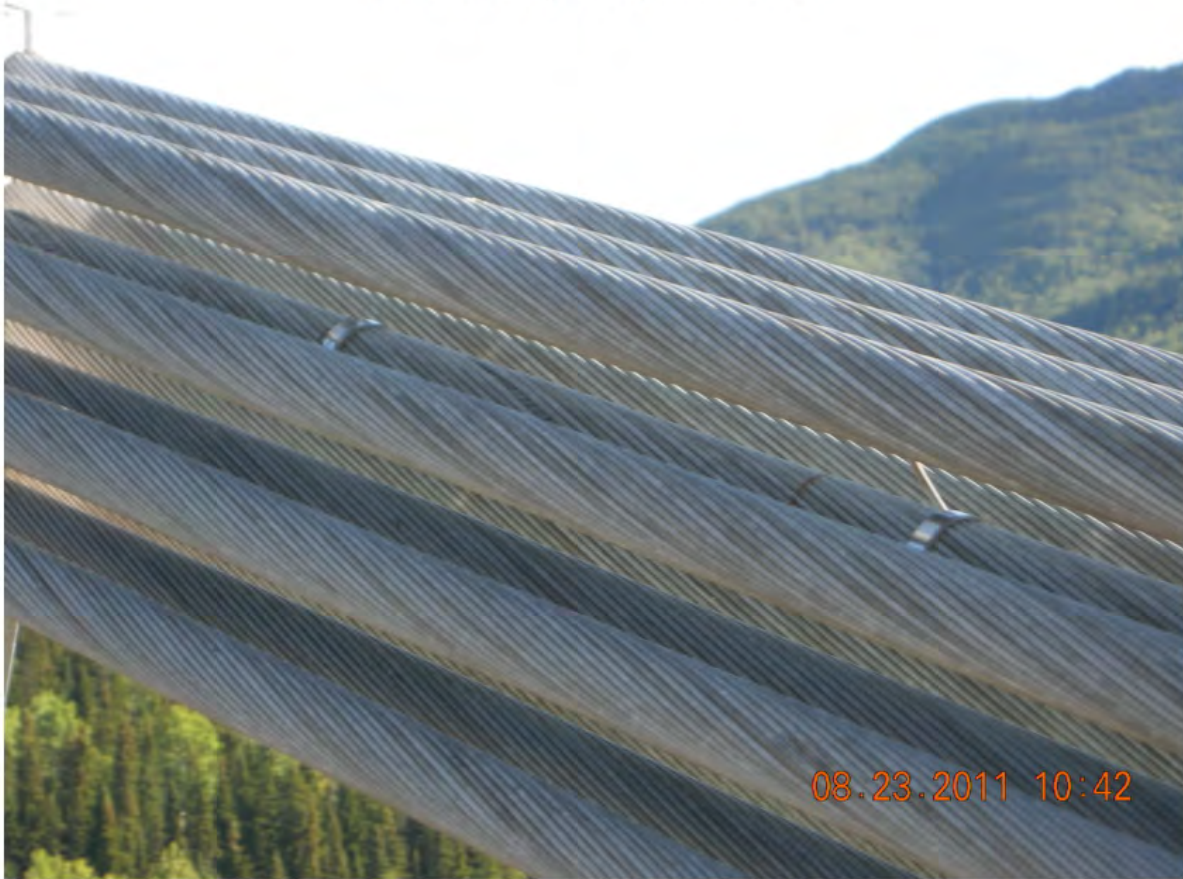
**P57 - Span 1 - East Cables 6S to 8S - 2 Additional Clamps on #8 Cable**

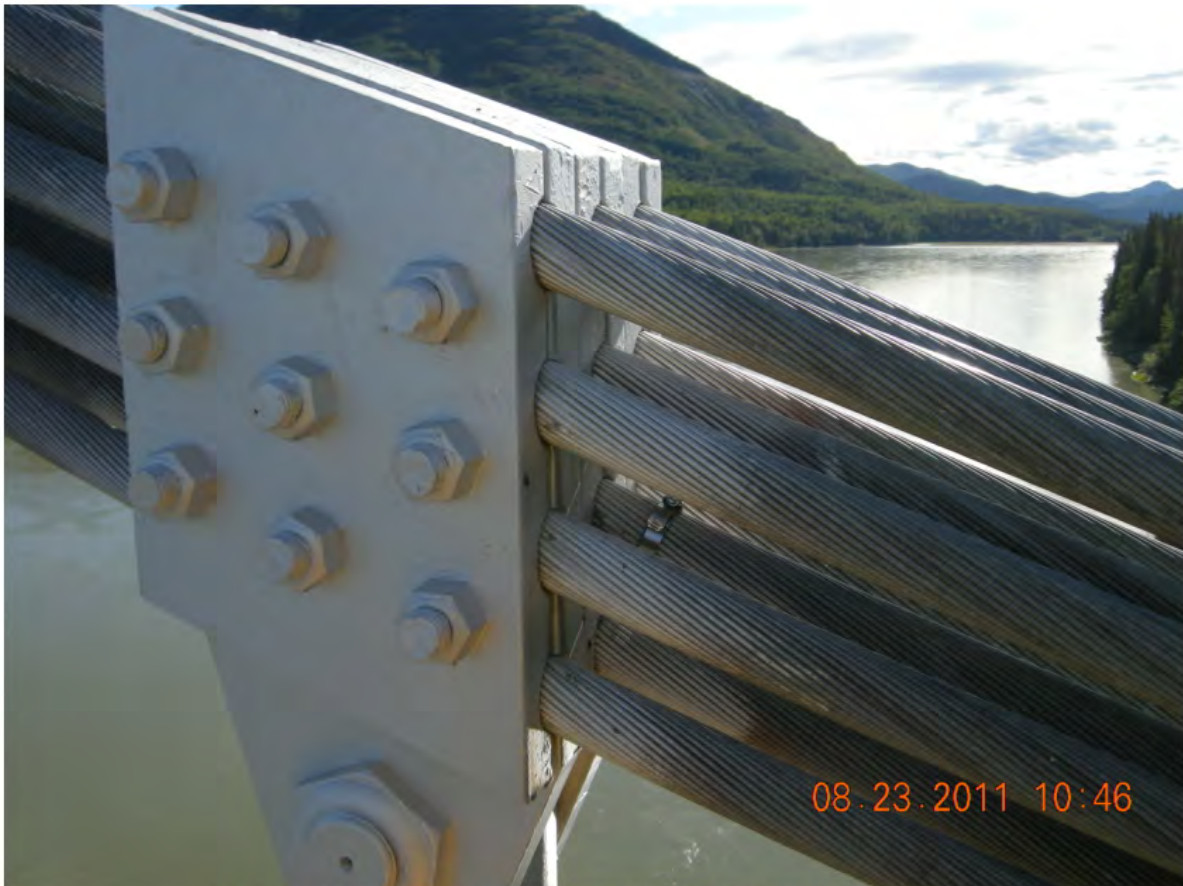
**P58 - Span 1 - East Cables 8S to 10S - 1 #5 Broken Wire Clamped**

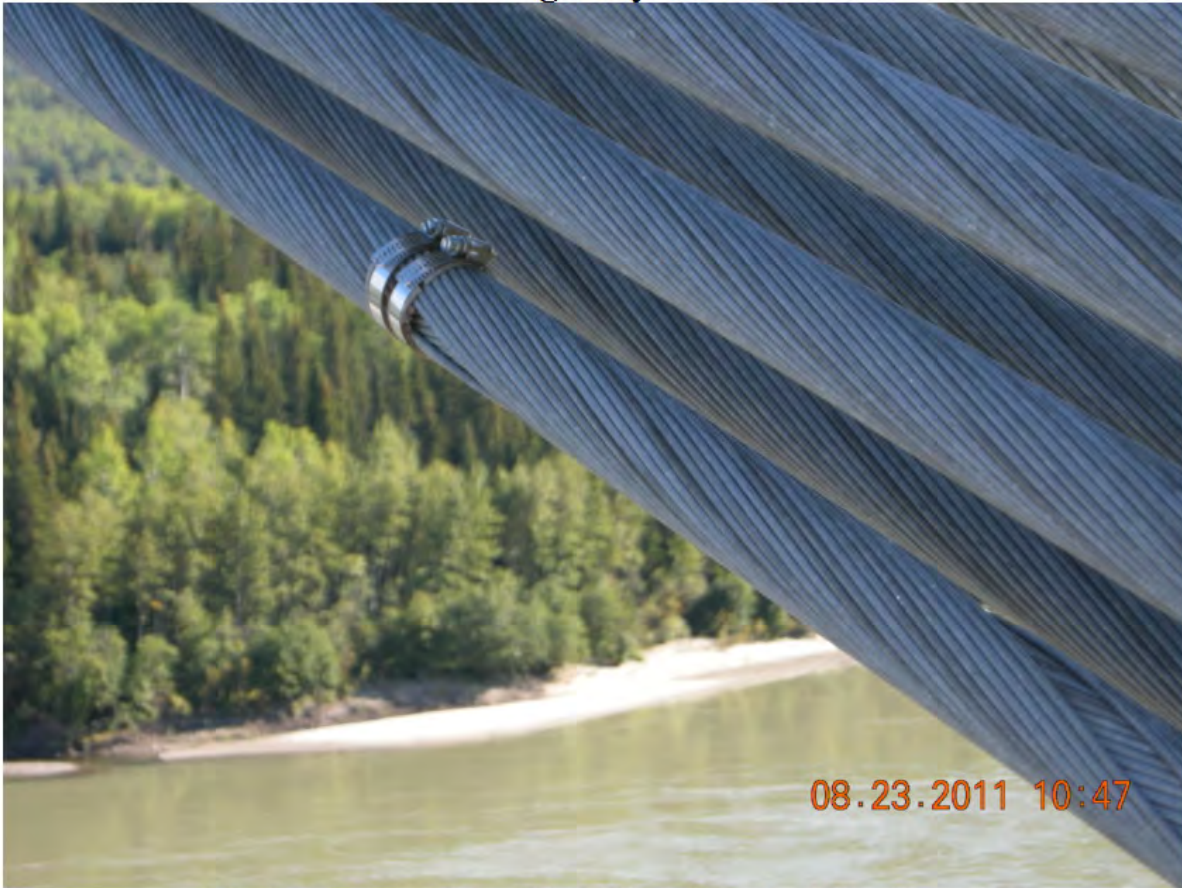
**Lower Liard River Bridge  
Alaska Highway km 763.3**

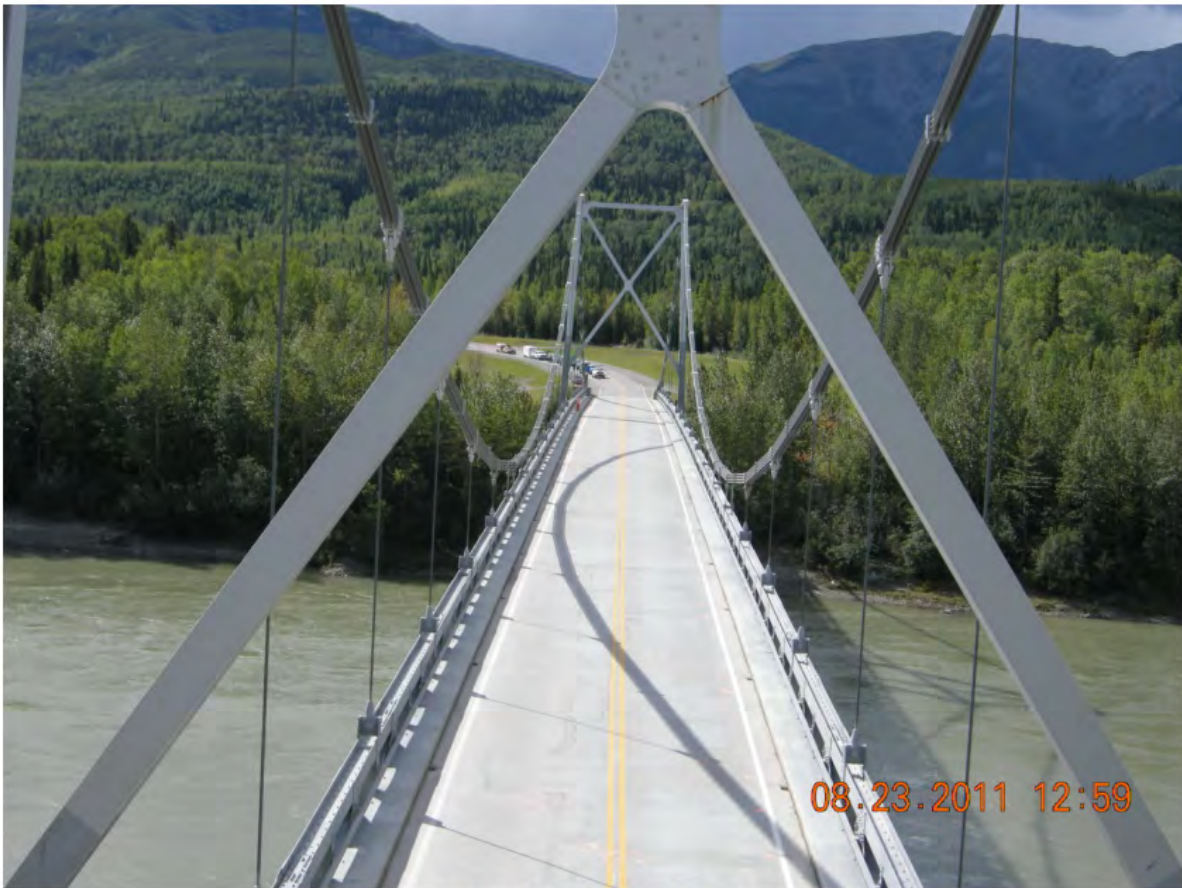
**P59 - Span 1 - East Cables 10S to 12S - 3 #1 Broken Wires Clamped**

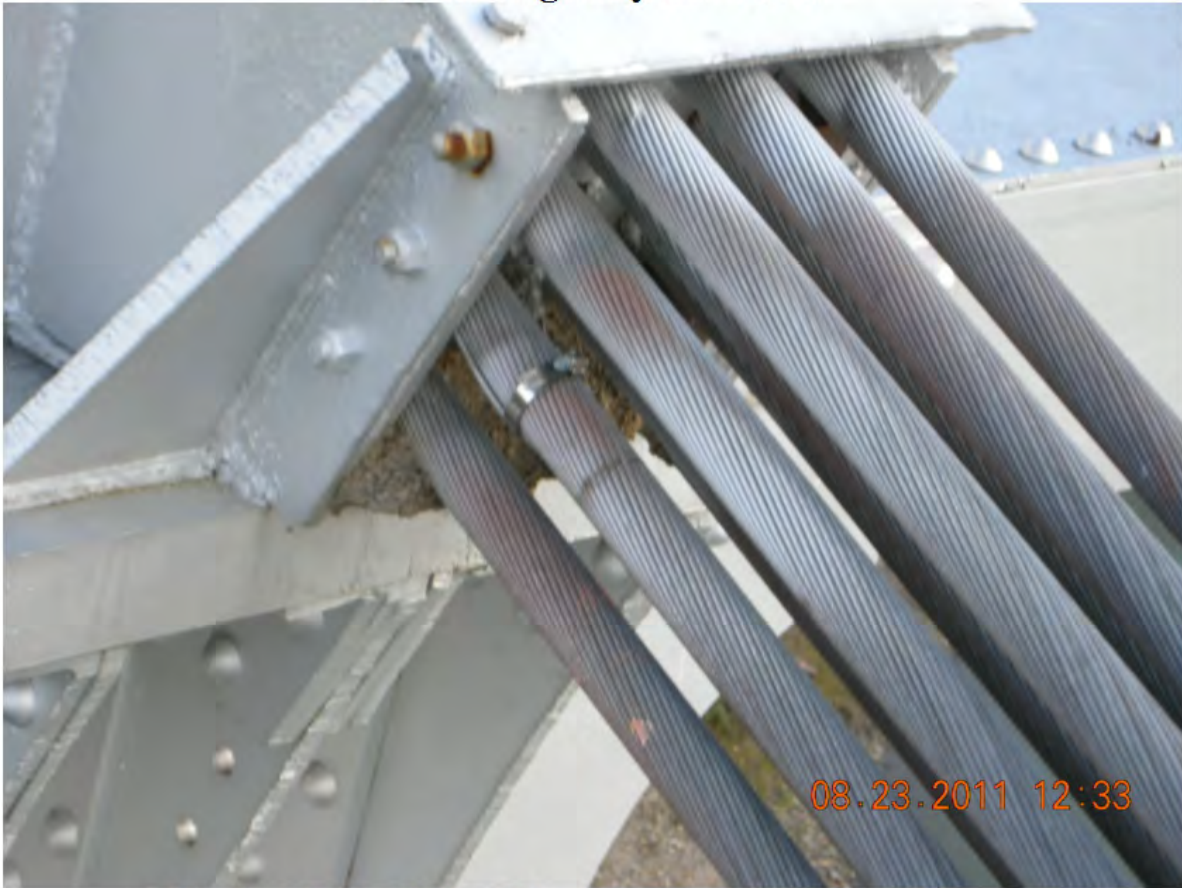
**P63 - Span 2 - West Cables 14N to 12N - One #6 Broken Wires Clamped**

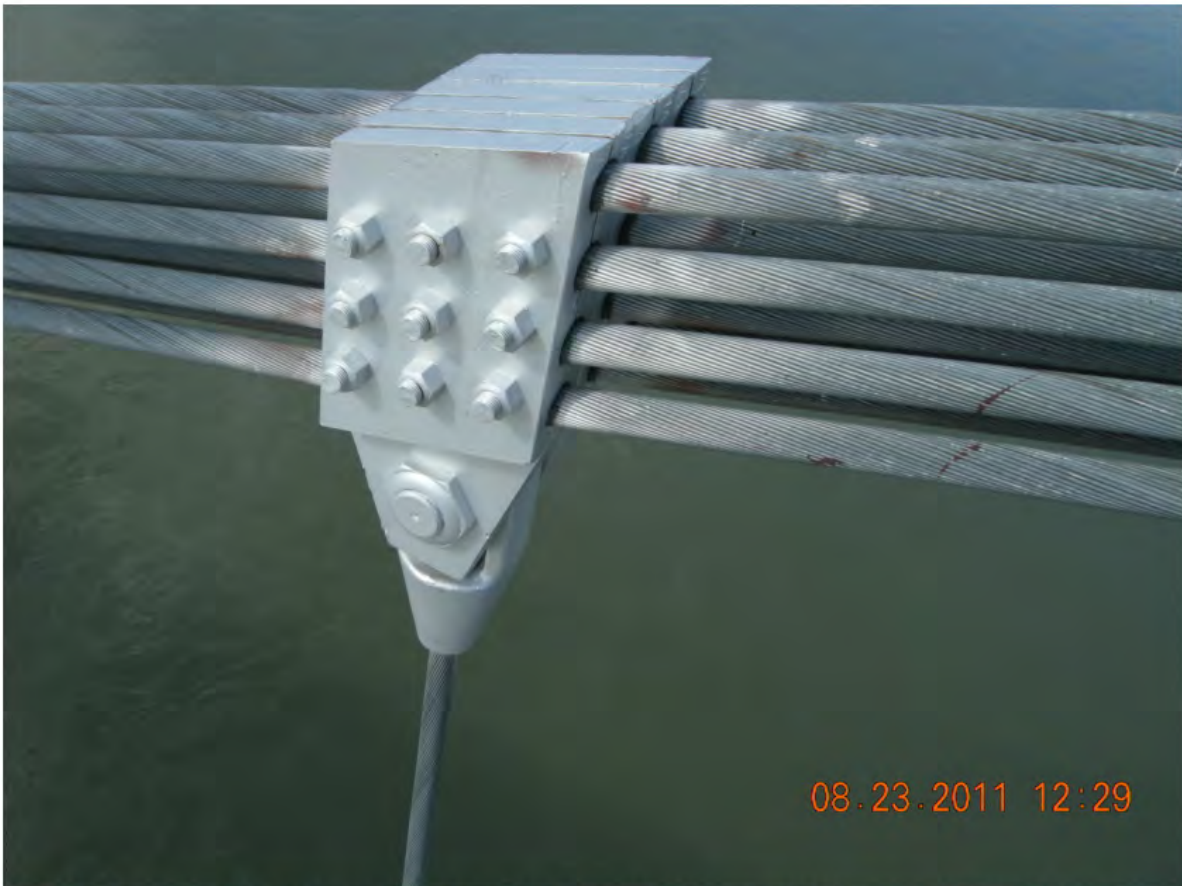
**P64 - Span 2 - West Hanger 14N - Slipped 5 mm as Previously Noted - No Additional Slippage**

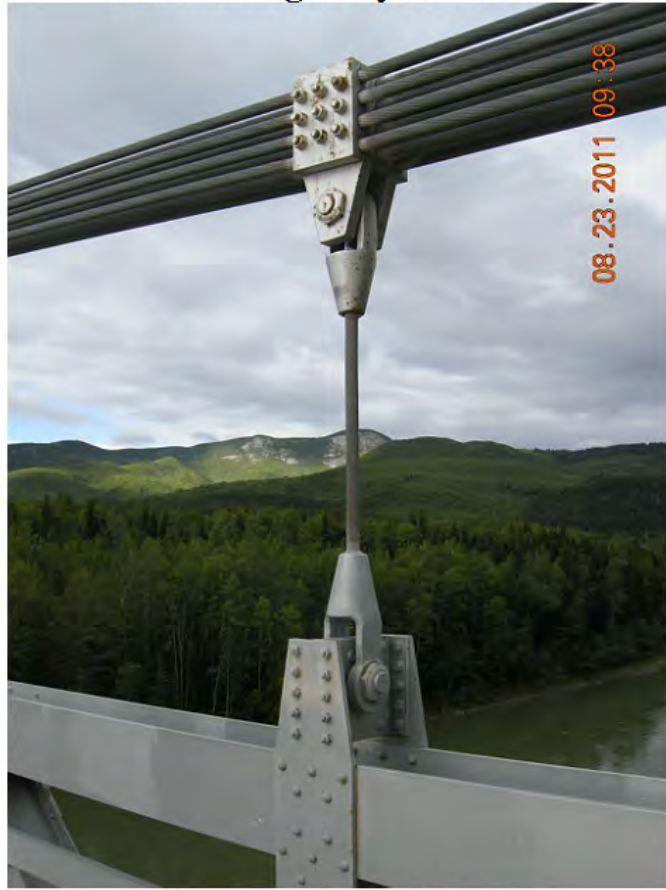
**P65 - Span 2 - West 22S Hanger**

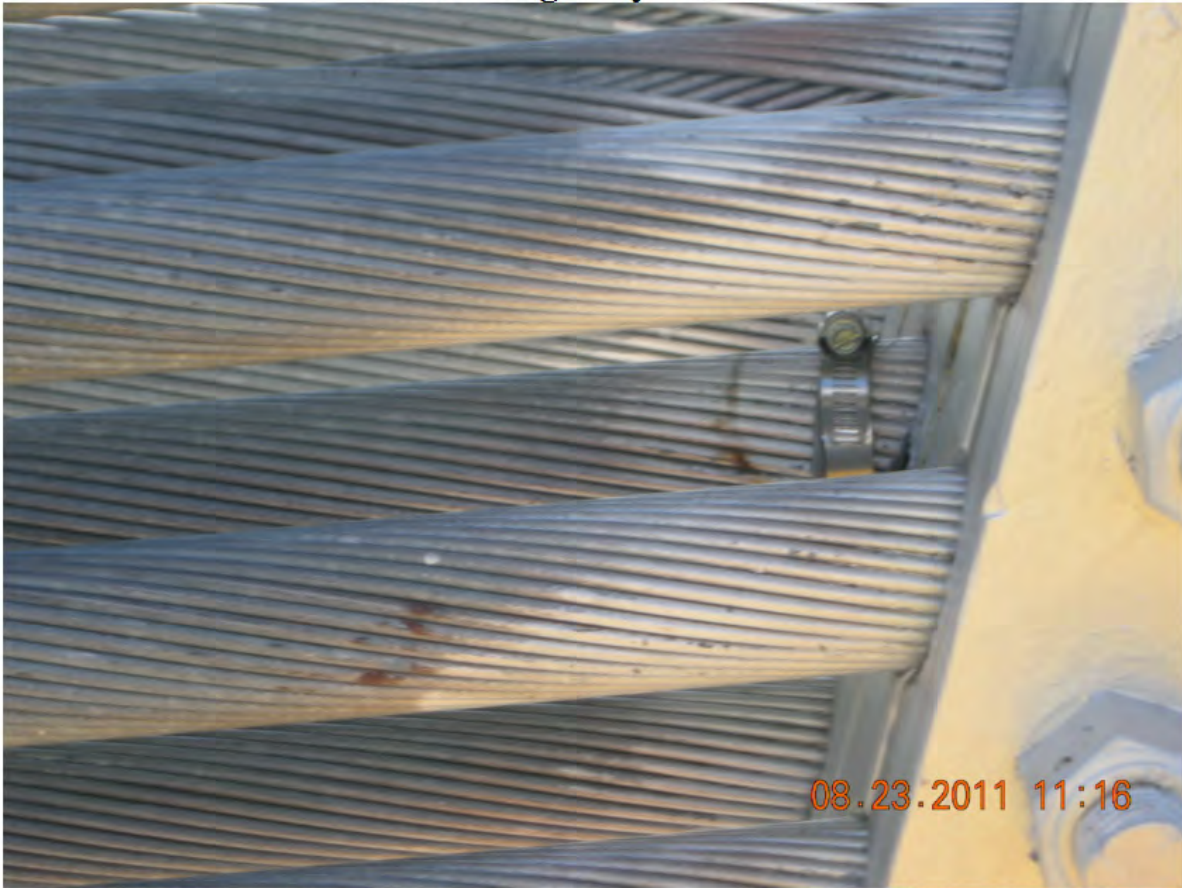
**Lower Liard River Bridge  
Alaska Highway km 763.3**

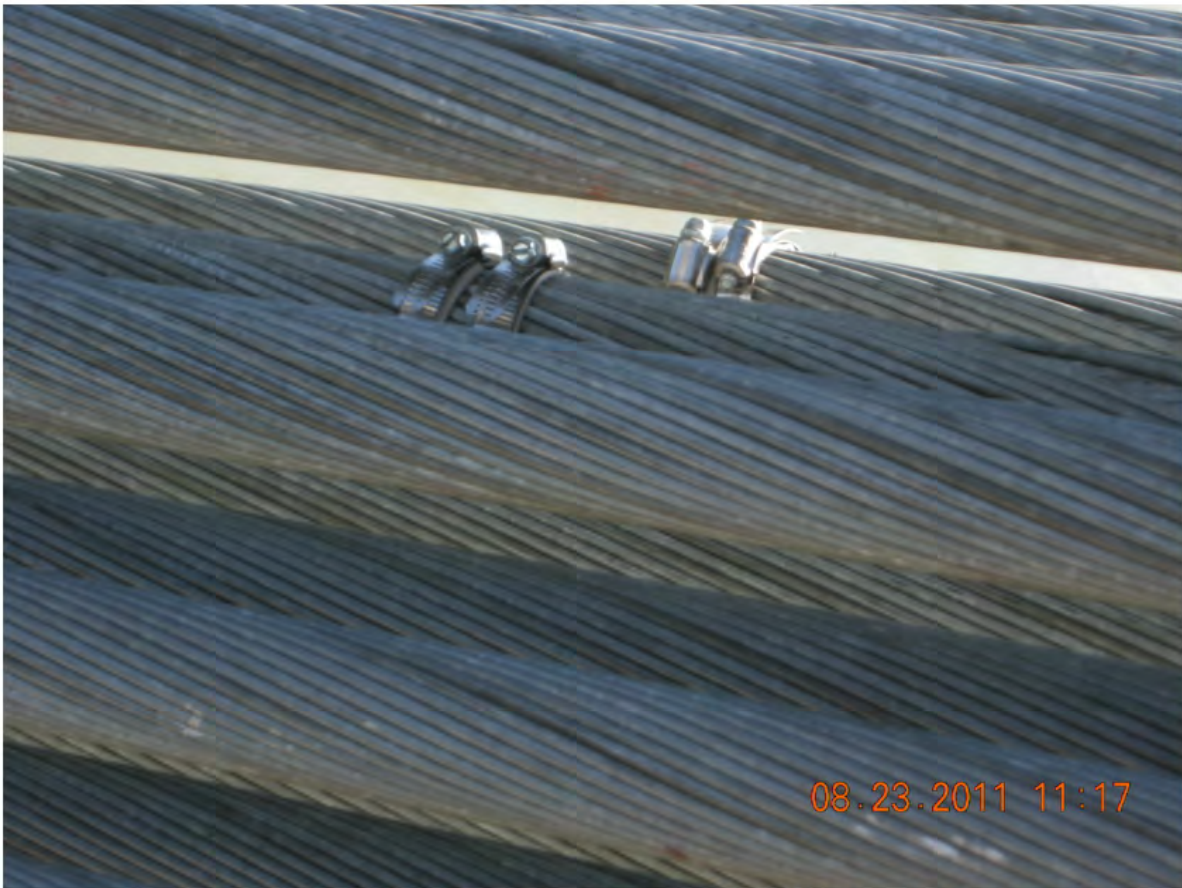
**P67 - Span 2 - East Cables 14S to 16S - 1 #5 Broken Wire Clamped - Two #8 and Two #9 Wires Broken Above are Clamped Further up the Cable**

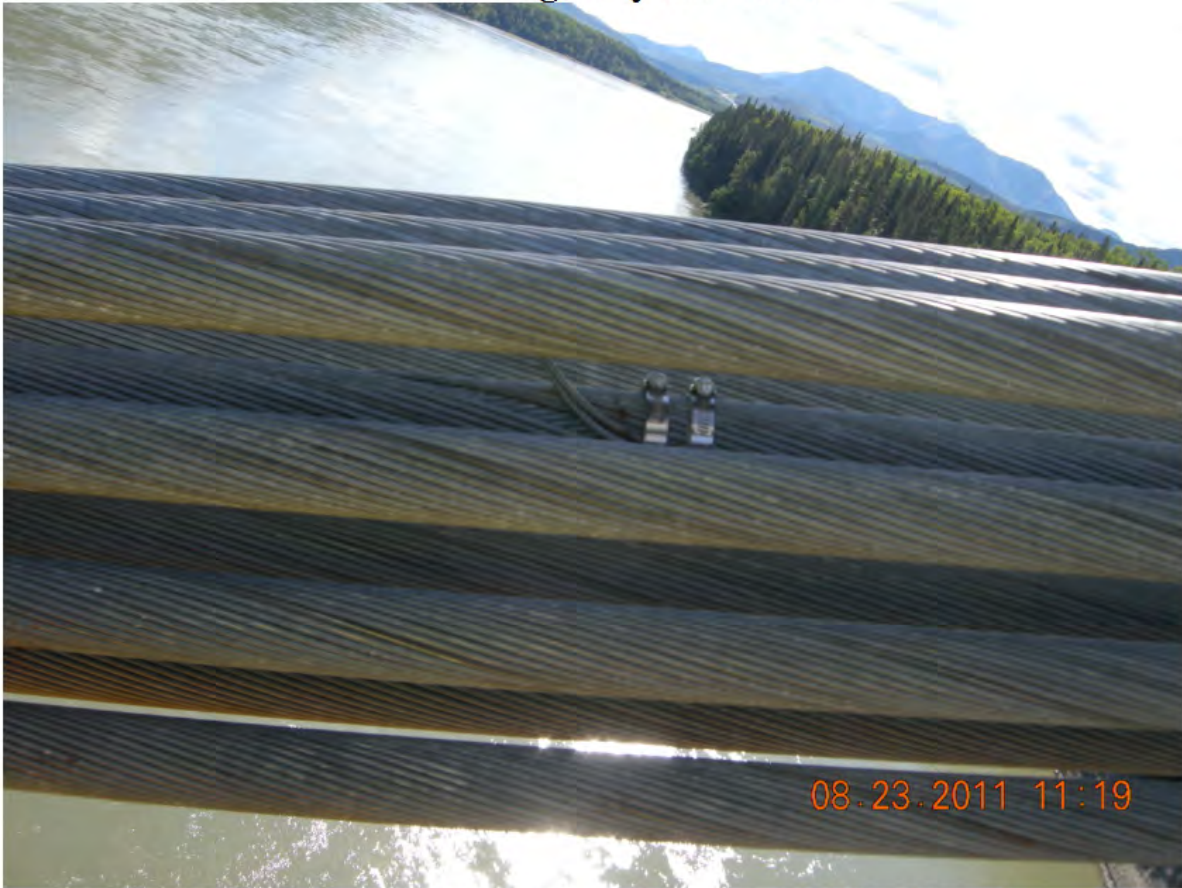
**P69 - Span 2 - East Cables 14S to 16S - Two #8 Broken Wires Clamped**

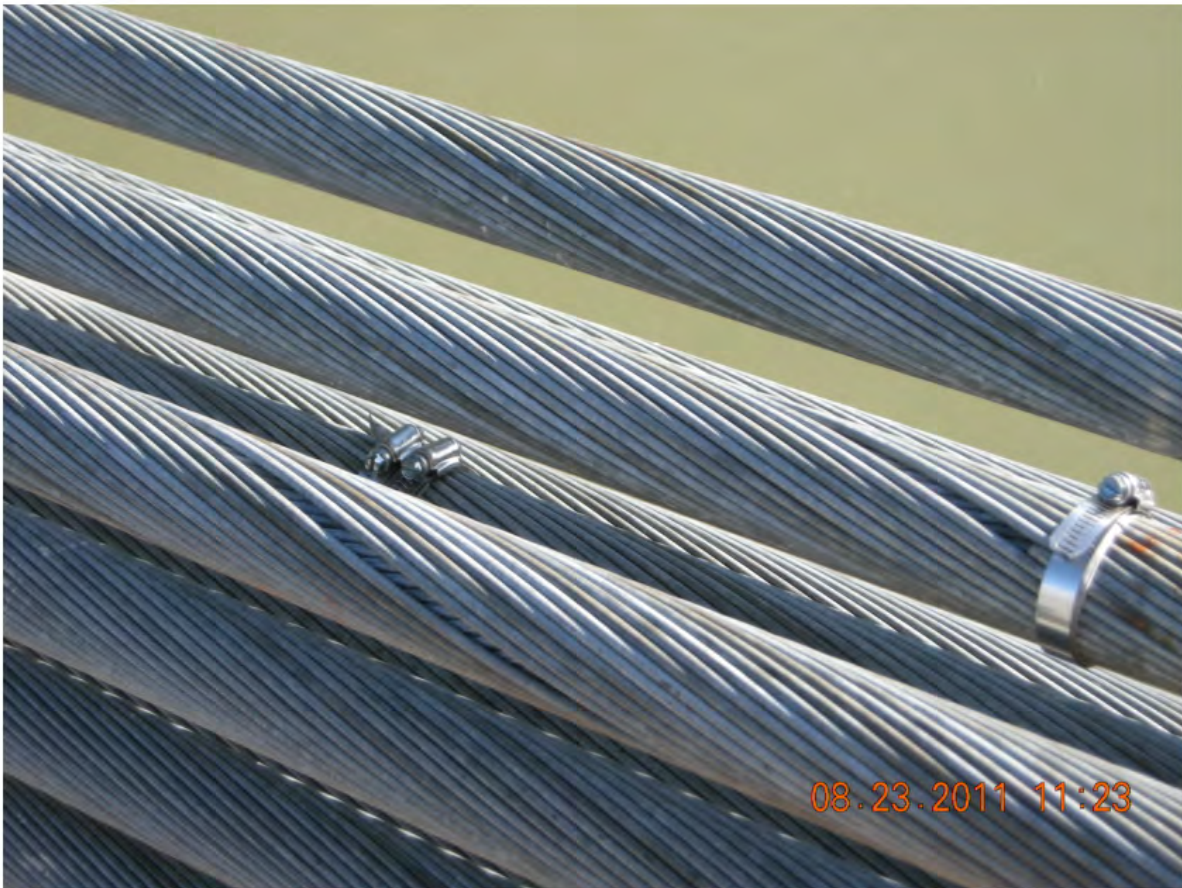
**P70 - Span 2 - East Cables 16S to 18S - One #8 and One #11 Broken Wire Clamped**

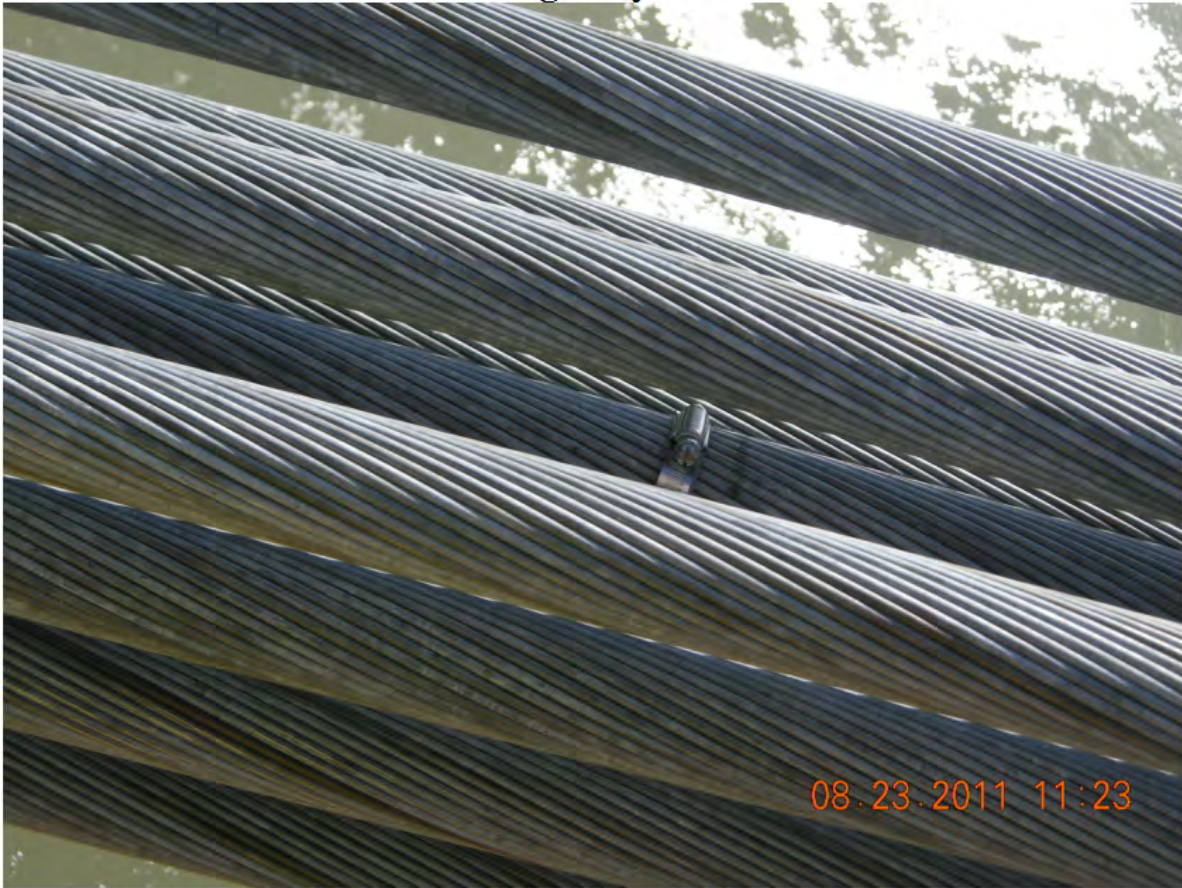
**P71 - Span 2 - East Cables 16S to 18S - One #8 Broken Wire Clamped**

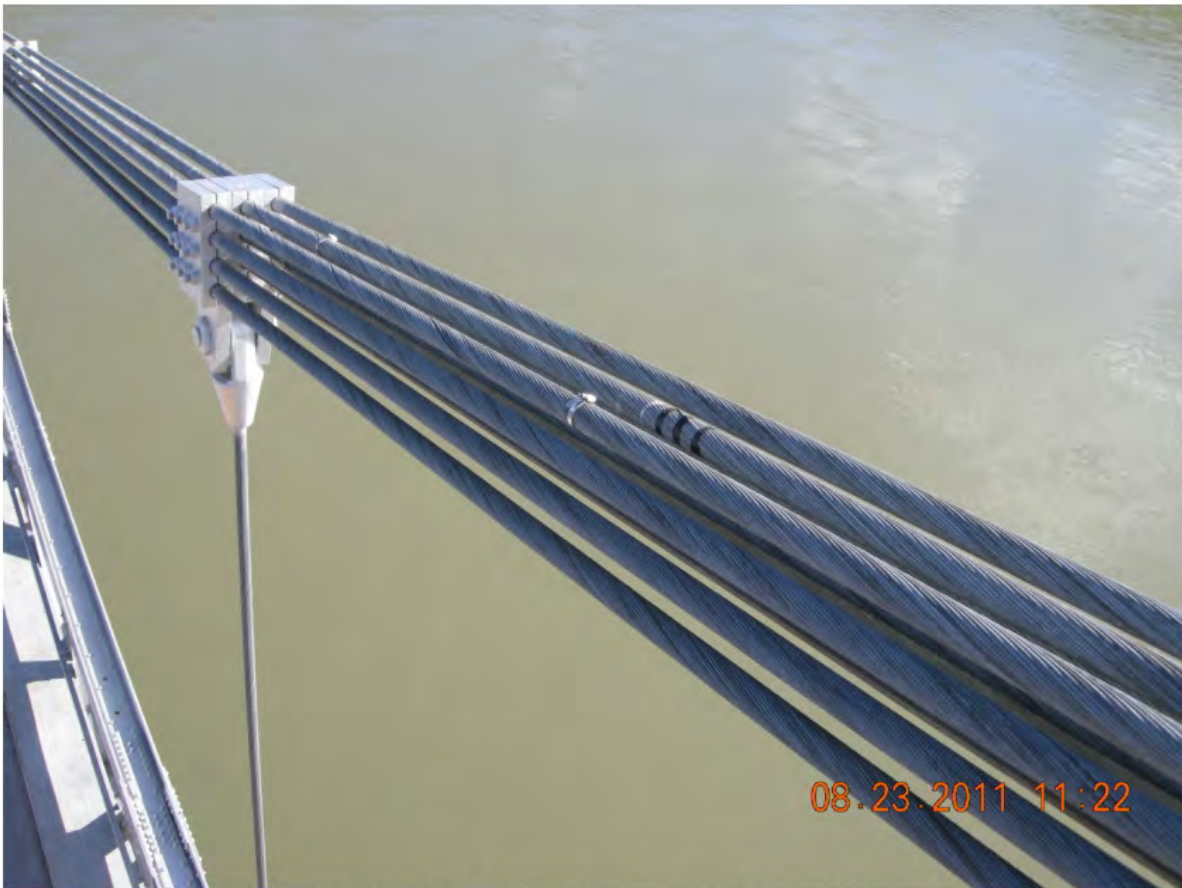
**P72 - Span 2 - East Cables 16S to 18S - One #10 and One #11 Broken Wire Clamped**
