# Lower Liard River Bridge Alaska Highway km 763.3

**ELEVATION**

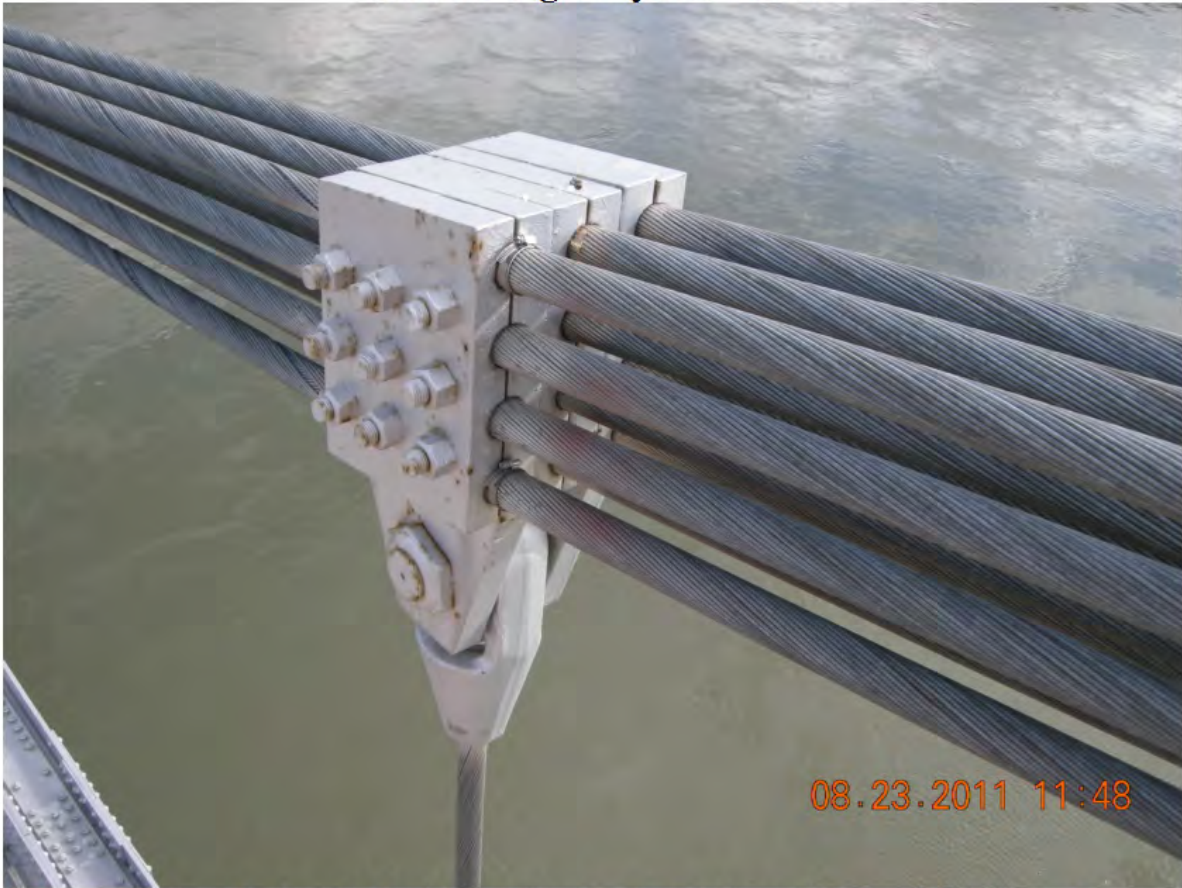
**Lower Liard River Bridge  
Alaska Highway km 763.3**

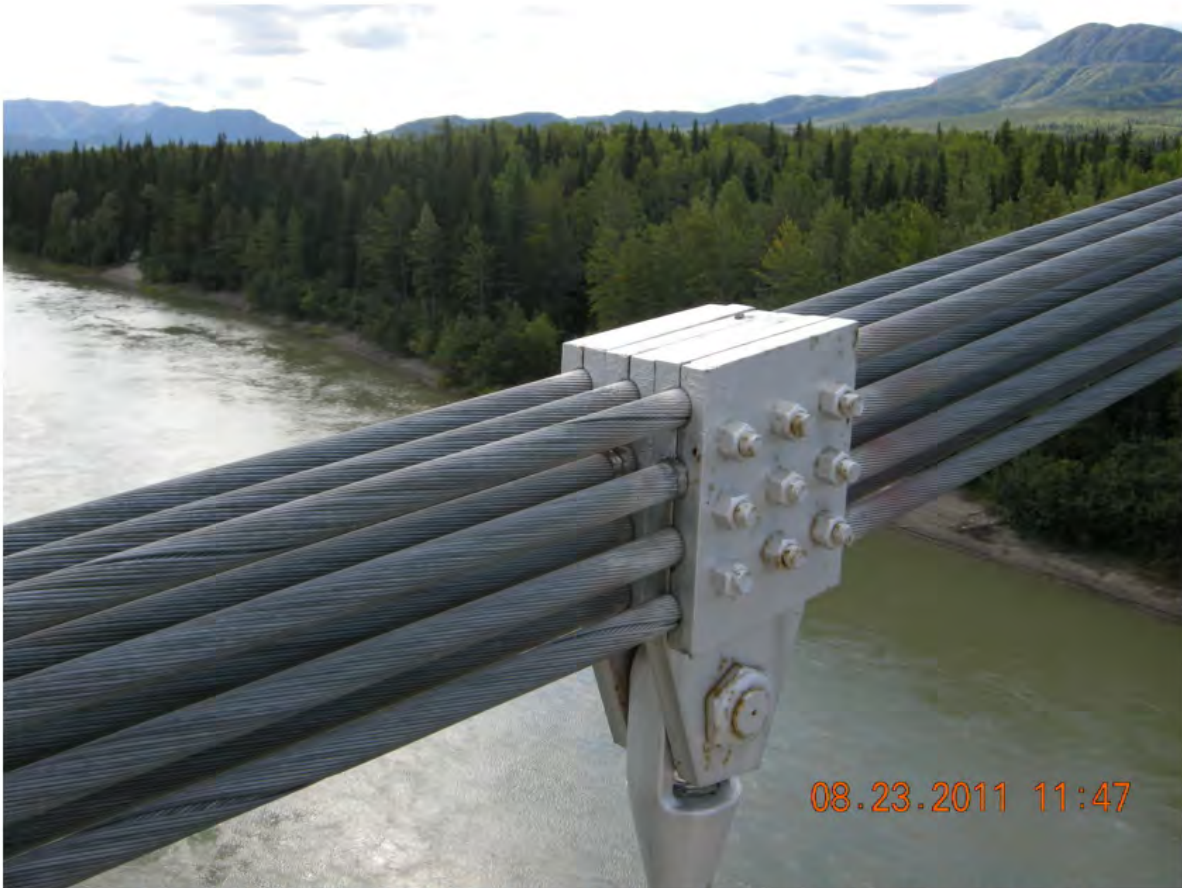
**P73 - Span 2 - East Cables 18S to 20S - One #1 and One #10 Broken Wire Clamped**

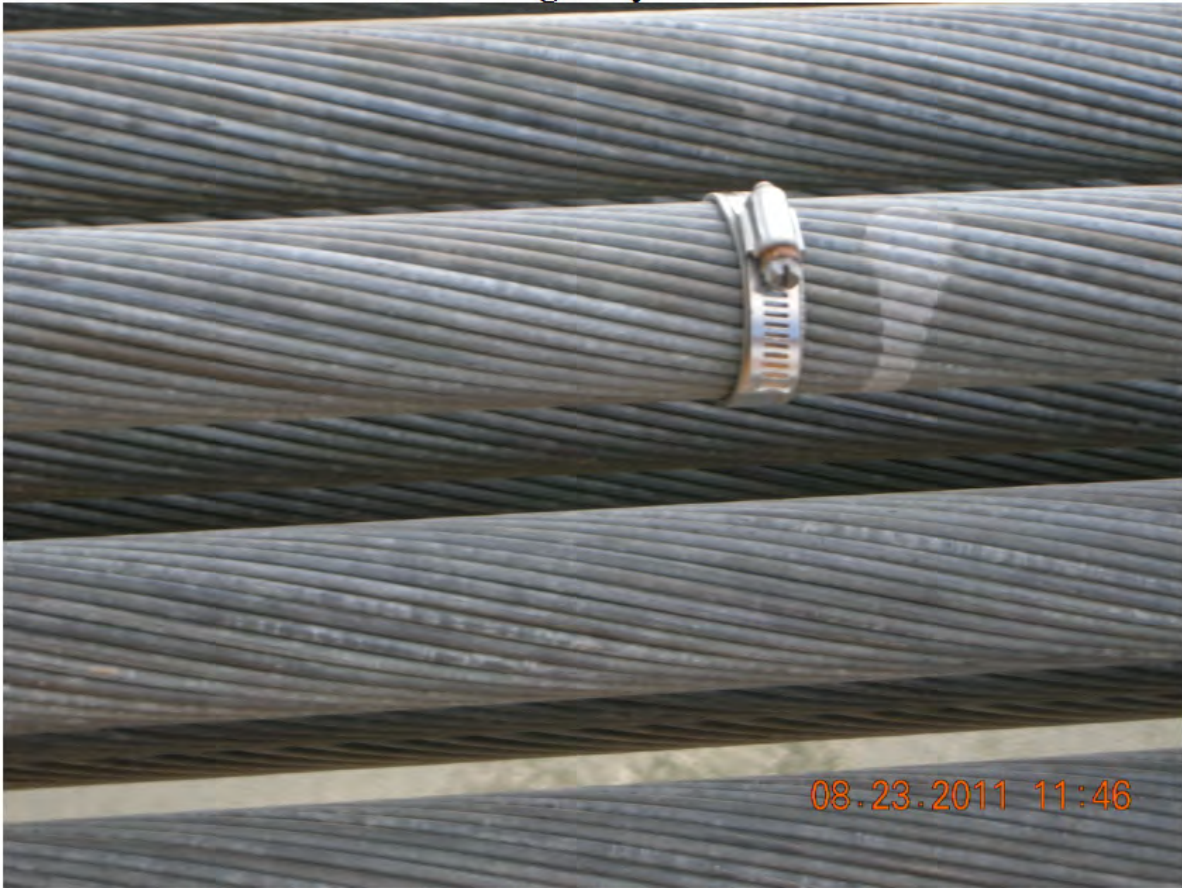
**Lower Liard River Bridge  
Alaska Highway km 763.3**

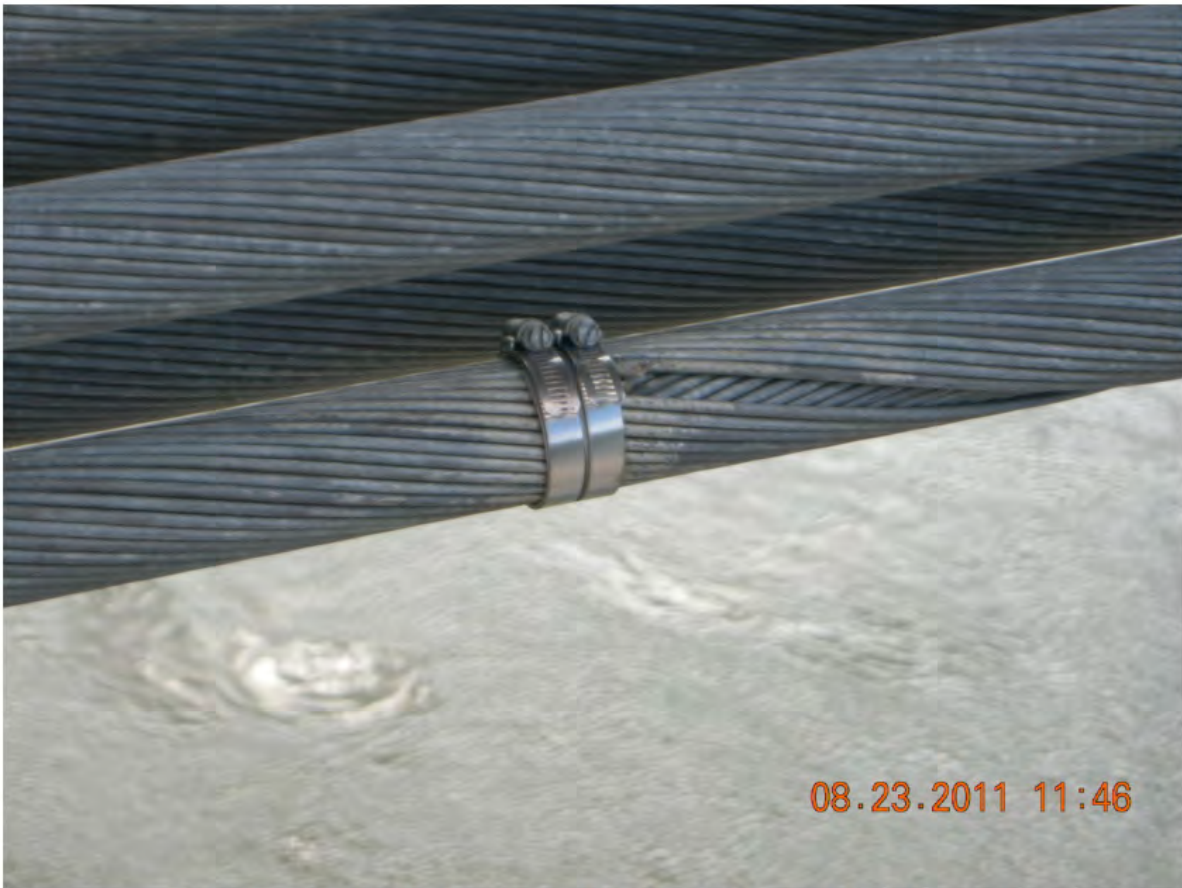
**P75 - Span 2 - East Cables 20S to 22S - One #10 Broken Wire Clamped**

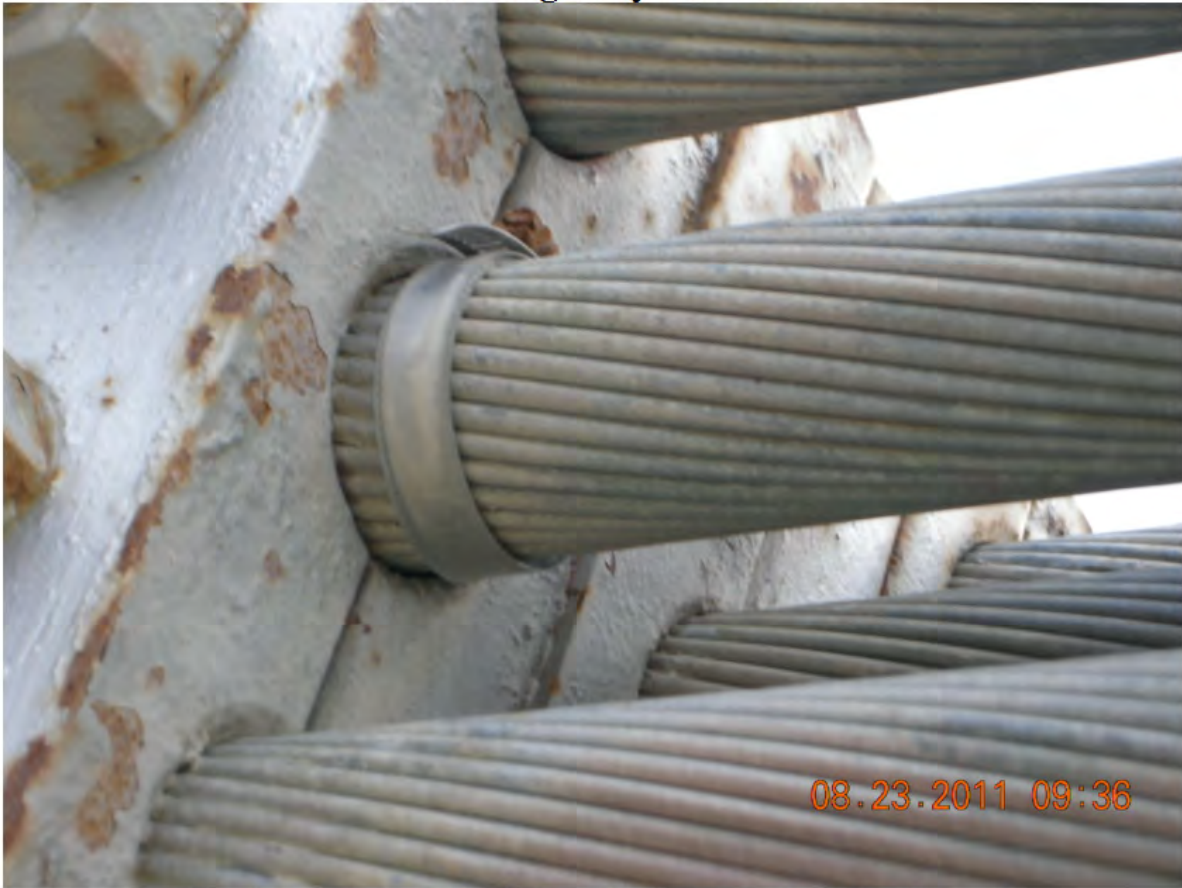
**P77 - Span 2 - East Cables 22S to 24S - One #7 Broken Wire Clamped**

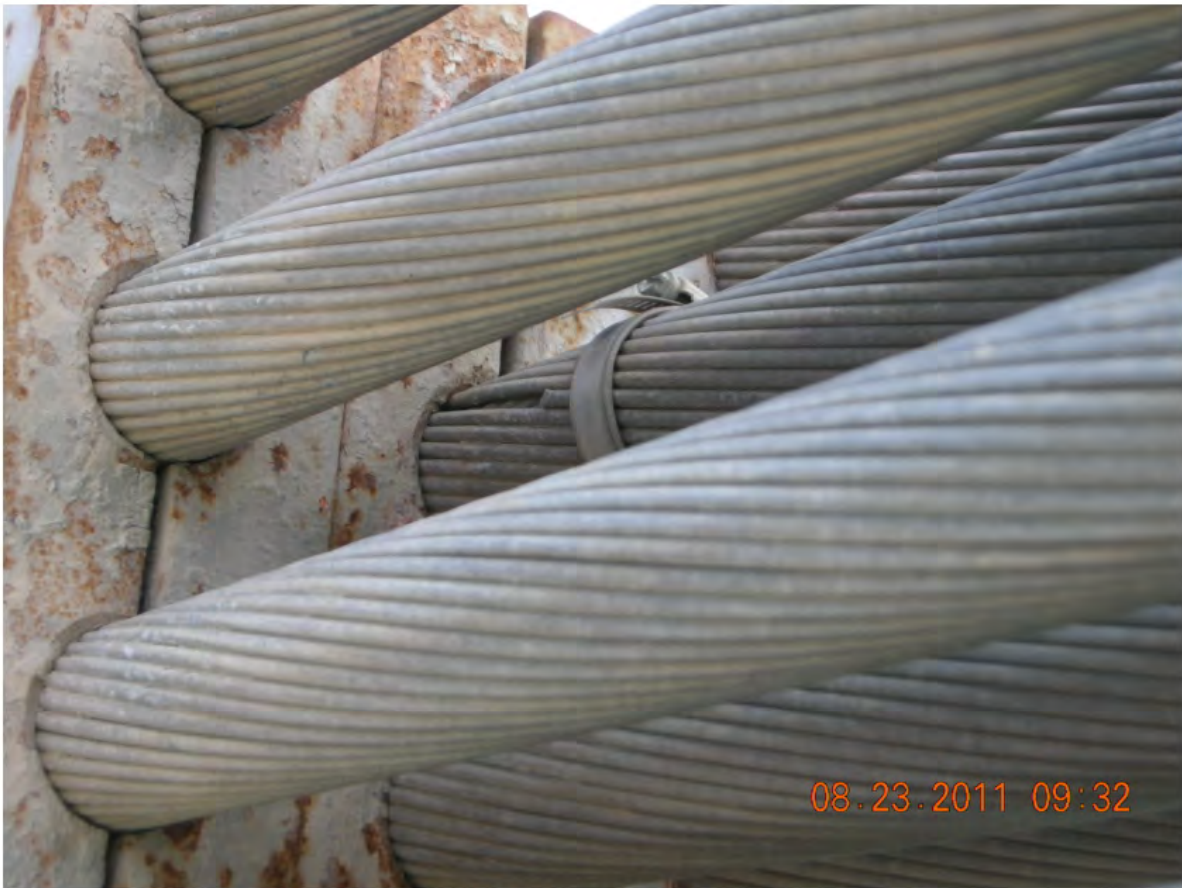
**P78 - Span 2 - East Cables 24S to 26S - 1 Clamp on #8**

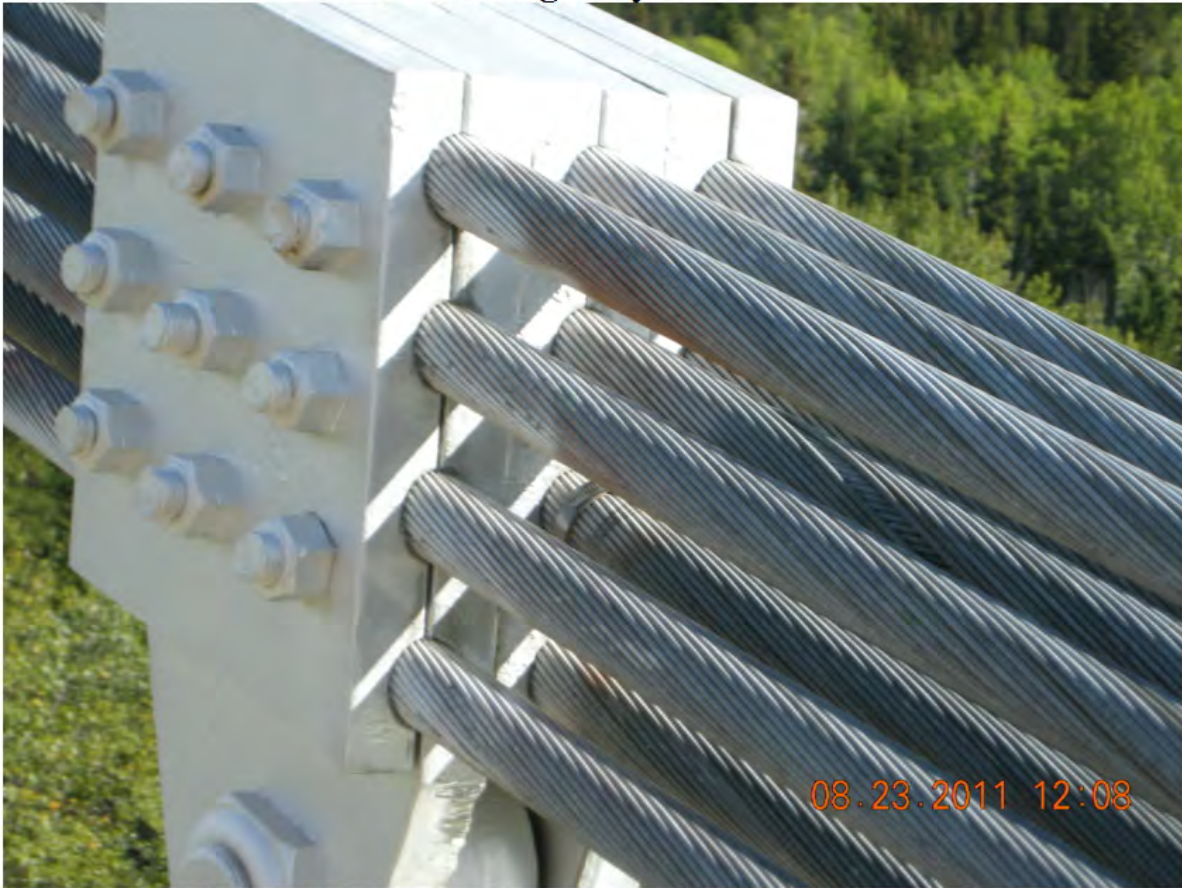
**P79 - Span 2 - East Cables 18N to 16N - One #5 Broken Wires Clamped**

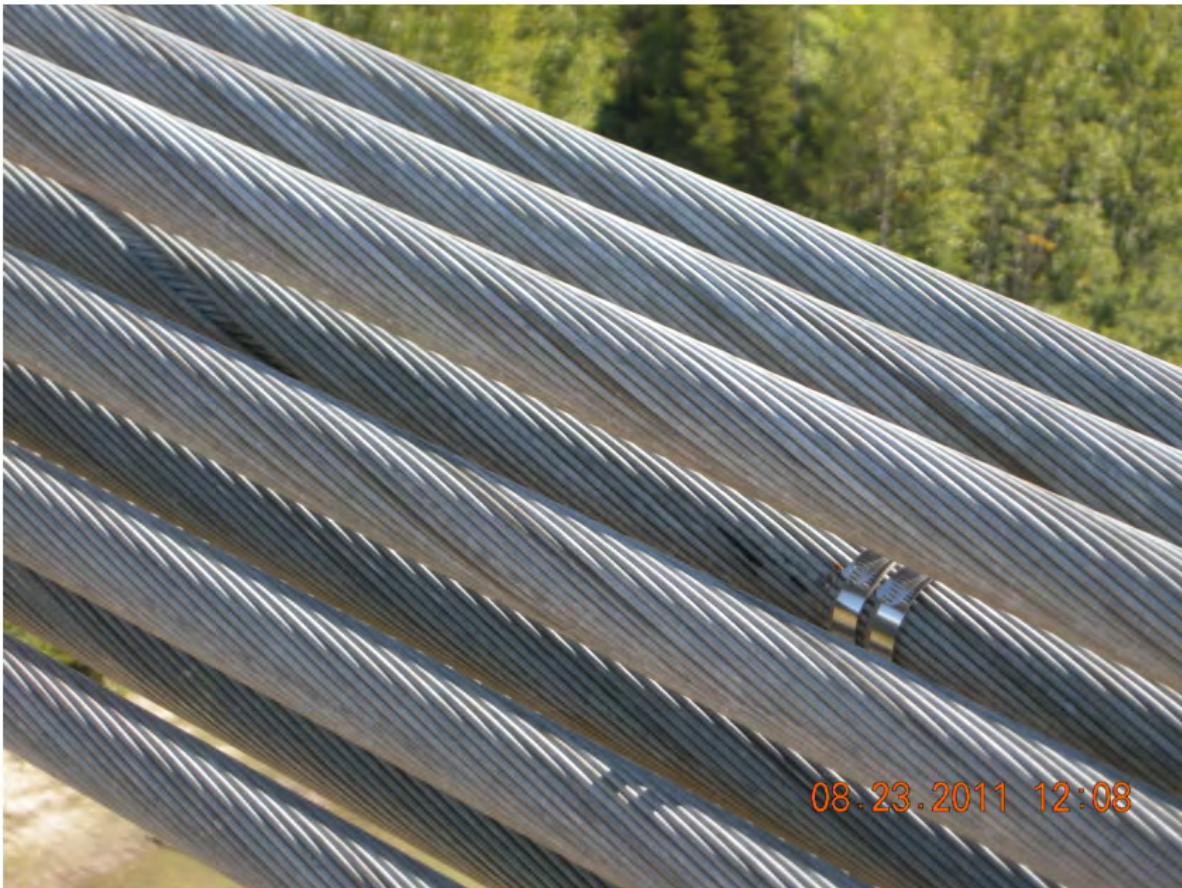
**P80 - Span 2 - East Cables 18N to 16N - Two #7 Broken Wires Clamped**

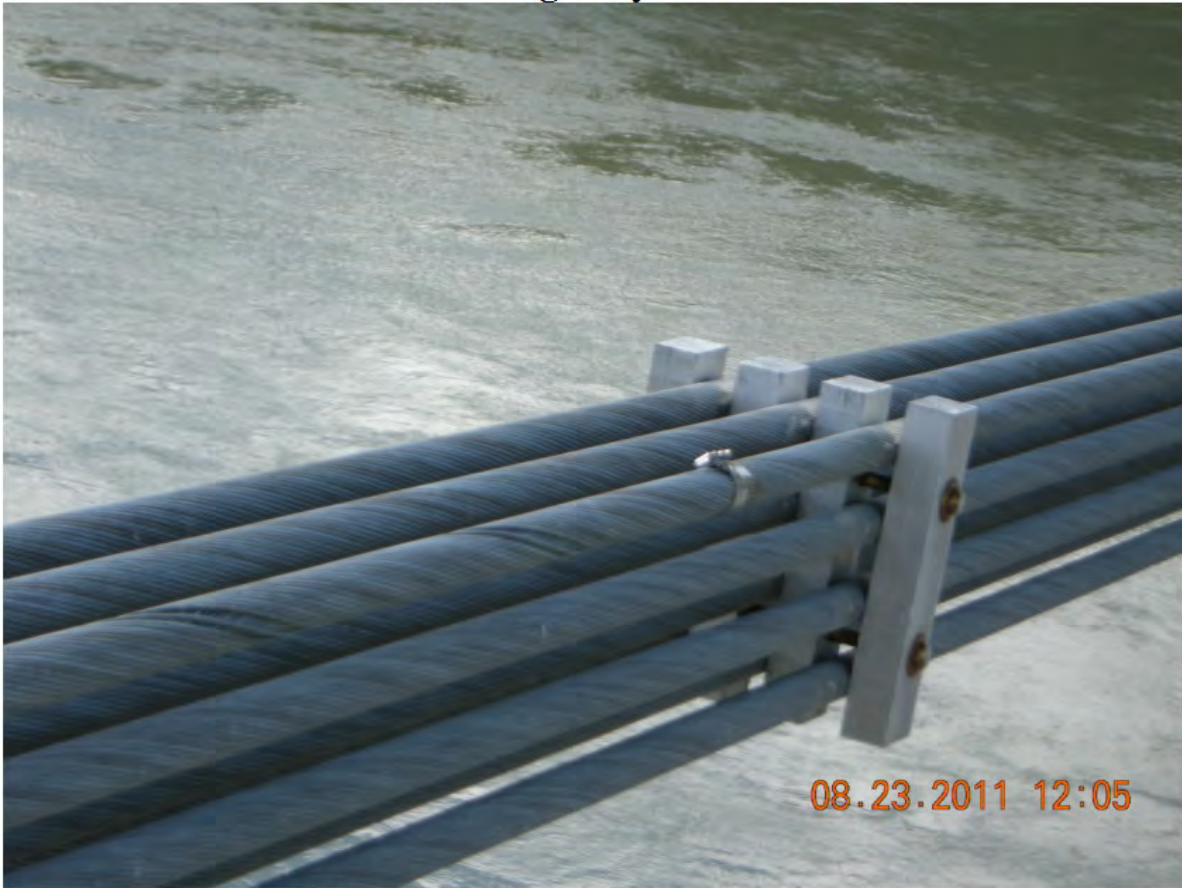
**P81 - Span 2 - East Cables 22N to 20N - Three #10 Broken Wires Clamped**

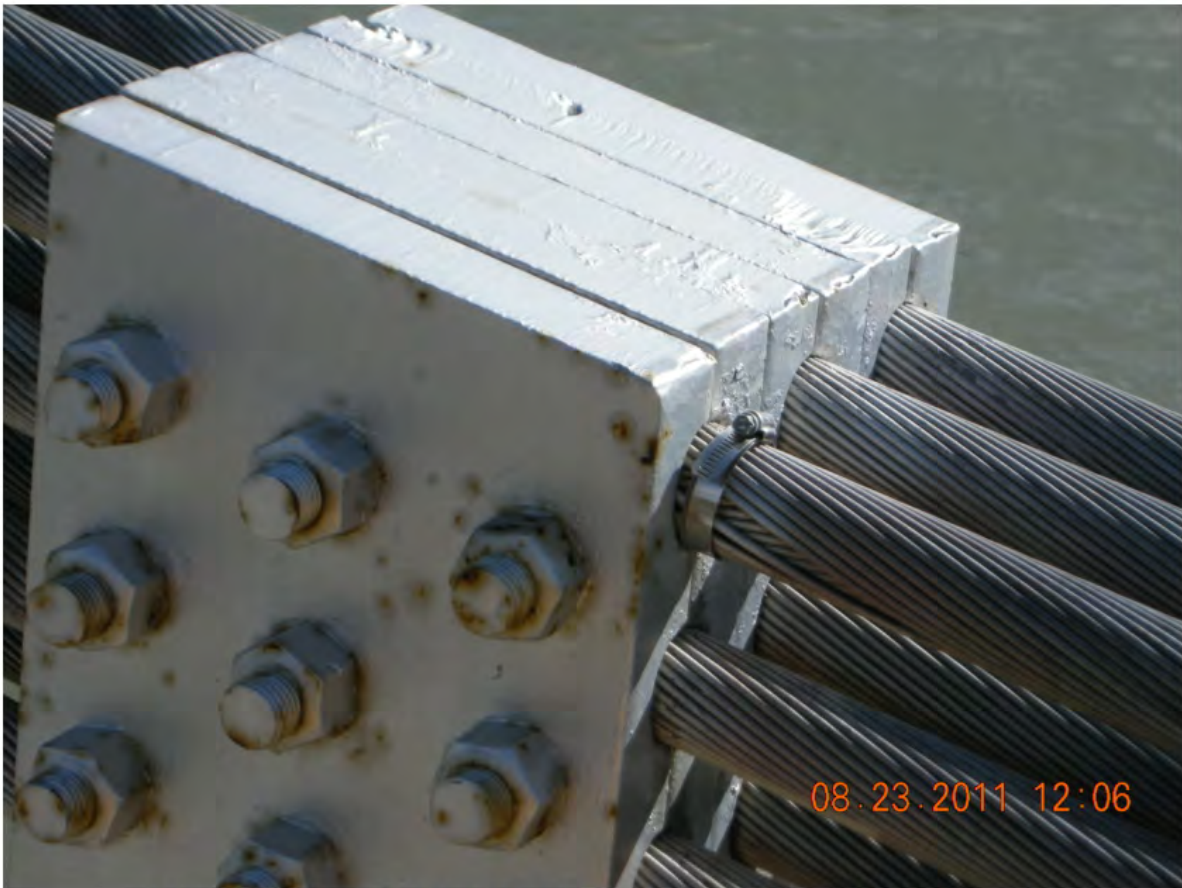
**P82 - Span 2 - East Cables 22N to 20N - Three #10 Broken Wires Clamped**

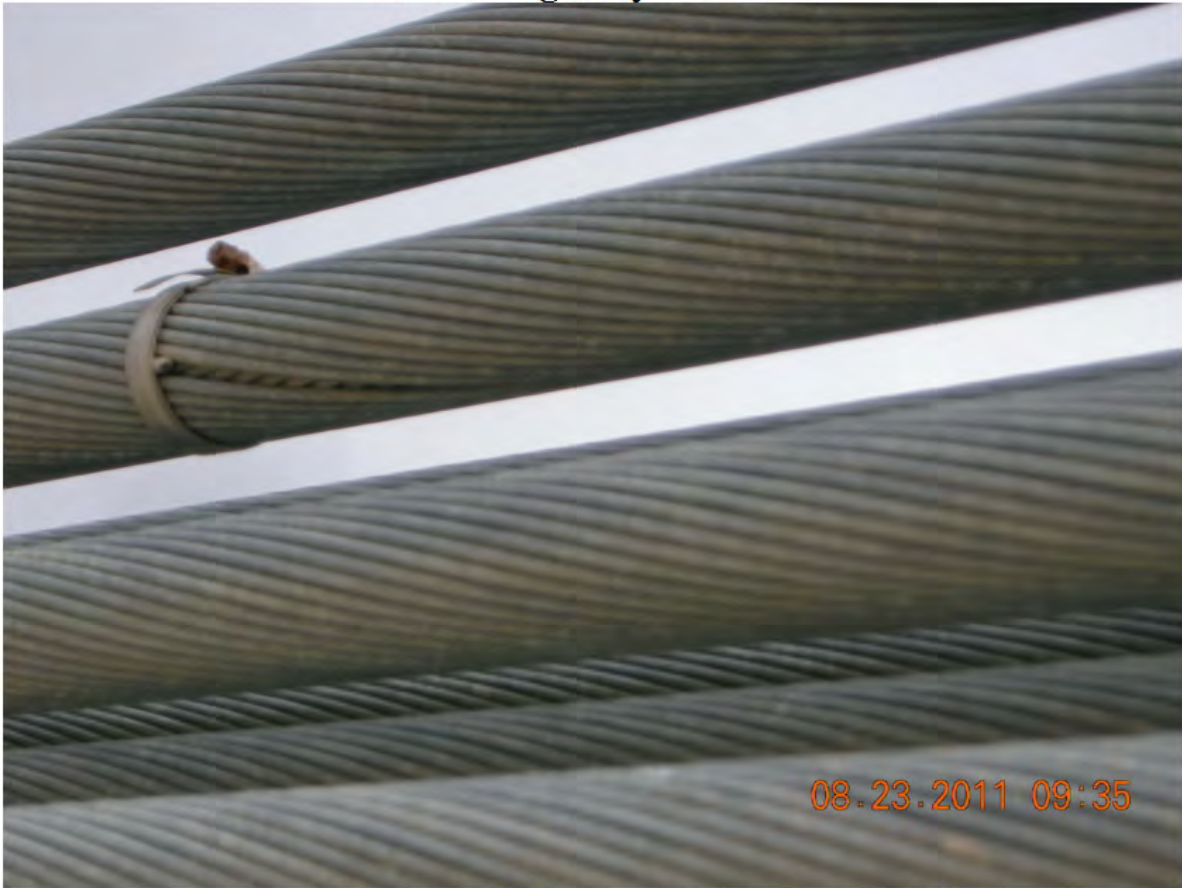
**Lower Liard River Bridge  
Alaska Highway km 763.3**

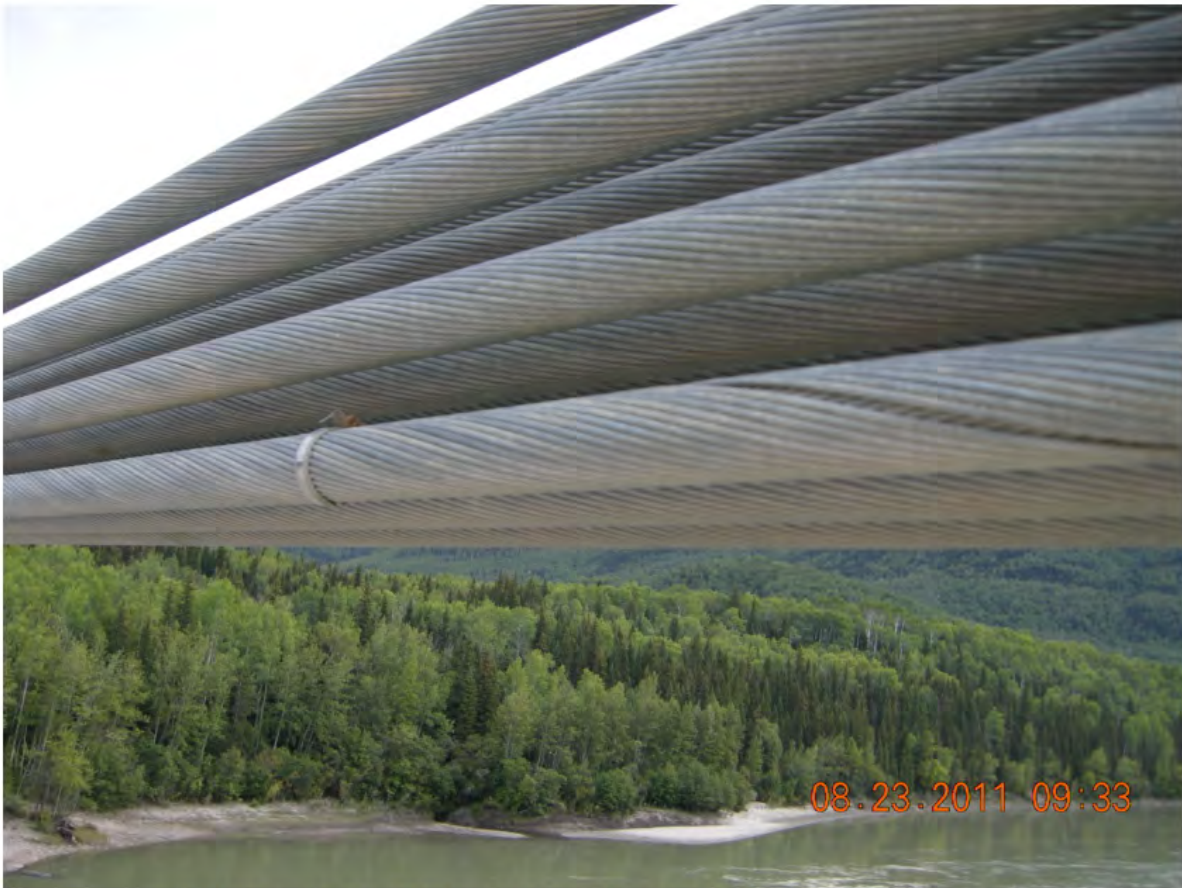
**P83 - Span 2 - East Cables 24N to 22N - One #7 Broken Wire Clamped**

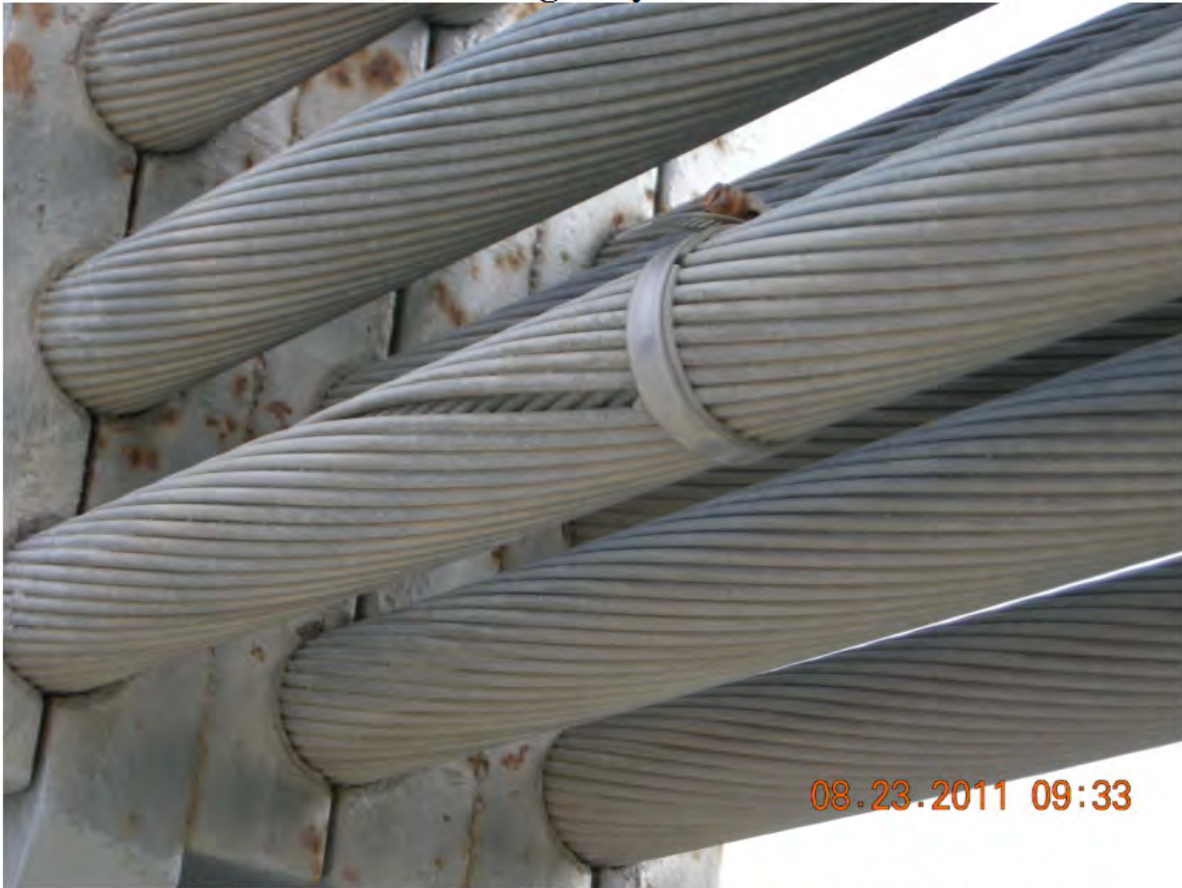
**Lower Liard River Bridge  
Alaska Highway km 763.3**

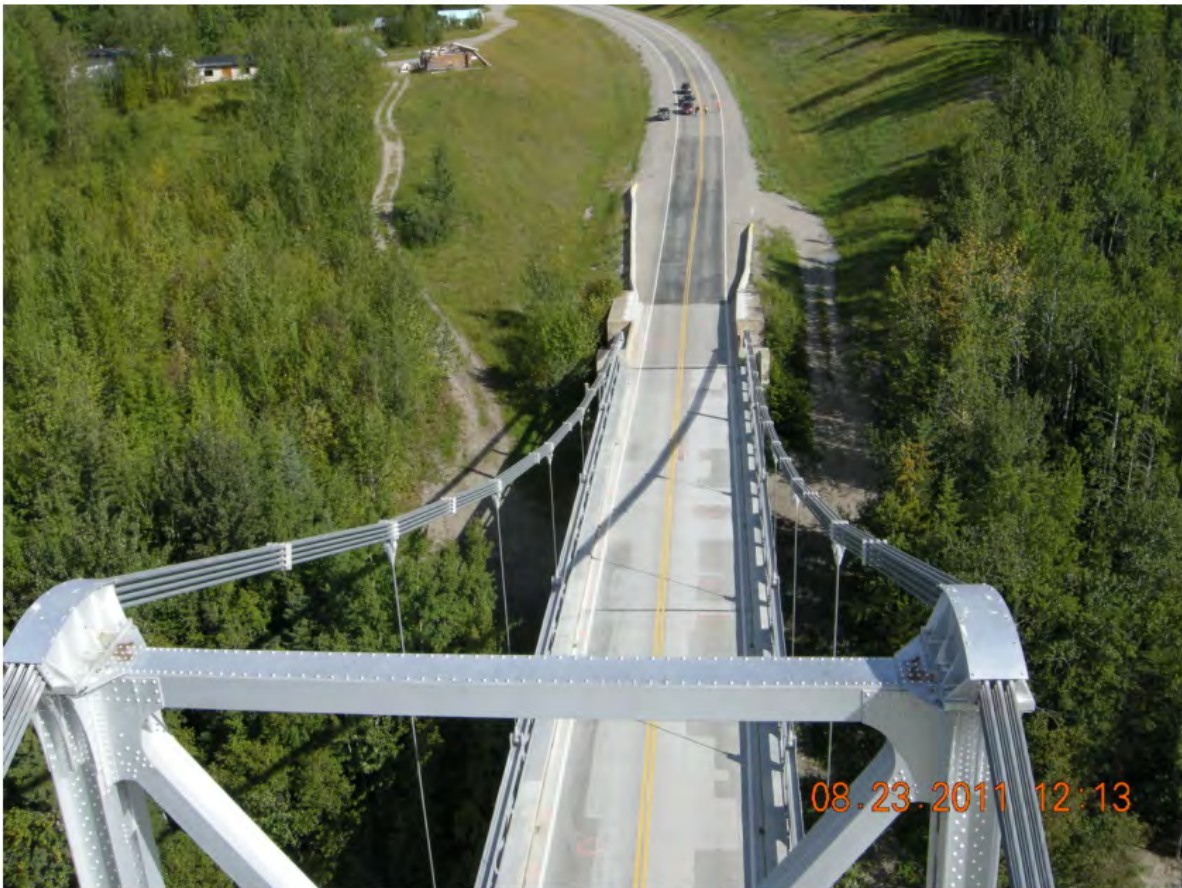
**P85 - Span 2 - East Cables 26N to 24N - Second #1 Broken Wire Clamped**

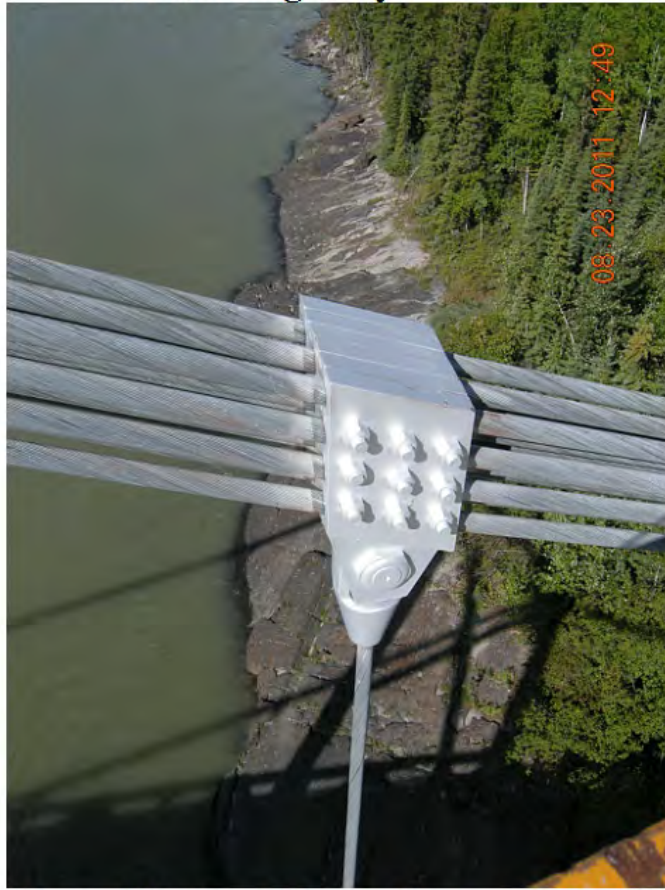
**P87 - Span 3 - West Hanger 10N - Slipped 25 mm as Previously Noted - No Additional Slippage**

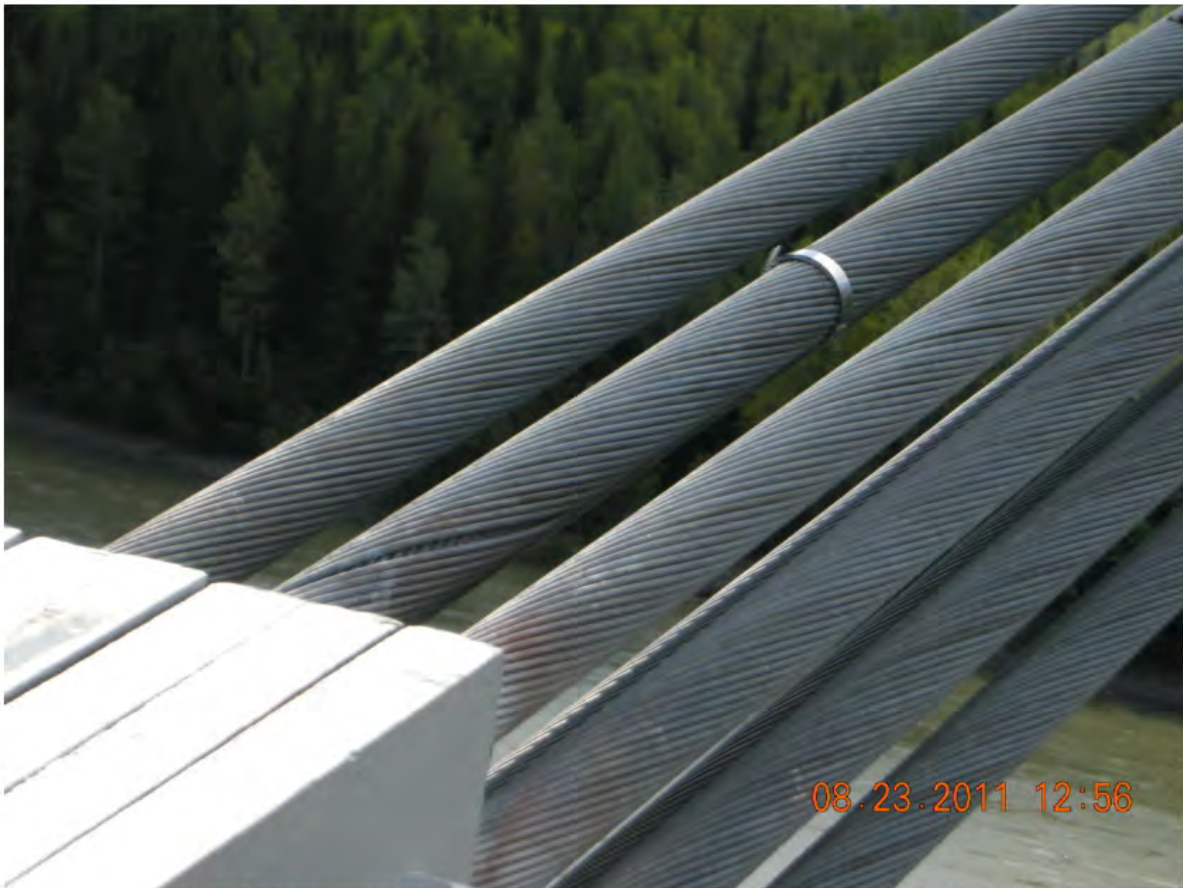
**P88 - Span 3 - East Cables 10N to 8N - One #11 Broken Wires Clamped**

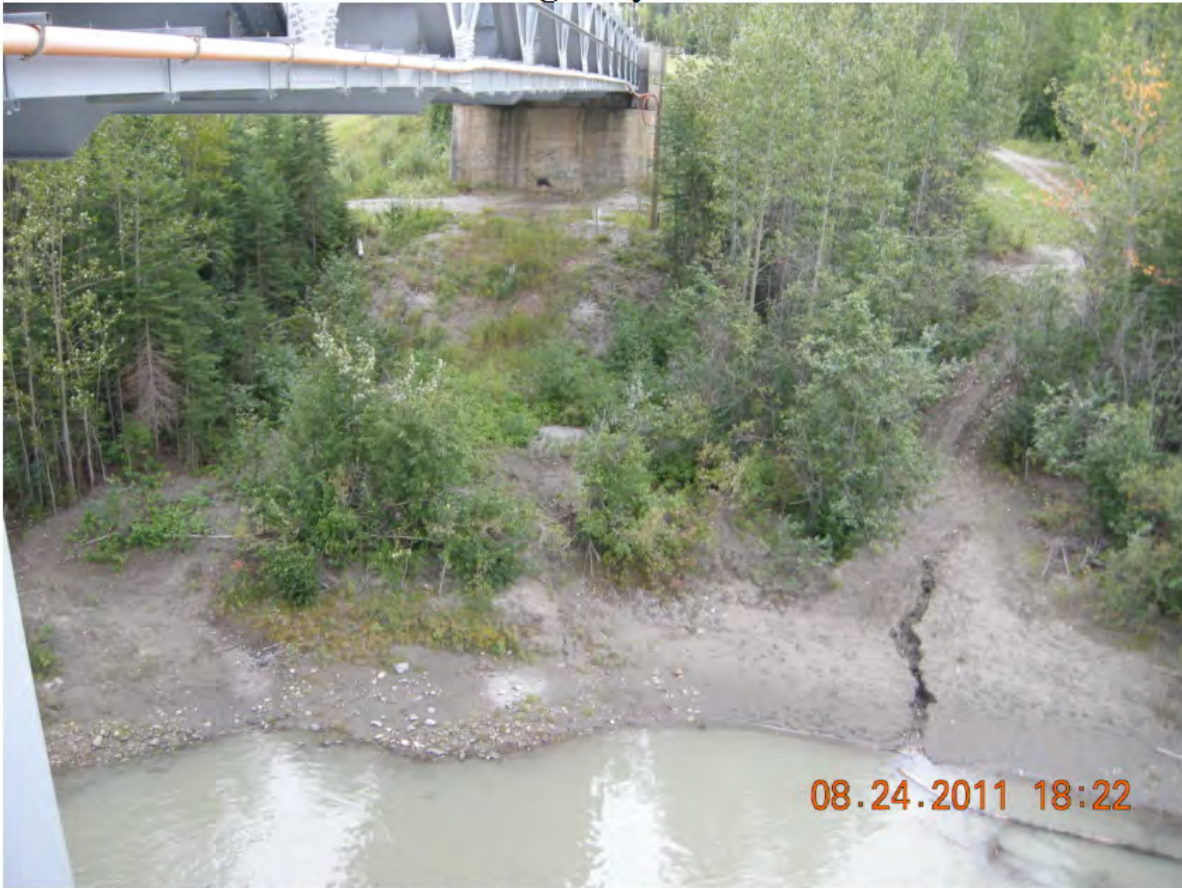
**P89 - South Abutment and Embankment - Minor Erosion Gully at Waterline**

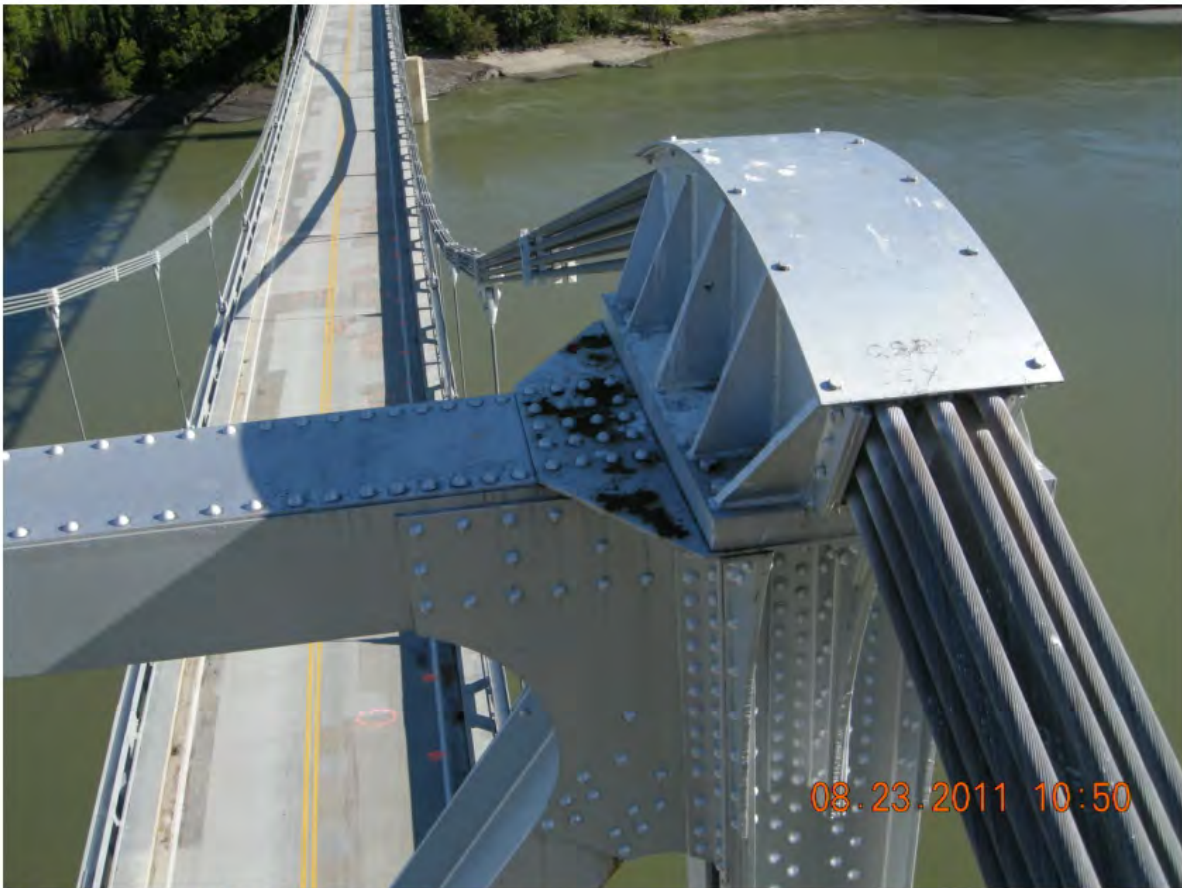
**P102 - South Tower - Saddle for East Cables - Paint Peeling and Light Surface Corrosion on top of Gusset Plate**

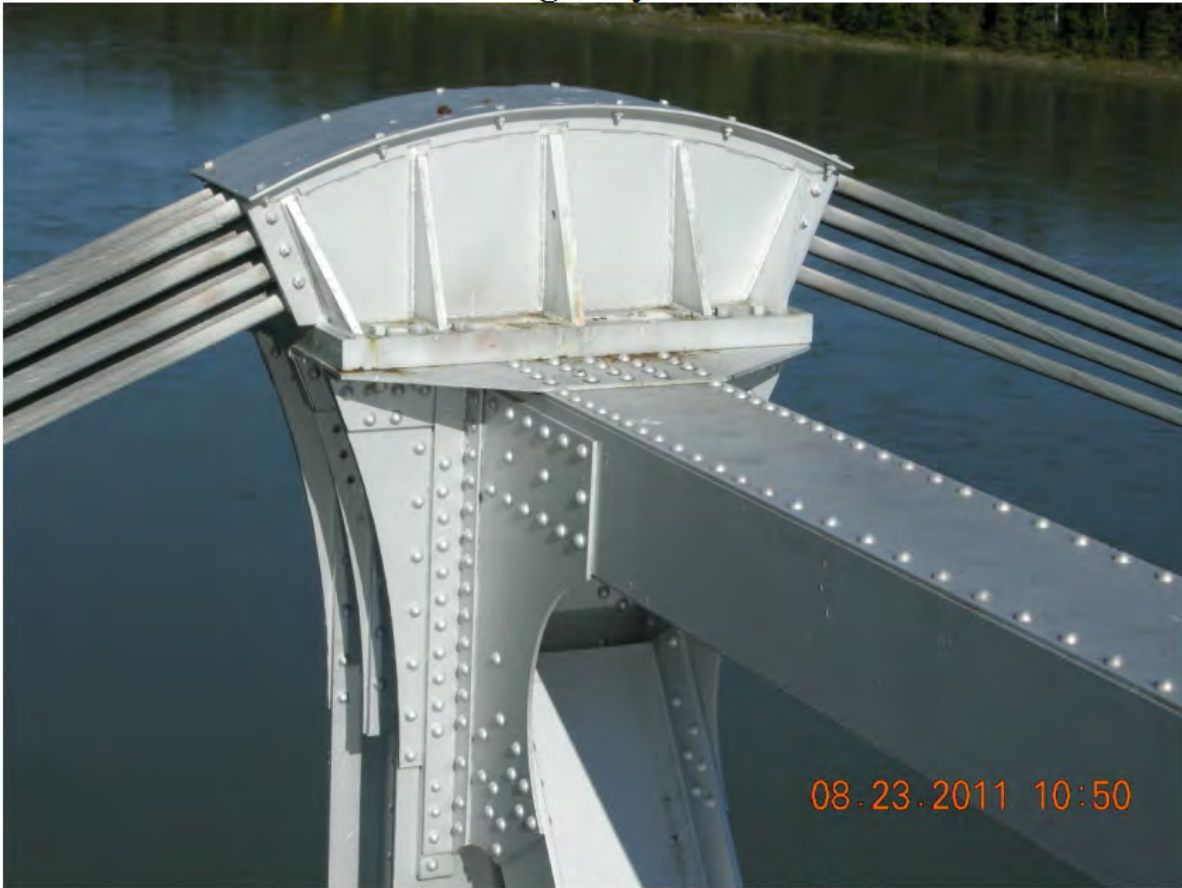
**P103 - South Tower - Saddle for West Cables**

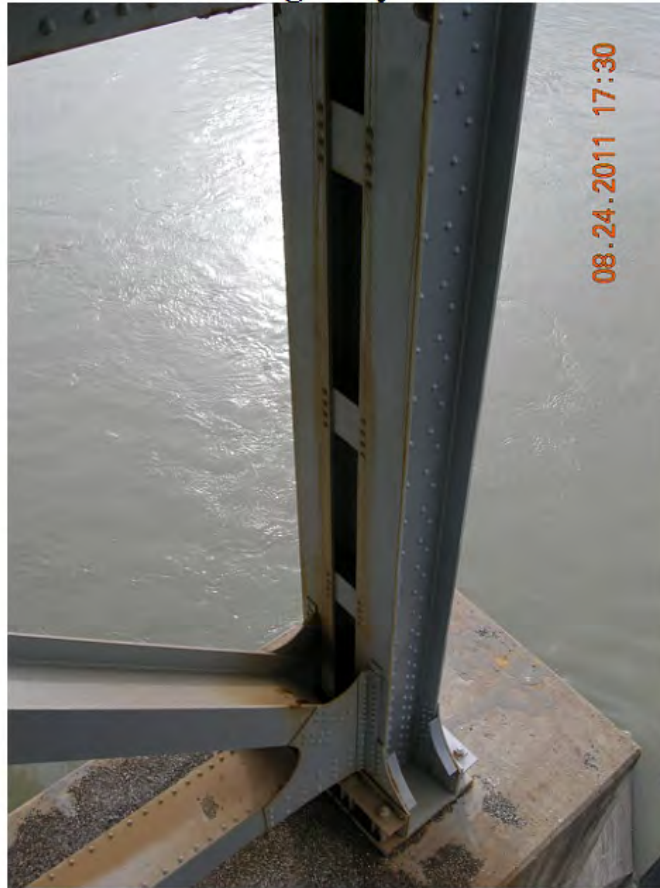
**P107 - North Tower - West Leg - Corrosion Staining Leaking from Unpainted Interior of Leg**

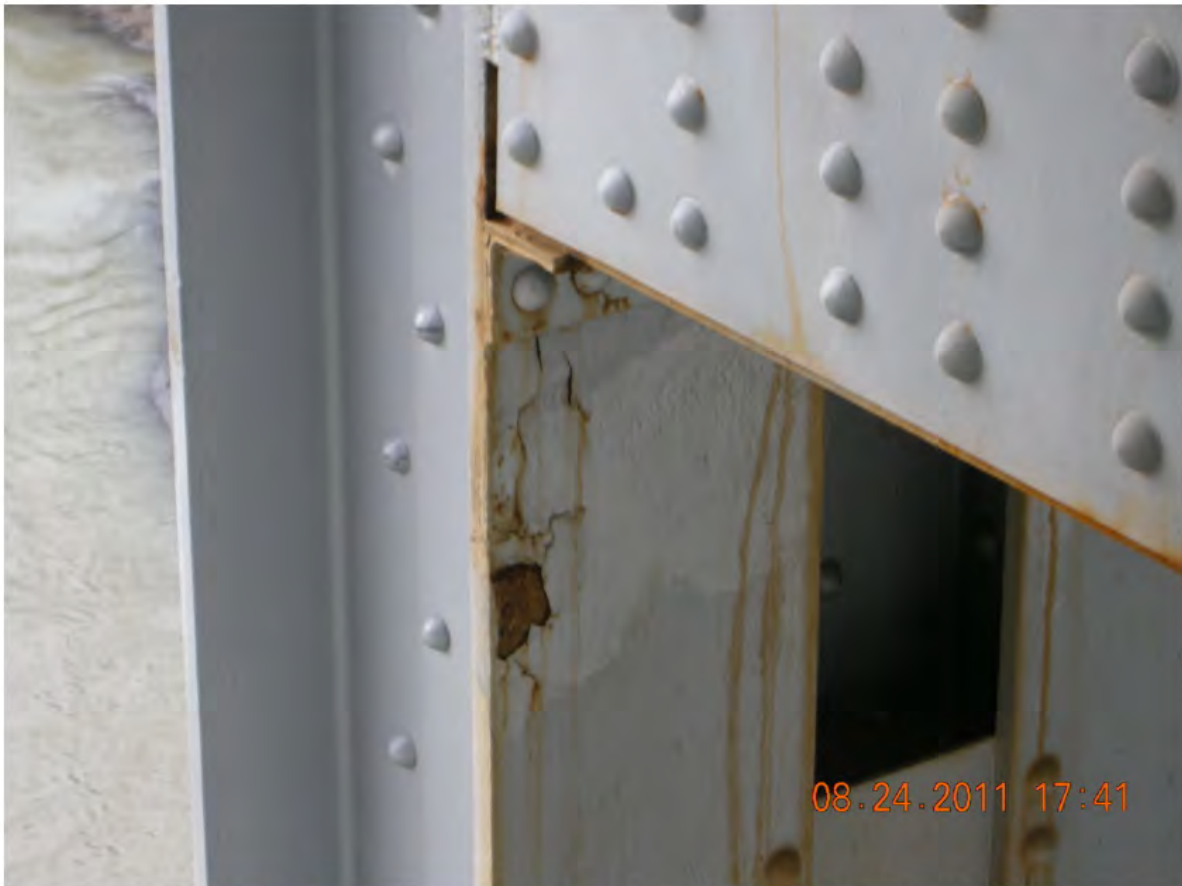
**P108 - North Tower - West Leg - Localized Paint Peeling below Deck**

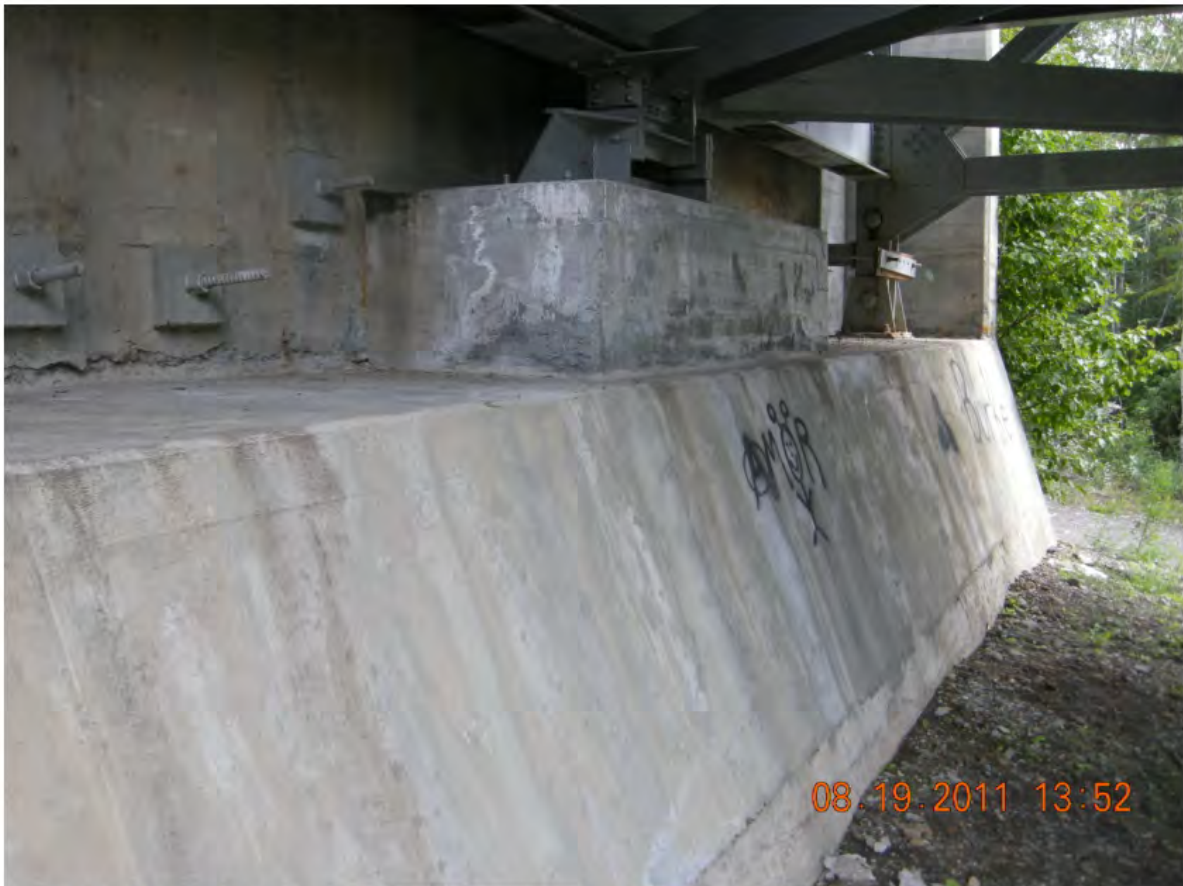
**P116 - North Abutment - Repairs Carried out to Spalls in Bearing Seat Since 2009 Inspection**

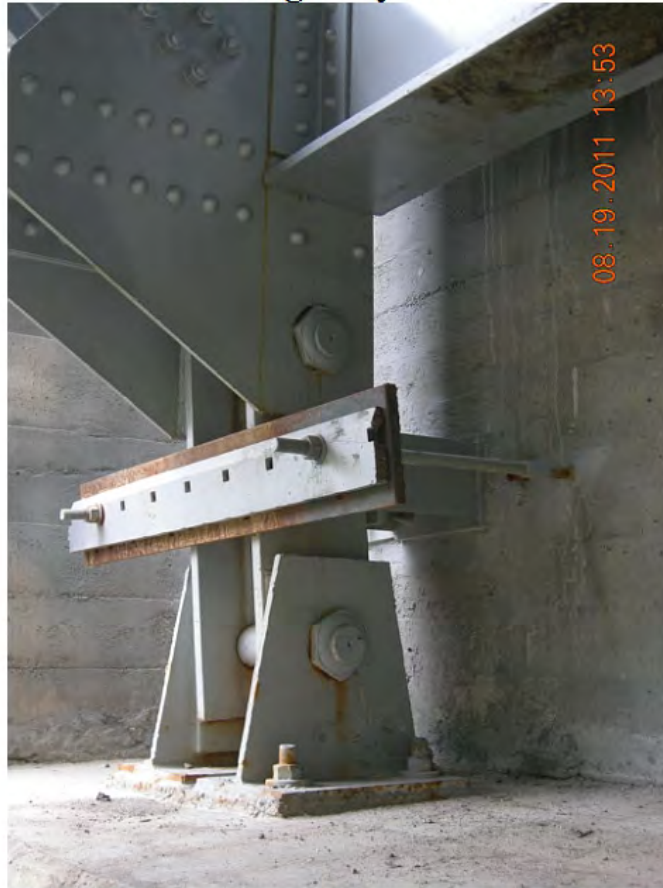
**P117 - North Abutment - Keeper Bars at NW Bearing**
