# Lower Liard River Bridge Alaska Highway km 763.3

**ELEVATION**

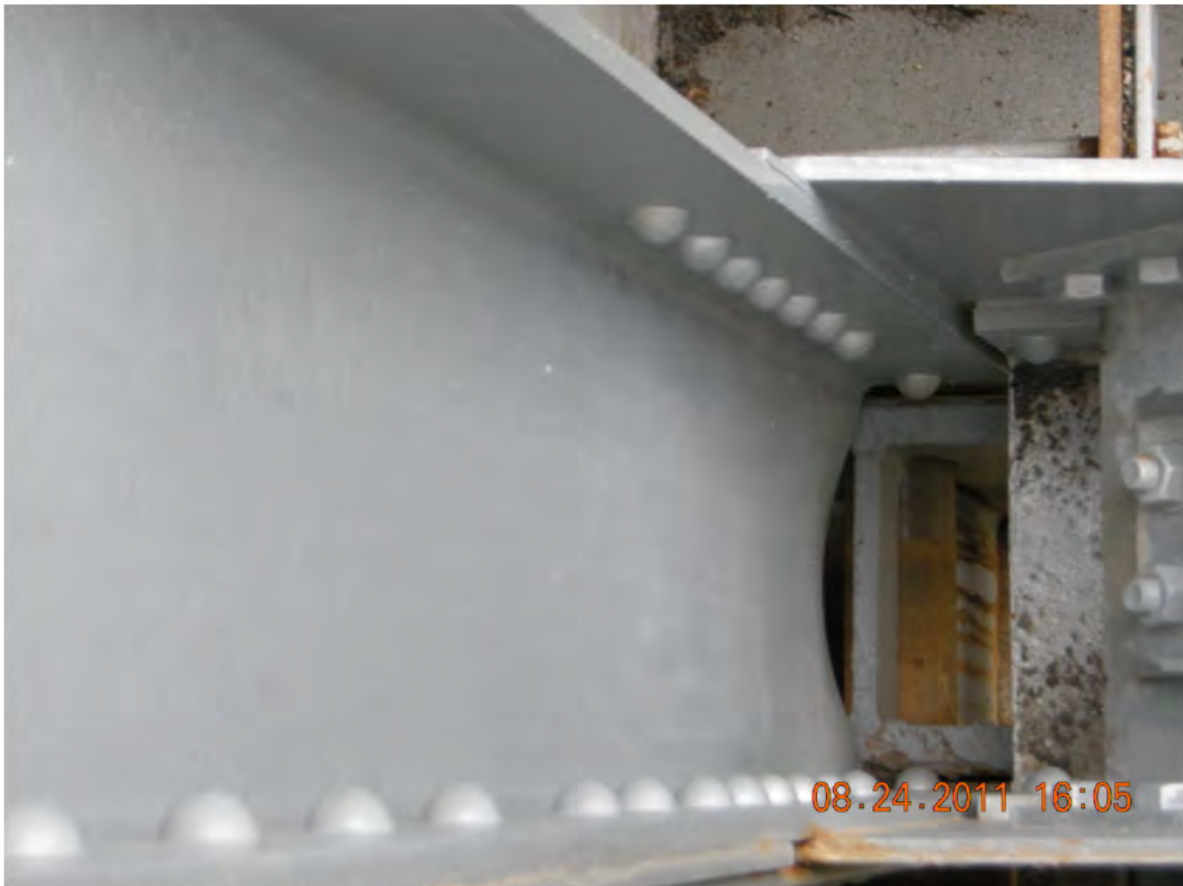
**P118 - Deck Truss Vertical at NE Corner of Bridge - Bent Web - No Cracking**

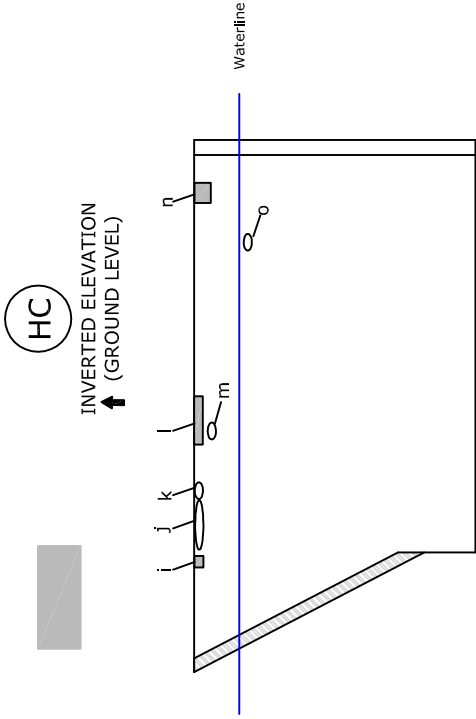
Exposed Concrete Footing

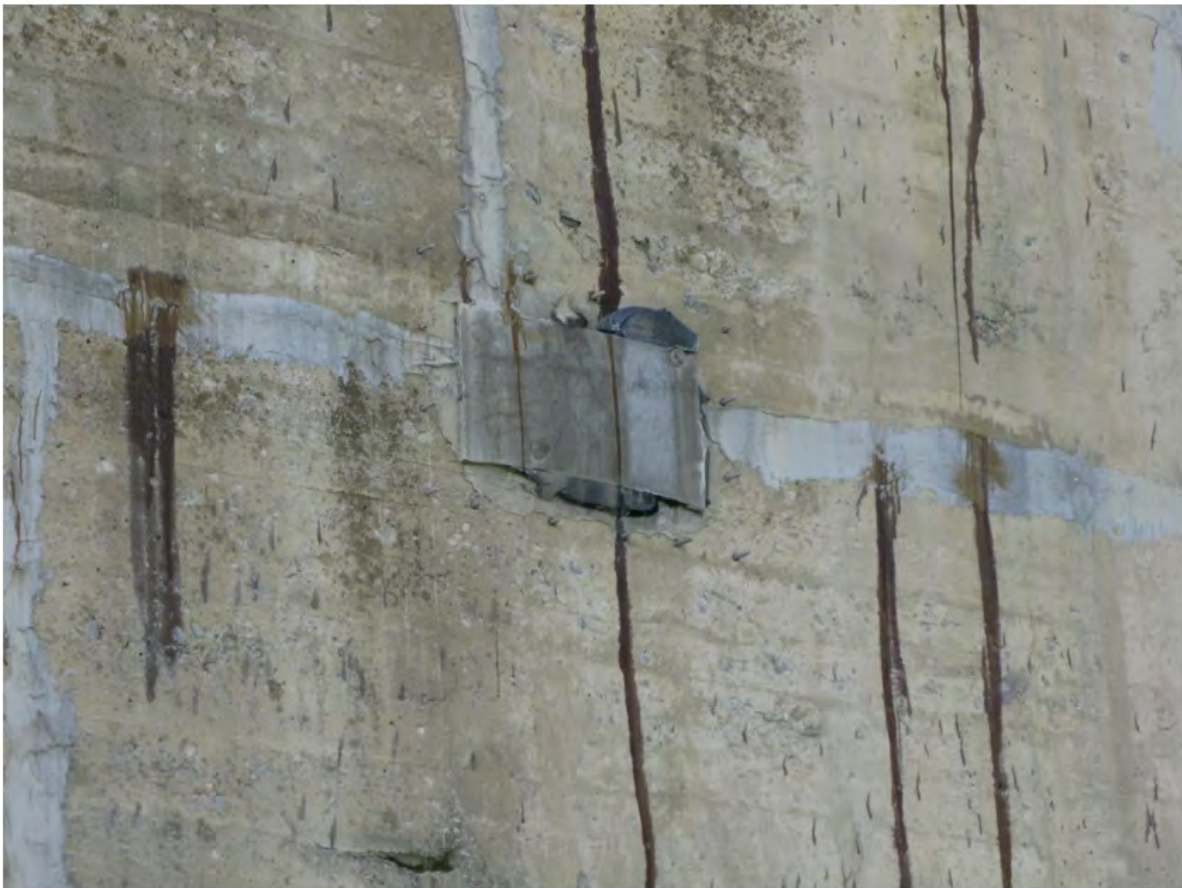
**UW04 - Pier 1 Spall repair HC face**

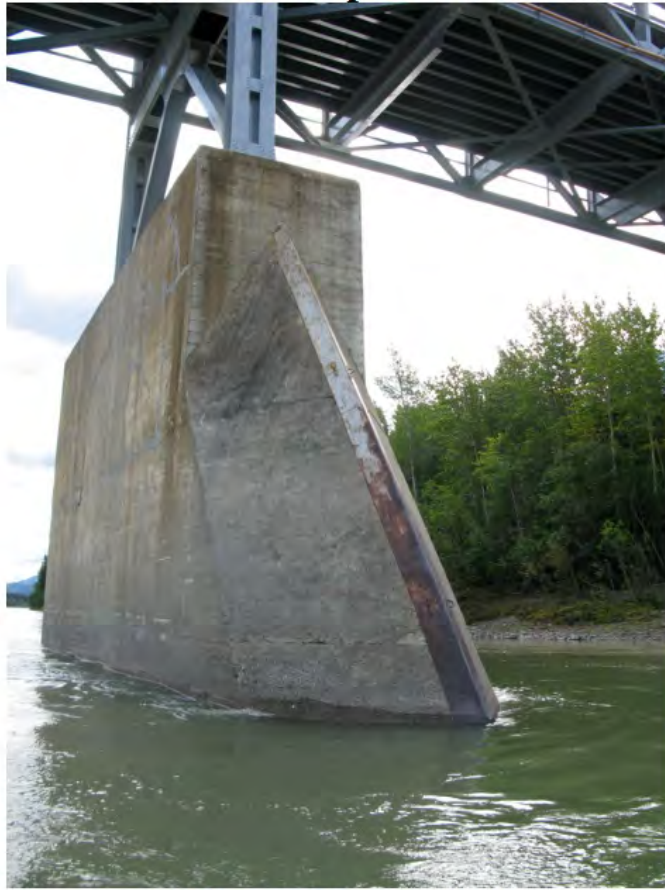
**UW05 - Pier 1 US nose HC side**

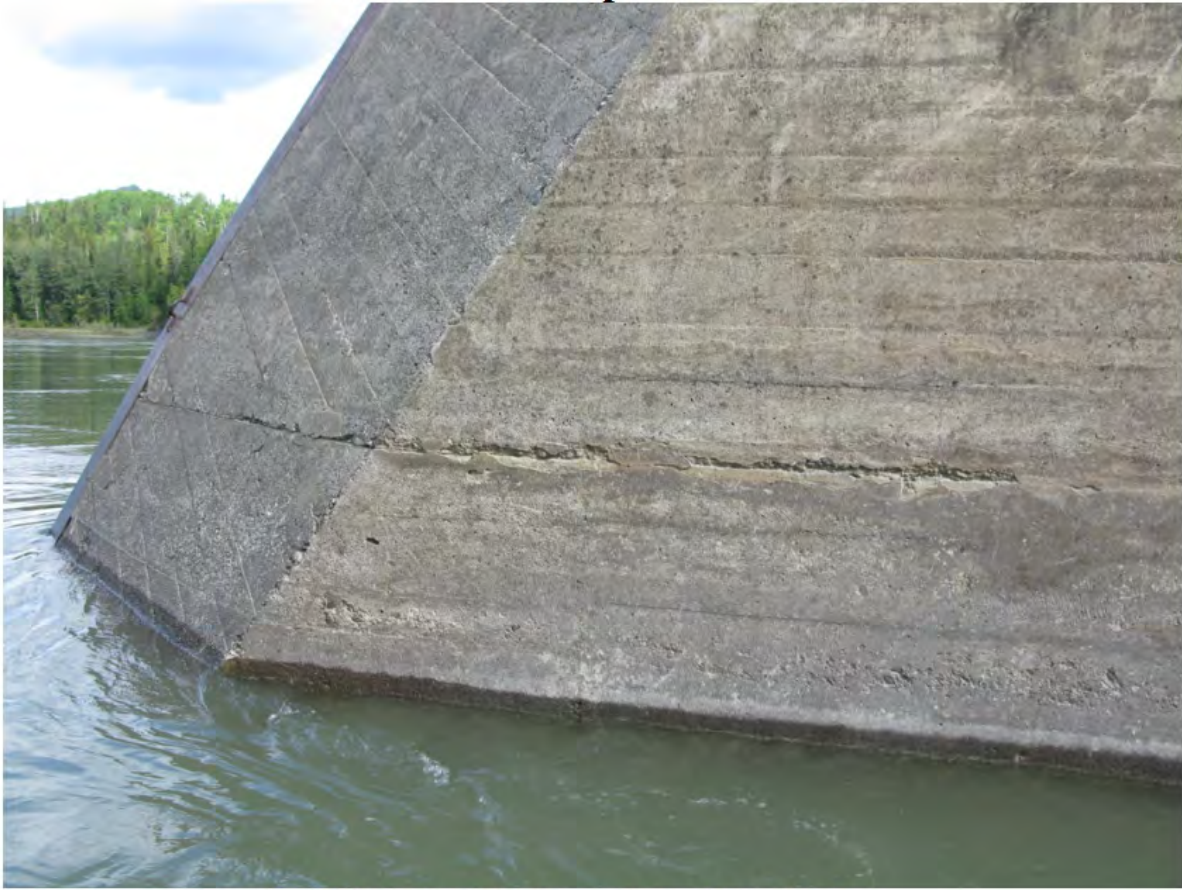
**UW07 - Pier 1 LC face spall at cold joint 5m long**

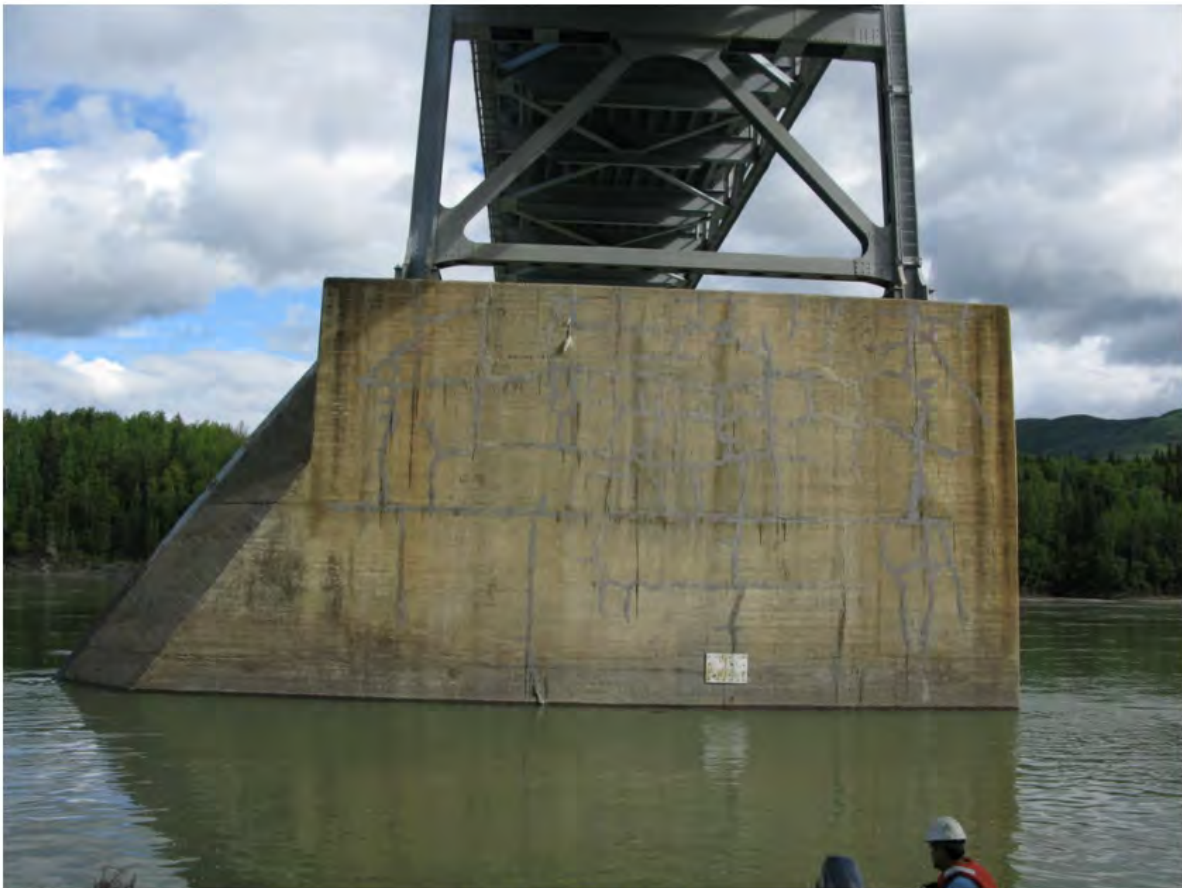
**UW08 - Pier 1 LC face**

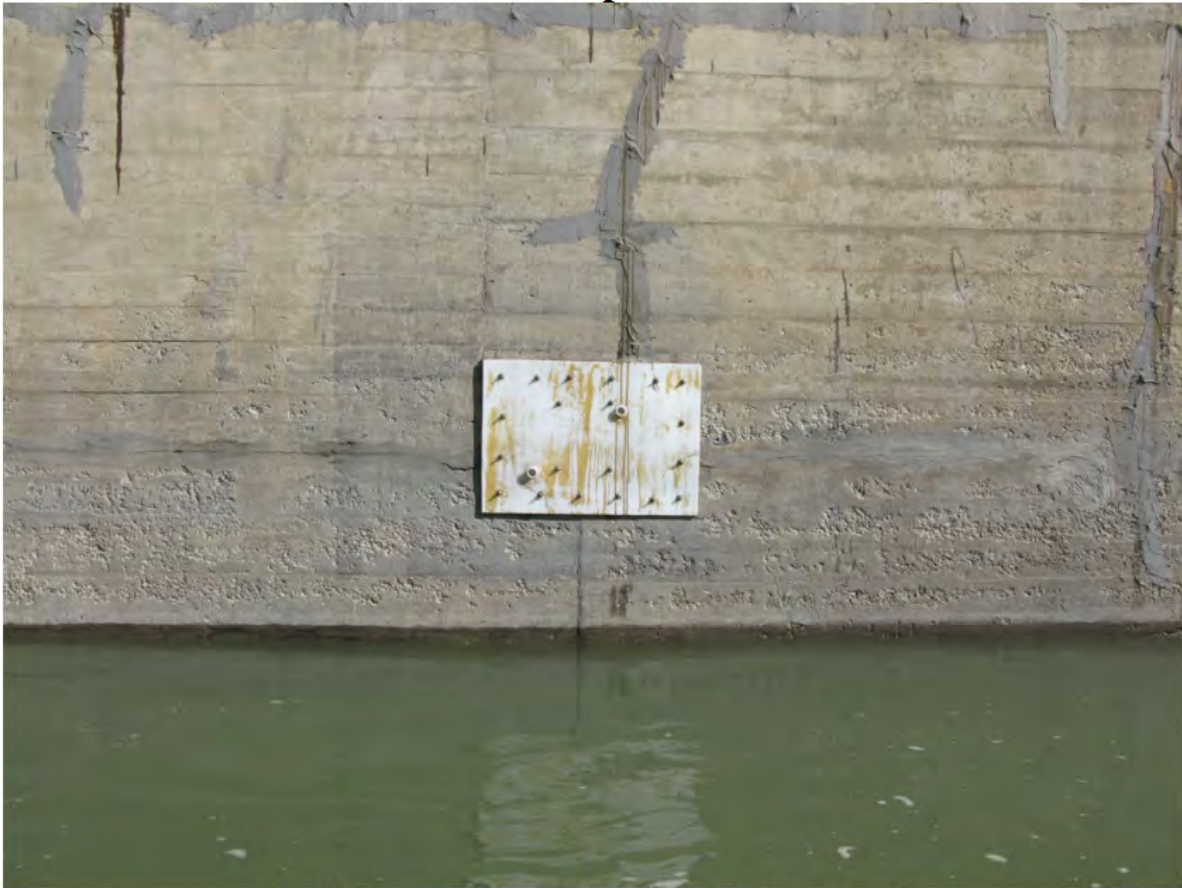
**UW09 - Pier 1 Spall repair LC face 1.5' above water 2**

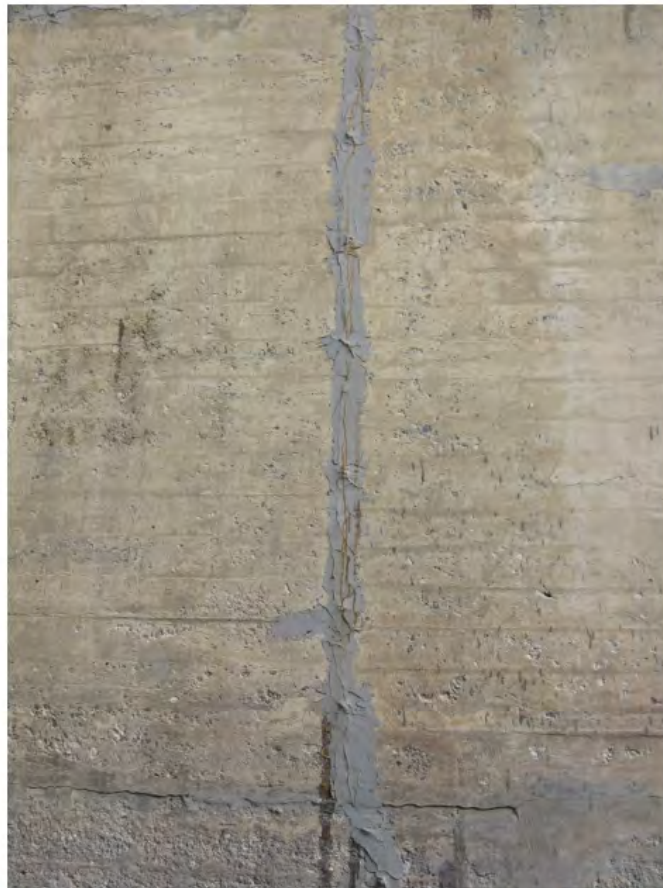
**UW10 - Pier 1 Typical crack repair with grout - Pier 1 LC face**

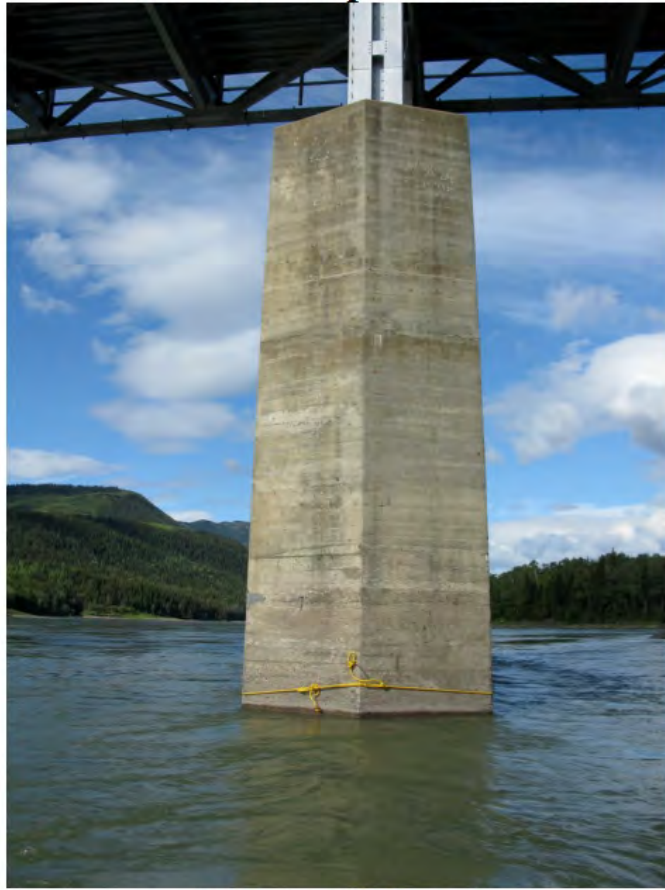
**UW11 - Pier 2 DS nose 2**

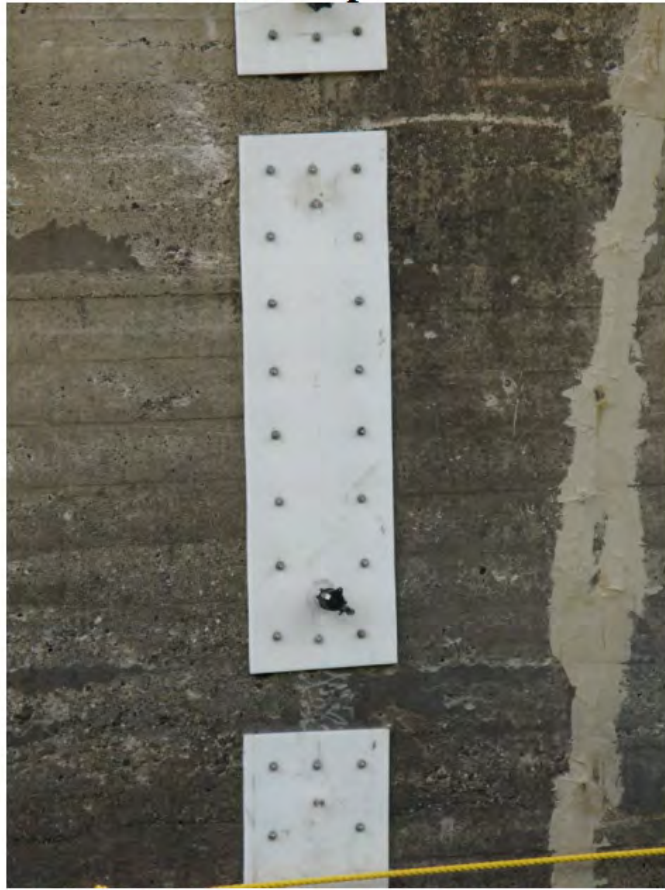
**UW13 - Pier 2 HC face close up of vertical repairs 16' from US**

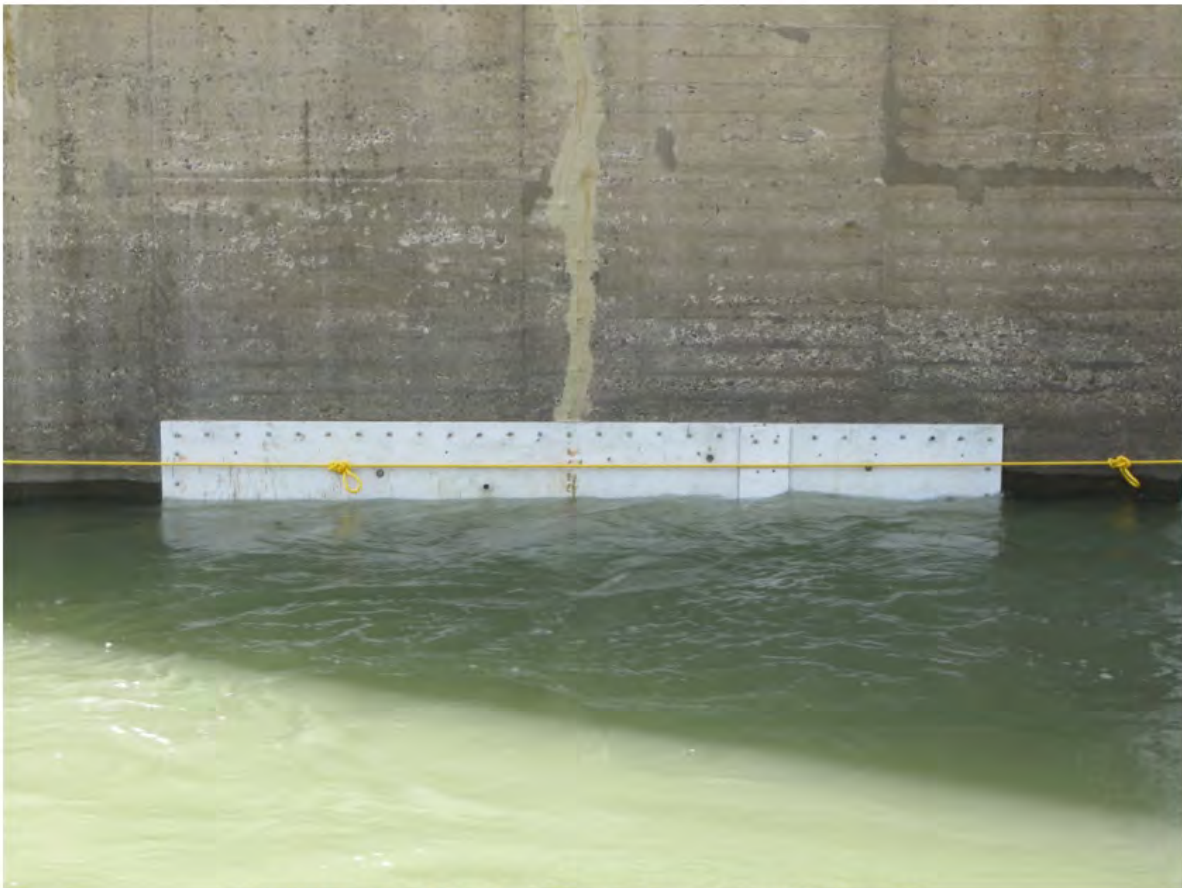
**UW14 - Pier 2 HC face close up horz repair 33' from US**

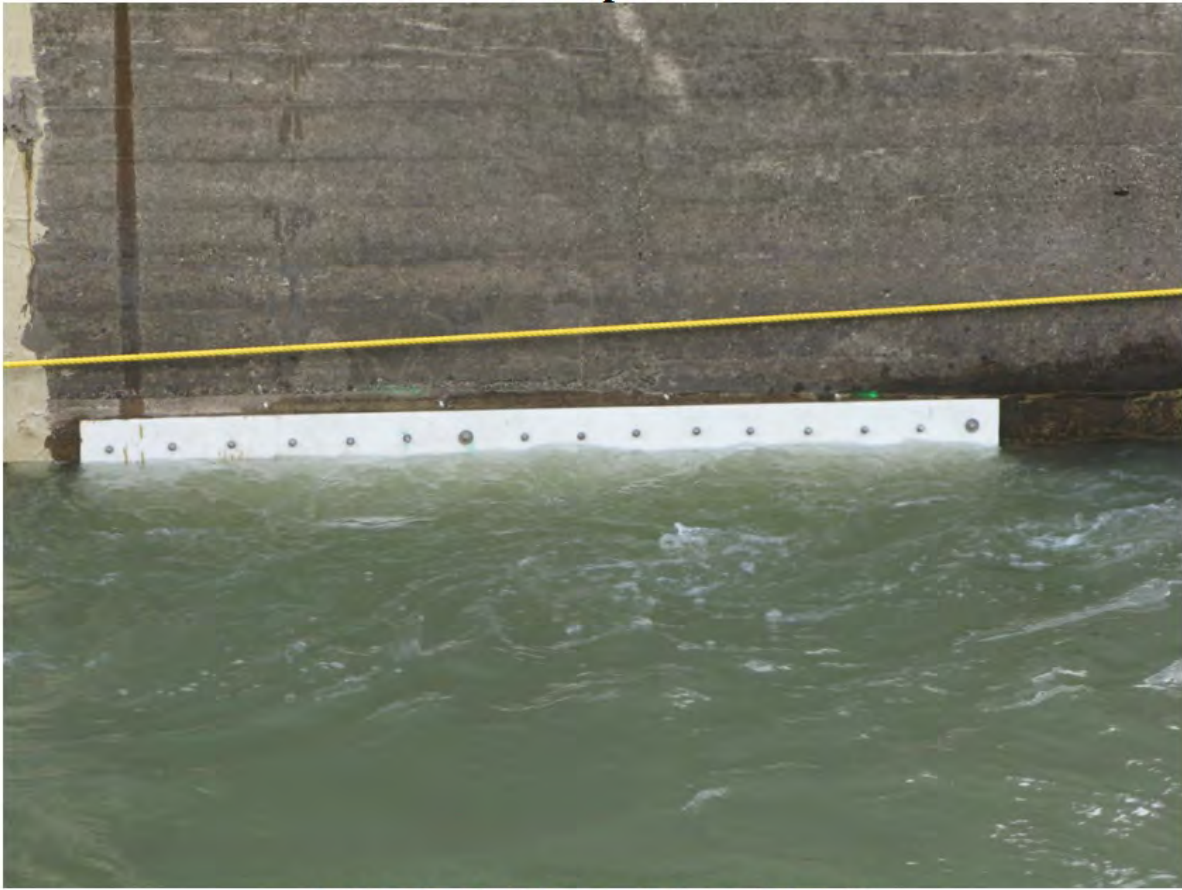
**UW15 - Pier 2 HC face repair horz. 16' from US**

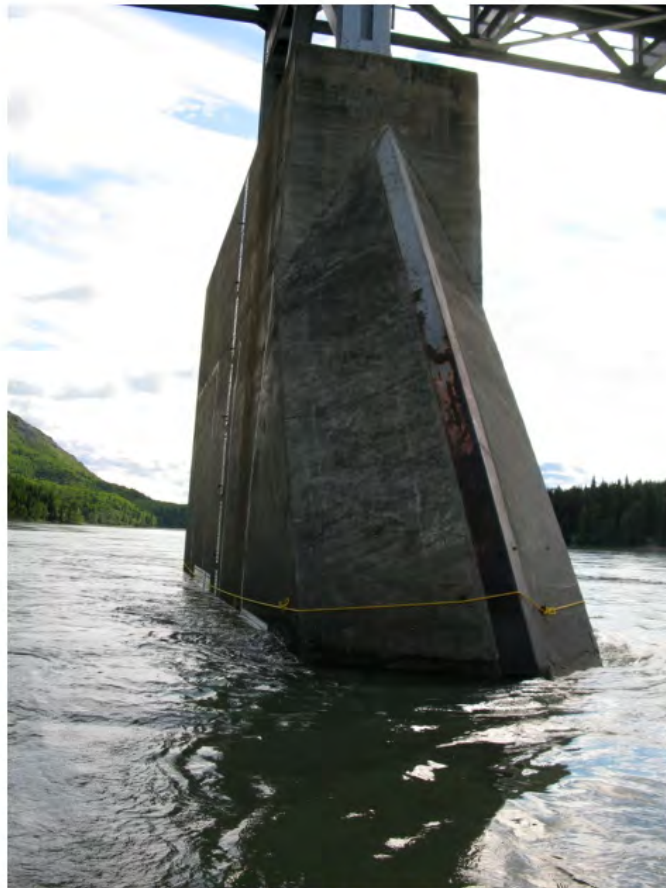
**UW16 - Pier 2 US nose HC face**

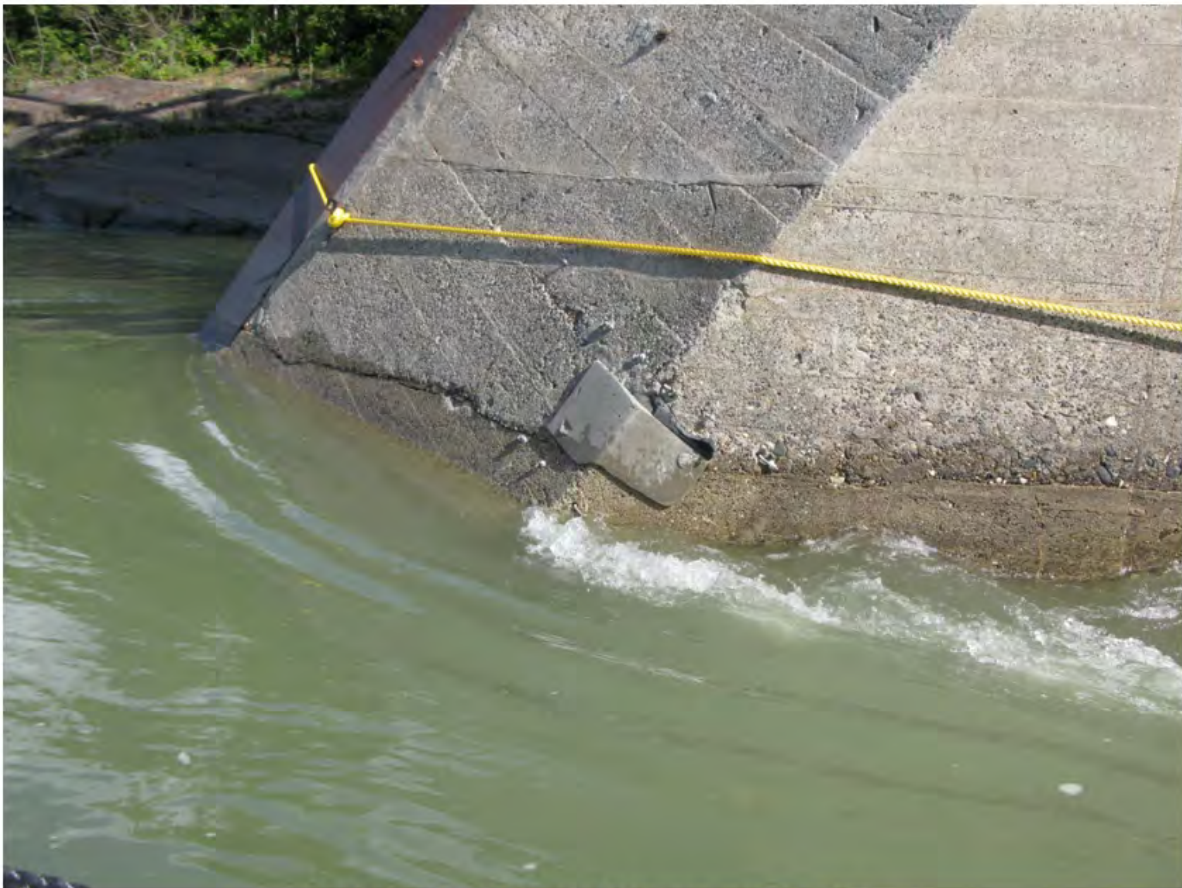
**UW18 - Pier 2 US nose LC face repair on nose**

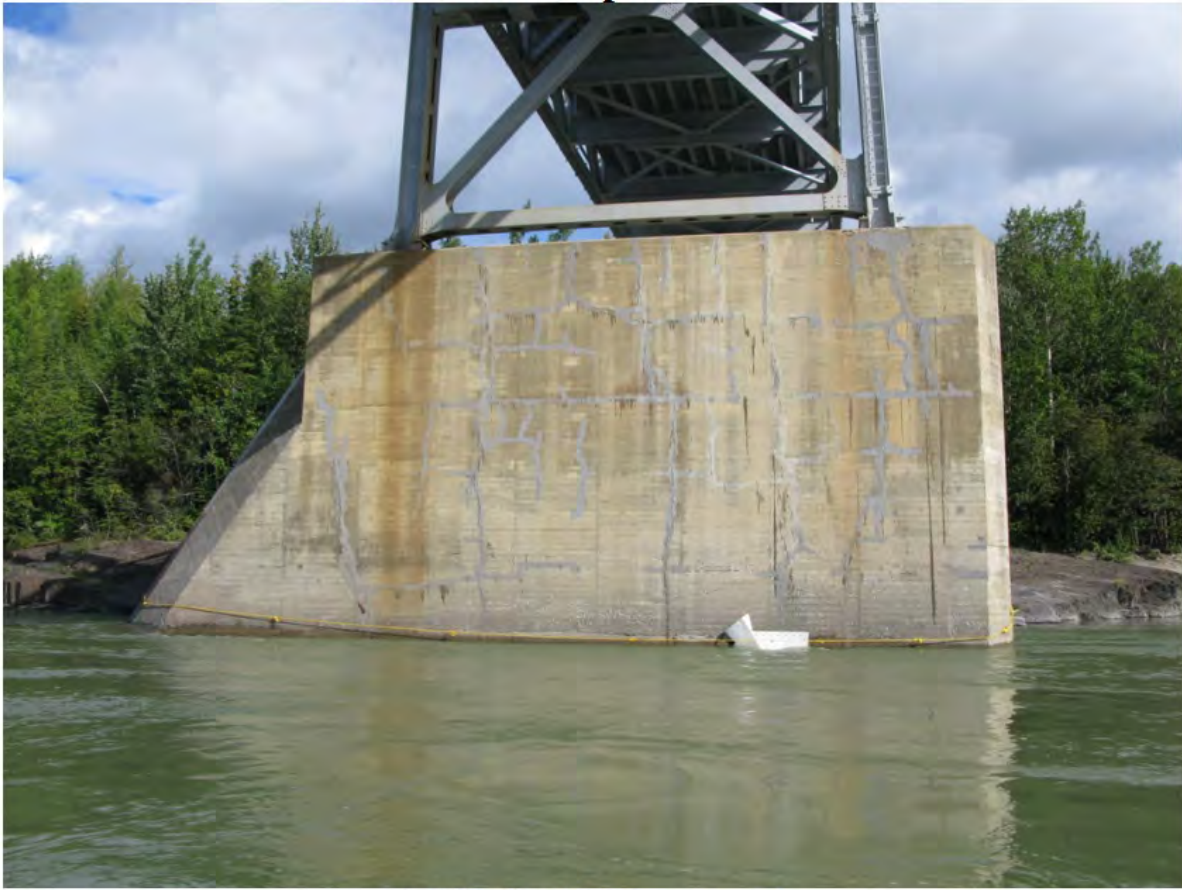
**UW19 - Pier 2 LC face genera 2**

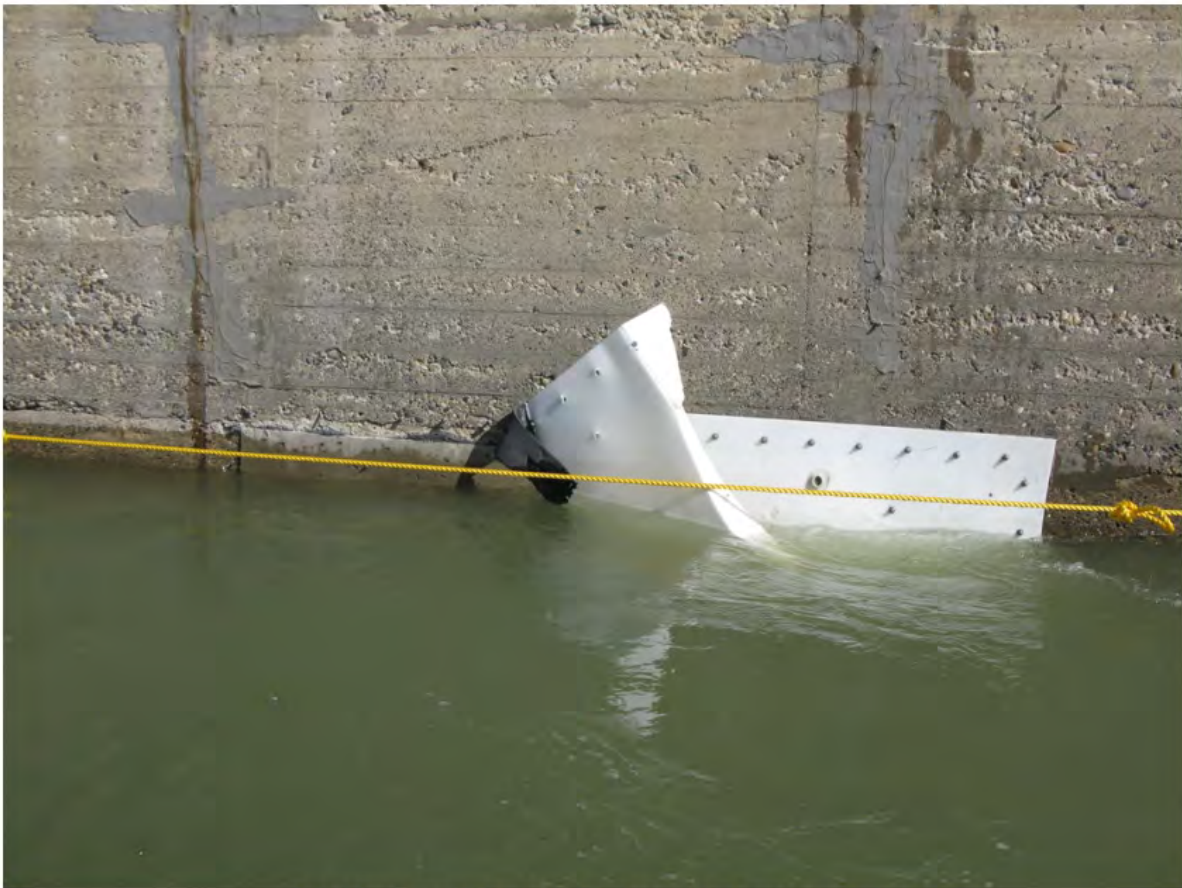
**UW20 - Pier 2 LC face 16' from DS damage repair**
