NATIONAL RESEARCH COUNCIL CANADA
1200 MONTREAL ROAD
OTTAWA, ONTARIO
K1A 0R6

DESIGNATED SUBSTANCES SURVEY

BUILDING M-55 OTTAWA, ON

March 2011

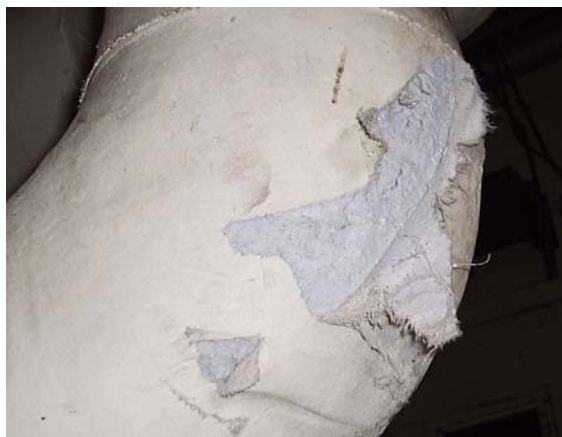
Mud Joint Compound

A representative photograph of mud joint compound fitting insulation. This material is a malleable grey insulation that has the appearance of granular mud. It appears smooth, round and hard when it is intact with appropriate exterior jacketing.

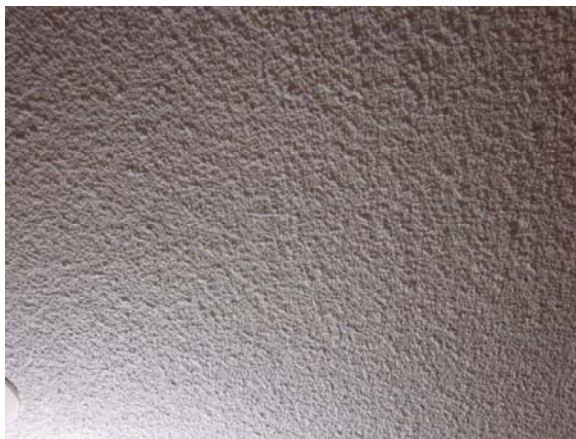
Ceiling Stucco

A representative photograph of plaster. ACM stucco is not distinguishable from non-ACM stucco by visual observation. Stucco is white, hard and textured and is non-friable in its original condition. Stucco is used as a finishing coat for walls and ceilings.

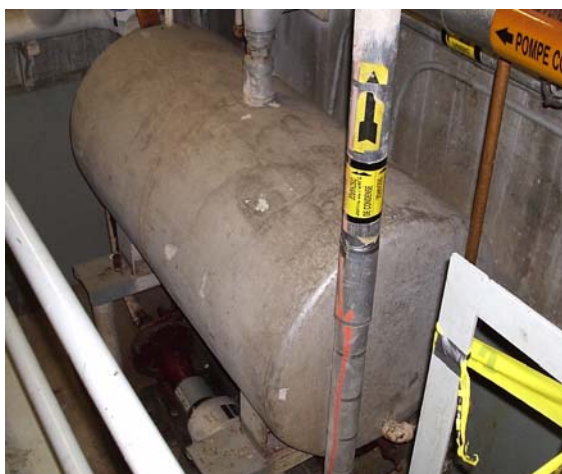
Tank Insulation

A representative photograph of tank insulation. This material is a malleable grey insulation that has the appearance of granular mud. It appears hard when it is intact with appropriate jacketing and is very similar to mud joint compound.

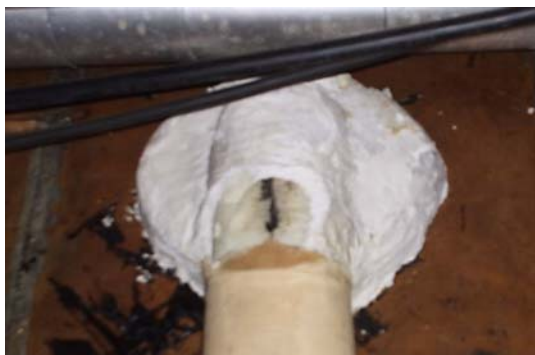
Thermal Patch

A representative photograph of a thermal patch. This material is a malleable grey insulation that has the appearance of granular mud. It appears smooth, round and soft. It is similar to mud joint compound but is softer and can be pulverized by hand pressure much easier.

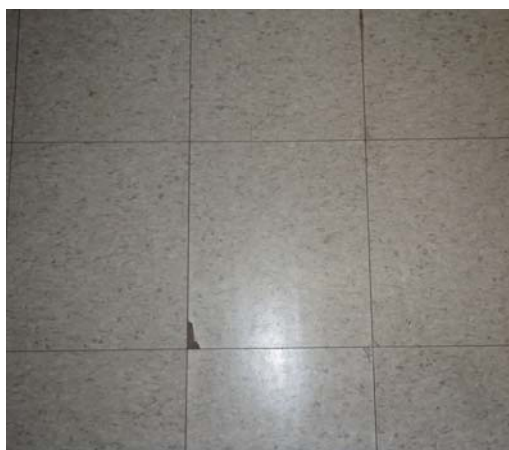
12"x12" Floor Tile

In the case of the 9” x 9” and 12” x 12” floor tiles, although PLM analytical results indicate that this material is non-asbestos, it is the opinion of Oakhill that this material does contain asbestos and that PLM analysis has limitations regarding separating bound materials such as floor tile to properly identify asbestos content. TEM analysis is recommended for this material.

A representative photograph of 12" x 12" vinyl asbestos floor tile (VAT). This material may be found in any number of different colours and patterns. VAT's are normally quite rigid and non-friable. VAT's are sometimes found under carpeting or they may be present as the only flooring.

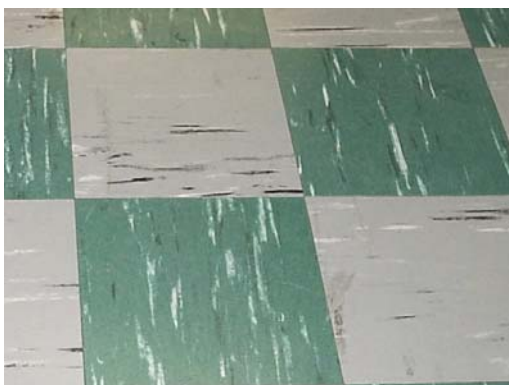
9" x 9" Floor Tile

A representative photograph of 9" x 9" vinyl asbestos floor tile (VAT). This material may be found in any number of different colours and patterns. VAT's are normally rigid and non-friable. VAT's are sometimes found under carpeting or they may be present as the only flooring.
