Appendix 'A'

**Lawn Floating Docks
Samples and Probes**

Call Up # 98
Project # R.0706635.013
Standing Offer # E0224-140972/001
9/06/2015

Report Completed By: Mary-Lynn Brinson

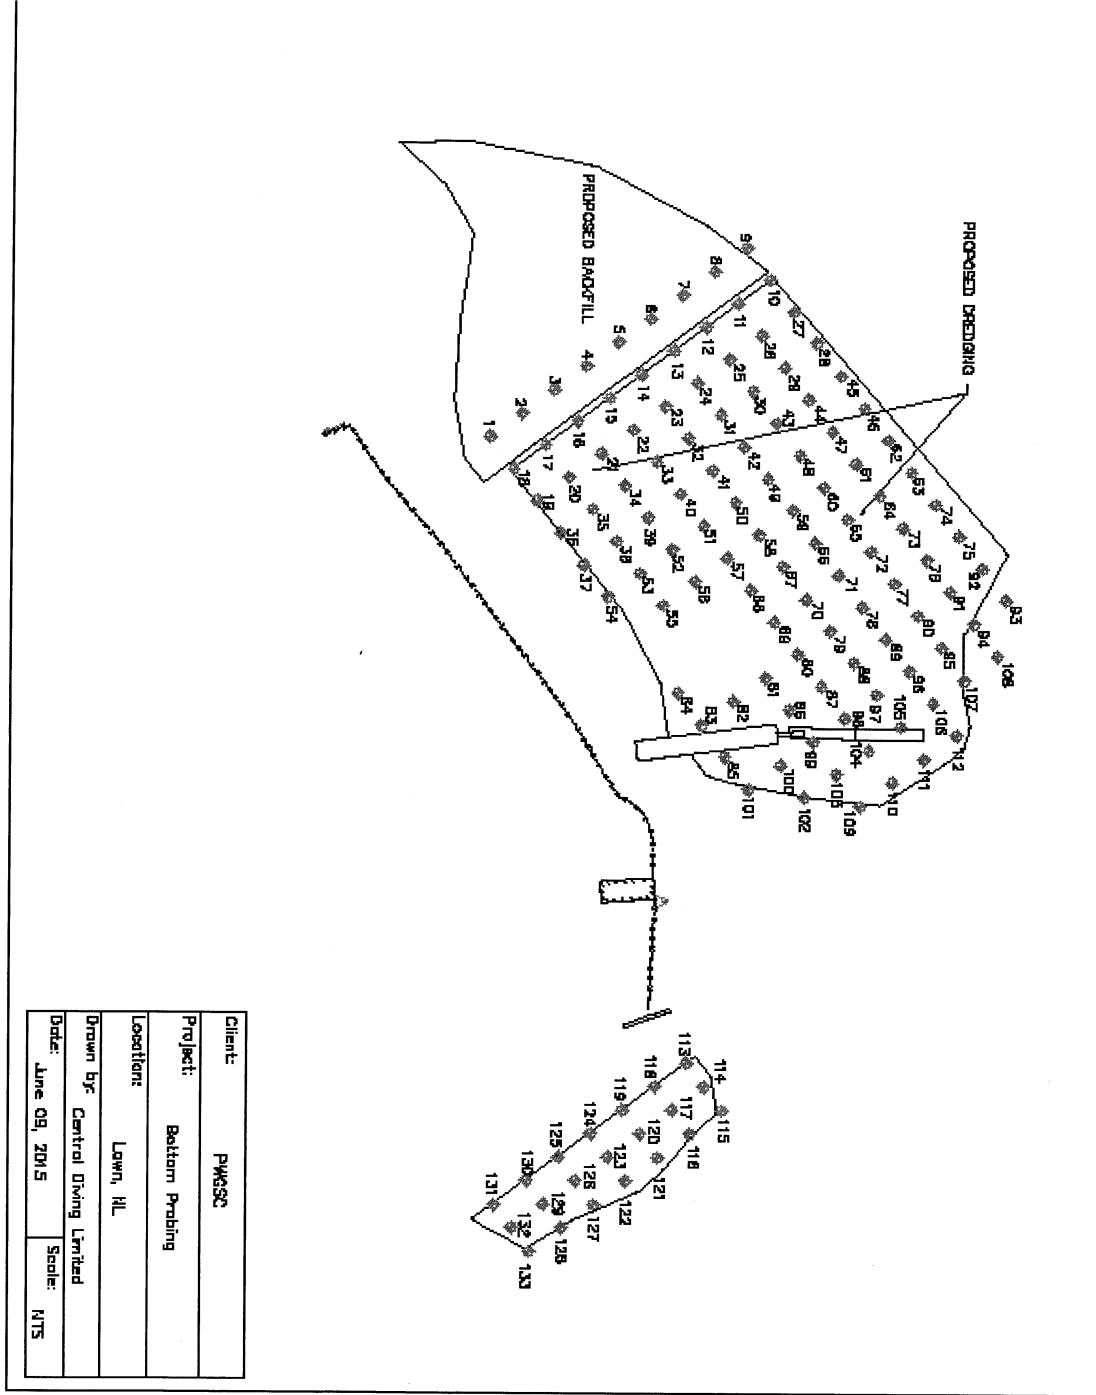
Figure 1: Probe Location Drawing

Probe #	Depth of Water(m)	Depth of Probe(m)	Bottom Type
1		1.5	Silt/Mud
2		.5	Rocky/Silt/Muddy
3		1.2	Mud
4		1	Silt/Mud
5		1.3	Silt/Mud
6		1.2	Muddy
7		0.4	Muddy/Rocky
8		1	Muddy/Rocky
9		0.5	Mud/Rocky
10		0.5	Mud
11		1.4	Mud
12		1.4	Mud
13		1	Rocky/Mud
14		1.1	Muddy/Rocky
15		0.9	Mud/ Rocks
16		1	Mud/ Rocks
17		0.7	Rocky/Muddy
18		1.1	Rocky/Sandy/Mud
19		0.8	Rocks/Sand/Mud
20		1.1	Mud
21		1.1	Mud
22		1	Silt/Mud/Rocks
23		0.9	Silt/Mud/Rocks
24		1	Silt/Mud/Rocks
25		1	Silt/Mud/Rocks
26		1	Silt/Mud/Rocks
27		1.3	Silt/Mud/Rocks
28		1	Silt/Mud/Rocks
29		0.9	Silt/Mud/Rocks
30		1.2	Silt/Mud/Rocks
31		0.6	Silt/Mud/Rocks
32		0.8	Silt/Mud/Rocks
33		1.1	Silt/Mud/Rocks
34		1.4	Silt/Mud/Rocks

Probe #	Depth of Water(m)	Depth of Probe(m)	Bottom Type
35		1.5	Silt/Mud/Rocks
36		0.7	Silt/Mud/Rocks
37		0.4	Silt/Mud/Rocks
38		1	Silt/Mud/Rocks
39		0.5	Silt/Mud/Rocks
40		0.6	Silt/Mud/Rocks
41		0.7	Silt/Mud/Rocks
42		0.8	Silt/Mud/Rocks
43		0.6	Silt/Mud/Rocks
44		0.8	Silt/Mud/Rocks
45		1.1	Silt/Mud/Rocks
46		0.6	Silt/Mud/Rocks
47		0.8	Silt/Mud/Rocks
48		0.5	Silt/Mud/Rocks
49		0.5	Silt/Mud/Rocks
50		0.4	Silt/Mud/Rocks
51		0.5	Silt/Mud/Rocks
52		0.3	Silt/Mud/Rocks
53		0.9	Silt/Mud/Rocks
54		1.3	Silt/Mud/Rocks
55		1.1	Silt/Mud/Rocks
56		0.4	Silt/Mud/Rocks
57		0.2	Mud
58		0.4	Mud/Rocks
59		0.4	Mud
60		0.3	Mud
61		0.3	Mud/Rocks
62		0.3	Mud/Rocks
63		0.2	Mud
64		0.1	Mud
65		0.1	Mud
66		0.3	Mud
67		0.3	Mud/Rocks
68		0.2	Mud/Rocks
69		0.2	Mud

Probe #	Depth of Water(m)	Depth of Probe(m)	Bottom Type
70		0.1	Mud/Rocks
71		0.1	Mud/Rocks
72		0.1	Mud
73		0.1	Mud
74		0.1	Mud
75		0.2	Mud
76		0.1	Mud
77		0.2	Mud/Rocks
78		0.9	Mud
79		0.7	Mud/Rocks
80		1.5+	Mud/Rocks
81		0.7	Mud/Rocks
82		0.3	Mud
83		0.4	Mud
84		1	Mud
85		1.5+	Mud
86		1.5	Mud
87		1.4	Mud
88		1.5+	Mud
89		1.5+	Mud/Rocks
90		0.95	Mud/Rocks
91		0.1	Mud
92		0.4	Mud
93		0.2	Mud
94		0.1	Mud
95		1.1	Mud
96		1.5+	Mud
97		1.5+	Mud
98		1.4	Mud
99		0.7	Mud/Rock
100		0.7	Mud/Rocks
101		1.5+	Mud/Rocks
102		1.5+	Mud
103		1.1	Mud/Rocks
104		1	Mud

Probe #	Depth of Water(m)	Depth of Probe(m)	Bottom Type
105		1.3	Mud
106		1.5+	Mud
107		0.9	Mud
108		0.1	Mud
109		0.85	Mud
110		0.8	Mud
111		0.9	Mud
112		0.9	Mud/Rocks
Outside Area			
113		0	Rock
114		0	Rock
115		0.4	Mud/Rocks
116		0.2	Mud/Rock
117		0.2	Mud/Rocks
118		0.1	Mud/Rocks
119		0.1	Mud/Rocks
120		0	Rock
121		0	Rock
122		0.2	Mud/Rock
123		0.4	Mud
124		0.3	Mud
125		0.1	Mud
126		0	Rock
127		0	Rock
128		0.4	Mud/Rock
129		0	Rock
130		0	Rock
131		1	Mud
132		0.4	Mud/Rocks
133		1.5+	Mud

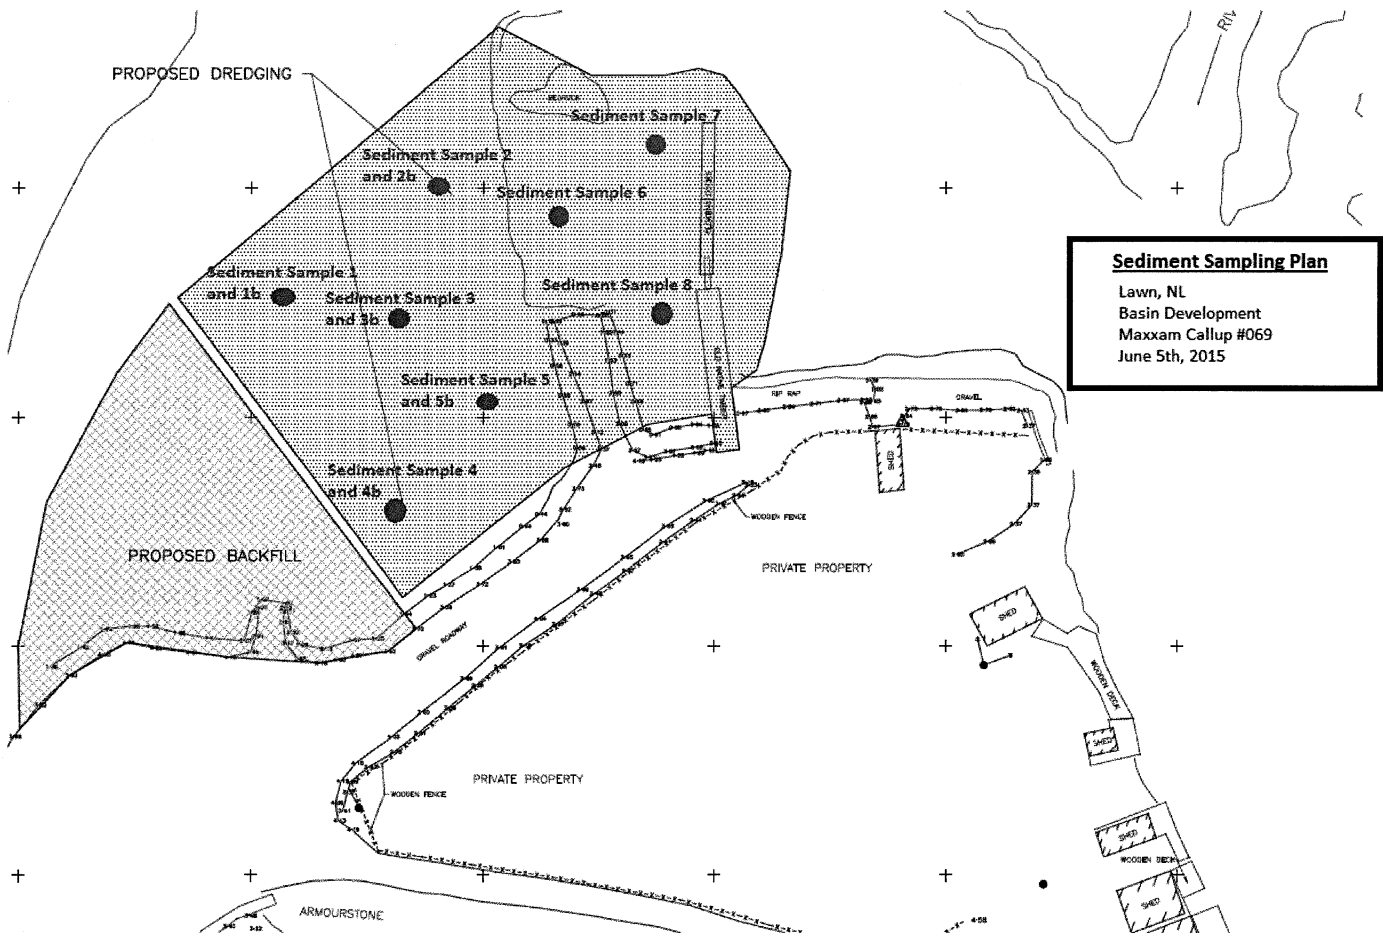
Figure 2: Sediment Samples Location Drawing

Probes were completed using a 10mm diameter steel rod (2m long) which was driven to refusal into the sea floor by the diver striking it with a 3kg hammer. Bottom sediment samples were collected from eight sites around the floating docks and in the basin area. Sites No.1 to No. 5 were composite samples. Sediment was collected at three different depths, 10cm, 50cm and 1.5m then mixed together. Two (250ml) jars were then filled using this mixture. Sites No. 6, No. 7 and No. 8 were typical samples with two 250ml jars filled at each site

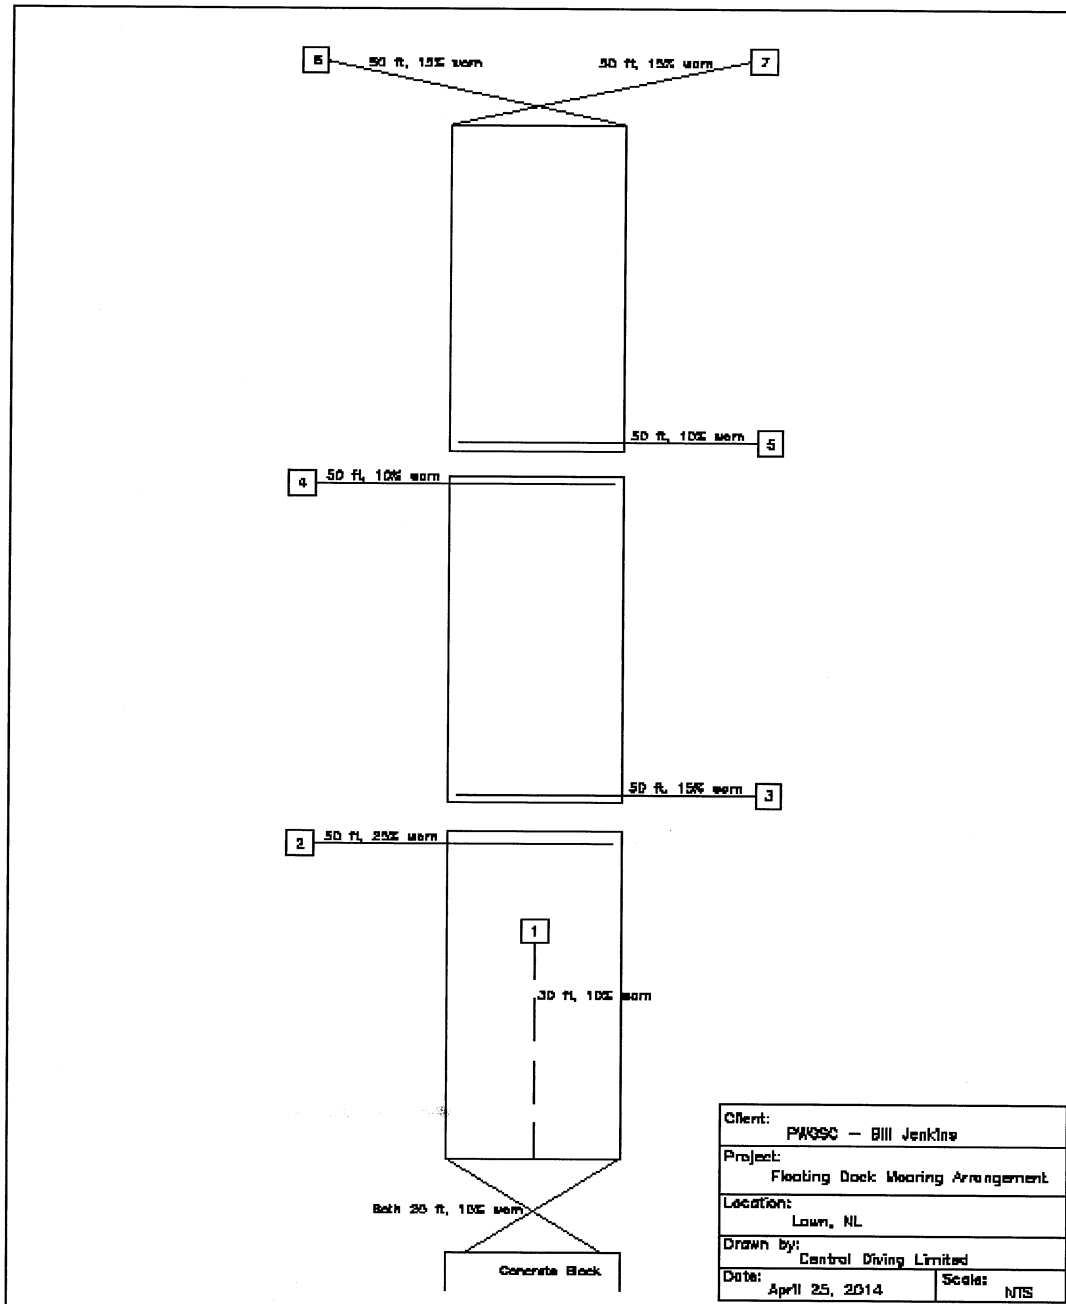
Figure 3: Sketch of Three Dock Assembly from Concrete Block (2014)

Block #	Chain Length (ft)	Chain Condition (% of wear)
Docks from Wharf		
1	75	10
2	75	20
3	100	10
4	60	NEW (2015)
5	80	15
Chains From Head Block	20 (20)	15 (Both)
NOTE: The chain from Block No.4 was replaced June, 2015		
Docks from Concrete Block		
1	30	10
2	50	25
3	50	15
4	50	10
5	50	10
6	50	15
7	50	15
Chains From Head Block	20 (Both)	10 (Both)
Docks from Finger Wharf		
1	50	NEW
2	50	10
3	40	10
4	40	10
5	70	NEW
Chains from Head Block	20 (Both)	One is NEW One is 15% Worn
