**Reference: Limited Hazardous Building Materials Assessment, Cape Sable Island Lighthouse,
Shelburne County, Nova Scotia, DFRP #02298, LL# 327, RPIS# MC 00086**

At the request of Public Works and Government Services Canada (PWGSC), on February 15, 2016, Stantec Consulting Ltd. (Stantec) completed a hazardous building materials assessment of the Cape Sable Island Lighthouse (subject building) located in Shelburne County, Nova Scotia.

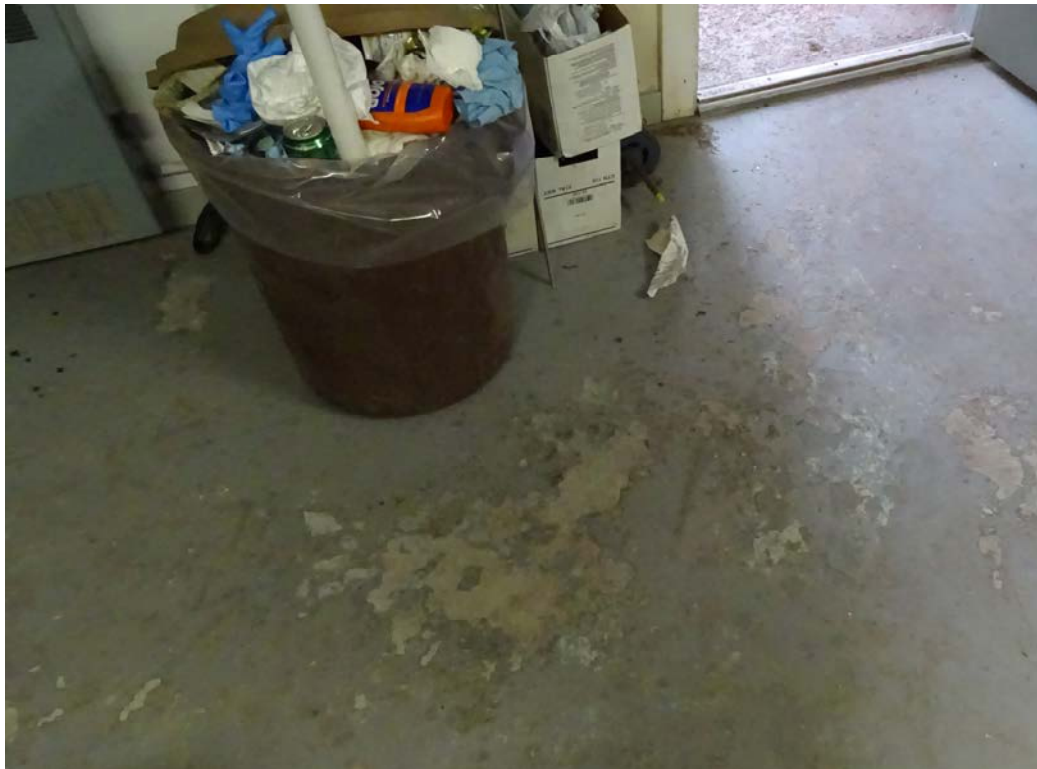
- PS-CSIL-01 (1,200 mg/kg): Gray paint over pale green paint on interior base level mechanical room floor;
- PS-CSIL-02 (42,000 mg/kg): Red paint on interior metal ladders and railings;
- PS-CSIL-03 (28,000 mg/kg): Red paint on interior concrete floors on all levels; and
- PS-CSIL-06 (55,000 mg/kg): White paint on wood trim in the interior lantern gallery.

- PS-CSIL-01 (0.43 mg/L): Gray paint over pale green paint on interior base level mechanical room floor;
- PS-CSIL-04 (0.093 mg/L): Gray paint on interior wood window trim in the 2nd level operations room;

PHOTO 1: Showing gray paint over pale green paint on base level mechanical room floor (PS-CSIL-01).

These paints are considered to be lead-containing and appropriate worker protection in accordance with the NS Labour and Workforce Development Code of Practice for Working with Inorganic Lead is required when disturbing this material. During renovation lead concentrations in air should not exceed the ACGIH TWA-TLV of 0.05 mg/m³. It is anticipated that following industry standard methods, abatement of the lead-based paint using Minimum Precautions is required. The lead-based paint abatement must only occur after the mercury abatement is completed.

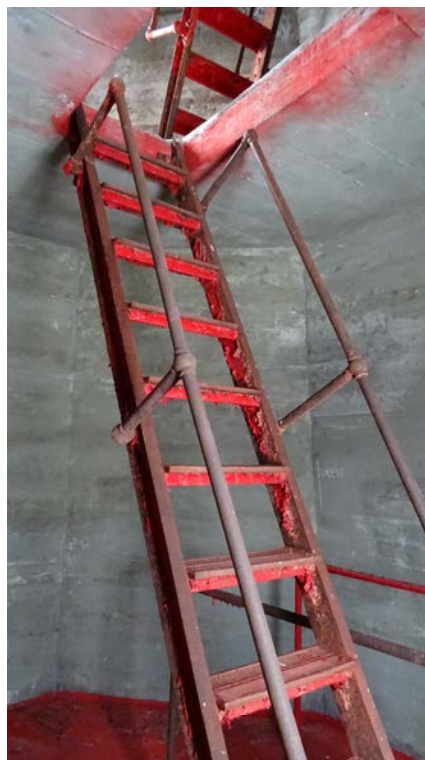
- PS-CSIL-02 (36 mg/L): Red paint on interior metal ladders and railings;
- PS-CSIL-03 (110 mg/L): Red paint on interior concrete floors on all levels; and
- PS-CSIL-06 (59 mg/L): White paint on wood trim in the interior lantern gallery.

PHOTO 2: Showing red paint on metal ladders and railings (PS-CSIL-02).

Analysis of the samples confirmed that the paint chips and paint plus substrate samples listed above exceed the allowable leachate concentration of 5 mg/L. Out of province disposal at an approved facility capable of accepting lead leachate toxic wastes is required.

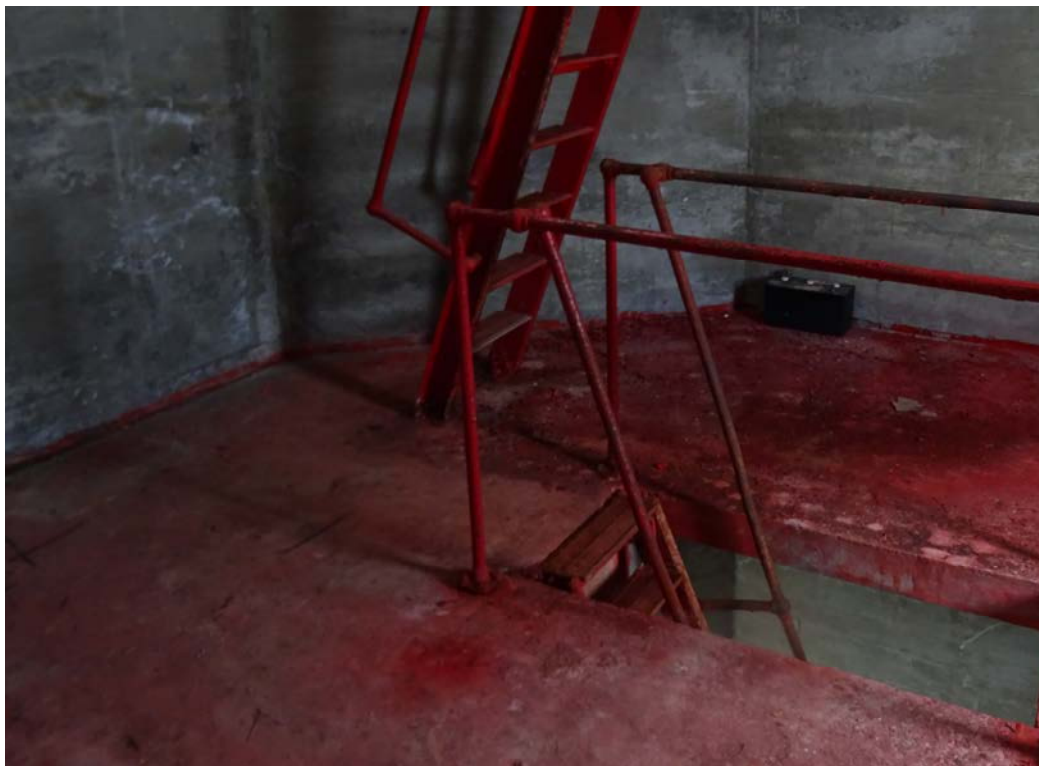
PHOTO 3: Showing red paint on concrete floors on all levels (PS-CSIL-03).

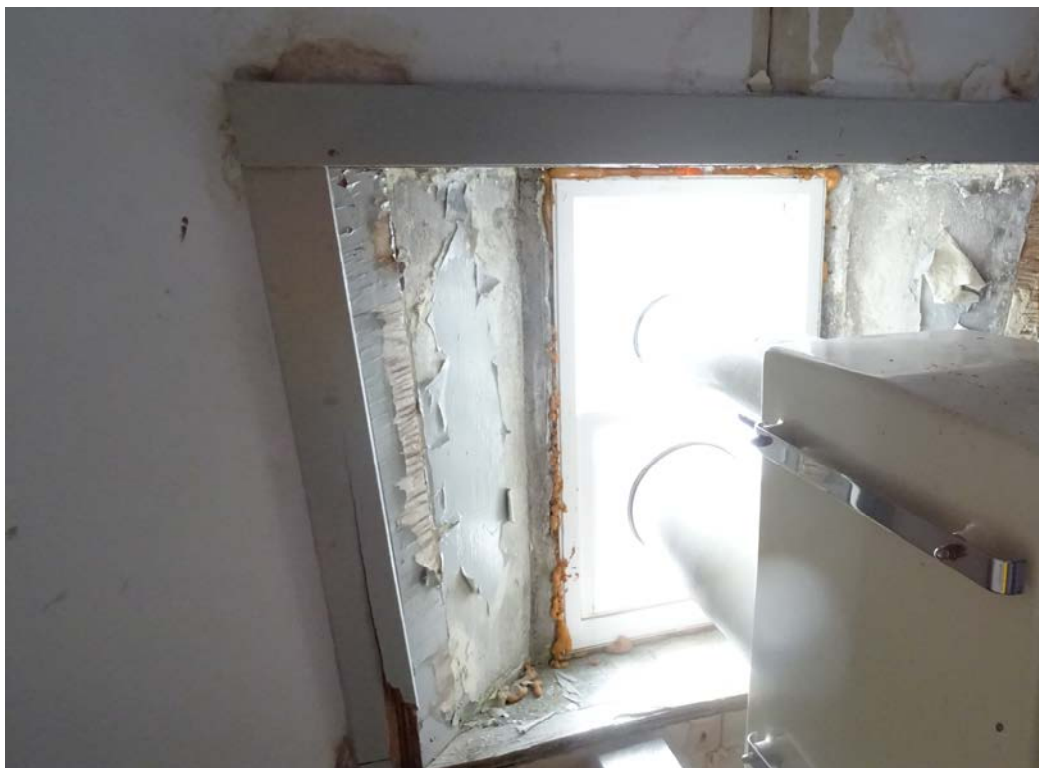
- PS-CSIL-04 (740 mg/kg): Gray paint on interior wood window trim in the 2nd level operations room.

- PS-CSIL-04 (0.023 mg/L): Gray paint on interior wood window trim in the 2nd level operations room; and
- PS-CSIL-05 (0.083 mg/L): White paint on interior drywall in 2nd level operations room.

PHOTO 4: Showing gray paint on wood window trim in the 2nd level operations room (PS-CSIL-04).

Analysis of the samples confirmed the paint samples listed above are suitable for disposal at an approved solid waste landfill or C&D facility pending final authorization from the facility operator.

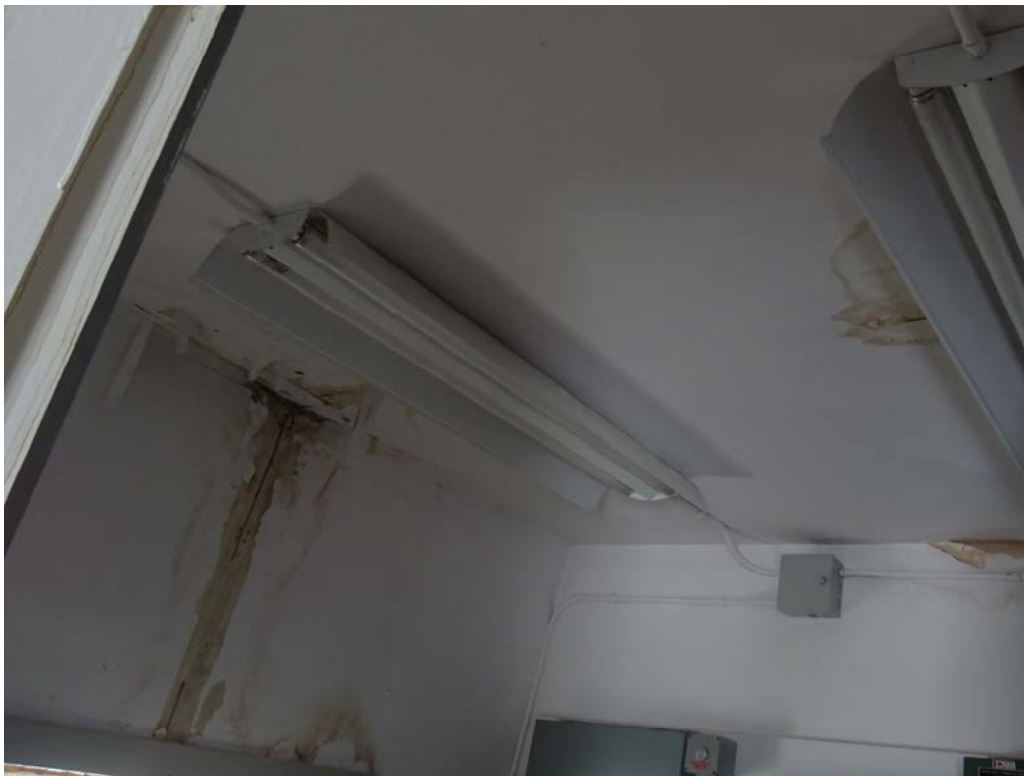
- PS-CSIL-05 (17 mg/kg): White paint on interior drywall in 2nd level operations room; and
- PS-CSIL-07 (67 mg/kg): White paint on exterior concrete;

- PS-CSIL-05 (0.0085 mg/L): White paint on interior drywall in 2nd level operations room; and
- PS-CSIL-07 (0.019 mg/L): White paint on exterior concrete.

Five suspected PCB-containing lamp ballasts were observed in the subject building at the time of the assessment. These lamp ballasts were Canadian General Electric "Gold Label" models with a model code of "17A240T", which indicates that PCBs may be present based on the Environment Canada document "Identification of Lamp Ballasts Containing PCBs." The light fixtures were energized at the time of the assessment and the date codes on the back of the ballast casings could not be accessed to confirm the manufacture date. When decommissioned, these date codes should be checked to confirm whether or not PCBs are present within the lamp ballasts.

PHOTO 5: Showing white paint on drywall in 2nd level operations room (PS-CSIL-05). Also showing light fixtures housing suspected PCB-containing lamp ballasts.

Should any equipment suspected of containing PCBs be uncovered during future renovation or demolition activities, they should be removed from service and properly disposed of to avoid the release of PCBs into the environment.

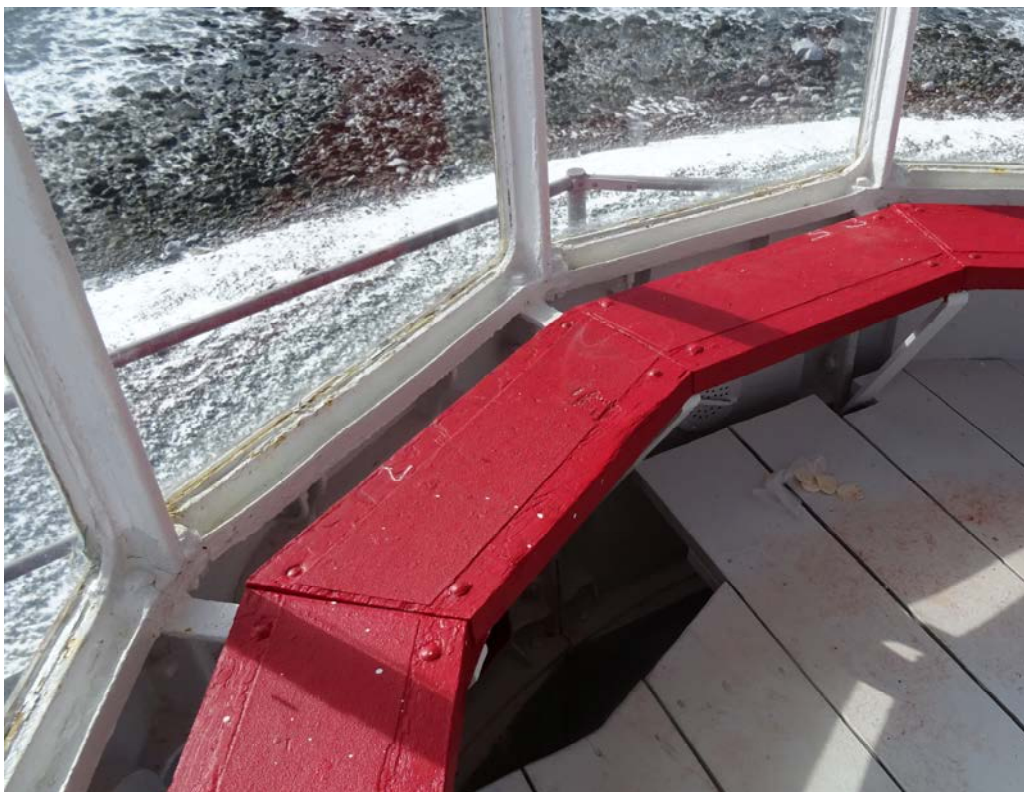
PHOTO 6: Showing white paint on wood floor and trim in the interior lantern gallery (PS-CSIL-06).

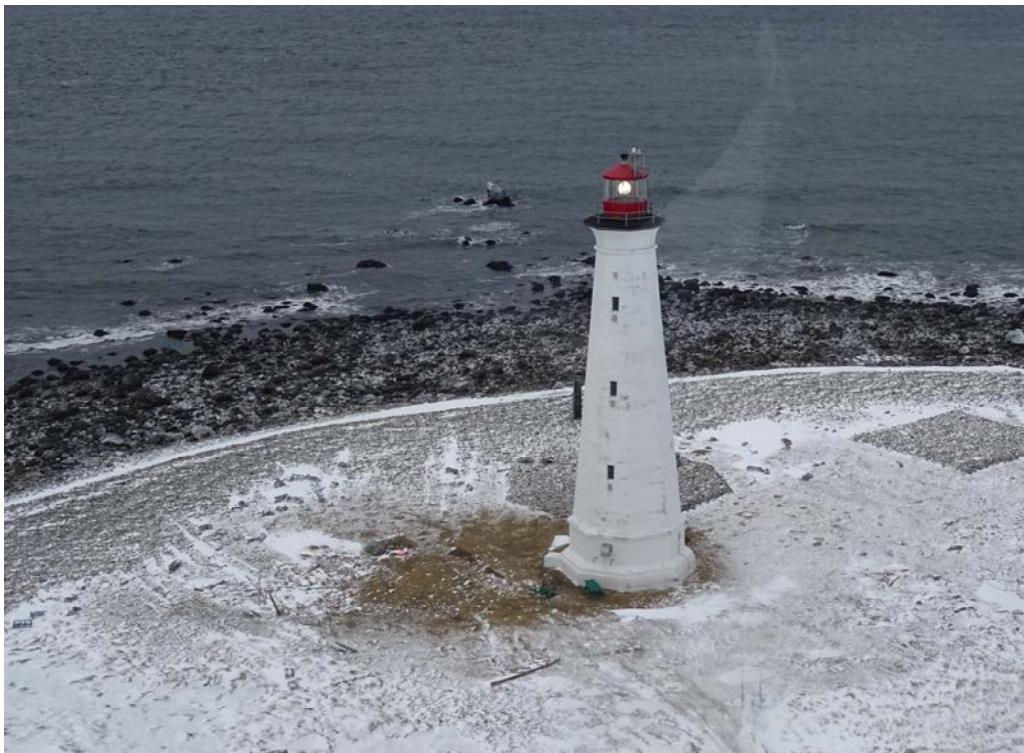
PHOTO 7: Showing the white paint on the exterior concrete of the lighthouse (PS-CSIL-07).

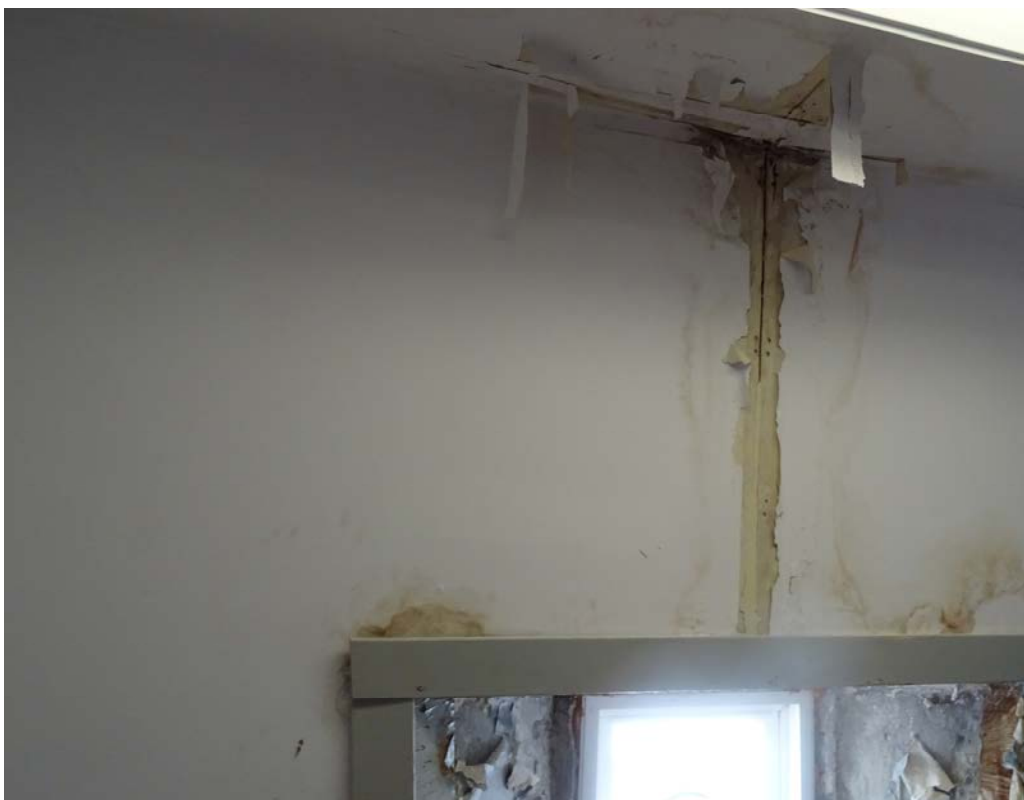
Analytical results indicate that 2% Chrysotile asbestos was detected in the drywall joint compound located in the base level mechanical room (BS-CSIL-01A) and 2nd level operations room (BS-CSIL-03A). The drywall joint compound in the 2nd level operations room was observed to be in poor condition at the time of the assessment with debris observed on the floor areas.

PHOTO 8: Showing the asbestos-containing drywall joint compound in poor condition in the 2nd level operations room (BS-CSIL-03A).

All asbestos containing materials identified in the subject building must be handled in accordance with the Nova Scotia Asbestos Waste Management Regulation, N.S. Reg. 53/95 and manifested as a Dangerous Good before transport. Should any other material(s) suspected to contain asbestos, be uncovered during renovation activities, work must stop, and the material(s) tested to determine whether asbestos is present.

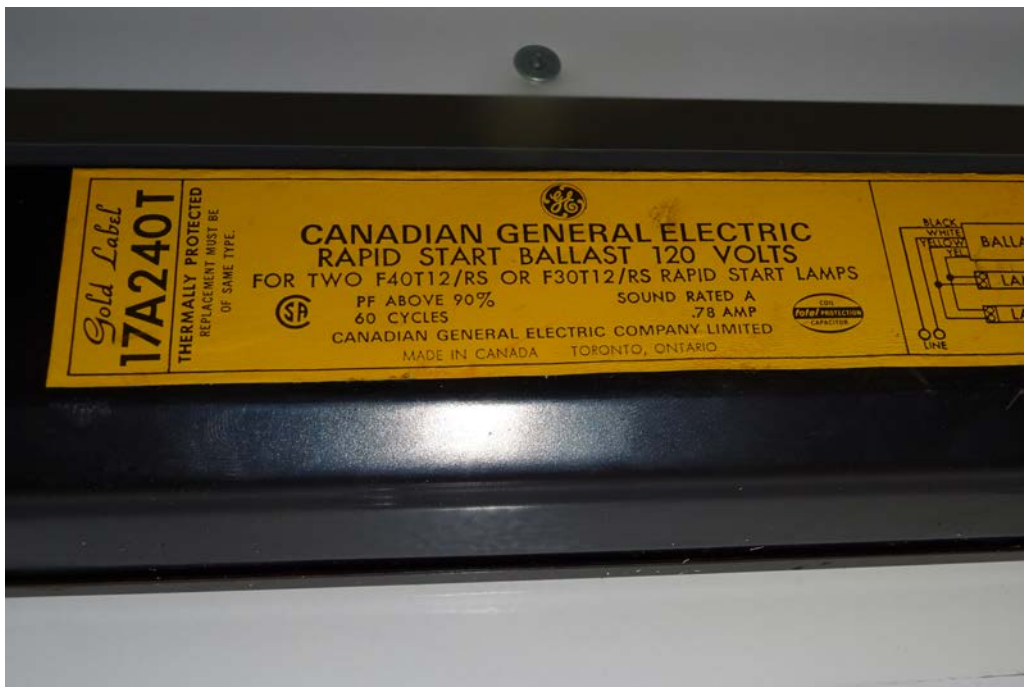
PHOTO 9: Showing suspected PCB-containing fluorescent lamp ballast in the lighthouse.
