**Reference: Limited Hazardous Building Materials Assessment, Sambro Island Lighthouse, Halifax County, Nova Scotia, DFRP #02835, LL# 507, RPIS# MC 00504**

At the request of Public Works and Government Services Canada (PWGSC), on February 15, 2016, Stantec Consulting Ltd. (Stantec) completed a hazardous building materials assessment of the Sambro Island Lighthouse (subject building) located in Halifax County, Nova Scotia.

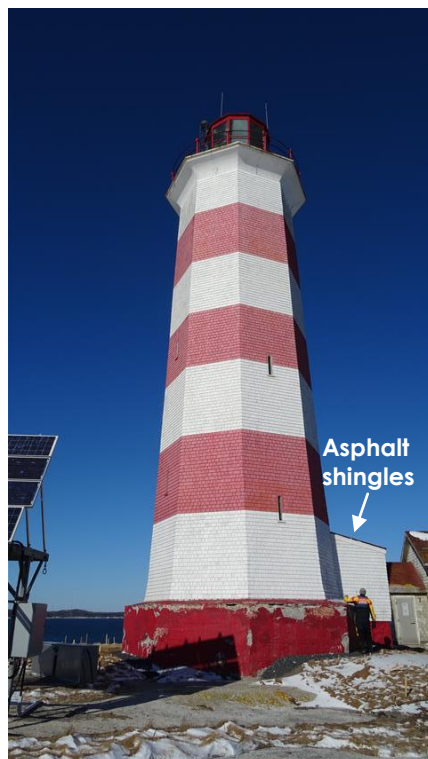
Analytical results indicate that 1.3% Chrysotile asbestos was detected in the red asphalt roof shingles located on the entrance wood framed structure (BS-SIL-02B).

- PS-SIL-01 (200 mg/kg): White paint on exterior wood shakes.
  - PS-SIL-01 Lab-Dup (180 mg/kg).

- PS-SIL-02 (3,500 mg/kg): Red paint on exterior concrete base;  
– PS-SIL-02 Lab-Dup (3,600 mg/kg).
- PS-SIL-03 (2,500 mg/kg): Red paint on exterior wood shakes;
- PS-SIL-04 (68,000 mg/kg): White paint on interior stone walls in lower 2/3 of lighthouse;
- PS-SIL-05 (46,000 mg/kg): White paint over red, cream and brown paint on interior wood trim;
- PS-SIL-06 (55,000 mg/kg): Grey paint over yellow and brown paint on interior stairs; and
- PS-SIL-07 (79,000 mg/kg): White paint over cream paint on interior concrete walls on upper 1/3 of lighthouse.

PHOTO 1: Showing exterior white (PS-SIL-01) and red (PS-SIL-03) paint on wood shakes, as well as the red paint on concrete base (PS-SIL-02). Arrow pointing at location of asbestos containing asphalt roof shingles (BS-SIL-02A).

All asbestos containing materials identified in the subject building must be handled in accordance with the Nova Scotia Asbestos Waste Management Regulation, N.S. Reg. 53/95 and manifested as a Dangerous Good before transport. Should any other material(s) suspected to contain asbestos, be uncovered during renovation activities, work must stop, and the material(s) tested to determine whether asbestos is present.

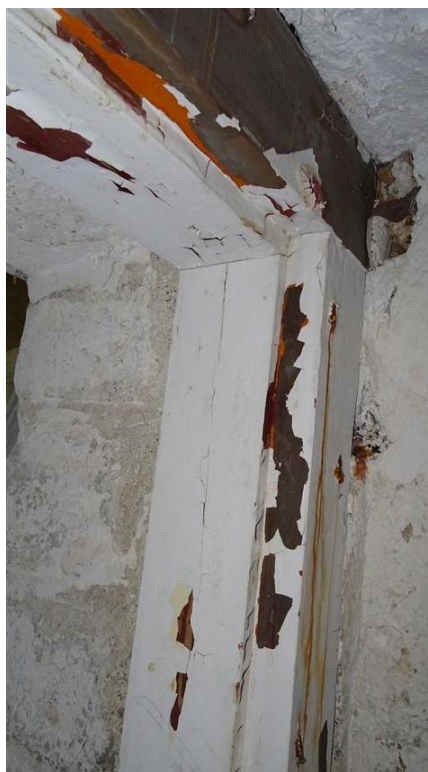
- PS-SIL-05 (72 mg/L): White paint over red, cream and brown paint on interior wood trim; and
- PS-SIL-06 (9.7 mg/L): Grey paint over yellow and brown paint on interior stairs.

PHOTO 2: Showing white paint over red, cream and brown paint on interior wood trim (PS-SIL-05).

Analysis of the samples confirmed that the paint chips and paint plus substrate samples listed above exceed the allowable leachate concentration of 5 mg/L. Out of province disposal at an approved facility capable of accepting lead leachate toxic wastes is required.

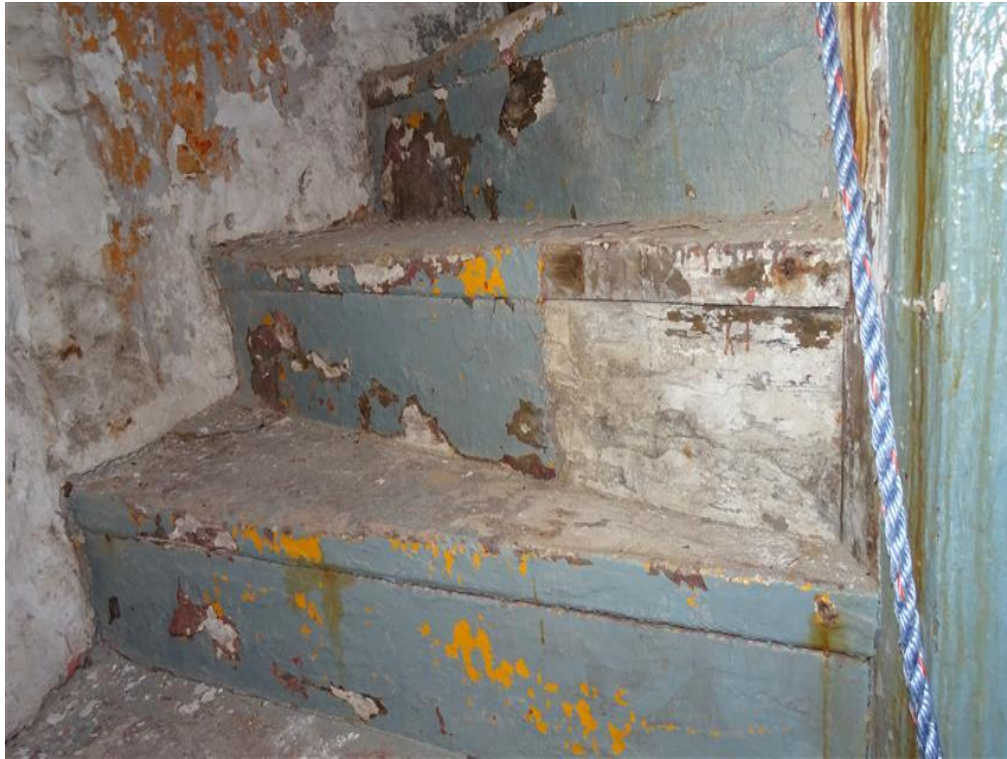
PHOTO 3: Showing grey paint over yellow and brown paint on interior wood stairs (PS-SIL-06).

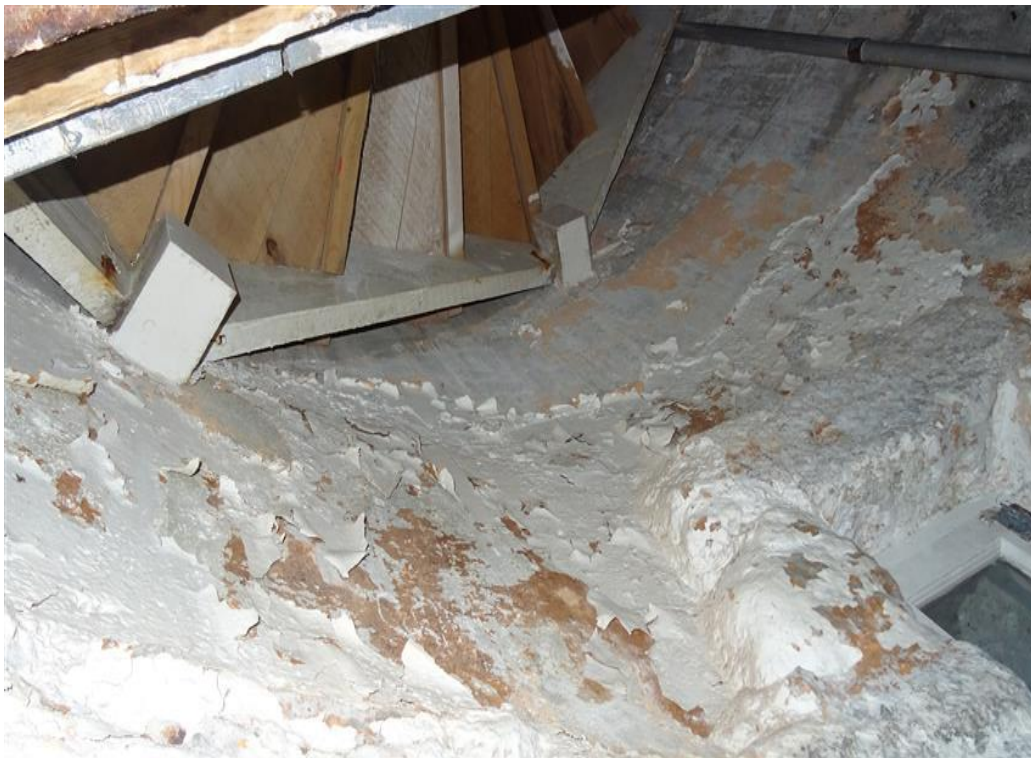
- PS-SIL-04 (260 mg/L): White paint on interior stone walls in lower 2/3 of lighthouse;
- PS-SIL-05 (61 mg/L): White paint over red, cream and brown paint on interior wood trim;
- PS-SIL-06 (49 mg/L): Grey paint over yellow and brown paint on interior stairs; and
- PS-SIL-07 (59 mg/L): White paint over cream paint on interior concrete walls on upper 1/3 of lighthouse.

PHOTO 4: Showing white paint on interior stone walls (PS-SIL-04).

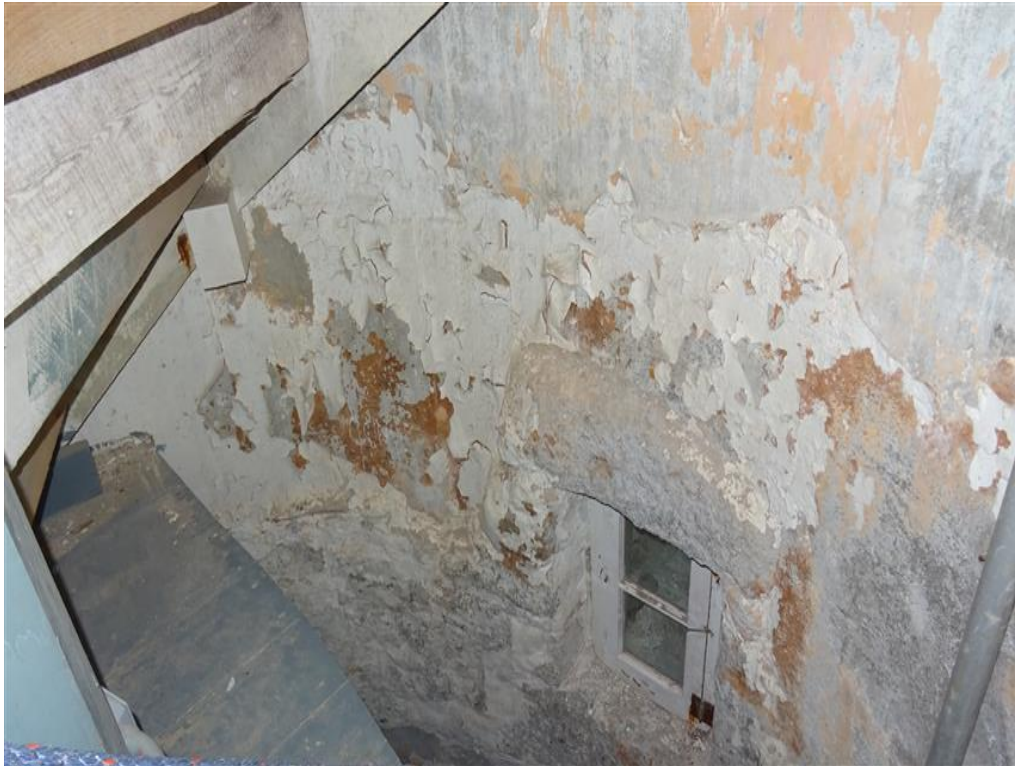
PHOTO 5: Example of white paint over cream paint on interior concrete walls (PS-SIL-07).
