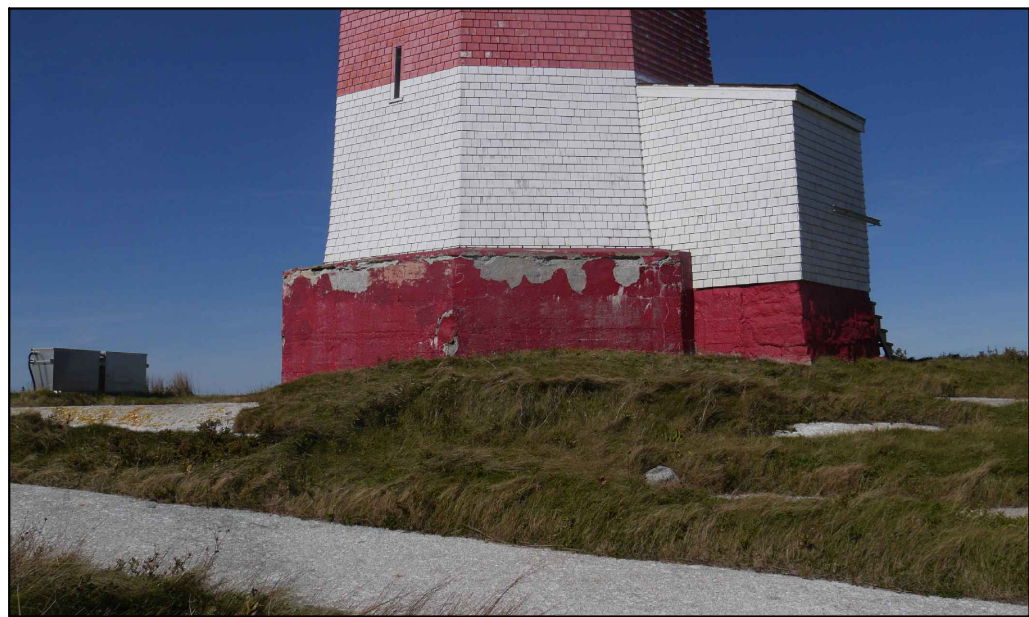
IMAGE 01 – CONCRETE BASE TO BE REBUILT, REFER TO STRUCTURAL

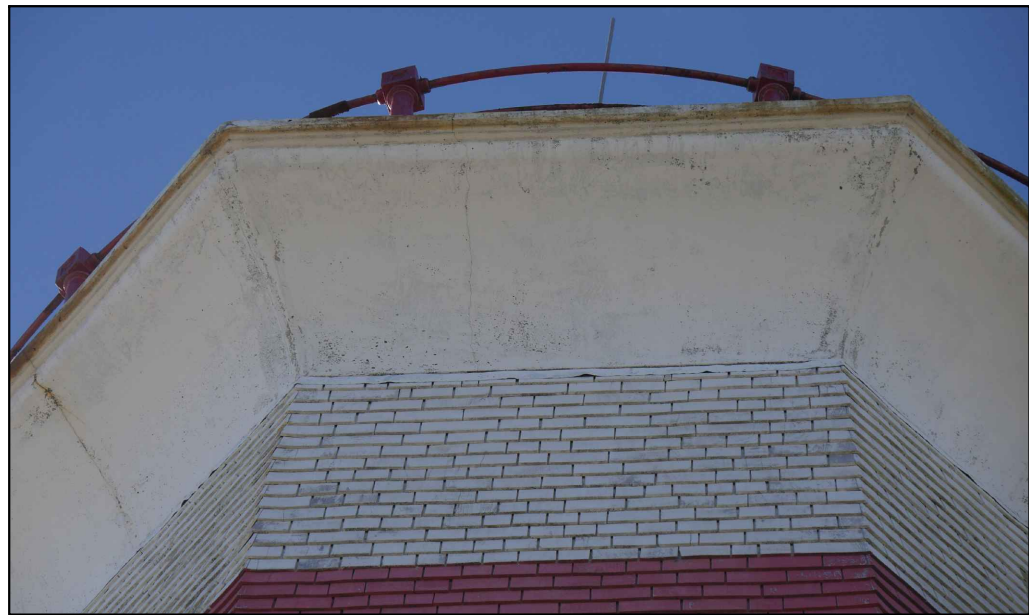
IMAGE 02 – TRANSITION AT TOP OF SHINGLES TO CONCRETE CAPITAL COLLAR

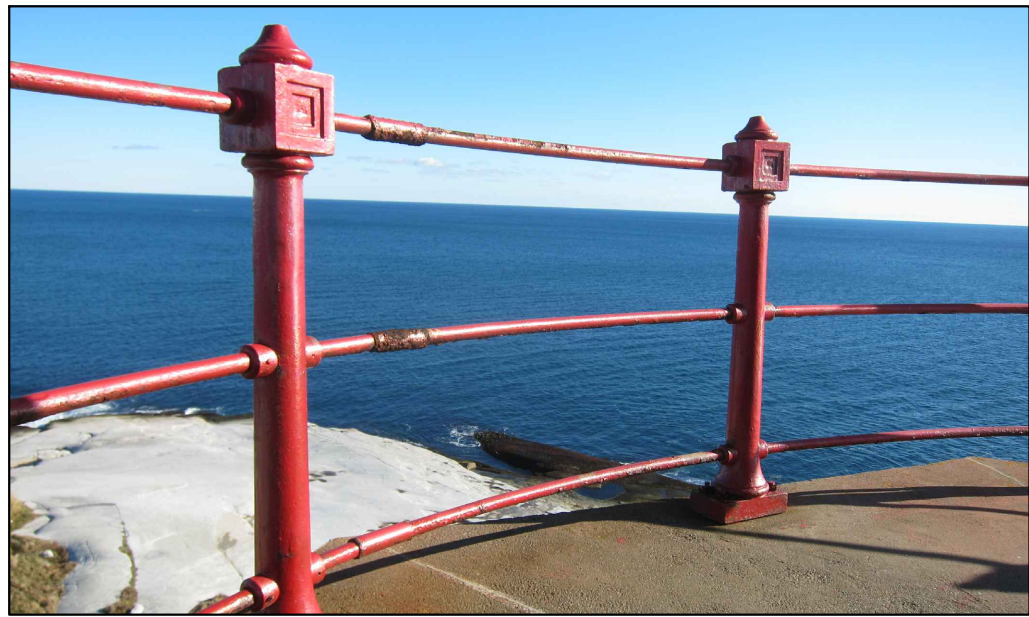
IMAGE 03 – GALLERY GUARDRAILS AND POSTS TO BE RESTORED

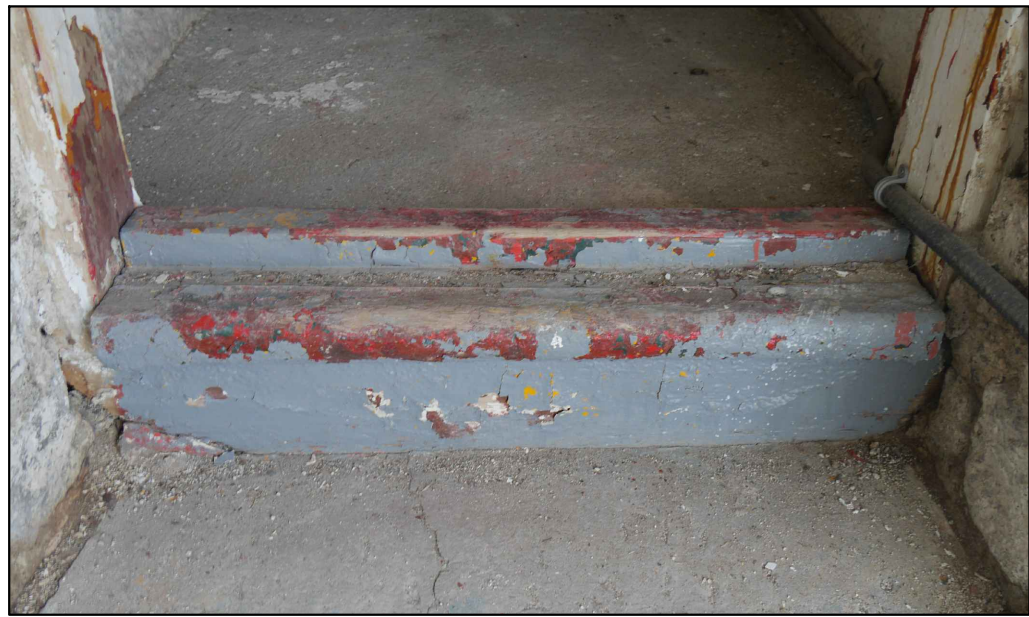
IMAGE 04 – INTERIOR STEPS AT ENTRY LEVEL TO BE RE-NAILED AND PAINTED

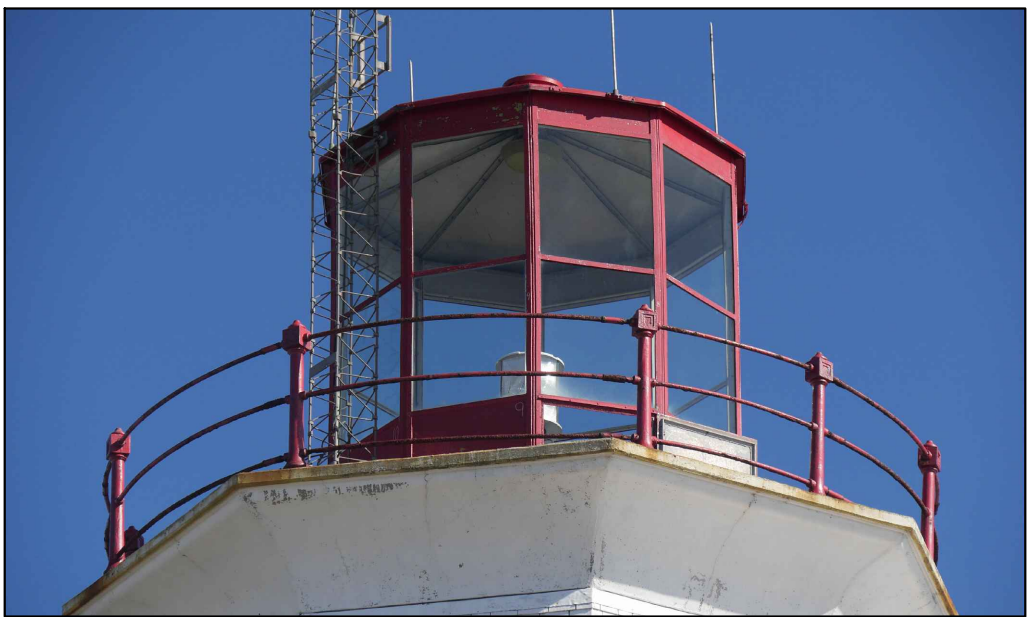
IMAGE 05 – LANTERN AND GALLERY GUARDRAIL TO BE RESTORED

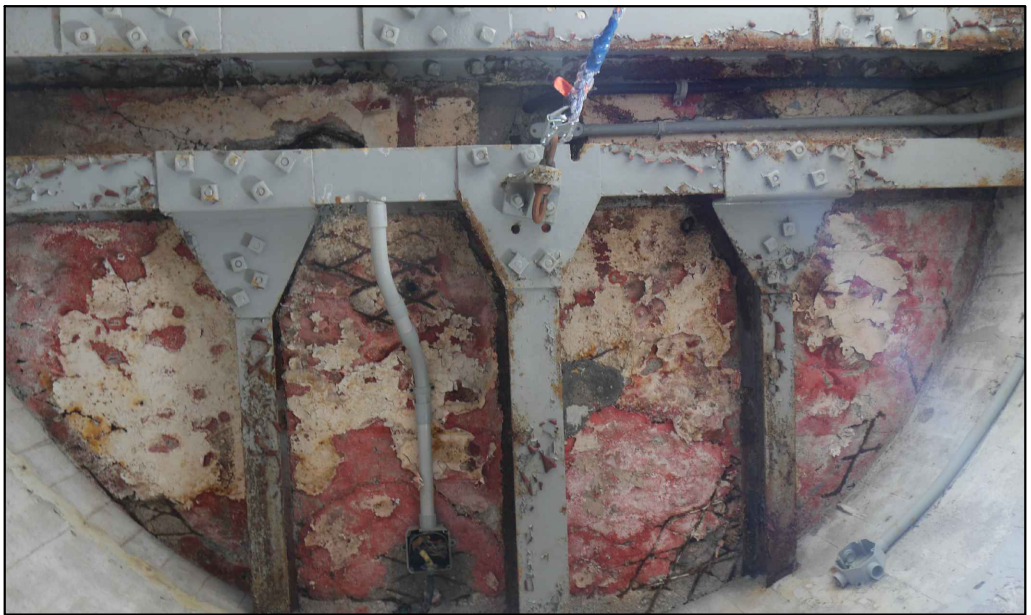
IMAGE 06 – UNDERSIDE OF GALLERY LEVEL FLOOR FRAMING, TO BE PREPARED, PRIMED AND PAINTED

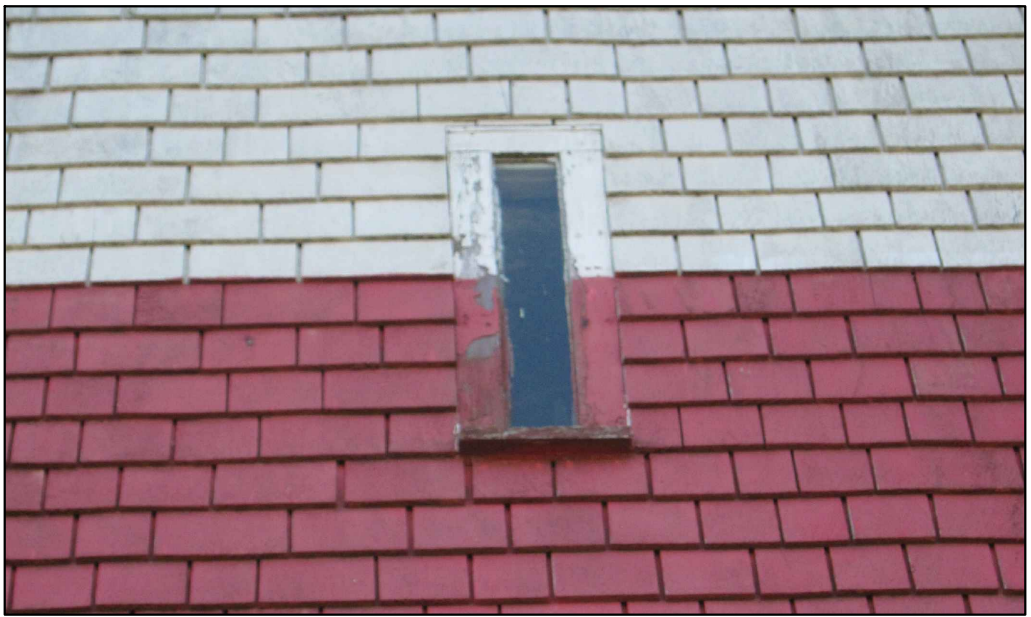
IMAGE 07 – TYPICAL WINDOW TO BE REPLACED

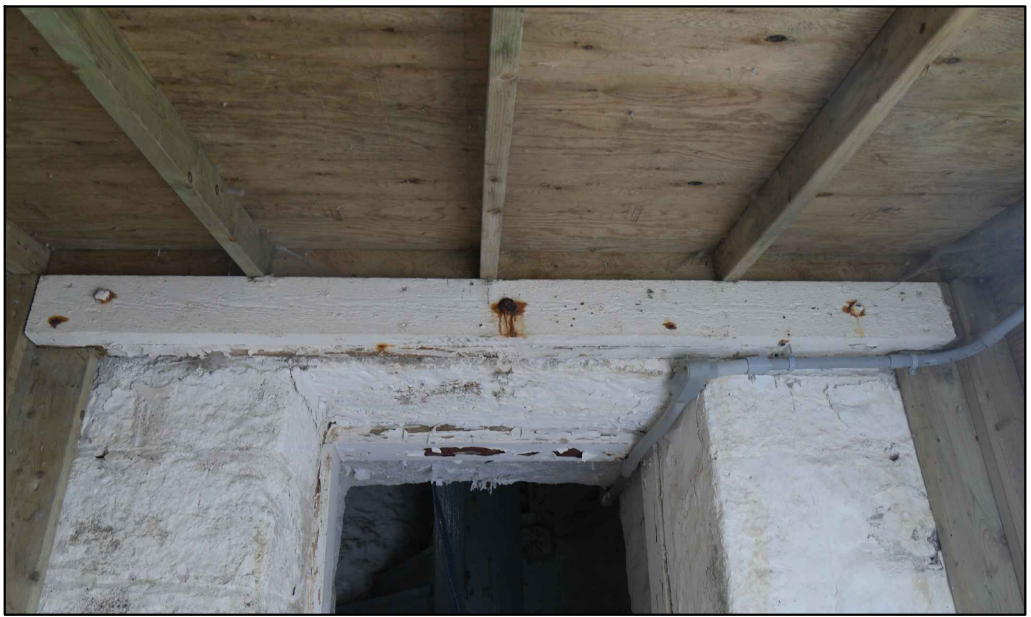
IMAGE 08 – INTERIOR MASONRY WALL AND WOOD LINTEL TO BE PAINTED
