PWGSC
Atlantic Region
Renovations to AAFC Lab
Bldg 25, SJRDC, St. John's, NL
Project No. R.078141.001

**PUBLIC WORKS AND GOVERNMENT SERVICES CANADA
AGRICULTURE AND AGRI-FOODS CANADA BUILDING 25
ATLANTIC COOL CROP CLIMATE RESEARCH FACILITY
MOUNT PEARL, NEWFOUNDLAND AND LABRADOR**

ASBESTOS MANAGEMENT PLAN

FINAL REPORT

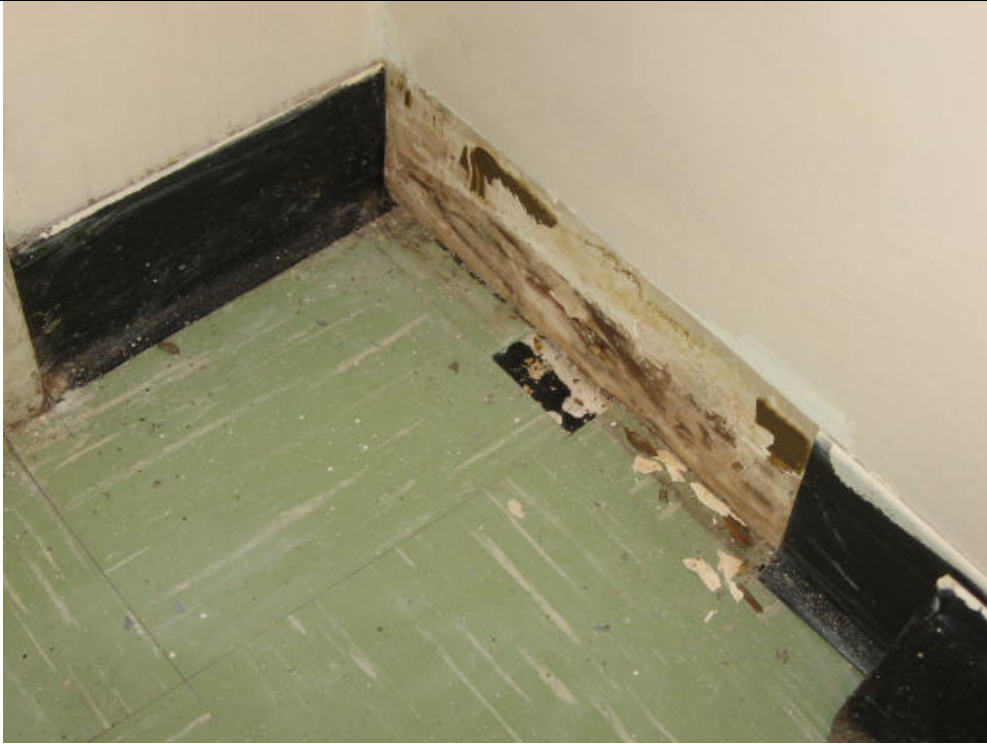
Photograph 1: Asbestos containing material (ACM), 23 x 23 cm, vinyl floor tile, Room No. SB-7 (Sample No. ACM 2). Note that eight other colours of ACM floor tile are also present in the building (no photos provided).

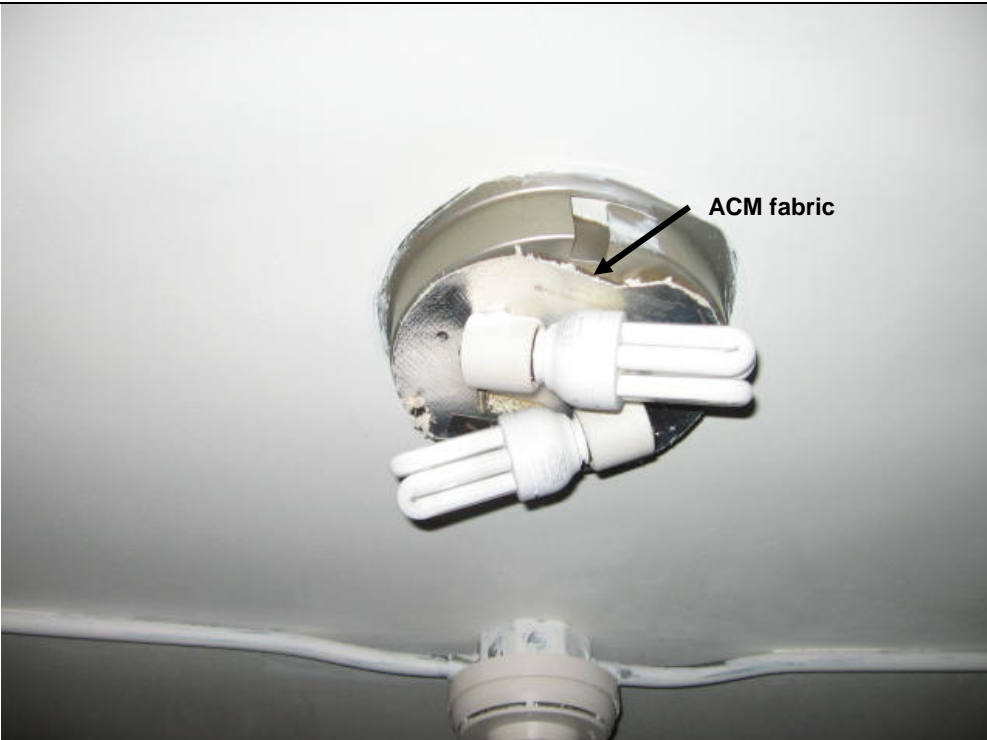
Photograph 2: ACM fabric on ceiling light fixture, Room No. SB-7. (Sample No. ACM 13)

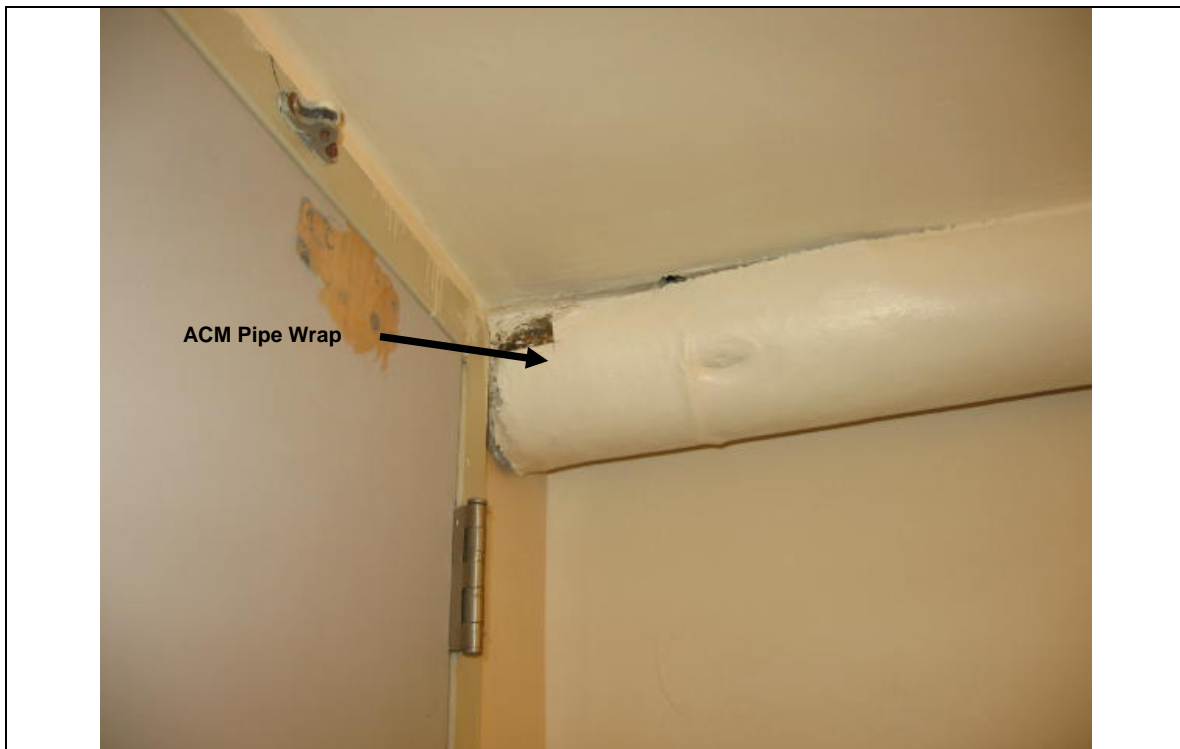
- Insulating pipe wrap on 300 mm diameter, steam header piping (white fibrous material) in Room No SB-1 (boiler room) was found to be 20 % amosite asbestos. Based on analytical results and visual observations, 40 linear metres of this pipe wrap was noted to be present in the boiler room (see Photo 6, Appendix 6); and
- Insulating pipe wrap (corrugated paper type) on water drain in sub-basement hall (10 % chrysotile asbestos). Based on analytical results and visual observations, 15 linear metres of this pipe wrap was noted to be located in the sub-basement halls room (see Photo 3).

Photograph 3: ACM pipe wrap insulation, corrugated paper-type, Room No. SB-7. (Sample No. ACM 14)

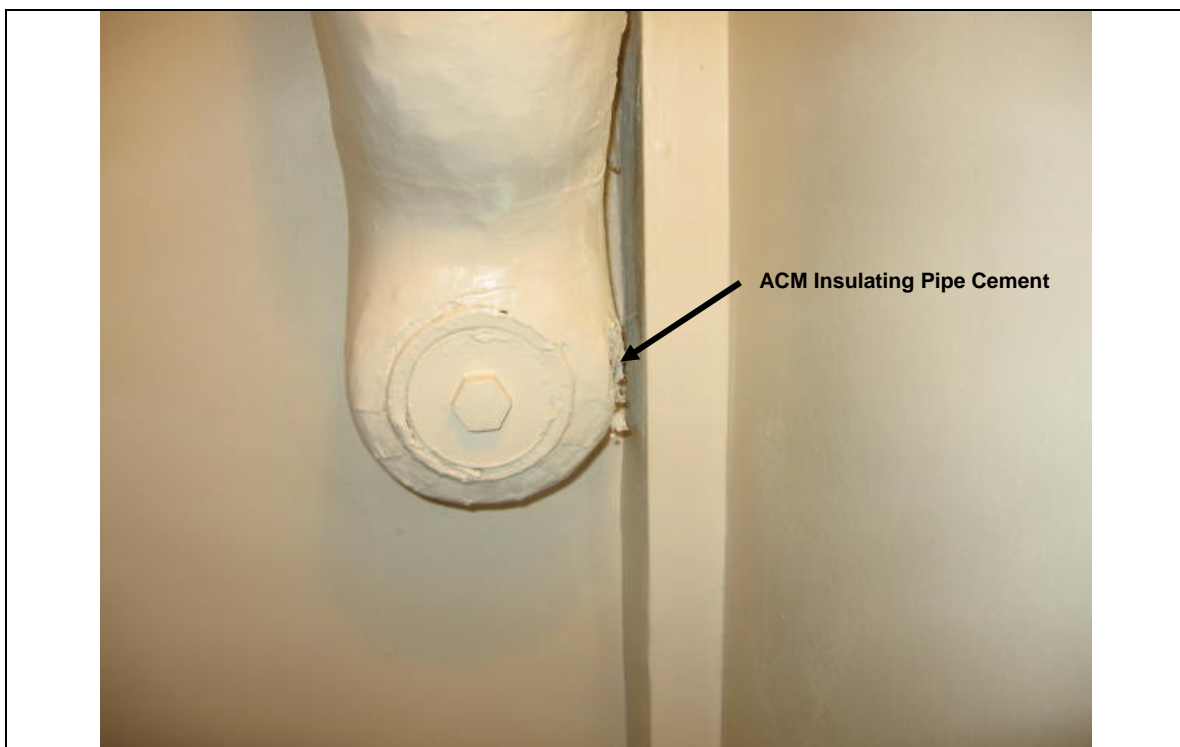
Insulating pipe cement was observed on pipe fittings throughout the Building. AMEC collected seven samples of this material as part of the ACM Survey. Six of seven samples of insulating cement located on pipe elbows, joints and pipe wrap ends were found to typically contain approximately 75 % chrysotile asbestos (see Photos 4, 5, 8, 9, 11 & 17).

Photograph 4: ACM insulating pipe cement, Room No. SB-7. (Sample No. ACM 15)

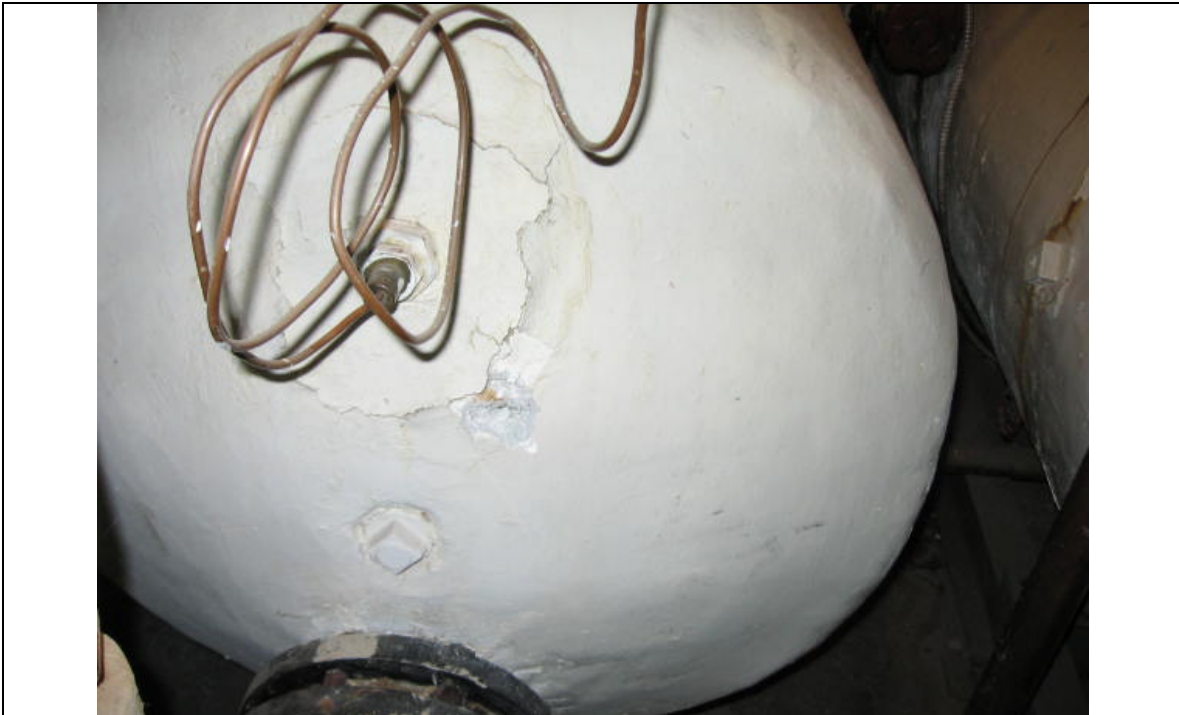
Photograph 7: ACM hot water tank insulation (2 tanks), Room No. B-2 (Sample No. ACM 22).

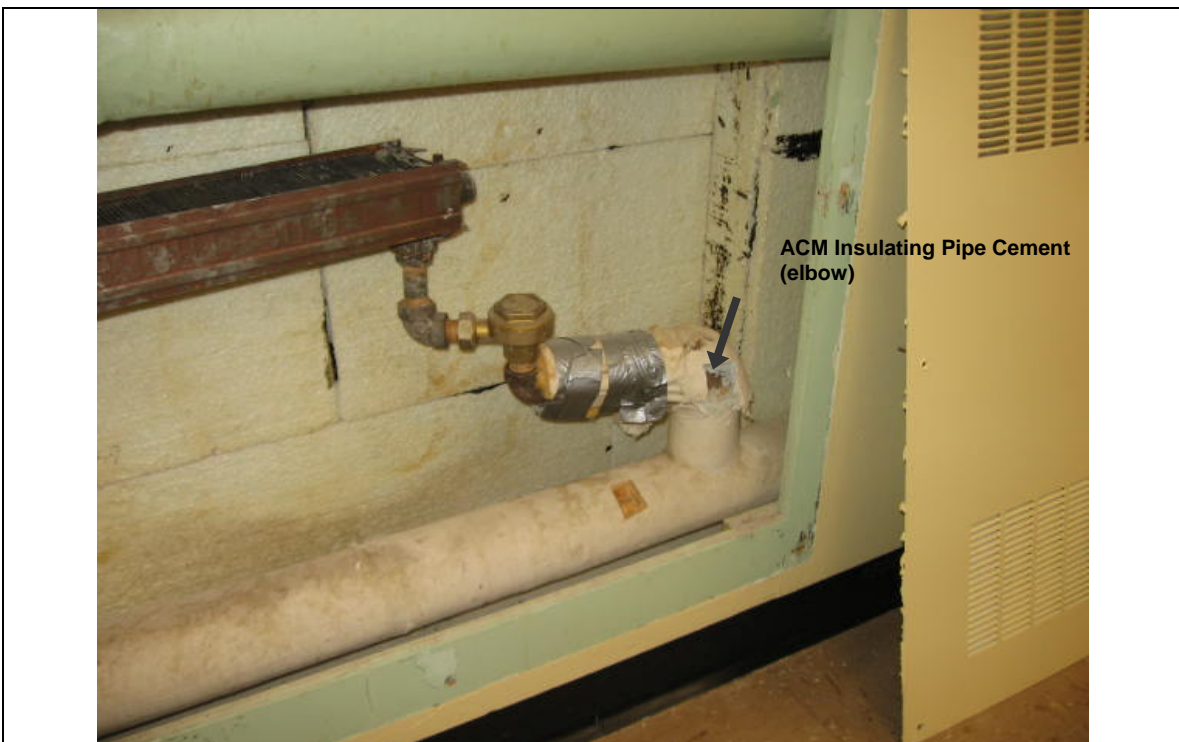
Photograph 8: ACM insulating pipe cement (elbow), located behind metal heater cover in Room No. 1-4. (Sample No. ACM 25).

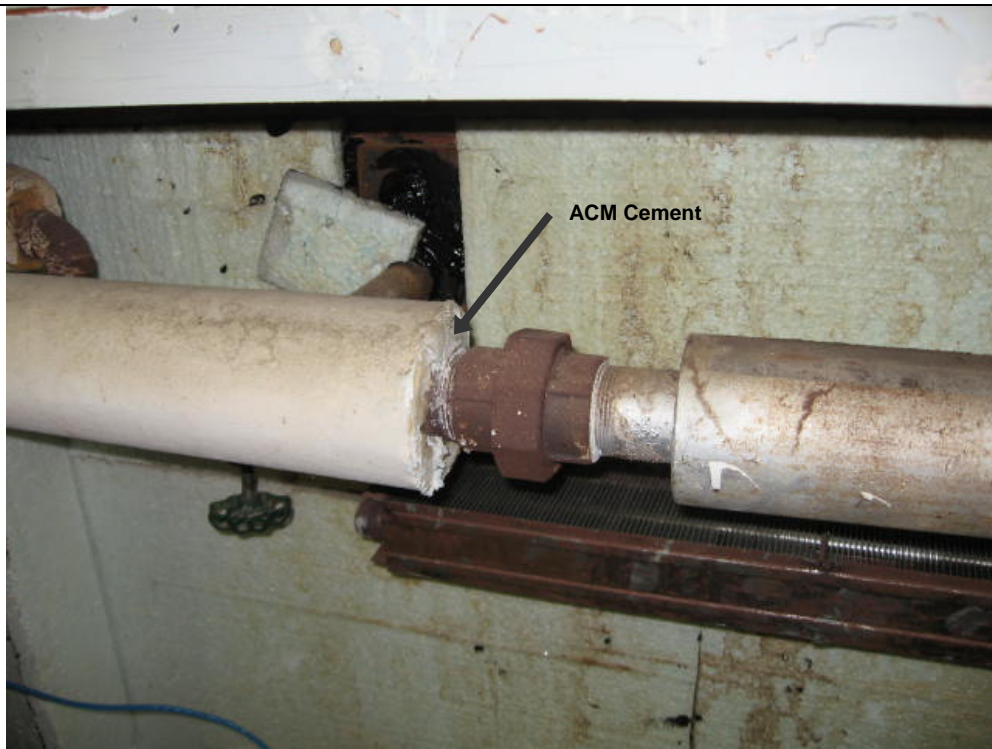
Photograph 9: ACM cement on end of fiberglass pipe wrap in Room No. 1-10 (Sample No. ACM 30).

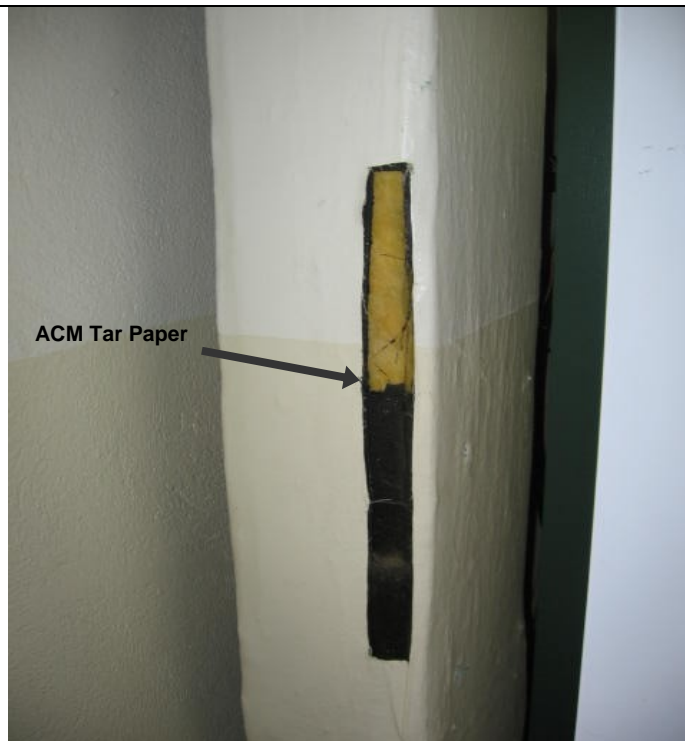
Photograph 10: ACM tar paper on duct (two) located in Room No. B-25. (Sample No. ACM 37)

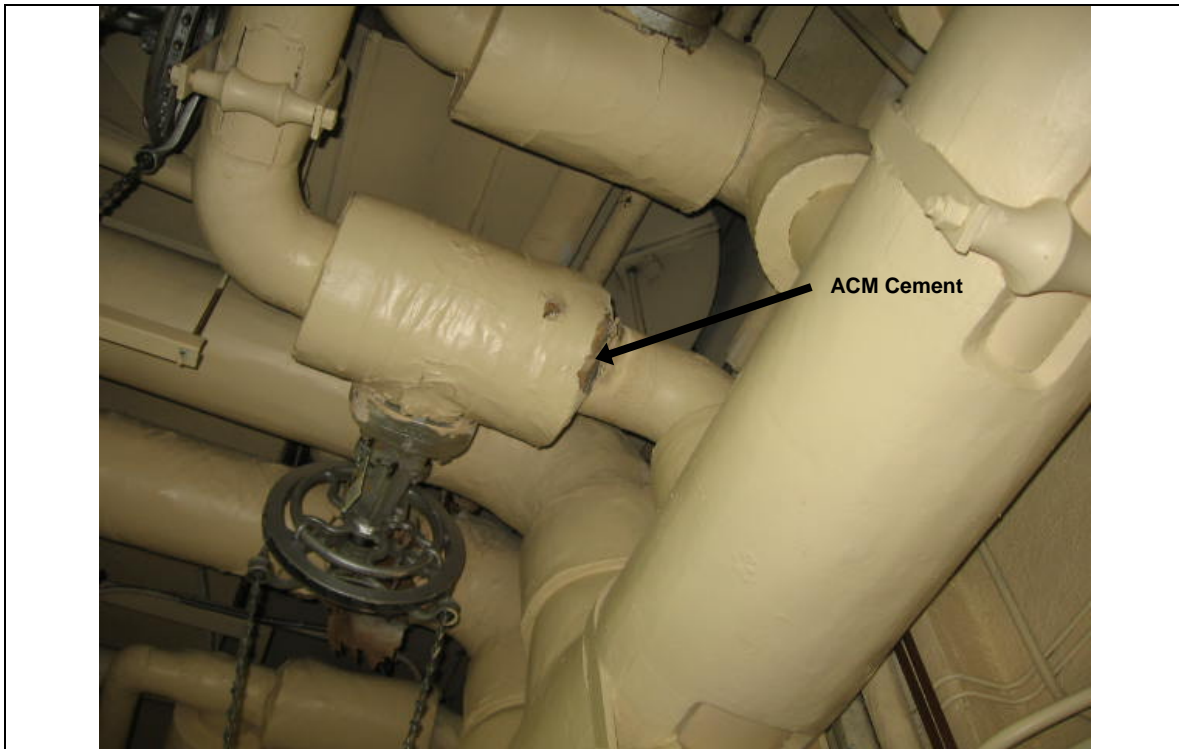
Photograph 11: ACM cement on end of fiberglass-insulated pipe valve. Room No. SB-1 (Sample No. ACM 38)

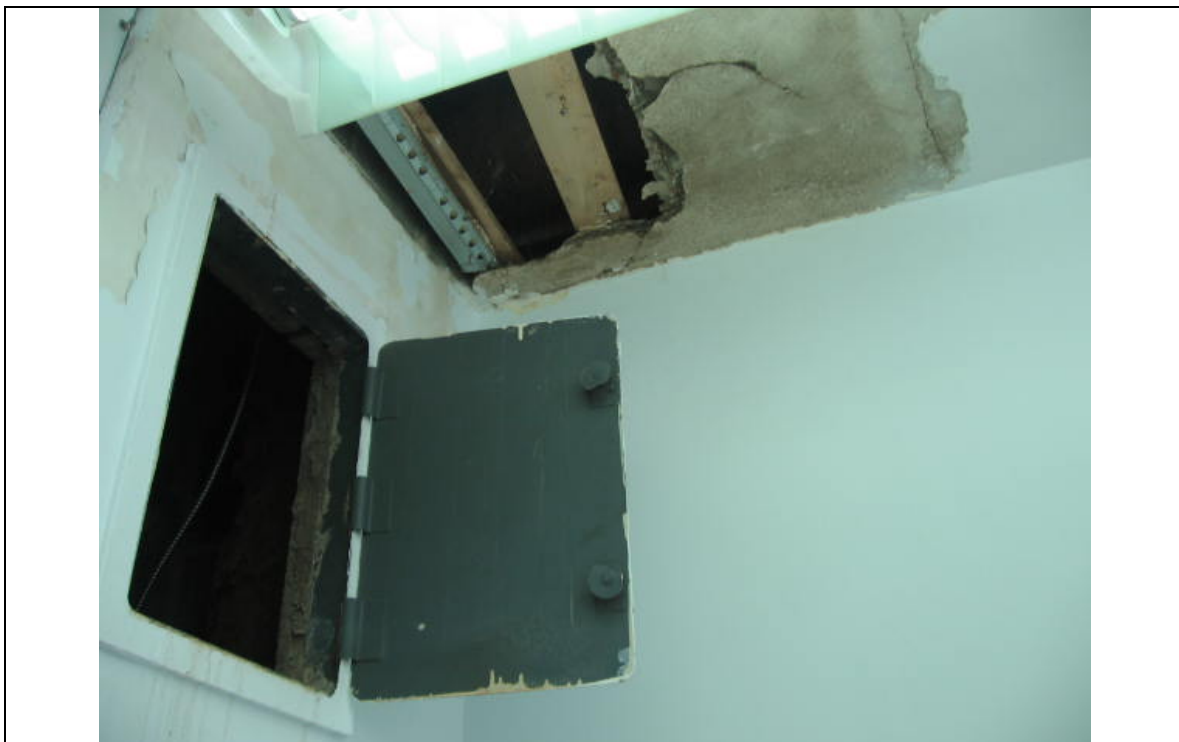
Photograph 12: Damaged ACM plaster ceiling, Room No. 1-16.

| Type of Damaged/Deteriorated ACM | Location | Recommendation |
|--|--|---|
| Deteriorated plaster ceiling. | Room No. 1-16 - From door entrance, left hand top corner area. | Temporarily cover areas with 6 mil polyethylene or plywood type material until area can be properly cleaned and stabilized by a professional abatement contractor or trained and qualified personnel within AAFC. |

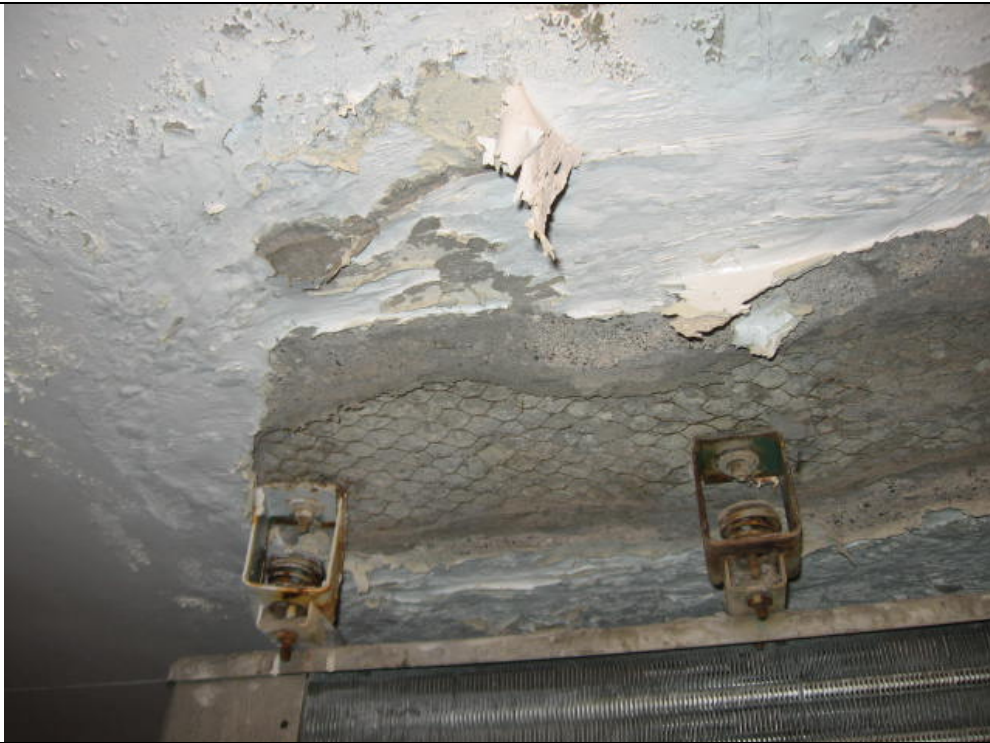
Photograph 15: Damaged plaster ceiling in Room No. B-21 (Freezer Room). (Sample No. ACM 47). Note that although analysis of this material showed no asbestos was detected, material should be treated as asbestos based on positive results of similar samples and non-homogeneous nature of material.

| Type of Damaged/Deteriorated ACM | Location | Recommendation |
|--|--|---|
| Deteriorated plaster ceiling. | Room No. B-21 (freezer room) - From door entrance, directly ahead. | Temporarily cover areas with 6 mil polyethylene or plywood type material until area can be properly cleaned and stabilized by a professional abatement contractor or trained and qualified personnel within AAFC. Note that although analysis of ceiling plaster in this room showed no asbestos was detected, this material should be treated as asbestos based on positive results of similar samples and non-homogeneous nature of material. |

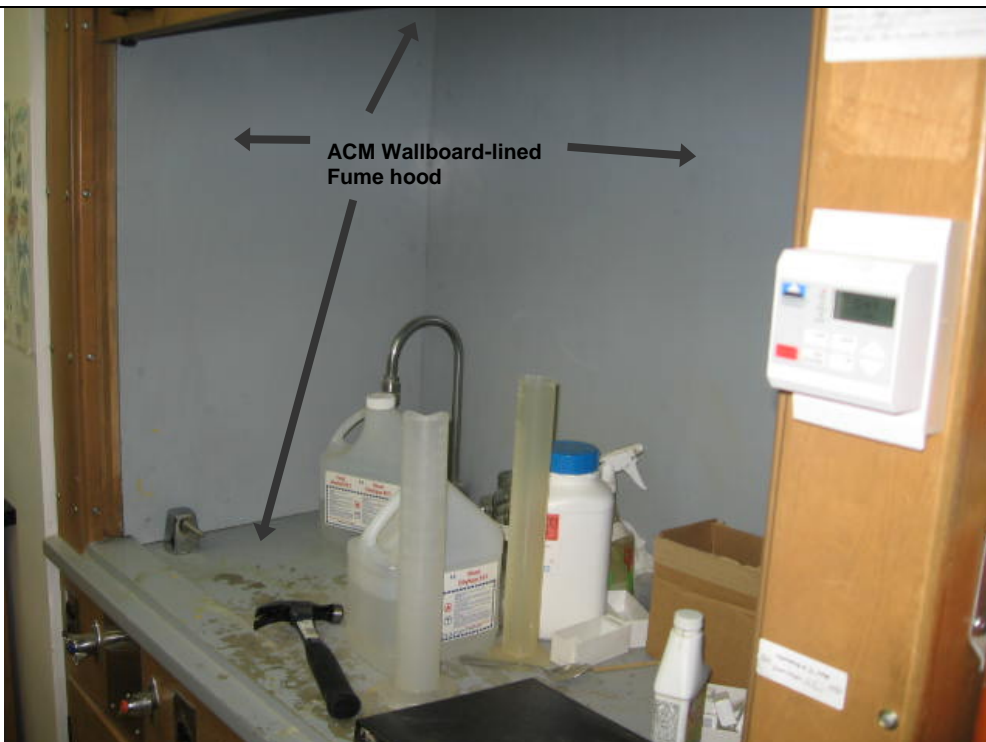
Photograph 16: ACM wallboard-lined fume hood in Room No. 1-17. (Sample No. ACM 48). Note it was reported that there are two other fume hoods containing this wallboard material, however they are covered with stainless steel sheeting.

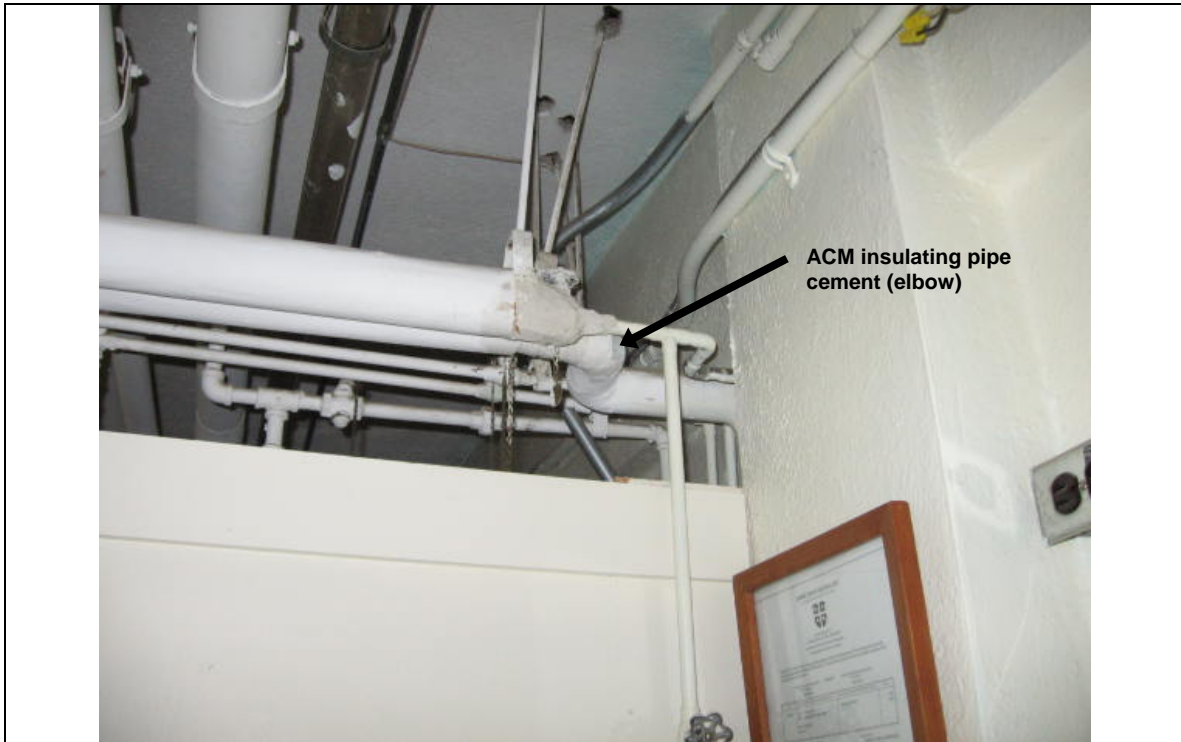
Photograph 17: ACM insulating pipe cement (elbow). Room No. B-25 (sample No. ACM 49)

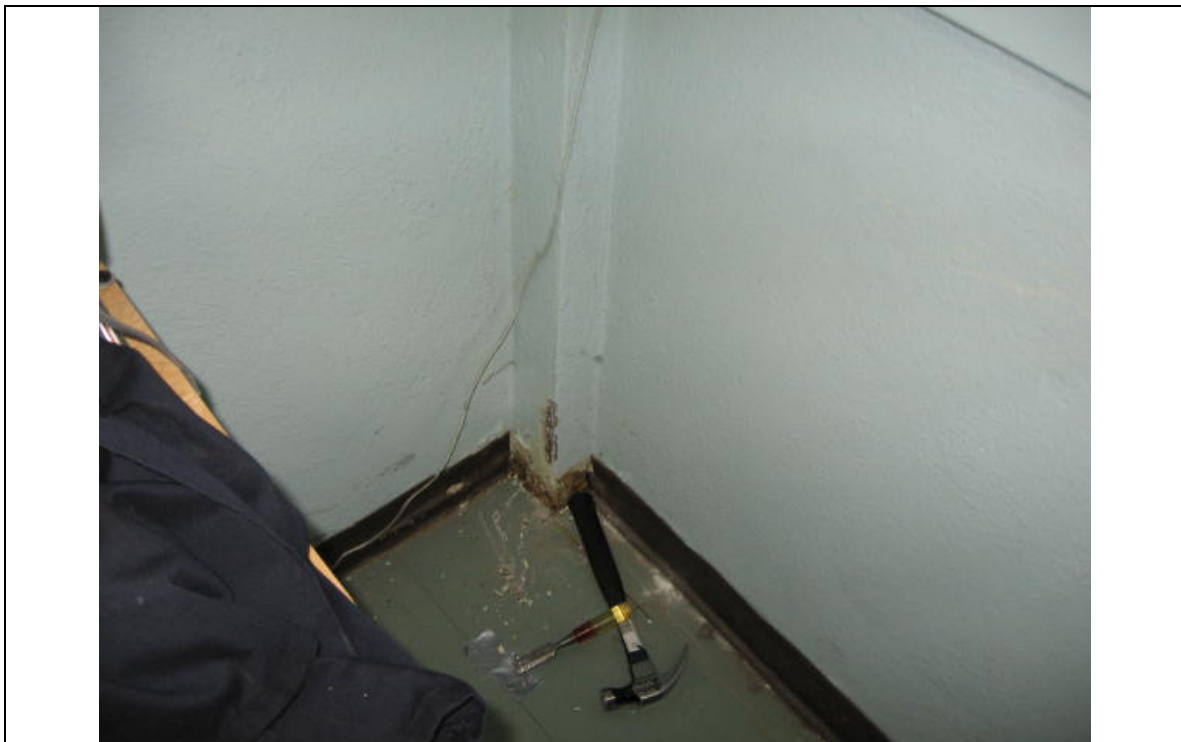
Photograph 18: ACM wall plaster, Room No. SB-1A (Sample No. ACM 50).

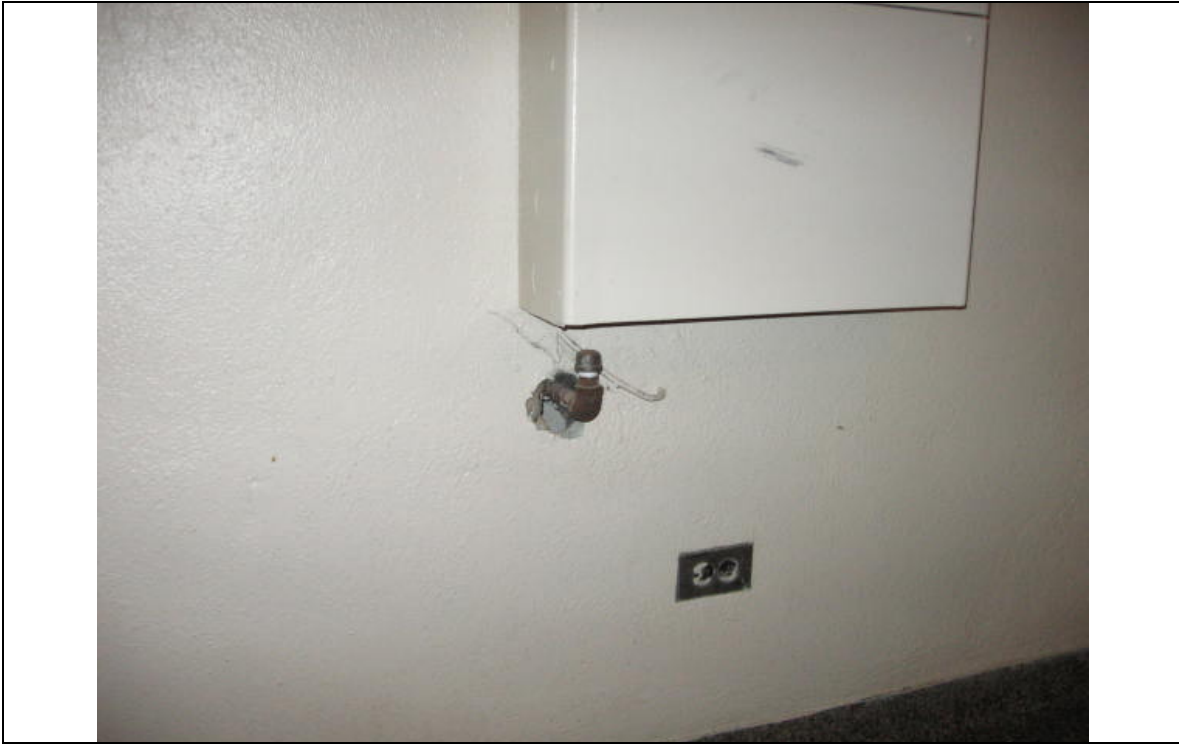
Photograph 19: ACM wall plaster, end of B-level hall (Sample No. ACM 51)
