Devis de substances désignées par les ingénieurs-conseils DST
Différents rapports de substances désignées

Site Offices

September 23, 2015

DST File No.: BE-OT-010540

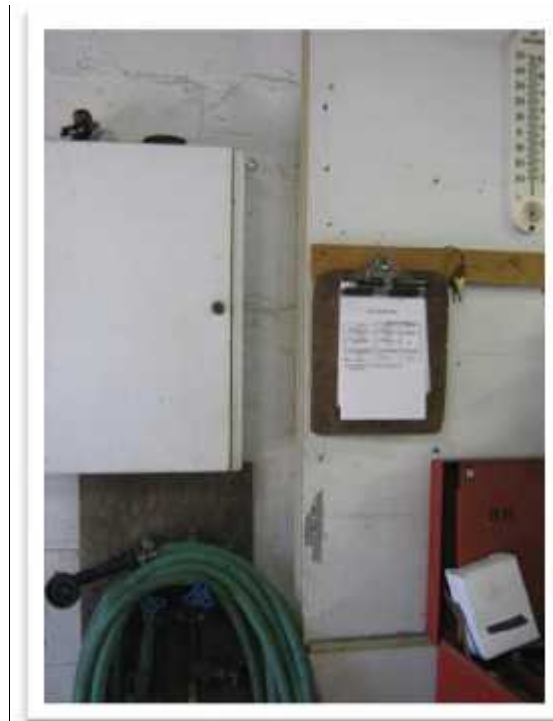
Photo 2: Drywall joint compound (Samples 243867-02A-C) sampled in the Garage does not contain asbestos.

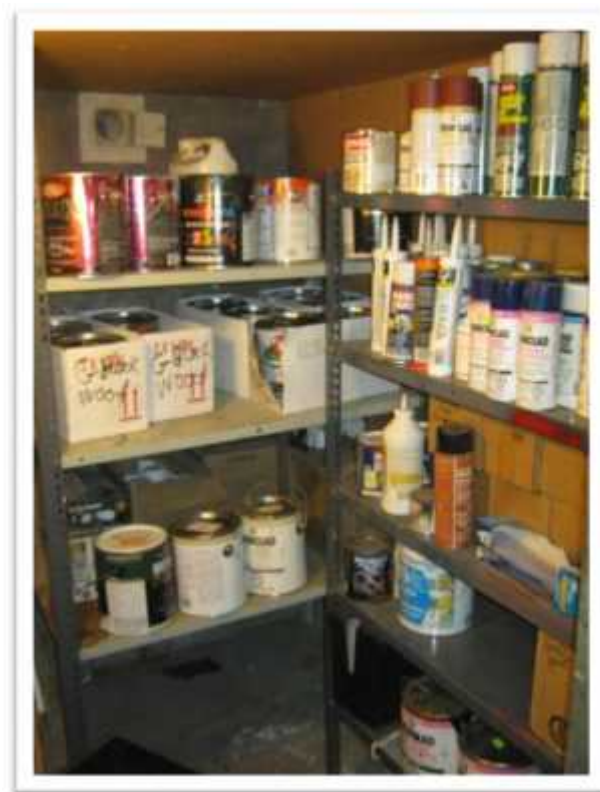
Paints, aerosols, oils, etc. were observed in the Garage and basement storage area chemical locker. These products are assumed to be used for maintenance activities.

Photo 4: Paints, aerosols, oils, etc. stored in the basement storage area chemical locker.

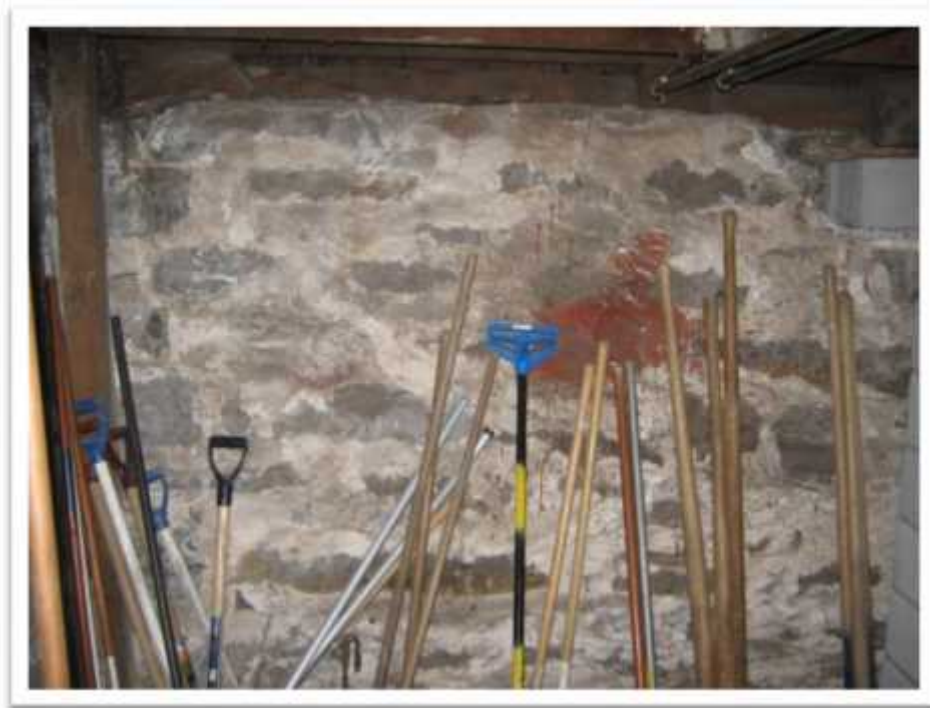
Photo 5: Stonework surface parging material (Samples 243867-03A-E) sampled does not contain asbestos.

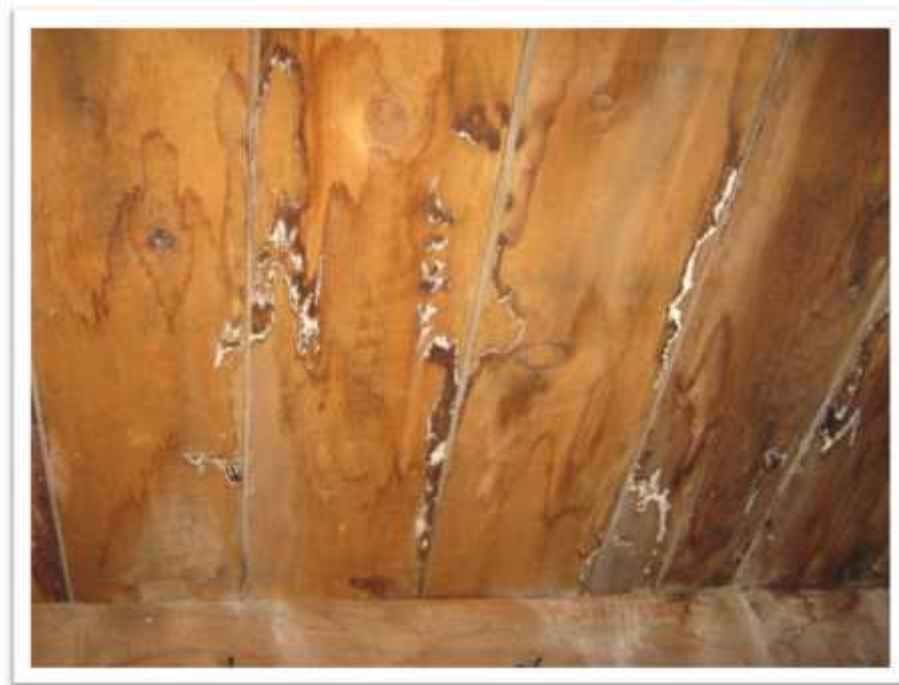
One (1) tape-lift sample (Sample 243867-TL-01) from the white-stained, wooden surface of the underside of the ground floor was collected in the Basement. Laboratory results showed low levels of hyaline mycelia fragments. The presence of these fragments indicates that mould is impacting this building material. There is approximately 10 square metre of obvious mould impacted wooden floorboard.

Photo 6: Mould impacted underside of wooden floorboards (Sample 243867-TL-01) was observed in the basement storage room. Affected area is approximately 10 square metres total.

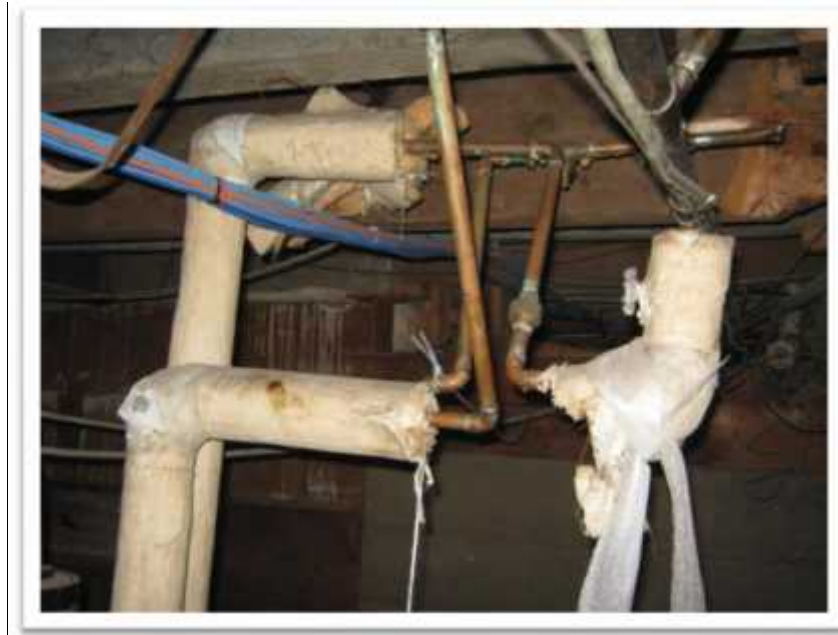
Friable asbestos-containing grey cement compound (DST Sample 243867-04A, JWEL Sample SA-04) was noted on pipe fittings in the basement storage/mechanical room. The material is exposed and considered to be in POOR condition. There are approximately 4 fittings. This material is accessible to maintenance staff.

Friable grey cement compound insulation (DST Sample 243867-04A, JWEL Sample SA-04) contains 90% Chrysotile asbestos and was identified on pipe fittings in the basement storage/mechanical room. The material is exposed and considered to be in POOR condition. There are approximately 4 fittings. This material is accessible to maintenance staff.

Photo 7: Grey cement compound on pipe fittings in the basement mechanical/storage room contains 90% chrysotile asbestos (Sample 243867-04-A). There are 4 fittings exposed and in POOR condition.

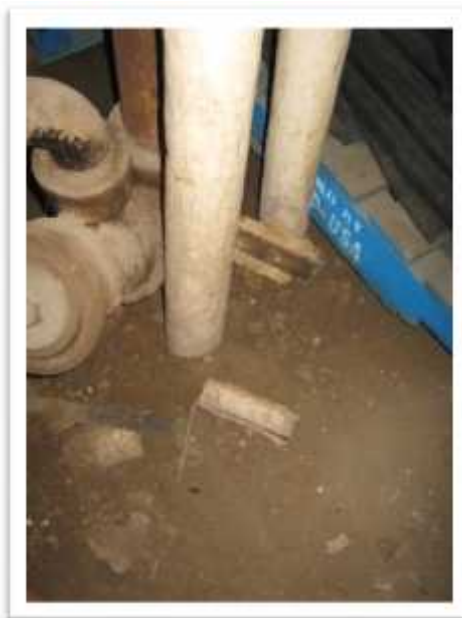
Friable asbestos-containing layered cardboard wrap insulation (Sample 243867-05A, JWEL Sample SA-05) was noted on pipes in the basement storage/mechanical room. Some debris associated with this material was also noted on the ground in this area. There is approximately 3 linear metres of layered cardboard wrap insulation on pipe runs which is in GOOD condition. The exposed debris is considered to be in POOR condition. There is less than one square metre of insulation debris.

Photo 8: Layered cardboard wrap insulation (Sample 243867-05A) noted on pipes the basement storage/mechanical room contains 20% Chrysotile asbestos in the tar paper layer. Some debris (POOR condition) associated with this material was also noted on the ground in this area.

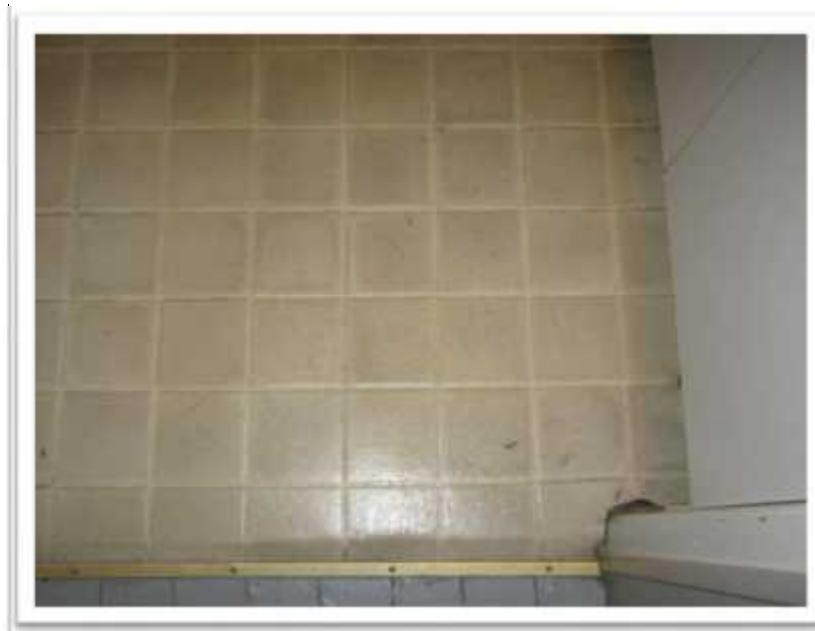
Photo 9: Light brown coloured vinyl sheet flooring (Samples 243867 06A-C) sampled does not contain asbestos (ground floor shower room pictured here).

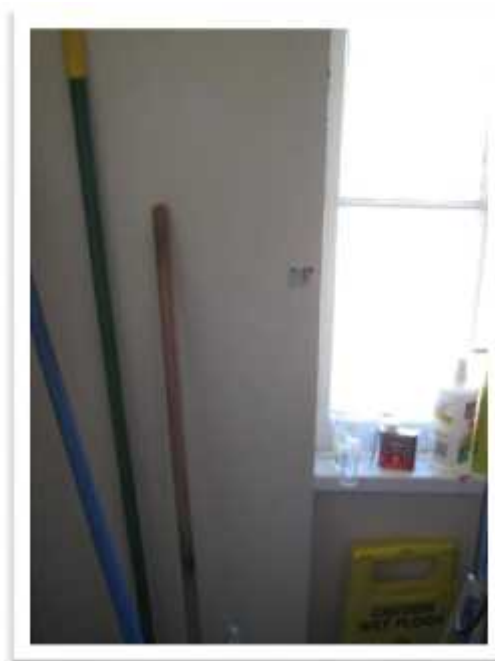
Photo 10: Drywall joint compound (Samples 243867-07A-E) sampled throughout the ground floor does not contain asbestos (ground floor shower room pictured here).

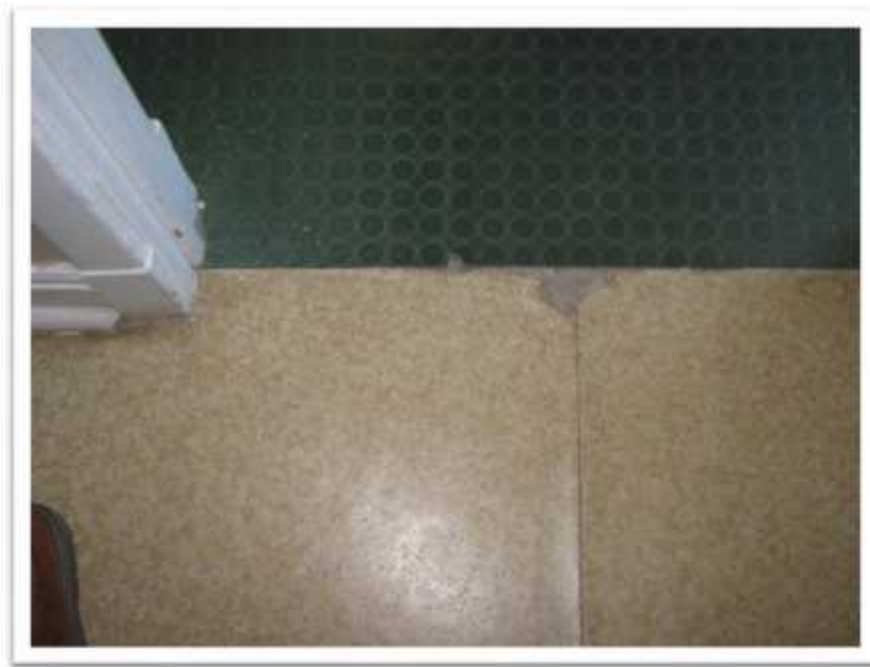
Photo 11: Brown vinyl sheet flooring sampled in the ground floor rear office does not contain asbestos (Samples 243867-08A-C).

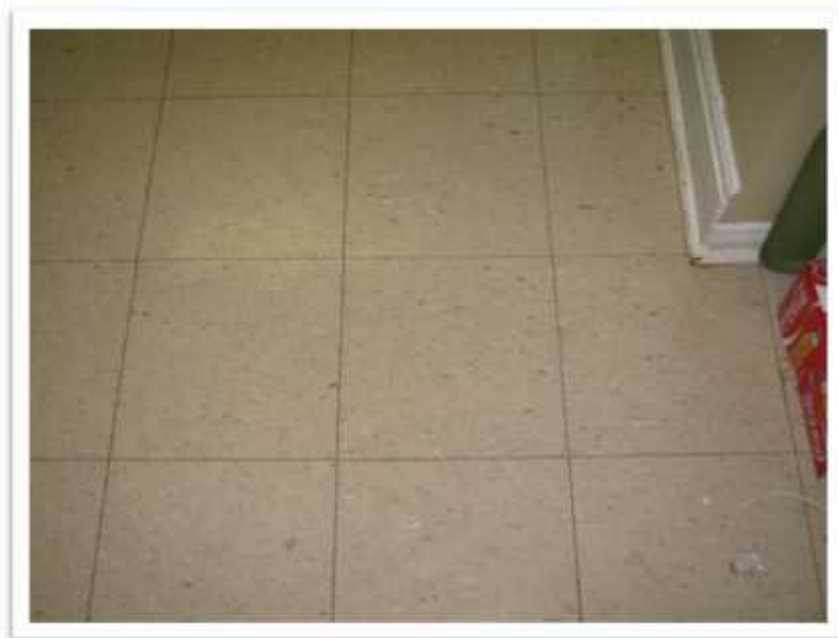
Photo 12: Brown 12" x 12" vinyl tile flooring sampled in the ground floor rear common area does not contain asbestos (Samples 243867-09A-C).

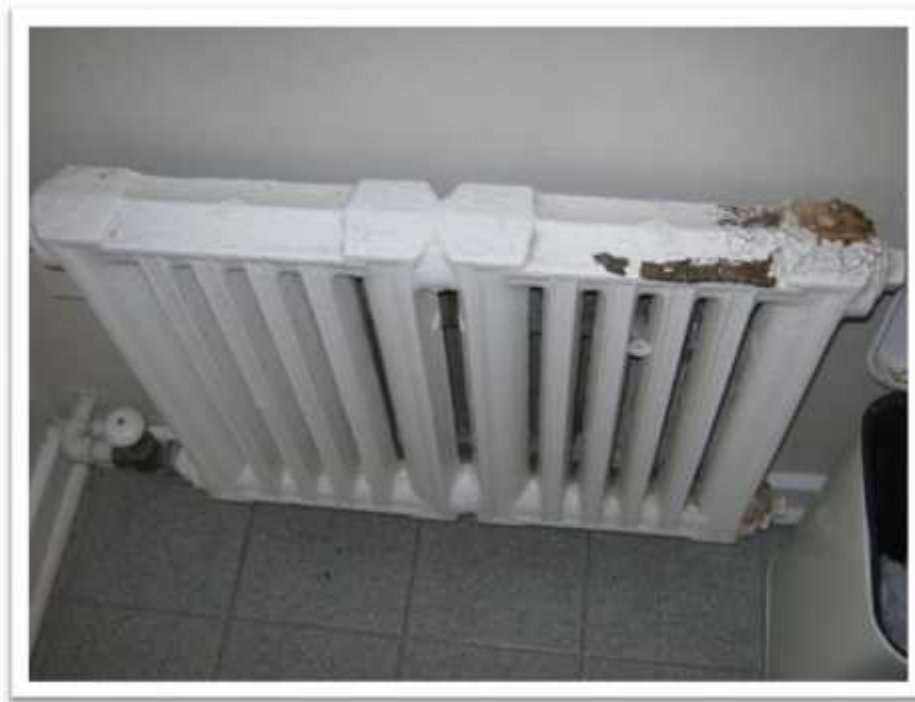
Photo 13: White radiator paint (Sample 243867-LP-01) contains 19,800 ppm lead.

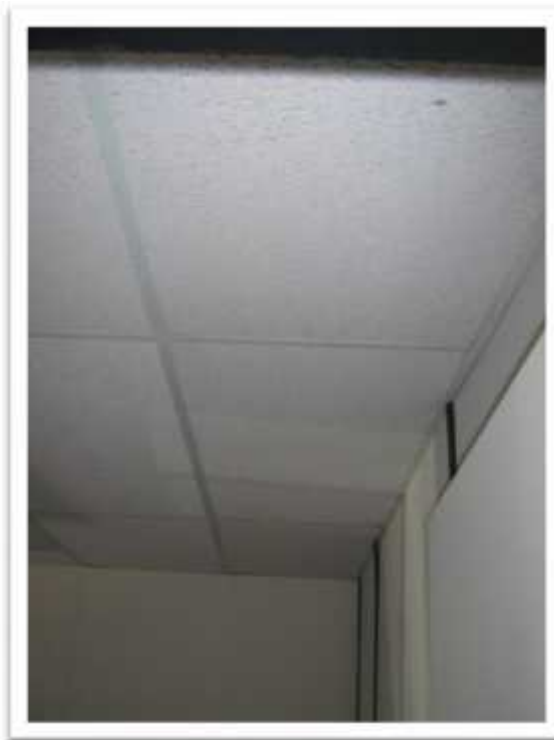
Photo 14: 2' x 4' lay-in ceiling tile sampled in the ground floor front offices does not contain asbestos (Samples 243867-10A-C).

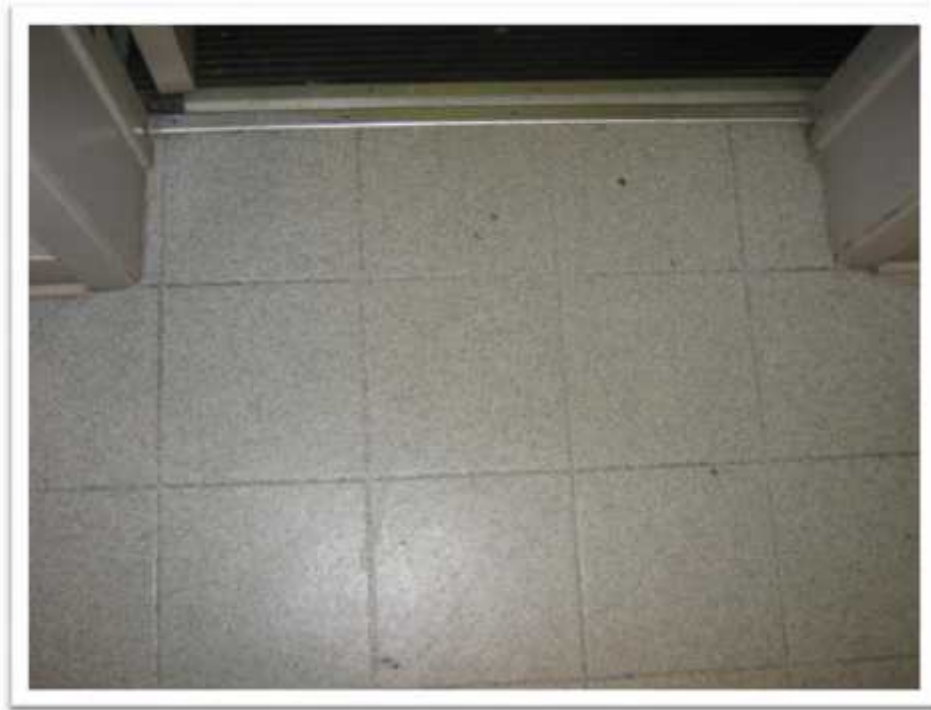
Photo 15: Grey/blue vinyl sheet flooring sampled throughout the ground floor does not contain asbestos (Samples 243867-11A-C).

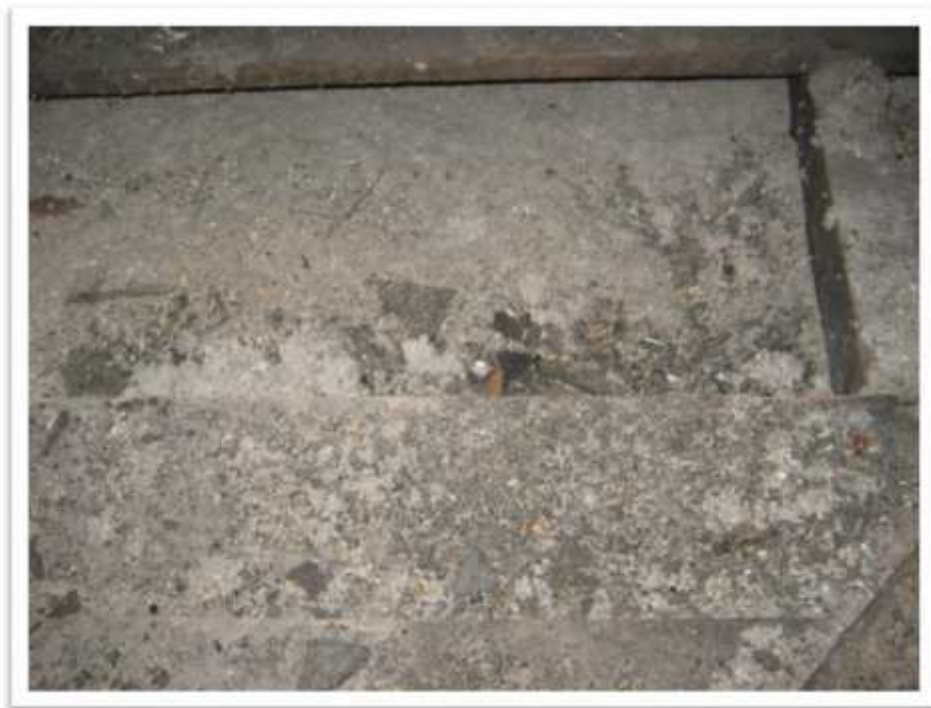
Photo 16: Roof shingle debris sampled in the attic does not contain asbestos (Samples 243867-12A-C).

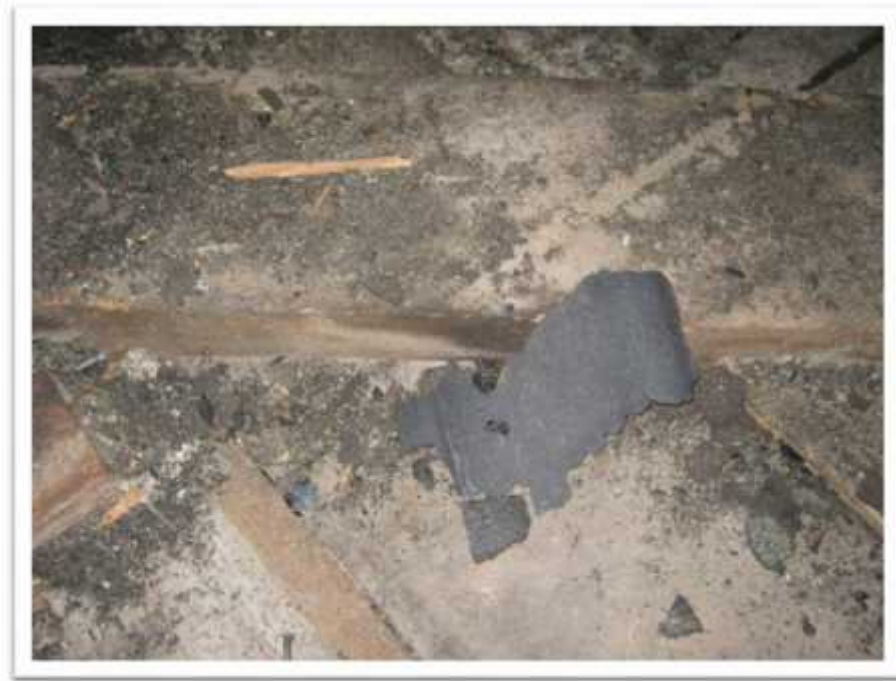
Non-friable asbestos-containing tar paper debris (Sample 243867-13A) was noted on the ground in the Attic. The material is exposed and considered to be in POOR condition. There is less than one square metre of debris. It is unsure if this material is remnants from roofing retrofit or if it remains concealed as part of the roof structure.

Photo 17: Tar paper debris in the attic (Sample 243867-13A) contains 1% chrysotile asbestos.

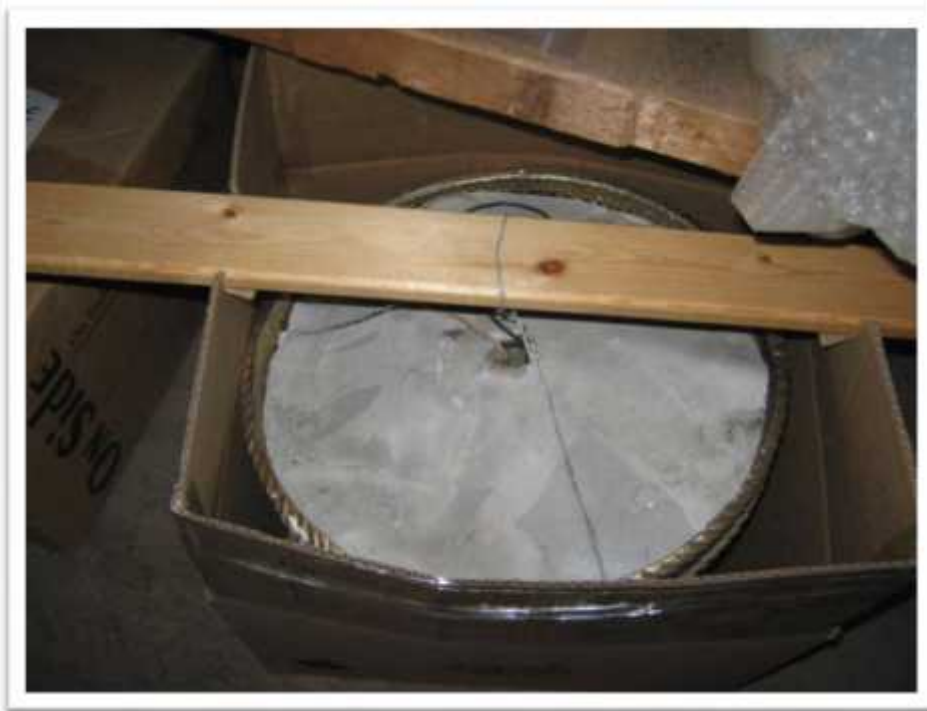
Friable suspect asbestos-containing light heat shields associated with light fixtures being stored in the attic were noted during the survey. This material was in good condition at the time of the survey and was thus not sampled in order to avoid damaging the material prior to potential future use. This material is accessible to maintenance staff.

Photo 18: Light heat shields on light fixtures stored in the attic are suspected to contain asbestos.

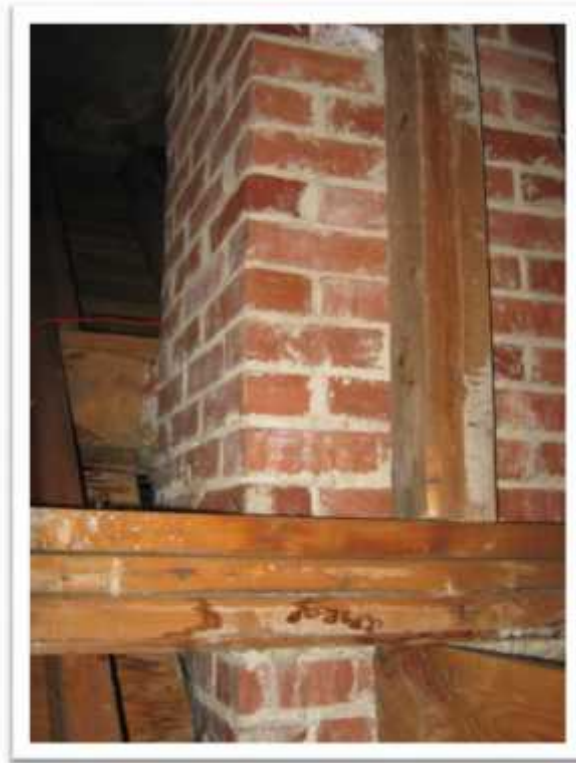
Photo 19: Chimney brick mortar sampled does not contain asbestos (Samples 243867-14A-C).

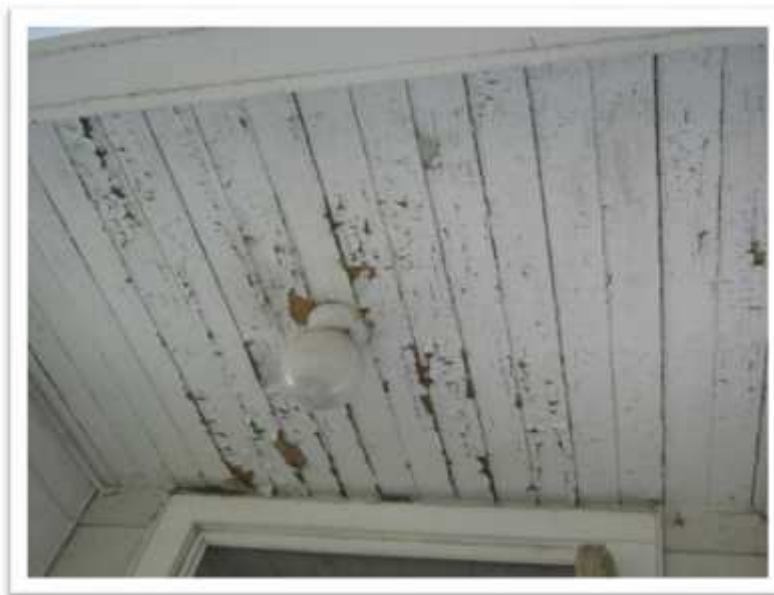
Photo 20: Exterior white porch paint at front entrance contains 200,000 ppm lead (Sample 243867-LP-02).

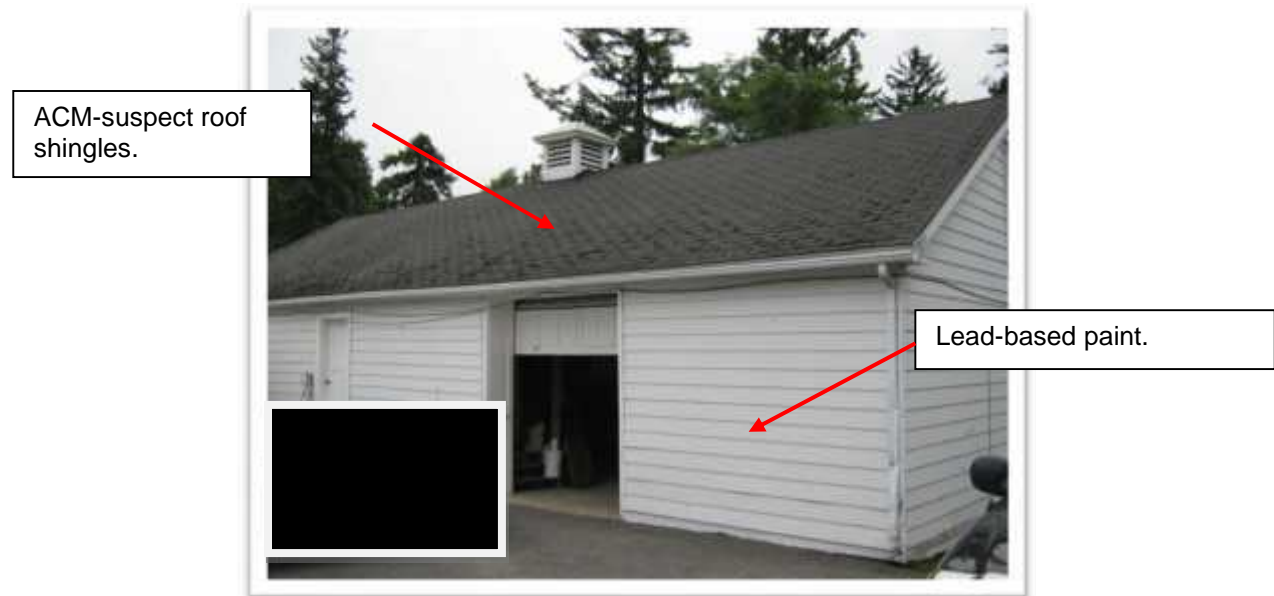
Photo 1: Exterior view of the Storage Shed. The exterior white paint has been tested and confirmed to be lead-based. The asphaltic roofing materials are ACM-suspect.

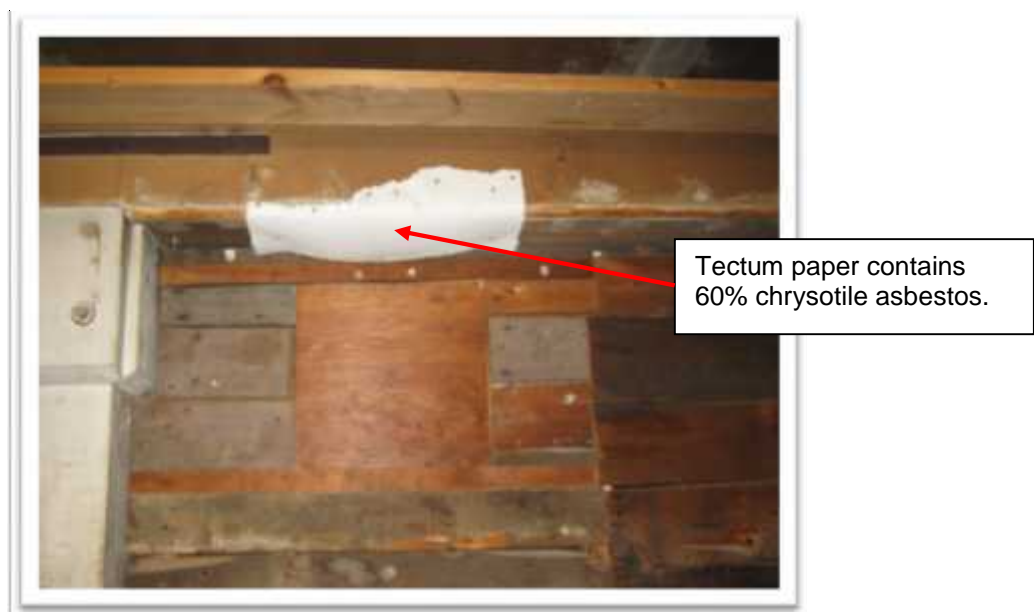
Photo 2: Tectum paper remnants have been tested and confirmed to contain 60% chrysotile asbestos. Type 2 removal is recommended for regulatory compliance.

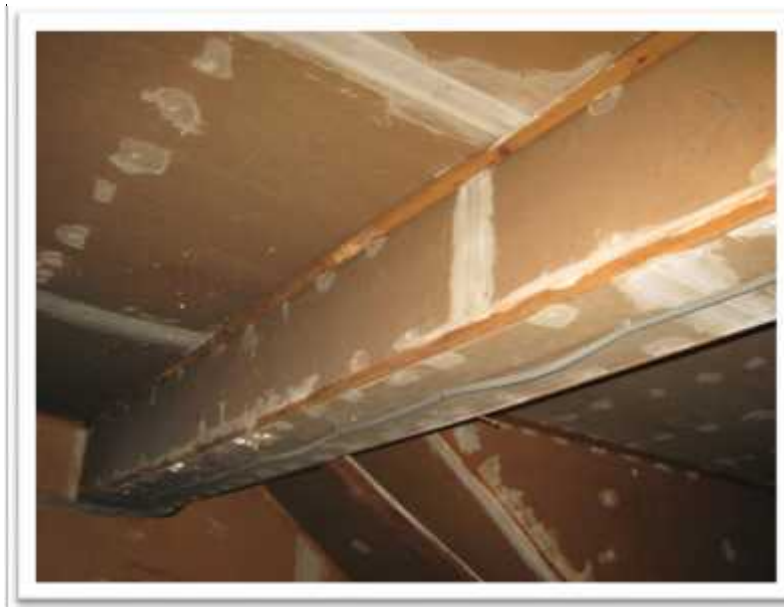
Photo 3: Drywall joint compound has been tested and does not contain regulated concentrations of asbestos.

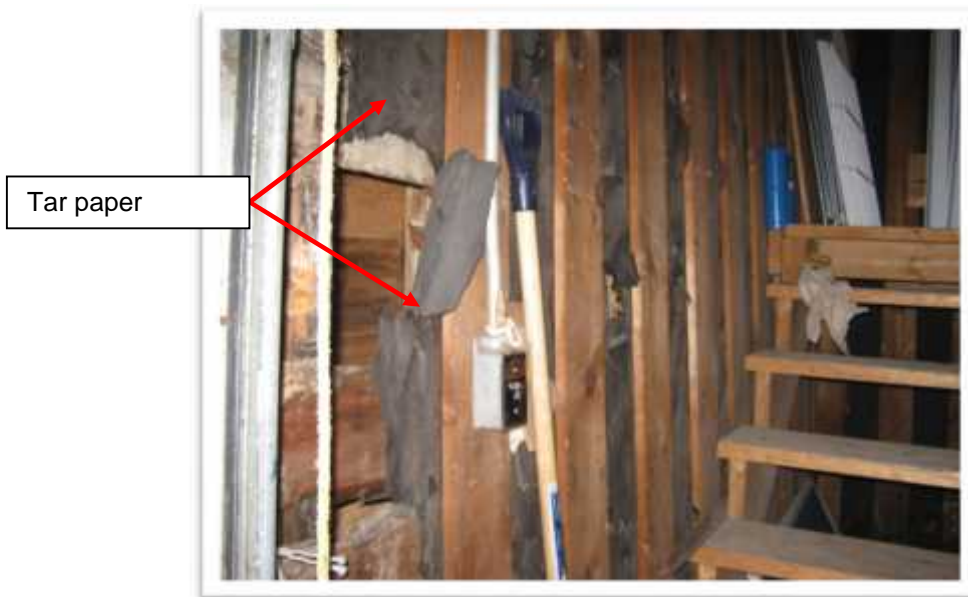
Photo 4: Tar paper has been tested and does not contain asbestos.

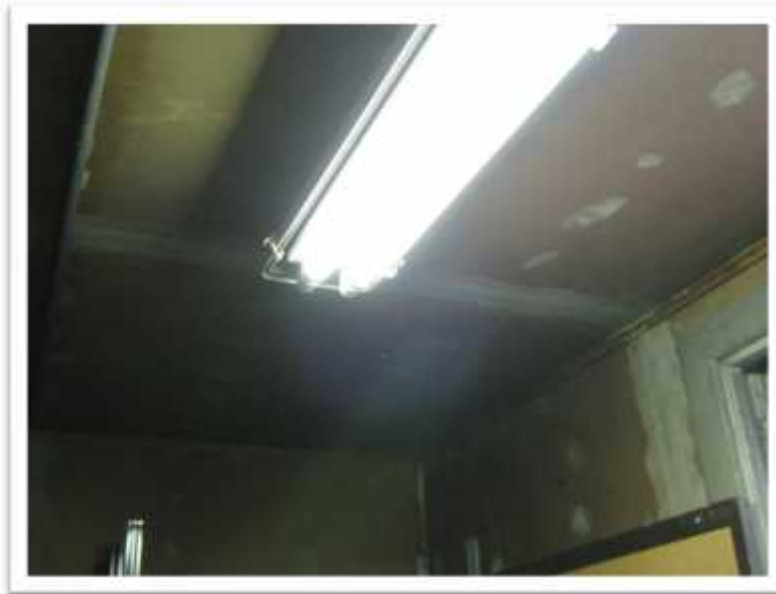
Photo 5: Typical fluorescent light fixture. Each light tube will contain a single droplet of mercury. The ballasts are also suspected to contain PCBs.

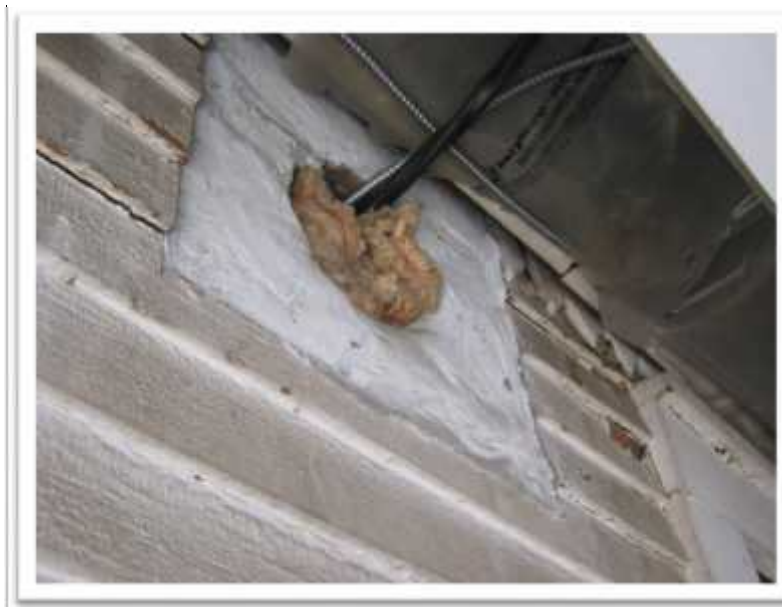
Photo 2: Parging cement over redundant opening in the west wall. Laboratory analysis has confirmed that the material (Sample 335846-01) does not contain asbestos.

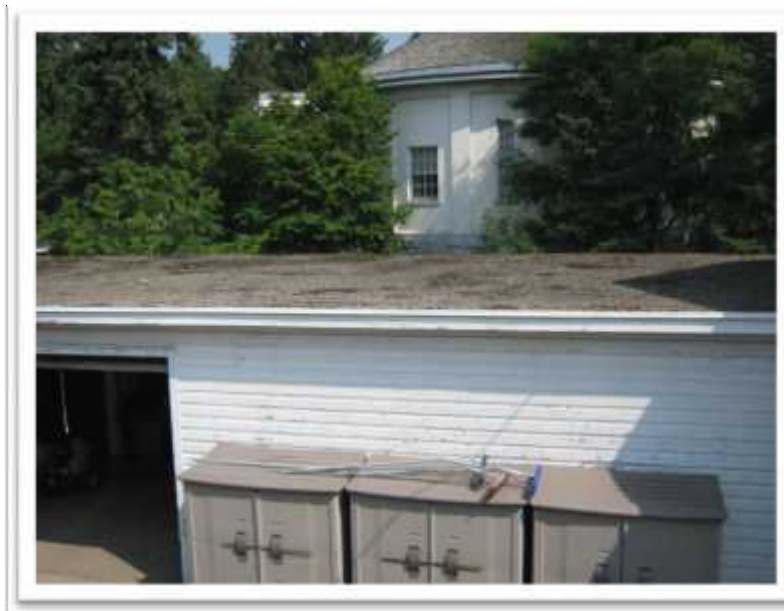
Photo 3: Roof of the Storage Garage. The asphalt materials are a suspected non-friable ACM.

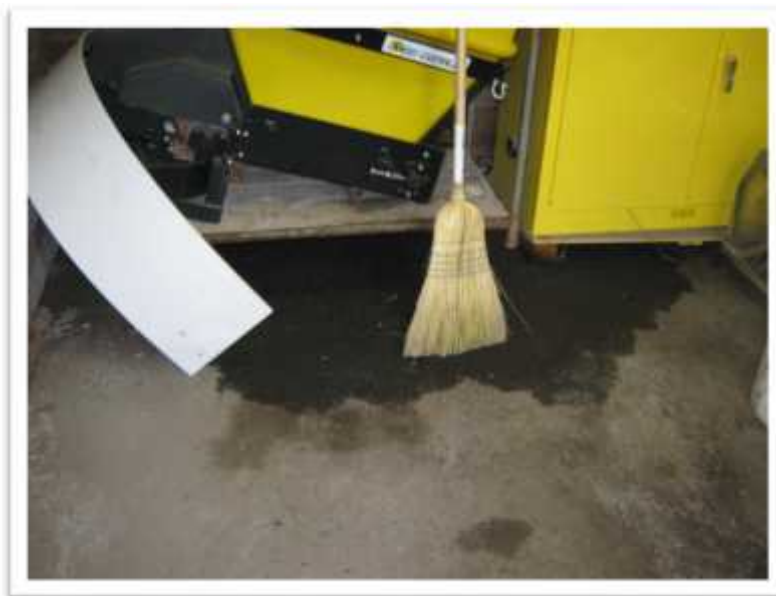
Photo 4: Typical example of a minor fuel spill on the concrete floor slab (which contains silica). In general, these spills appear to have been cleaned with adsorbent materials.

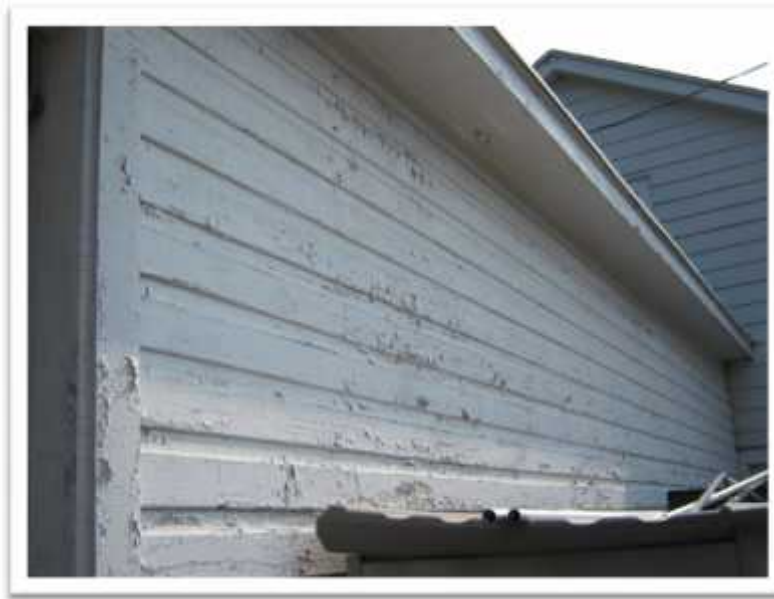
Photo 5: Exterior white paint (Sample 335846-LP-01) contains 13,700 ppm lead. This paint is delaminating from its wood substrate and is in POOR condition. Remedial action is required.

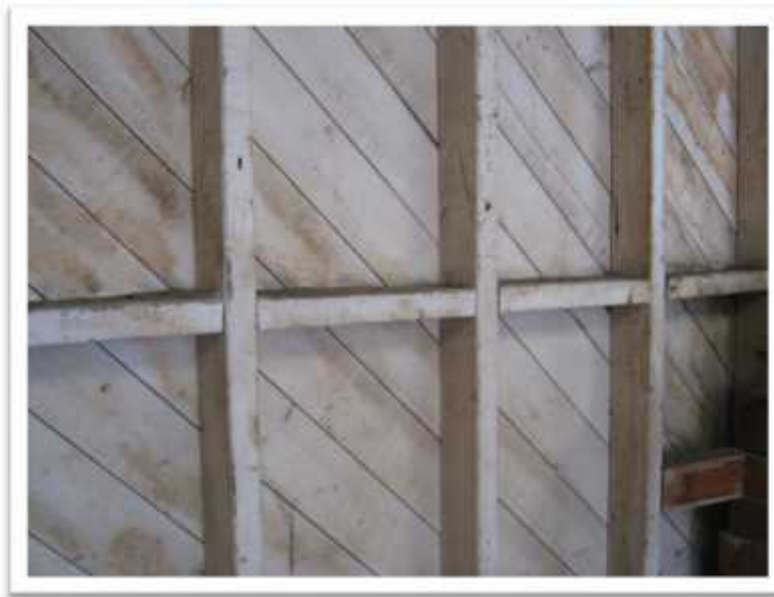
Photo 6: Interior beige paint (Sample 335846-LP-02) contains 4,170 ppm lead. This paint retains its bond with the wood substrate and is on GOOD condition. No remedial action is required.

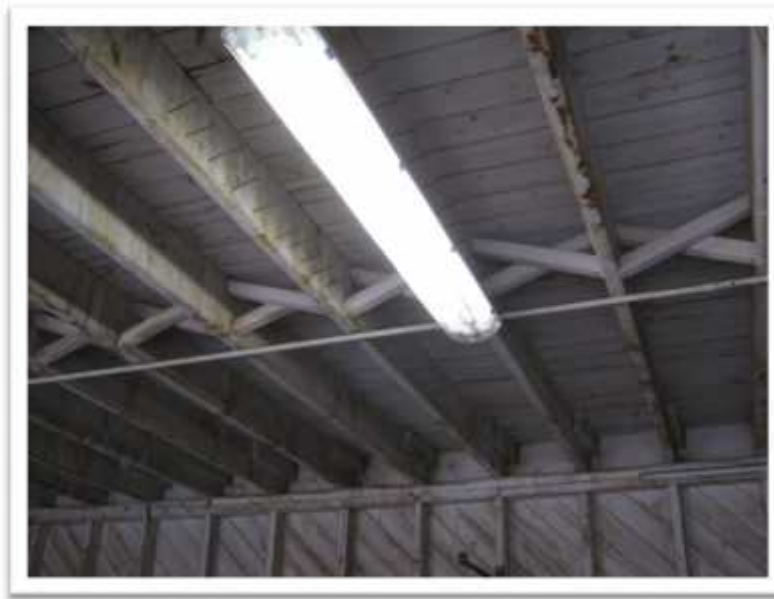
Photo 7: Typical fluorescent light fixture with T8 tubes is not expected to contain a PCB ballast. Each tube will, however, contain a droplet of mercury which vapourizes when the tube is energized.

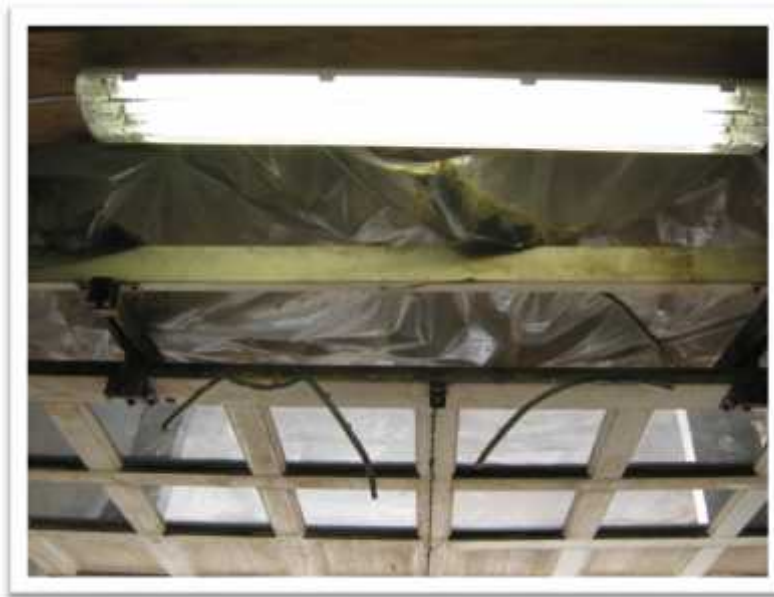
Photo 8: Mould impacted materials above the polyethylene sheeting suspended from the rafters. DST recommends Level II CCA mould remediation.

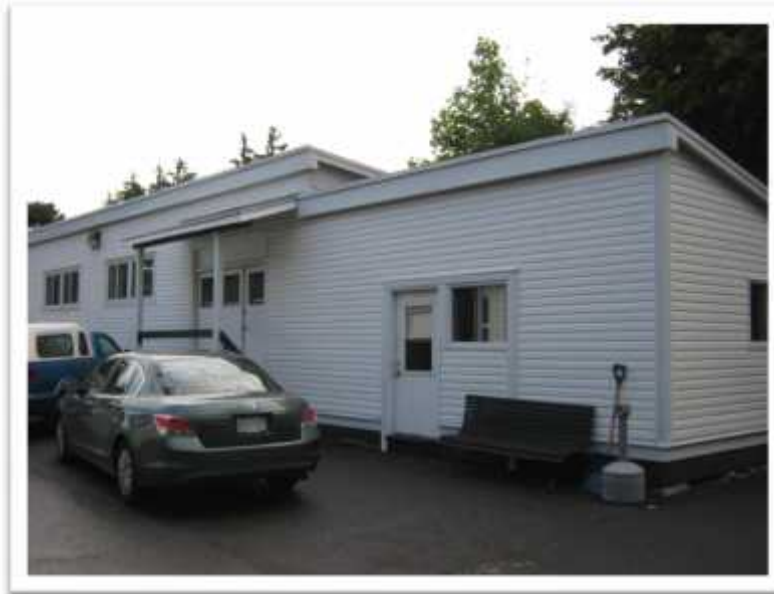
Photo 1: Exterior view of the Shop. Asphaltic roofing materials and window caulking are both non-friable suspected ACMs.

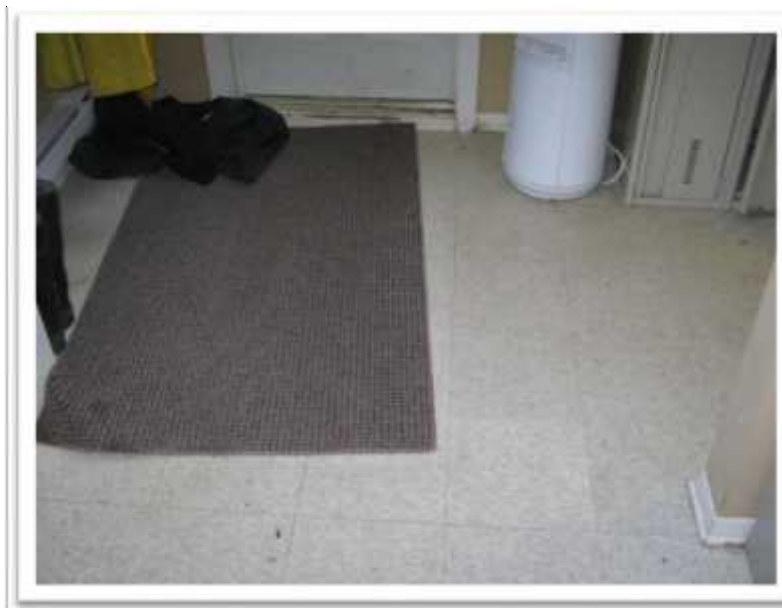
Photo 2: Vinyl floor tiles in Survey Location #3 have been tested (Samples 94189-01A-C) and confirmed to contain no asbestos.

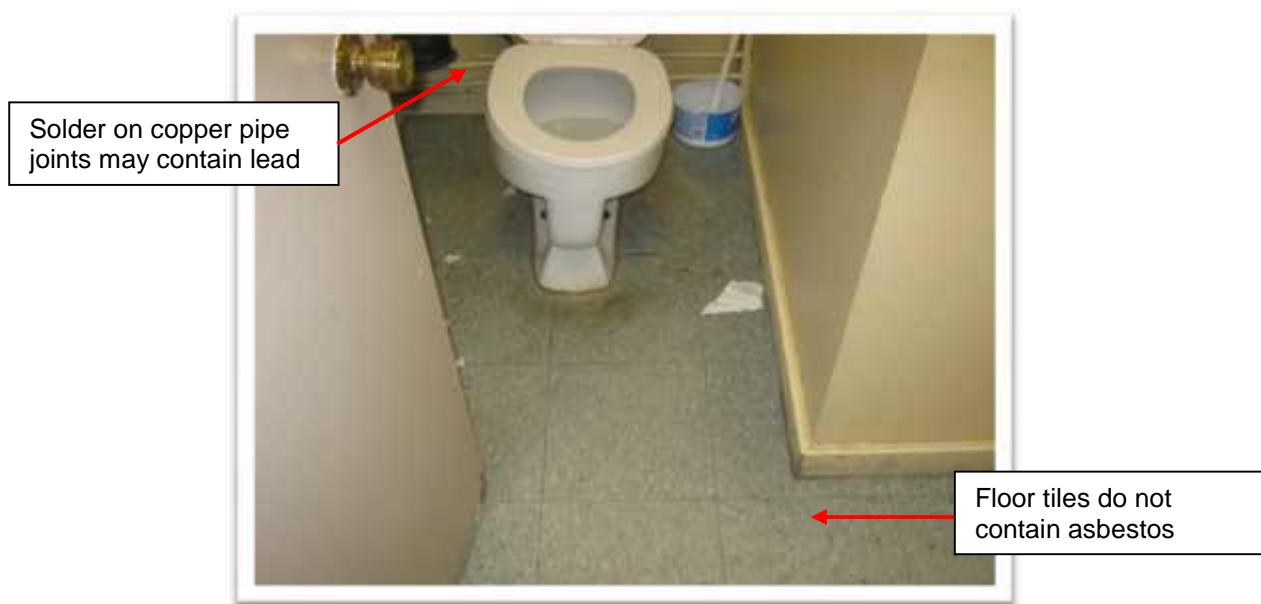
Photo 3: Vinyl floor tiles in Survey Location #5 (Bathroom) have been tested (Samples 94189-03A-C) and confirmed to contain no asbestos.

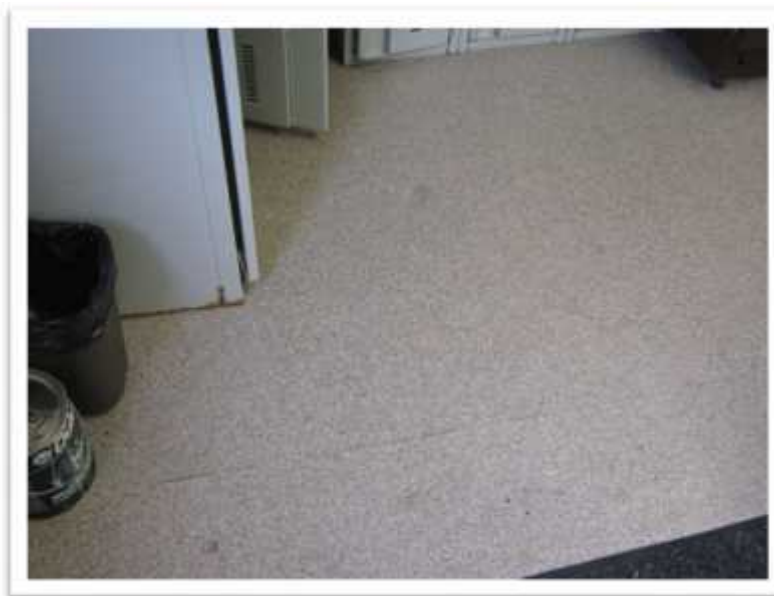
Photo 4: Vinyl sheet flooring in Survey Location #7 has been tested (Samples 94189-04A-C) and confirmed to contain no asbestos.

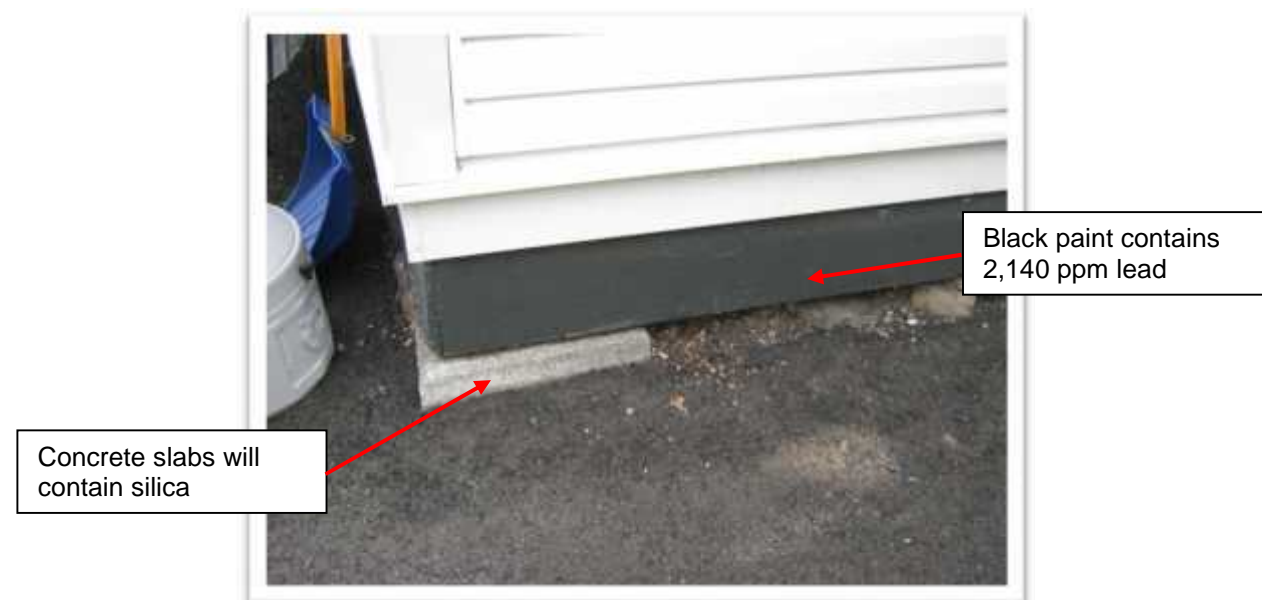
Photo 5: The exterior black paint (Sample 94189-LP-03) on the wood skirts at the base of the building's exterior contains 2,140 ppm lead. This is classified as a lead-based paint. The concrete corner slabs will contain silica.

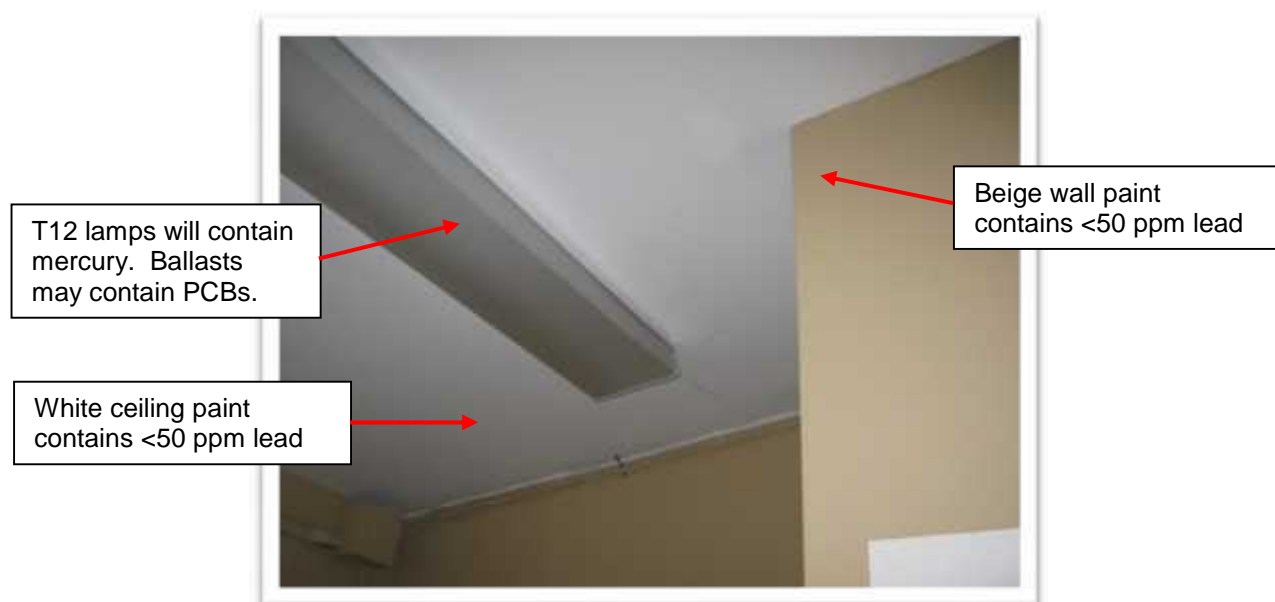
Photo 6: Typical fluorescent light fixture. The T12 lamps will contain liquid mercury which vapourizes when the lamp is energized. The fixture may contain a PCB ballast. White ceiling paint and beige wall paint have both been tested and confirmed to contain <50 ppm lead.

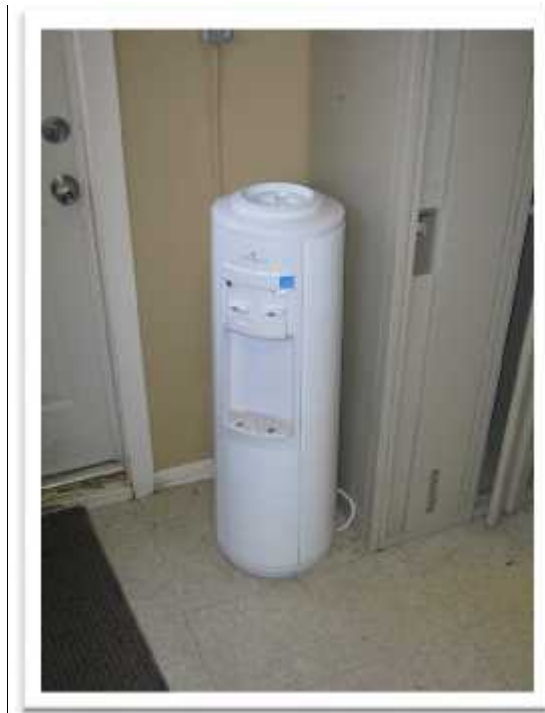
Photo 7: Typical water cooler will contain an ODS-suspect refrigerant. Refrigerators and window mounted air conditioners will also contain ODS-suspect refrigerants. None of this equipment is an integral part of the building structure or its finishes.
