**Designated Substances and Hazardous Materials Assessment  
(Specific to Planned Renovations)**

**WSP Canada Inc.**

867 Lakeshore Road  
Burlington, Ontario

**Issued Date:** August 18, 2015

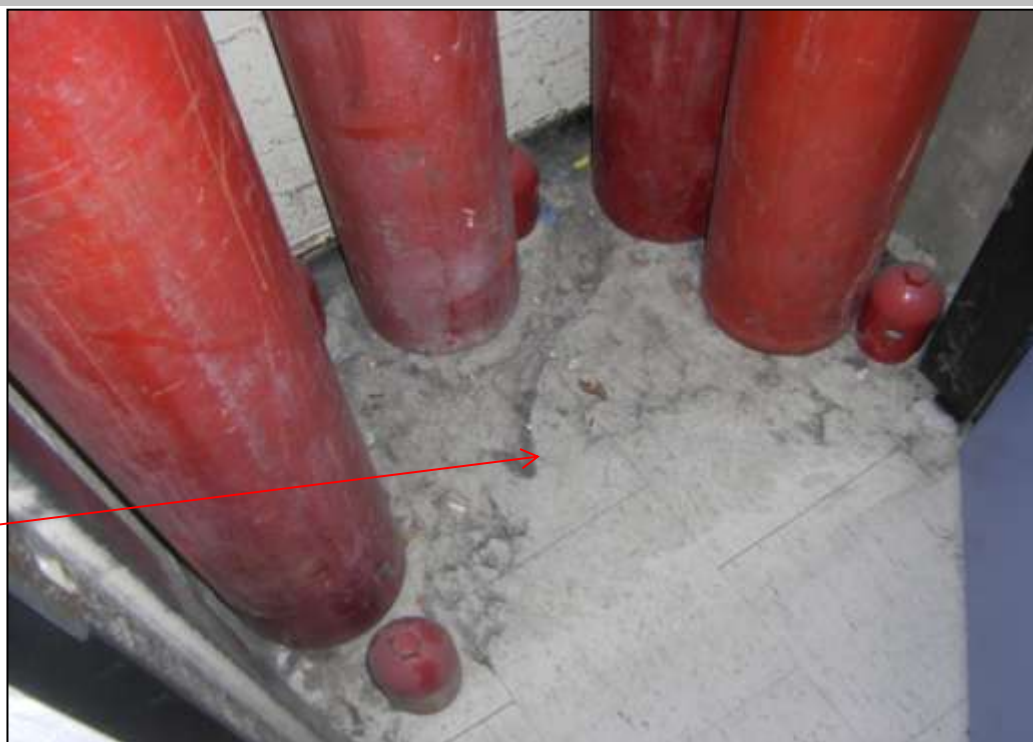
1. Floor tile – 12" x 12" (sample code: HF-01)
  - Non-friable material
  - Identified within room L758
  - Approximately 12 square feet

Floor Tile - 12" x 12" (HF-01)

**Analytical Result: 2% Chrysotile Asbestos**

Removal of asbestos-containing non-friable floor tile shall be conducted underneath Type 1 asbestos operations as per Section 14 of O. Reg. 278/05, as amended.

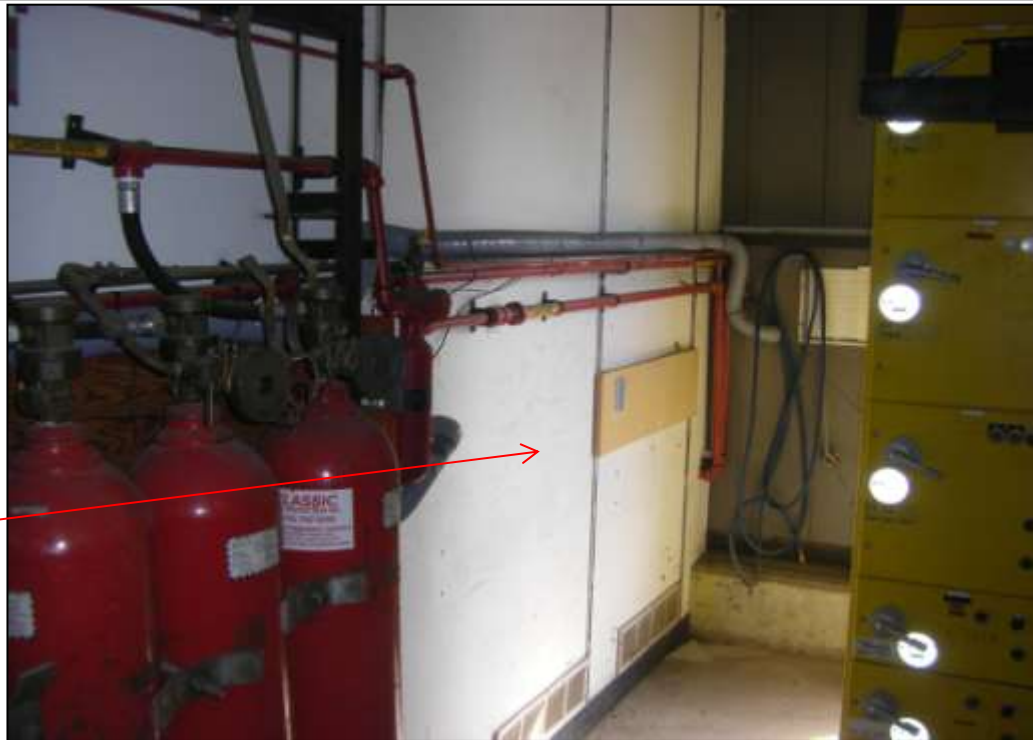
Wall Material (HW-01)

**Analytical Result:** Non Asbestos-Containing

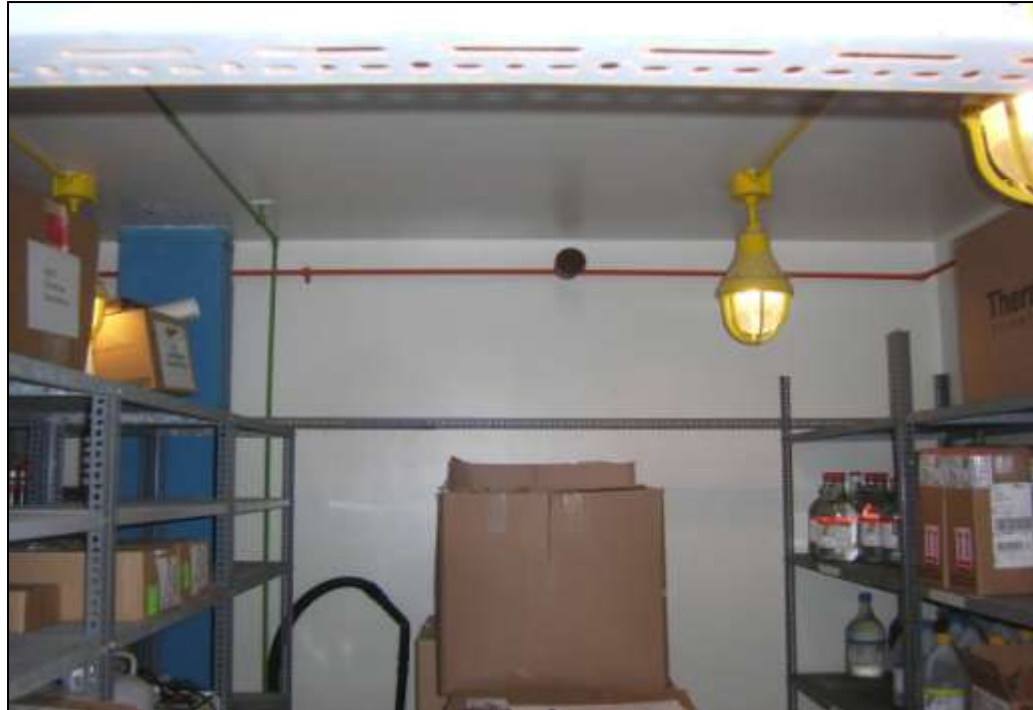
Plaster Wall - Base and Skim (HW-02)

**Analytical Result:** Non Asbestos-Containing

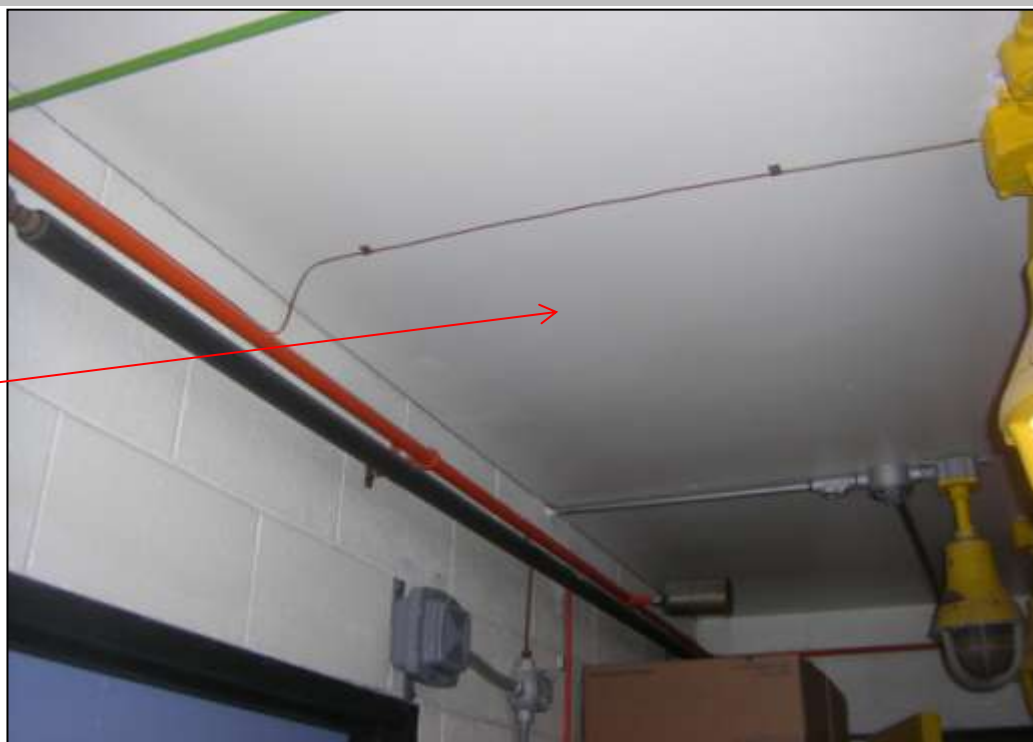
Plaster Ceiling - Base and Skim (HC-01)

**Analytical Result:** Non Asbestos-Containing

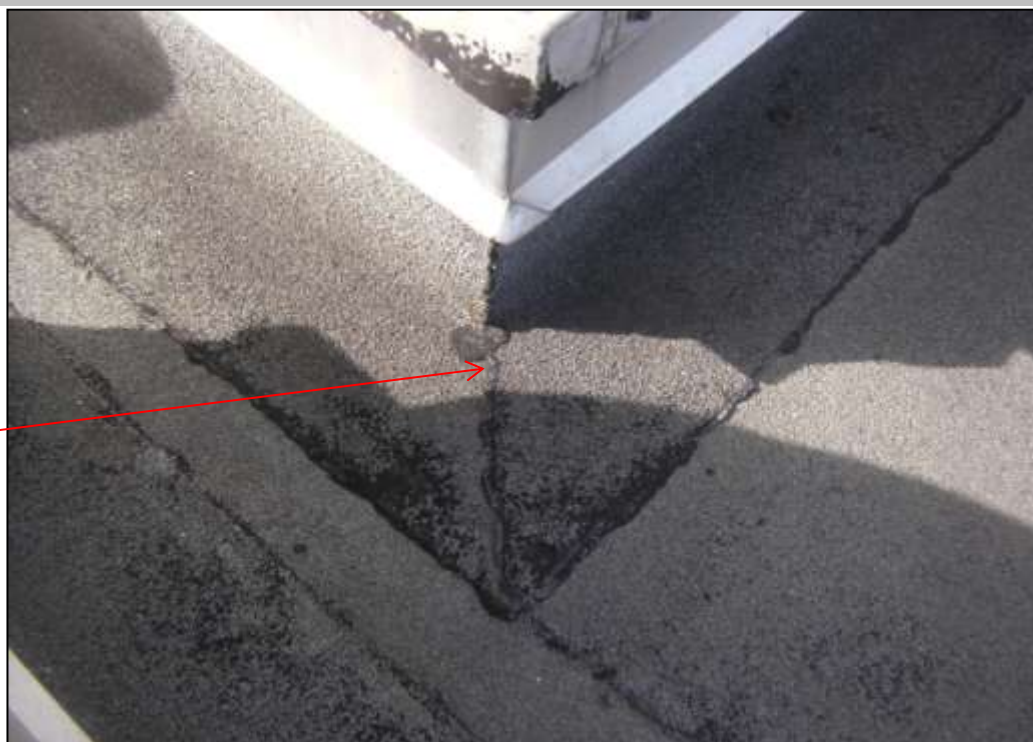
Shingle Tar - Roof Top at Pressure Hatch (HM-01)

**Analytical Result:** Non Asbestos-Containing

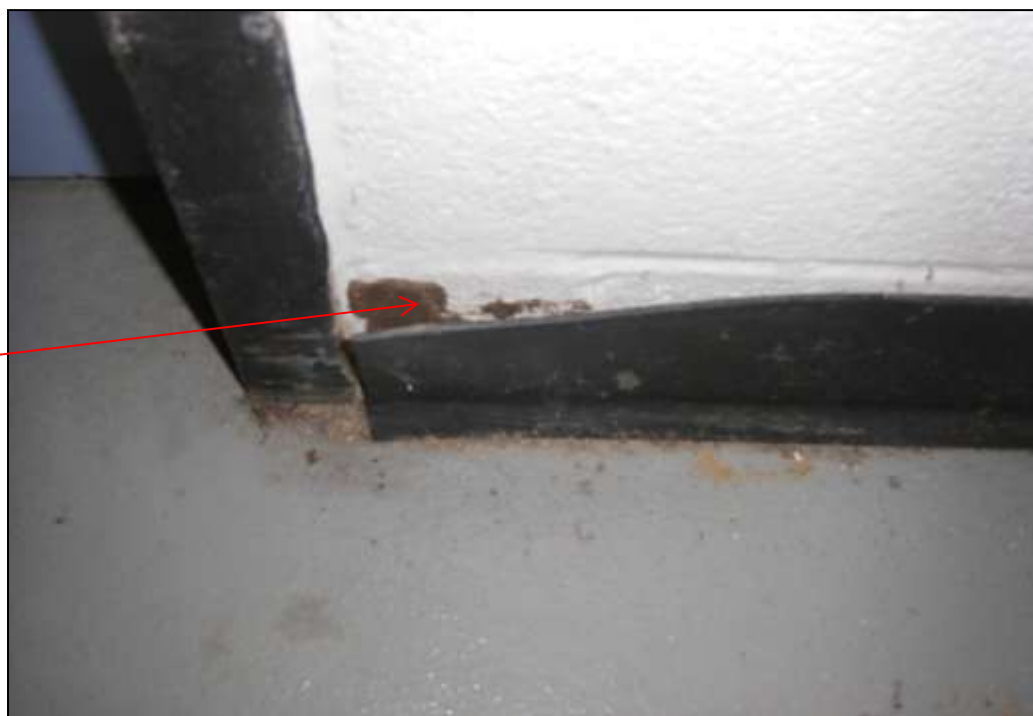
Base Cove Mastic (HM-02)

**Analytical Result:** Non Asbestos-Containing

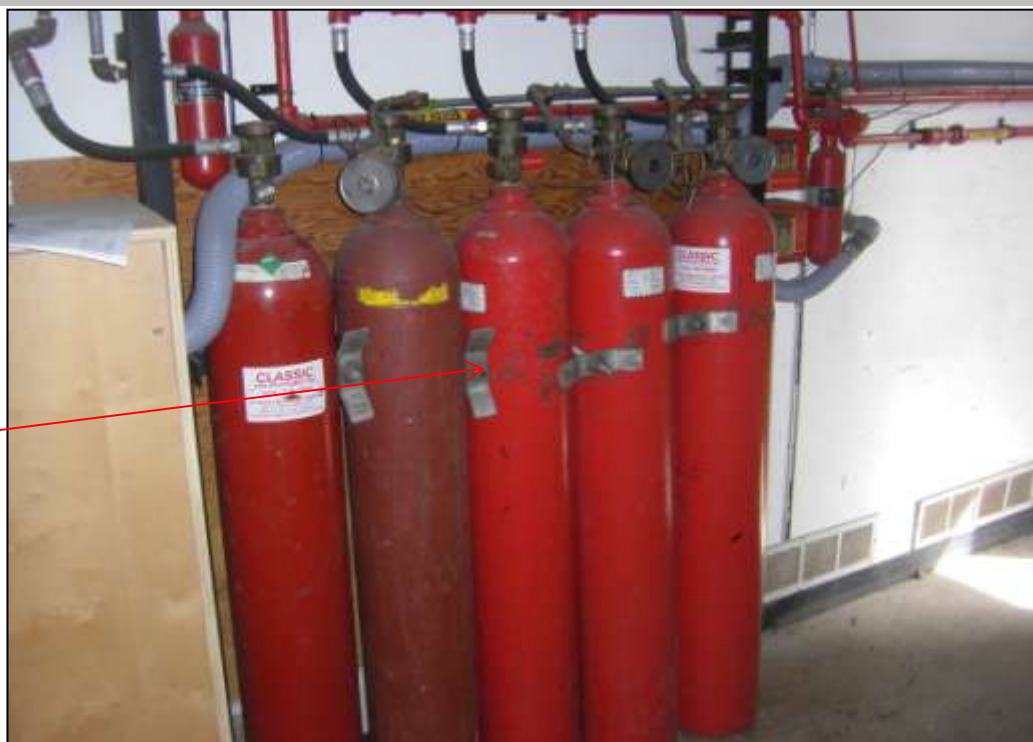
Red Paint (P01)

**Analytical Result:** Lead-Containing

Removal of lead-containing surface coating materials need to comply with the requirement with the Ministry of Labour, Guideline: Lead on Construction Projects, April 2011.

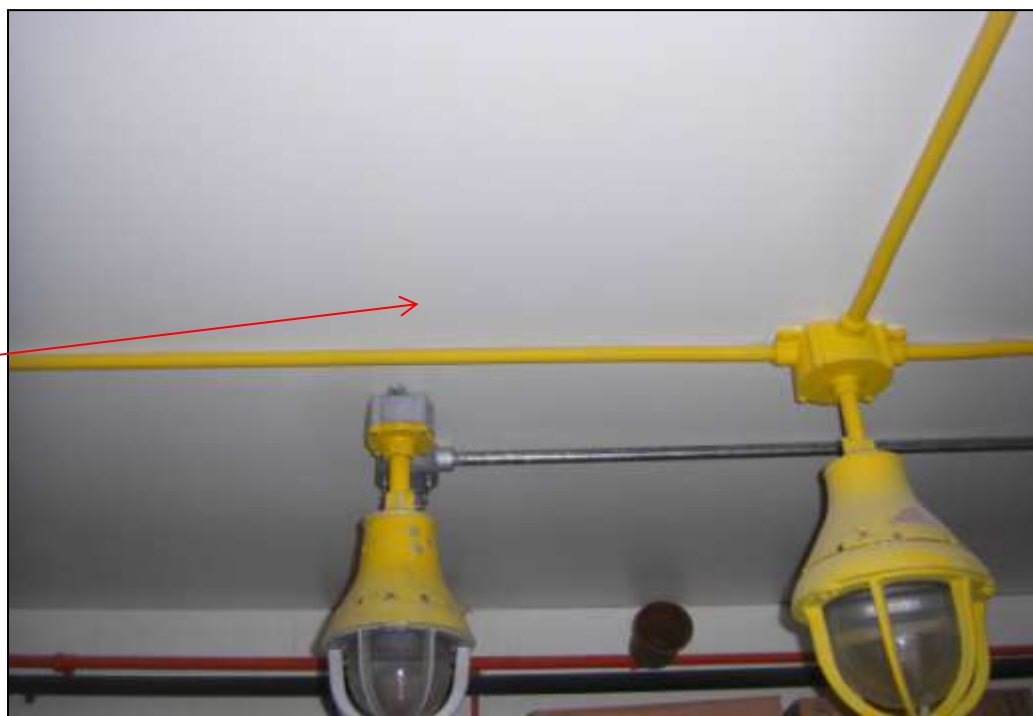
Off White Paint (P02)

**Analytical Result:** Non Lead-Containing

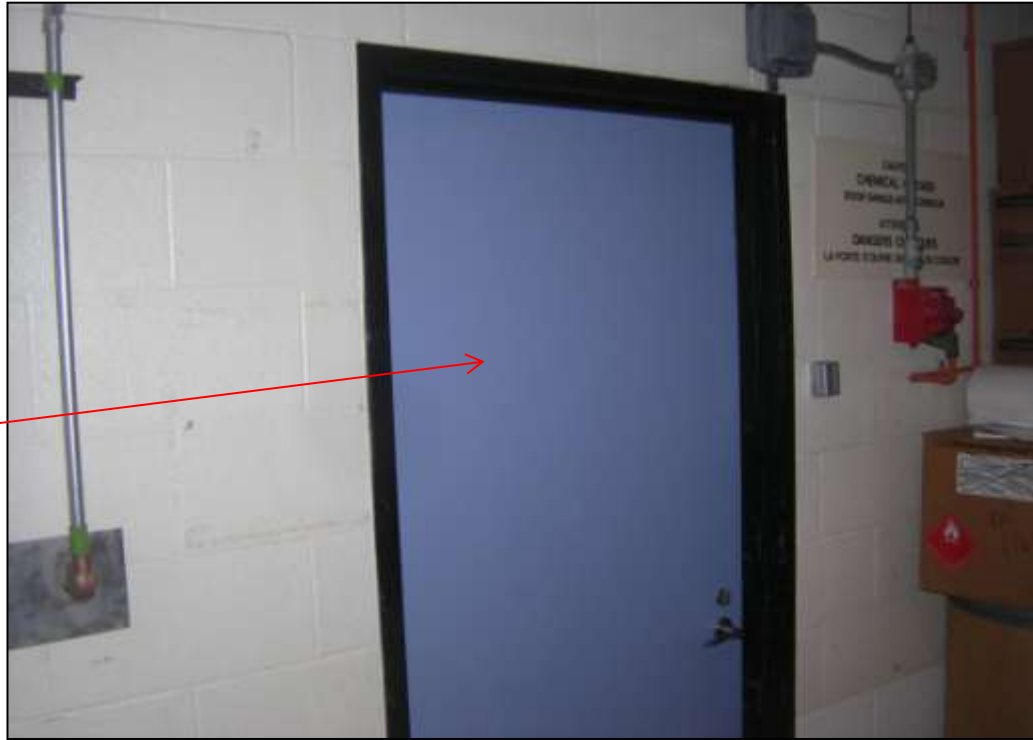
Grey/Blue Paint (P03)

**Analytical Result:** Lead-Containing

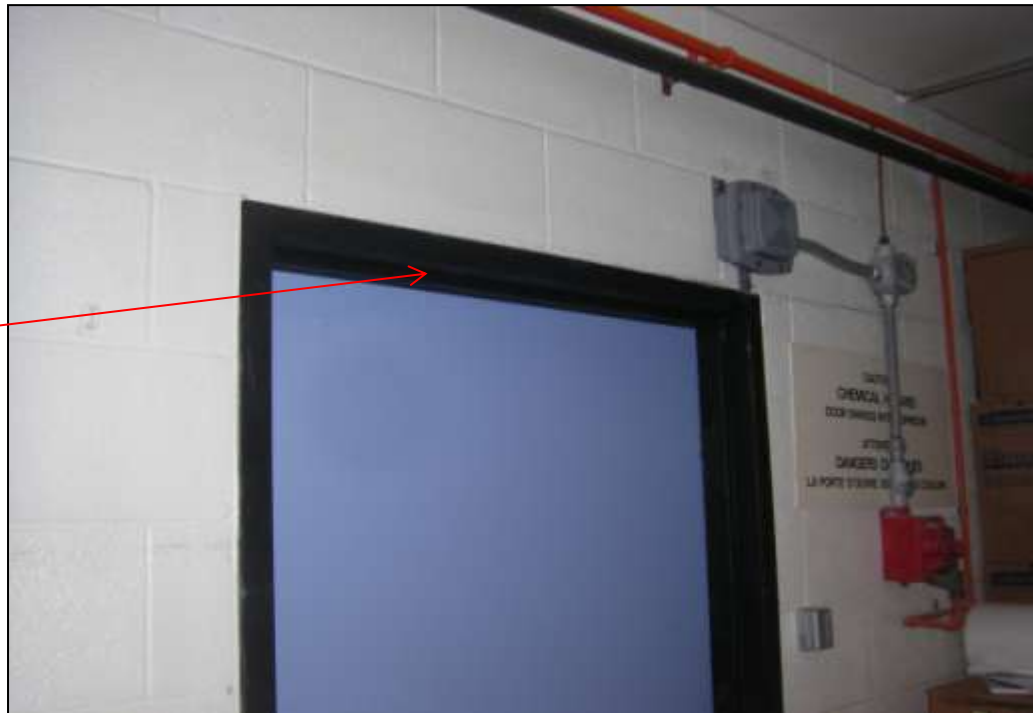
Black Paint (P04)

**Analytical Result:** Lead-Containing

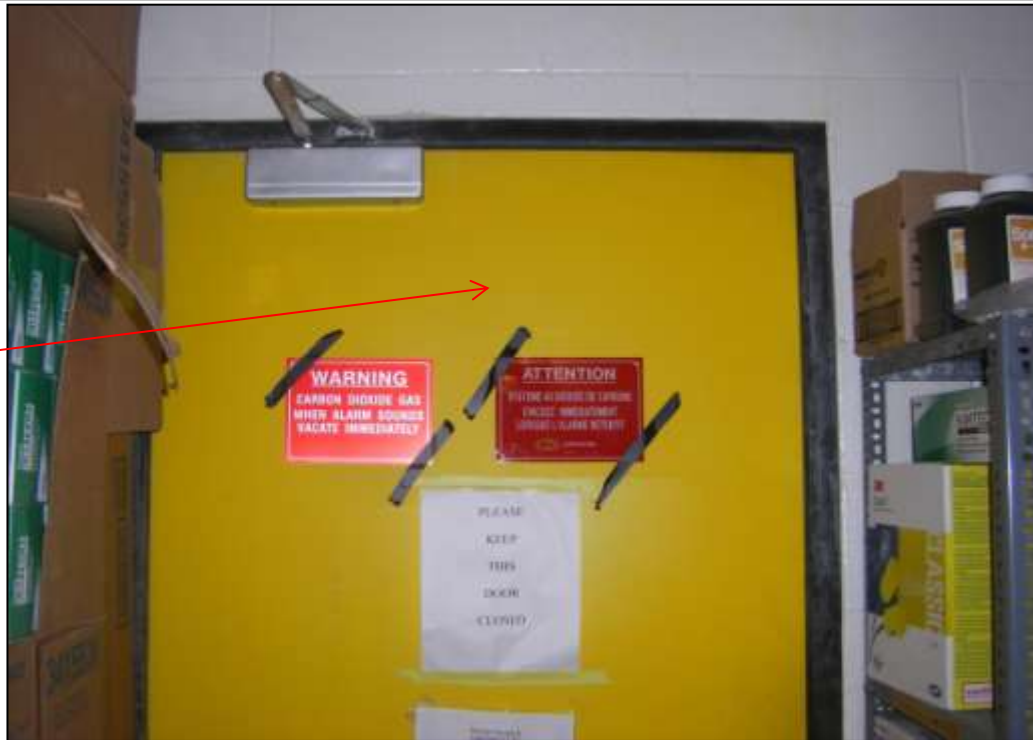
Yellow Paint (P05)

**Analytical Result: Lead-Containing**

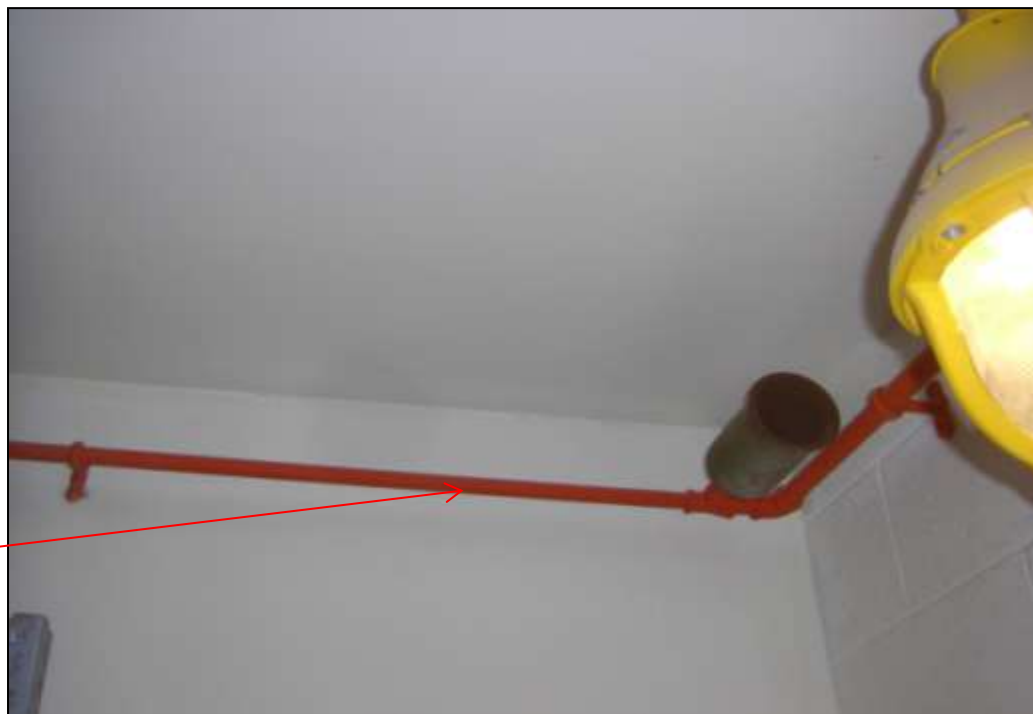
Orange Paint (P06)

**Analytical Result: Lead-Containing**

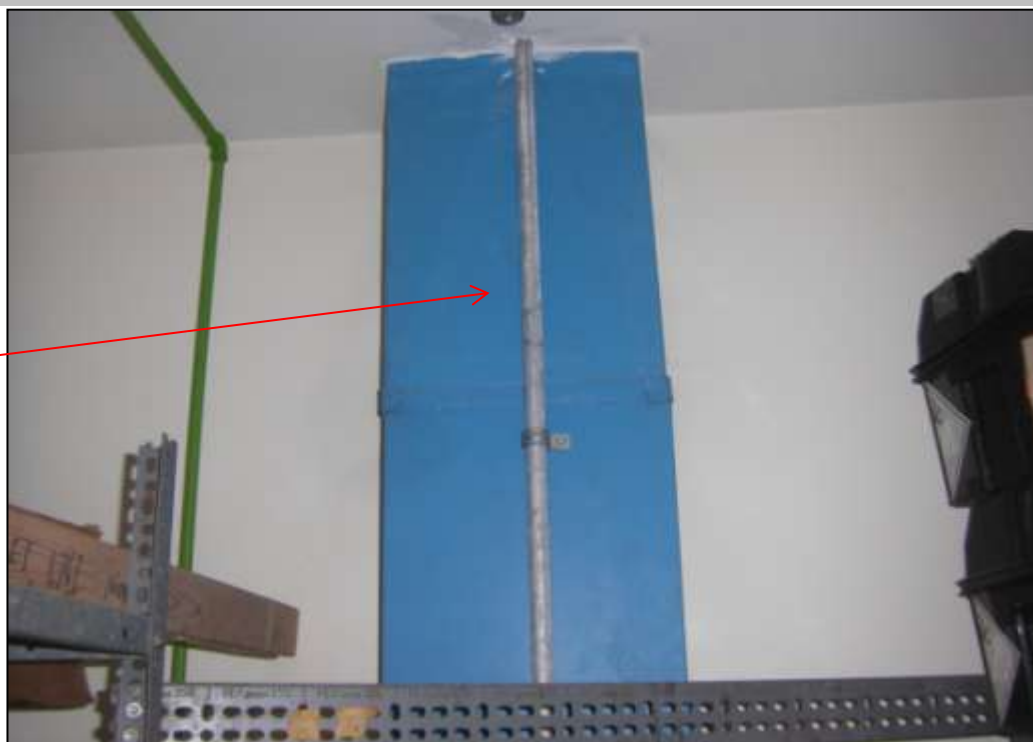
Aqua Paint (P07)

**Analytical Result:** Lead-Containing
