Parks Canada Agency

GEOTECHNICAL AND PAVEMENT ASSESSMENT  
TRANS CANADA HIGHWAY TWINNING PROJECT KM 82-88  
ALBERTA AND BRITISH COLUMBIA, CANADA

V33101067

December 2010

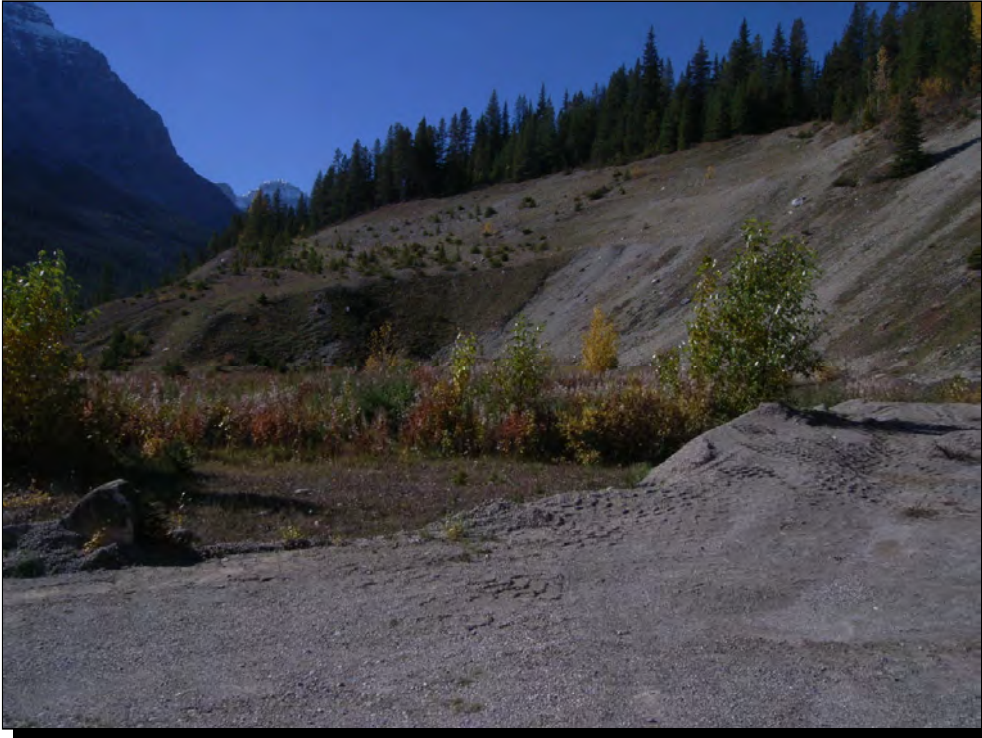
**Photo 1**  
Existing Borrow Pit at Km 87.5 – Looking West

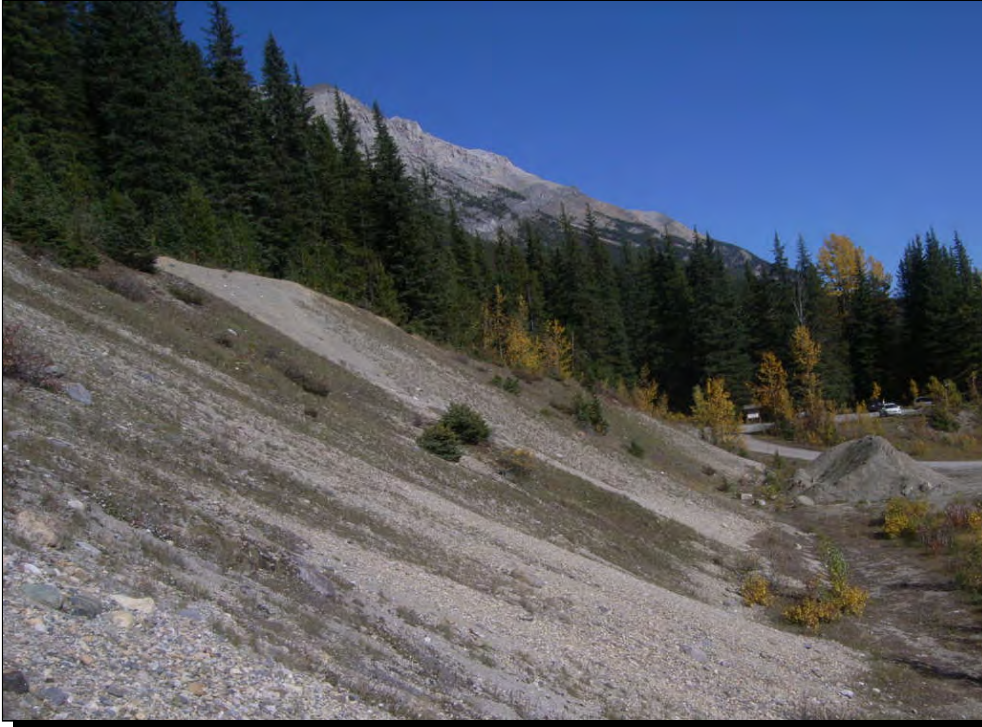
**Photo 2**  
Existing Borrow Pit at Km 87.5 – Looking East

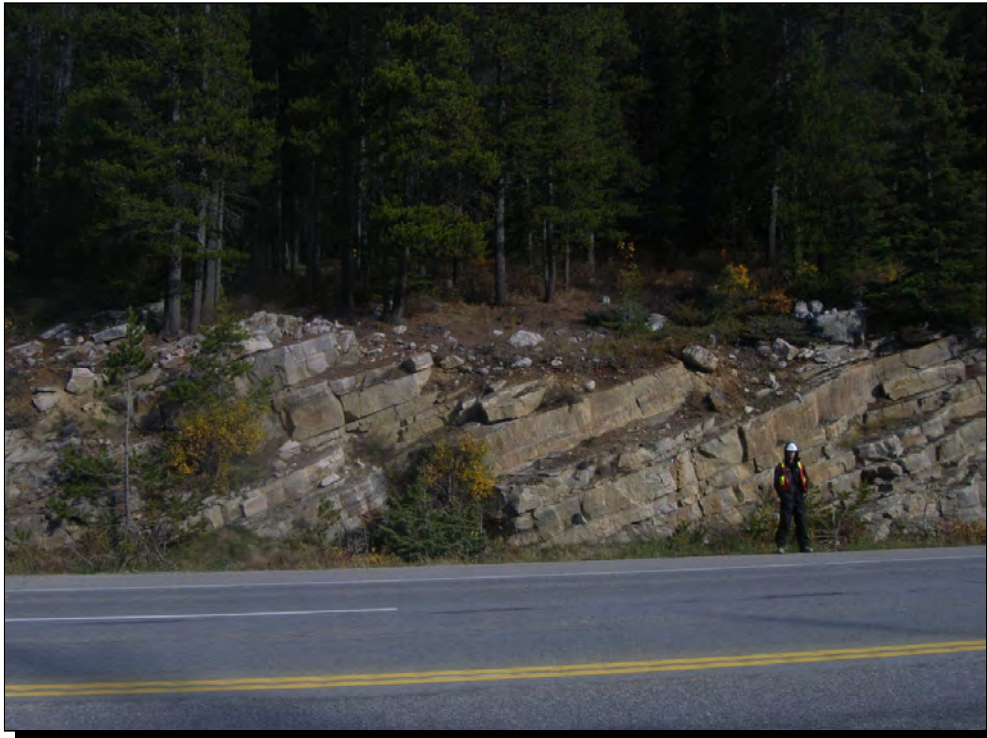
The second joint set dips sub-horizontally to the south. The joints are widely spaced, moderately persistent and the surfaces are slightly rough and planar. The condition of the rock mass is “good” based on the RQD. There is minor rock debris at the base of the slope. Photograph 1 in Appendix D shows a representative section of this slope.

**Photo 1**  
Slope 1: Km 82+700 to 83+000

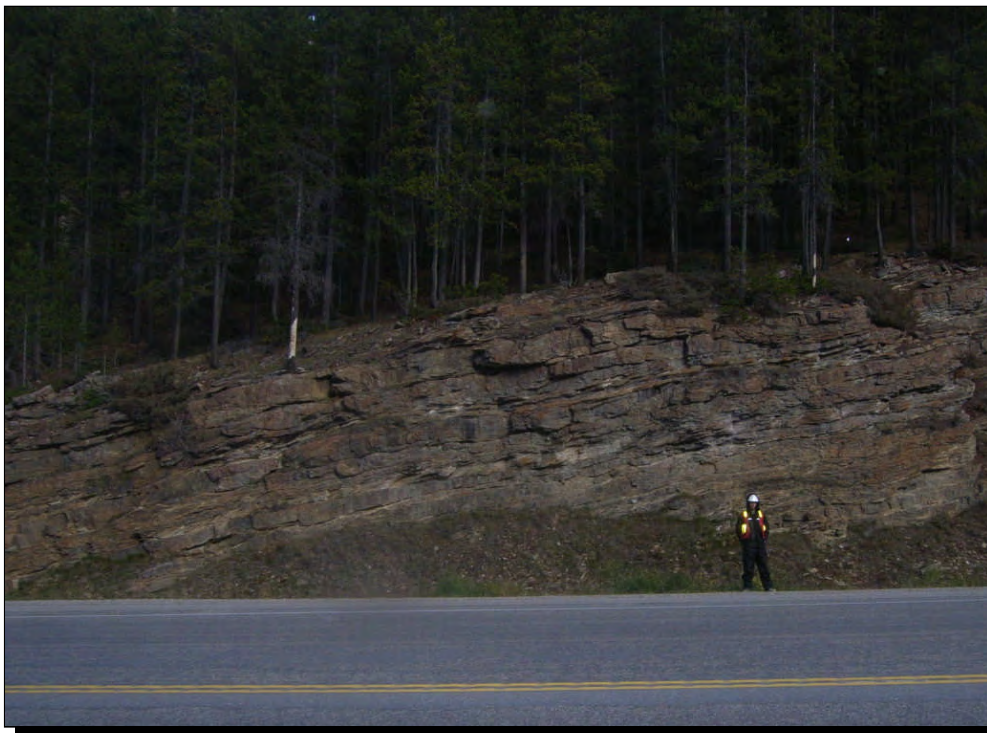
**Photo 2**  
Slope 2: Km 83+300 to 83+500

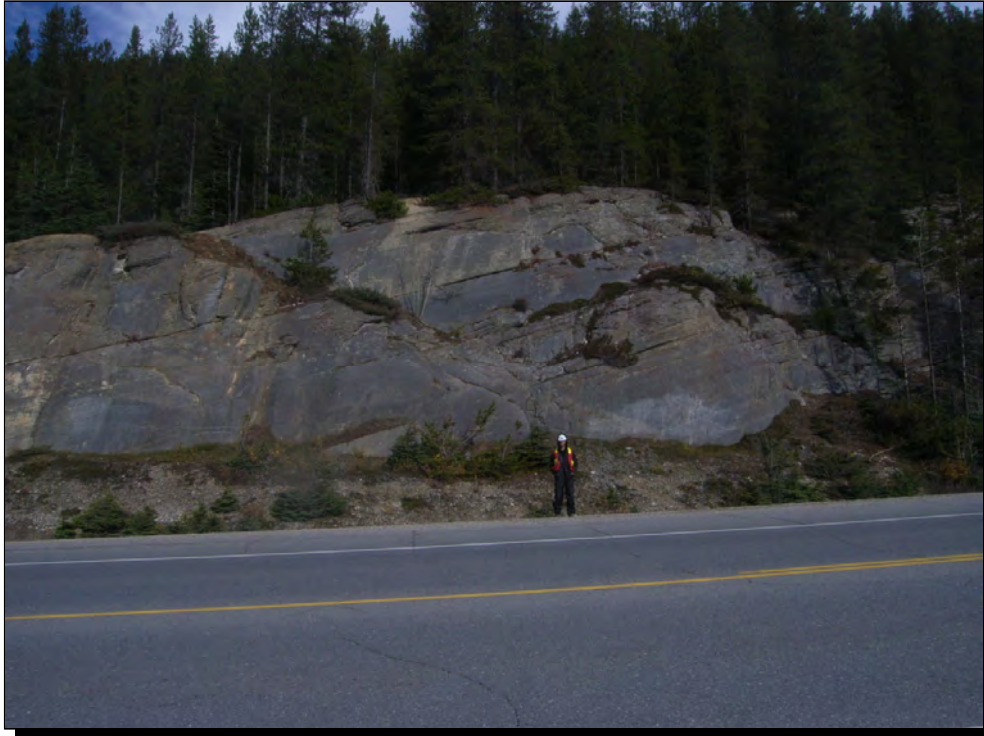
**Photo 3**  
Slope 3: Km 85+000 to 85+200

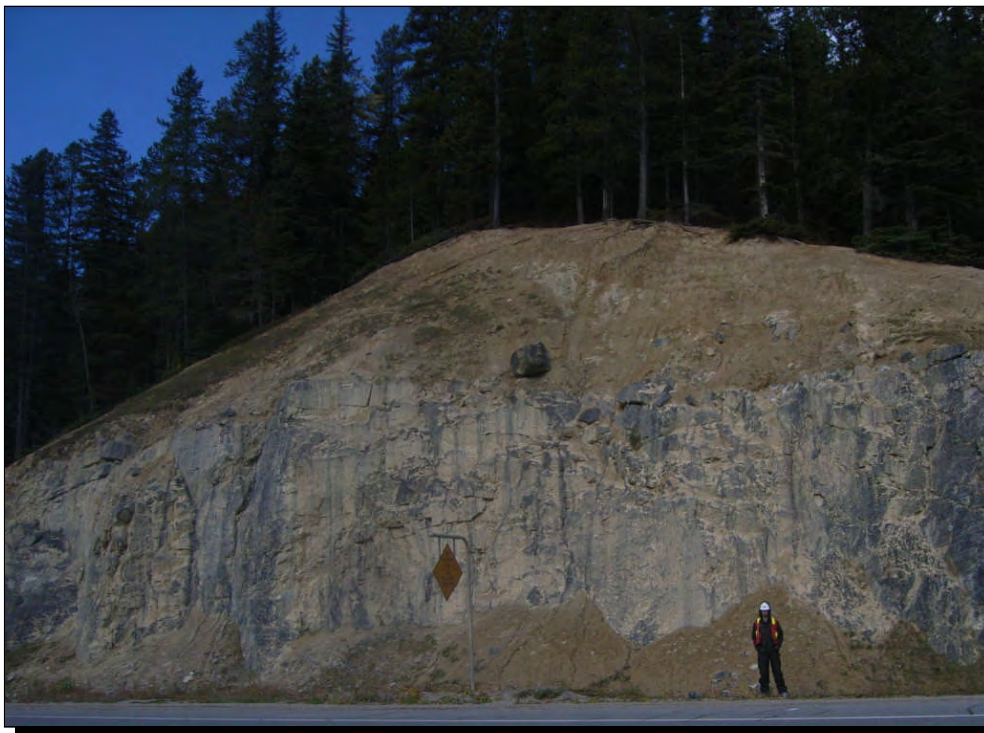
**Photo 4**  
Slope 4: Km 85+200 to 85+400

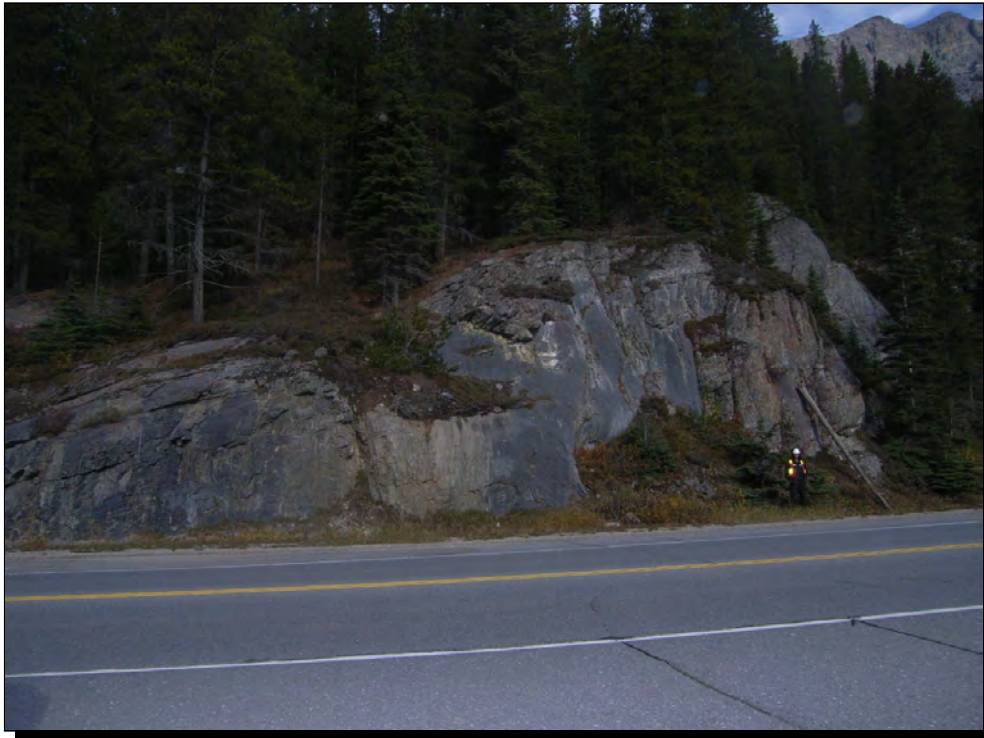
**Photo 5**  
Slope 5: Km 85+400 to 85+500

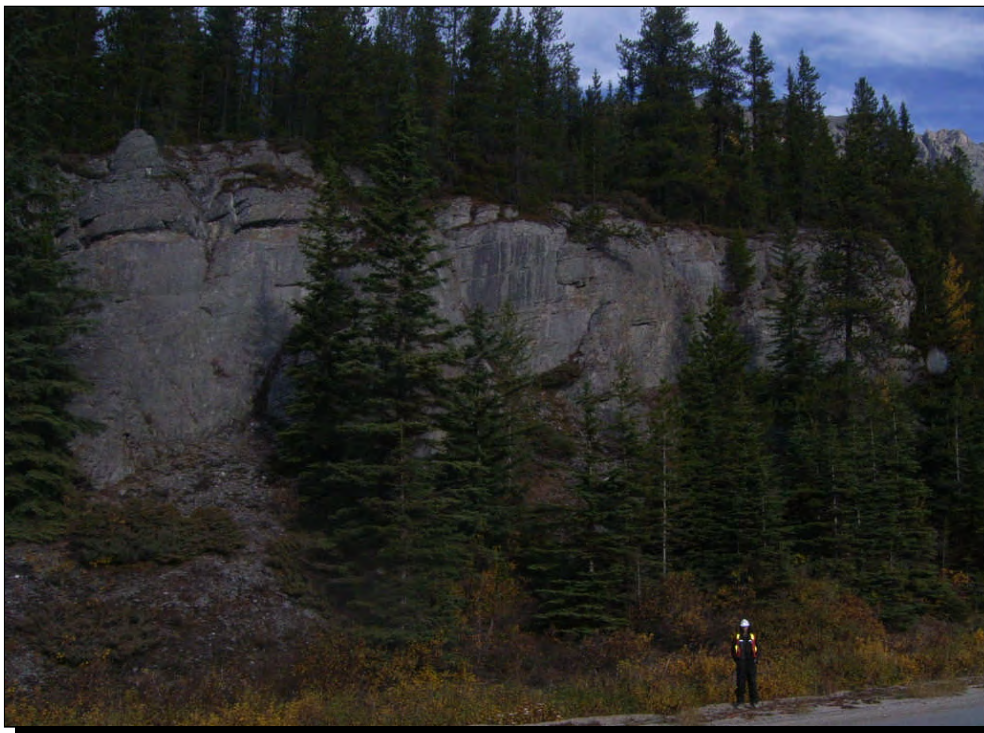
**Photo 6**  
Slope 6: Km 85+500 to 85+800
