December 22, 2015

Re: Food Services Building – Investigation of Saturated Crawlspace

Ft3 Architecture Landscape Interior Design were commissioned by Public Works and Government Services Canada to investigate saturation of an existing crawlspace found within the Food Services Building located at the RCMP Training Depot in Regina, Saskatchewan.

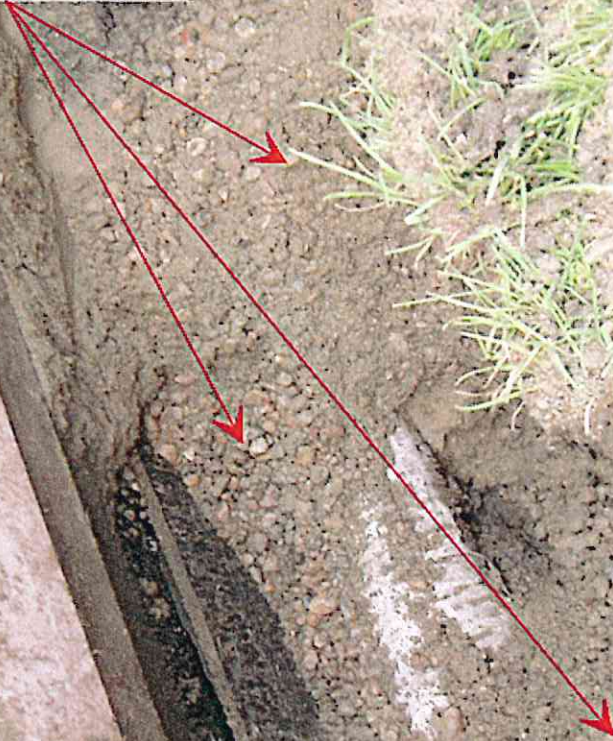
RAWLSPACE INVESTIGATION - EXTERIOR WEEPING TILE

MIXTURE CONTAINS
TOO MUCH SMALL
SEDIMENT. LARGE
CRUSHED GRAVEL IS
REQUIRED AS PER
ORIGINAL DRAWINGS.

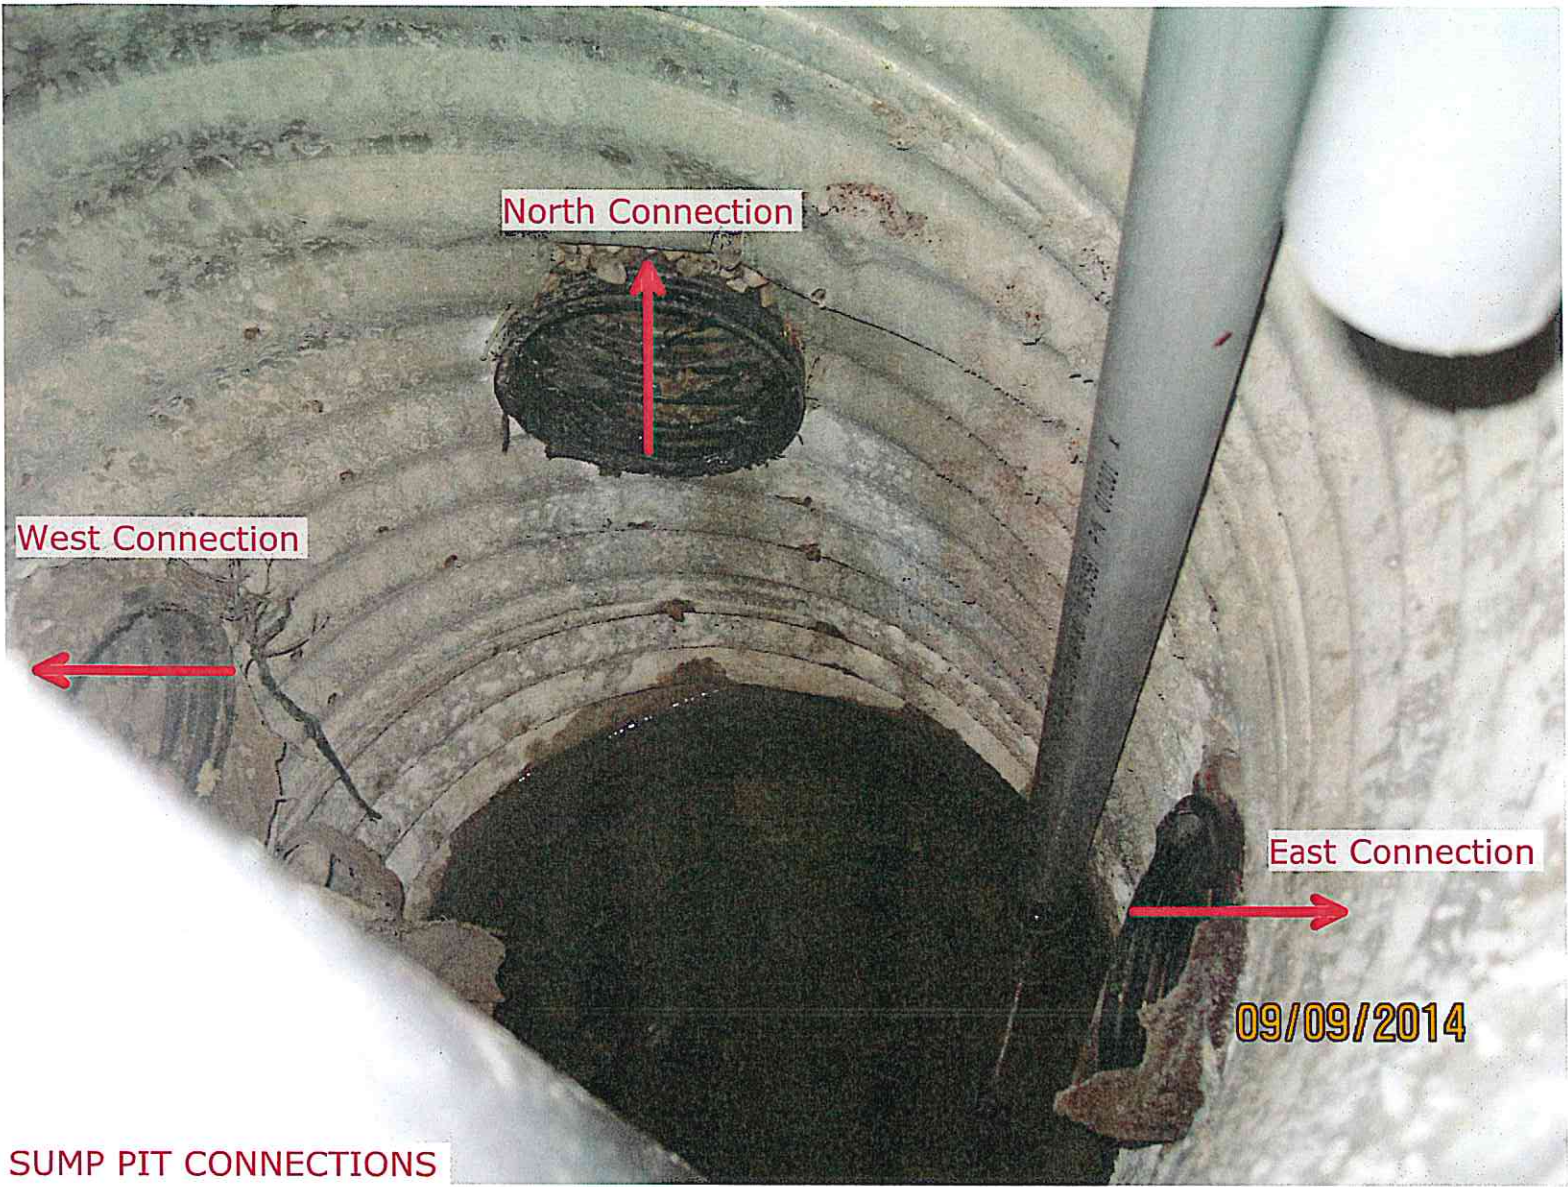
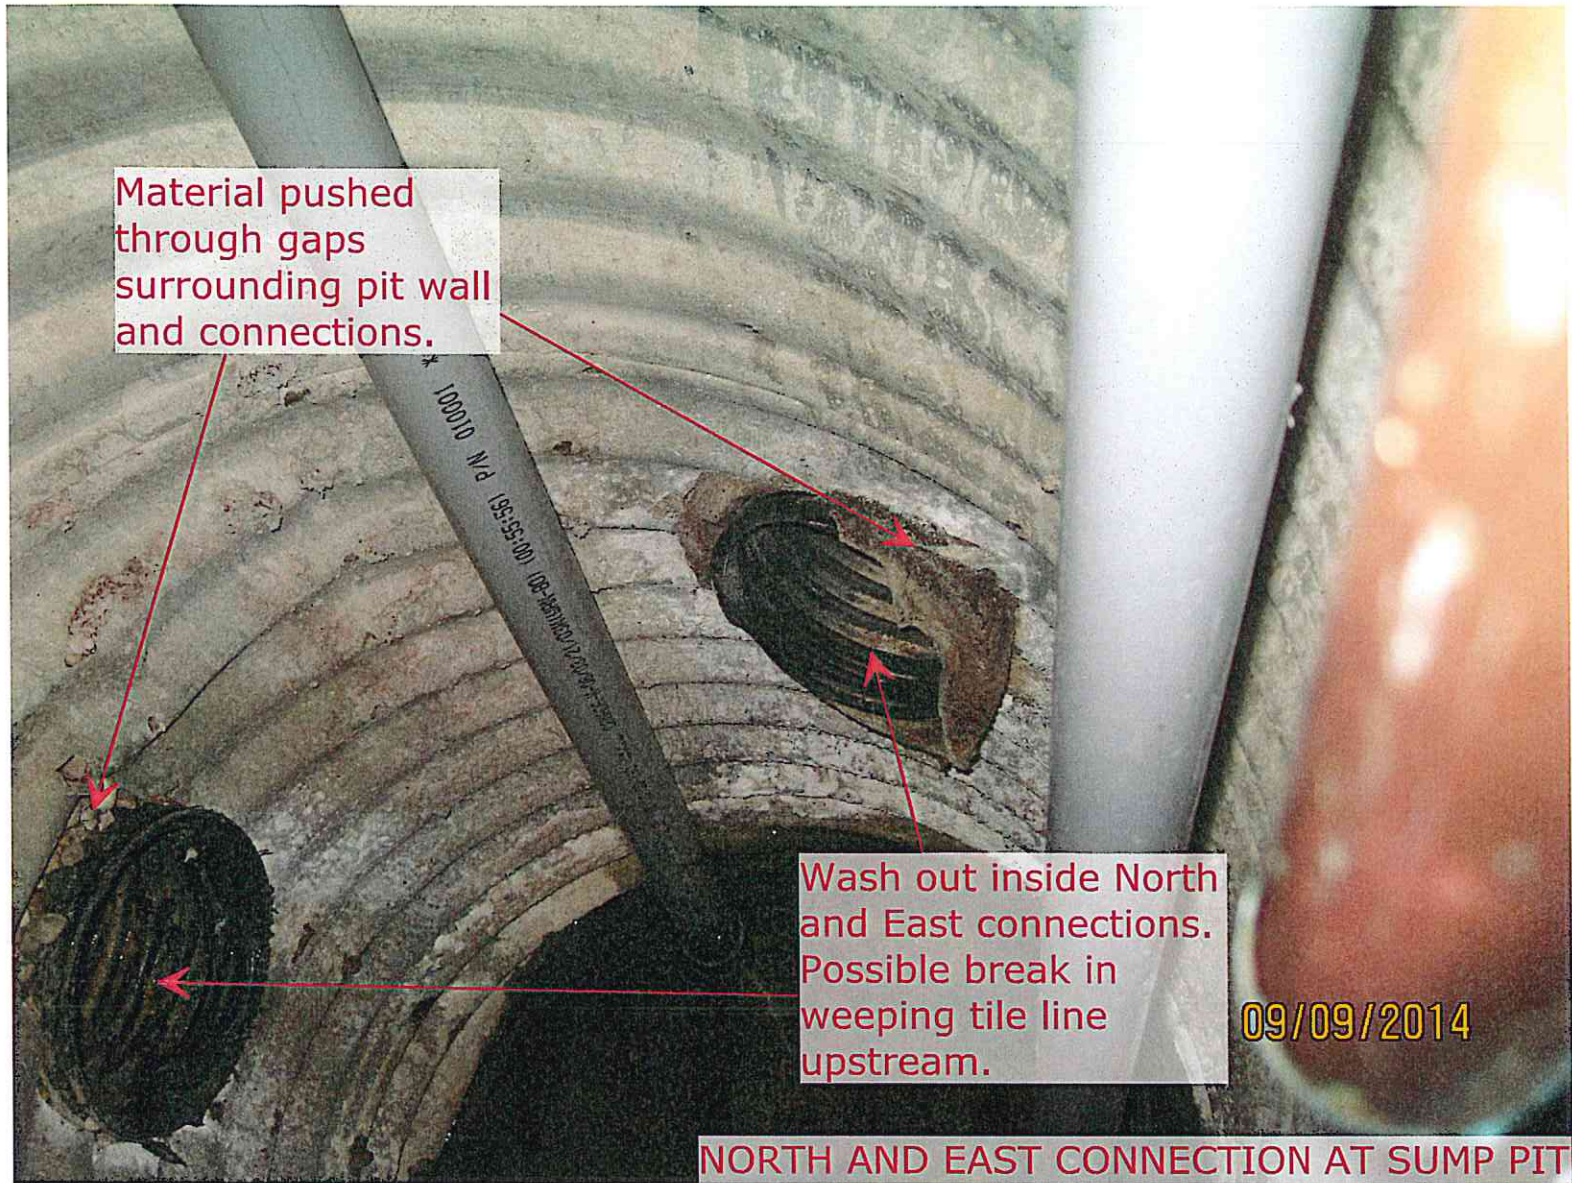
NORTH AND EAST CONNECTION AT SUMP PIT

A closer examination of the sump pit internally identified water at the very bottom of the pit due most likely to migration via the bottom seam of the pit walls atop the pit floor and not the weeping tile inverts. This can be considered the high point of the water level beneath the crawlspace floor and only in the immediate vicinity of the sump pit. The migration of water at this juncture is due most likely to a failure in the water tight seal between the sump pit walls and sump pit floor.

There was a considerable amount of wash out noticed both inside the North and East connections along with material pushed through the gap surrounding the pit wall and the connections. We conclude there is a possible break in the weeping tile line upstream allowing for material to wash into the weeping tile as well allowing for trench material to be washed into the gap surrounding the connections and the sump pit wall.

Material pushed through gaps surrounding pit wall and connections.

Wash out inside North and East connections. Possible break in weeping tile line upstream.

North and East connections have darker appearance in relation to West connection indicating they were wet at some point but not recently.

Water at the bottom of Sump Pit possibly due to migration via failure of bottom seam of pit connection.

Considerable amount of wash out noticed inside North and East connection.

We recommend a camera be used to scope the weeping tile from the sump pit up stream as far as possible. This further investigation could reinforce our findings as to the possibility of a crushed or disconnected weeping tile at point of entry into the crawlspace or other possible locations, the non use of perforated weeping tile as main connection runs and a poor slope of weeping tile trenches.

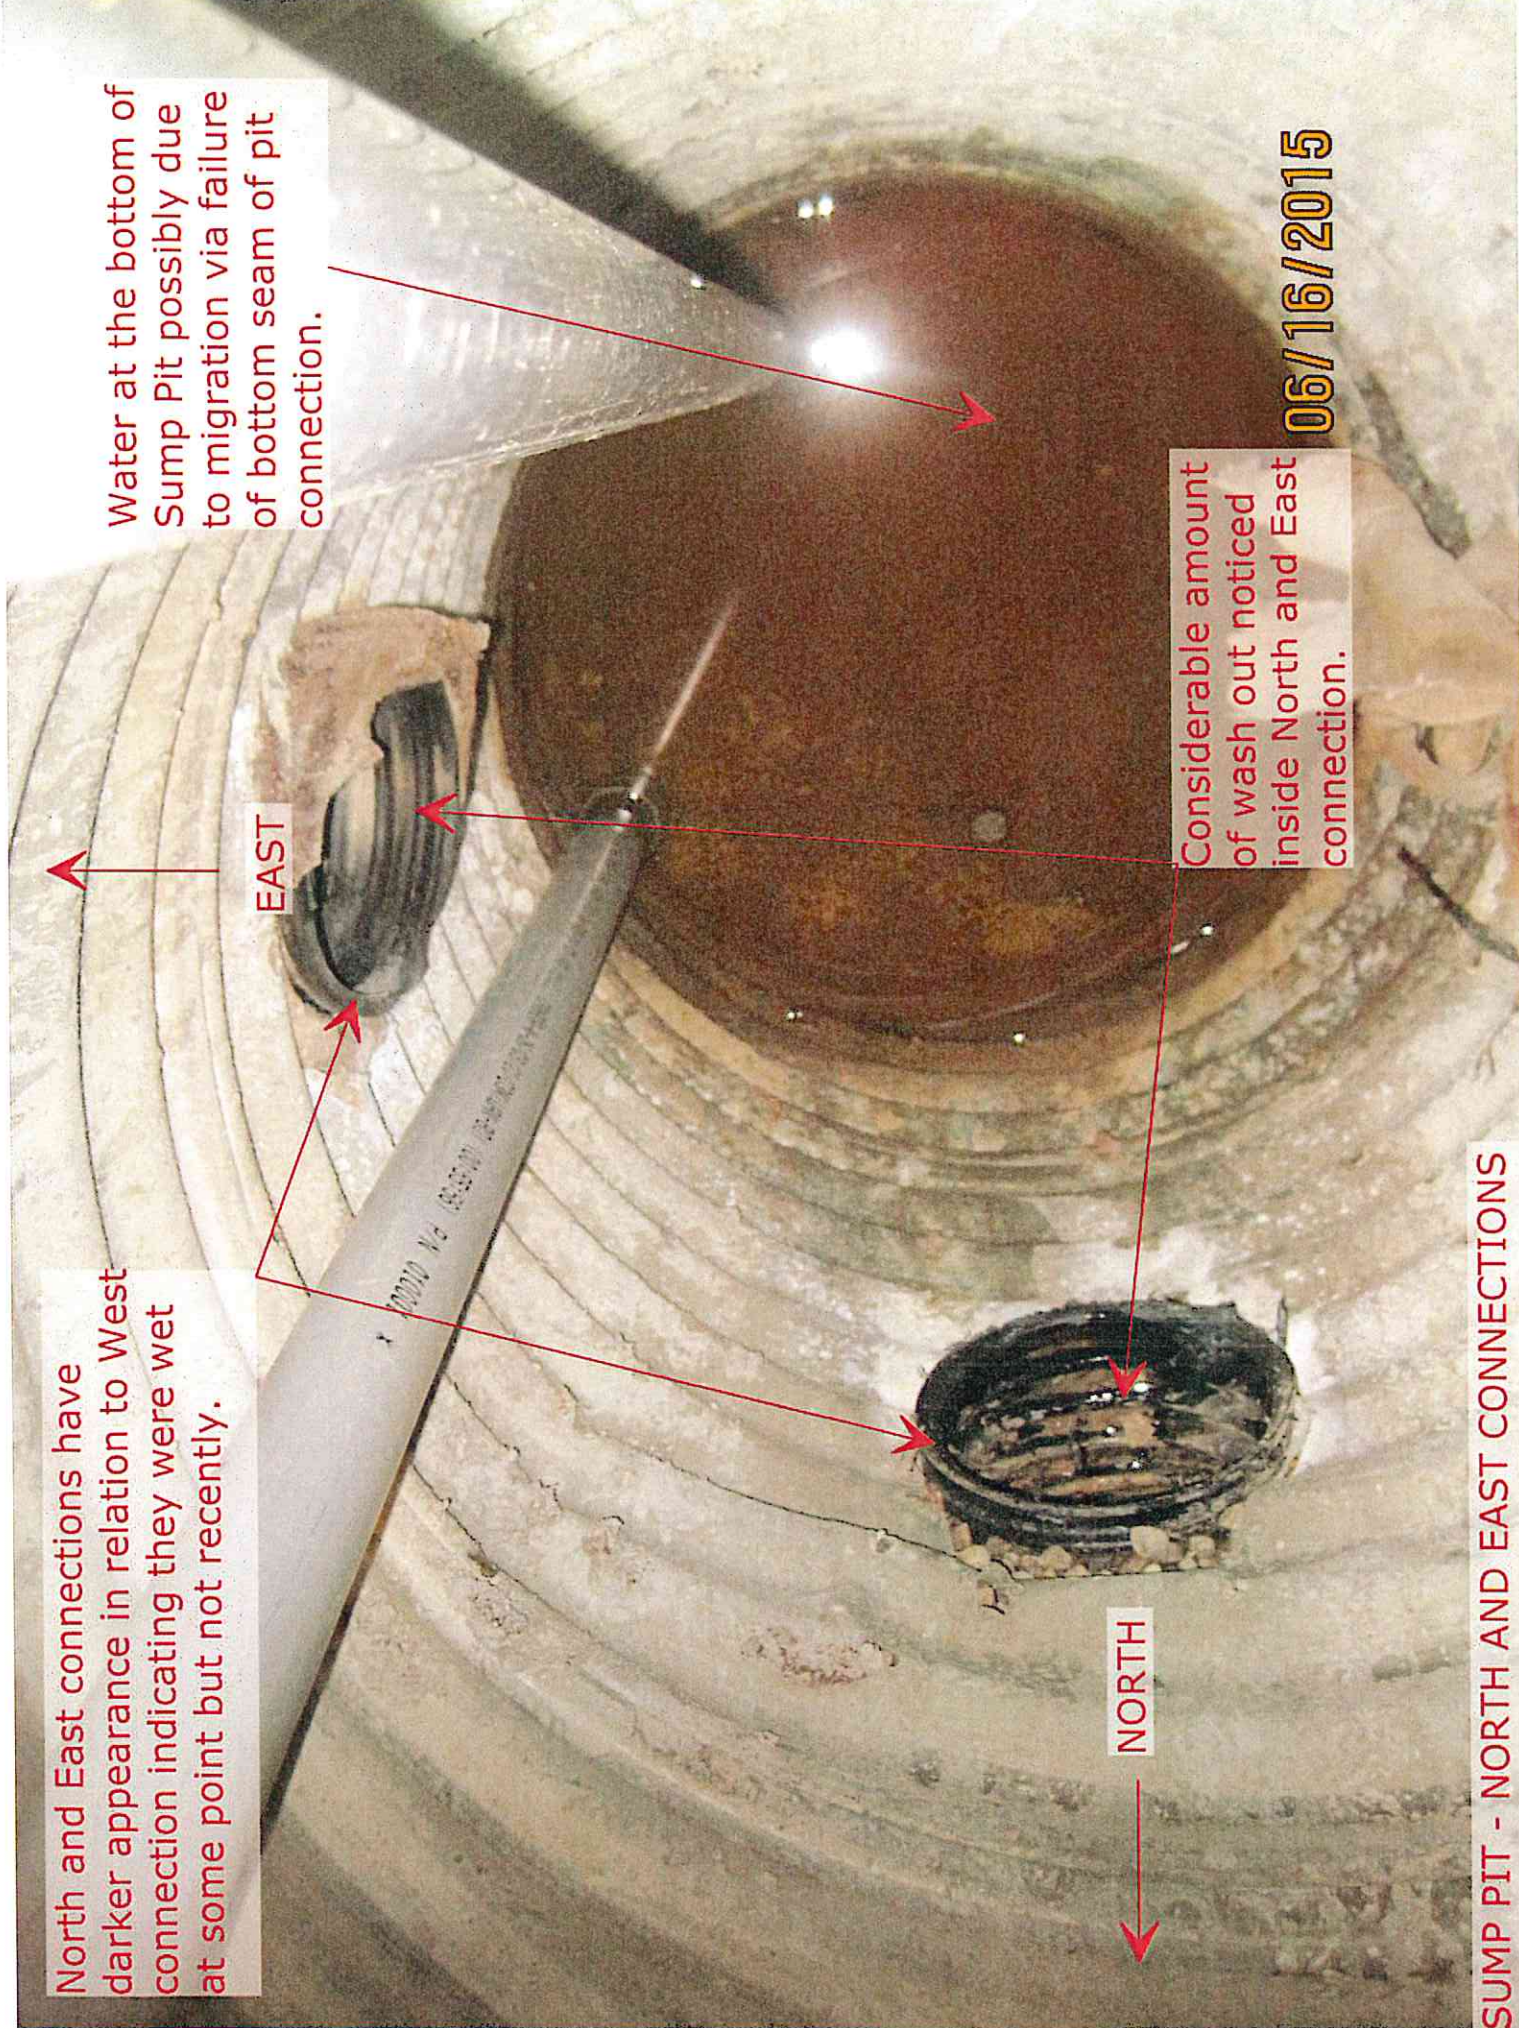
SUMP PIT - NORTH AND EAST CONNECTIONS

There was no clear staining on the corrugated pit walls below the weeping tile connections at the inside of the sump pit. The two weeping tile connections considered North and East seem to have been wet but not recently (*we have included time lapsed photos from 09/09/14 and 06/16/15*) and this is derived by a dark like appearance in relationship to the weeping tile connection on the west side of the pit wall. We note on the revisit the east connection inside the sump pit was completely dry and the north had minor amount of moisture.

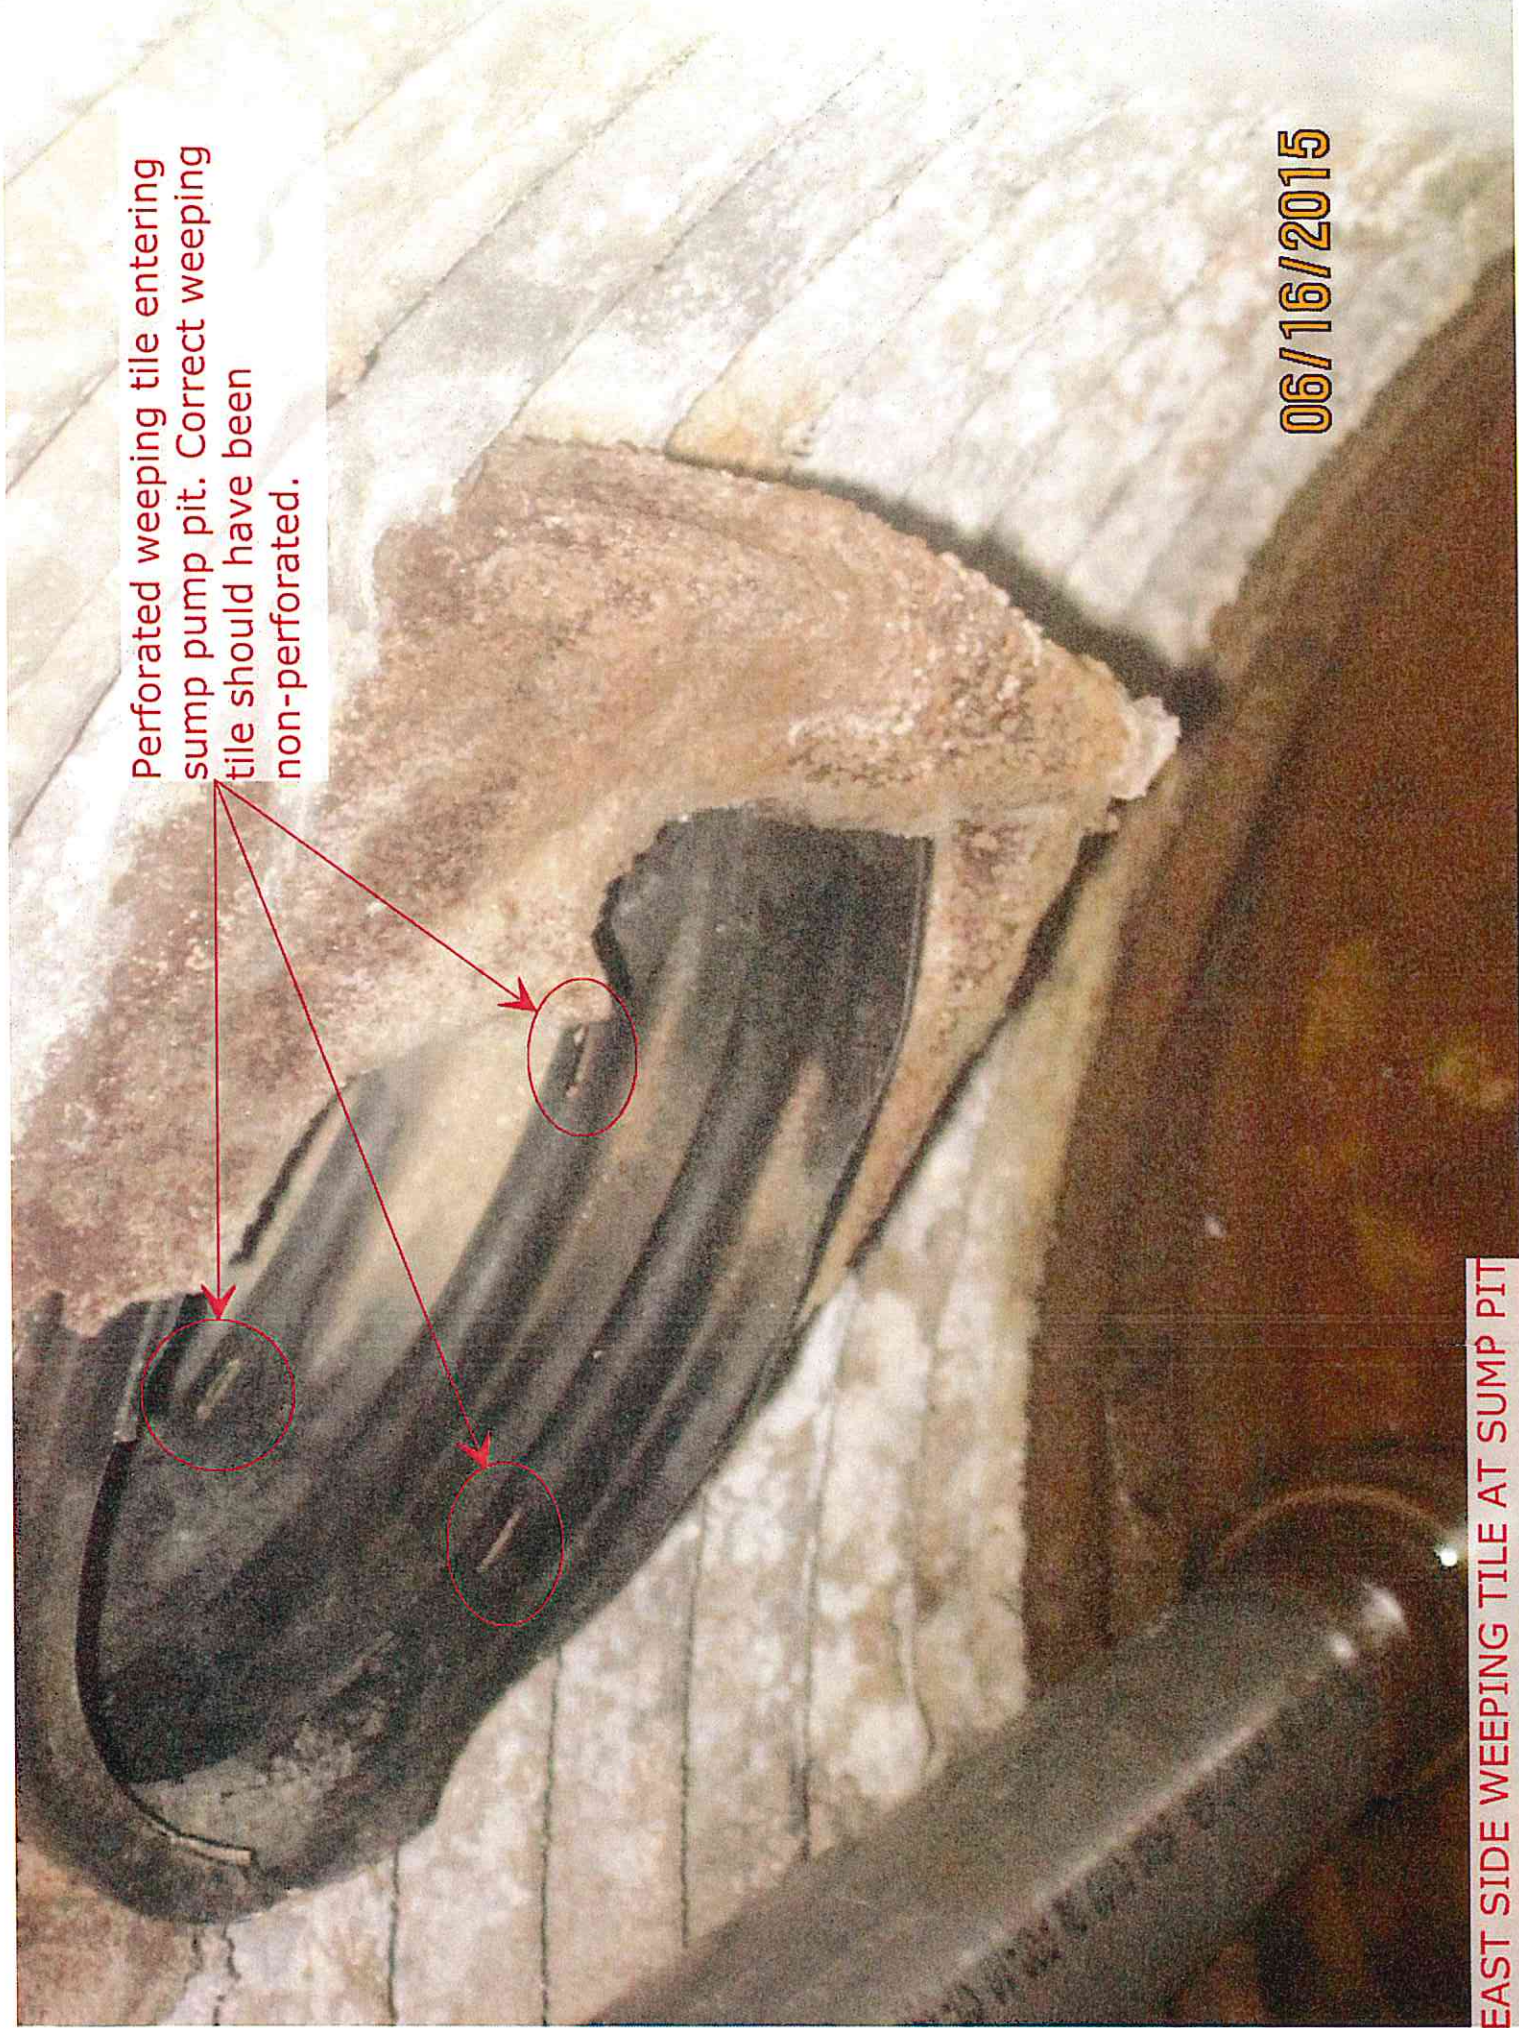
EAST SIDE WEEPING TILE AT SUMP PIT

The writer noted the North and East connections in the sump pit were found to be perforated type weeping tile leading to believe there was *no solid weeping tile (non-perforated) installed from below the grade beam to the sump pit*. It is good practise to install a solid line of weeping tile c/w with a minimal 1% slope directly from perforated weeping tile installed outside of the grade beams (see attached photo and design detail) to a sump pit within a crawlspace. This required *“non-perforated”* weeping tile to be installed in sloped trenches is then connected to perforated weeping tile all of which is installed beneath the crawlspace floor. Based on our findings *we conclude there was no non-perforated weeping tile* installed to carry water into the sump pit examined.

The above noted scenario and noted detail is the correct design intent for collection and distribution of water within any weeping tile system. Based on our findings we question if the *non-perforated* weeping tile was ever used as the main connection run routed through the crawlspace and into the sump pits. We refer you to the attached (enlarged) photo that clearly shows the weeping tile penetrating the sump pit as having perforations giving evidence to the use of incorrect weeping tile used as "main connection run".

Perforated weeping tile entering sump pump pit. Correct weeping tile should have been non-perforated.

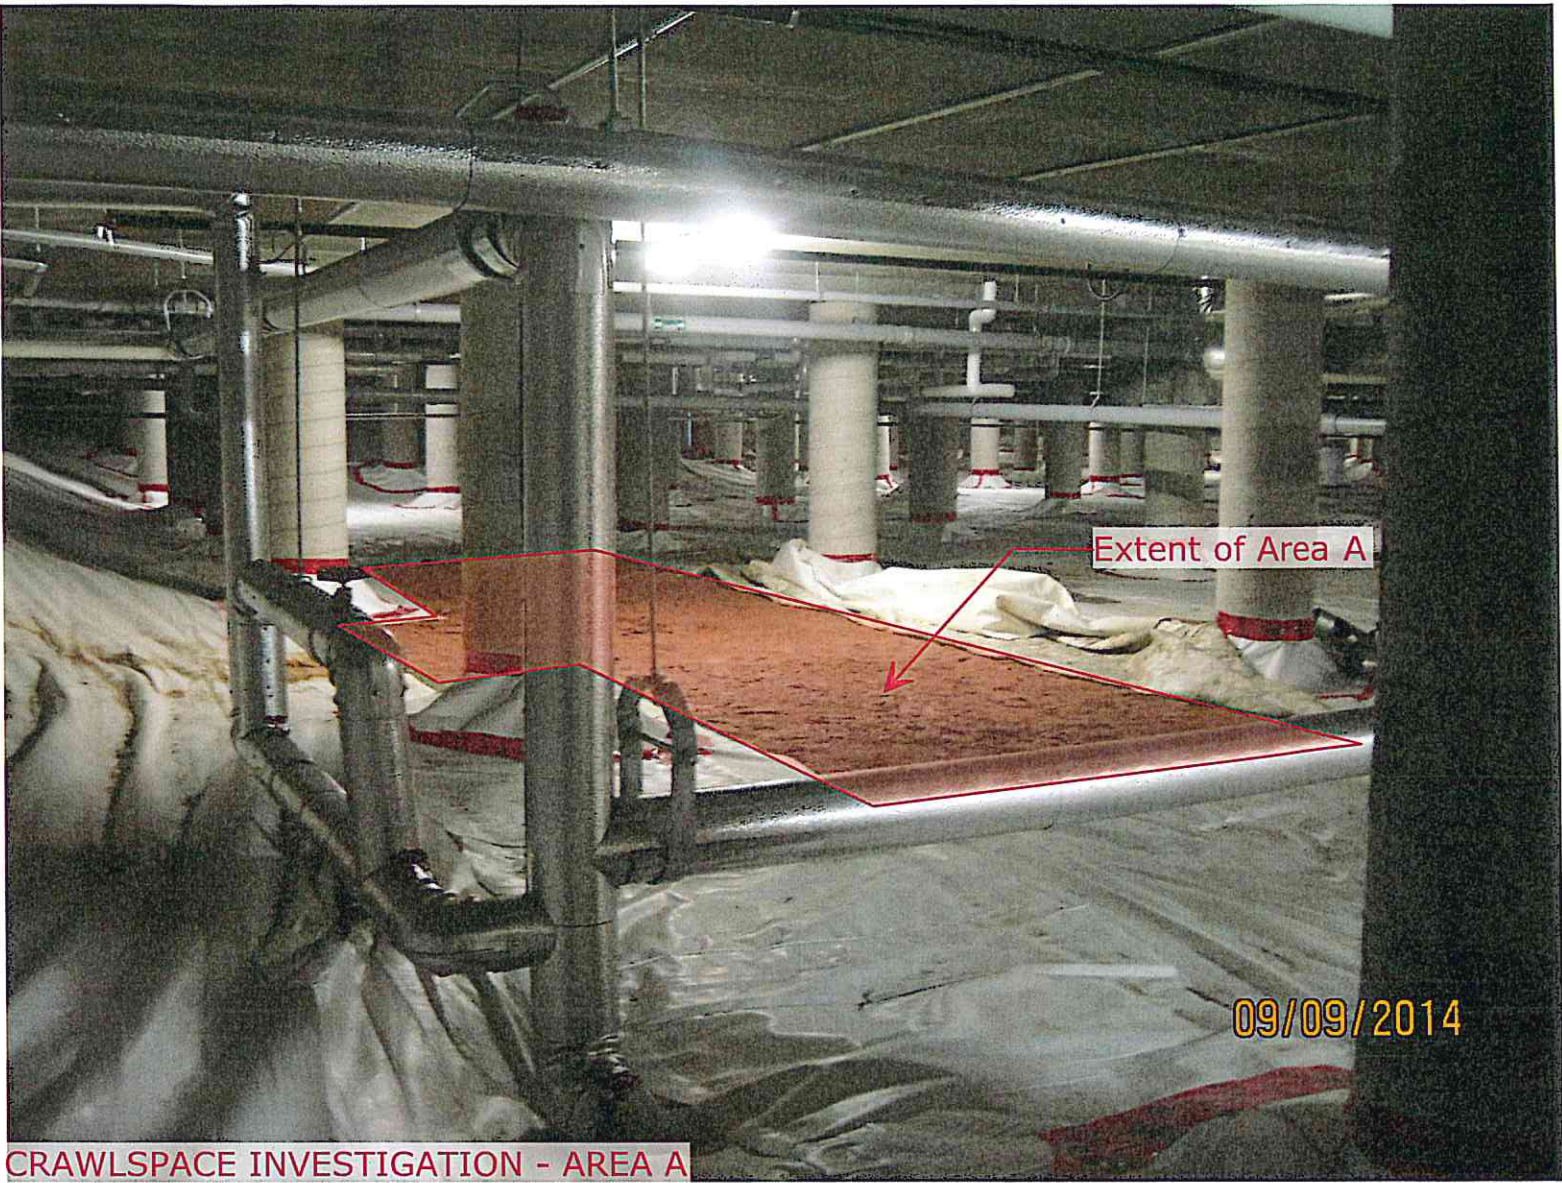
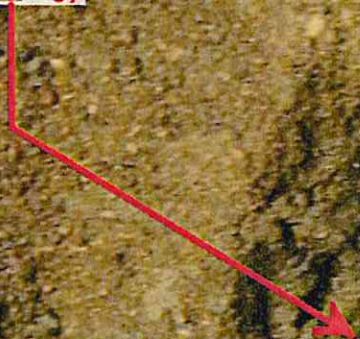
SOIL CONDITION AT AREA A

Excessive water saturation in soil.

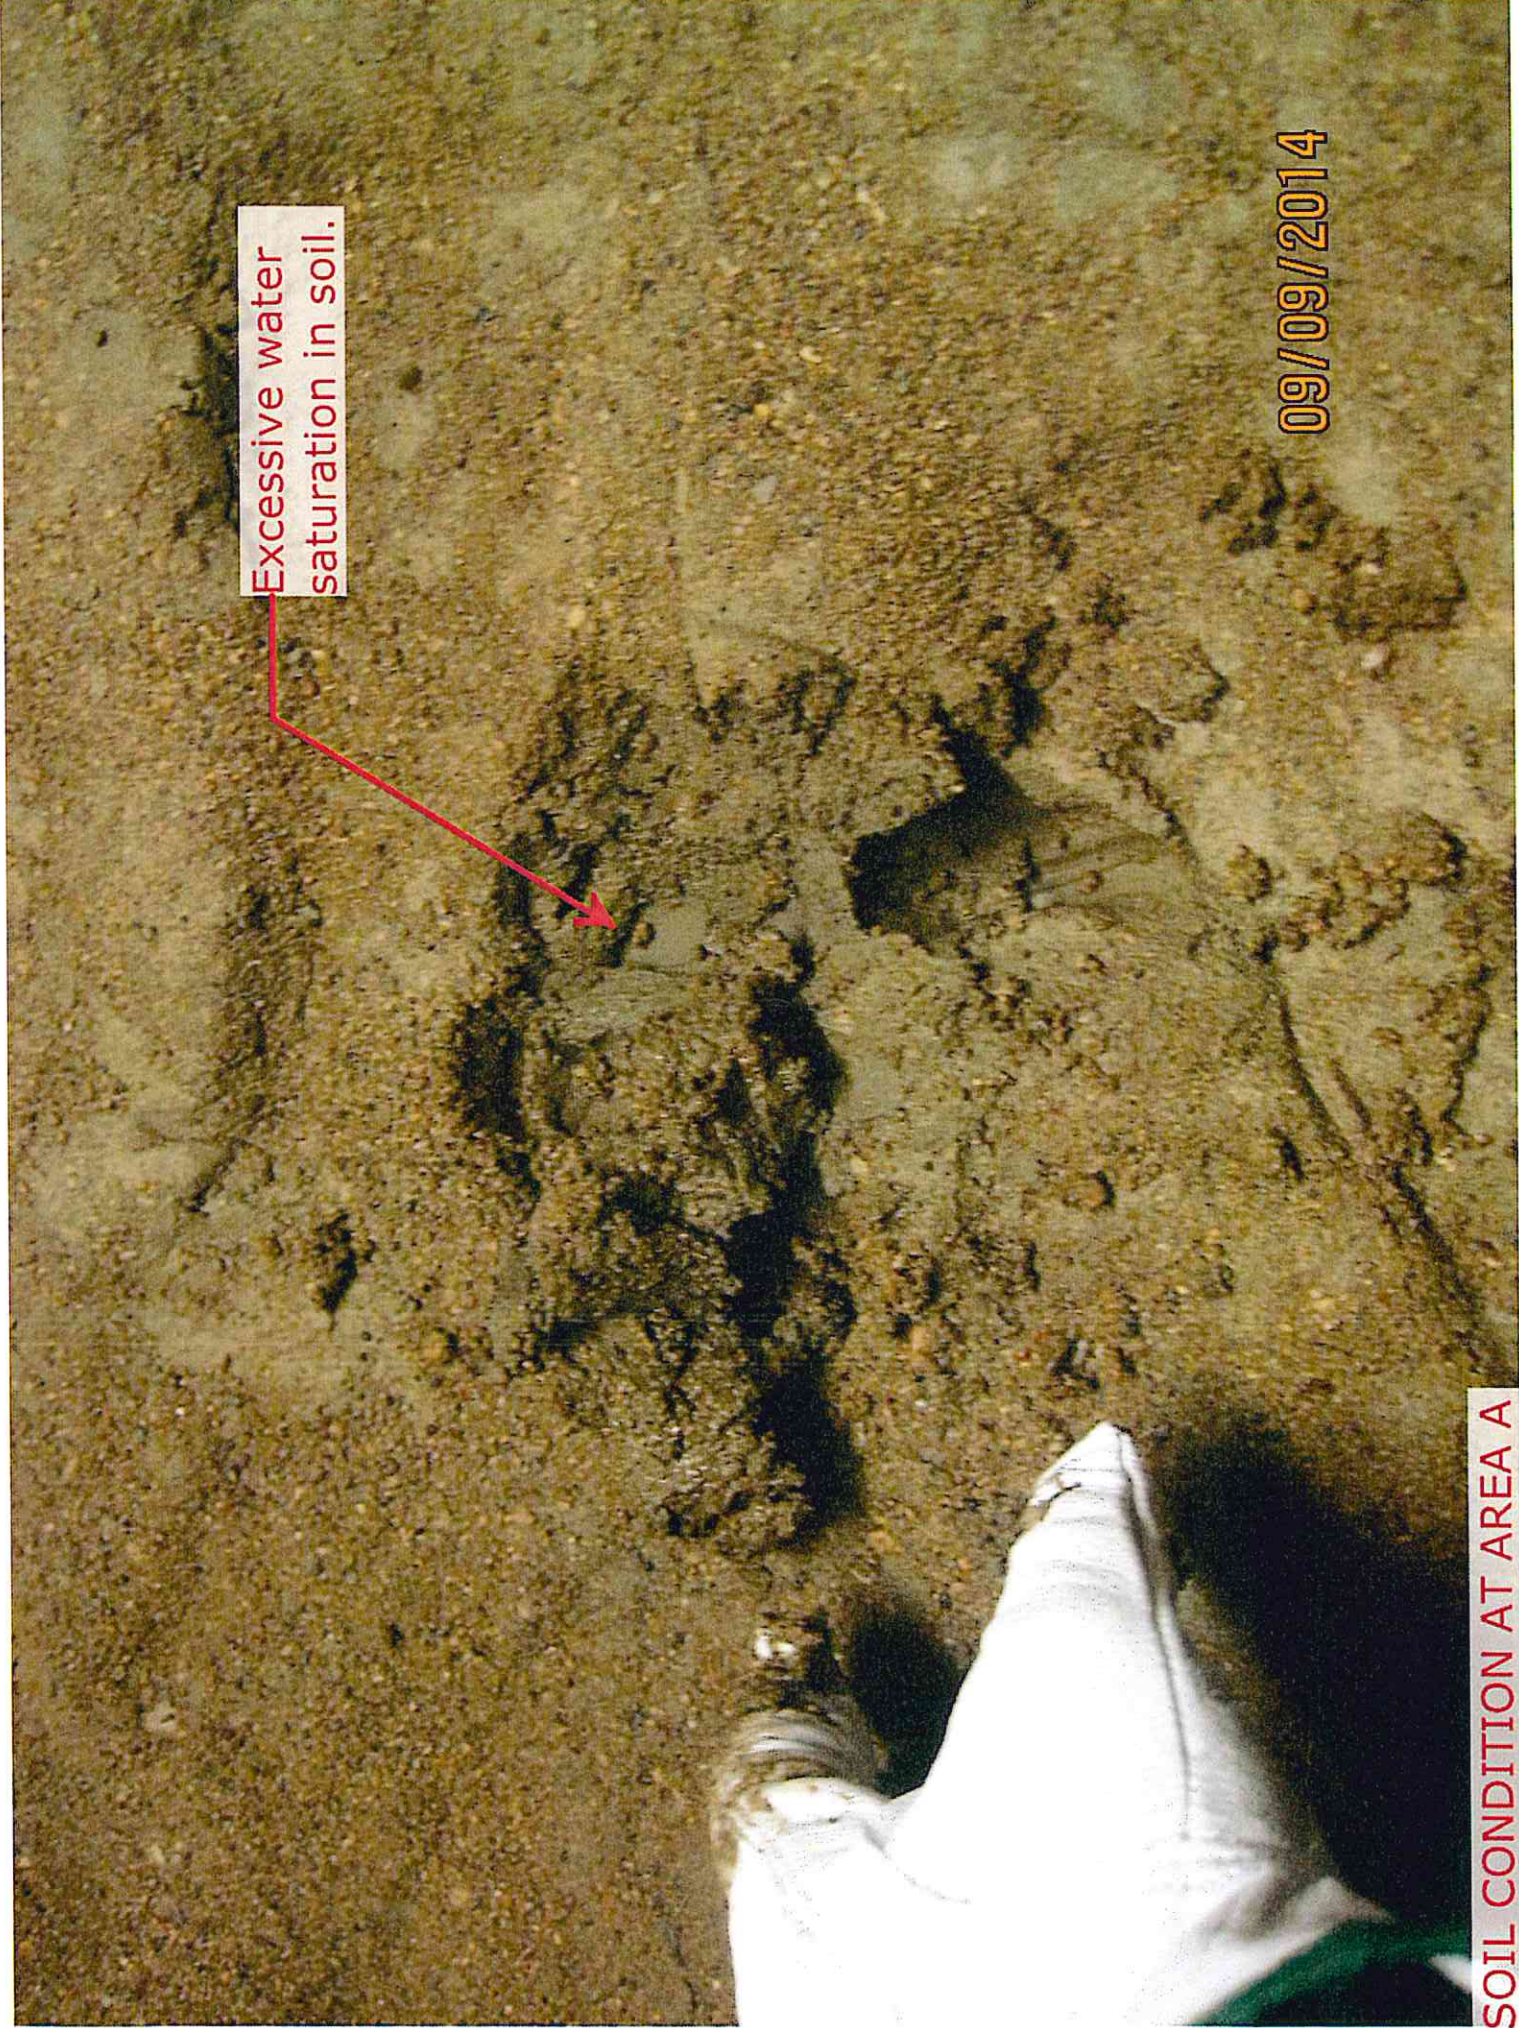
CRAWLSPACE INVESTIGATION - AREA A

This area located between grids G-F / 6-7 had the Permalon removed exposing the saturated soil of the crawlspace. It was clear this area had been taking on moisture over a long period of time. The soil was comprised of a slight amount of sand and majority of clay, with the clay having maximized the amount of absorption it was capable of during this long period of time (see photos dated September 9th, 2014). We had revisited the site on July 16th 2015 and concluded considerable amount of drying had occurred (see photos) and most likely due to low levels of water infiltration having taken place thus allowing for this to occur. This area was still saturated approximately 10 months after our initial review.

Area located between grid lines G-F and 6-7 showing heavily saturated soil. Soil comprised of mostly clay and a slight amount of sand.

Permalon removed.

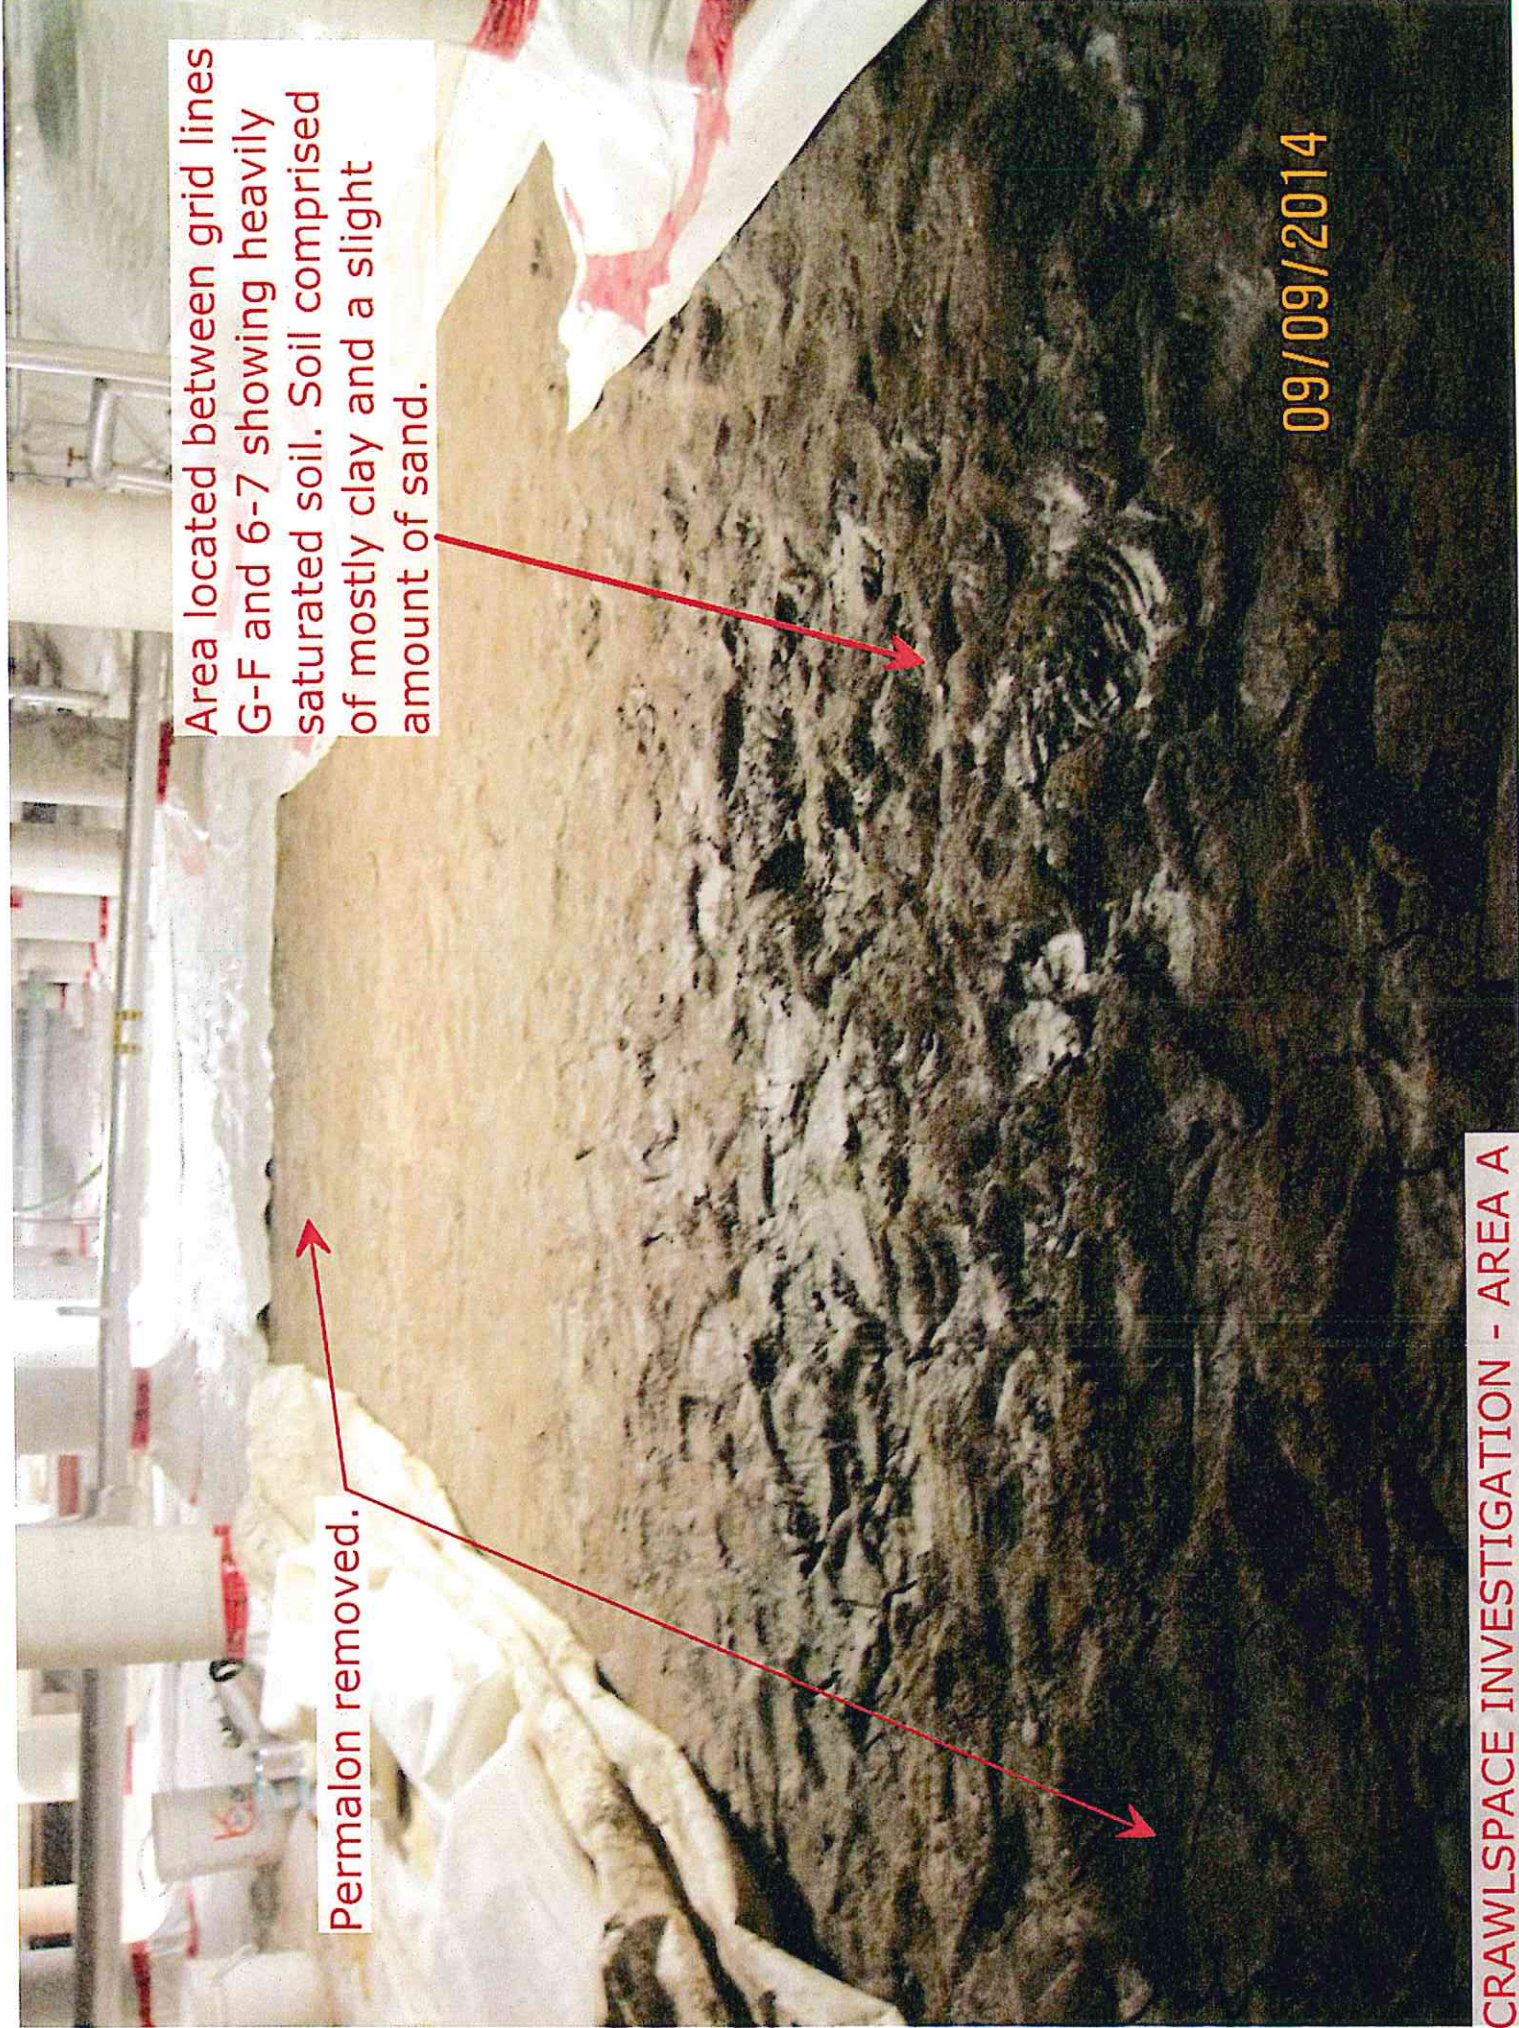
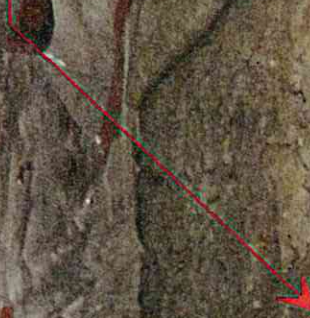
RAWLSPACE INVESTIGATION - AREA A

HEAVILY SATURATED AREA

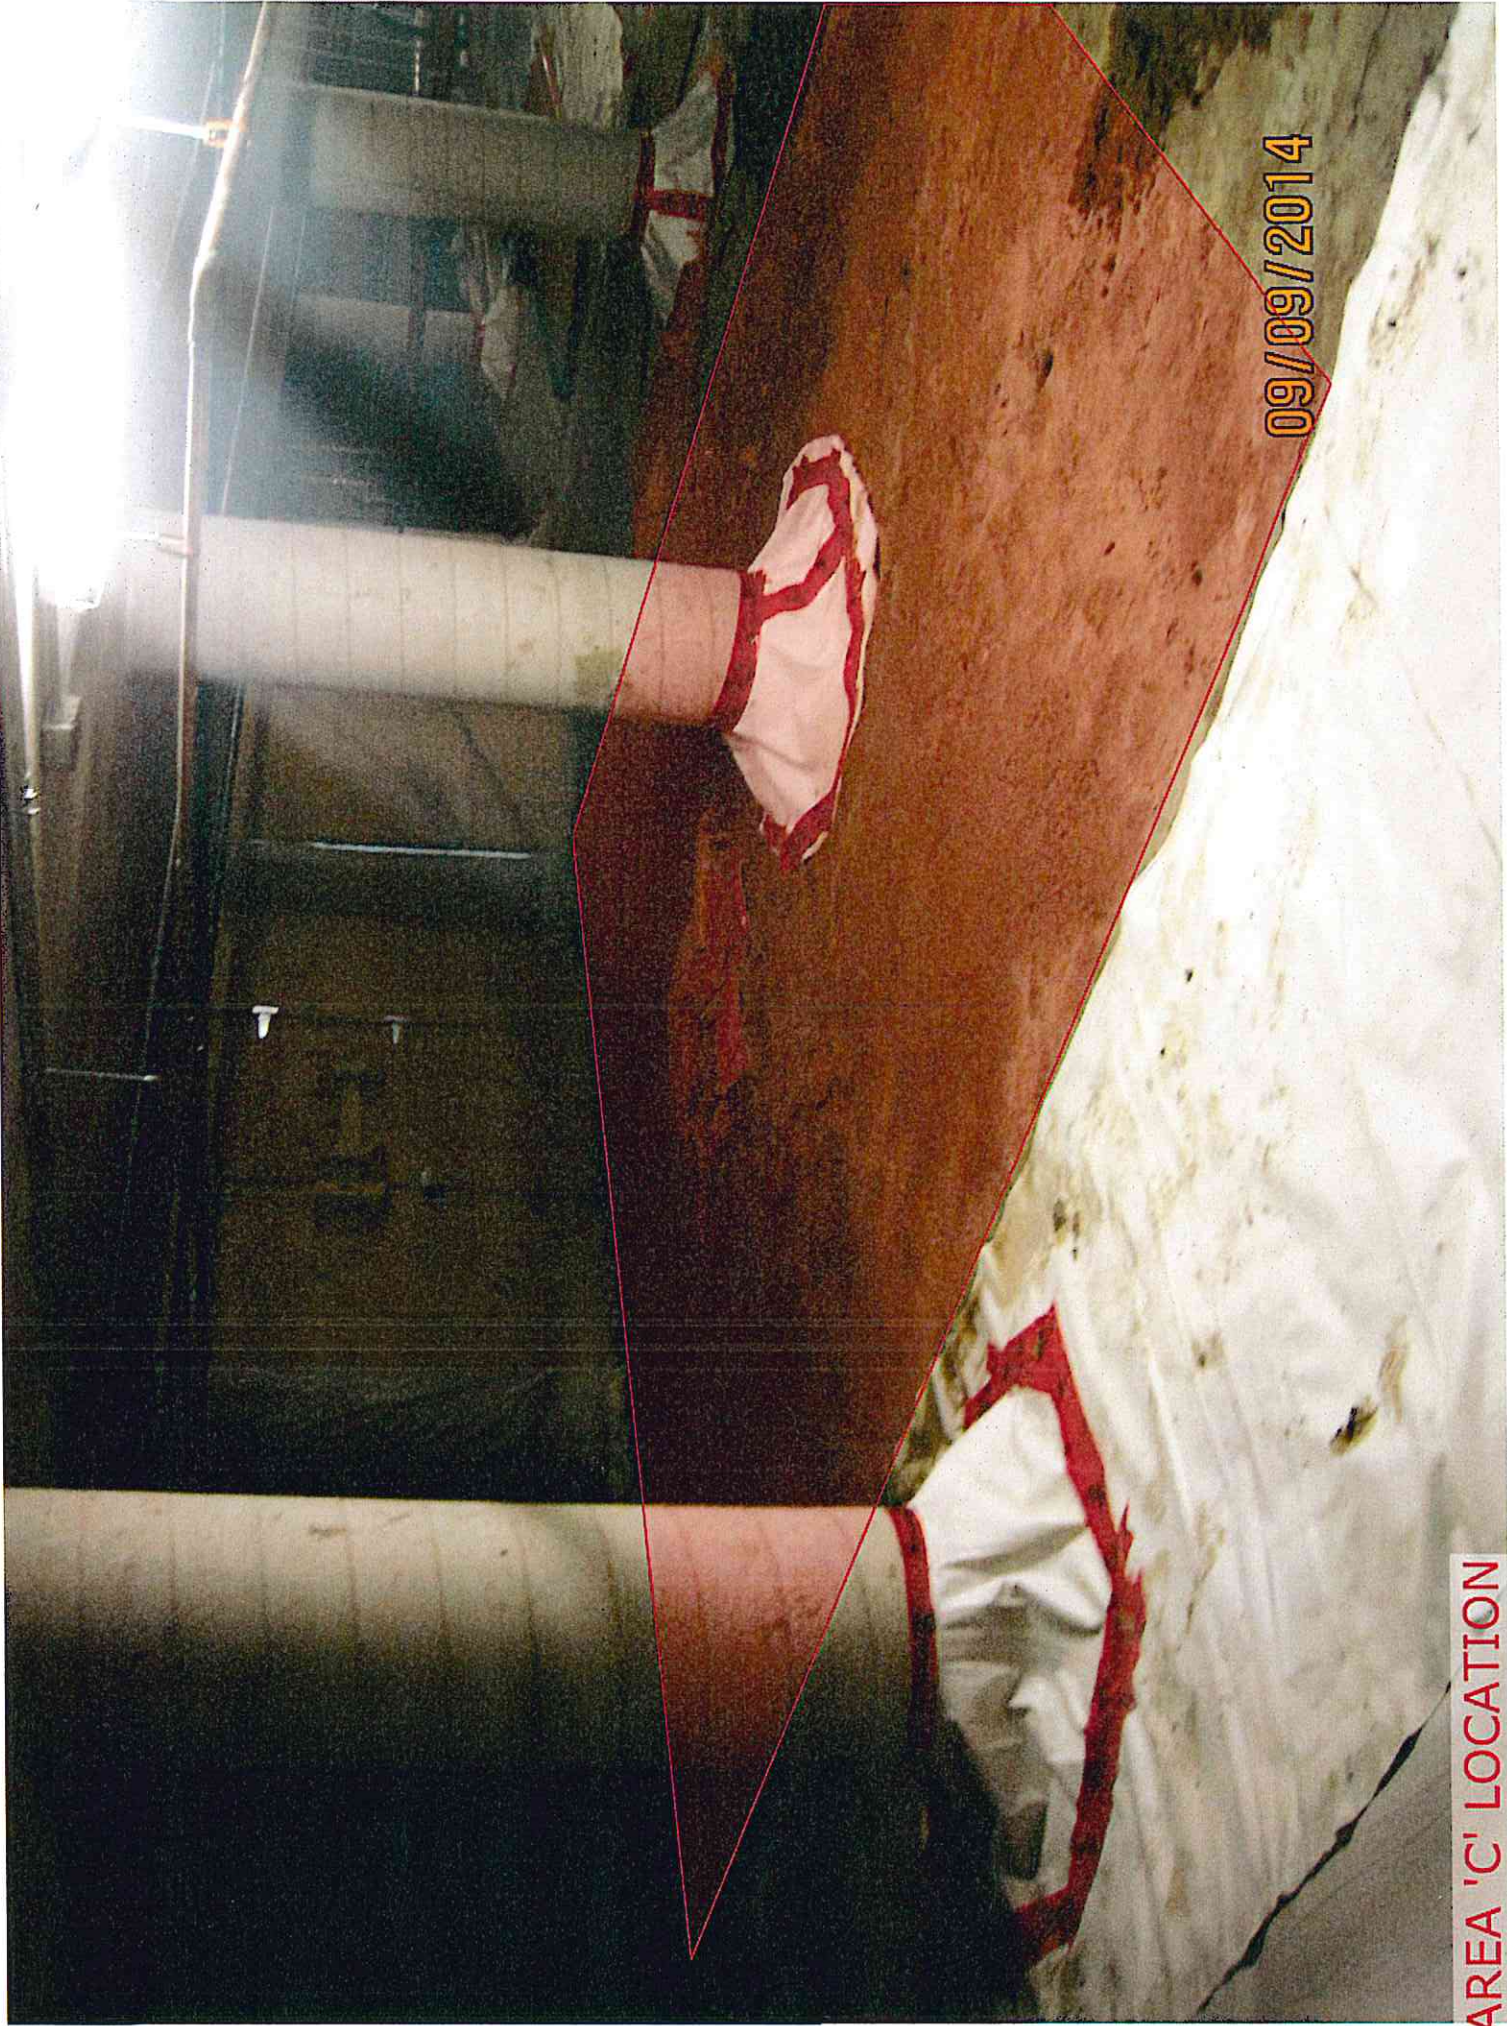
AREA 'C' LOCATION

The area known as “Area C” is located in front of the future knock out panel and new tunnel entry. This area had the largest amount of permalyn removed and was considered the most heavily saturated area in overall square footage. There was evidence of sever saturation similar to that found in Area “A”.
