December 22, 2015

Re: Food Services Building – Investigation of Saturated Crawlspace

Ft3 Architecture Landscape Interior Design were commissioned by Public Works and Government Services Canada to investigate saturation of an existing crawlspace found within the Food Services Building located at the RCMP Training Depot in Regina, Saskatchewan.

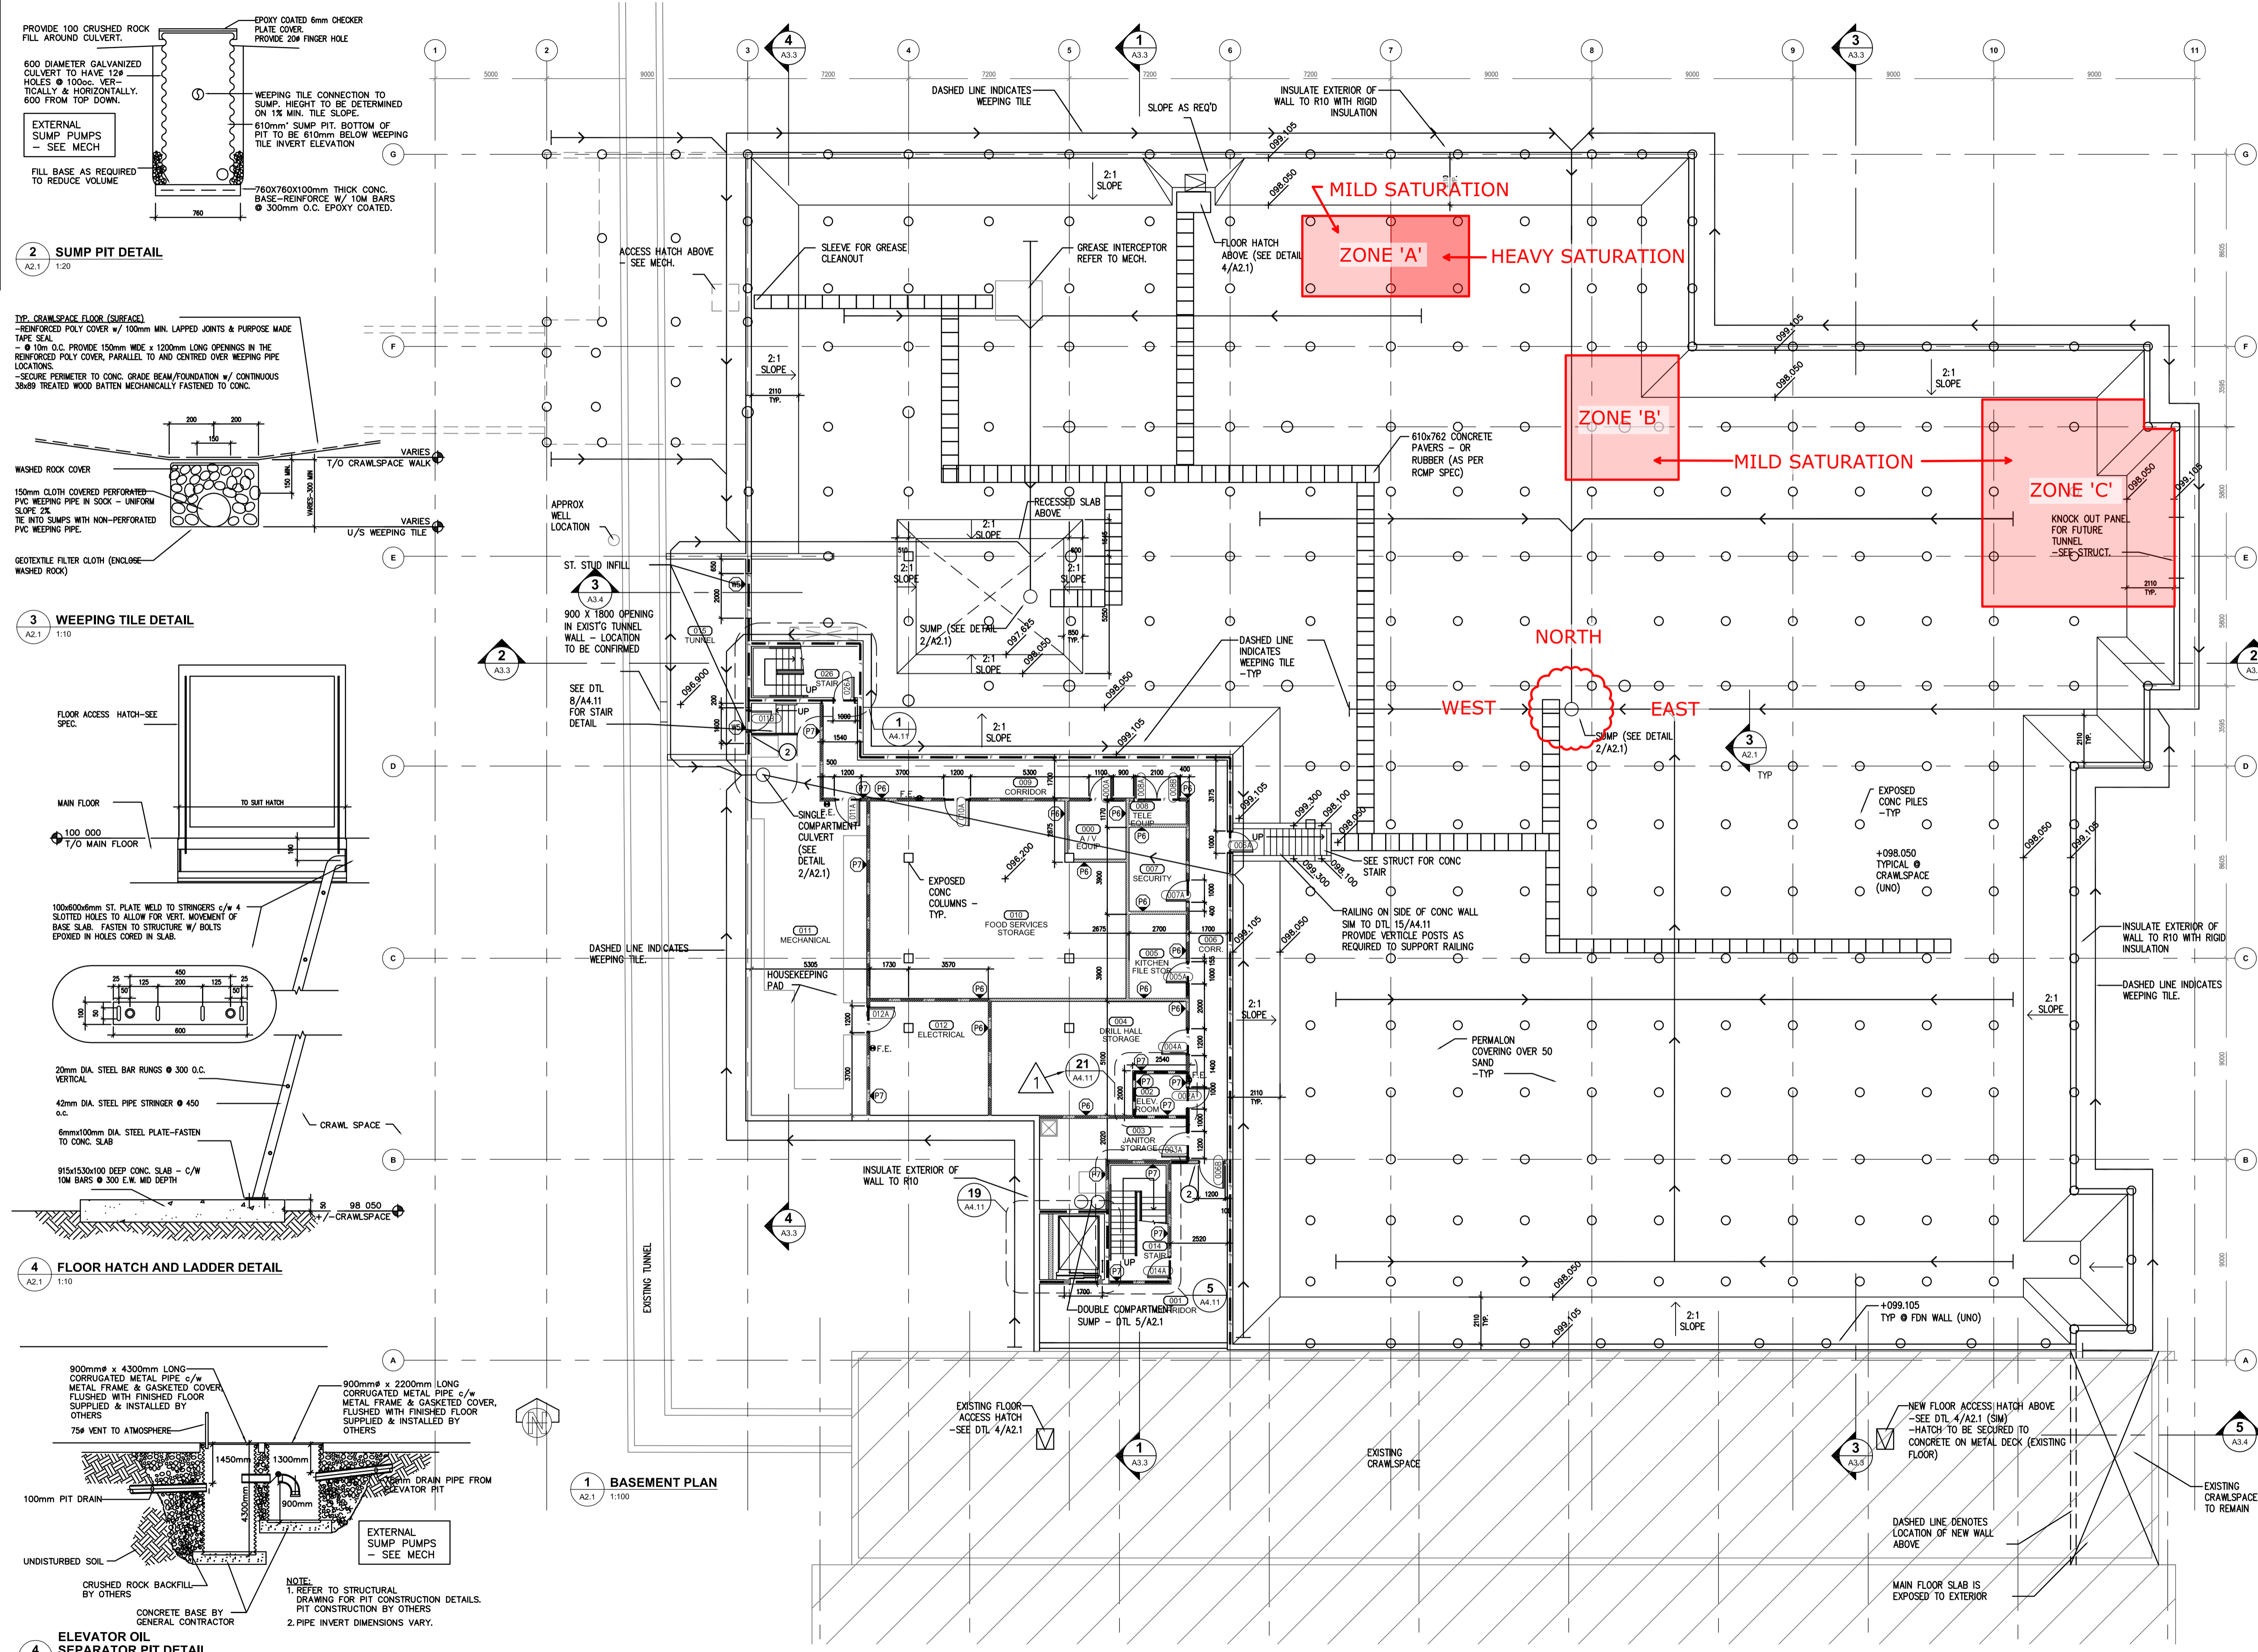
Drawing title/Titre du dessin
BASEMENT & CRAWLSPACE PLAN

There were three notable locations of sever water saturation and these are identified on the attached weeping tile drawing (A2.1) of the crawlspace. The following report will serve to identify possible rationale as to why the saturation is occurring based on our findings and go to provide recommendations in providing further in-depth investigation.

The writer, while en-route to the other notable exposed area of the crawlspace floor (Area “C”), found Area “B” to also be very saturated (see drawing A2.1 attached). The permalyn had not been removed in this area however the soil beneath the permalyn was found to be very soft. The permalyn was not removed and the writer took note of the extent of size of saturation evident and this is shown on the attached drawing.

In reviewing the attached drawing A2.1 the writer identified the sump pit located west of grid 8 between grids E-D as the sump pit servicing weeping tile routed through or adjacent those saturated areas of crawlspace floor noted above.

The use of Non-perforated weeping tile is a requirement for the "main connection runs". These main connection runs tie into the exterior perforated perimeter weeping tile at the grade beams and the interior crawlspace perforated weeping tile also connect to these main connection runs which are routed to the sump pits. Detail 3/A2.1 on attached drawing A2.1 (*Basement and Crawlspace Plan*) clearly identifies the perforated weeping tile required within the interior of the crawlspace and is to be connected to the Non-perforated weeping tile which is then routed into the sump pits. This is evident by the notation under detail 3/A2.1 "tie into sump pits with non-perforated PVC weeping pipe".
