MACHIAS SEAL ISLAND LIGHTHOUSE RESTORATION

SECTION DETAIL PHOTOS

A300

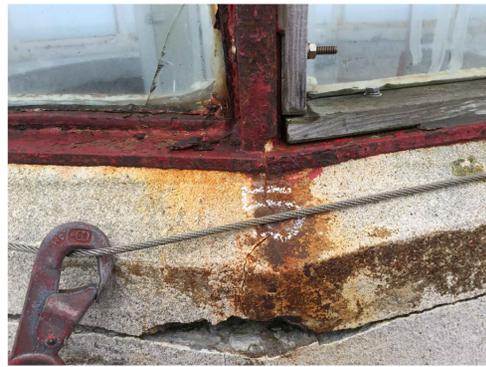
PHOTO 02 - DETAIL VIEW OF DAMAGE AT EXTERIOR LANTERN CONCRETE CURB. REPAIR CONCRETE; REFER TO STRUCTURAL.

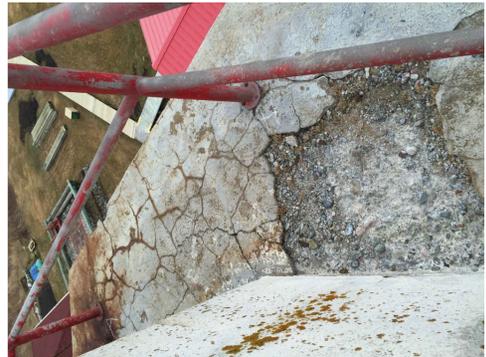
PHOTO 06 - TYPICAL CONDITION OF GALLERY LEVEL SLAB. TO BE REBUILT AND NEW TRAFFIC COATING PROVIDED. NEW RAIL TO BE 125mm FROM GALLERY EDGE. REFER TO DETAIL 1/A500.

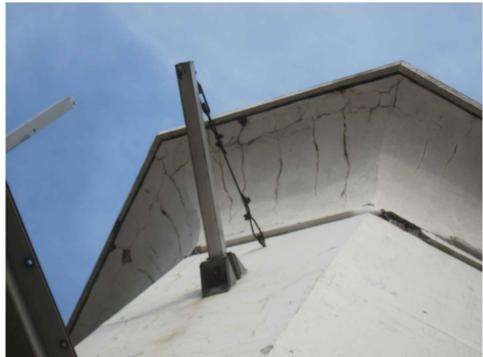
PHOTO 05 - TYPICAL CONDITION OF UNDERSIDE GALLERY LEVEL SLAB TO BE REBUILT. EXISTING METAL BRACKET TO BE DISASSEMBLED AND STORED. PENETRATIONS TO BE SEALED, REFER TO STRUCTURAL.

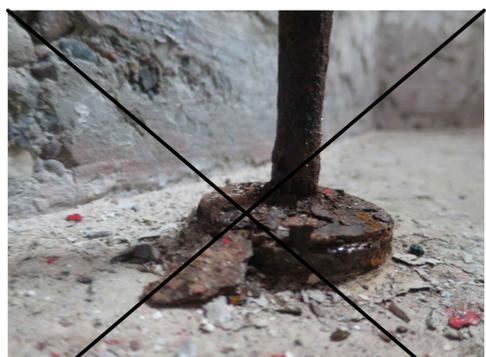
PHOTO 04 - DETAIL OF EXISTING RO5 BOOT TO BE REPLACED.

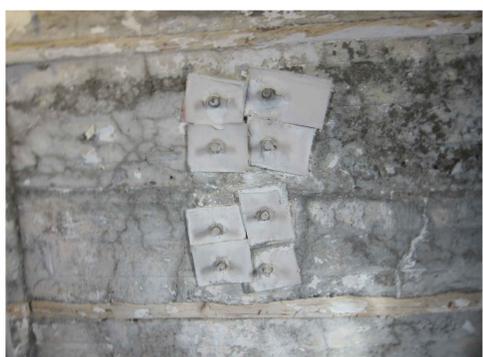
PHOTO 03 - DETAIL OF ANCHOR BOLTS TO BE REMOVED AND HAND PATCHED.

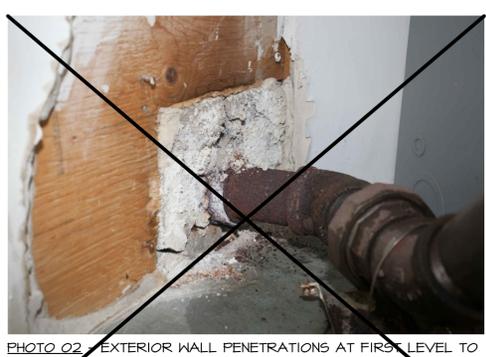
PHOTO 02 - EXTERIOR WALL PENETRATIONS AT FIRST LEVEL TO BE PROPERLY SEALED WITH FIRE PROTECTION AROUND EXHAUST. PROVIDE NEW DRYWALL FINISH, PRIME & PAINT.

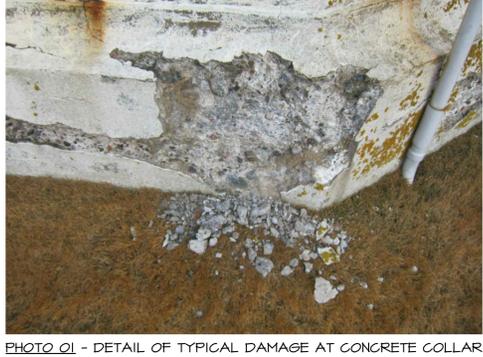
PHOTO 01 - DETAIL OF TYPICAL DAMAGE AT CONCRETE COLLAR BASE. COLLAR TO BE CHIPPED BACK TO SOUND MATERIAL AND REBUILT. REFER TO STRUCTURAL.
