**MACHIAS SEAL ISLAND
LIGHTHOUSE
RESTORATION**

DETAIL PHOTOS

R.080316.001

A301

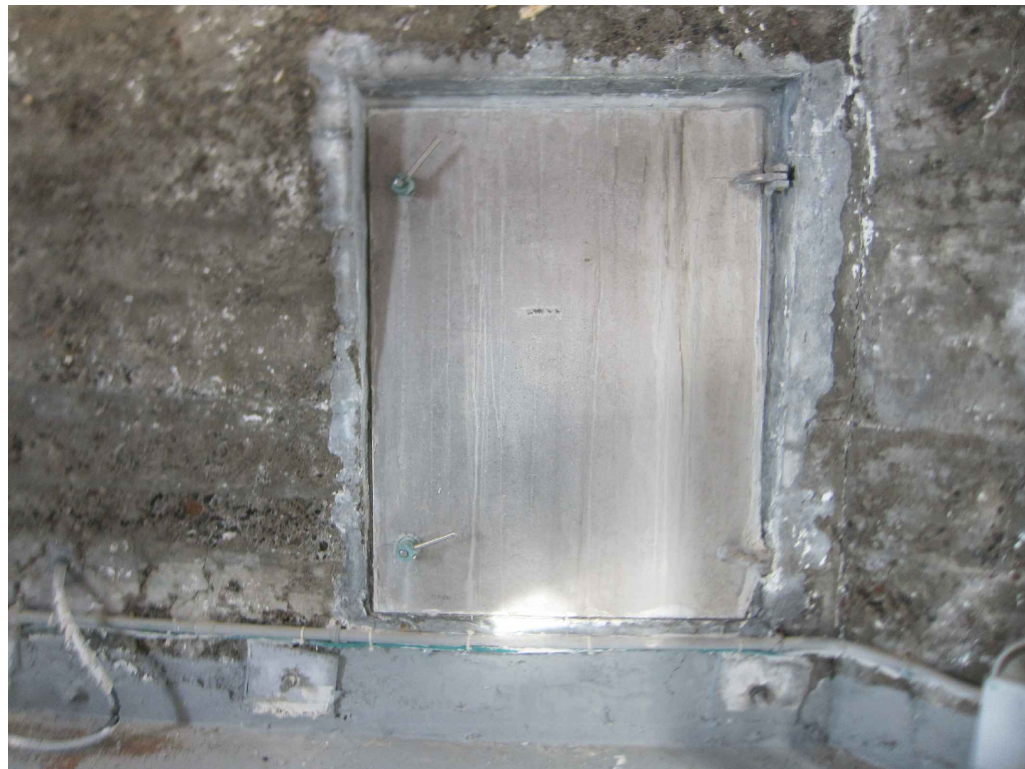
PHOTO 15 - INTERIOR OF SECOND FLOOR PLATFORM ACCESS DOOR. REMOVE DOOR, ROUGHEN EDGES AND FILL WITH CONCRETE. REFER TO STRUCTURAL.

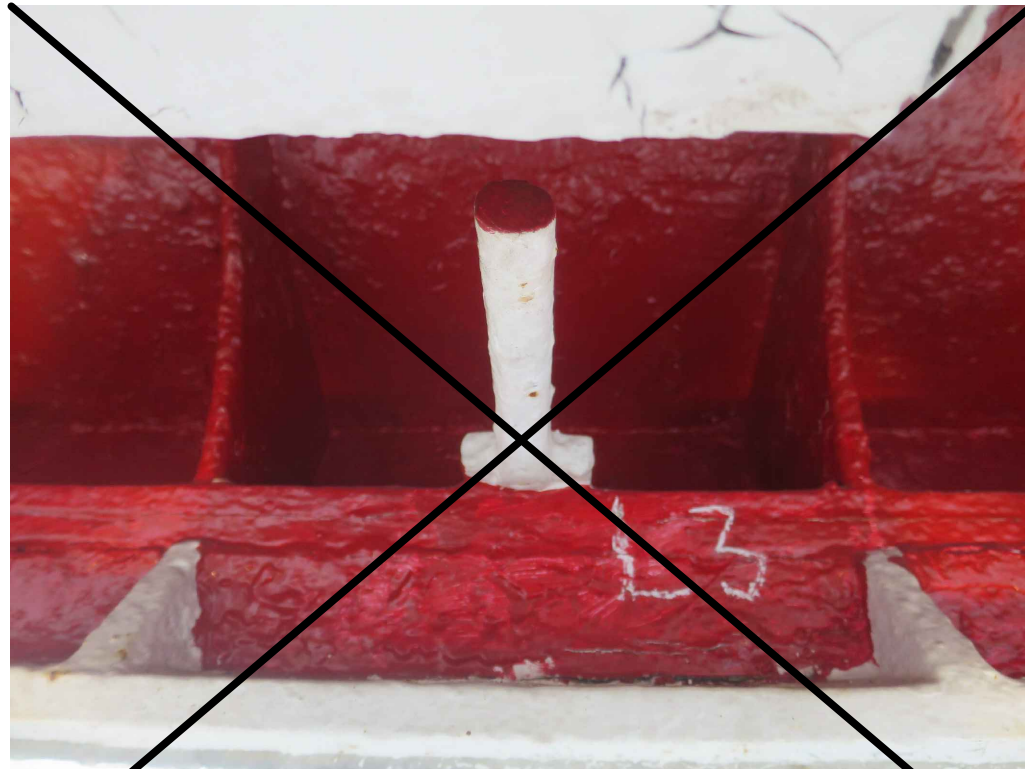
PHOTO 12 - DETAIL VIEW OF INTERIOR LANTERN TIE BAR TO BE REPLACED TO MATCH ORIGINAL. REFER TO STRUCTURAL.

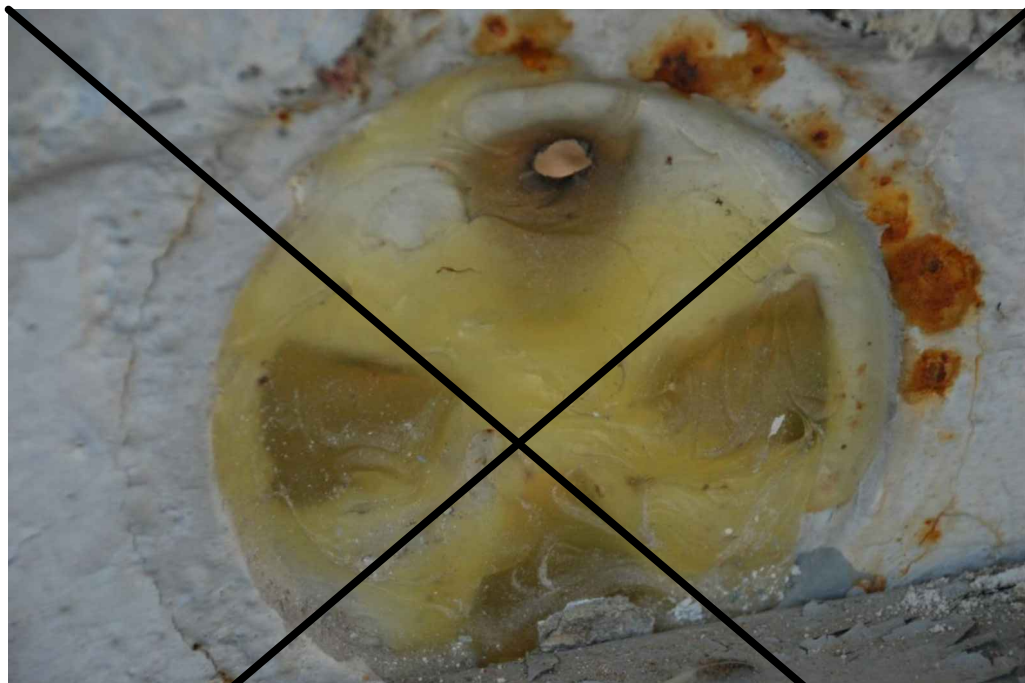
PHOTO 13 - DETAIL OF EXISTING LANTERN VENT WITH FAILED RUBBER SEAL, INTERIOR. REMOVE SEAL, PAINT AND CORROSION. PROVIDE REPLACEMENT CAP WITH GASKET AND INSTALL IN "CLOSED" POSITION. MAKE-GOOD ANY DAMAGE TO CONCRETE SUSTAINED DURING REMOVAL.

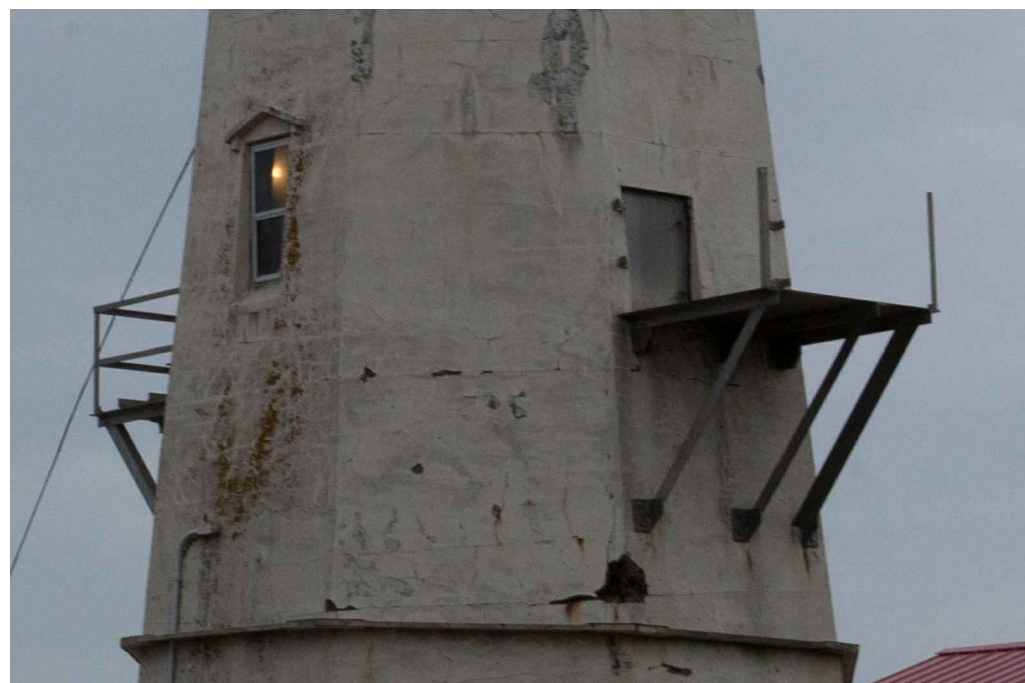
PHOTO 11 - EXISTING PLATFORMS TO BE REMOVED. EXISTING PLATFORM ACCESS DOORS TO BE REMOVED. REINSTATE CONCRETE TO MATCH EXISTING BOARD FORM FINISH. REFER TO STRUCTURAL.

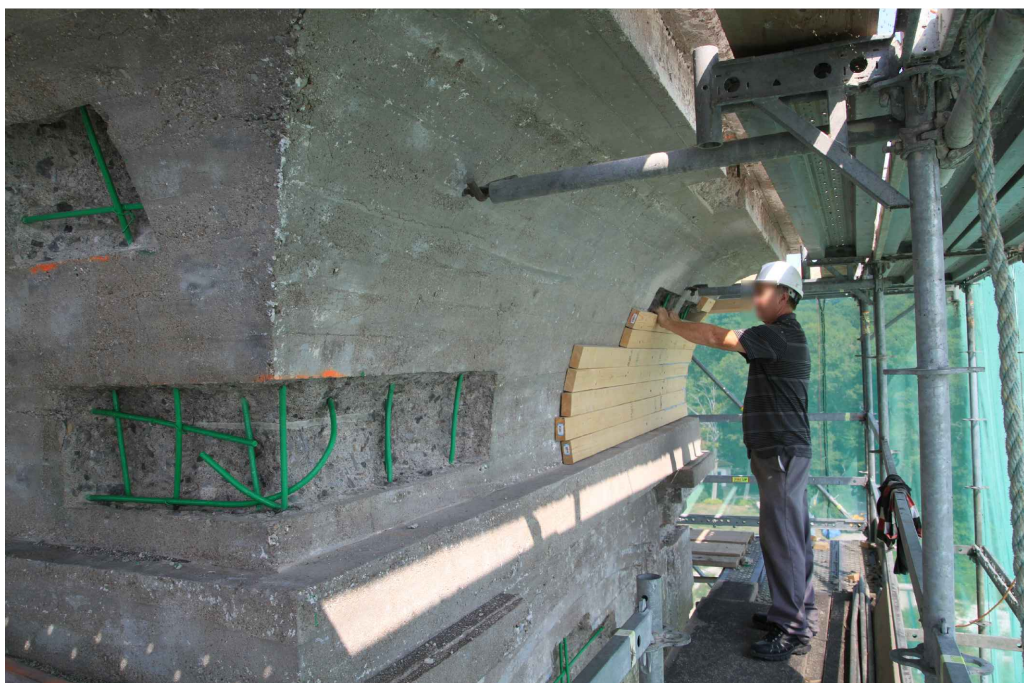
PHOTO 17 - EXAMPLE OF BOARD-FORMED CONCRETE FINISH TECHNIQUE BEING APPLIED AT POINT ABINO LIGHTHOUSE, ONTARIO. ALL CONCRETE REPAIRS TO HAVE BOARD FORMED FINISH.

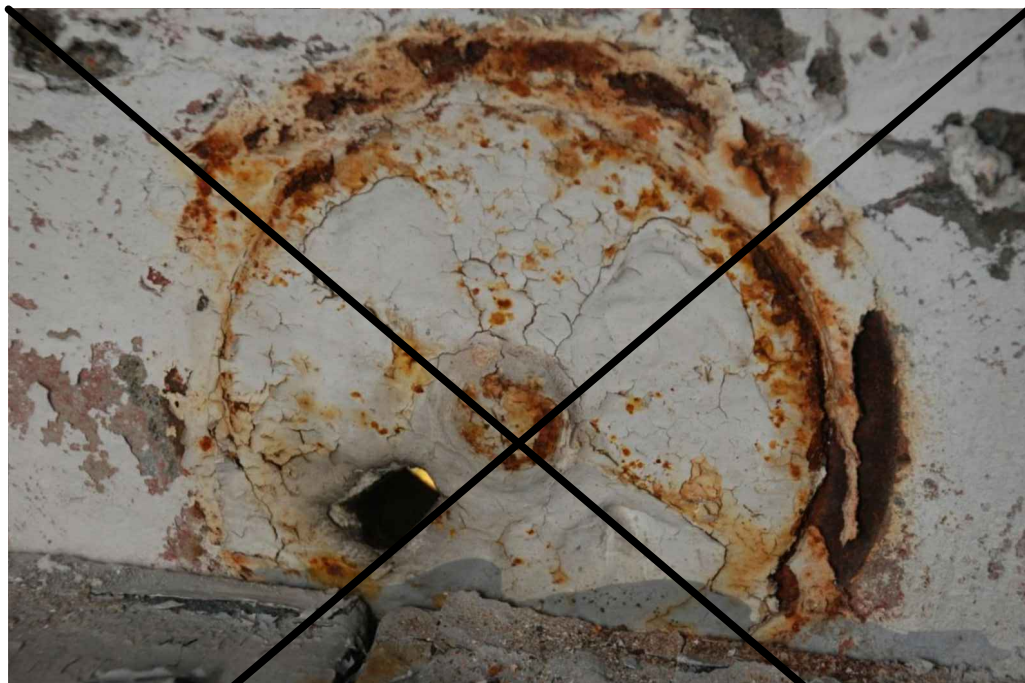
PHOTO 14 - DETAIL OF EXISTING LANTERN VENT, INTERIOR. REMOVE CAP AND REMOVE PAINT AND CORROSION. PROVIDE GASKET FOR SEAL AND REINSTATE CAP IN "CLOSED" POSITION. MAKE-GOOD ANY DAMAGE TO CONCRETE SUSTAINED DURING REMOVAL OF CAP.

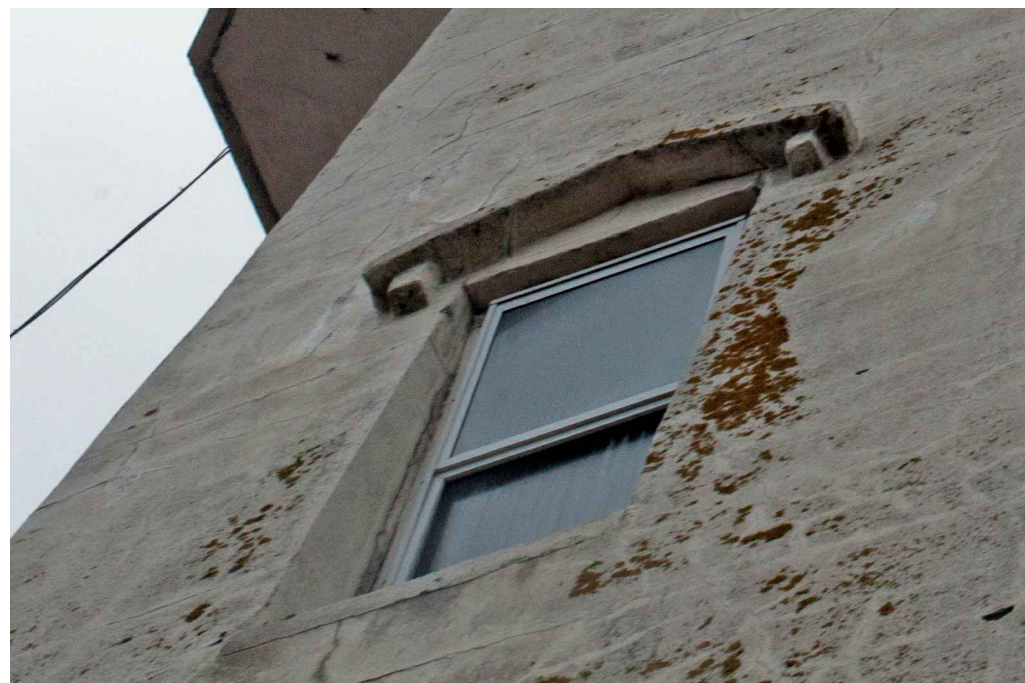
PHOTO 10 - TYPICAL CONCRETE PEDIMENTS AT WINDOWS W13, W14, W15 & W16 TO BE REPAIRED IN PLACE. NEW CONCRETE PEDIMENTS AT WINDOWS W17 & W18. REFER TO STRUCTURAL.

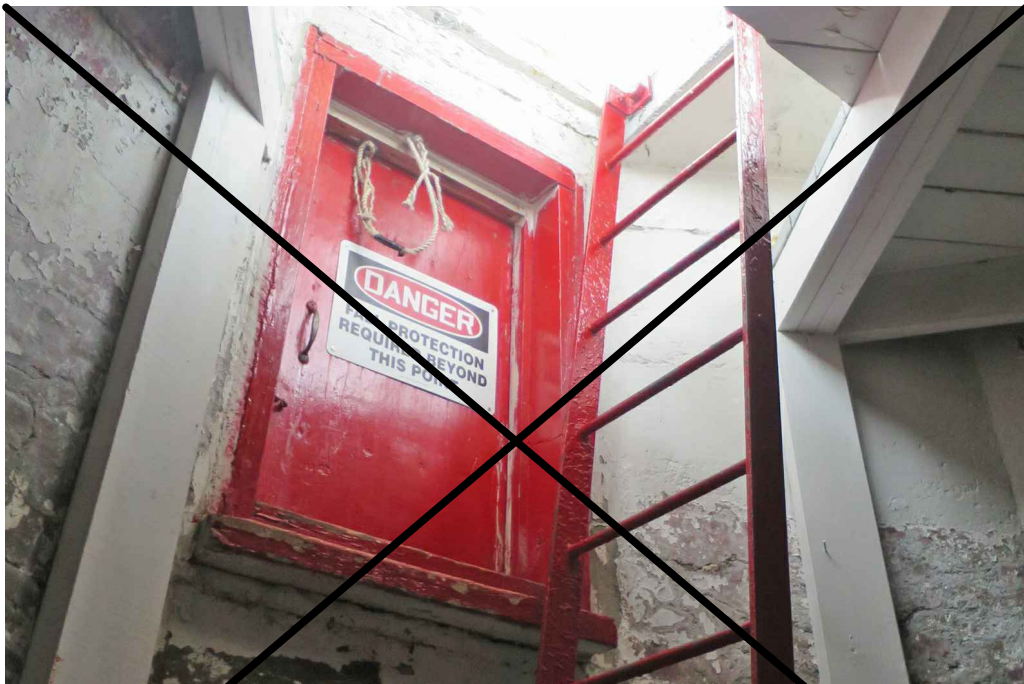
PHOTO 16 - INTERIOR OF GALLERY HATCH. SILL AND HEAD CASING ARE ORIGINAL AND ARE TO BE RETAINED. JAMBS AND DOOR TO BE REPLACED. REFER TO DETAIL 3/A500

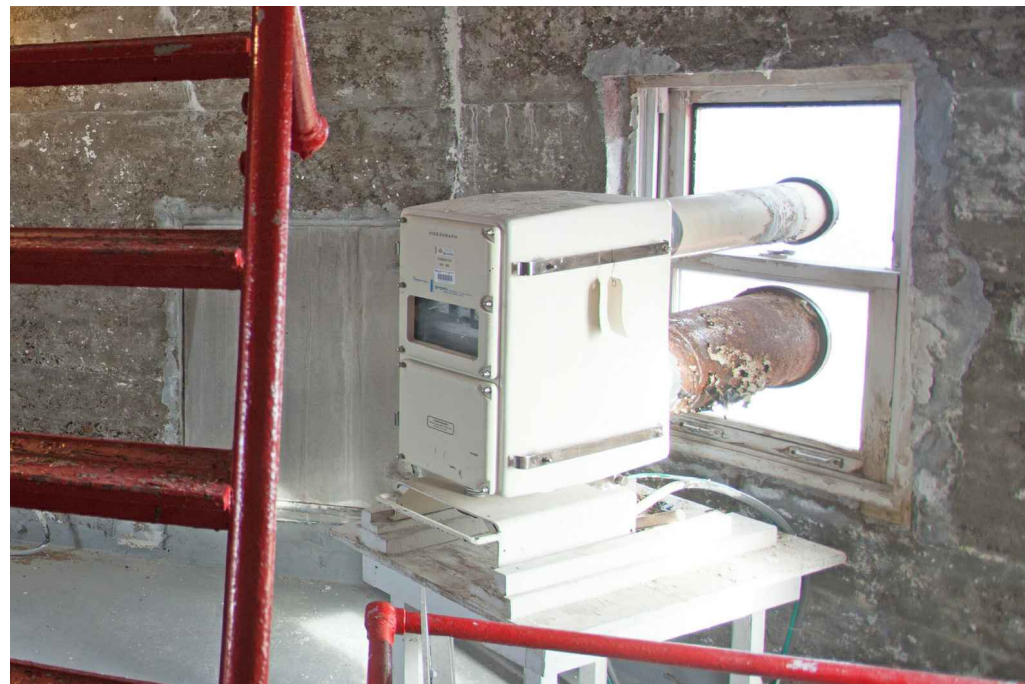
PHOTO 04 -INTERIOR VIEW SHOWING FOG DETECTOR TO BE REMOVED BY OTHERS. FOG DETECTOR WINDOW TO BE REMOVED WITH INSIDE FACE OF OPENING ROUGHENED AND FILLED WITH CONCRETE. REFER TO STRUCTURAL.
