Stantec Consulting Ltd.
845 Prospect Street, Fredericton NB E3B 2T7

June 8, 2016
File: 121812027

Reference: Limited Hazardous Building Materials Assessment, Machias Seal Island Lighthouse, Charlotte County, New Brunswick, LL# 6, DFRP# 03984, and RPIS# MD00190

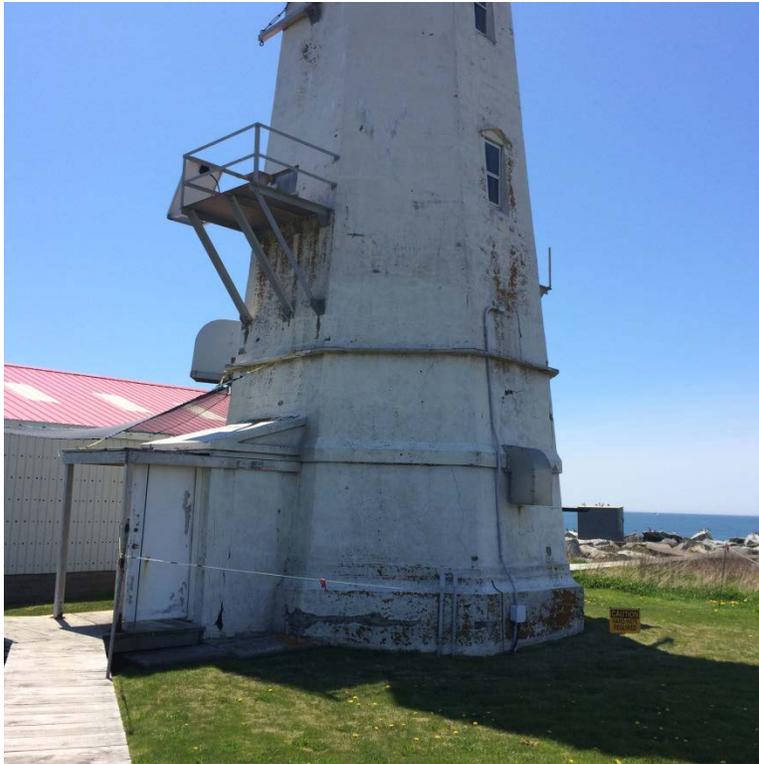
PHOTO 3: View of peeling white paint on the exterior of the light tower looking south.

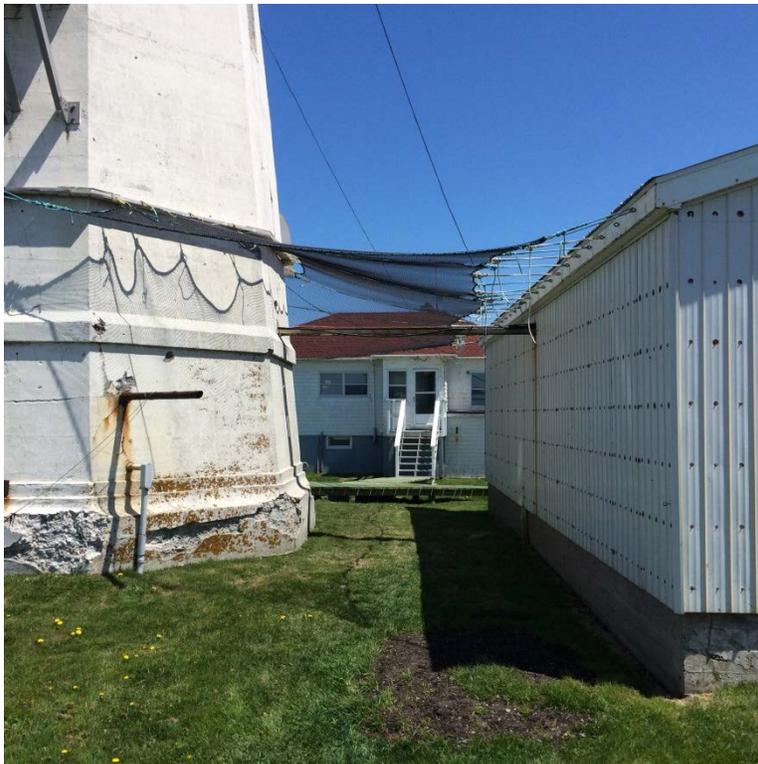
PHOTO 4: View of peeling white paint on the exterior light tower looking northeast. Note the crumbling concrete at the base of the tower.

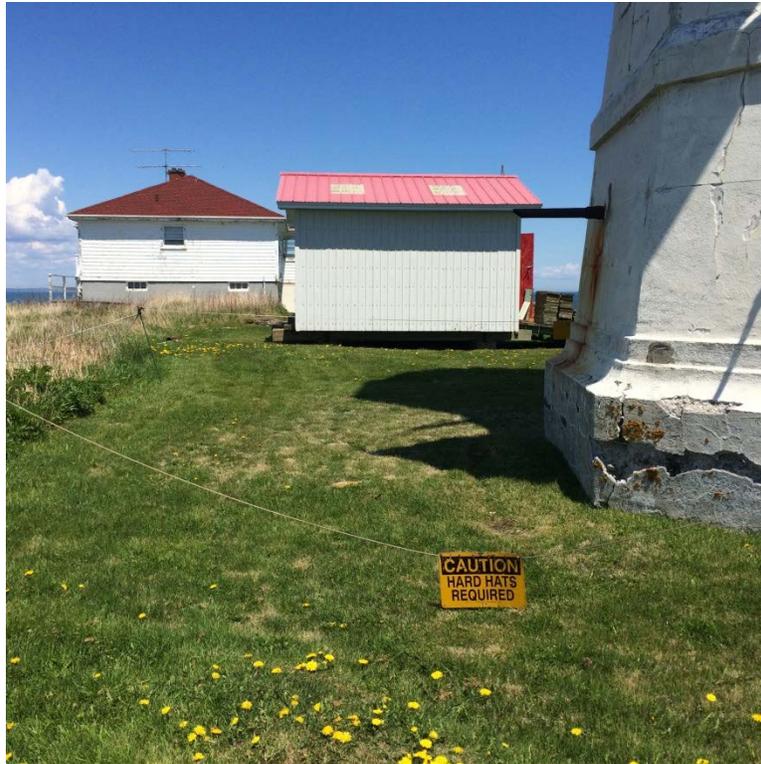
PHOTO 5: View of white paint on the exterior of the light tower looking north.

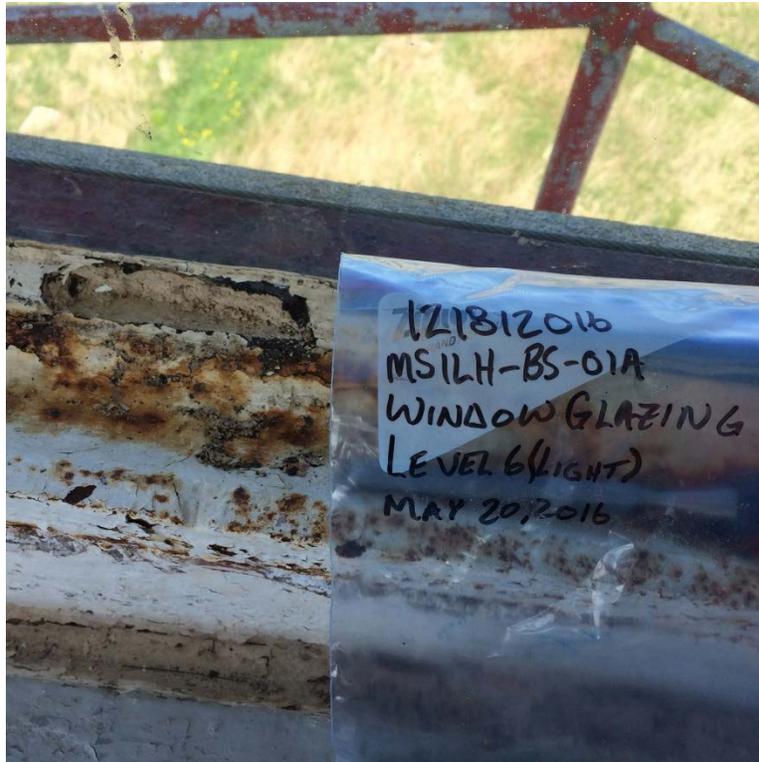
PHOTO 7: View of sample BS-01A (window glazing) obtained from window of Level 6 (light level). Asbestos was not detected in the sample.

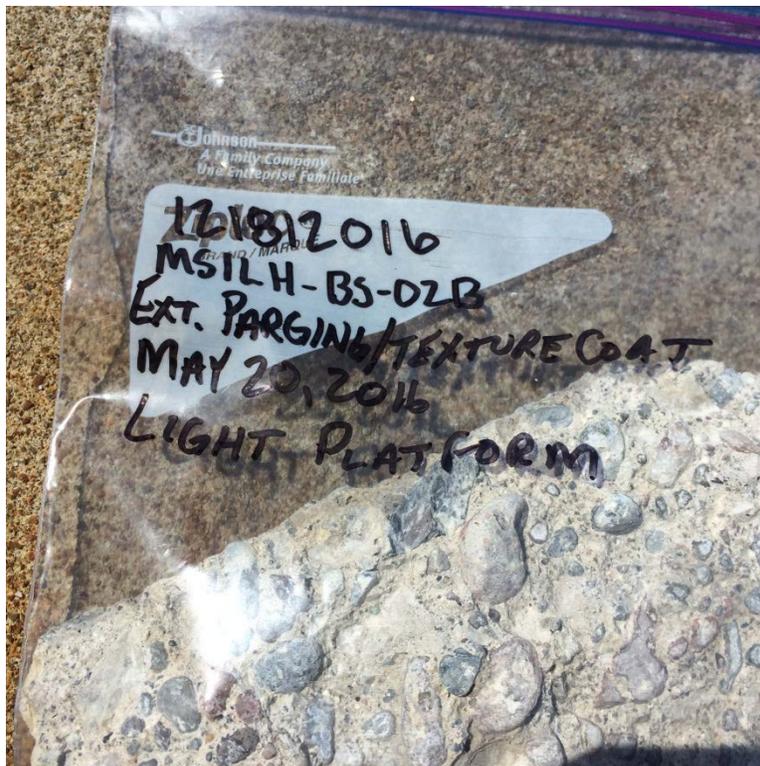
PHOTO 8: View of sample BS-02B (parging/texture coating) obtained from the exterior platform at the light level). Asbestos was not detected in the sample.

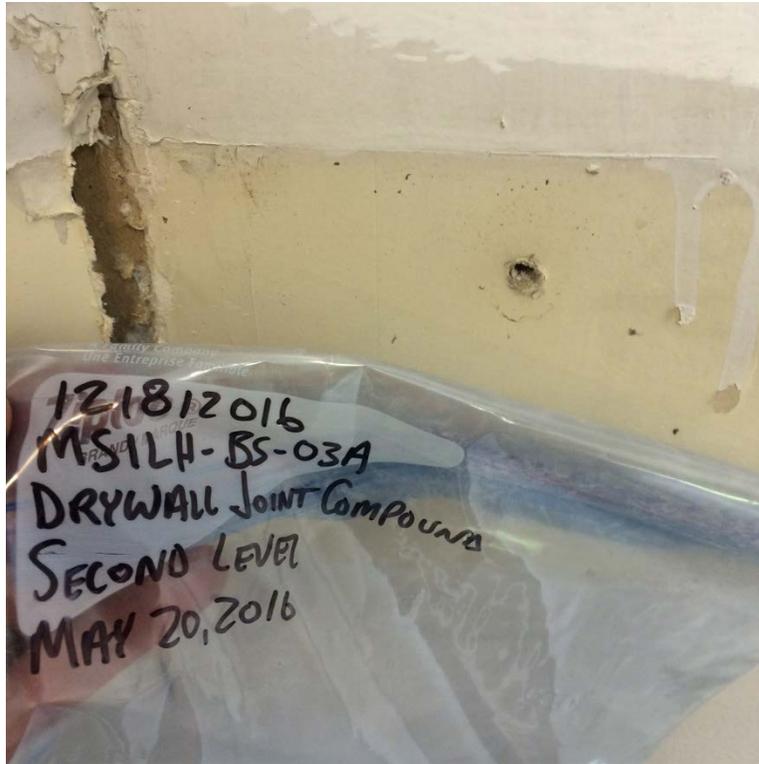
PHOTO 9: View of sample BS-03A (drywall joint compound) obtained from the second level. Asbestos was not detected in the sample.

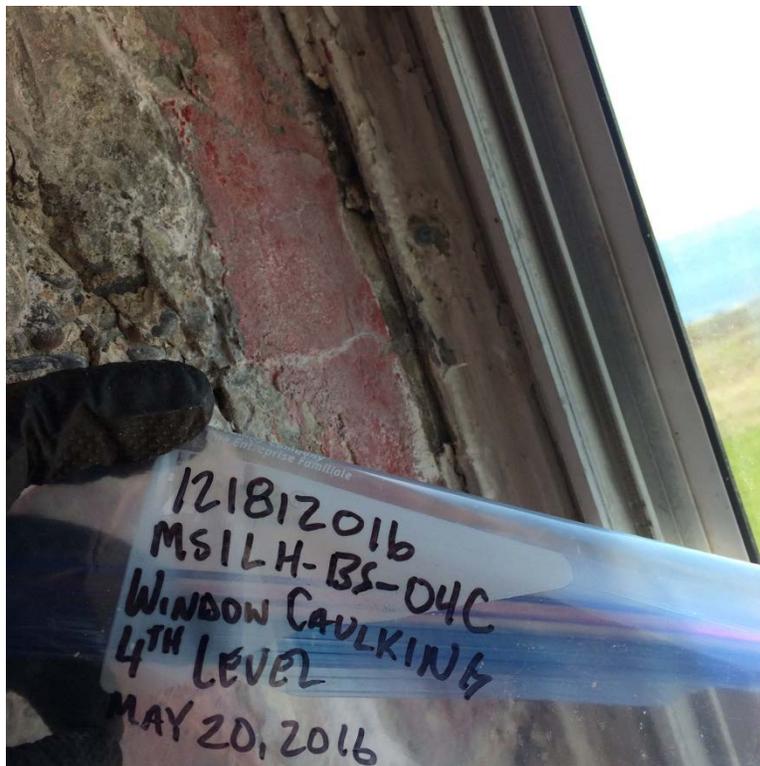
PHOTO 10: View of sample BS-04A (window caulking) obtained from the fourth level. Asbestos was not detected in the sample.

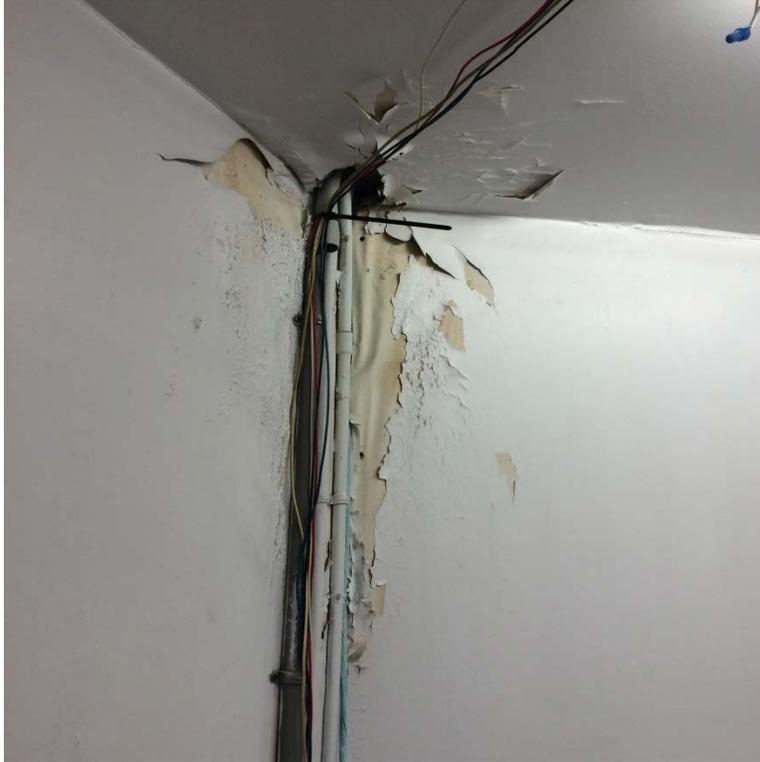
- red/red over brown colour paint chips - Interior railings, ladders, floor hatch, and door, and exterior railing and cupola, (sample PS-01); and
- white colour paint chips - Interior walls and ceilings, light level window frame, and exterior tower walls, (sample PS-02).

Based on laboratory analysis, the above paint chip samples were identified as lead leachate toxic (> 5 mg/L) and cannot be disposed of at a Regional Solid Waste Landfill.

PHOTO 11: View of white paint on interior drywall on Level 2. A sample of white paint chips from this area (PS-02) was found to be lead leachate toxic (i.e. lead leachate concentration was ≥ 5 mg/L).

Based on laboratory analysis, paint chip samples PS-01 (red/red over brown paint chips), and PS-02 (white paint chips), were identified to be lead leachate toxic (> 5 mg/L) and cannot be disposed of at a Regional Solid Waste Landfill. Loose and flaking lead-leachate toxic paint chips should be removed by a certified contractor and disposed of at an approved hazardous waste disposal facility capable of handling lead leachate toxic waste. Should any non-metallic substrate material covered with these two paints require disposal, a paint with substrate sample should be submitted for analysis, or the material should be assumed to be lead leachate toxic and disposed of accordingly. It is assumed that any metal, steel etc. covered with these paints requiring removal will be recycled.

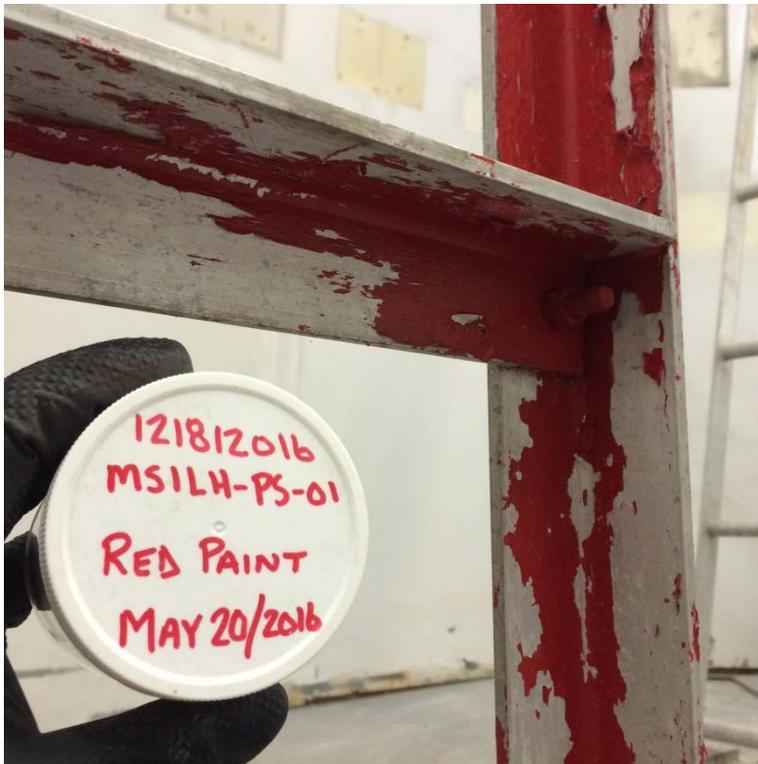
PHOTO 12: View of red paint on metal on Level 2. Samples of red paint chips collected from ladders on this level and other reds were combined into sample PS-01 which was found to be lead leachate toxic (i.e. lead leachate concentration was ≥ 5 mg/L).

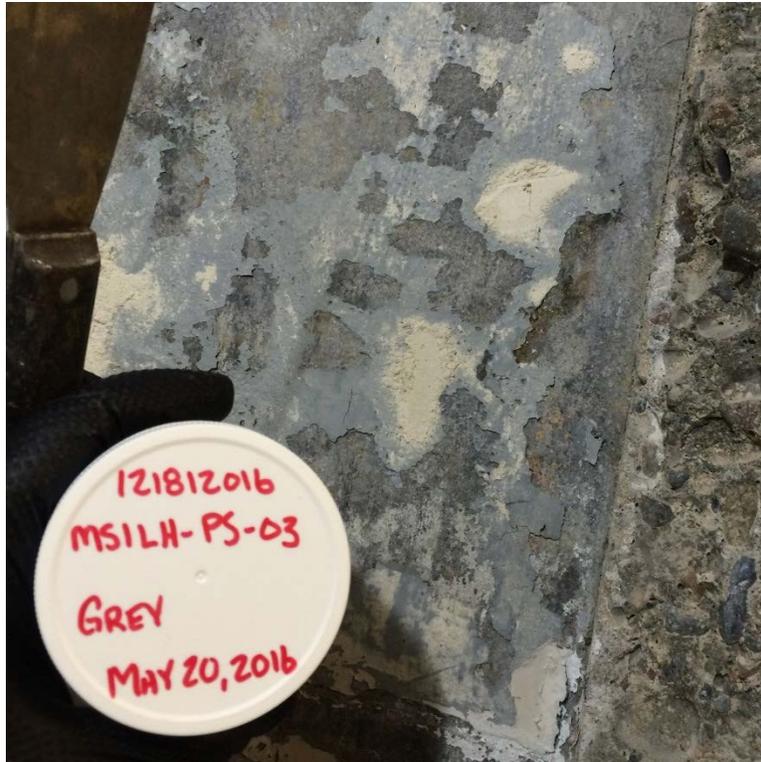
- PS-03 (1.0 mg/L): Grey paint on interior floors.

Analysis of the sample confirmed grey paint is suitable for disposal at an approved solid waste landfill facility pending final authorization from the facility operator.

PHOTO 13: View of grey floor paint from Level 3. A sample of grey paint chips collected from this area (PS-03) was found not to be lead leachate toxic (i.e. lead leachate concentration was <5 mg/L).

Paint sample PS-03 (grey paint chips) was found to have a lead concentration > 1,000 mg/kg (i.e., lead-containing) but found not to have a lead leachate concentration above the NBDELG guideline of 5 mg/L. Grey paint and its substrate can be disposed of at a Regional Solid Waste Landfill provided permission is obtained from the facility.

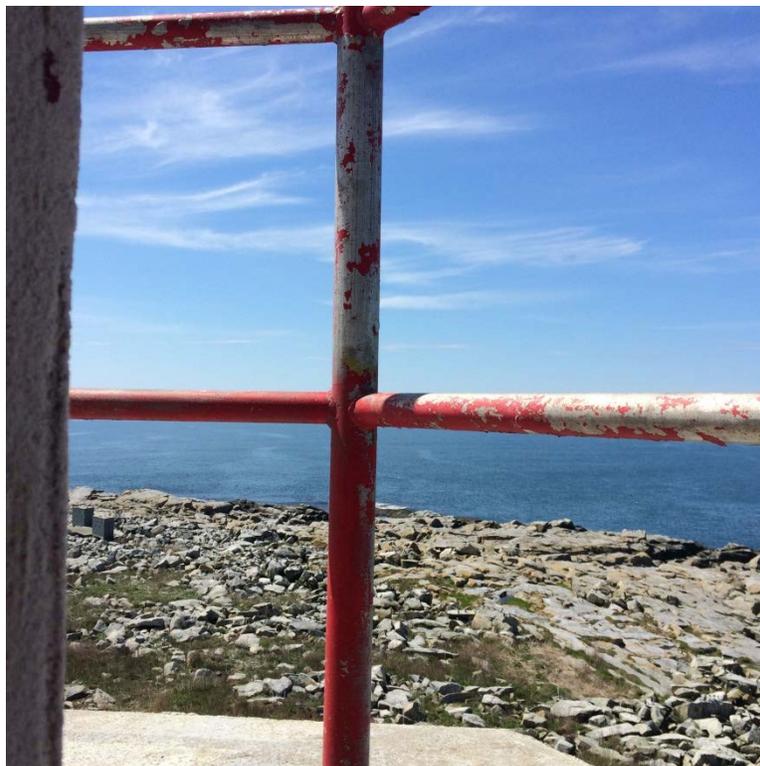
PHOTO 14: Exterior view of railing around cupola. The red paint is generally in poor condition.

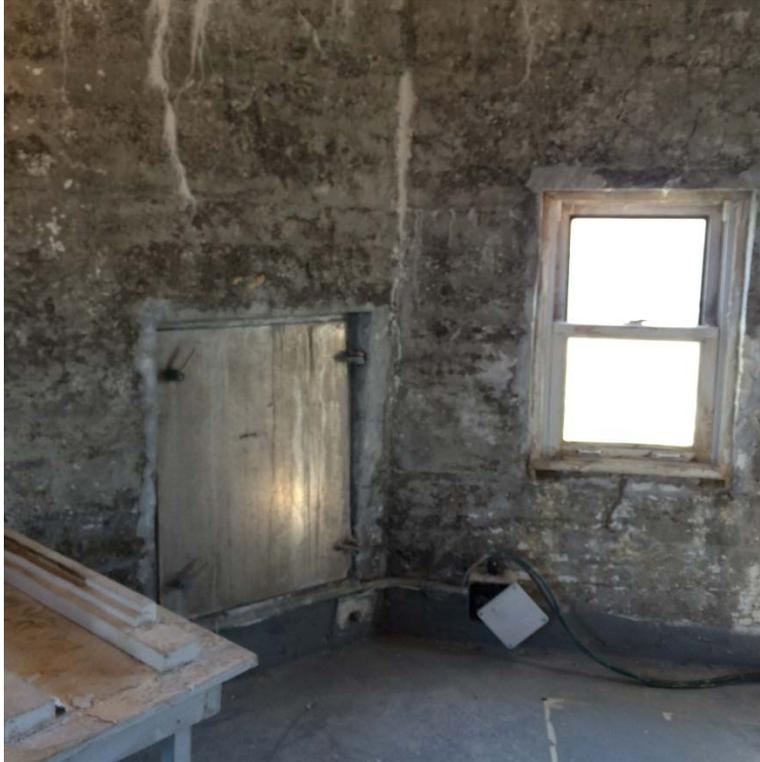
PHOTO 15: Interior view of Level 3. White paint on concrete walls is in poor condition.

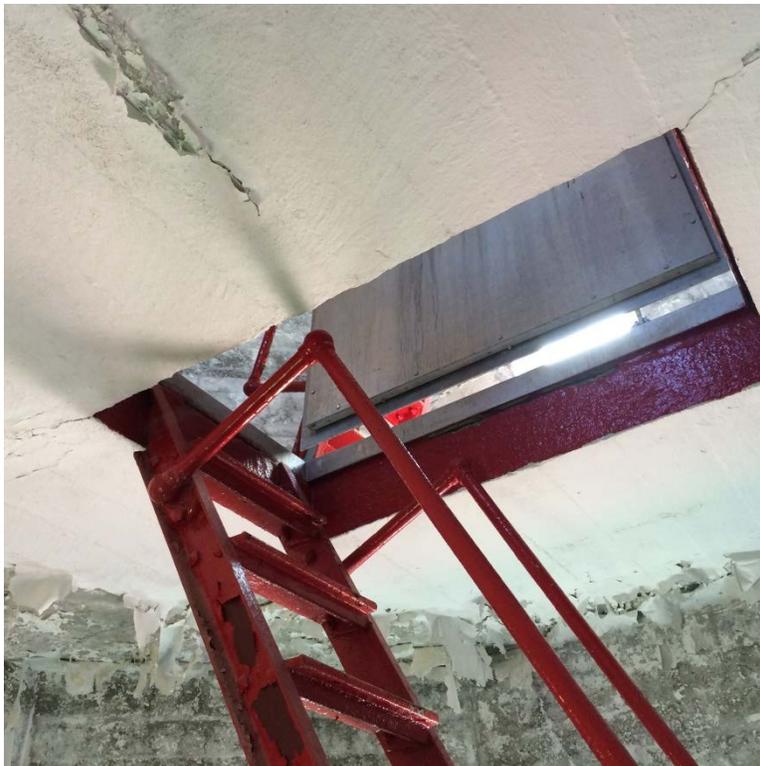
PHOTO 16: Interior view of Level 3. White ceiling paint and wall paint, both on concrete, is in poor condition.

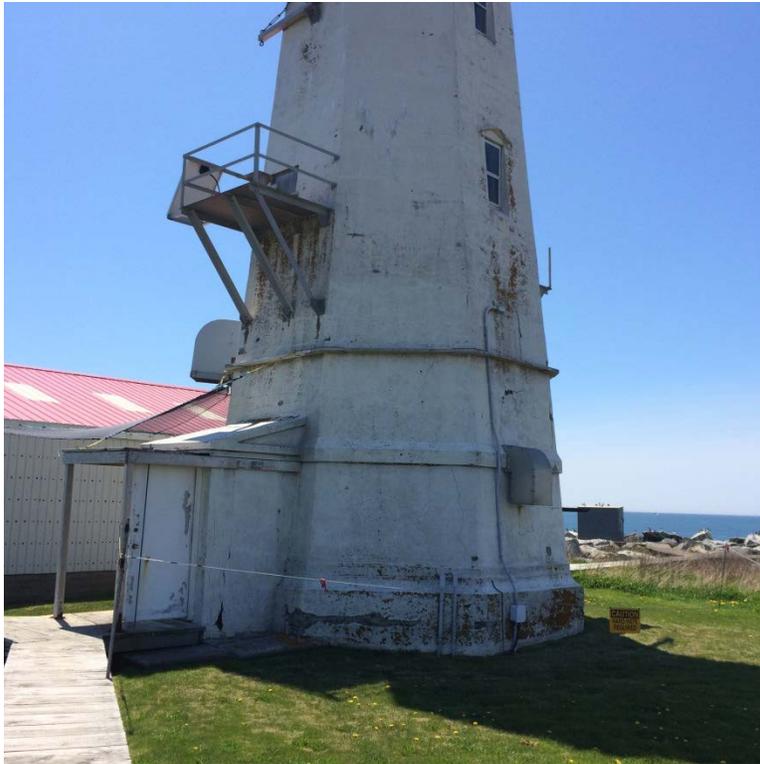
Two exterior platforms located on the light tower were inaccessible at the time of the site visit (see photos 17 and 18, Attachment B). As such, sampling was not conducted in these areas.

PHOTO 17: View of exterior inaccessible platform located over the entrance to the light tower.

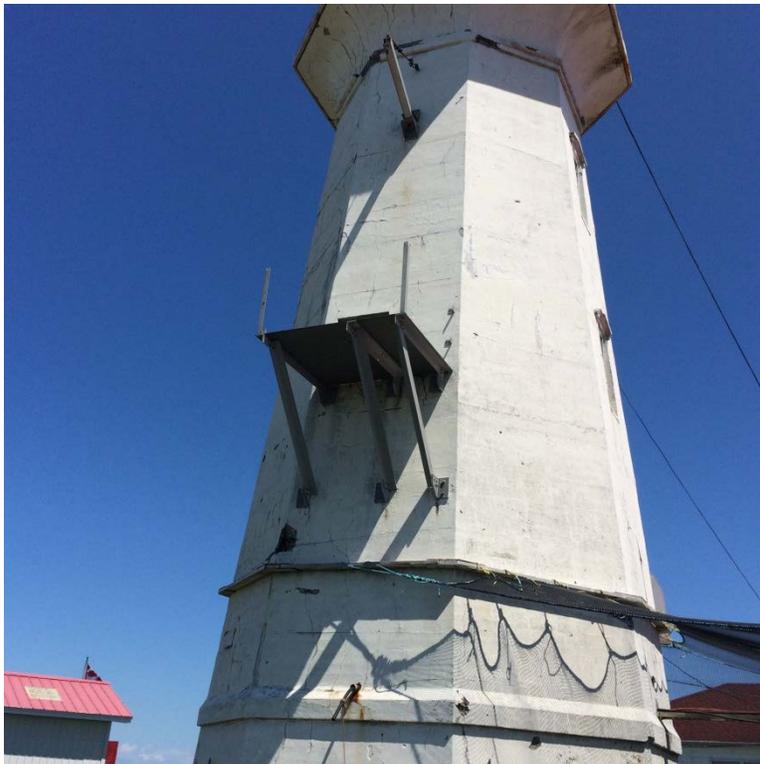
PHOTO 18: View of second exterior inaccessible platform located at the rear of the light tower.
