## **SOW – MARINE RAILWAY REPAIRS**

### **CCG BASE KENORA**

### **KENORA, ON**

**Marine Railway  
Underwater Inspection**

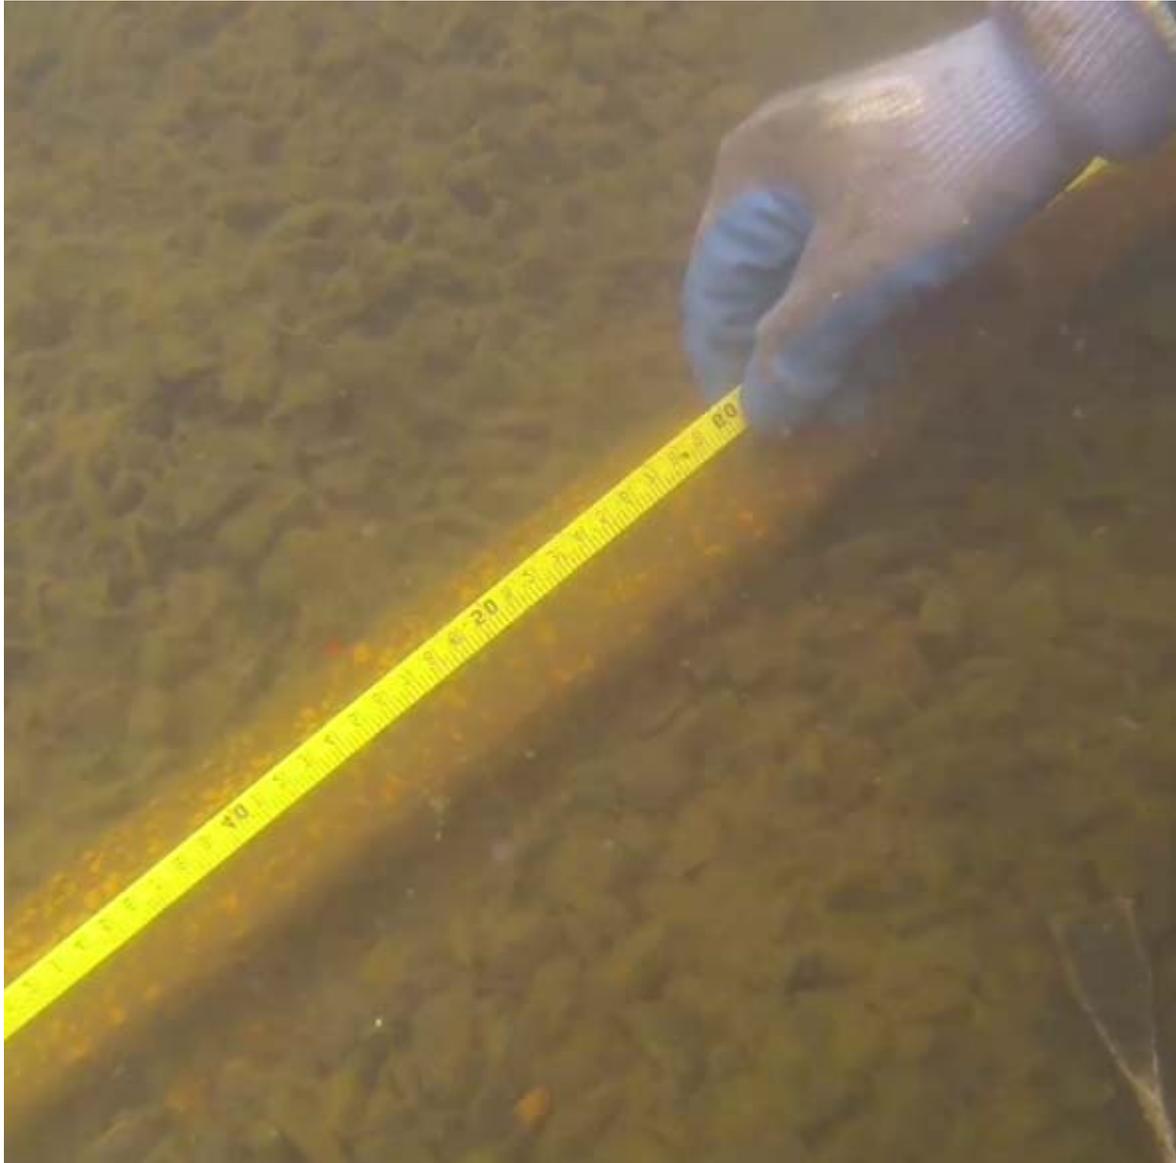
Existing ballast, near shore

Ballast to be removed to sleeper elevation

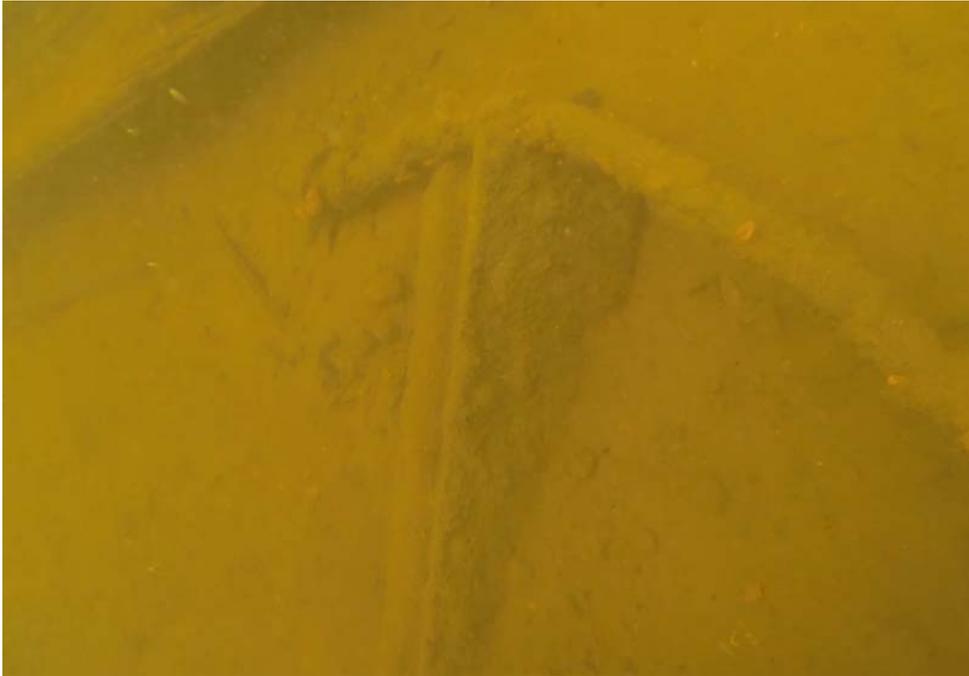
Damaged connecting rod

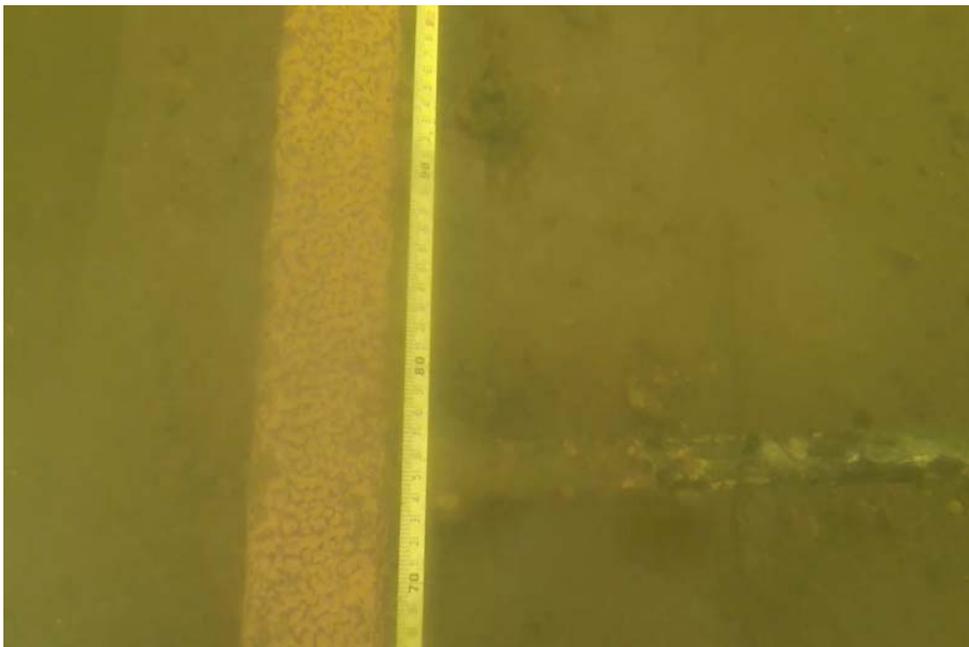
Existing connecting rod

Note longitudinal orientation of existing timber sleeper

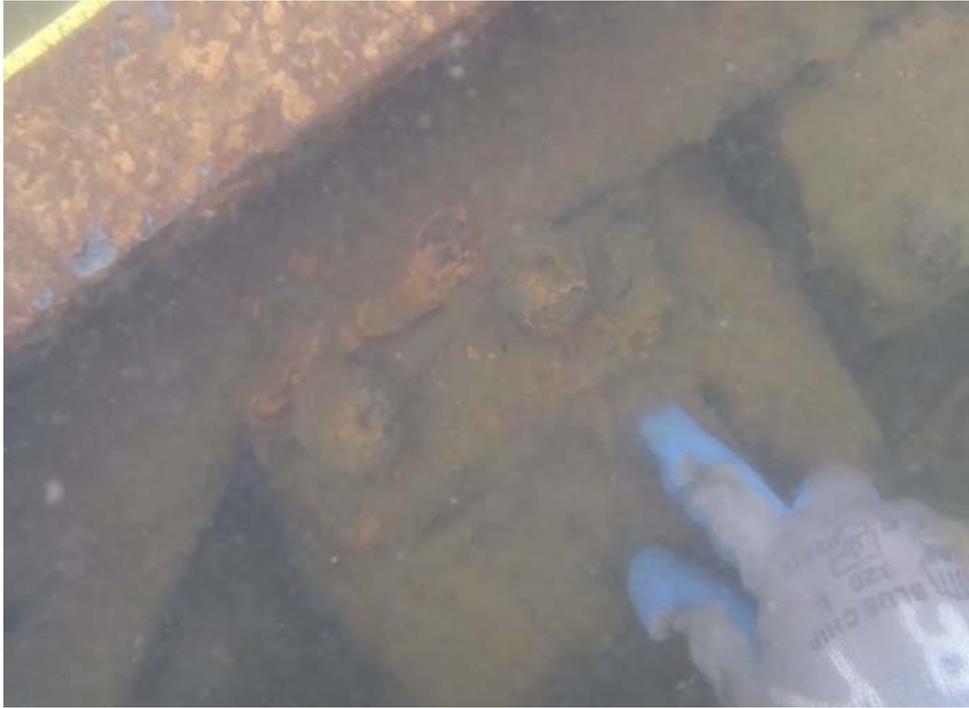
Existing Tie plates, typical, sleeper dimension/orientation varies

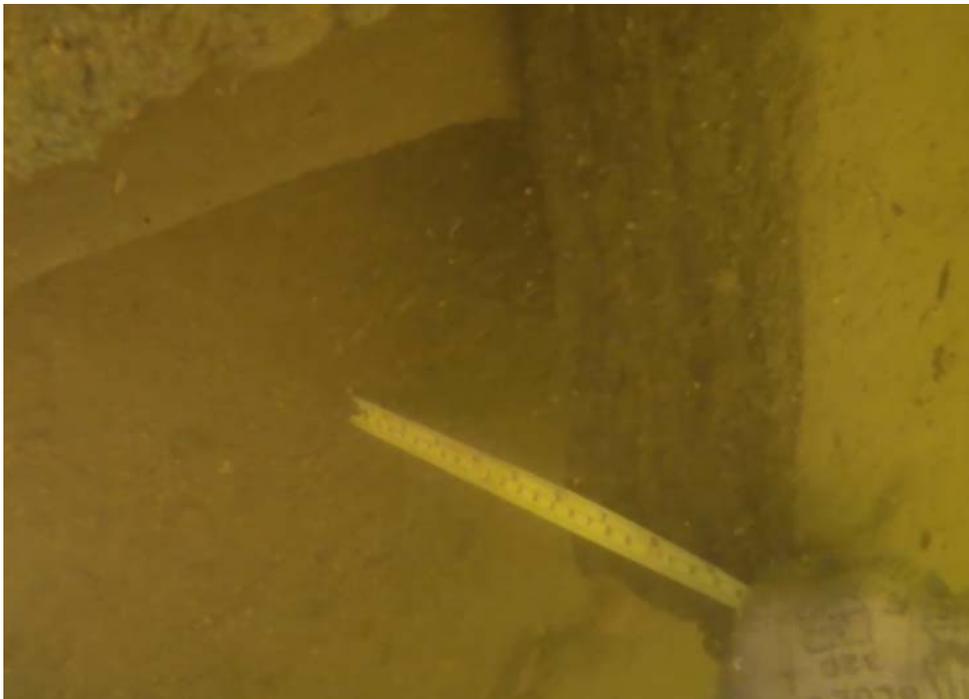
Unsupported sleeper, toward rail termination

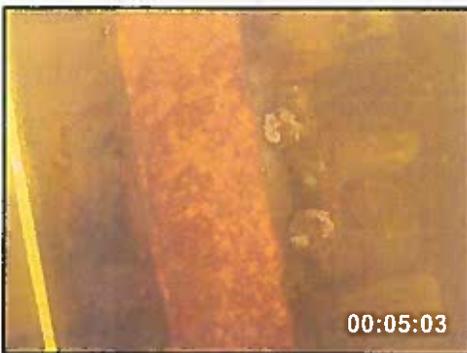
5.55m / (00:04:02 / 00:05:03)

Splintered and rotten wooden sleeper end. Spikes elevated off tie plate, 25mm gap between the bottom of the east rail to the top of the wooden sleeper.

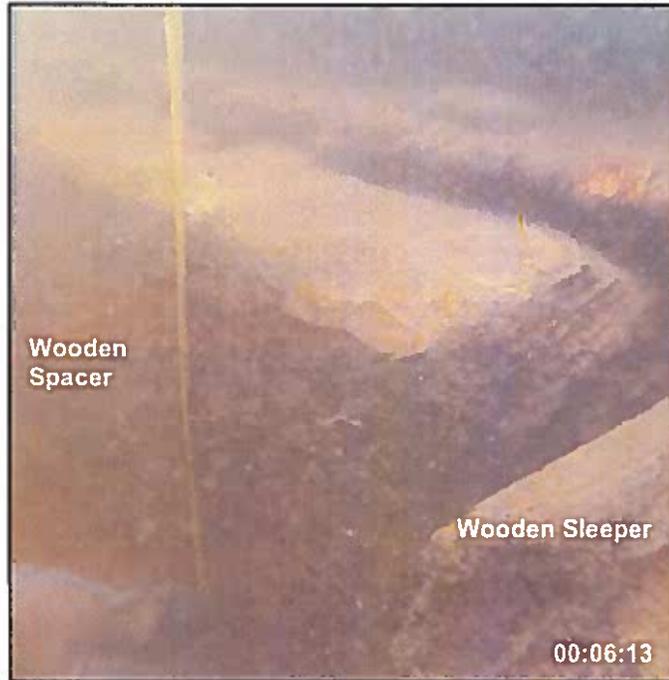
5.95m / (00:06:13)  
Typical wooden spacer 9"x12"  
Appears to be in good condition

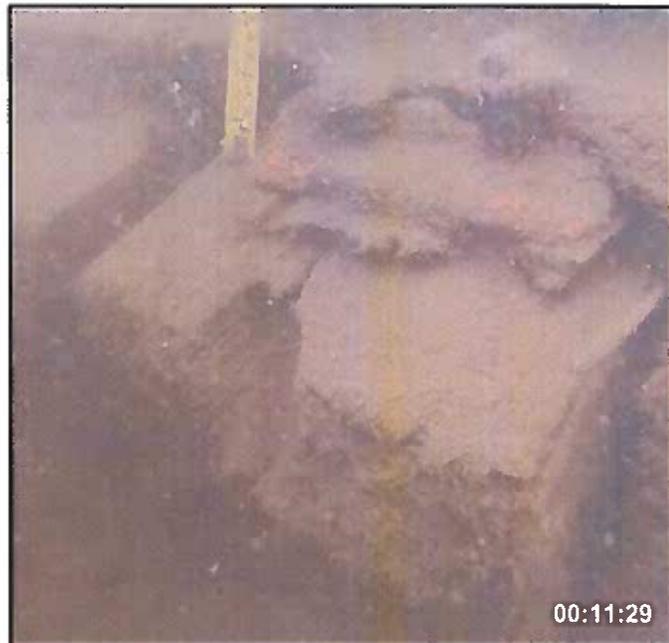
7.20m / (00:11:29)  
Tie plate and spikes elevated, 50mm gap between the bottom of the east rail to the top of the wooden sleeper

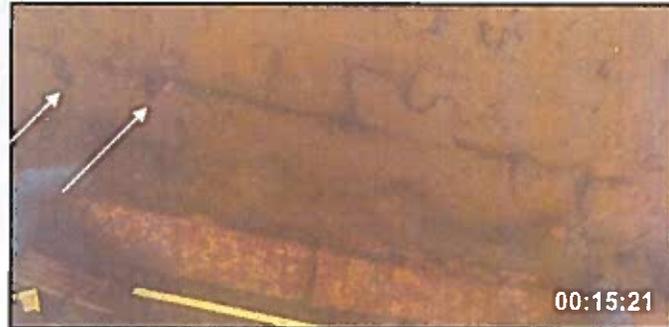
10.12m / (00:15:21)

Joint with connection plate, missing both spikes northeast side of joint. The furthest southeast spike is slightly elevated. Timber running under the rail protrudes from cover. No deflection between rail sections at the joint

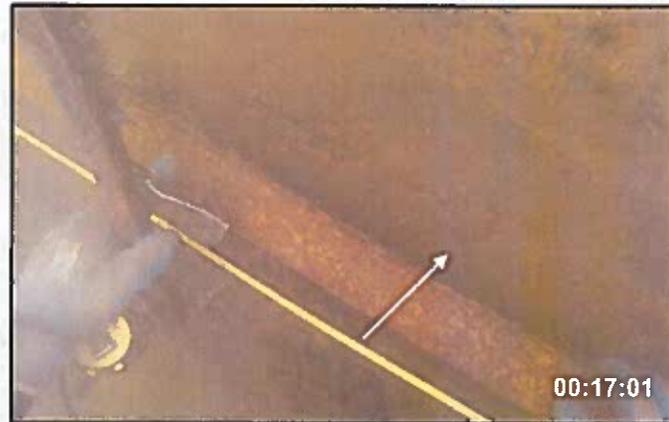
11.10m / (00:17:01)

Single spike securing the bottom flange of the rail.

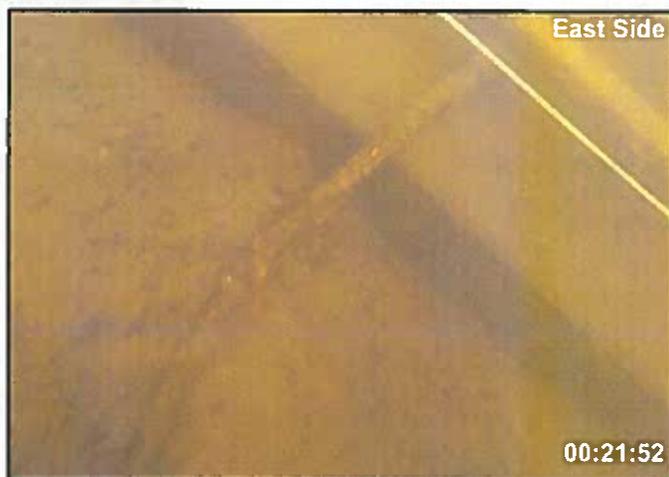
14.40m / (00:21:35 / 00:21:52)

Connecting rod damaged and pulled out of west rail

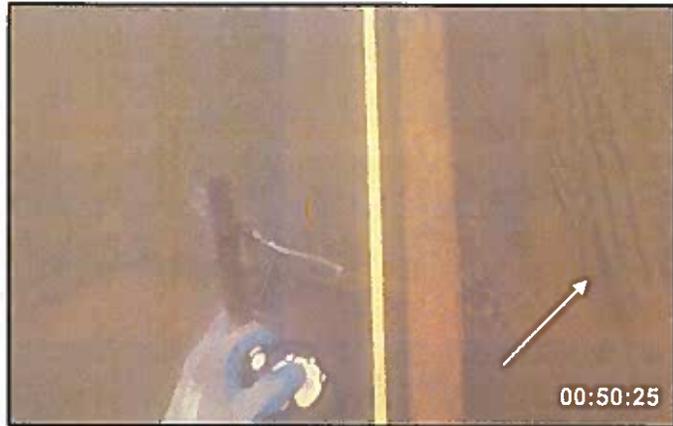
**14.40m / (00:50:25)**  
East side of timber, splintered

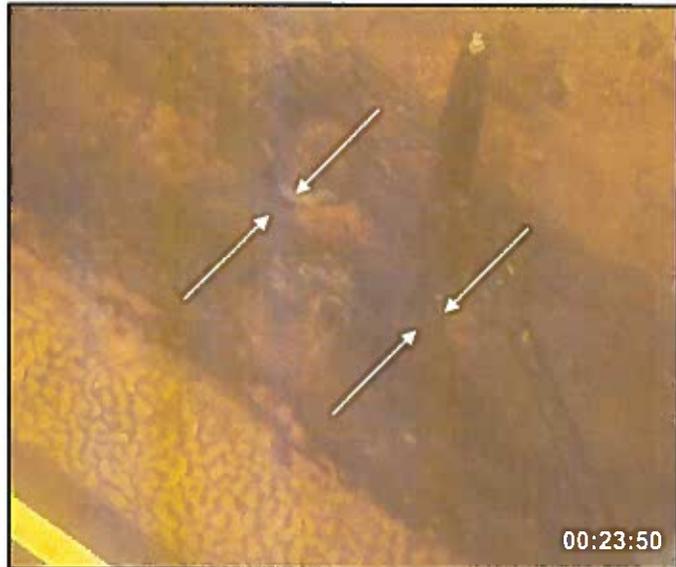
**15.27m / (00:23:50)**  
Connection plate secure to both rail sections, no deflection. There is a gap between the two northeast spikes and the connection plate as seen in the image

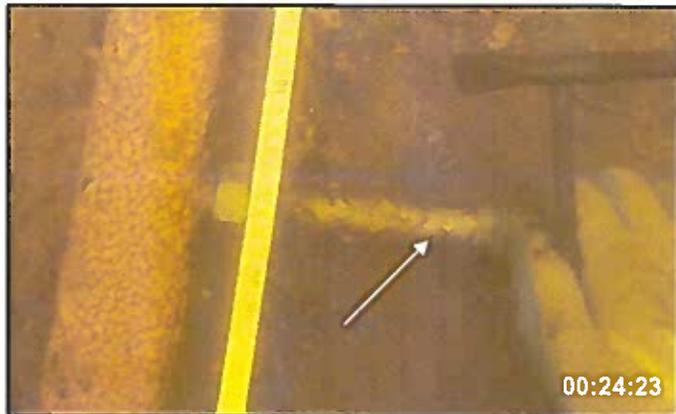
**18.06m / (00:24:23)**  
Connecting rod secure, minor corrosion

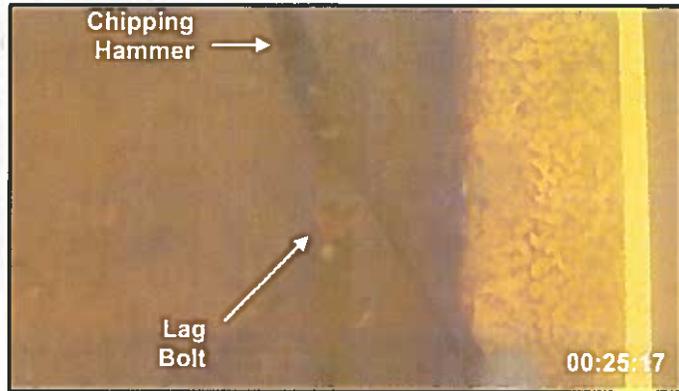
**20.20m / (00:25:17)**

Lag bolt with washer connecting the rail's bottom flange to the timber. Lag bolt and washer elevated, rail is not secure.

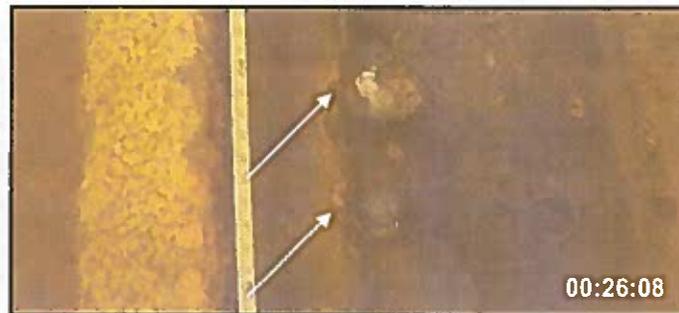
**21.20m / (00:26:08)**

Spike and lag bolt elevated, rail is not secure. Invert of 25mm between bottom of rail and top of timber

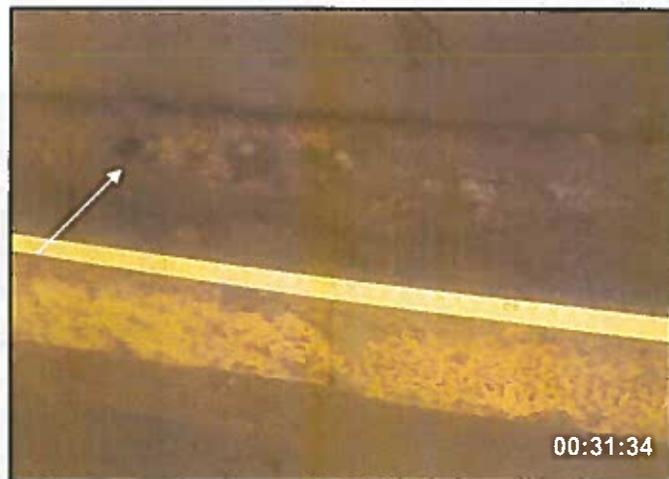
**25.50m / (00:31:34)**

Connection plate secure to both rail sections, no deflection. Spikes missing along the west side of the track

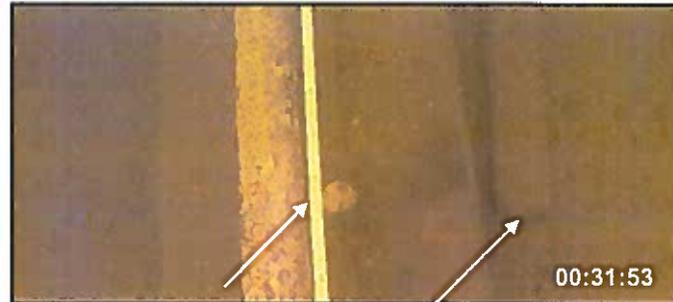
**26.70m / (00:31:53)**  
Spike elevated by 100mm, above the timber, securing the east rail. Diagonal rail support begins.

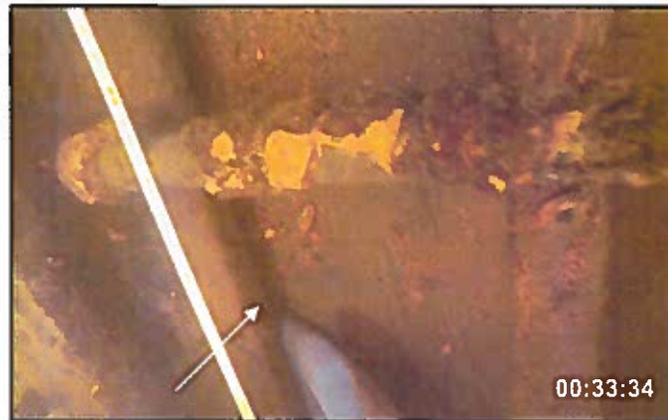
**28.77m / (00:33:34)** – Connecting Rod and 25mm gap between bottom of rail and top of timber.

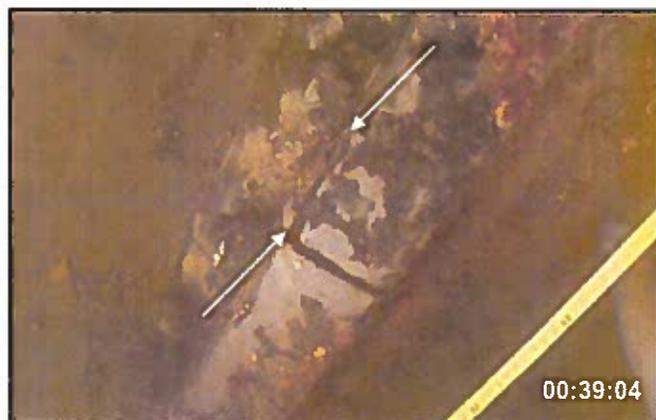
**33.36 / (00:39:04)**  
Connection plate and fastener secure to both rail sections, South rail slightly proud with a 60mm longitudinal crack.

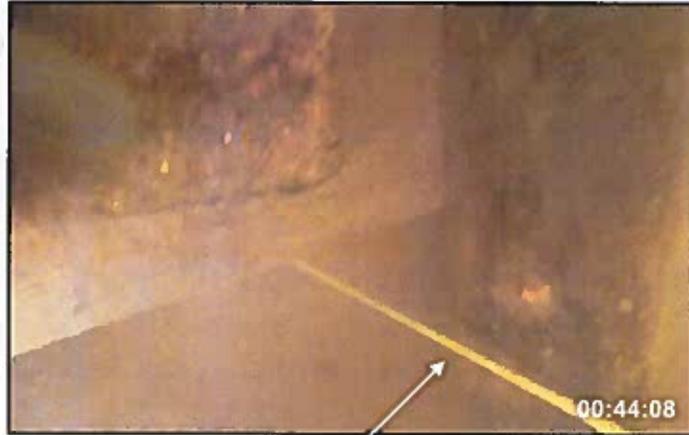
35.96 / (00:44:08)  
150mm gap between lake bottom and  
bottom of timber sleeper.

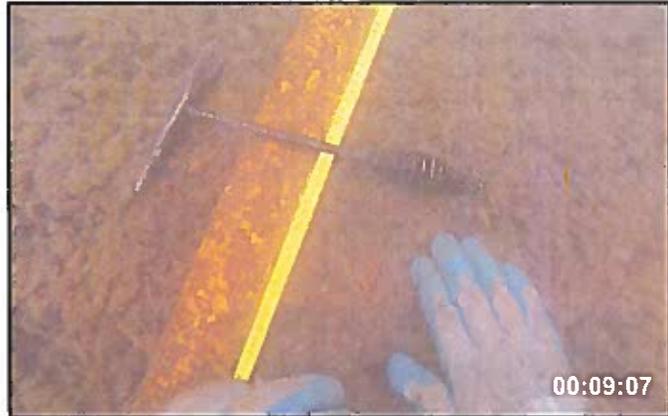
**6.60m / (00:09:07)**

Ballast proud of top of rail

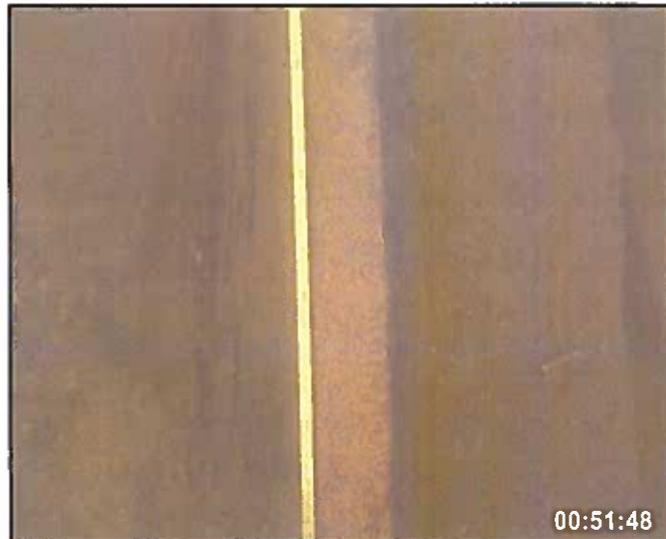
**14.00m / (00:51:48 / 00:52:05)**

Base timber splintered from 14.00m - 15.30m. The connecting rod at 14.40m is disconnected, buried rail in the sediment nearby (file 00h21m35s.png). It appears the original rail was dislodged causing damage to the timber, rail is not centered on timber

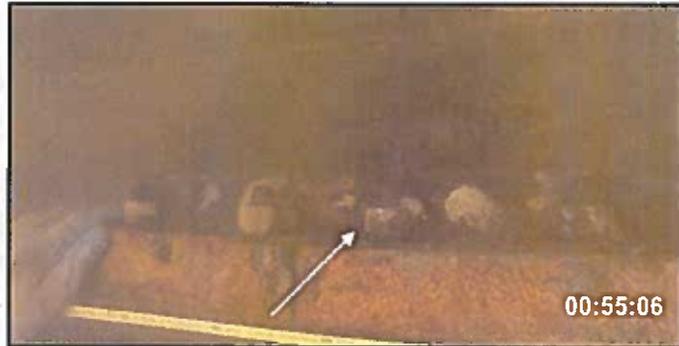
15.60m / (00:55:06)

Connection plate secure to both rail sections, no deflection. One fastener is loose

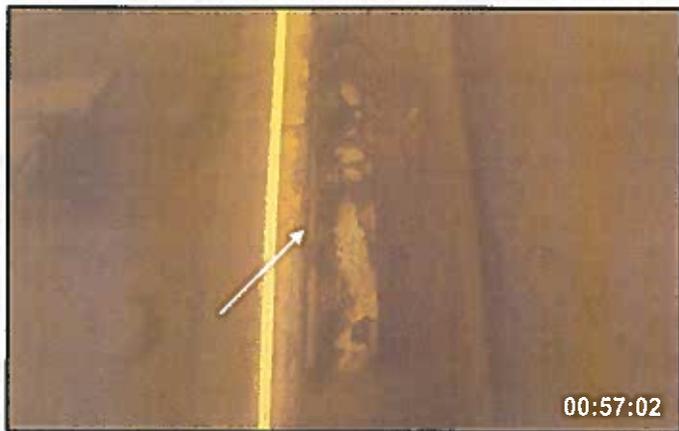
24.60m / (00:57:02)

Connection plate secure to both rails, only one spike located on the southwest corner.

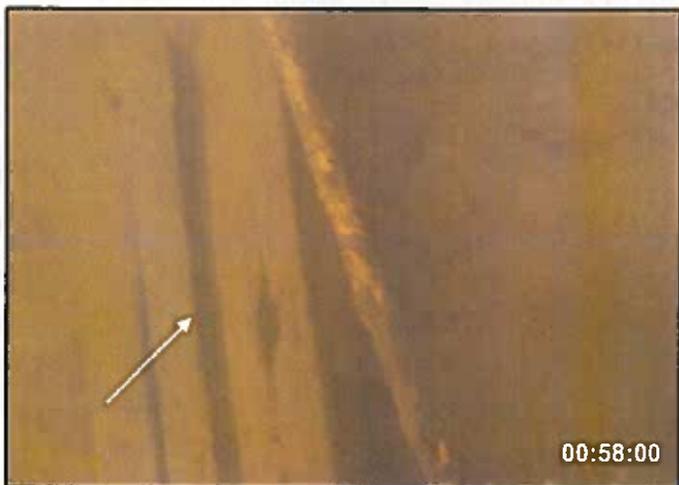
25.07m / (00:58:00) – Disconnected timber situated under connecting rod in middle of rail

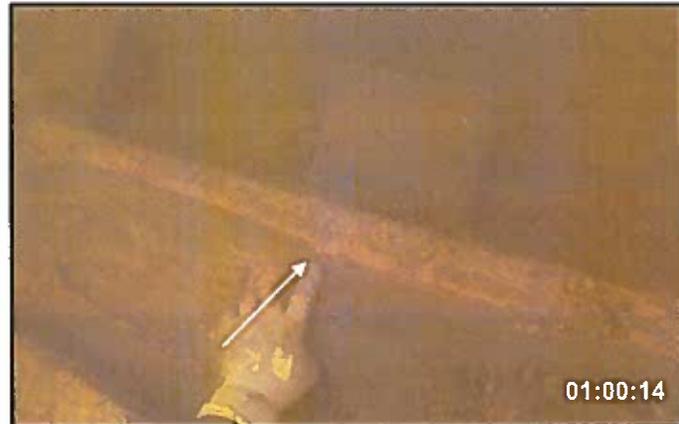
**28.16m / (01:00:14)**  
C-channel securing two timber sections  
(file 01h00m14s.png)

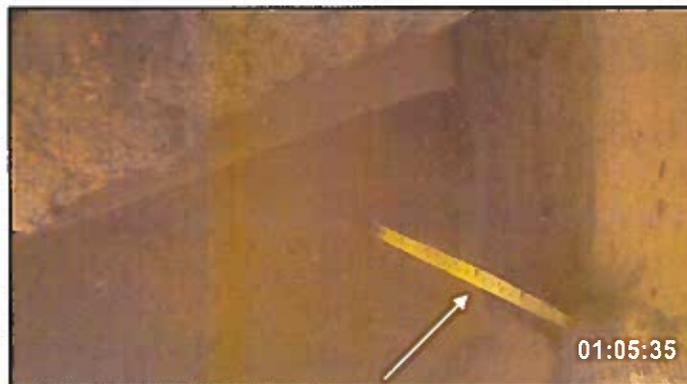
**End of Rail Sleeper/ (01:05:35)**  
150mm gap between lake bottom and  
bottom of timber sleeper, west side of  
rail (file 01h05m35s.png)

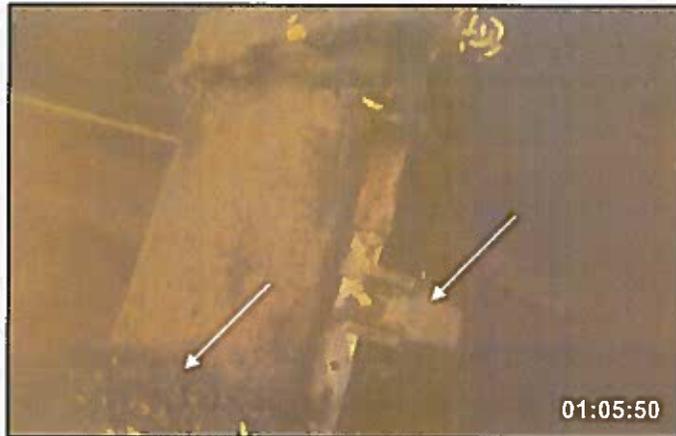
**Top of End Stop / (01:05:50)**  
Secured with end stop bracket and chain wrapped around timber sleeper

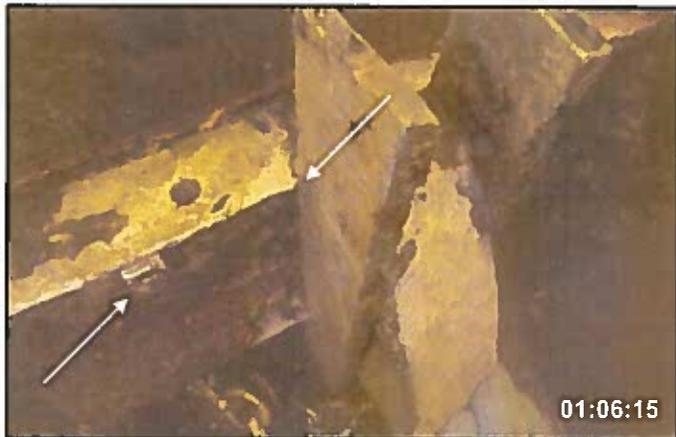
**End Stop Bracket / (01:06:15)**  
C-Channel welded to end stop bracket and fastened to timber

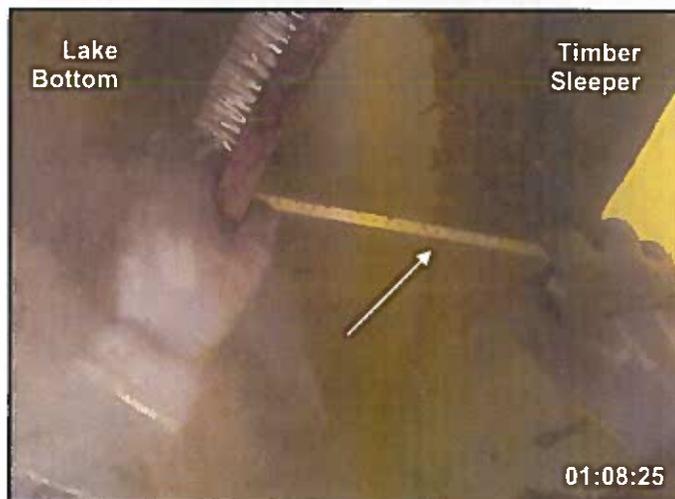
**End of Rail Sleeper / (01:08:25)**  
180mm gap between lake bottom and the bottom of timber sleeper, along the centre line of the rail (file 01h08m25s.png)

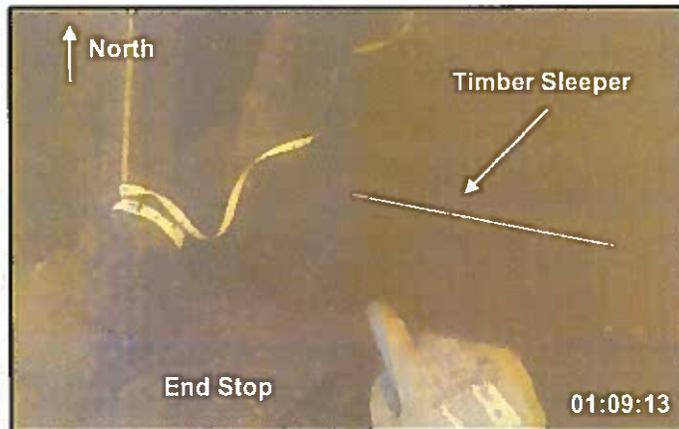
**End of Rail / (01:09:13)**

End stop is not square to rails, west end appears to be further south from east end
